# RESIDENTIAL BUILDING SURVEY

Apartment

West Kensington, London. W14

Mr X

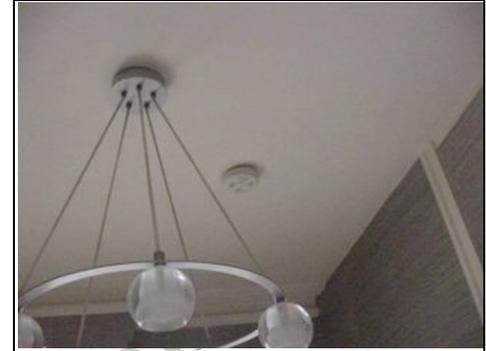
Battery operated single smoke detector

We would recommend that an integral fire alarm system is added to the whole property.

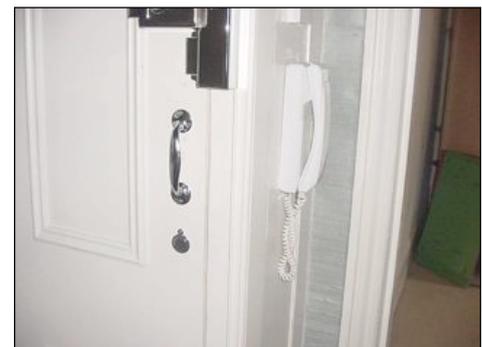
Telephone entry

At present you have a voice only door entrance system, we would recommend that you have it changed to a video entry system which is particularly important when you are on the first floor as this means that you get to see the person as well as hear them

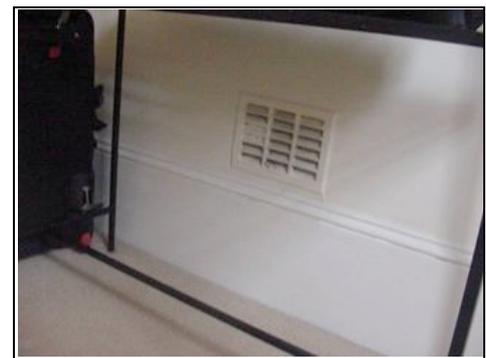
We noted that some of the chimneys (there would have been one in each room remember that in years gone by the only heating would have been via a chimney) appear to have had the vents blocked.

Vent to chimney rear left hand side

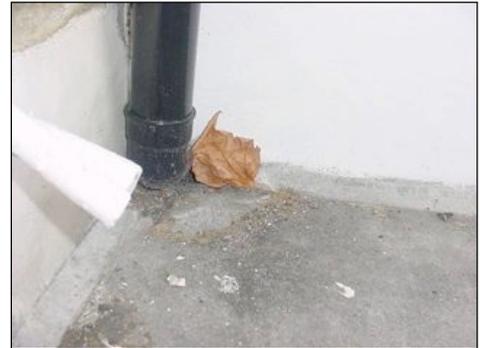
There is a shared entrance area with the associated roof this roof is adjacent to your family shower room and we noted that it had a new roof on it which is asphalt, ideally this should have a reflective paint added to it, we also noted a small drainage outlet, in our experience these typically get blocked. Additionally during our question and answer session we spoke to the present owners about this and were advised that they had literally seen it full of water and they do keep an eye on it and regularly clear the roof.

Small outlet (hidden behind the leaf)

**ACTION REQUIRED:** You will need regular maintenance to stop the small drainage outlet from getting blocked by clearing it of leaves etc. The only way we know of resolving this matter long term is to make the outlet much larger.

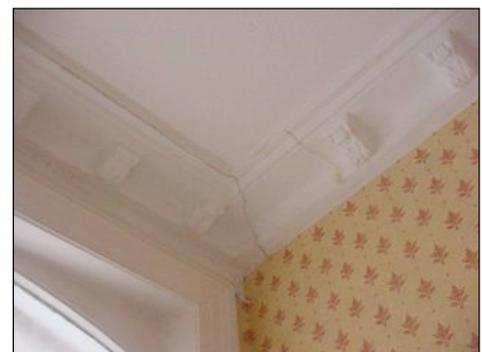
You may have seen some cracking as you enter the property to the ceiling, you will also see some cracking to the bricks outside. We believe that this is a direct result of water getting into the structure over the years from the roof problem that

Hairline cracking in entrance hall

we have just mentioned so you can see how important it is to ensure that the flat roof over the entrance is maintained to ensure that the water does not build up on it. kept free of water.

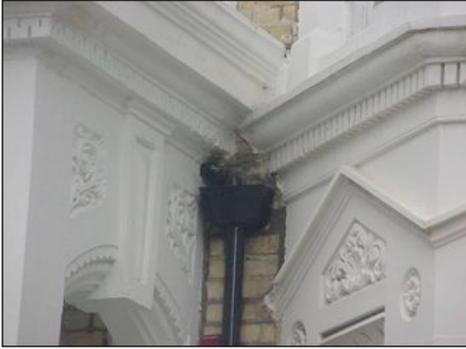
Awkward configuration of rainwater goods to the entrance porch may lead to dampness getting into the property

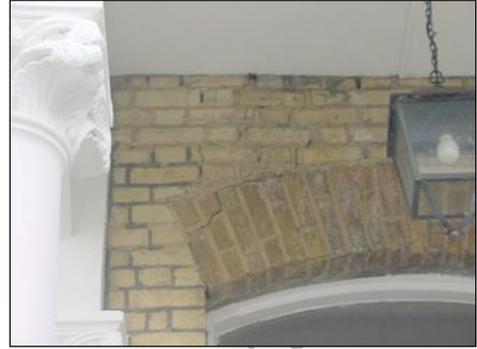
Cracking to left hand side brick arch at the front of the property

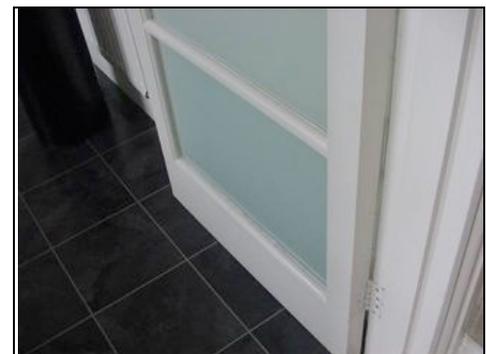
We noted a door with glazing showing no British Standards kite mark we suggest that you replace with safety glass. In a worst case scenario is someone walks into it it can be dangerous.

Door without safety glass

**ACTION REQUIRED:** Replace glass with safety glass.

**ANTICIPATED COST:** Around £250 may be cheaper to have the door replaced; quotations required.

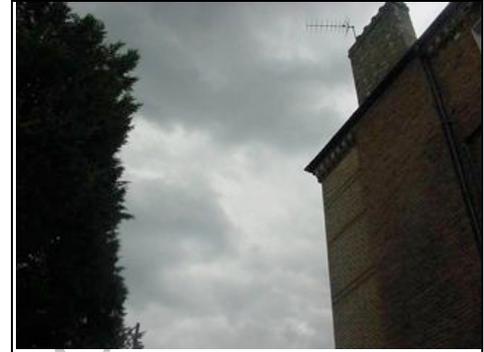
There are trees nearby to the right hand side these can cause damage to the structure, you need to make sure that they are regularly maintained, they look to have been loped in this year at some point but you do need to keep an eye continually to ensure that they are maintained.

**ACTION REQUIRED:** You need to establish who owns the trees and who should ensure to maintain them!

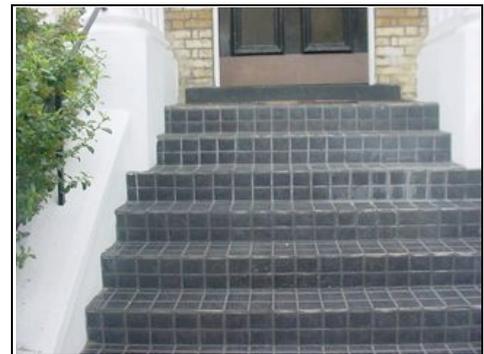
Entrance stairs

Typically we find that these leak water into the apartment adjacent to it and there may be some future costs in relation to this.

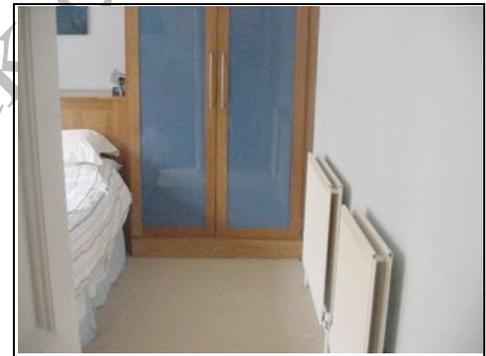
We noted dated internal radiators, for example to the bedrooms. We were not able to see that many of the radiators as they were covered.

Radiators not next to a window

**ACTION REQUIRED:** We therefore would recommend that when you carry out your refurbishment that you put radiators underneath the windows (this is the best place for them as it allows air circulation without this it increases the likelihood of condensation/black mould in the corners of the rooms).

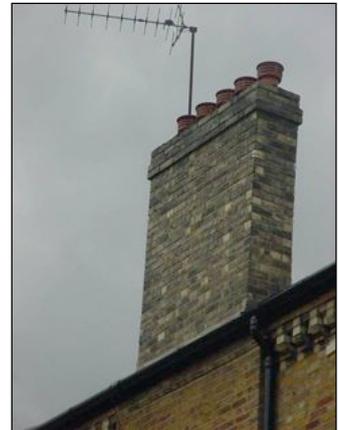
Chimney One

This chimney is difficult to view but from what we could see of it, it was a substantial brick chimney with five chimney pots. We could just see parts of the lead flashing which looked in average condition.

**ACTION REQUIRED:** With such large chimneys we believe there should be an annual check, access can be gained from the top floor flat we believe.

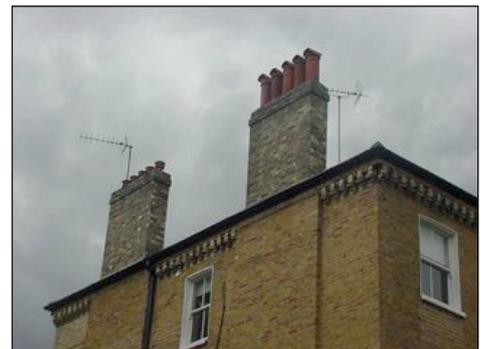
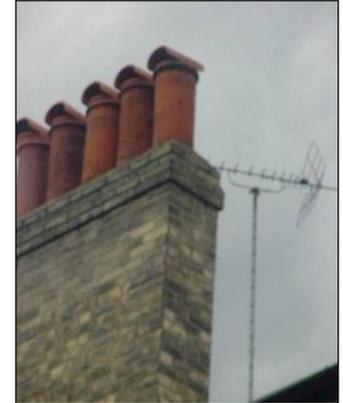
Chimney Two

Again we had difficulty viewing this chimney from ground level, it was a substantial brick built chimney with five large chimney pots sitting fairly straight therefore we would assume they are in reasonable condition from this.

**ACTION REQUIRED:** As previously described access required to check condition.

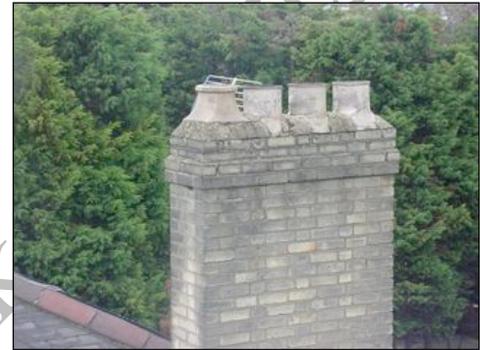
Chimney Three

We had the benefit of being able to view these from the adjoining property. We again were able to see it was a substantial brick built chimney with four chimney pots and lead flashing. We were unable to see the flaunchings on the very top. We can see from that the chimney pots have been re-bedded which is typical on such large chimneys.

**ACTION REQUIRED:** Again we believe they should be inspected every year.

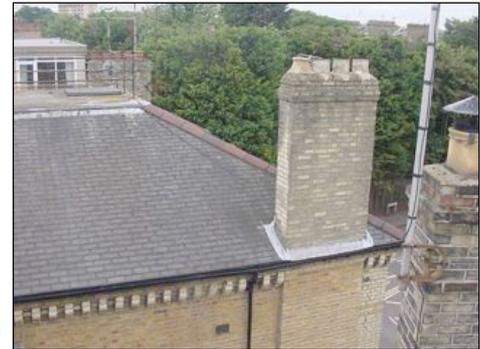
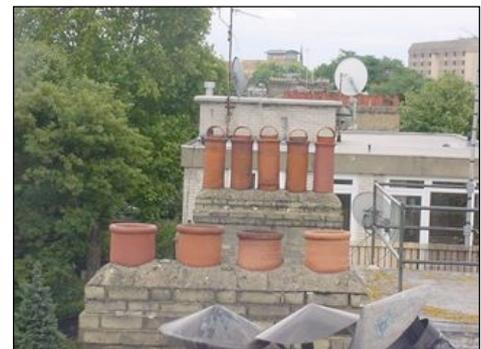
### Chimney Four – rear left hand side

We had the benefit of being able to view these from the adjoining property. We again were able to see it was a substantial brick built chimney with four chimney pots and lead flashings. We noticed some hairline cracking to the flaunchings but were unable to get a good view of it due to the chimney of the adjoining property being in the way (remember we were viewing these from next doors roof).

In the foreground you can see the chimney pots of Chimney Four rear left hand

**ACTION REQUIRED:** As previously described a yearly inspection is recommended.

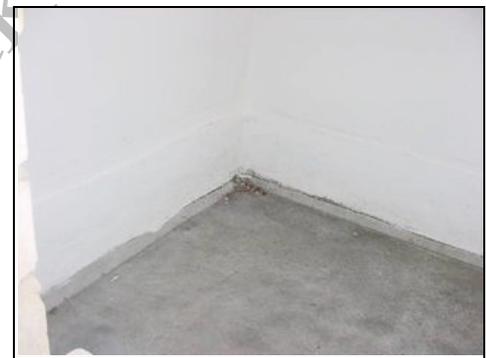
Flat roof entrance area

This has been recently covered in asphalt (we know this from our question and answer session with the present owner) and looked in reasonable condition. We believe this roof is a few years into its 25 year plus life, the main concern we have for this roof is the outlet, please see our comments in the Executive Summary.

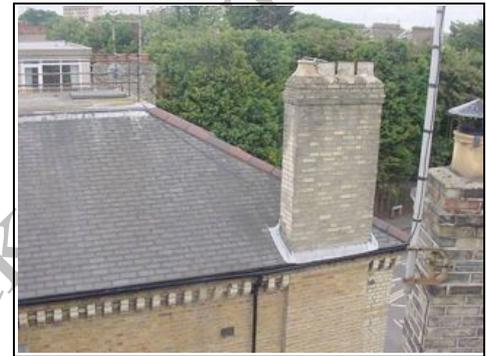
Gutters and downpipe

Generally they appear in average condition, we spoke to the occupier during the question and answer session about these and were advised that some of these had been recently replaced.

**ACTION REQUIRED:** We would always recommend that the gutters and downpipes are cleaned out, the joints are checked and the alignment checked to ensure that the gutters fall towards the downpipes. In this case you should have an annual maintenance contract particularly as you have trees nearby.

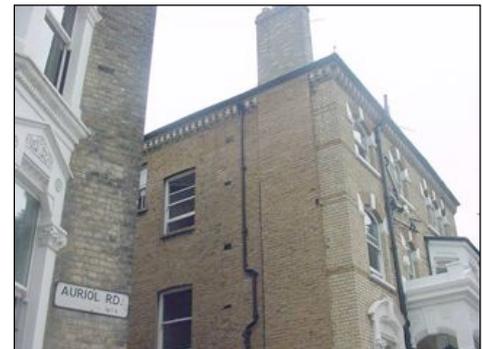
There is a kink in the downpipe and assume it is to reduce the speed the water.

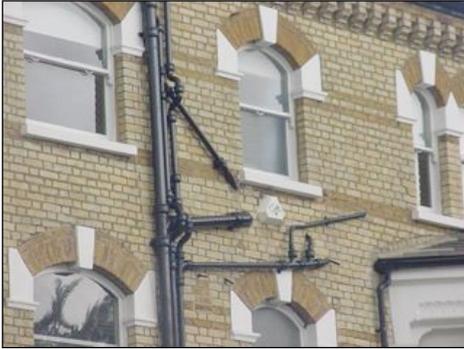
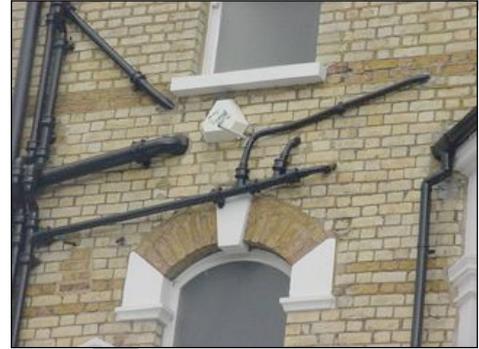
Soil and vent pipes

Soil and Vent pipes look to be predominately cast iron with this age of property cast iron will be in need of regular maintenance. We also noted what we believe to be some lead pipes, please see the photos, as far as we are aware there is no danger with lead pipes being used as waste pipes only as service pipes.

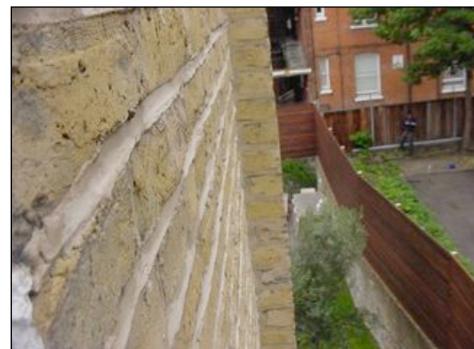
We believe in some areas the property has been proud pointed which is not ideal for example around the soft red brick arches which in our opinion will cause deterioration in the not too distant future.

Proud pointing above and repointing below

**ACTION REQUIRED:** During our question and answer session the owners advised that it had been recently repointed and we would comment that it looks to have been repointed in a strongish cement mortar. Unfortunately this is the wrong sort of mortar it would have been more appropriate to have

repointed in lime mortar and in years to come this will mean that you will need to carry out repointing.

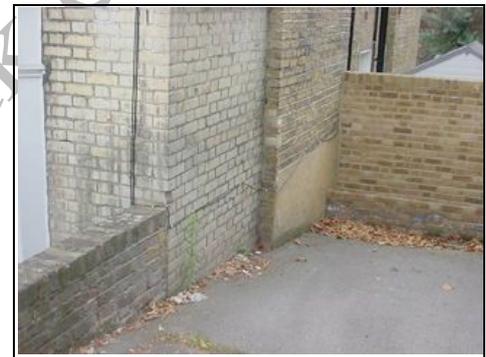
There is a small area of render to the right hand side of the property and bring it to your attention as we think there is likely to be some dampness in the area from the general fall of the driveway, which in a shared agreement you may have responsibility for.

Brickwork with render

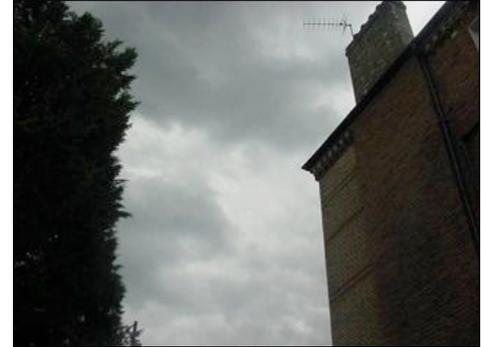
Next doors trees are very close to the building and need maintenance, we recommend you speak to next door about the trees to ensure they are happy to maintain them

Tree higher than building

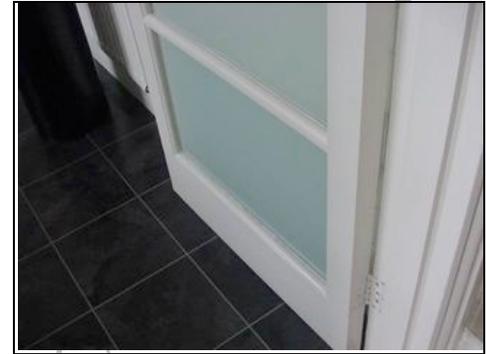
The property has a glazed panel doors internally. From a safety point of view and current Building Regulations (who monitor minimum standards on new properties) requires that a toughened glass be used to prevent any problems. In this instance we could not see a kite mark.

**ACTION REQUIRED:** Please see our comments in the Executive Summary Glass door without safety glass

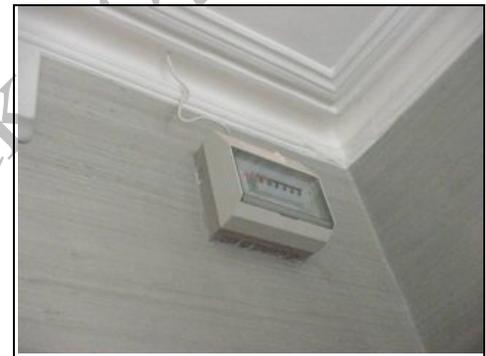
Fuse board

The electric fuses and consumer units were located in the hallway just outside the shower room. We would date the fuse board as being from the 1980s and, whilst not the best now available, it is reasonable.
