RESIDENTIAL BUILDING SURVEY

XXXXX

Ealing

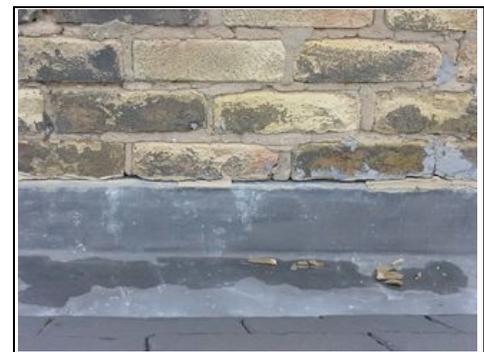
Joint failing to middle chimney

Close up of joint

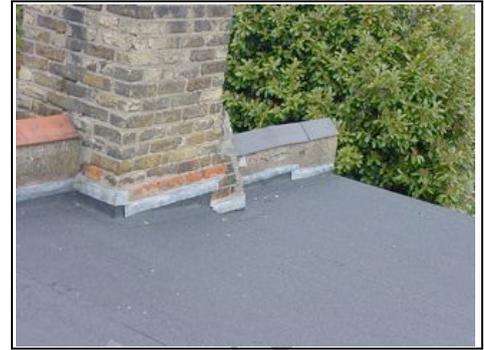
We were pleased to see that the rear roof had a modern mineral felt. It is likely to be a third of the way through its natural life and as flat roofs are problematic we would recommend that you reinstate the roof light which is currently felted over.

Flat roof, next door looks to have had problems with it

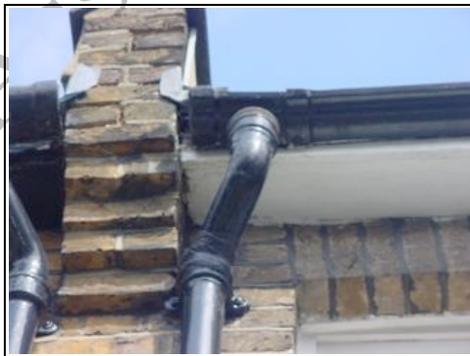
The property has a mixture of original cast iron and modern replacement plastic gutters and downpipes with some of the original remaining cast iron gutters and downpipes being bandaged together at the front of the property which is not ideal.

Bandaged cast iron gutter

ACTION REQUIRED: Repairs to cast iron gutters and downpipes i.e. remove the bandage and either replace or repair. Cast iron of this age often requires a bitumen lining.

ANTICIPATED COST: £1000 to £2000 to carry out proper repairs; please obtain quotations.

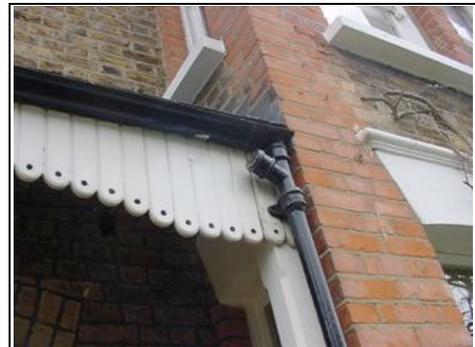
Unusual cast iron downpipe on the front roof with extra branch on the downpipe

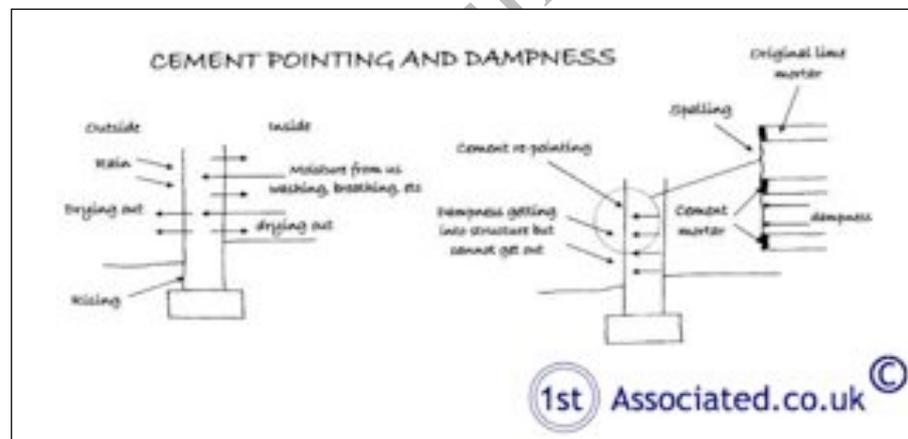
The property has Flemish Bond brickwork which has been incorrectly re-pointed using a cement mortar as opposed to a lime based mortar. Cement mortar smothers the building not allowing it to breathe whereas traditional lime mortar used on properties of this age, type and style allow the property to breathe.

Cement re-pointing

ACTION REQUIRED: Gradual re-pointing in a lime mortar, the good thing about cement mortar is that it falls off on its own, particularly when helped with a soft brush. We would recommend yearly visits by an experienced, time served bricklayer who knows how to work in lime mortar which will gradually allow the building to breathe and reduce the dampness within the building.

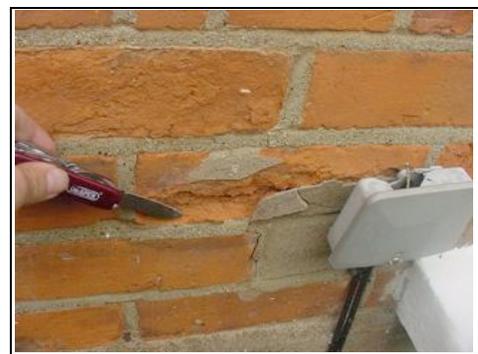
Deterioration to brickwork incorrectly re-pointed in cement mortar

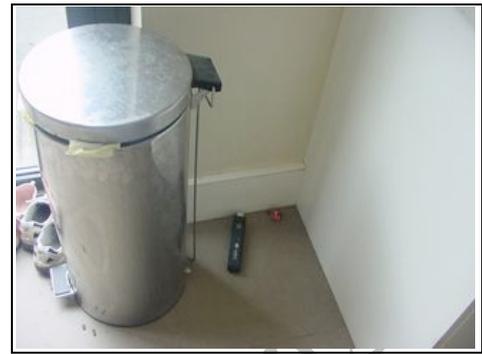
Dry lining to kitchen therefore unable to take damp meter readings

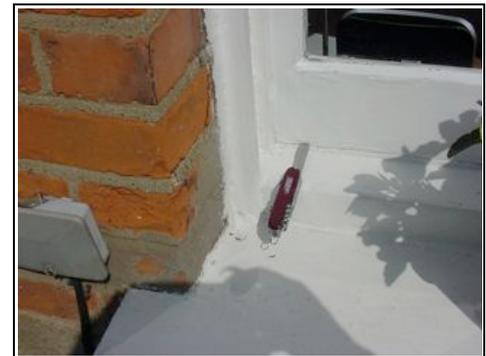
The windows to the front of the property have suffered, particularly in the sunlight, whilst the windows that we opened did open when we carried out our knife test we found that the windows had been filled and were soft.

ACTION REQUIRED: Professional repairs are necessary.

ANTICIPATED COST: Set aside the sum of £2000 to £5000 to have professional repairs carried out to the windows including easing and adjusting; please obtain quotations.

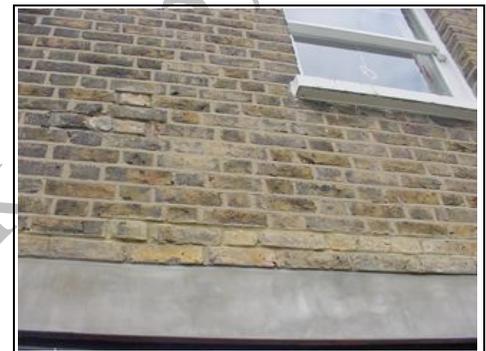
There is a rear sliding, folding door which we have concerns about the adding of these types of modern doors to a property such as this as there is a considerable span which needs to be supported. As such Local Authority Approvals should have been obtained.

Looking for cracks above sliding, folding doors to rear

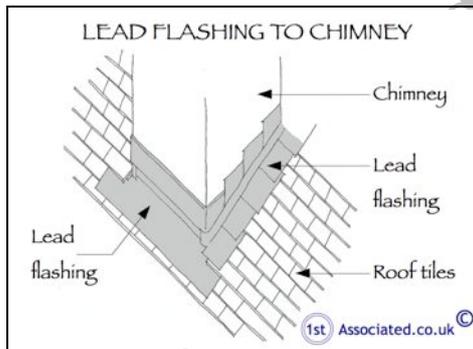
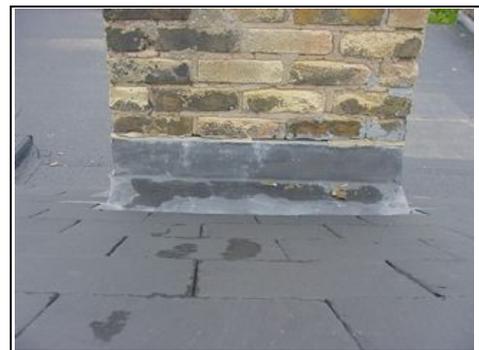
This chimney is the one that we have identified in the Executive Summary as having a defective flashing and as such this sort of modern builder error would be likely to be in the other two chimneys.

Chimney One requiring flashing to be correctly bedded into brickwork

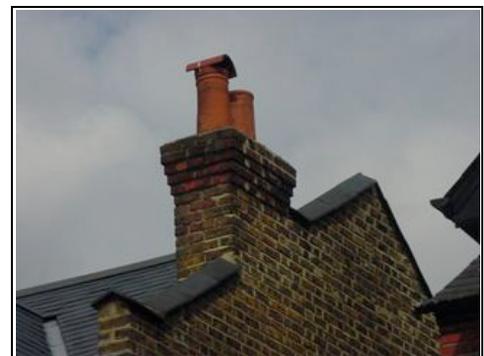
Chimney Three

Again, this chimney is also built with two chimney pots. We could not see the flashings and again we would recommend the flashings are inspected.

ACTION REQUIRED: Check the whole chimney and particularly look at the flashings. Periodically inspect the chimney.

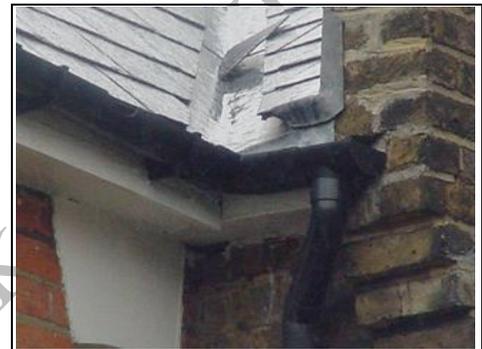
Valley gutters are generally considered to be weak areas on a roof. The valley gutter is used where a roof changes direction. In this case we believe the valley gutters could either be lead or Glass Reinforced Plastic (GRP) given the condition of the lead work to the chimney.

Glass Reinforced Plastic (GRP) valley gutter

ACTION REQUIRED: The valley gutters should be checked at high level with a roofer with long ladders. We would recommend a roofer takes photographs of any problems.

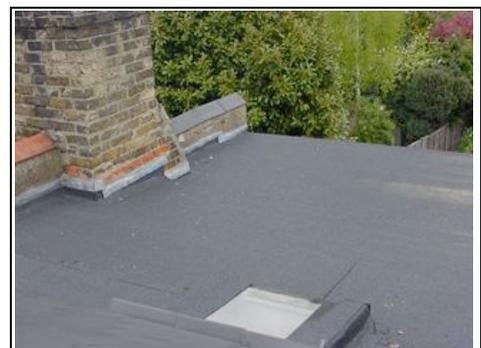
Roof light partly felted over

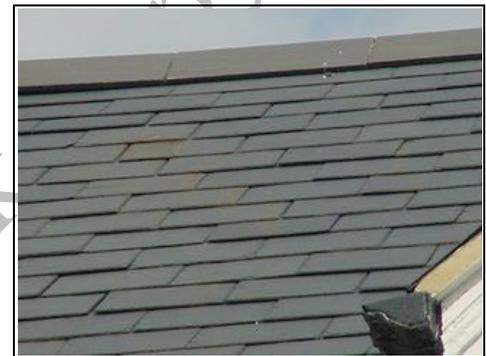
Main roof

The main roof is pitched and clad with manmade slates, and, from ground level, this looks in below average condition considering the roofs age type and style. We are used to seeing a manmade slate roof that is very flat which is not what you have got in this case.

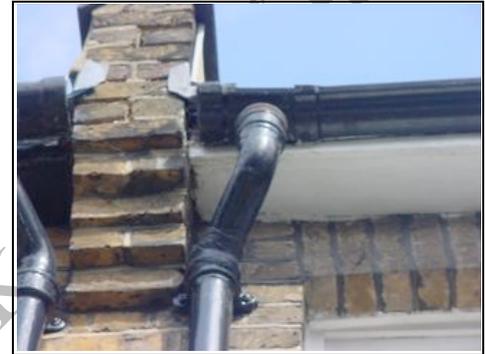
Bandaged cast iron gutter and downpipe

ACTION REQUIRED: We would recommend you stand outside the property next time it rains heavily and see how well the drains cope with the rainwater particularly looking at the guttering and the joints.

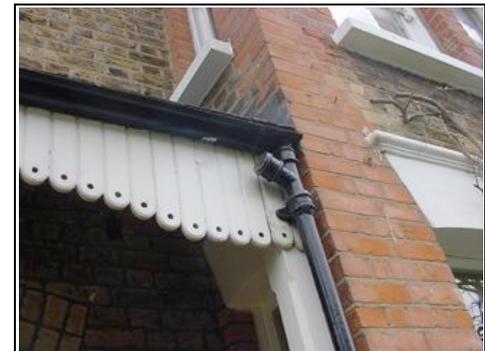
Unusual cast iron gutter and downpipe to the front roof with extra branch

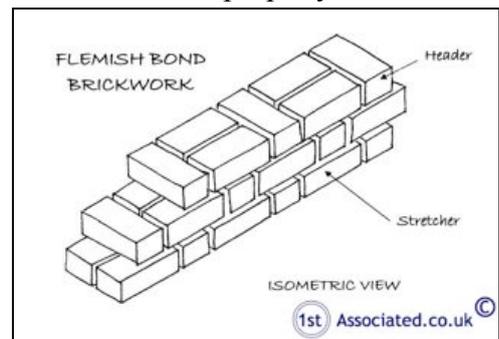
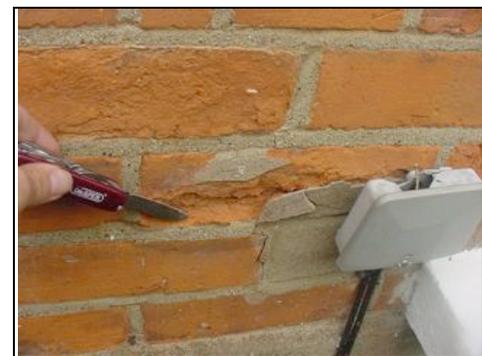
Deterioration to brickwork incorrectly re-pointed in cement mortar rather than lime based mortar

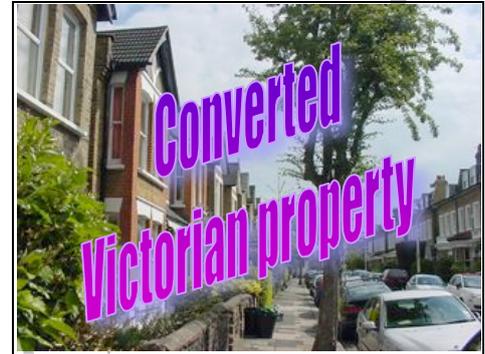
The tree is located nearby

ACTION REQUIRED: Your Legal Advisor to check and confirm who is liable and responsible for the tree. If it is the Local Authorities responsibility you need to ensure regular maintenance is carried out.

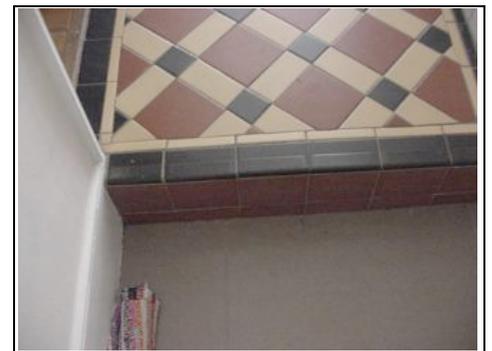
Step - suspended timber floor to concrete floor

ACTION REQUIRED: Add a vent to the back of the suspended timber floor if not present.

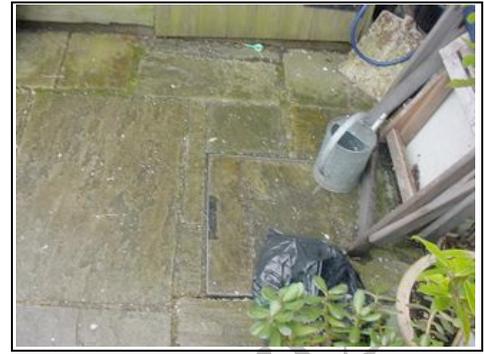
Manhole Two

At the time of our survey we were unable to lift and inspect manhole two. The manholes are not possible to lift without specialist lifting gear.
