# RESIDENTIAL BUILDING SURVEY

## Ealing

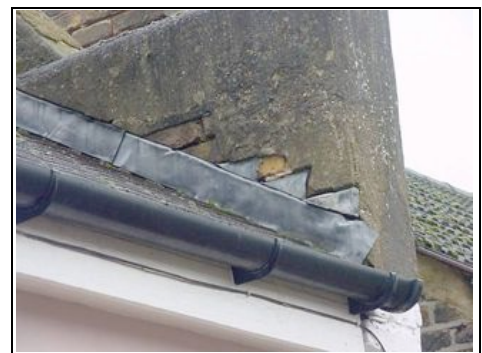
The flashing to the rear left hand parapet wall is poor and rather than stepping with the joint has been cut through the brickwork. There are also render repairs required.

Poorly fitted flashing to the rear left hand parapet wall

**ACTION REQUIRED:** Check lead flashing and carry out render repairs to the parapet walls. This may need scaffolding.

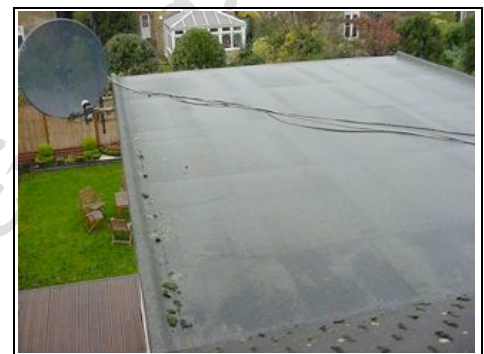
- i) There is a risk of water getting in below although we couldn't visually see any at the time of our inspection and
- ii) That the roof will deteriorate quicker than is typically expected, which in our experience has a life of fifteen to twenty five years.

Flat roof to rear of property

**ACTION REQUIRED:** With the felt roof you need to expect there to be an above average number of repairs sooner rather than later. With the wood decking covered roof, we recommend removing the wood decking to expose the roof to check the condition of it. We expect it could go one of two ways, either a perfect example of roofing with the exception of the flashing or a roof in poor condition.

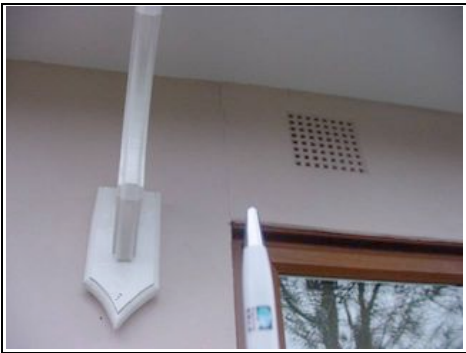
We can see throughout the rear of the property there is cracking to the render particularly on the left hand side at high level. We can also see that repairs have been carried out to cracking indicating that it is a known about problem. The cracking could be for many reasons, from movement to the cement being too hard at the rear of the property; however we feel that you need to specifically ask the current owners if any underpinning or structural work has taken place to the property.

Crack in the render to the rear

**ACTION REQUIRED:** To be on the safe side, we would recommend the present owners put in an insurance claim identifying this cracking was noted during the course of a building survey, but as it was a one-off inspection it couldn't be conclusive. The insurance company will then carry out monitoring over a period, usually a year (as recommended by the Building Research Establishment) and carry out work as necessary. This all needs to be in writing as this would then limit your cost to the excess within the insurance and any supplements they would then charge you if and when work was carried out.

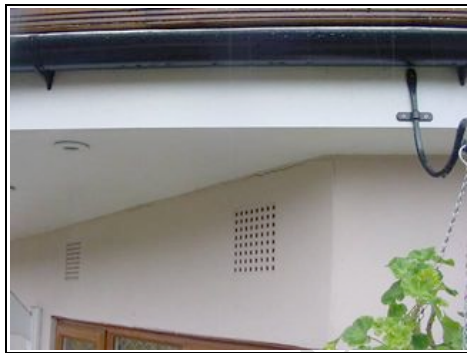
Crack at high level

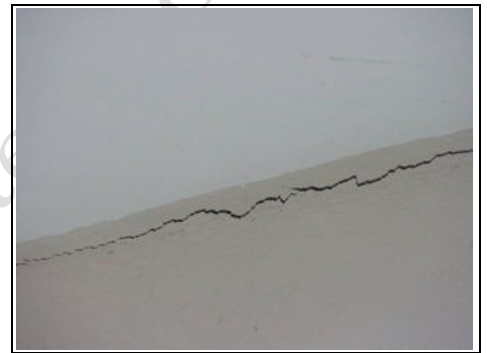
Close up of crack at high level

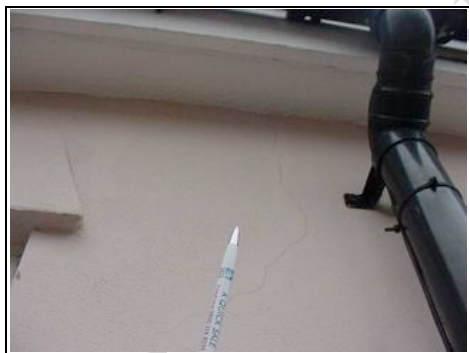
Cracking to the rear left hand side

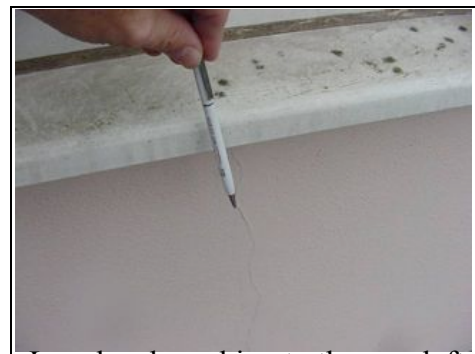
Low level cracking to the rear left hand side

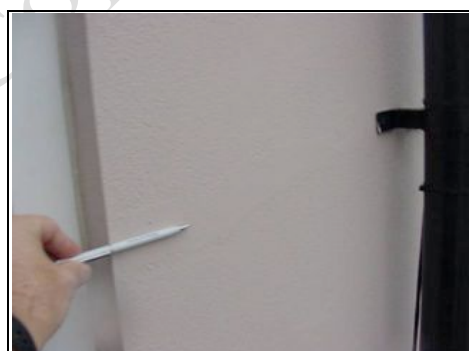
Covered up cracking

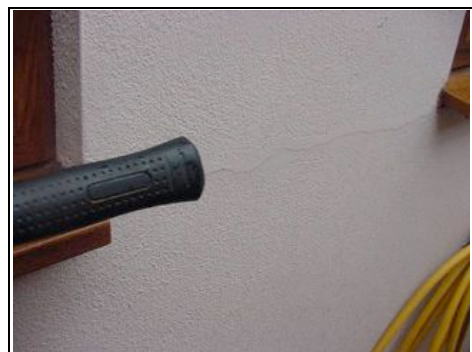
Cracking to the render

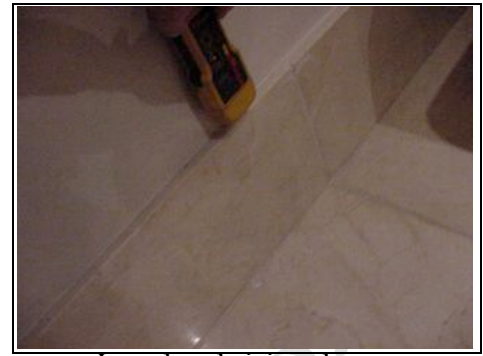
We have found rising damp on the right hand side of the property and we believe we would also find it to the rear if the walls weren't hidden by the kitchen units. This we believe is due to the high ground level.

Low level rising damp

**ACTION REQUIRED:** We would recommend in the first instance the lowering of the ground level around the right hand side and rear of the property. Unfortunately this would be quite a lot of work as the whole area has been paved which is part of the problem as they have been added over the existing ground level rather than lowering it. This has then allowed the dampness in.

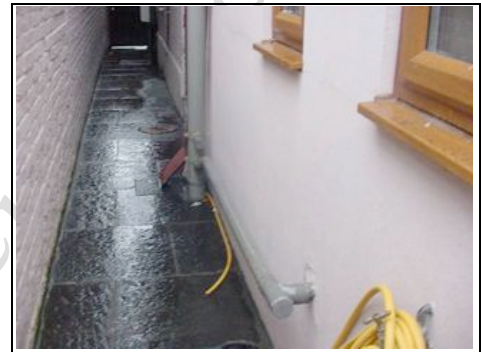
Right hand side is too high and needs the ground level lowering

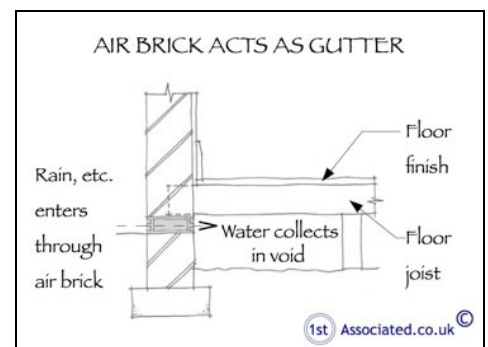
We suspect that additional airbricks were originally to the rear but these have been covered up by the decorative paving slabs that have been added.

**ACTION REQUIRED:** You need to ensure that all the current air vents are clear and allow a flow of air. You need to open up a section of the floor to check the condition of the timber underneath. If there is any dampness or deterioration then we would recommend additional airbricks are added to the rear.

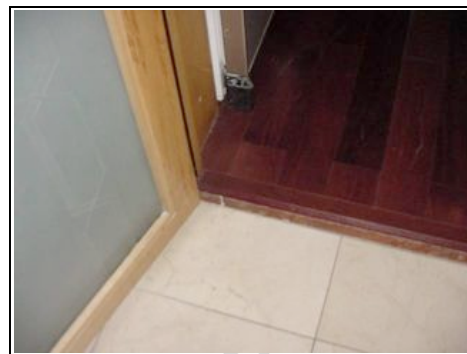
Throughout the property there are ceramic tiles onto wooden suspended timber floors. This mix of solid material in the form of the tiles onto a timber which deflects and moves with the seasons does get differential movement, which requires re-grouting. Over the years, the only way we have found around this is to have an expansion joint and sit on top of the tile coving which we don't see in this instance. If this isn't put into the original design, then it is very difficult to add it afterwards. Unfortunately we couldn't see it in this instance.

Tiles to wooden floor with a step on the ground floor

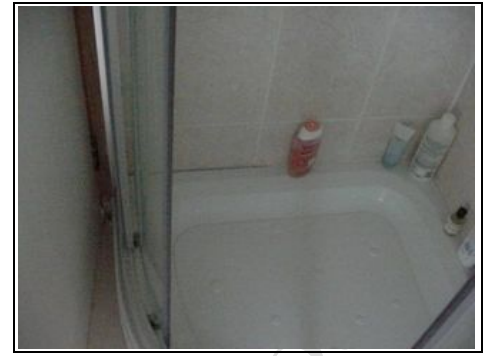
We could see some deterioration to some of the showers. This can often occur where the shower isn't bedded down properly and a hollow shower is used rather than a solid shower.

Deterioration to shower

**ACTION REQUIRED:** Each shower to be checked for deterioration and re-mastic.

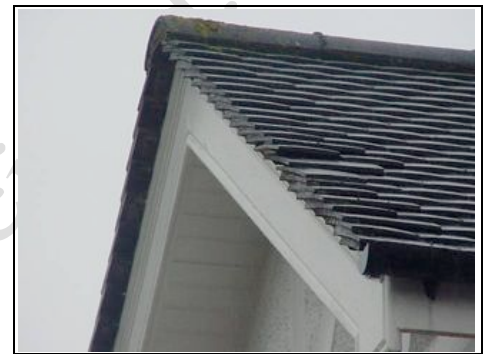
The main roof is hipped, pitched and clad with small concrete tiles and, from ground level, this looks in average condition considering the roofs age type and style. With this age of roof there will usually be a few missing or displaced tiles, this is nothing unusual. In this instance we could see some displaced tiles to the front gable end. These looked like they had been lifted by the wind and need replacing.

Tiles slightly displaced to the front

**ACTION REQUIRED:** A roofer to replace displaced tiles. Carry out periodic inspections and maintenance of the roof, as required.

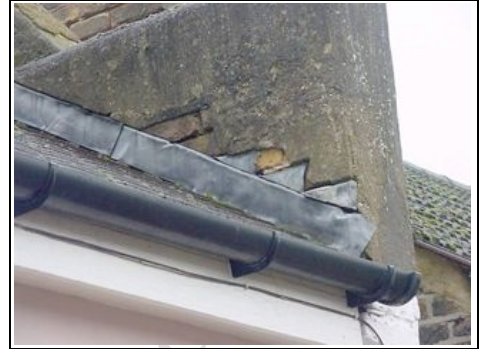
In this case there is a parapet wall to the left hand side. It is a brick built parapet wall that has been rendered and is in below average condition. Please see our comments in the Executive Summary.

Poorly fitted flashing to the rear left hand parapet wall

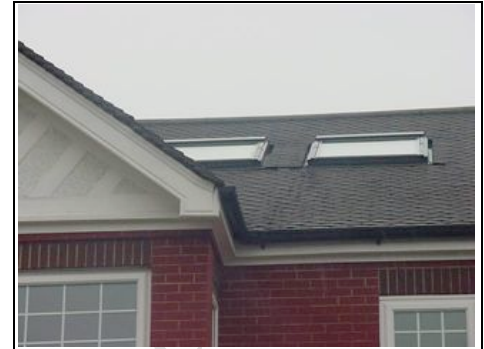
Three roof windows have been added to the front and one to the side as part of the loft conversion. These are a modern manufactured roof light and looked in reasonable condition. The important factor with roof lights is the flashing around them, in this instance we could see it looked in average condition although there was some moss sitting around it.

Roof windows

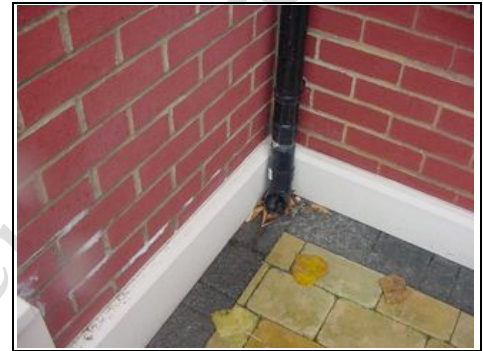
From ground level the gutters and downpipes are plastic and are in average condition. There may be some minor leaks, but we feel that most people could live with these. Carry out repairs within the next six to twelve months.

Plastic downpipe discharging onto the ground

**ACTION REQUIRED:** We would recommend you stand outside the property next time it rains heavily and see how well the drains cope with the rainwater particularly looking at the guttering and the joints. We would always recommend that the gutters and downpipes are cleaned out, the joints are checked and the alignment checked to ensure that the gutters fall towards the downpipes.

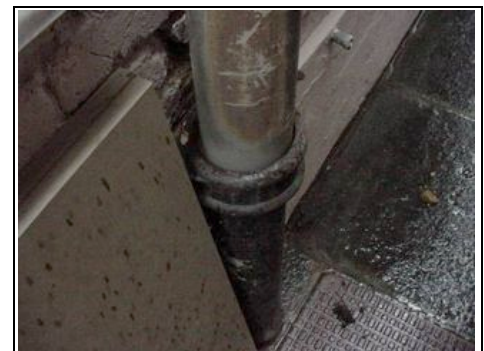
Cast iron of this age can crack and rust and needs regular maintenance.

Soil and vent pipe – cast iron to plastic

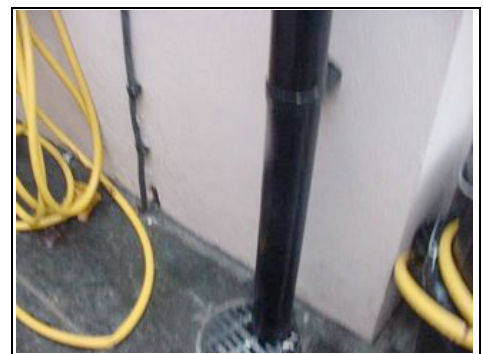
No bell mouth

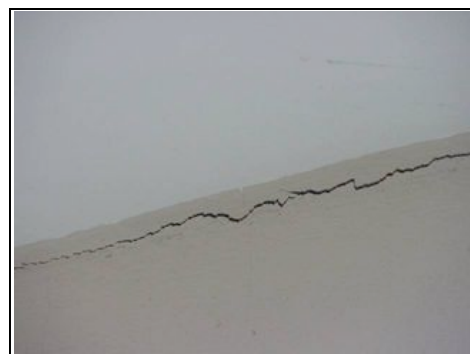
Close up of crack at high level

We would remind you that any hairline cracks that appear, which tends to be the case with render, need to be sealed as soon as possible to stop dampness and water getting in and causing blisters and hollow areas.

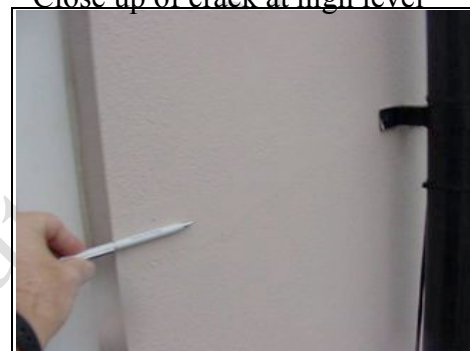
Old cracks that have been repaired previously

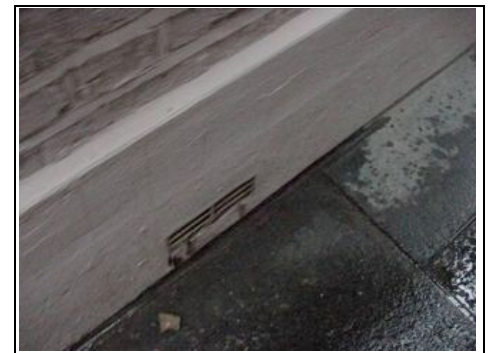
Airbrick acting as a gutter on the right hand side

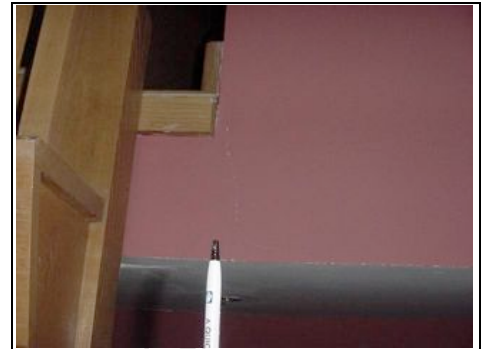
Hairline cracking on the stairway on top floor

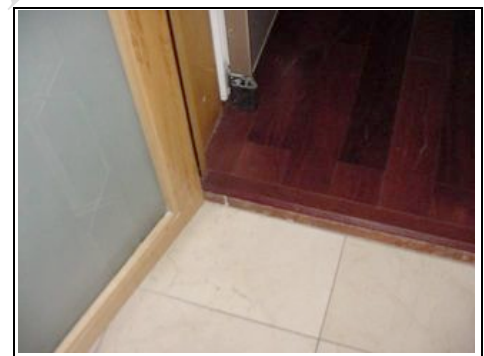
Tiles to wooden floor with a step on the ground floor

**ACTION REQUIRED:** Please see our comments within the Executive Summary with regards to the problems that can occur where ceramic tiles are laid over timber floors.

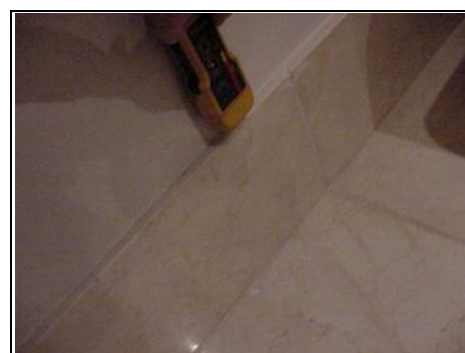
A random visual inspection and tests with a moisture meter have been taken to the perimeter walls. In this particular case we have found rising damp to the right hand side of the property.

Rising damp

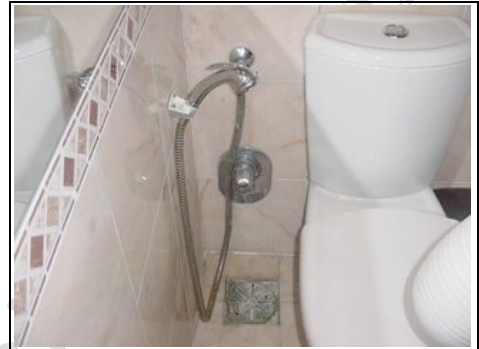
Washer unit in downstairs w.c. is leaking
