DEFECTS REPORT AND BUILDING SURVEY

XXX
Hackney,
London.
E8 XXX

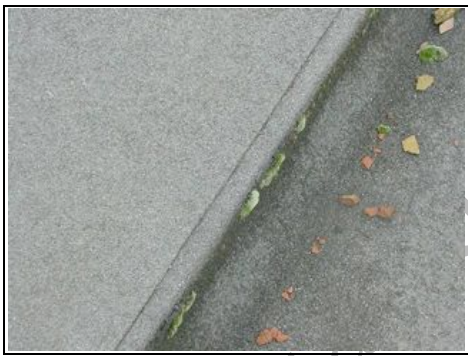
The property has a flat roof that is finished in felt. We can see areas of poor workmanship including blistering and lapping of the felt that has now lost its bond.

Blistering and moss to felt

ACTION REQUIRED: Short term - the roof covering needs attention and any blisters should be cut out. Any areas where the bonding has been lost should be re-bonded. However we feel the roof is badly designed and to some extent you will be repairing a problem that will become a bigger problem in future years.

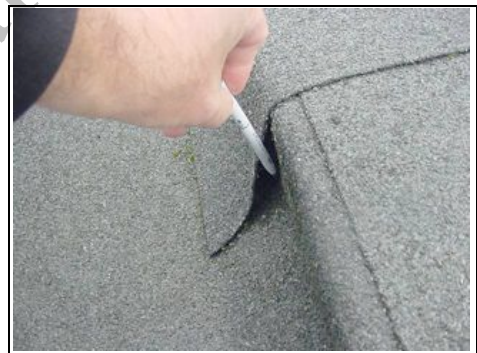
Felt becoming un-bonded

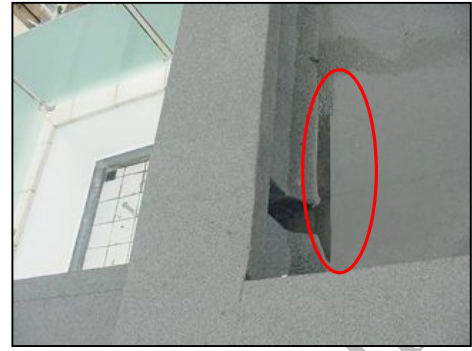
1.2.1) This is a flat, flat roof rather than having a fall of 15-22 degrees and as such water will sit on the roof which will, sooner or later, cause ponding (literally ponds of water) which will cause accelerated deterioration to the roof together with sagging in areas of the roof.

Water sits on the roof

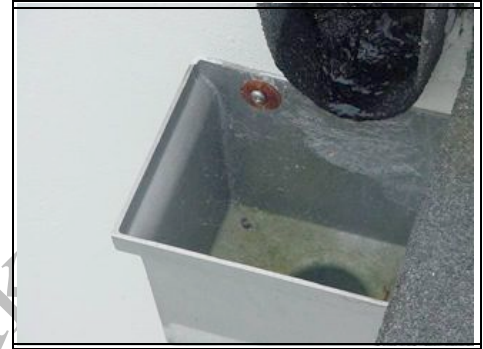
1.2.2) The way water discharges centrally from the roof via a hopper head. We would much prefer to see external gutters and downpipes as if any problems do occur they can be easily identified. The problem with internal guttering is that it is hidden within service ducts and can therefore leak for some time without you noticing it, until there is a major problem.

Hopper head

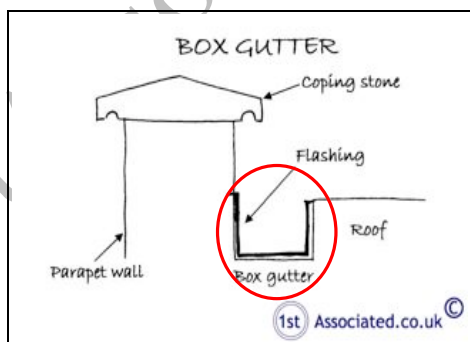
1.2.3) The right hand side box gutter is difficult to access and the outlet is less than 100mm which we believe is the minimum required/recommended for this roof and further investigation is required.

Box gutter circled

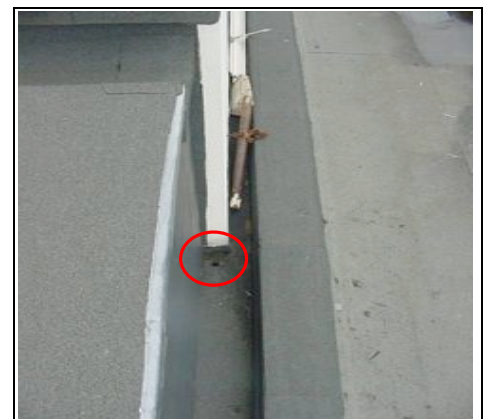
Box gutter (right) and small outlet circled

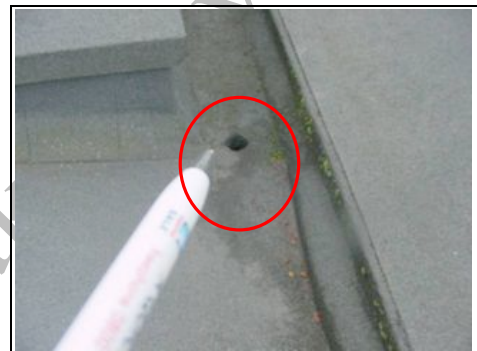
ACTION REQUIRED: Short term- the gulleys and the roof need to drain towards the outlets. There is an additional problem with the outlets in that they have been formed into 100 mm pipes and as such are less than 100mm. We would add that we have recently been dealing with a problem where the entire roof leak was caused by the poor detailing around the outlet.

Small outlet on main roof

Long term - we feel the best way forward in the long term will be to start again with the roof and have a roof that has a considerable fall with different outlets (ideally external). If they are internal then the entirety of the downpipes need to be checked, ensuring that the downpipes travel in an easy route to the drainage points - if not they will leak over time.

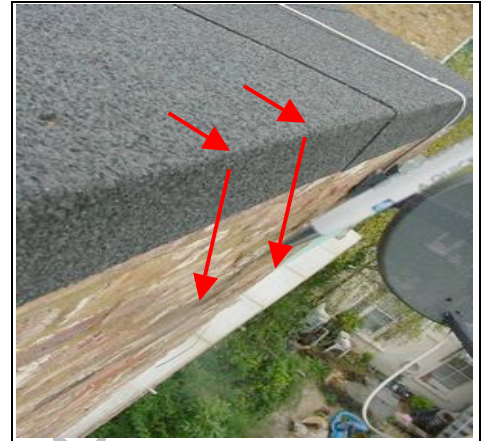
Rear of property – no drip detail
Rainwater will discharge down the wall

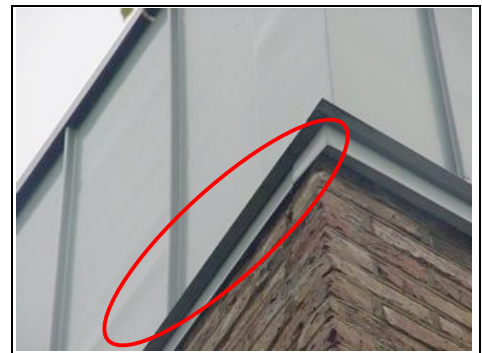
Front and side- poor drip detail-
water discharges onto the
brickwork

ACTION REQUIRED: You need to obtain legal advice with regards to ownership of the area surrounding the property and whether you are allowed to carry out work within the adjoining neighbours air space. If you do not legally have rights of access then we strongly recommend that you speak to the owners and negotiate.

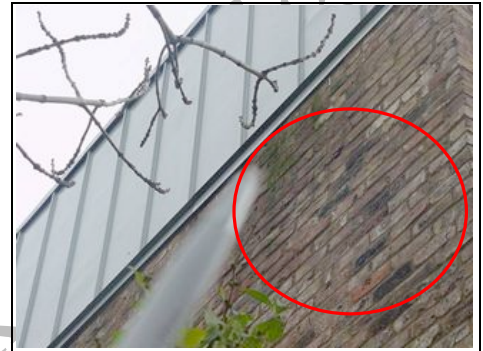
We also note moss, lichen and pattern staining together with, no doubt, dampness to the brickwork/walls.

Moss and pattern staining -left

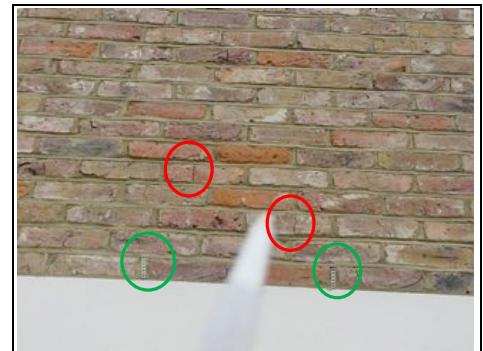
More worryingly there appears to be cracking in the brickwork which can be caused by the combination of saturation and the drying out or it could be a feature of the original brick.

Cracks in brickwork (red)
Weep holes (green)

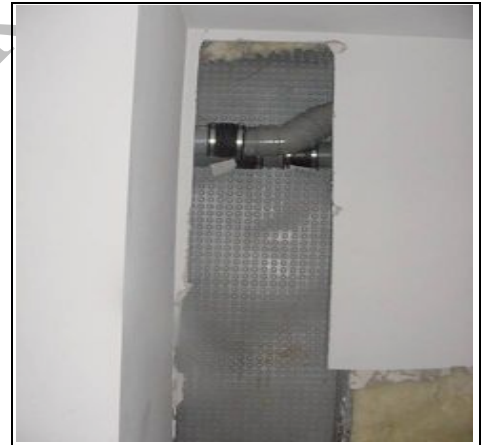
Where we could see the plumbing it looked to be a relatively poor standard of plumbing workmanship, for example, within the lower ground floor, left hand corner, where the pipes have been poorly jointed causing them to leak.

Leaking joint

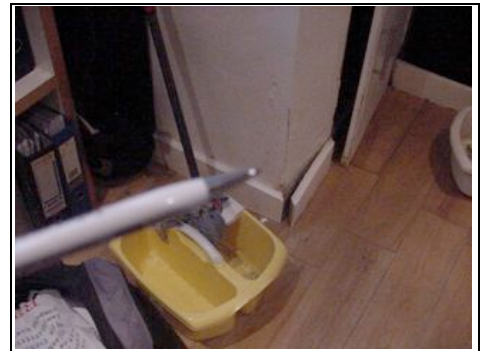
Dampness to adjoining Wall

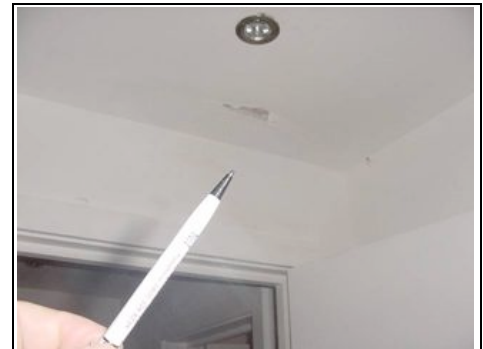
This in our experience occurs where there is a water leak or condensation occurring and this then tracks along the electric cables and through the lights which tend to be the low point.

Dampness coming through the ceiling

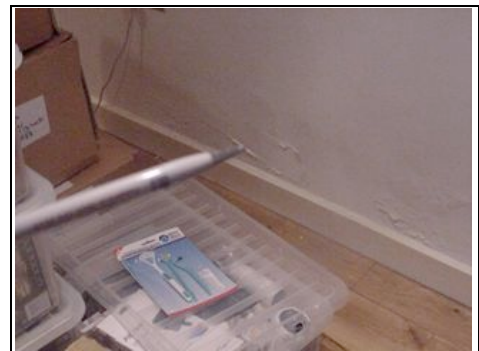
Our concern is that the tanking to the floor has not been carried out properly and so dampness from the ground is coming up which, we would say, is evident by the efflorescence visible in the front bedroom/store room on the lower ground floor. This efflorescence shows that salt is present and would indicate that this water is from the ground. This could also account for the cupping/twisting in the timber.

Efflorescence in the store area at front of lower ground floor

ACTION REQUIRED: Most tanking will have a guarantee. You do need to ensure that the plumbing is not leaking so that this cannot be blamed by the tanking contractor.

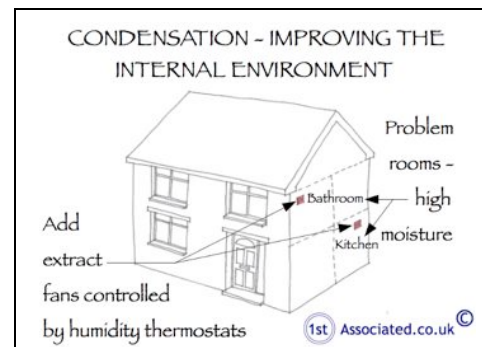
We are increasingly coming across problems with condensation in highly insulated houses, such as this, which also have cold elements in the structure such as the concrete floor which can cause cold bridging. There are also other possible cold elements within the structure (we have not had the benefit of opening up the structure).

Condensation

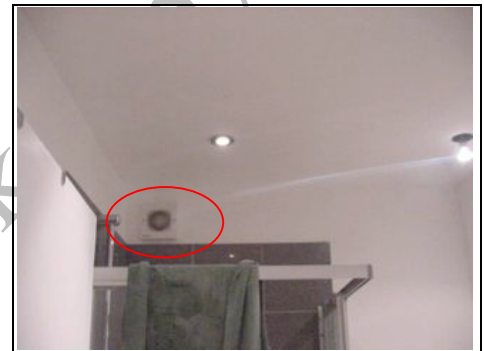
Replace with large humidity controlled extract fans

ACTION REQUIRED: We recommend that large humidity controlled extract fans are added, by large we mean 150mm minimum. These need to be vented to external air.

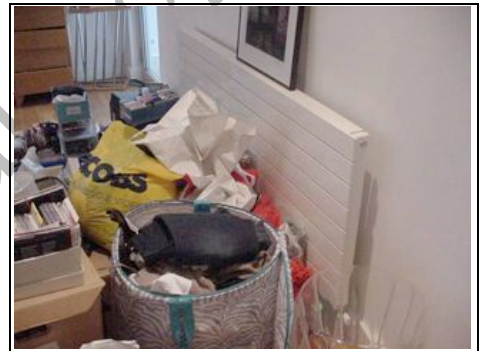
Internal radiator

Internal radiators should be moved underneath windows

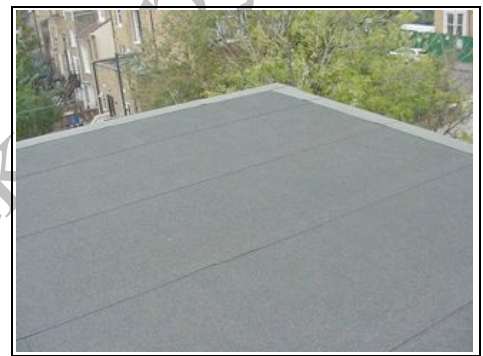
Flat roof

The perimeter is a different colour
has it been repaired already?

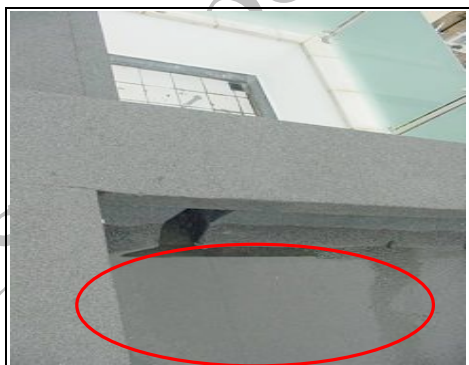
Ponding on roof

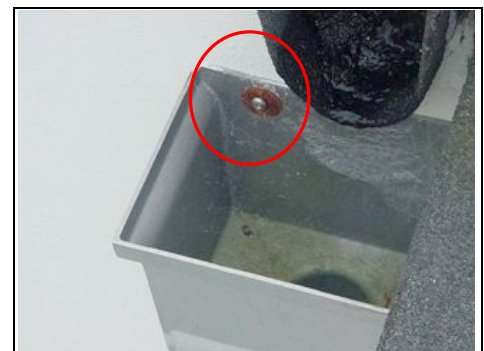
Hopper head with rusting washer

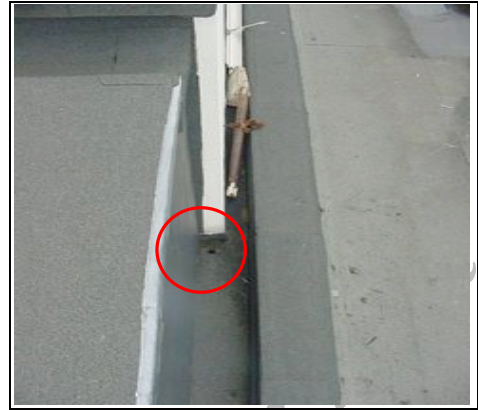
This is a very poor detail. We much prefer to see box gutters carried out in lead as these cope and adjust with movement within the building. There is a build- up of debris in the gutter that needs to be removed.

Box gutter with small opening

ACTION REQUIRED: We would recommend these areas are opened up and checked but you will need a roofer on hand that knows what they are doing when this is taking place.

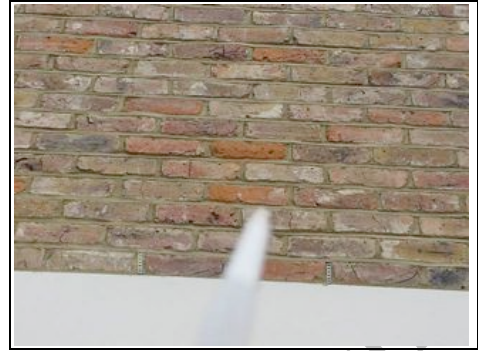
We believe this relates to dampness in the structure but it may have been an original 'feature' of the brick but we are not certain about this. However, we can point in you in the direction of a brick expert who we have had dealings with and who may well be able to advise us further on this.

Cracking in brickwork

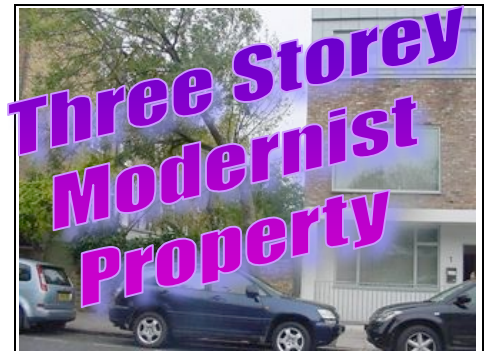
There are trees within what insurance companies would term as influencing distance of the property. We hope with a modern building such as this that these trees have been allowed for in the design. However given the other problems in the property we cannot be certain of this.

Trees to the front

ACTION REQUIRED: Ideally it would be good to open up the foundations to check what has been carried out. We would expect the type of information that is gathered if a claim is made against the NHBC, Architects and Builders.

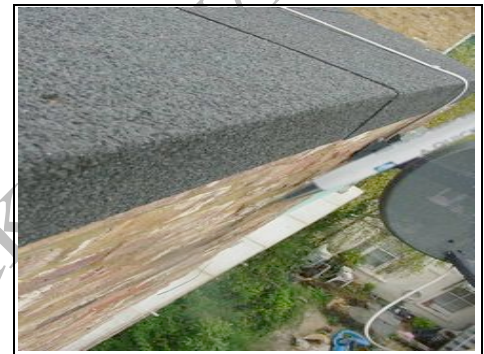
They have been formed in felt in this particular instance which is far from ideal and further investigation is required as to how the designers felt this would be an acceptable way of discharging rainwater off the roof.

Felt

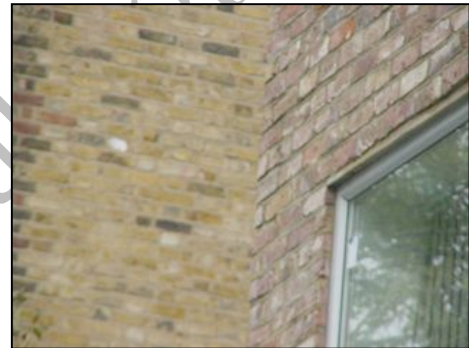
Window may be too far forward

ACTION REQUIRED: Further investigation will need to be carried out with regards to this.

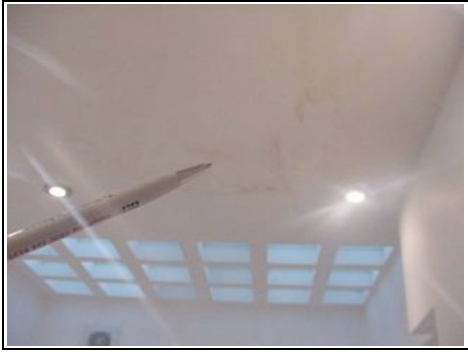
Staining to ceiling

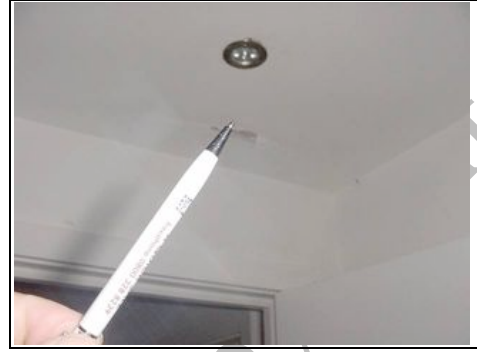
Dampness coming through the ceiling

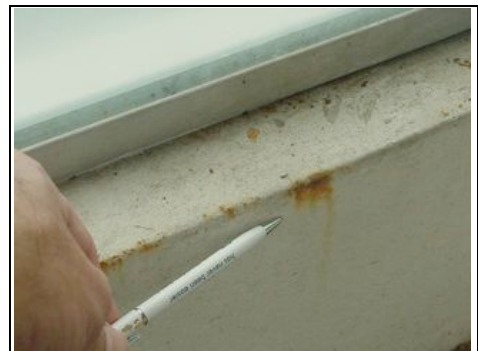
Balcony
Internal bead being used externally

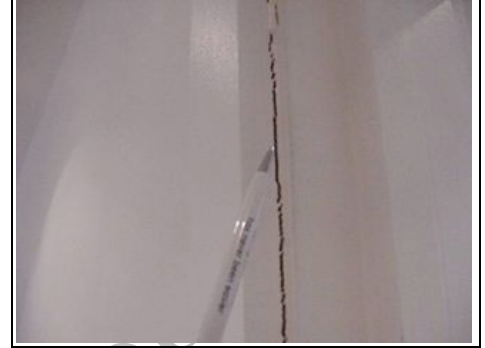
Door leading to balcony
cracking visible
