RESIDENTIAL BUILDING SURVEY

XXXXXXXXXXXXX,
South Tottenham,
Haringey,
N15 xxx

**Victorian
Terraced
Property**

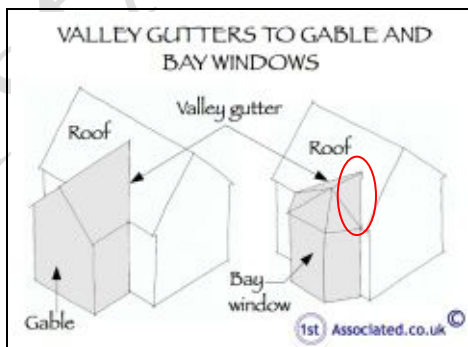
We noted very narrow valley gutters to the roof which tend to become blocked.

Valley gutters

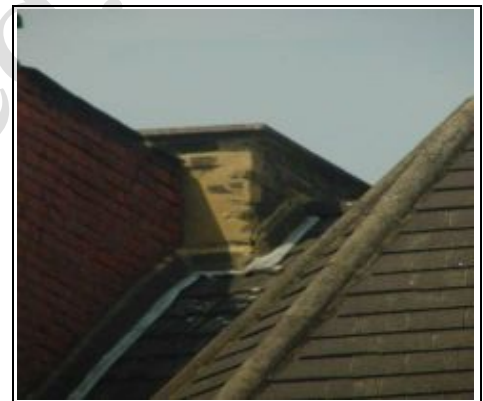
Chimney left

2.0) Left chimney condition and removal

We can see that the chimney at high level has been lowered and has been poorly re-pointed. In addition to this we can see, from within the roof space, that the chimney has been removed completely to first floor level and is now supported by gallows brackets. This is a system that Building Control now rarely permits.

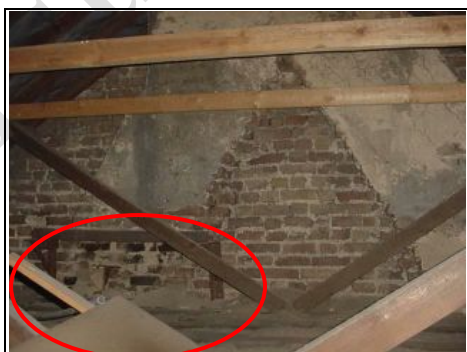
Having said that, the chimney alterations have stood the test of time, however, it may mean in the future that this will devalue the property slightly due to this defect in the property.

Chimney removed and supported by gallows brackets

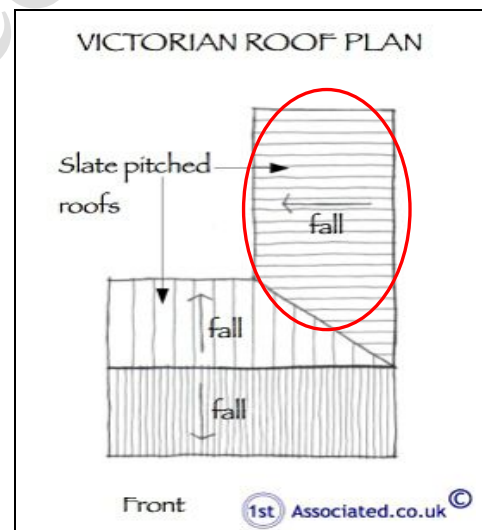
This would originally have been a slate roof but it has now been re-roofed with a concrete tile. The rear roof appears to have once been in a poor condition as the common rafters have been replaced and there also appears to be a replacement purlin.

This roof was originally slate but has been replaced with concrete

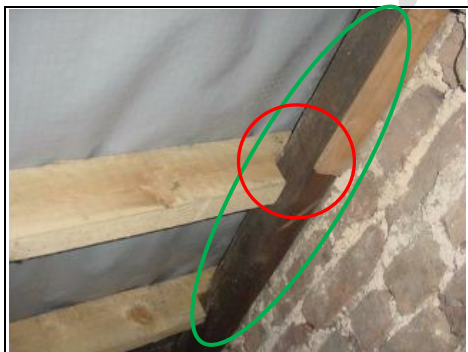
We are particularly concerned that the new timbers have been incorrectly cut to approximately half their width where they meet the wall plate; typically it should be much less than this. In fact, we noted that some older timbers have not been cut at all and others only up to a third of their width.

New timbers have been cut
incorrectly (red circle) where they
meet the wall plate (green oval)

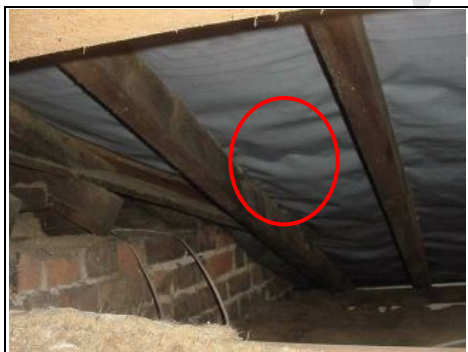
This plastic underlayer was used for some years before it was realised it helped promote condensation. We could see some dampness within the roof which we believe to be condensation; however it is possible the roof is leaking.

Dampness in roof may be condensation

ACTION REQUIRED: We would recommend that ventilation is added in the form of vented roof tiles to reduce the chance of timber deterioration.

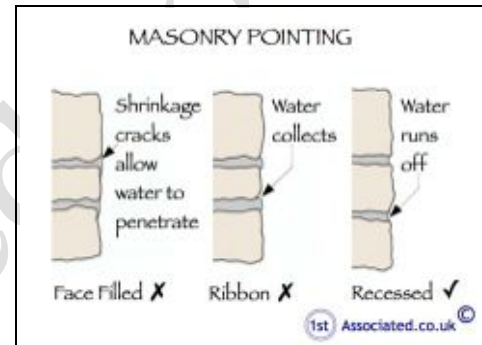
Re-pointing

Unfortunately the cement re-pointing, whilst well meaning, is not appropriate for this type of older construction. This has been used instead of a lime based mortar. We recommend you use lime mortar in any future repairs regardless of what the builders say! Using lime mortar will limit further damage to the brickwork, which is almost impossible to repair successfully. We would add that many, if not most, of the properties that

ACTION REQUIRED: The cement mortar should be removed (it will eventually fall out on its own but a soft brush will help it). We recommend you find a time served brick layer who is able to carry out the re-pointing in lime mortar and gradually replace sections of the cement mortar with lime mortar.

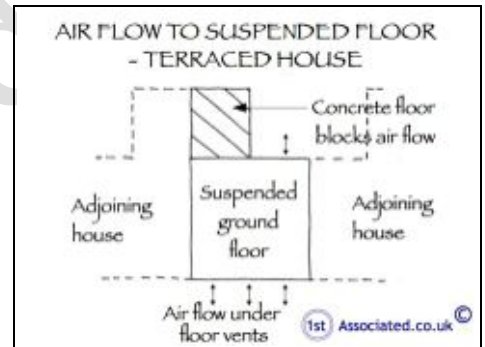
There was dampness evident to the rear of the property in the lounge. We believe this dampness to be caused by a lack of airflow under the suspended timber floor, partly caused by the concrete floor to the kitchen and also due to the re-pointing in a cement mortar.

Air flow under floor

ANTICIPATED COST: £200 to £400, possibly more, you will need to open up the floor to check. The amount of work will depend upon the condition of the timbers / floor. Additional work would be to repair / replace floor joists and supporting timbers and possibly floor boards although this is a worst case scenario and felt unlikely from the deflection in the floor; please obtain quotations.

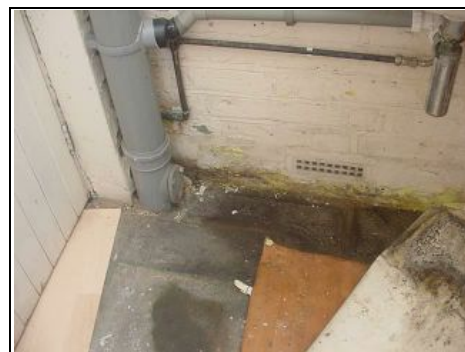
We could not locate a manhole to the rear of the property. This may have been hidden under the vinyl; we did lift approximately a quarter of this and could not see it. We often find that older properties such as this do not have manholes. Typically with older properties there will be push fit drains that will have leaked over the years.

Lifting the vinyl to check for the manhole

ACTION REQUIRED: Lift all the vinyl to check if there is a manhole when all items have been removed. If there is not a manhole then the only way to be certain regarding the condition of the drains is to have a closed circuit TV camera report carried out. We ran the taps for fifteen minutes with no build up or back up but this does not identify the condition of the drains.

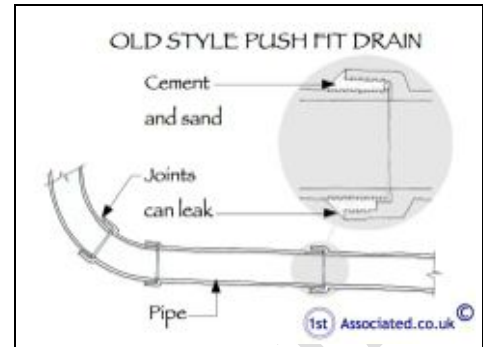
Push fit drainage is typical of older drains that leak slightly

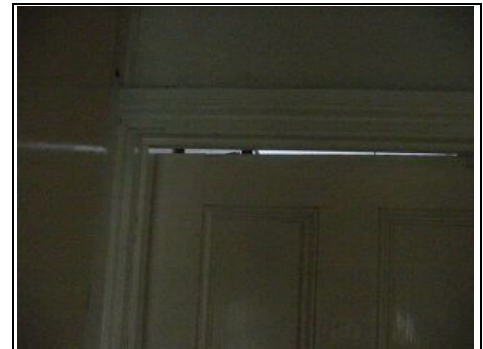
We did note some minor movement in the property visible in the door and the cracking of the plaster. This could possibly relate to the heavier concrete tiles that have been added to the roof, which are no longer allowed to be used without Building Regulations approval or possibly where the drains have leaked over many years. Unfortunately it is very difficult to be certain.

Gap above door

ACTION REQUIRED: No action required other than to have a closed circuit TV camera report carried out of the drains, as mentioned, in the near future to check water is not leaking under the structure.

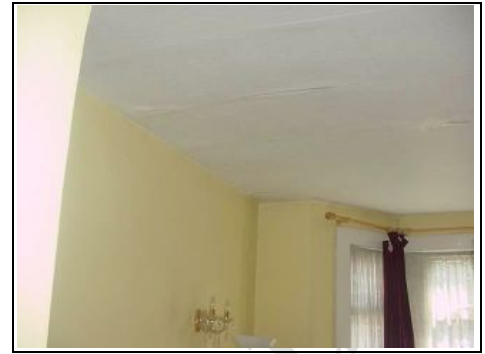
Deterioration can be seen in the internal walls and ceilings over and above what we would expect to see. This indicates to us that the lime plaster has deteriorated with age and in some cases we feel it is being held in place by the wallpaper.

Paper is coming away from the ceiling in the lounge

We would usually recommend lining the walls where this is the case to avoid extensive re-plastering. In this case the walls have been papered in vinyl wall paper which limits the breathability of the wall and as such we would recommend this is removed. We would recommend a trial/test area is carried out first.

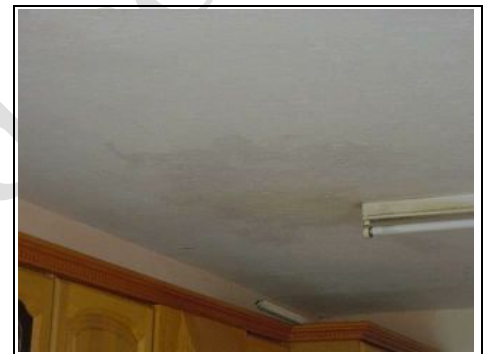
Ceiling damage in the kitchen

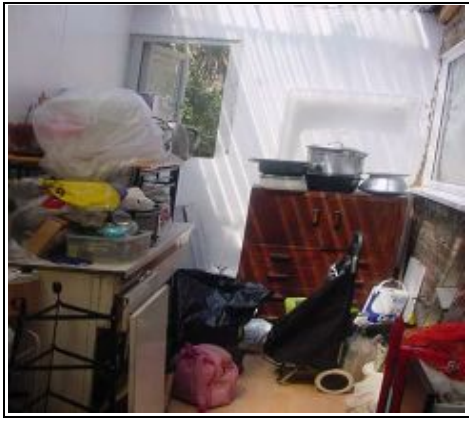
We would term the standard of the lean-to as DIY and as discussed with you we would expect it to be replaced in the not too distant future.

DIY standard

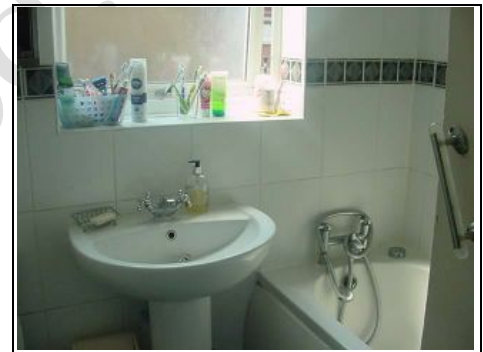
The bathroom is dated and the sink is cracked. You may or may not be aware that bathroom suites can be purchased relatively cheaply.

Dated bathroom

ACTION REQUIRED: In due course replace the bathroom suite.

ANTICIPATED COST: As much or as little as you wish to spend starting from about £300; please obtain quotations.

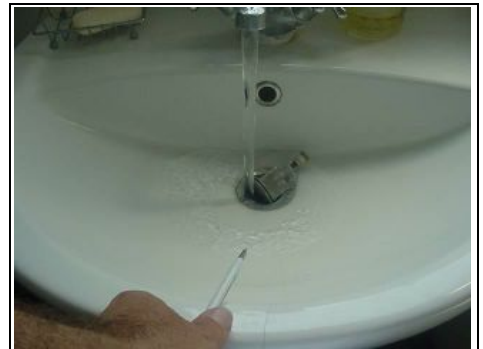
Sink is cracked

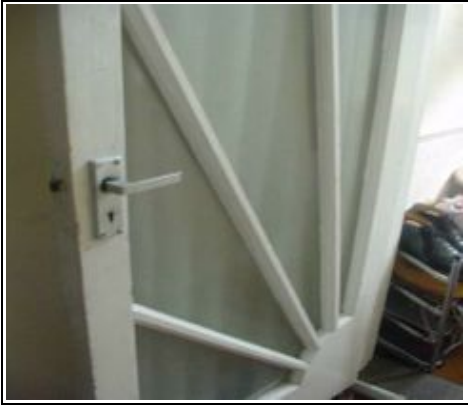
We noted some 1960's/ 1970's glazed doors in the property. We could not see the British Standard Kite mark on the glass in the doors which although not unusual in this age of property it does indicate it is not safety glass.

No safety glass in entrance door

ACTION REQUIRED: We would recommend that the glass is replaced with safety glass. Sometimes it can be more economical to replace the doors completely.

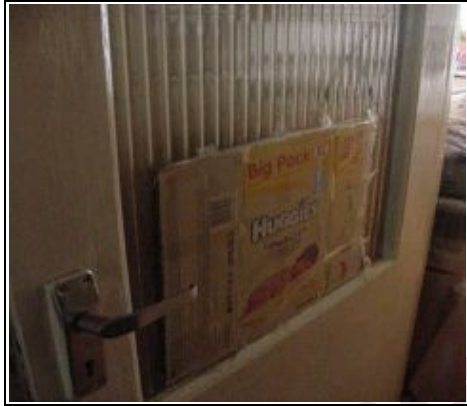
Crack in glazed door

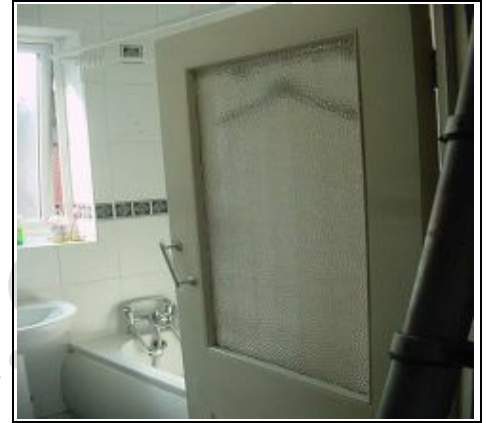
Glazed door to bathroom

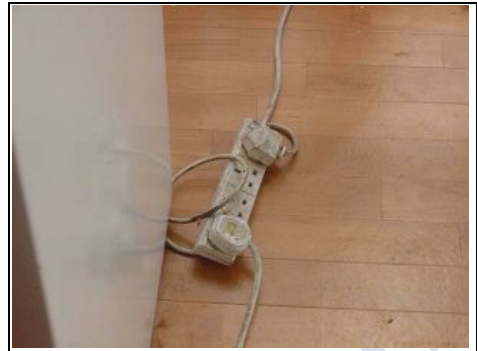
Lack of socket points

ACTION REQUIRED: Budget to expect a complete re-wire in this type of property. We would recommend that the fuse board is replaced and that extra socket points are added where required.

ANTICIPATED COST: Expect costs for a full rewire to be in the region of £3,500 to £5,000. A partial re-wire can cost from £1,000 upwards. To replace the fuse board, £150 to £400; please obtain quotations.

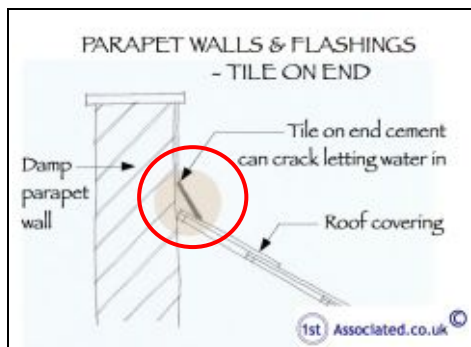
In this case there are parapet walls built from brick with a tiled coping stone and a tile on edge flashing. We can comment that generally these flashings do eventually leak although in this case there does look to be metal underneath them but this does not appear to be lead.

Tile on edge flashing

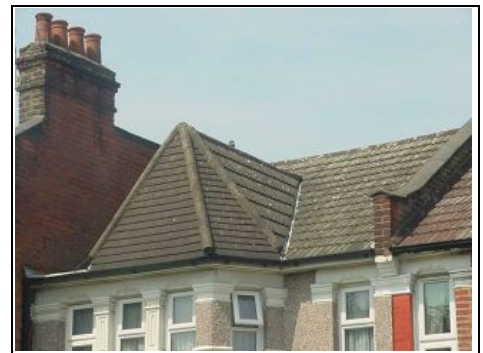
Main roof

From ground level, this roof looks in average condition considering its age, type and style. We would comment that the detailing to the roof is below average to poor. The detailing makes it difficult for us to make a conclusive comment regarding the roof as any roof is reliant on the detailing to keep it watertight.

There are no obvious signs at the moment of what we would term as structurally significant leaks but you do need to be aware of the quality of this roof. Unfortunately to rectify this will be a major job.

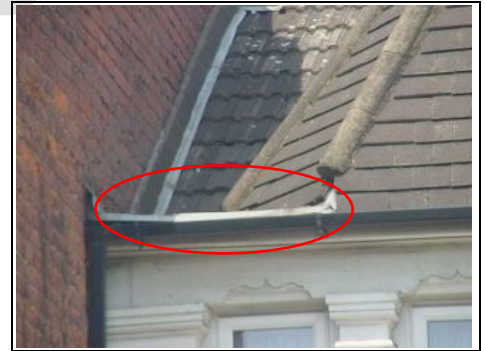
Very unusually there is a small flat roof to the left hand side of the main roof. We cannot be sure but we suspect this is a weak area and is liable to leak.

Flat roof (front left)

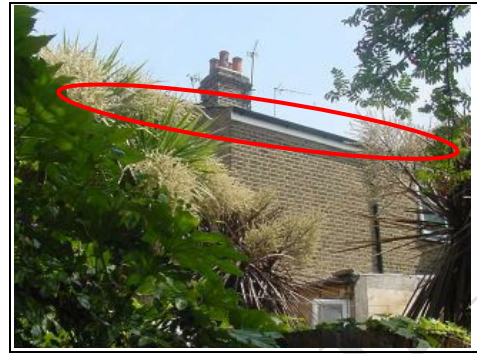
Rear roof

Our concern with this rear roof, as mentioned, is that the some of the timbers have been replaced meaning it was once in very poor condition.

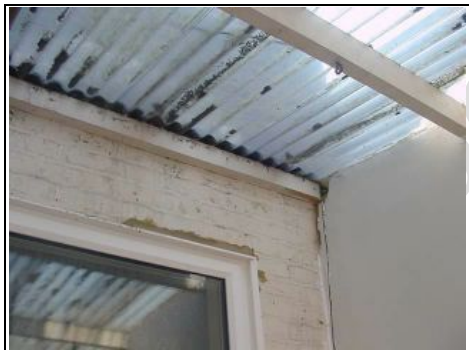
Lean-to roof

We have termed this lean-to as being to a DIY standard. The roof is a relatively thin, corrugated plastic and may well leak during the winter months or heavy wind driven rain.

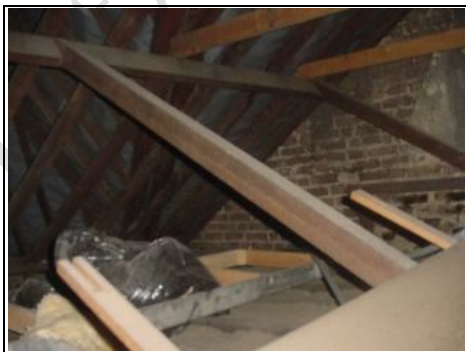
This type of roof structure has what is known as a cut timber roof, this has been amended. The amendments are, we believe, props being added to the central wall or the bracing timbers, it is difficult to tell. A cut timber roof is a roof that is purpose made and hand built on site. Without the original design details we cannot categorically confirm that there are no defects.

Cut timber roof with timbers added

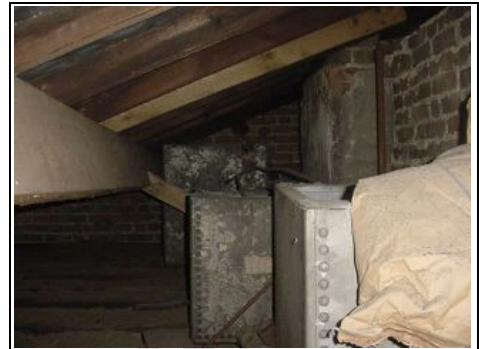
We noted old water tanks in the rear roof that will need to be removed.

Water tanks need to be removed

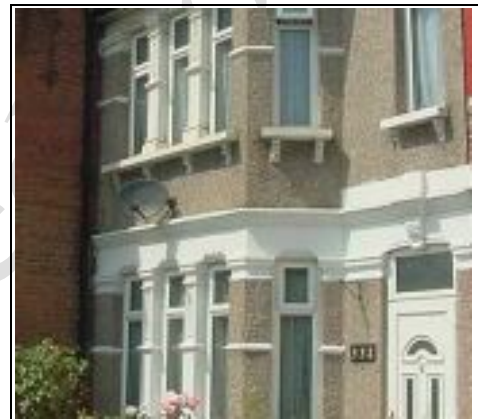
The front external walls are finished in pebbledash render. We are always wary when we see render has been added as it usually means they have been rendered for a particular reason. In this case we believe it is probably due to dampness in the walls rather than aesthetic reasons as other properties in the road still have the original brick finish.

Render to the front

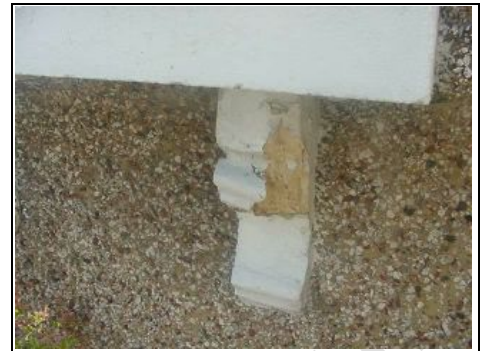
There is stone detailing to the front of the property that is painted white. We noted that the corbels under the windows sill are starting to deteriorate and would benefit from repair.

Damage to corbel

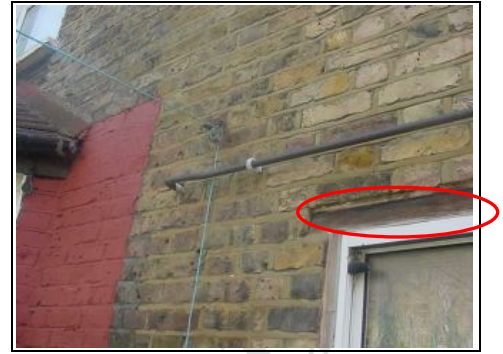
We noted a timber lintel to the rear of the property. Whilst a timber lintel is not unusual in this age of property it is relatively unusual where alterations have taken place, such as where sliding doors have been added and where typically they would have transferred over to a metal or concrete metal. This does point out to us that there have been a fair amount of DIY alterations to this property.

Timber lintel above the patio door

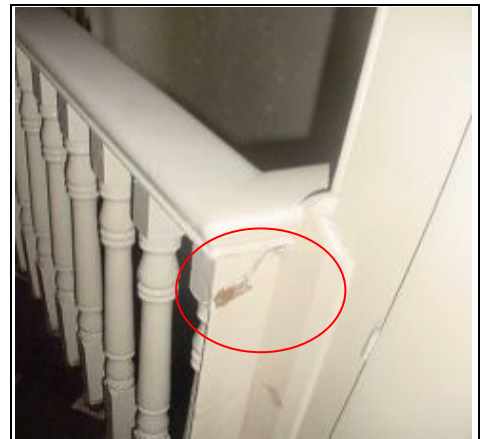
Damage to balustrade on landing needs repair

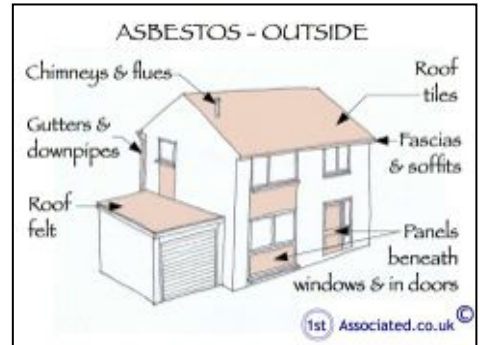
Asbestos externally

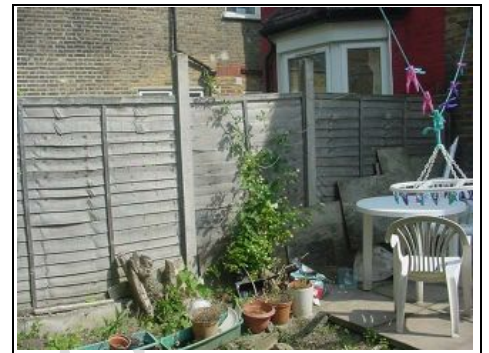
Fence needs staining
