## RESIDENTIAL BUILDING SURVEY

XXXXXXXXXXXX,  
Winchmore Hill,  
London  
N21 xxx

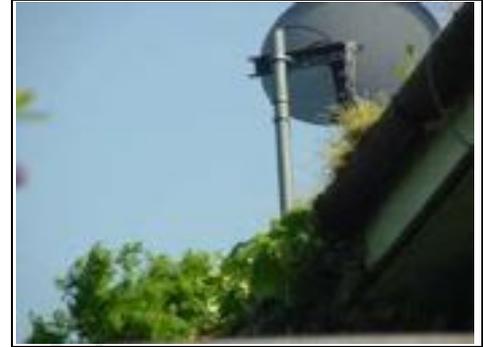
You can literally see grass growing from the rear gutters. This needs to be cleared and all the junctions and joints checked to the gutters and downpipes. We noted that some of them looked to be leaking from the staining on them.

Grass growing out of gutters

**ACTION REQUIRED:** Clear gutters and check junctions and joints.

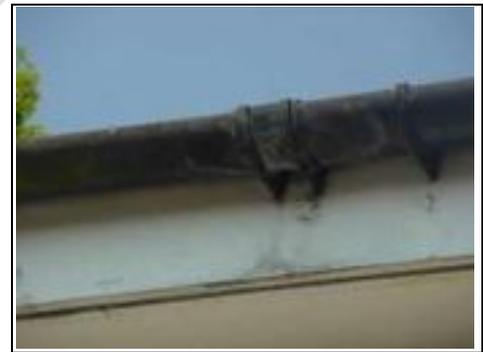
Gutters and downpipe clearly leaking

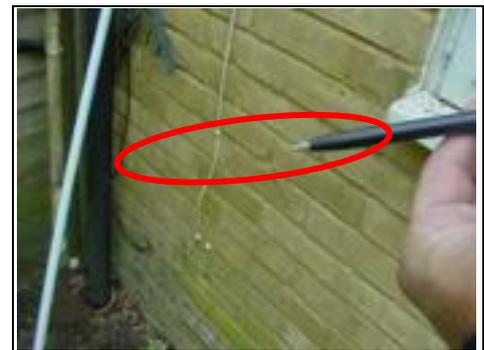
We noted cracking over the rear door and stepped cracking adjacent to the rear window. This could again relate to the rainwater drains to the rear right corner, or it could relate to dampness being caused by the ivy to the rear which does not look to have been maintained for a very long time.

Crack to rear of property

**ACTION REQUIRED:** This should be monitored as we believe this

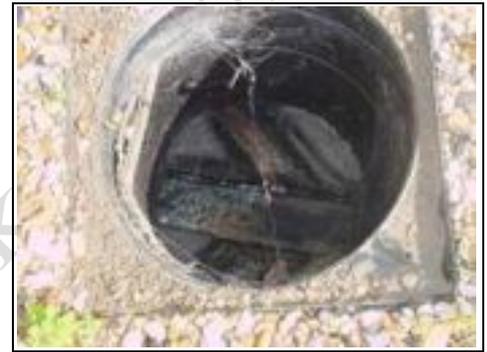
We double checked the drains and still found them slow to run away. In fact, they seemed to be going slightly uphill.

Water was slow to run away from the drains, in fact water sat in the drains

**ACTION REQUIRED:** Ideally live with these and if they are still not working we would recommend they are pressure jetted and have a closed circuit TV camera report.

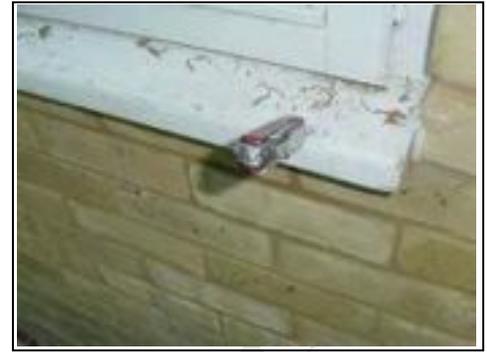
You have timber windows which are in need of redecoration. We tend to find that this era of timber double glazed windows tends to be relatively poor quality timber that has to be very well maintained to stop it from rotting.

Checking the condition of the timber window sill

**ACTION REQUIRED:** Carry out Redecoration.

**ANTICIPATED COST:** £1,000 to £2,000; please obtain quotations.

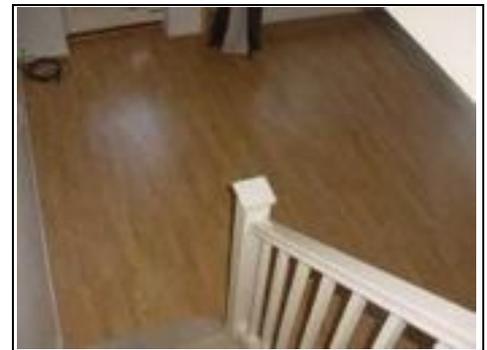
Generally the property needs redecorating throughout. Also the laminated floor is poorly fitted and is starting to wear in high use areas, such as the hallway entrance to the property.

Laminate flooring in lounge

**ACTION REQUIRED:** We would ultimately recommend that this is replaced with properly fitted good quality laminate flooring.

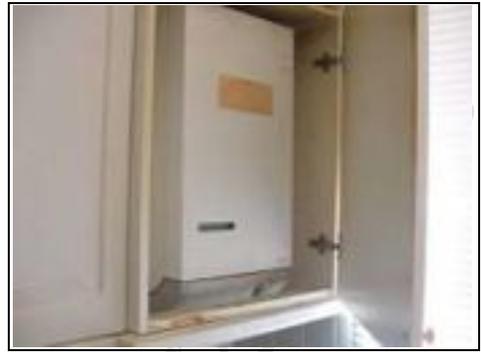
The Prima profile wall mounted boiler in the kitchen looks to be coming to the end of its natural life. You may experience difficulty in obtaining parts with an older boiler such as this.

Prima boiler has seen better days

**ACTION REQUIRED:** We recommend the boiler is serviced and then look to replace it as soon as possible. The Institute of Electrical Engineers standards (IEE) recommend a test and report whenever a property changes occupancy. This should be carried out by an NICEIC registered and approved electrical contractor or equivalent.

**ANTICIPATED COST:** In the region of £2,000 to £3,000 to ultimately replace the boiler; please obtain quotations.

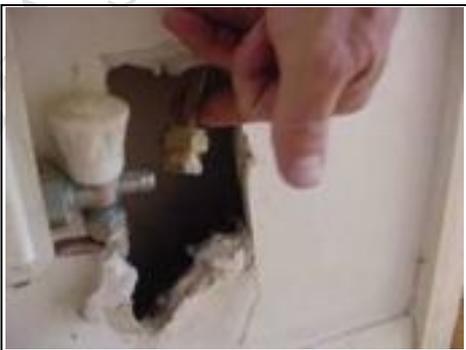
The radiator in the hallway looks to have been disconnected and is not working. We also noticed staining in the rear bedroom which looks like it has come from a leaking radiator.

Hole in wall and disconnected radiator

**ACTION REQUIRED:** The heating needs to be looked at and switched on before exchange of contracts or assume that it is not working and that you will need to modify it. We also noted it had micro bore pipes which do tend to block.

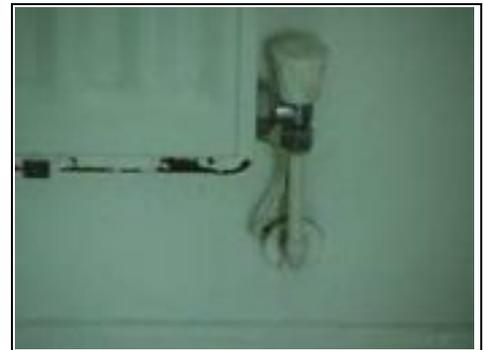
Rusting radiator

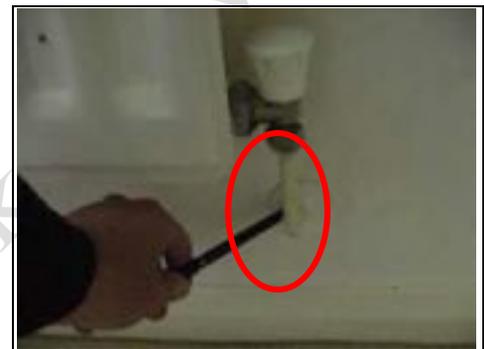
Micro bore pipe

**ANTICIPATED COST:** We would set aside the sum of £1,000 to £2,000 for pressure jetting the system and repairing the damaged pipe.

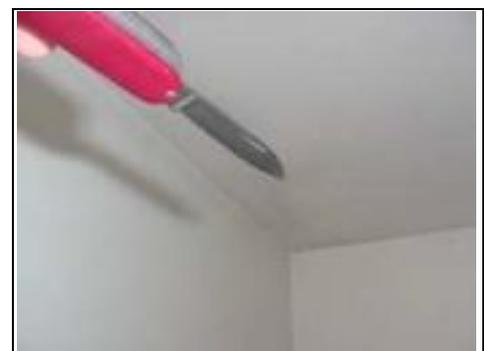
We noted the extract fans did not seem to be working that well and this has resulted in mould and moss that has been painted over in the front bedroom. There has also been some painting over in the rear bedroom.

Knife pointing at mould in front bedroom (difficult to see in photo)

**ACTION REQUIRED:** Replace all the extract fans with large humidity

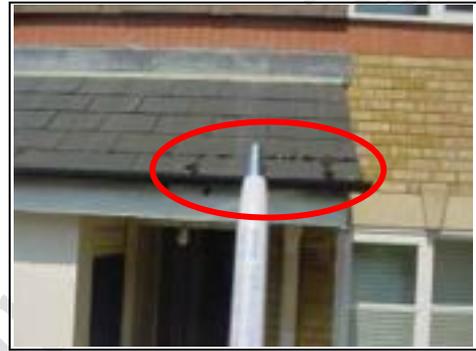
Moss on porch roof

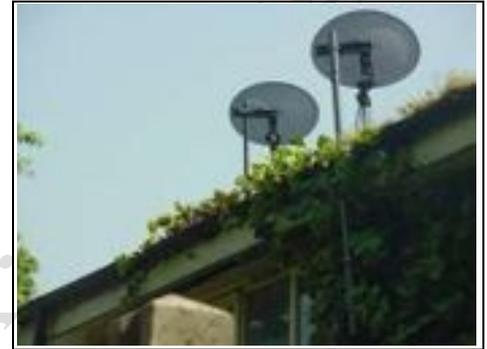
There may be some minor leaks but most people would be happy to live with these providing repairs are carried out within the next six to twelve months.

Ivy and grass in gutters  
(photo taken from neighbour's property)

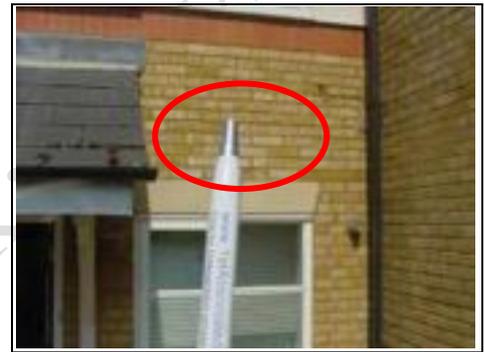
We noted some efflorescence on the brickwork.

Efflorescence

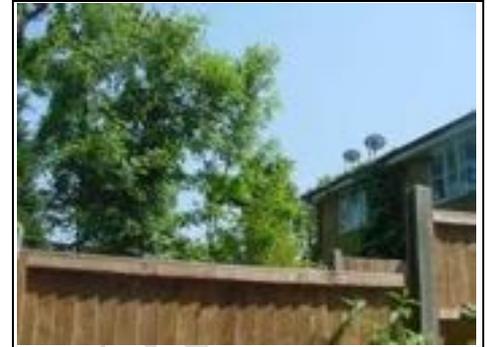
Trees (taken from neighbour's garden)

**ACTION REQUIRED:** You do need to cut the trees back considerably and then review. Ultimately you may need an Arboriculturalist (not a tree surgeon) to view the trees and give an opinion on whether the trees will affect the property or we will be happy to revisit.

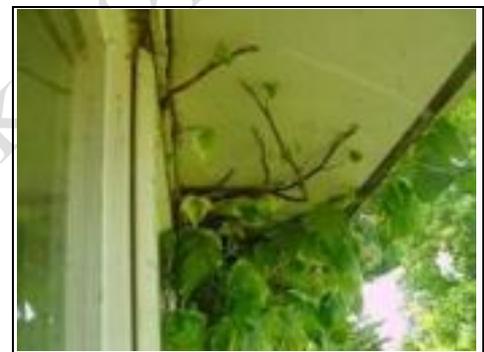
The fascias and soffits are timber. They are painted and we would comment they are in below average condition for their age, type and style. A fascia has dropped down to the rear which is why the window was hitting it when we opened it. We noted that the ivy is around the fascias and soffits.

Ivy on fascias and soffits

**ACTION REQUIRED:** High level work likely to be in the region of £500 to £1,000 dependent upon problems found.

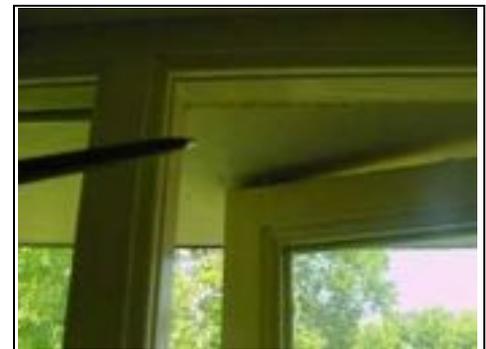
Fascia board dropped down and the window hits it when it is opened

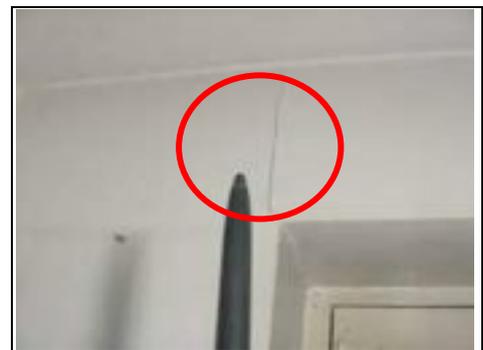
Hairline cracks internally indicate some movement to the property which can be initial settlement but as mentioned it may relate to the drains in this particular era of property.

Crack to rear of lounge

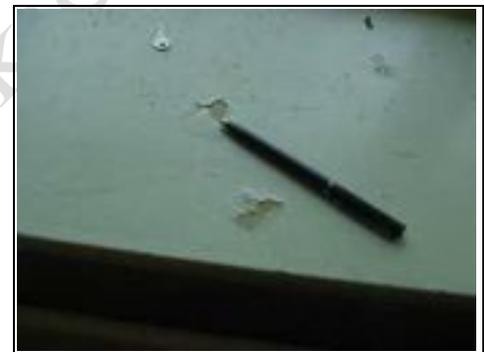
Peeling paint noted on the window sill- this is a sign of condensation

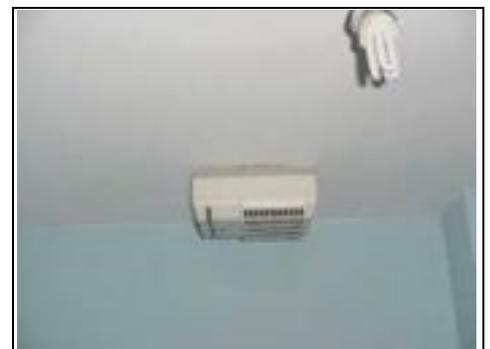
Insufficient extract fan in bathroom

A way of helping to reduce condensation is to have good large extract fans with large humidity controlled thermostats within the kitchens and bathrooms and also in any areas where you intend to dry clothes which are moisture generating areas.

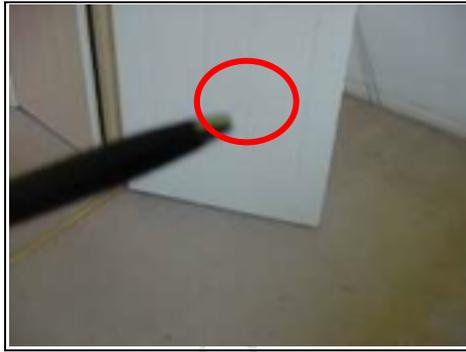
The property has modern hollow egg box construction doors. We noted some damage to the doors and some of the ironmongery needs repairing or replacing.

Damage to door

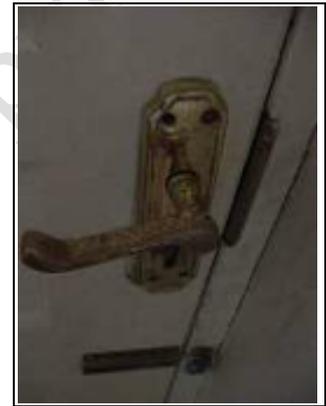
Ironmongery needs repair/replacing

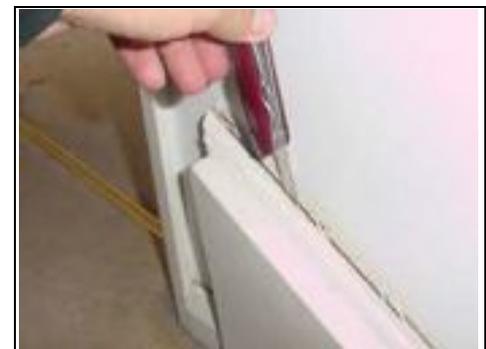
The skirtings are coming away on the staircase, again indicating some movement in the property; please see our comments on the drains in the Executive Summary

Skirting coming away from stairs

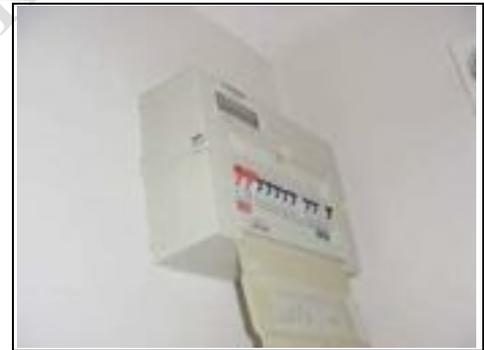
The electric fuses and consumer units were located in the cloakroom on the ground floor. The fuse board looked to be original and better are now available.

Fuse Board

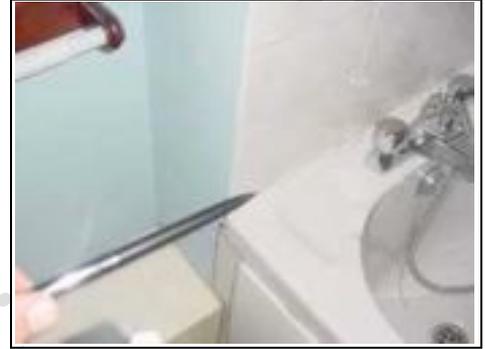
The property has a three piece bathroom suite, consisting of a bath, wash hand basin and WC, which looks in average condition, subject to some day-to-day wear and tear, as one would expect. We noticed that the mastic seals have deteriorated and if the bath is to be used then you need to re-new the seals.

The bath needs to be re-sealed

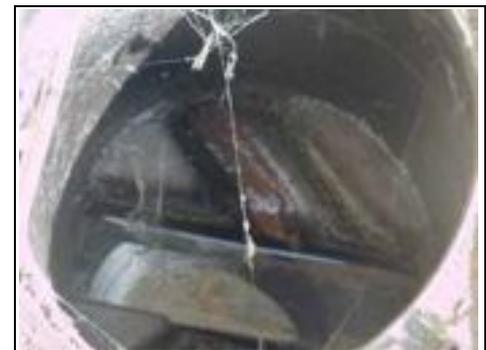
Whilst we ran the tap for 15 minutes we are concerned that water is sitting in the drains and would recommend a closed circuit TV camera report is carried out to be certain of the condition of the drains.

Water sitting in manhole after we turned the taps on

**ACTION REQUIRED:** Please see our comments in the Executive Summary.
