RESIDENTIAL BUILDING SURVEY

XXX

Wood Green,
London.
N22 XXX

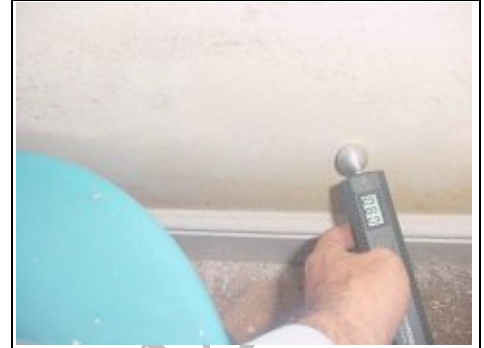
The property has dampness throughout which we believe has been caused by a combination of things. The dampness has been visually checked for and is obvious in many areas but we have also used an electronic damp resistance meter which can be seen in the photo.

Testing for dampness

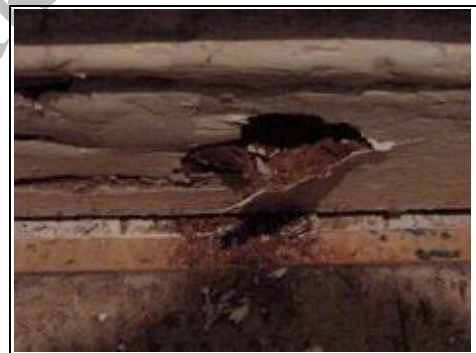
We believe that the dampness and the lack of air flow underneath the property have caused dry rot. If this is not the case then there is certainly a severe case of wet rot. We cannot be one hundred per cent certain of which this is without opening up the floor.

Dry rot

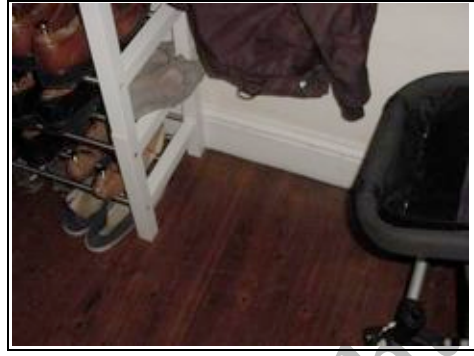
We visited a neighbouring property which has undergone a complete refurbishment however the floor in that property also feels soft underfoot. In this case it may not be possible to solve the problem of dry rot as even if you resolve it in your side of the property it could return, unless of course the neighbour is prepared to carry out works to their property.

Neighbours property, adjacent area to where dry rot is. New skirting and flooring added

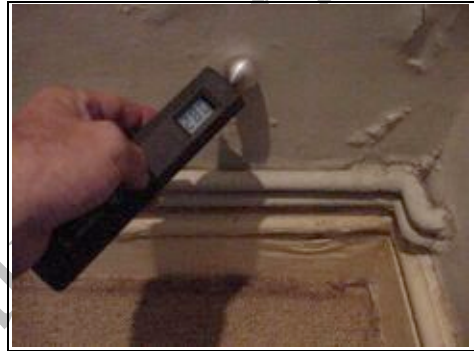
We believe this problem relates to the lack of airflow underneath the building and the concrete slab to the rear of the property. We recorded damp readings in the 70's to 90's when typically we would expect reading in these areas to be in the 30's to 60's.

High damp readings

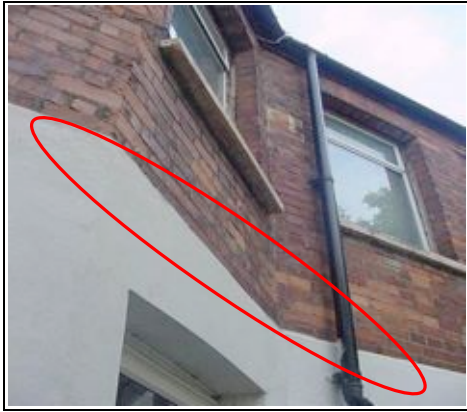
The render to the property is not detailed correctly where it meets the brickwork and is allowing water/dampness down the back of it. We noted blistering and also cracking in the render caused by the use of a plastic based paint.

Incorrect detail where render meets brickwork allows the water to travel down the back of the render

ACTION REQUIRED: This is a very difficult detail to resolve with regards to the render. We have seen these details masticed and also lead put over them but at the end of the day we feel that the detail is poor and that the rendering should be continued to the top of the building as the bricks at first floor level are in poor condition.

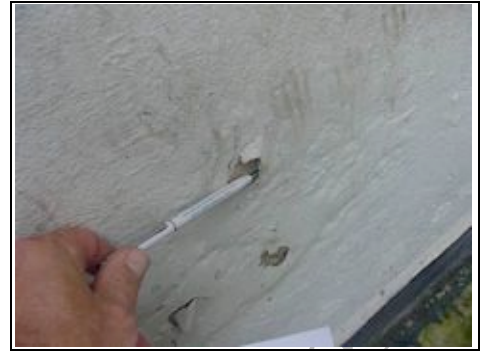
Blistering due to the use of plastic based paint

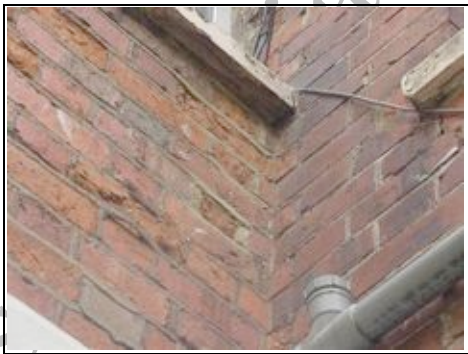
We noted incorrect re-pointing carried out in a cement mortar and spalling to the brick work. This re-pointing should have been carried out in a lime mortar that allows older properties such as this to breathe.

Spalling brick work

ACTION REQUIRED: We would recommend that the rear upper parts of the property are rendered and painted. This will be a shared cost.

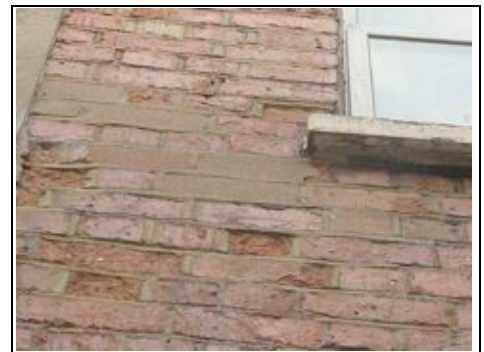
Cement re-pointing

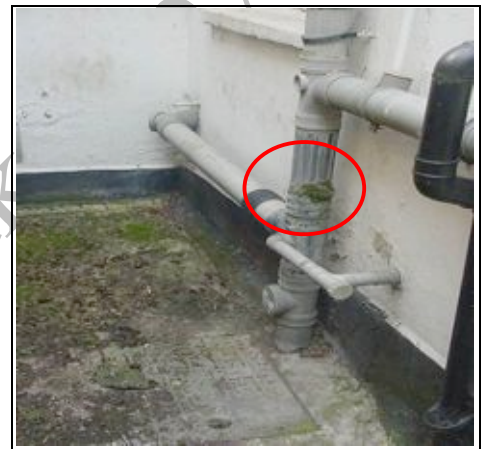
We noted to the rear right hand side that the soil and vent pipe is discharging sewerage. This will be a shared cost to resolve.

Soil and vent pipe is leaking

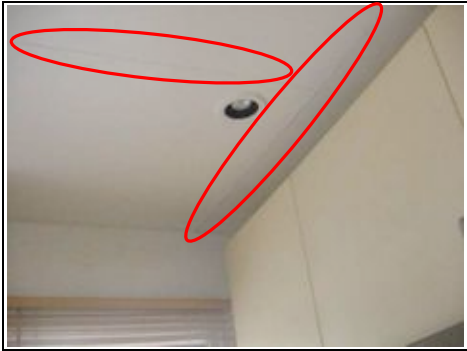
We noted hairline cracking to the front lounge in the lath and plaster ceiling and also to the plasterboard within the kitchen area. Both cracks are acceptable for the age of the property and indicate there may have been a slight twist in the building. This is nothing unusual for a terraced property built in clay soil near to a tree.

Cracking to the plasterboard in the kitchen

ACTION REQUIRED: Fill the cracks and redecorate. However it is very likely the cracks will reappear.

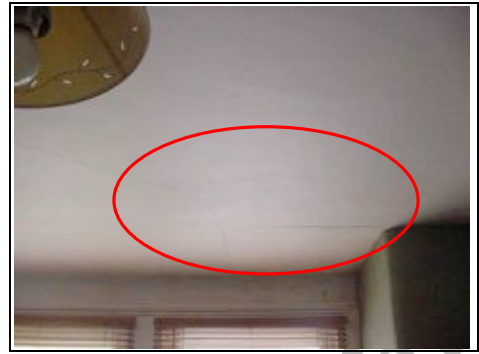
Cracking to front lounge ceiling

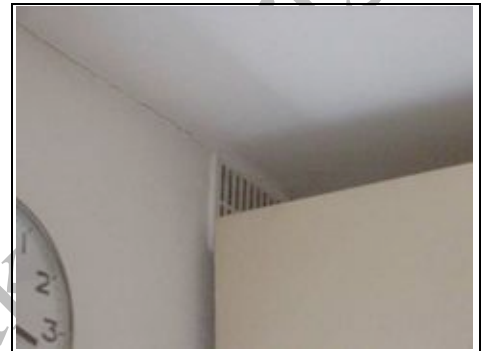
Cracking in kitchen due to mixing old and new materials

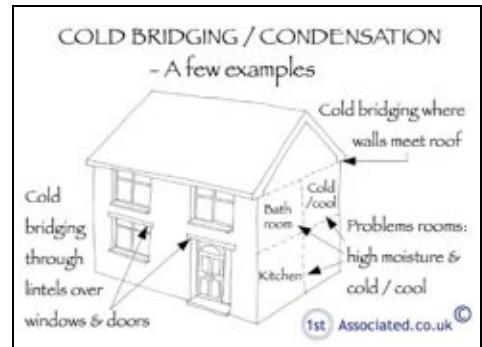
A characteristic of this property is that it will suffer from cold bridging due to the era it was constructed in and elements within it. For example, within the kitchen and bathroom there are no extract fans to remove moisture which then tends to cause condensation.

Cold bridging

ACTION REQUIRED: We would recommend that large humidity controlled extract fans are added.

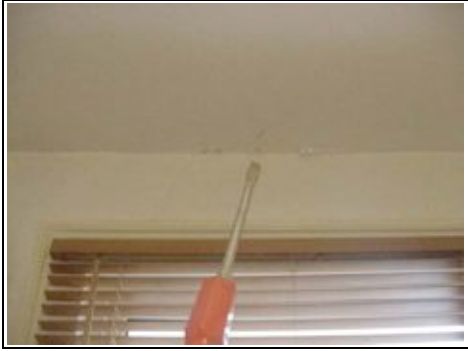
Peeling paint visible in bathroom caused by condensation

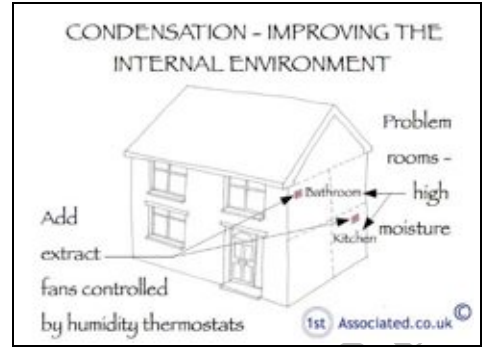
Condensation

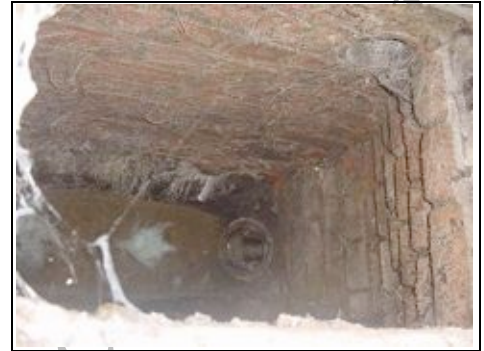
During our inspection we noted that the front manhole has roots growing within it.

Roots in the front manhole

ACTION REQUIRED: The roots in the front drain need to be cut back/killed and repairs/improvements need to be carried out to the rear manhole to bring it up to standard.

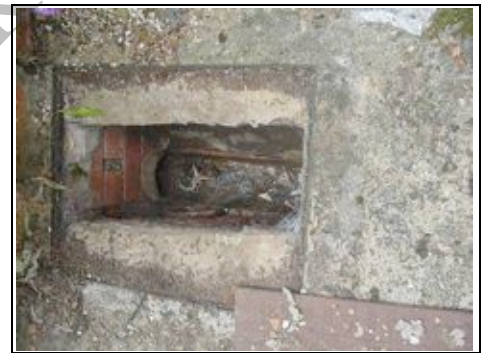
The manhole to the rear right hand corner has been built to a DIY standard with no shoes to the incoming pipe and the manhole is generally very narrow with some deterioration to the brickwork.

DIY standard manhole

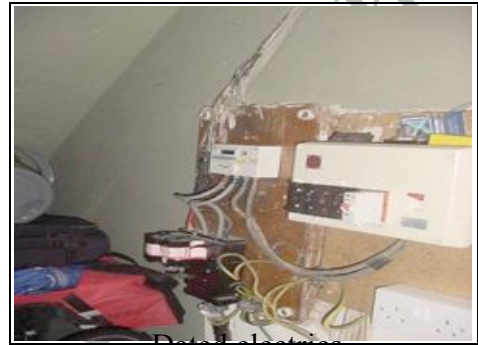
Dated electrics

ACTION REQUIRED: We would recommend that this is replaced and an Institute of Electrical Engineers (IEE) test and report is carried out by an NICEIC registered and approved electrical contractor or equivalent .

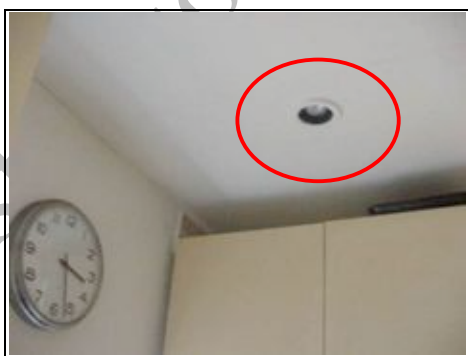
The lighting is dated and may have faulty fittings. We are aware that fires have been caused by this type of fitting. In fact we surveyed a property a few weeks ago where the entire roof had been destroyed by fire.

Ceiling light, circa 1970's

ACTION REQUIRED: Replace with low voltage lights ideally LED lights.

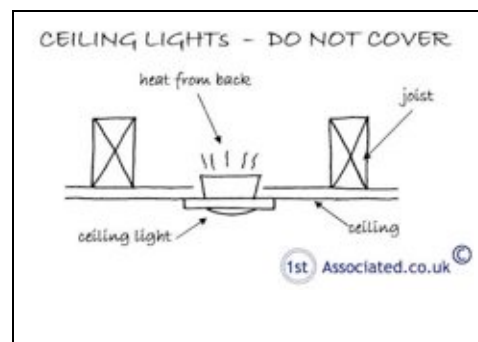
Ceiling lights

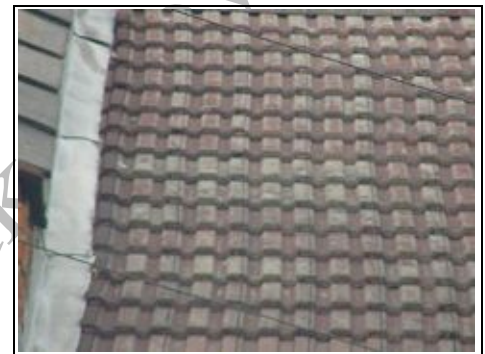
The main roof is pitched and clad with concrete tiles, and, from ground level, this looks in below average condition considering the roofs age type and style. We noted that the red protective coating to the concrete tiles is wearing away. This is something we are coming across more often and it leaves the white exposed concrete of the tiles beneath and which we would say the jury is still out on as to how well this weathers.

Concrete tiles on main roof

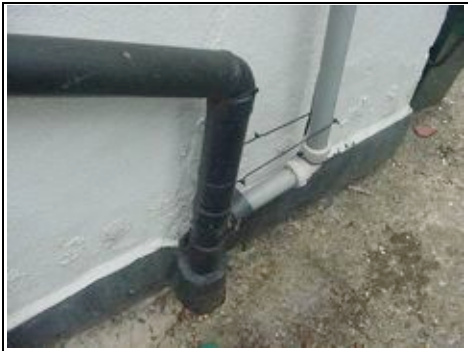
The soil and vent pipes and wastepipes are plastic. We noted they were discharging sewerage.

Cable ties holding plumbing together

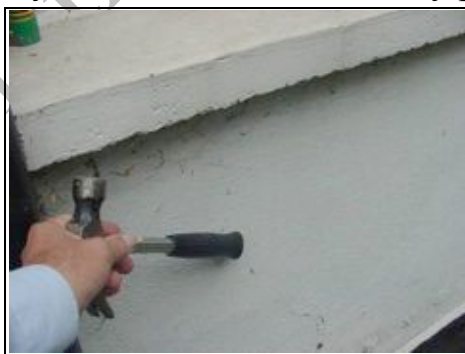
We have carried out a tap test (literally hitting the render with the back of a hammer). We found it to be in below average condition for its age, type and style with about ten to twenty per cent of hollow areas.

Tap test

ACTION REQUIRED: We would recommend in the summer of 2014 that the whole of the render on both this ground floor flat and the upstairs neighbours flat is tap tested and checked for hollow areas and then work carried out.

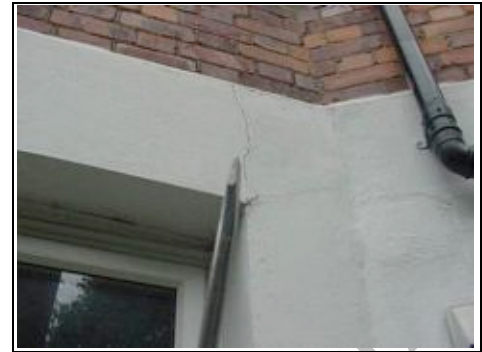
We believe this cracking has been caused by the detail between the render and the brickwork and as such is very difficult to resolve one hundred per cent. Please see our comments within the Executive Summary.

Cracking around window

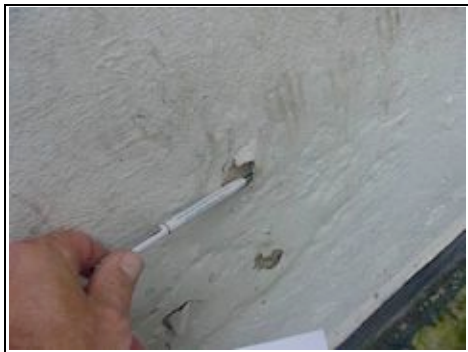
Blistering render

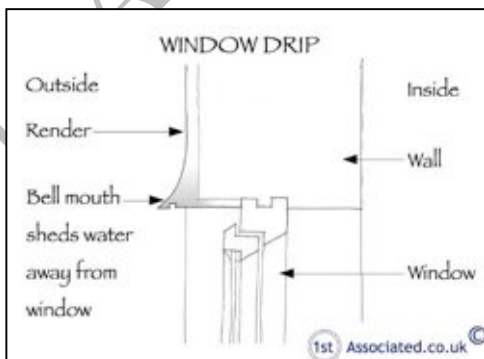
In this case we found no drip detail to the windows.

Window drip detail

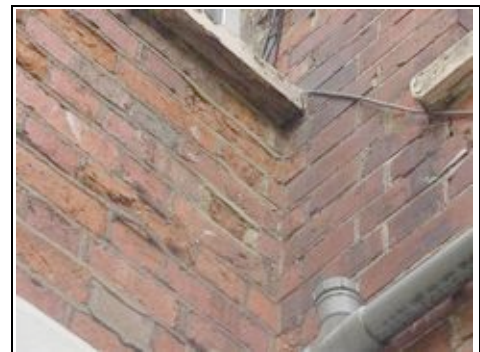
Spalling brickwork

ACTION REQUIRED: Please see our comments within the Executive Summary.

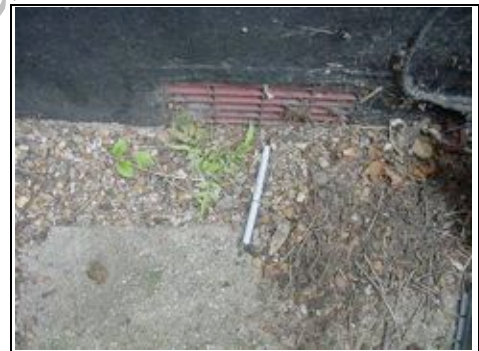
In this case we can see the airbricks to the front are acting as gutters and/or have been concealed.

Air brick acting as a gutter

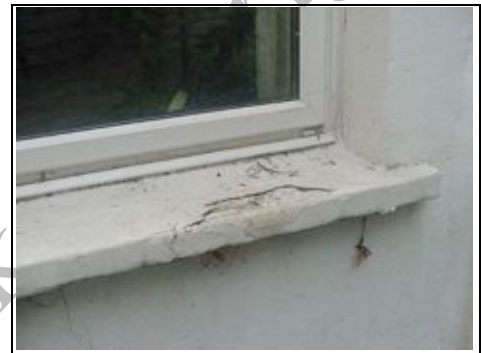
The sills seem to be quite level and did not allow water to run off them. You can see in the photo that where the water has sat on the sill it has generally deteriorated.

Window sills need repair

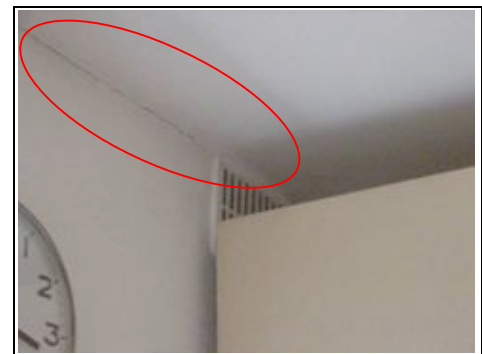
Cracking where walls meet the ceiling

ACTION REQUIRED: Please see our comments within the Executive Summary.

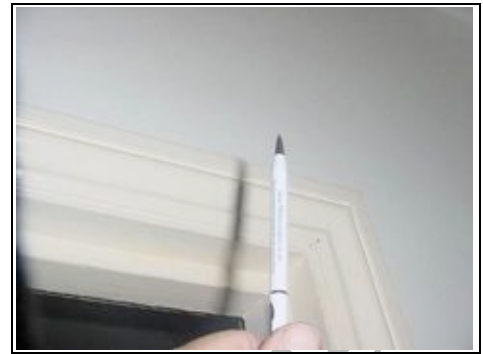
Cracking above lounge door

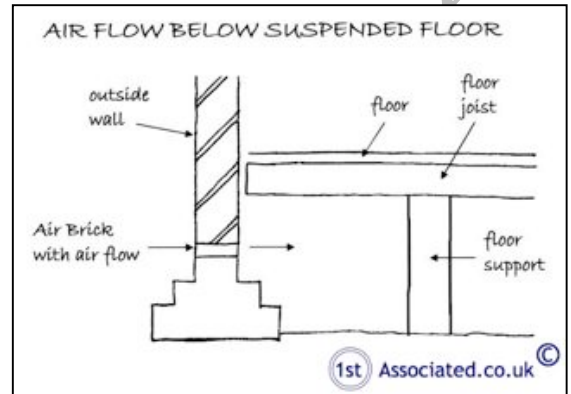
The timber floor feels very soft underfoot which is why we think there is either dry rot or wet rot.

Suspended timber floor

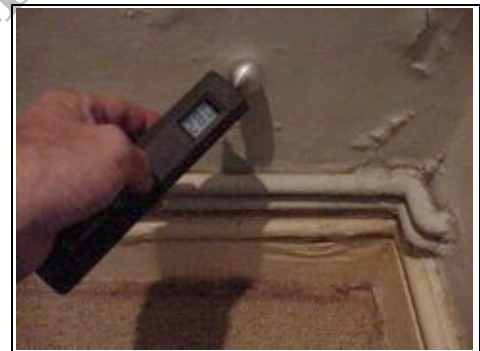
A random visual inspection and tests with a moisture meter have been taken to the perimeter walls. In this particular case we have found rising damp throughout the property.

Testing for rising damp

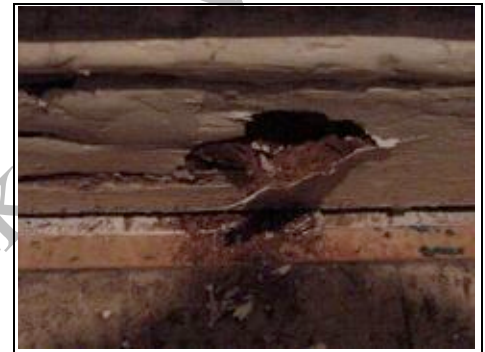
Dry rot

ACTION REQUIRED: We would recommend that the floor is opened up before you purchase the property and a massive discount obtained. Please see our comments within the Executive Summary.

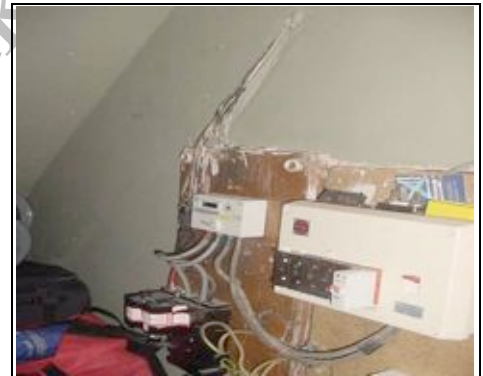
Fuse Board

ACTION REQUIRED: We would recommend this is replaced.

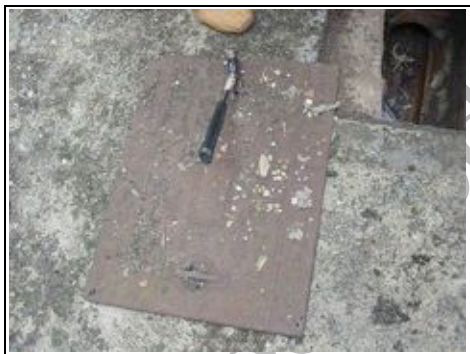
Rusting manhole cover

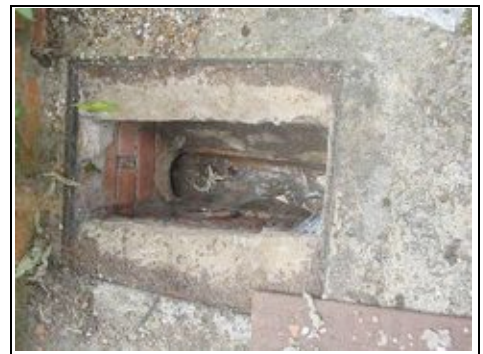
DIY standard
