# RESIDENTIAL BUILDING SURVEY

XXXXXXXXXX,  
Stroud Green,  
Finsbury Park,  
N4 xxx

Firstly, may we thank you for your instructions of xxxxxxxxxxxx; we have now undertaken a Building Survey (formerly known as a Structural Survey) of the aforementioned property. This Survey was carried out on xxxxxxxxxxxx.

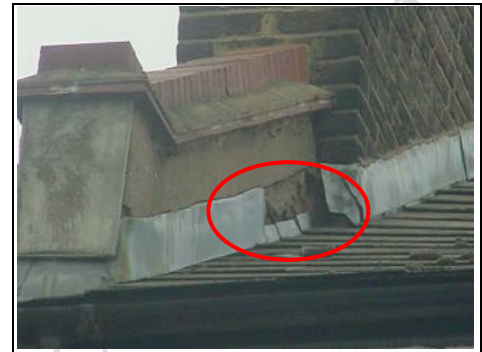
We can see the lead flashing has come away to the parapet wall. There could be problems with dampness getting into the structure as we note the parapet wall is rendered. This is often carried out when there are dampness problems.

Lead flashing has come away

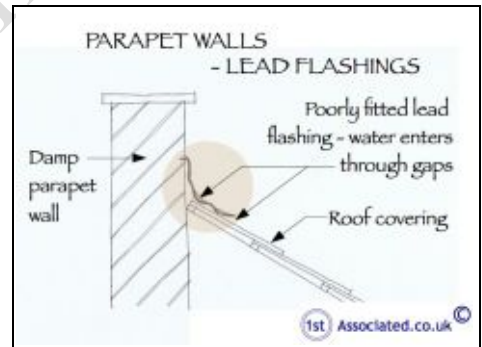
Poorly fitted lead flashing

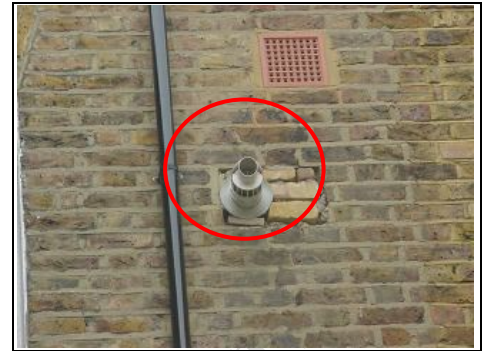
It should be noted that boilers have been added to the property and we could see to the rear, where the flues protrude, that these have not been bricked in and sealed properly. This, we would suggest, is due to the expense of carrying out high level work externally as it requires scaffolding.

Flues have not been blocked in properly

**ACTION REQUIRED:** At some point there should be a shared cost with regard to carrying out repairs to the flues. It may be possible to gain access to carry out the work via a scaffolding tower.

**ANTICIPATED COST:** A few hundred pounds, plus the cost of the tower scaffolding; please obtain quotations.

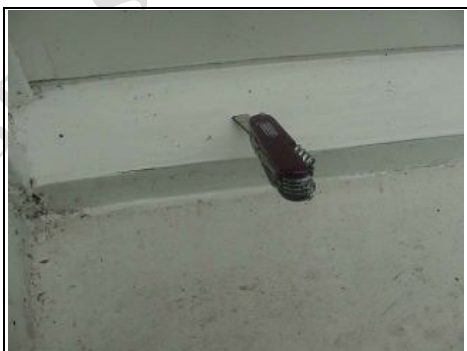
When we carried out our knife test on the timber windows we found them to be softer than expected.

Knife test

**ACTION REQUIRED:** It appears as if the windows have been filled over the years and they may require timber splicing in the next time they are repaired.

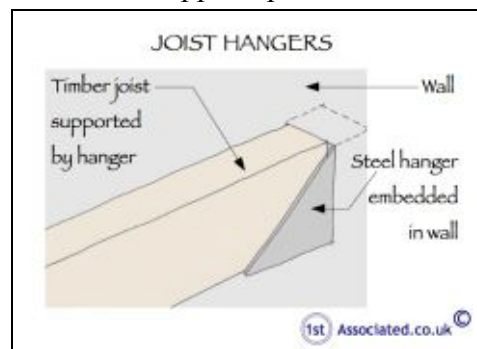
New timber beams supporting the floor with joist hangers on the right hand side

Joist hanger

**ACTION REQUIRED:** Propping of the floor is not an ideal solution. Some of the work is DIY standard and other work looks to have been carried out professionally where joist hangers are in place, although the timber does seem very thin. To some extent this area is not our main concern as it is accessible and therefore repairable. It will of course be necessary that everyone in the building has a share in the cost of this repair. We would recommend a meeting with the owners of the other flats in the building to explain the problems that have been found.

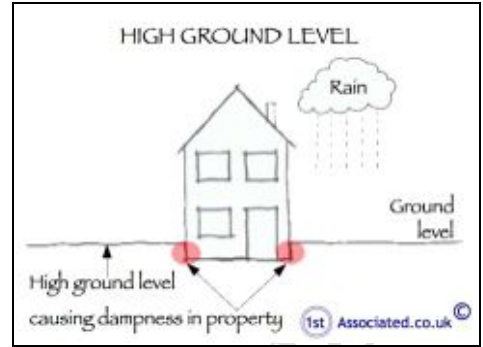
We found dampness in the property with readings higher than we would normally expect. We believe this is likely to be due to high ground levels and the re-pointing of the property which has been carried out in a cement mortar (more about this later).

Our concern is that the dampness has affected the suspended timber floor in the property.

High ground level

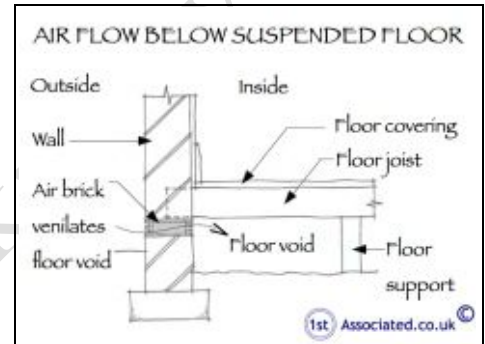
Air flow under the suspended floor

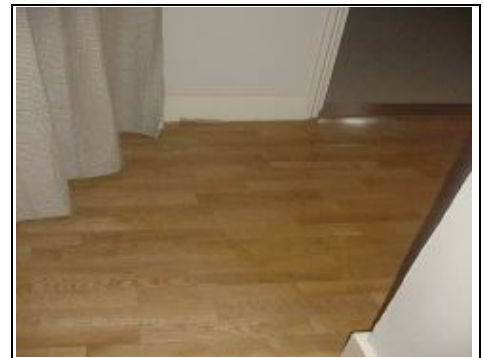
If you recall we carried out an impact test (jumping up and down) in the lounge and we found deflection over and above what we would expect around the bay window.

Laminate flooring hiding the floor beneath

**ACTION REQUIRED:** Ultimately this area of the floor needs to be lifted and inspected before the winter of 2013. The worst case scenario would be woodworm, wet rot or even dry rot and in which case the timber would need replacing.

**ANTICIPATED COST:** Dependent upon the extent of the problem the cost would range from £1,000 to £5,000. You

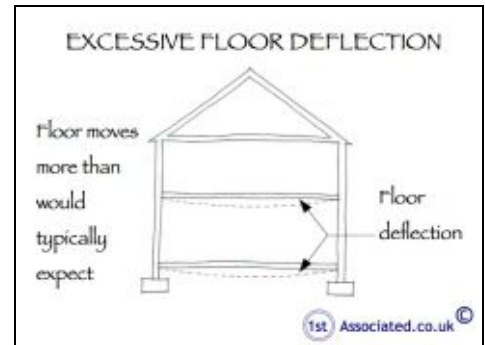
Deflection

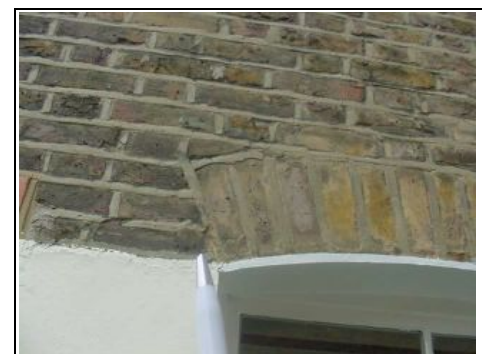
Bricks re-pointed in cement mortar

Unfortunately the cement re-pointing, whilst well meaning, is not appropriate for this type of older construction. This has been used instead of a lime based mortar. We recommend you use lime mortar in any future repairs regardless of what the builders say! Using lime mortar will limit further damage to the brickwork, which is almost impossible to repair successfully. We would add that many, if not most, of the properties that are re-pointed now are re-pointed wrongly; it is only in recent years that we have discovered the problems that can occur from it.

**ACTION REQUIRED:** The cement mortar should be removed (it will eventually fall out on its own but a soft brush will help it). We recommend you find the oldest, time served brick layer that you can who is able to carry out the re-pointing in lime mortar and to gradually replace sections of the cement mortar with lime mortar over the years.

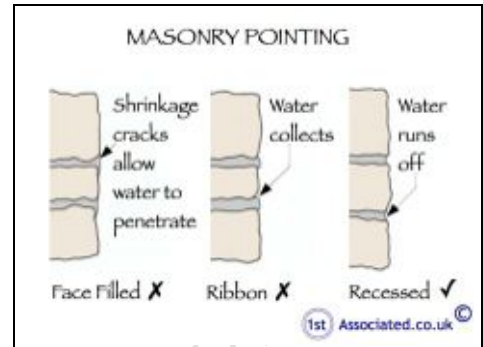
Re-pointing

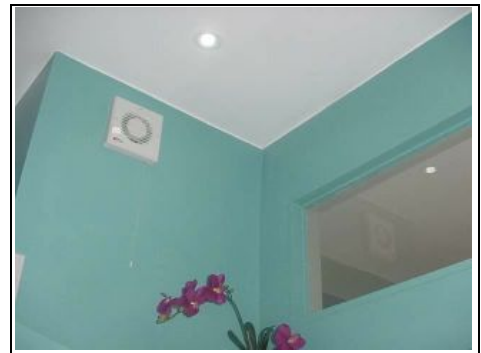
The property has an internal shower room which would usually tend to cause condensation in properties.

This small extract fan should be replaced with a large humidity controlled extract fan

**ACTION REQUIRED:** We would recommend that the present extract fan is replaced with a humidity controlled extract fan. As discussed, there should be an over run on the extract fan which, at present, there isn't. We also think that bigger and better are now available such as these humidity controlled extract fans. At the same time we would also add a fan to the kitchen/breakfast room to reduce humidity in this area.

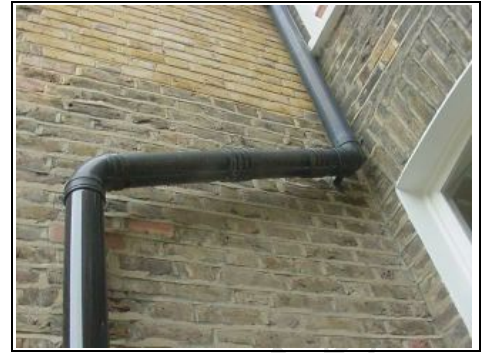
To the rear of the property is what we term as DIY drainage and what looks to be a spaghetti junction of soil and vent pipes and wastepipes. These have such sharp swan neck bends that there is a possibility that they will leak.

Soils and vent pipe with swan neck bend

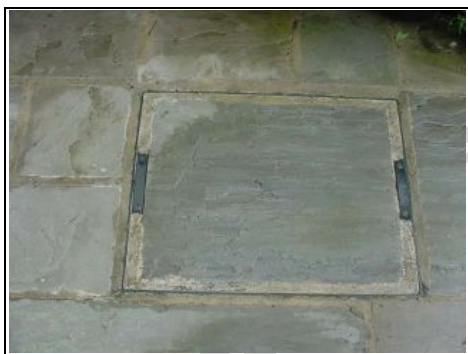
If you recall, we also mentioned that the rear drain looks to have been replaced. In this age of property there are many problems associated with drains as they often had push fit drains which leaked. Originally drains for this era of property would have been the latest thing!

Drain to the rear  
We did not lift this

**ACTION REQUIRED:** Your solicitor to enquire in writing if there are any problems with the drains and also we would recommend that as part of the shared responsibility and shared costs that a closed circuit TV camera report should be carried out to check the condition of the drains.

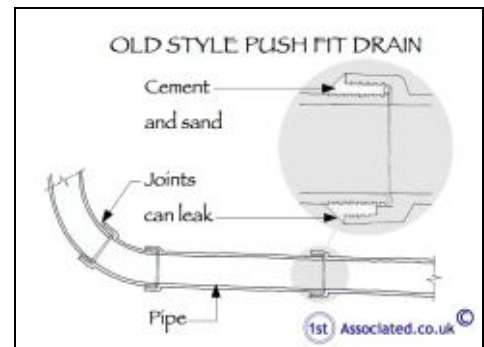
Push fit drains

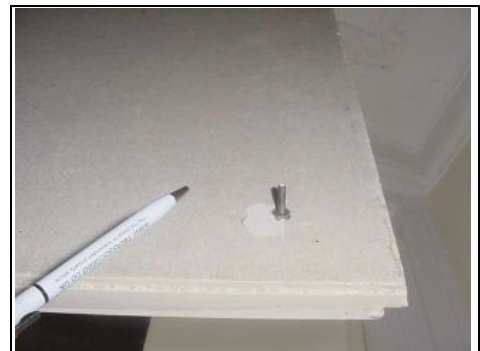
We found what could be an Asbestos lining to the electric cupboard and also to the basement area. Asbestos was a very common material that was used in years gone by and now has many health hazards associated with it. You can Google this to find out more on Asbestos.

Possible Asbestos in the door  
This should be a half an hour to an hour fire resistant door

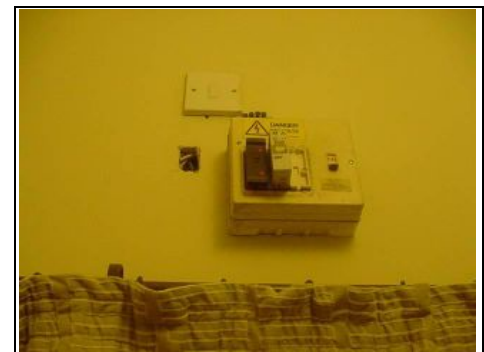
Dated electrics

**ACTION REQUIRED:** We would recommend that you replace this with a modern fuse board and at the same time you may wish to add extra electrical points and the property did not appear to have very many ( this is often the case with older properties).

**ANTICIPATED COST:** £250 to £500 to replace the fuse board. You may also require extra socket points added an extra cost; please obtain quotations.

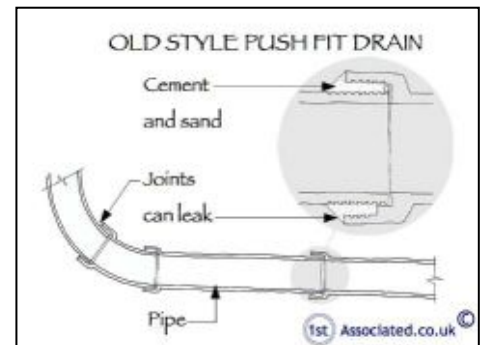
In older properties, such as this, drainage was often push fitted together rather than bonded together which means that they may leak over the years. Whilst we ran the tap for 15 minutes without any build up or blockages the only way to be 100% certain of the condition of the drains is to have a closed circuit TV camera report.

Push fit drain

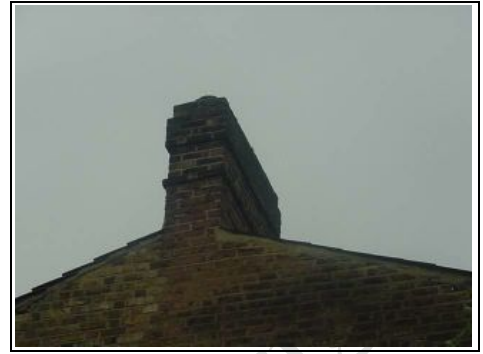
The chimney to the rear of the property is also brick built and was built in a similar manner to the first chimney, though we would comment that this one appeared to be in need of some re-pointing work.

Chimney rear

**ACTION REQUIRED:** When work is carried out to the rear of the property we would recommend that the rear chimney and parapet wall are re-pointed, no later than 2014.

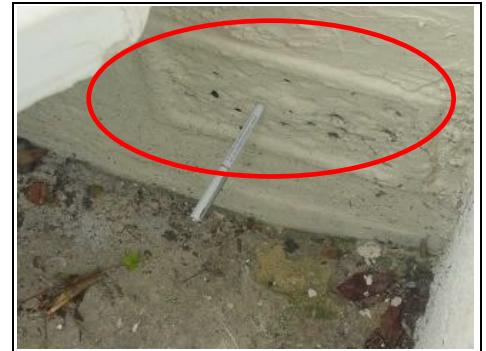
Airbrick to the front needs unblocking to allow airflow under the suspended timber floor

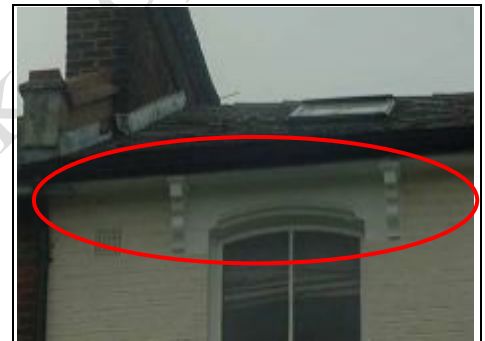
The fascias and soffits are timber with brackets. They are painted and we would comment they are in below average condition for their age, type and style due to the fact that the fascia is coming away.

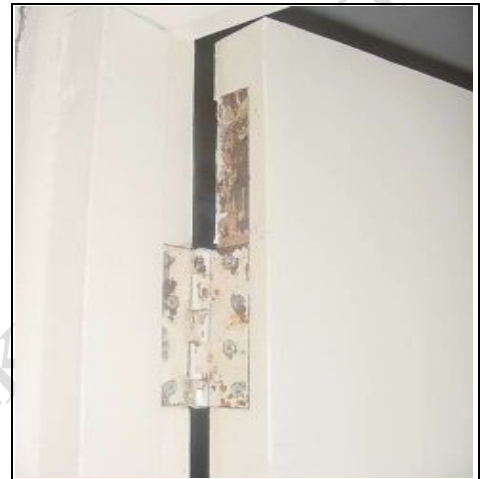
Hinge has been moved on the door

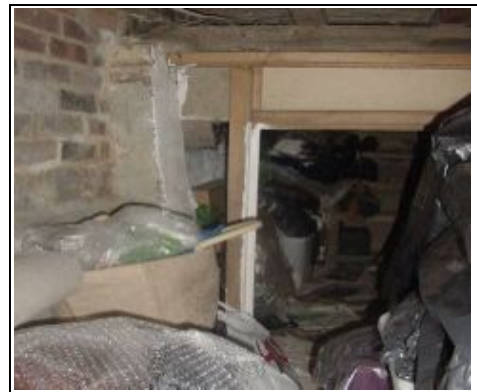
We can see the suspended timber floor from within the cellar which also forms the ceiling of the cellar. We can see that props have been added to the floor.

General view of the cellar

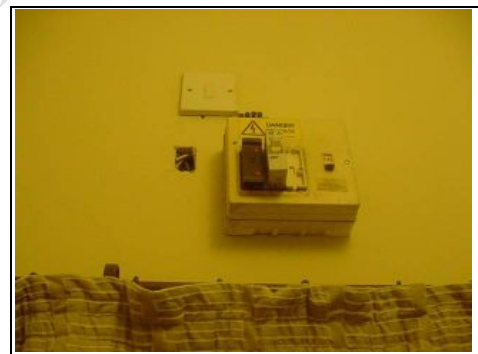
The electric fuses and consumer units were located in the entrance hallway. The fuse board looked dated, circa 1960's, and better are now available. In multi occupied properties a defective fuse board can be particularly dangerous. All the flats should have their electrics tested as a fire above you could obviously be a problem almost as much as if it were within your property.

Fuse Board

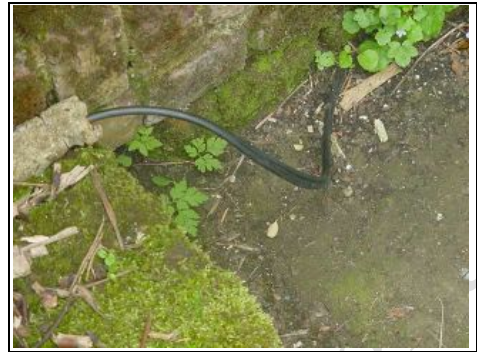
This can often be chewed or eaten by rodents. We have recently heard that they consider this food!

Exposed cable in garden

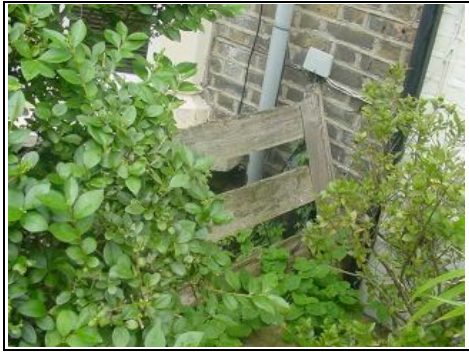
Fence missing front  
left hand side
