RESIDENTIAL BUILDING SURVEY

**Dulwich,
London.
SE22 XXX.**

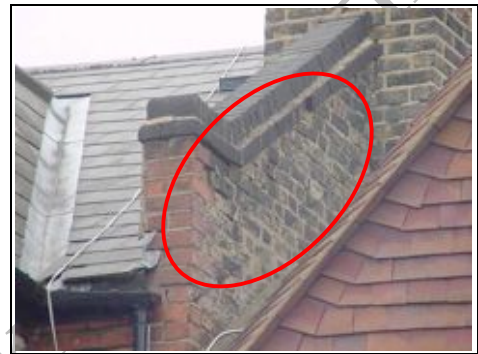
We could see that the left parapet wall needs re-pointing. Usually areas at high level weather more than those at low level. There may also be some re-pointing needed to the chimney areas. Unfortunately, we cannot see the chimney areas properly and in the case of the rear chimney, not at all.

ACTION REQUIRED: We would recommend re-pointing the parapet wall within the next two years and that you also check the flashings and the chimneys.

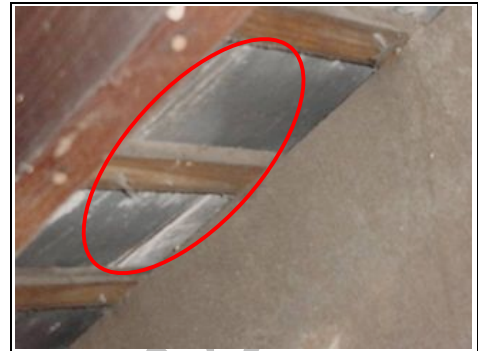
Rear roof

Slates are visible where the protective underlayer has deteriorated (see the next section)

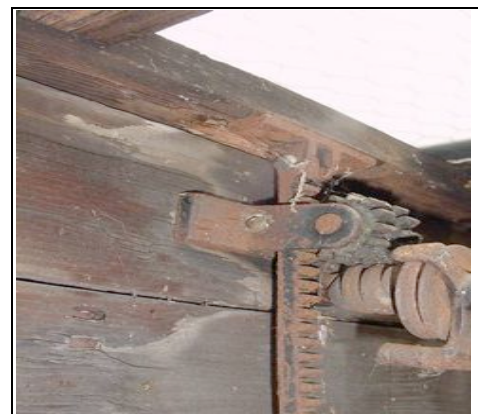
There is a roof window to the roof but unfortunately we were unable to open this window to view the roof. The window has a metal mechanism that opens it but this has rusted. We can see some dampness coming in via the window and is probably the reason the mechanism has rusted over.

Mechanism for opening the window has rusted

ACTION REQUIRED: We would recommend that the window mechanism is eased and adjusted to get this in working order. It would be a shame to have to replace it as it has an almost antique value! This would then allow a proper view of the rear roof, parapet walls and rear chimney.

ANTICIPATED COST: Likely to be in the region of a few hundred pounds but would save the cost of a tower scaffold to the rear as it will allow the roof to be viewed; please obtain quotations.

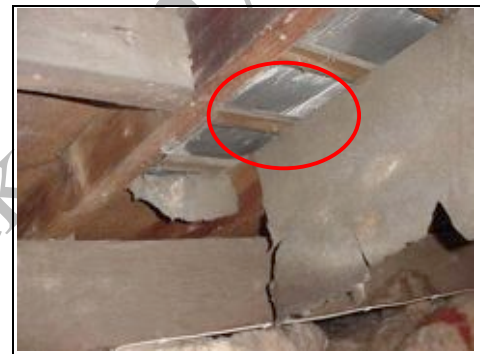
Protective underlayer

The roof has one of the earliest types of protective underlayers known as building paper; this is deteriorating more than we would usually expect to see. Without the secondary protective underlayer the roof is more prone to leaking.

Where the building paper is deteriorating we can see white on the tiles which is salt from the rain water getting through

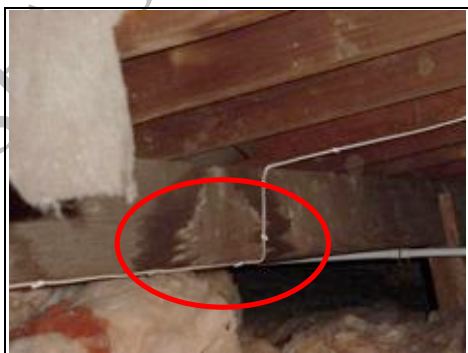
Where the protective underlayer has deteriorated we can see dampness is getting into the property.

Dampness coming in where the building paper has deteriorated

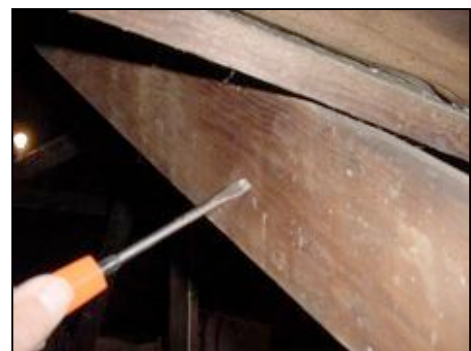
Checking to see if the timber is soft that would indicate woodworm, wet rot or dry rot

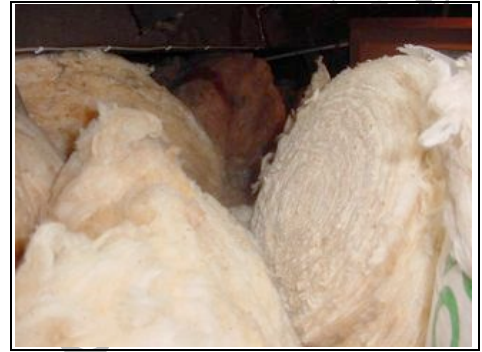
Mass of insulation

There is a mass of insulation within the roof and also bundles of excess insulation. This combined with the lack of ventilation in the roof may have caused condensation in the roof space which could explain why the building paper has deteriorated.

Bundles of excess insulation

ACTION REQUIRED: To replace all of the underlayer is almost as expensive as re-roofing the property as it would require scaffolding which is a major cost. It would also require removing all of the roof tiles and battens then adding the protective under layer and then re-battening and re-tiling. We would therefore recommend patch repairs are carried out. We would also recommend adding ventilation to the roof.

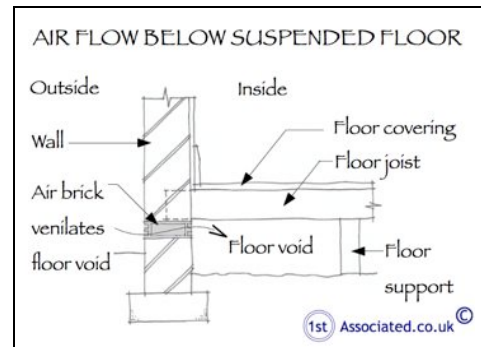
Suspended timber floor

The property has a suspended timber floor which needs airflow underneath it via airbricks to prevent deterioration. We can see that the airbricks to the rear of the property are too low.

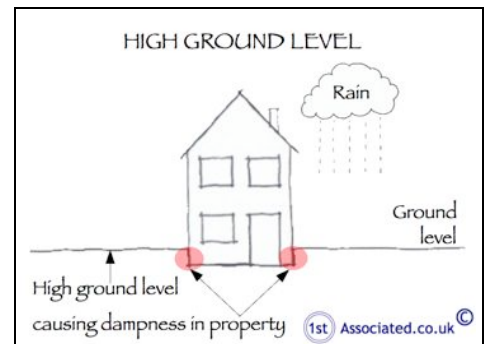
High ground level, the airbricks have been covered over

High ground level

This means that the floor may have problems with wet rot or in a worst case scenario dry rot and wood worm. We simply cannot see this to advise as the top of the floor has then been covered with a laminate flooring, this stops the floor from breathing and seals in any dampness problems.

ACTION REQUIRED: A worst case scenario will mean replacing floorboards due to wet rot, dry rot or woodworm. You need to open up all the airbricks and ensure they are protected from acting as gutters allowing water into the property. We would suggest lifting a section of floor beneath the staircase to check the condition.

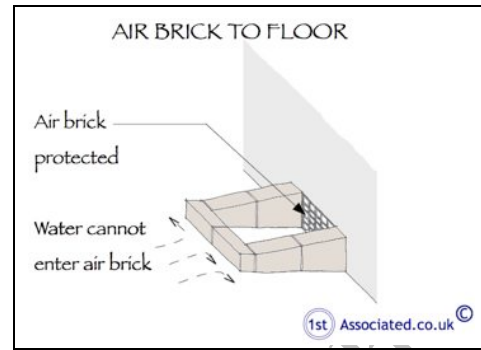
Protected air brick stops water entering the air brick.

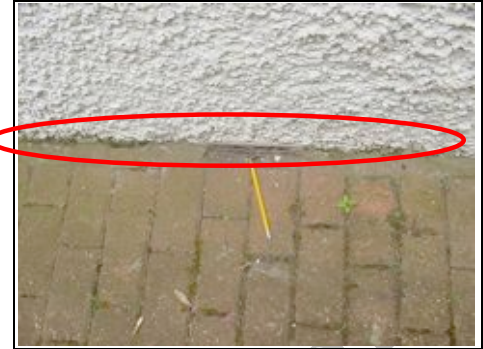
Bell mouth detail

No bell mouth to render

ACTION REQUIRED: We would recommend that a bell mouth is added to the base of the property to reduce dampness.

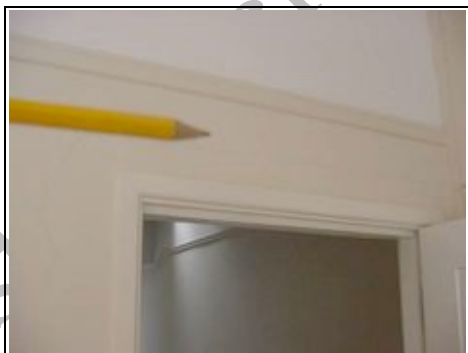
There is hairline cracking to the front bedroom around the door. We can also see some movement to the doors and door frames.

Hairline cracking above and to the side of the door to the master bedroom

This is not that unusual in this age of property and we suspect it may relate to the drains leaking as originally in this age of property they would have been push-fit drains.

ACTION REQUIRED: Your Legal Advisor to specifically ask in writing if repair work has been carried out to the drainage system. We would also enquire with the insurers to see if there have been any problems in relation to the drains and associated insurance claims that may affect your premium or your ability to obtain insurance.

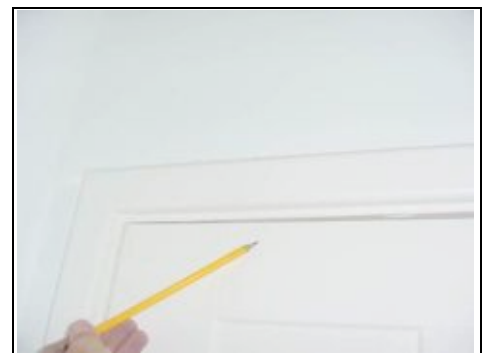
Doors can show signs of movement

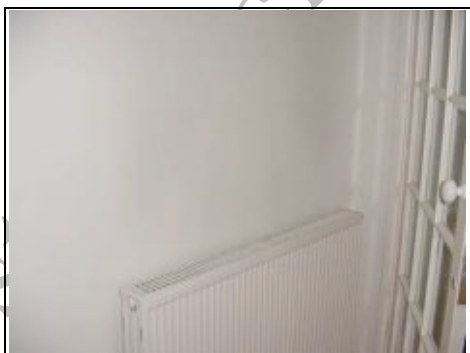
We noted some internal radiators. These do not allow the air to flow as well as radiators placed under the windows.

Internal radiator

ACTION REQUIRED: Ideally, where possible, move them under the window otherwise ensure there are large humidity controlled extract fans in the kitchen, bathroom, en suite and any room used for laundry/drying of clothes.

ANTICIPATED COST: A large humidity controlled extract fan is usually £200 - £300; please obtain quotations

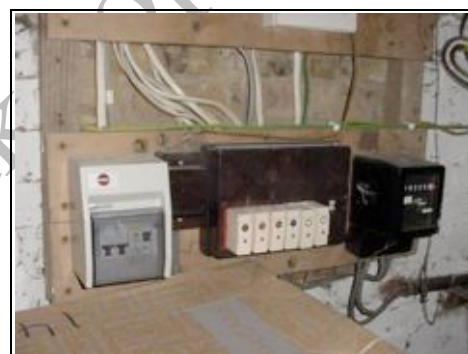
Fuse board

As previously mentioned the electric fuse board is dated and we would recommend it is replaced. The Institute of Electrical Engineers standards (IEE) recommend a test and report whenever a property changes occupancy. This should be carried out by an NICEIC registered and approved electrical contractor or equivalent.

ACTION REQUIRED: We would recommend that the fuse board is upgraded.

ANTICIPATED COST: £300 to £600 to replace the fuse board. At the same time we would allow for new socket points; please obtain quotations.

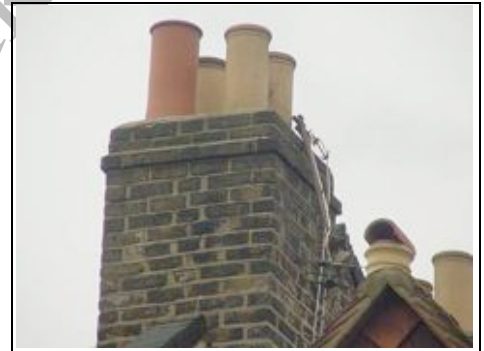
Chimney- front left

This chimney is brick built with four chimney pots (two of which we believe are yours). We could not see the flashing properly. From what we could see from ground level it looked in average condition considering its age, type and style but we would add that we could only see two sides of it.

ACTION REQUIRED: We noted that the parapet wall was weathered and needs re-pointing so we would check the chimney when the work to the parapet wall is being carried out.

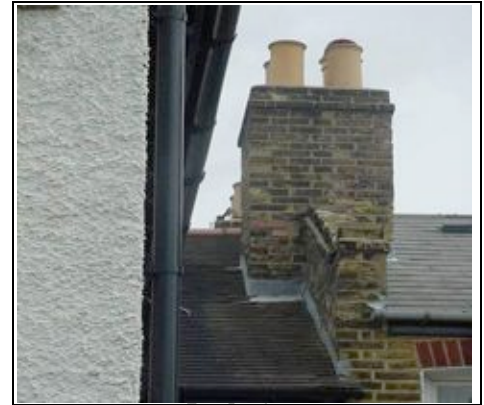
Rear left chimney

This chimney is brick built with a lead flashing and four pots (two of which we believe are yours). From what we could see from ground level it looked in average condition considering its age, type and style but in this case our view was very limited to the left side of the chimney (all directions given as you face the front of the property).

ACTION REQUIRED: Again we would comment that the parapet wall has deteriorated and weathered and we would recommend that this chimney is checked as well when work is carried out to the parapet wall. You may be able to get a better view once the roof window is opened up. Please see our comment on this within the Executive Summary.

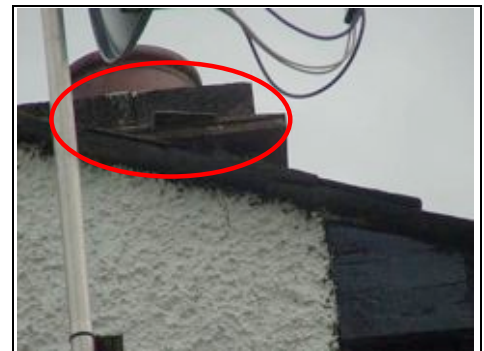
Rear chimney

Only the chimney pot is visible

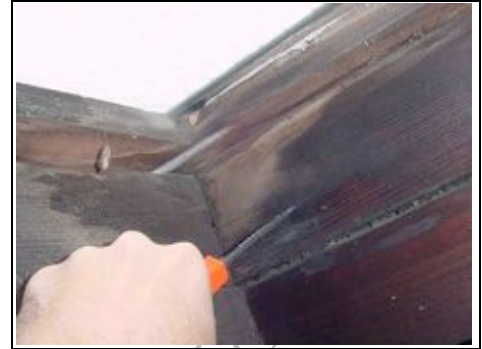
We could not open the purpose made roof window but we could see some dampness was getting in. Ideally we would have liked to open this window so that we could see the chimneys and parapet walls as well as the rear roof.

Roof window, dampness is coming in

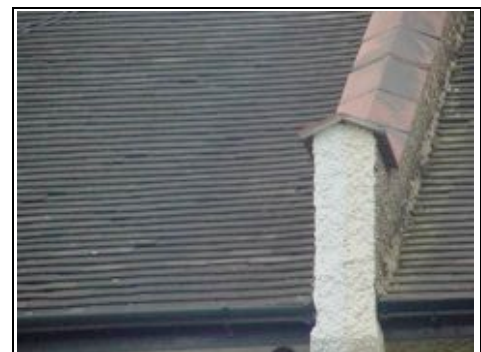
With this age of roof there will usually be a few missing or displaced tiles and which there is in this case, this is nothing unusual. Our concern with the missing tiles is that the secondary protective underlayer also known as sarking felt is deteriorating.

Slipped tiles

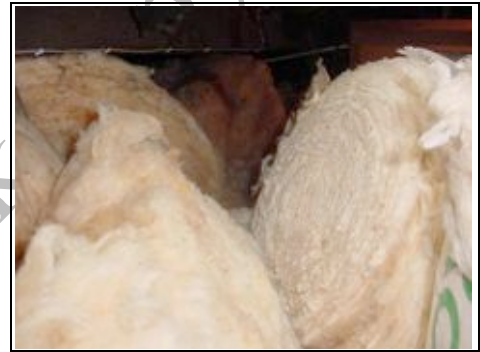
Our examination was limited by the general configuration of the roof, the mass of insulation and the bundles of insulation that have literally been left in the roof together with stored items. What we could see was generally found to be in slightly below average condition for its age, type and style particularly due to the condition of the underlayer. It is, however, feasible that there are problems in the roof that are hidden.

Bundles of insulation. This is the problem when you pay for an amount of insulation rather than for it to be installed properly

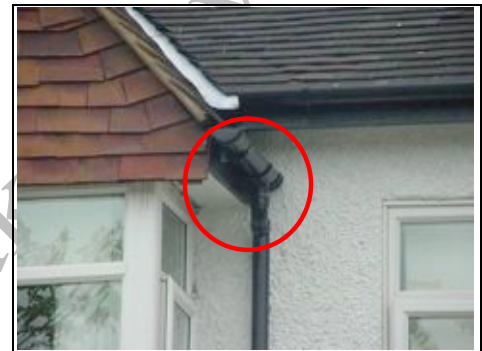
We also recommend that the gutters and downpipes are cleaned out as we can see what looks to be a piece of pipe in the gutter. The joints also need to be checked and the alignment checked to ensure that the gutters fall towards the downpipes.

Plastic gutters and downpipes

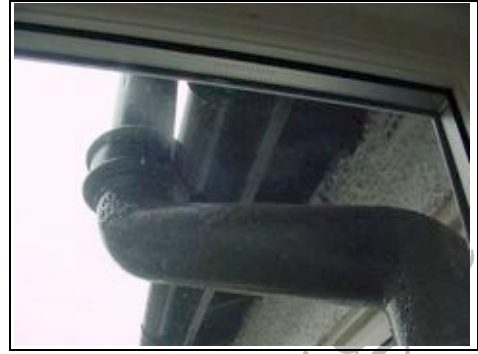
The property has a combination of cast iron and plastic soil and vent pipes. Cast iron of this age can crack and rust and needs regular maintenance particularly painting around the back of it.

Cast iron soil and vent pipe

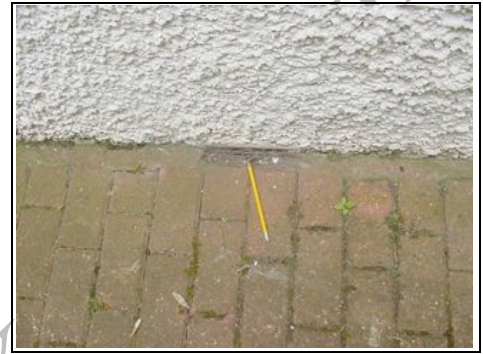
All modern properties should incorporate a damp proof course (DPC) and good building practice dictates that a differential of 150mm (6 inches) should be maintained between the damp proof course and ground levels. In this case the render will be hiding any DPC. With this era of property a damp proof course may have been added, however, although this was a regulation under the London Building Act many people resisted carrying this out. Our main concern is the high ground level that we believe will cause dampness in this property.

There may be a DPC hidden by the render but we cannot be sure of this

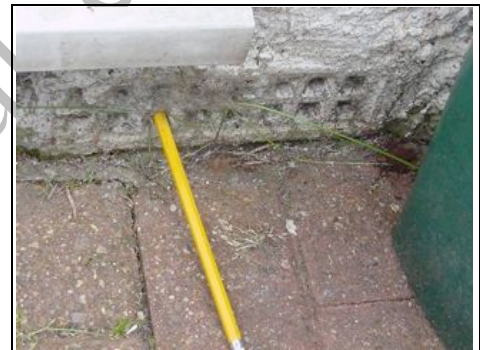
The property has a suspended timber floor and air bricks are essential to have a through flow of air as this helps to reduce the chances of wet rot, dry rot and woodworm. In this case the air bricks are too low or almost covered up (we suspect some are completely covered up).

Air brick to the rear is too low

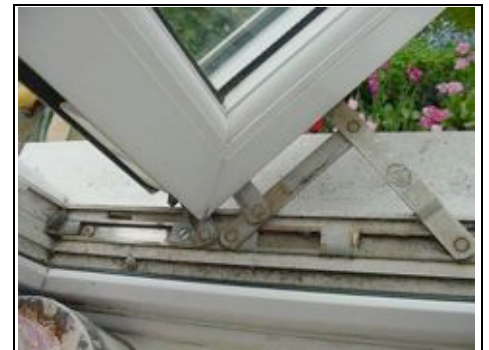
Rusting to the window hinges

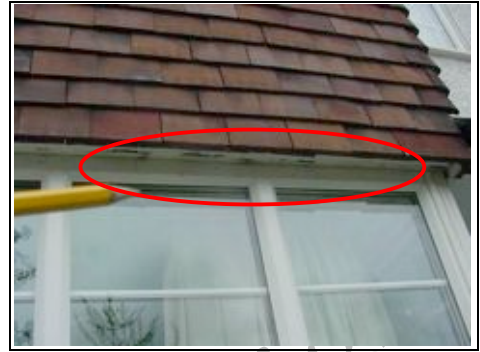
Windows need sealant

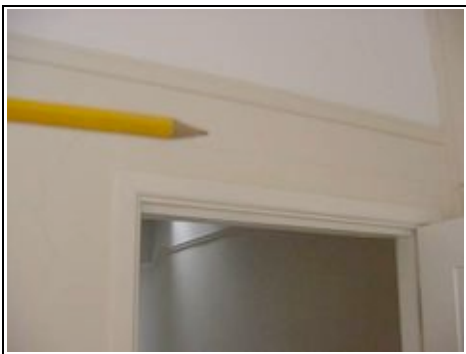
Hairline cracking above and to the side of the door in the master bedroom

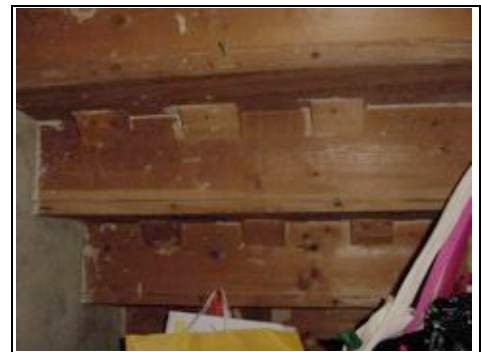
We noted that the underside of the staircase was exposed. It is more normal today to have a half hour fire barrier to stop fire spreading from the ground floor to the first floor in a worst case scenario. You may wish to take a view on whether you add this.

Stairs are not lined

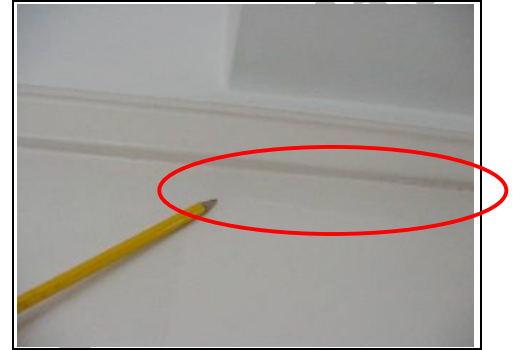
Internal decorations are in average condition. We could see that some redecoration has taken place recently which could be to prepare the property to sell or to hide something.

The new paint does not quite reach the picture rail in some places and a difference in colour is visible

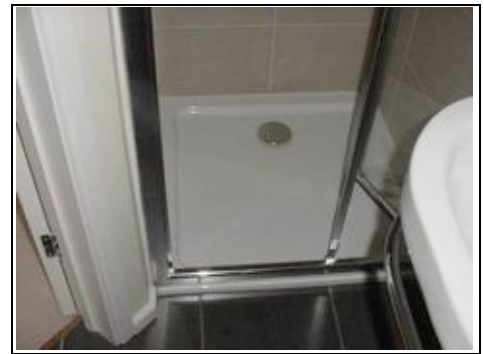
Shallow shower tray, there can be problems with these overflowing

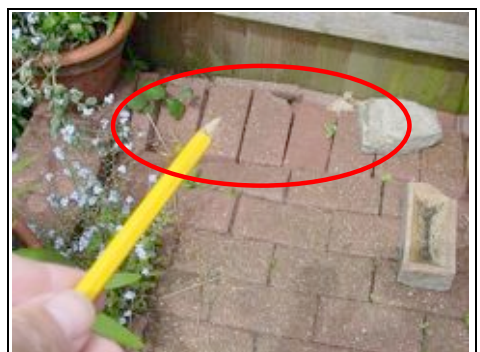
Loose brick paves
