JOB REFERENCE: XXX

# RESIDENTIAL BUILDING SURVEY

**XXX**  
**Camberwell,**  
**London.**  
**SE5 XXX**

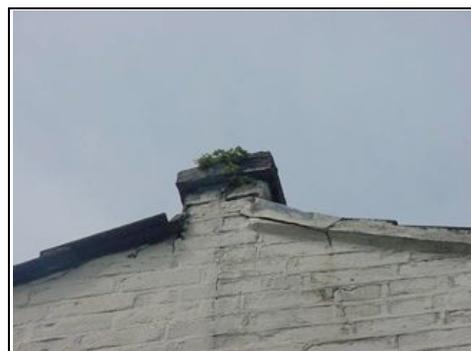
The parapet walls to the property, which run to the left and right hand side to the front and back. To the rear we noted vegetation growth, which indicates to us that there could be problems with the parapet wall.

Vegetation on top of rear parapet wall

**ACTION REQUIRED:** High level inspection is recommended to the roof areas, particularly the rear. It may be possible to access the area using a tower scaffold.

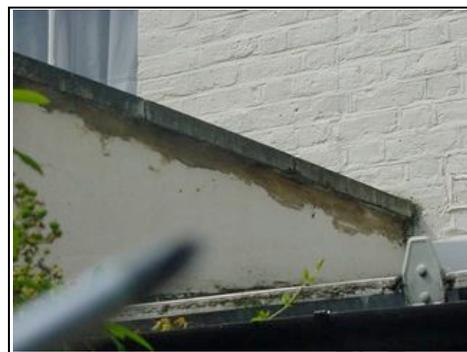
There is a parapet wall over the rear polycarbonate roof. The coping stones look like they have been re-bedded.

Coping stones look like they have been re-bedded

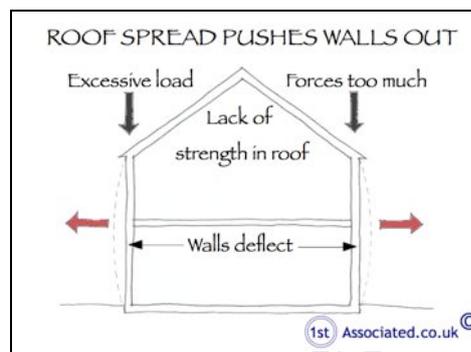
Originally this roof would have had slate tiles, these have been replaced probably in the XXX with concrete tiles which are heavier than the original slate tiles. Today you require Building Regulations Approval from the Local Authority to carry out such work to avoid causing problems with the building, particularly what is known as roof spread.

Roof spread

**ACTION REQUIRED:** If you want a belt and braces approach we would recommend adding in additional strengthening timbers in the form of horizontal purlins, possibly extra supports to the existing purlins.

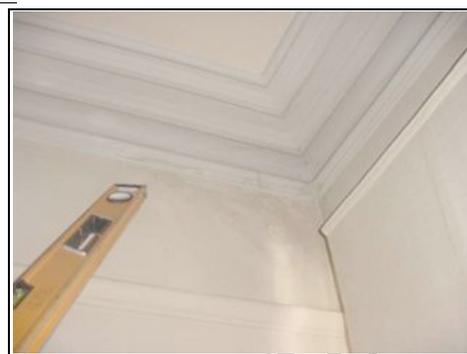
There is dampness to the front right hand corner of the property (all directions given as you face the property). It is difficult to be 100% certain where the dampness is coming from, but having reviewed the photos we suspect it is either coming from the sit on gutter, the damaged rendered parapet wall or the tile on edge flashing that next door have.

Dampness coming from roof/gutters

**ACTION REQUIRED:** Starting with basics, the guttering should be checked to ensure that it is clear, the water is running away and that it is watertight. We would, however, in the long term recommend that underneath the guttering you have a secondary lead protection against any future leaking gutters if possible. It may or may not be possible depending upon the roof detail, but we feel secondary protection is the best way forward.

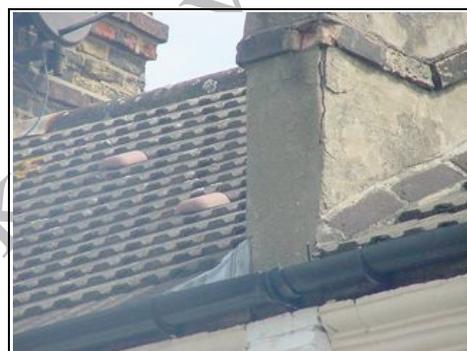
We think the most likely cause of the dampness is the sit on gutter, which we have come across considerable problems with in the past.

Sit on gutter

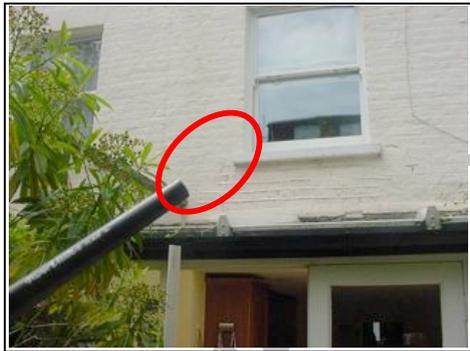
We can see movement cracks to the rear of the property around the windows. We can also see them internally around the door areas and on some of the exterior walls.

Cracking to rear of property at low level

There has been movement, as is relatively common on this Era of property, and we suspect this relates to the drains which often leak over the years, as they were the older style push fit drains. Unfortunately in this instance we have not been able to check the drains, other than running the water for 15 minutes, as there is no manhole to the rear of the property.

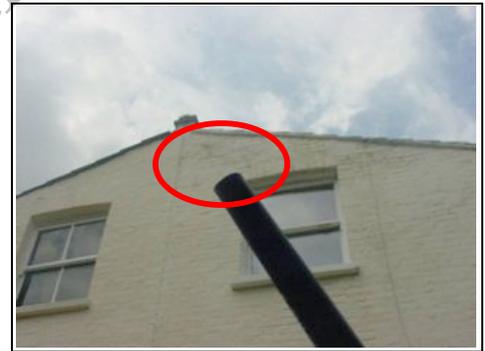
Cracking to rear of property at high level

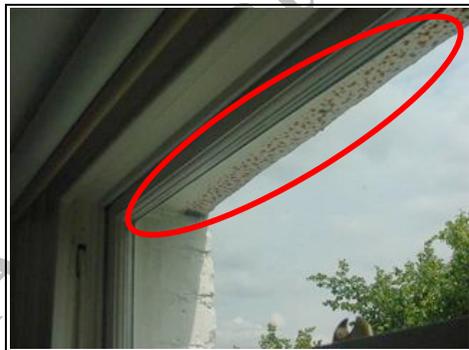
In this case, we can see there is a metal lintel, this has possibly been added due to the soldier course of bricks being defective although we cannot visually see any major defects to the lintels, but equally very rarely do people add and amend buildings without any reason, and it is worth keeping an eye on the rusting lintels. We would of course paint them.

Rusting to lintel

**ACTION REQUIRED:** Keep an eye on the rusting lintels and re-decorate them.

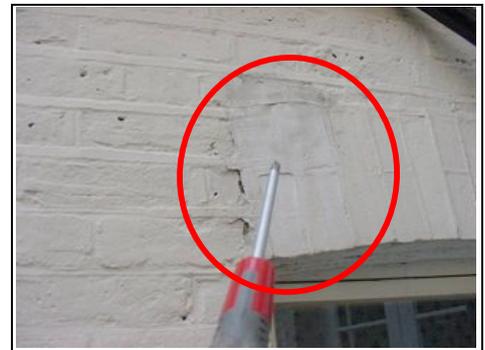
Repairs to soldier course  
above window

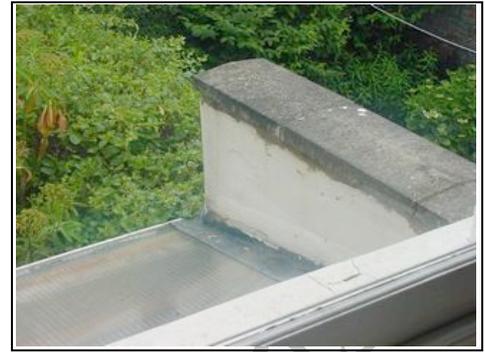
Polycarbonate roof to rear

**ACTION REQUIRED:** Change to glass roof. We also recommend that at the same time you carry out checks to the flashings, as part of the mortar is missing in one area.

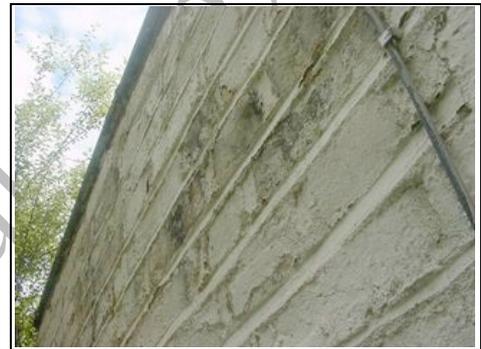
With the surrounding parapet wall there looks to be a problem with the width of the coping stone, which does not look wide enough and is discharging water down the side wall, together with the fact there does not look to be a damp proof membrane beneath it.

Coping stone is not large enough and there is no drip detail

**ANTICIPATED COST:** To replace the coping stones, re-bed and add a damp proof course underneath we would expect costs in the region of £750 to £1,500, plus you will of course have to re-decorate. Please obtain quotations.

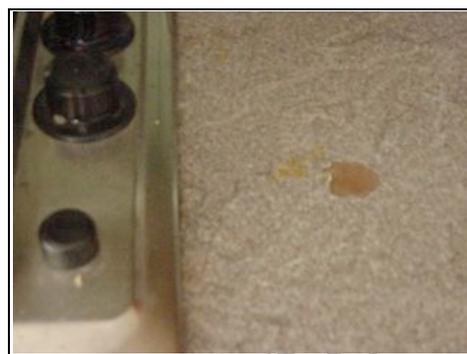
The kitchen worktops are worn out.

Worn out worktops

**ACTION REQUIRED:** We recommend these are replaced. You may also wish to upgrade the kitchen as the wear and tear is above what we would expect to see.

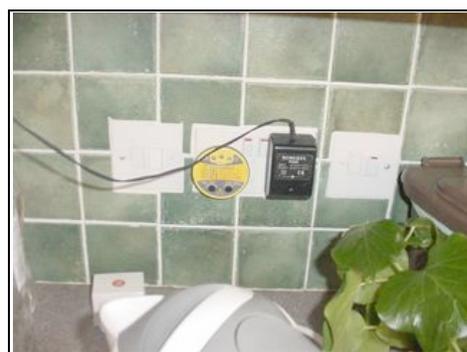
Earth test failed

**ACTION REQUIRED:** Have the electrics checked. The Institute of Electrical Engineers standards (IEE) recommend a test and report whenever a property changes occupancy. This should be carried out by an NICEIC registered and approved electrical contractor or equivalent.

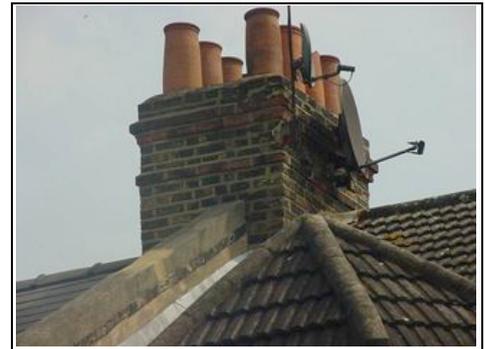
This chimney is brick finished with a lead flashing and numerous chimney pots. From what we could see from ground level it looked in slightly below average condition considering its age, type and style.

Chimney to front left side

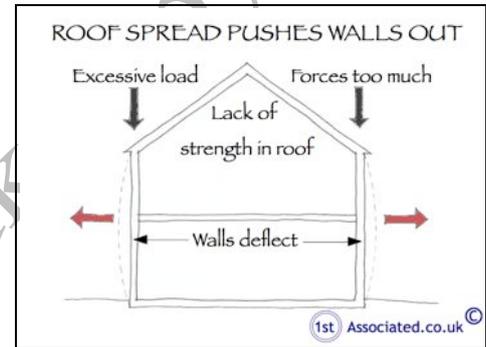
A heavier concrete tile has replaced the original slate and therefore there should be additional roof support which there is not the case in this instance and which could cause roof spread.

Roof spread

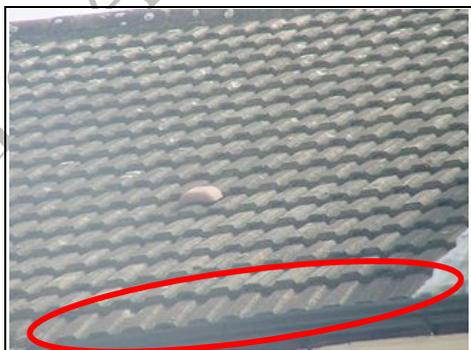
We noted minor moss, which is not unusual, but it also it does look like the tilting fillet has not been added. The idea of a tilting fillet is to flow down the speed of rain, but there are often problems with re-roofing where a thicker concrete tile is used in this instance, it then means that the tiles do not align with the gutter. In this particular, case with a sit on gutter, this can make a dampness problem where the tiles effectively tip the rainwater down behind the guttering.

Concrete roof tiles – no tilting fillet

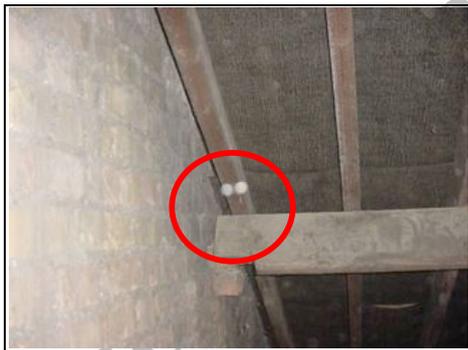
Purlin – delicately positioned on bricks

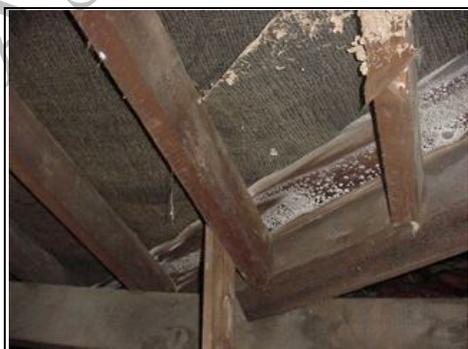
Staining coming in possibly via rear valley gutter

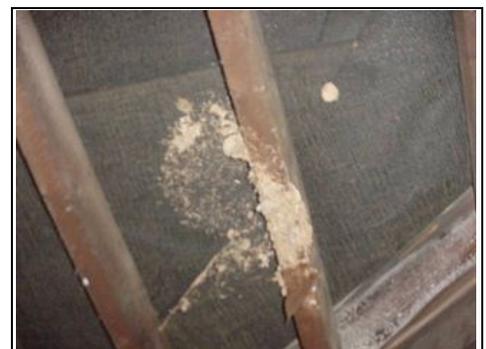
Wasp's nest – which we were pleased to see has now gone

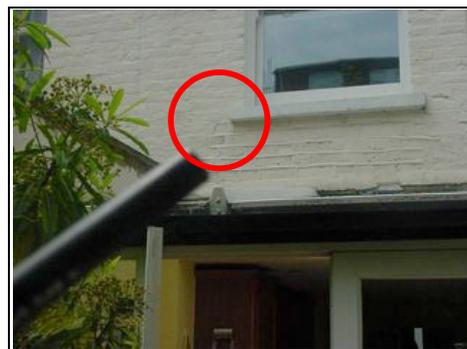
Crack in brickwork

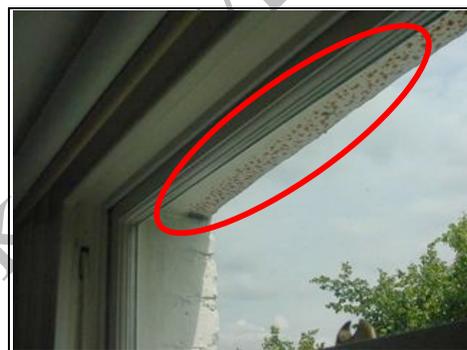
Rusting metal lintels

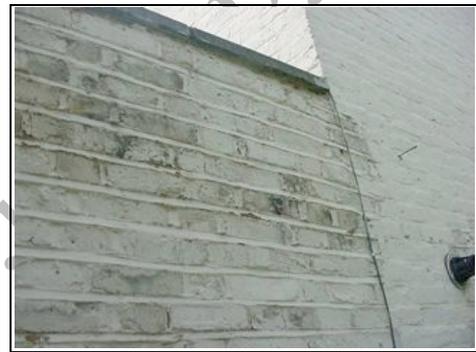
Do not under estimate the redecoration of this property. The entirety of the property will need redecorating in a few years time. Presently, the parapet walls need redecorating.

Rear low level parapet wall in need of redecoration

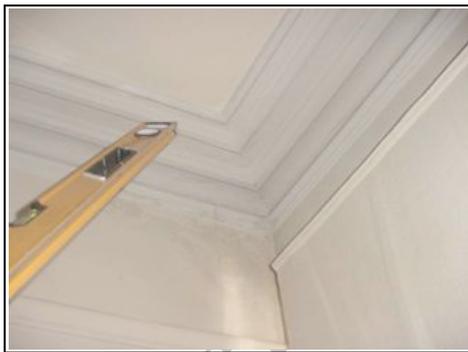
Moulding to the front right hand corner of the master bedroom (albeit that there is dampness coming in – please see our comments in the Executive Summary)

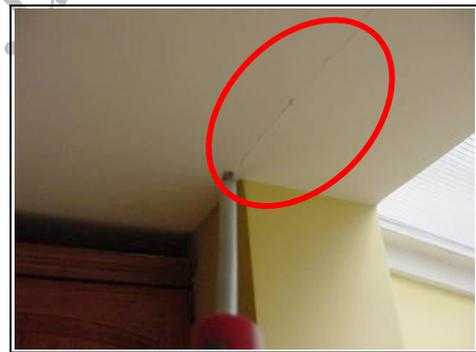
We noted some hairline cracks modern plasterboard in the kitchen area.

Plasterboard crack to ceiling

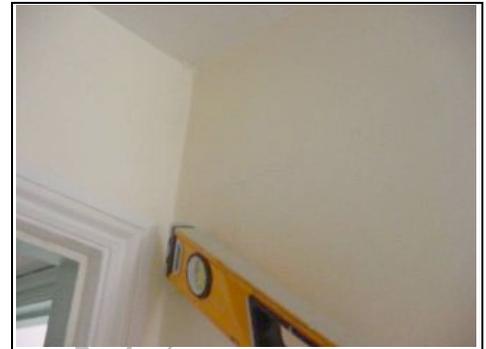
There is some hairline cracking; please see our comments in the Executive Summary in relation to movement in the building possibly relating to the drains.

Hairline cracking in top floor bedroom

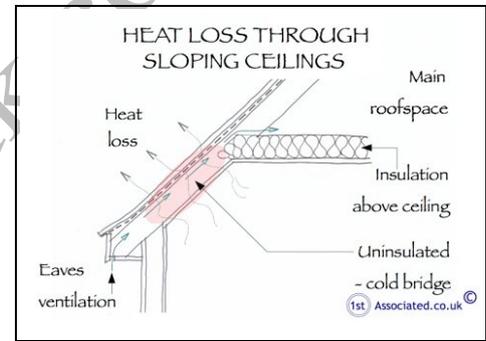
Cold bridging from a sloping ceiling

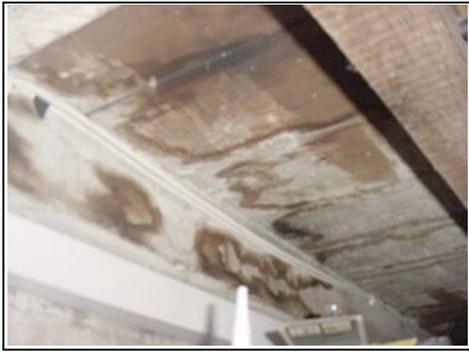
Dampness noted in cellar to the suspended timber floor/ joist and floorboards

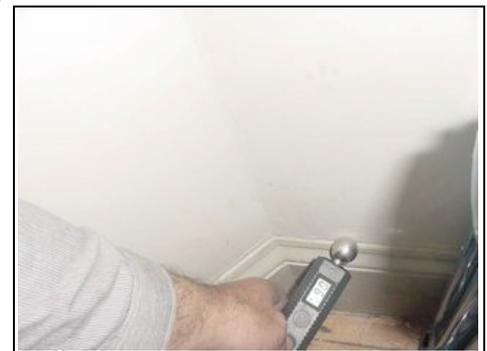
A random visual inspection and tests with a moisture meter have been taken to the perimeter walls. The majority of the property had no significant rising damp but there were slightly higher readings than we would expect in the kitchen area. This may relate to condensation but we think it is more likely to relate to high ground level.

Slightly high damp meter readings to rear kitchen area

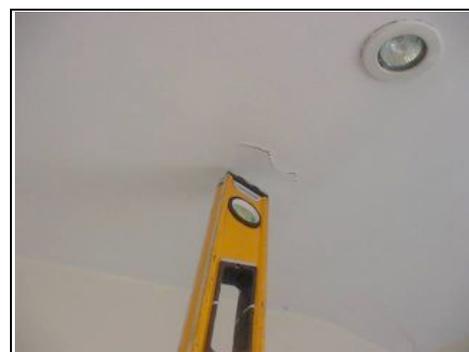
At the time of the inspection we noticed flaking paint within the top floor bathroom to the ceiling, which indicates to us that there is condensation. However, we would add that it depends upon how you utilise the building. If you do your washing and then dry it in a room without opening a window you will, of course, get condensation. Common sense is needed and a balance between heating, cooling and ventilation of properties and opening windows to air the property regularly.

Paintwork coming off due to condensation

**ACTION REQUIRED:** We would recommend large humidity controlled extract fans be added to kitchens, bathrooms and drying areas.

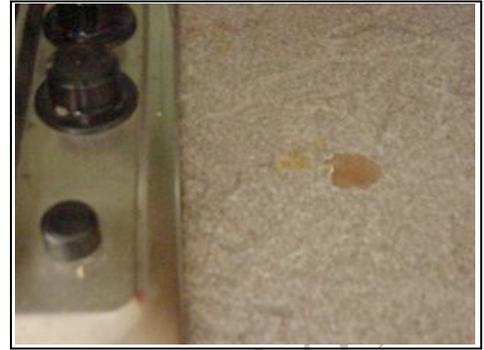
Worn out worktops

**ACTION REQUIRED:** We recommend replacement of the worktop. You may also wish to upgrade the kitchen as the wear and tear is above what we would normally expect.

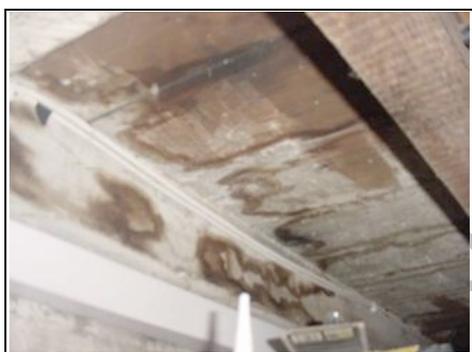
We had very limited access to this area due to the mass of stored items. We did note there was dampness coming in to the ceiling (the ground floor); please see our comments on this. We would add that we could barely get into the cellar area and would be more than happy to come back and inspect again.

Dampness in cellar

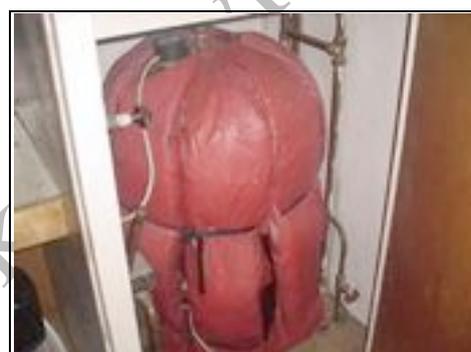
Older style cylinder with loose insulation jacket
