# RESIDENTIAL BUILDING SURVEY

xxxxxxxxxxxxx,  
Streatham,  
London,  
SW16

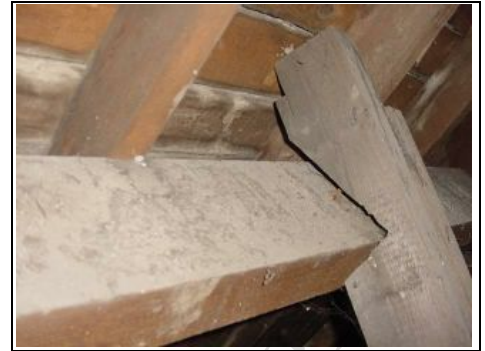
Difference in thickness of struts,  
red circle indicates thin strut

Timbers to props cut too deeply  
known as a bird mouth

**ACTION REQUIRED:** We would recommend that the purlins are supported properly and also that the thickness of the struts are increased to the brick supports that are built in around them.

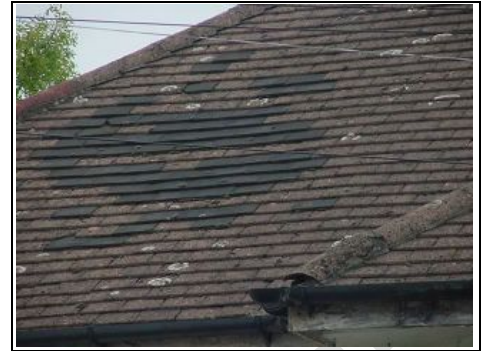
We can see some tiles have been replaced to the front of the property (we had a limited view of the rear of the roof) but we can see numerous damp areas to the front and rear of the property from within the loft/roof space.

Replacement roof tiles

**ACTION REQUIRED:** If you are having major works carried out then it will be worth considering replacement of the roof. We would recommend that this is carried out in the summer of 2014.

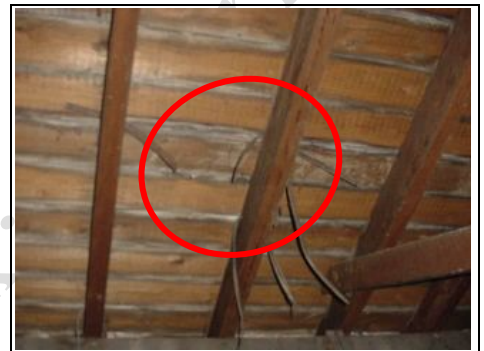
We can see that dampness is coming in internally by the damp, close boarded timbers (in the loft/roof space). Over the years this dampness tends to cause deterioration to the nibs on the tiles which then slide off the roof.

Dampness visible

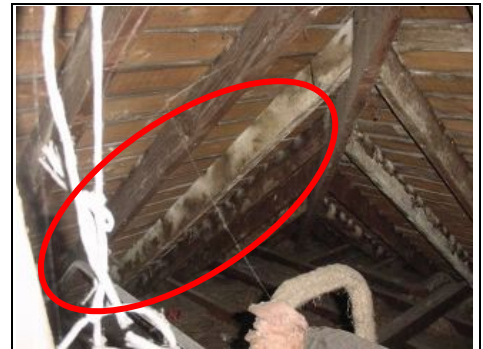
Dampness coming through on ridge

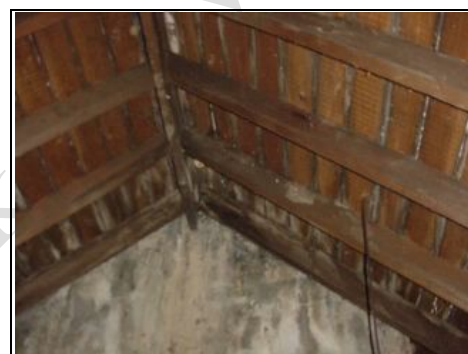
Although there do not look to be any problems with the chimney from the outside (remember we could only see the front of the chimney) from within the loft/roof space we could see damp staining.

Dampness around chimney

**ACTION REQUIRED:** When work is being carried out to the roof you need to check around the chimney to identify where the dampness is getting in. In this age of chimney dampness is usually coming in via the flashing.

**ANTICIPATED COST:** If this repair is carried out as part of the roofing work with scaffolding already in place then it is likely to cost in the hundreds of pounds range but if this is specifically carried out on its own then scaffolding on its own is likely to be £1,000 plus. We would recommend this is carried out in the summer of 2014; please obtain quotations.

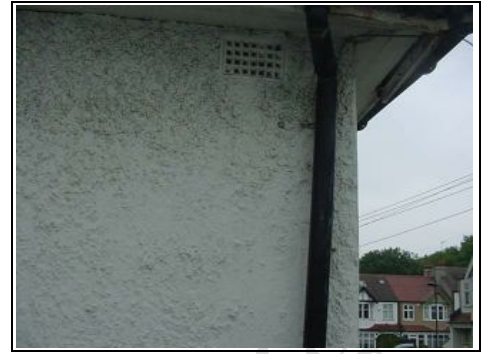
Render of this age increasingly needs maintenance. We can see areas of blown render and we can see areas where render has been repaired and repainted.

Roughcast render repaired with areas of smoother render.

**ACTION REQUIRED:** Patch repairs are required to the render, we would recommend this is carried out in the summer of 2014. Again if you are looking to extend the building considerably then you may wish to re-render the entire property.

**ANTICIPATED COST:** For a patch repair we would expect costs in the region of £1,000 - £2,000. For a completely new render complete with insulation (which may well be worth doing due to the cold bridging problems in this era of property) would cost in the region of £6,000 - £9,000, this would be best carried out with the neighbouring property if possible; please obtain quotations.

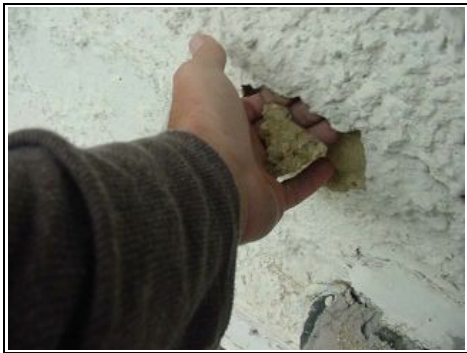
Deteriorating render

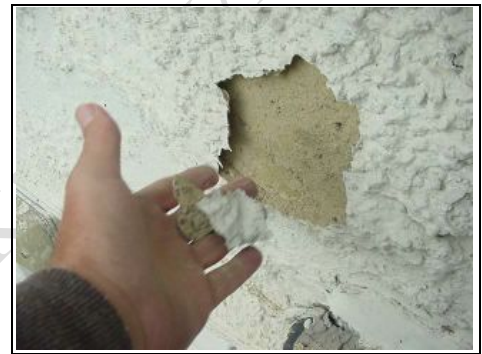
Deterioration to render

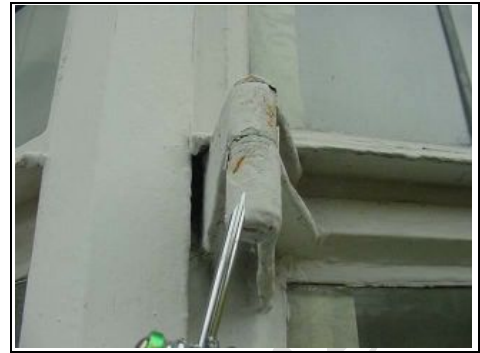
The property has metal windows often known by the trade name/generic name of crittal windows. These have rusted and warped and in turn this means that they can't be closed properly and will be draughty. We have also noticed some cracked glass. They are all very typical problems with this era of metal window when not properly maintained.

Rusting to window

The Local Authority needs to be contacted to check if the windows can be changed. If they can, then this is probably the most economic solution however we believe from talking to the builder next door that these windows cannot be changed which may mean that this property is in a conservation area or that the property could even be listed.

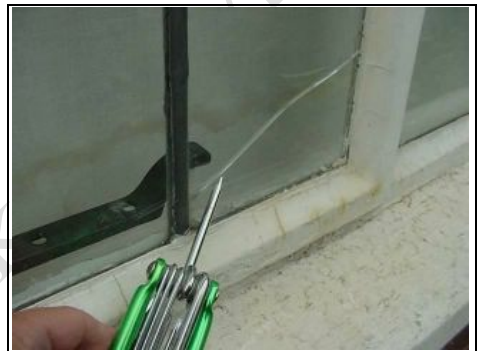
Cracking to glass

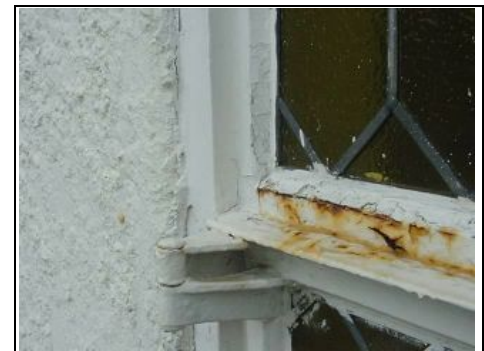
Rusting to crittal windows

**ANTICIPATED COST:** The cost of refurbishing the metal windows is very difficult to estimate. We would also add that there are some timber windows and French doors to the rear that need new timbers splicing into them. We would expect total costs in the region of £4,000 to £6,000; please obtain quotations.

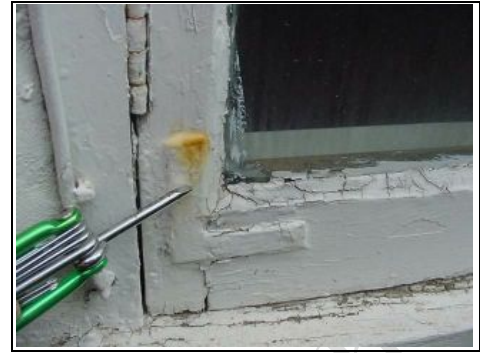
L brackets on windows indicating they have deteriorated

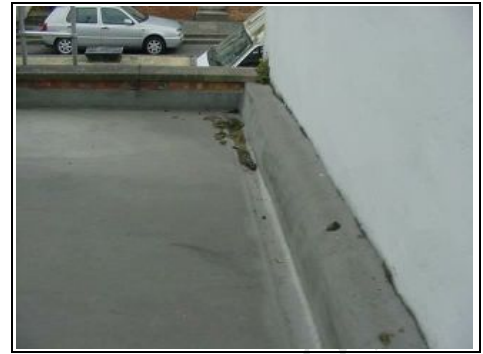
The Asphalt roof to the garage has deteriorated particularly to the perimeter where it joins the main building. We would add that Asphalt is considered to be the Rolls Royce of flat roofs.

Asphalt to garage

**ACTION REQUIRED:** We would carry out repairs with Asphalt as eighty percent of the roof is fine.

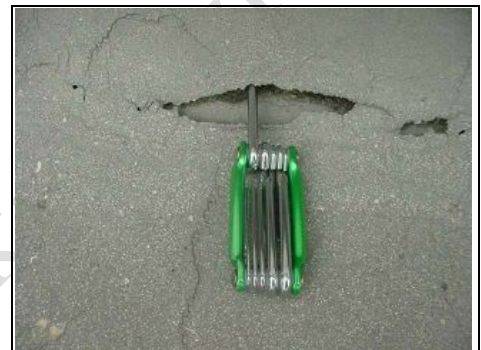
Holes to asphalt roof

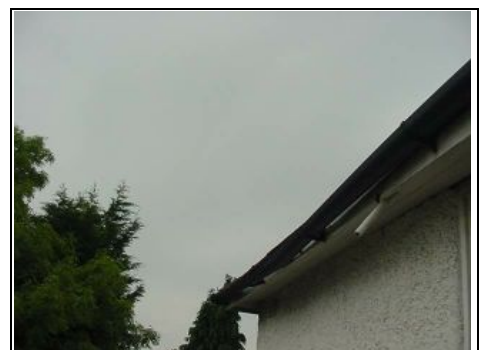
Twist/drop in the gutter

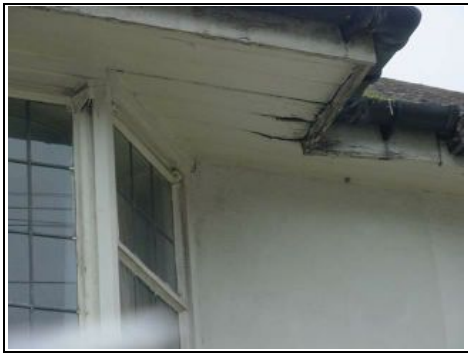
Fascias and soffits deteriorating  
due to leaking gutters!

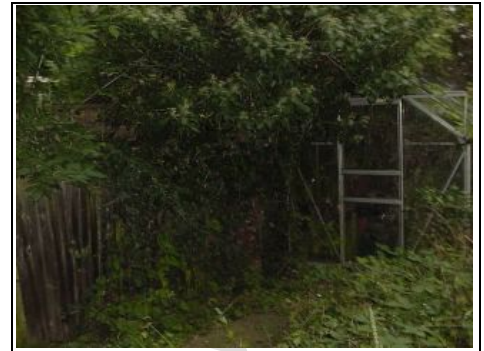
Garden is overgrown

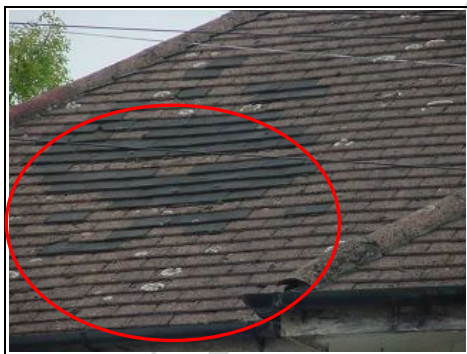
Replacement roof tiles

**ACTION REQUIRED:** Please read our comments within the Executive Summary. This roof we believe is worse than it initially looked. Until repairs are carried out, recommended in the summer of 2014, then periodic inspections and maintenance of the roof, should be carried out, this is be dependent on the weather.

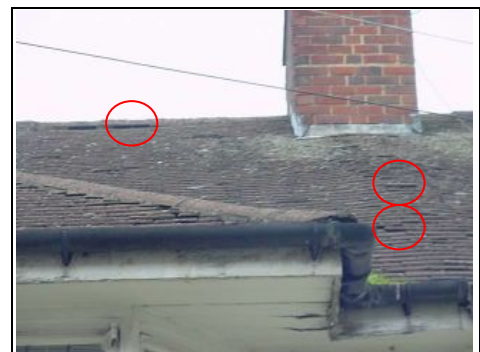
The main roof is hipped and clad in nibbed tiles and, from ground level, this looks in slightly below average condition due to the tiles that we can see that have been replaced and also where some are lifting.

General lifting of tiles in areas

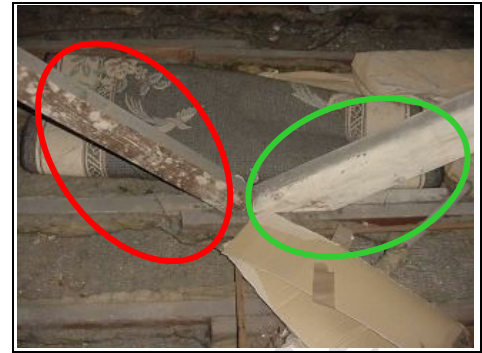
Difference in thickness of struts,  
red circle indicates thin strut

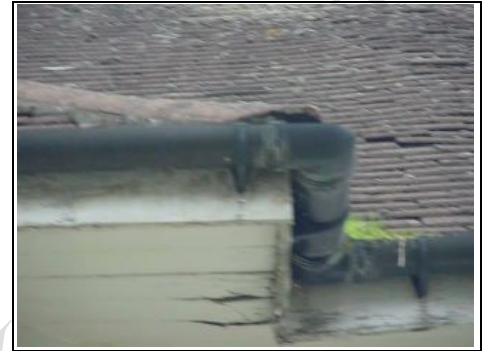
The property has predominantly plastic gutters and downpipes with possibly some of the original cast iron remaining. We noted grass growing from the gutters and there is a gutter that is twisting/dropping to the left side which can often be due to the bracket positions from the original cast iron gutters being used.

Plastic gutter full of grass

We would expect the gutters in general to leak quite a lot.

**ACTION REQUIRED:** We would always recommend you stand outside the property next time it rains heavily and see how well the drains cope with the rainwater particularly looking at the guttering and the joints.

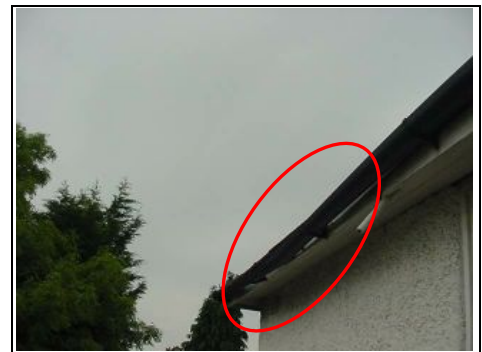
Guttering dropping to left side

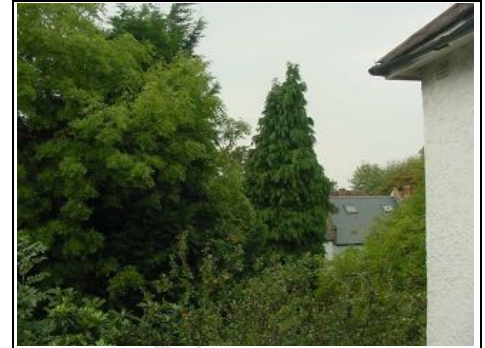
There are trees within what insurance companies would term as influencing distance of the property. The amount of trees made it difficult to take a photo of the rear and to see the roof, chimney and high level areas.

**ACTION REQUIRED:** The trees need cutting back.

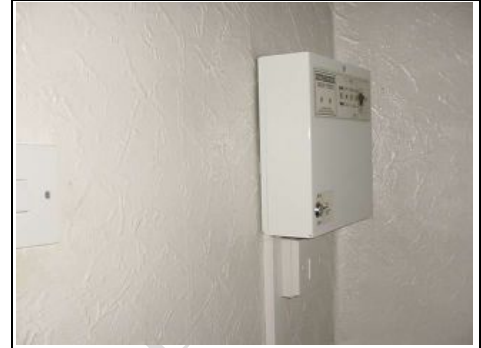
Alarm, we assume is not working

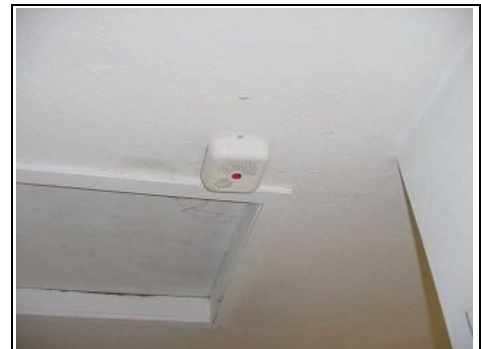
Battery operated smoke alarm needs improving

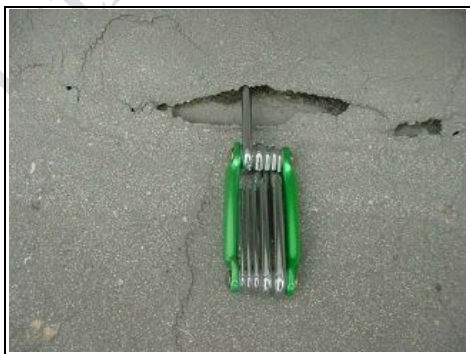
There is deterioration to the garage roof. Please see our comments in the Executive Summary.

Holes to asphalt roof

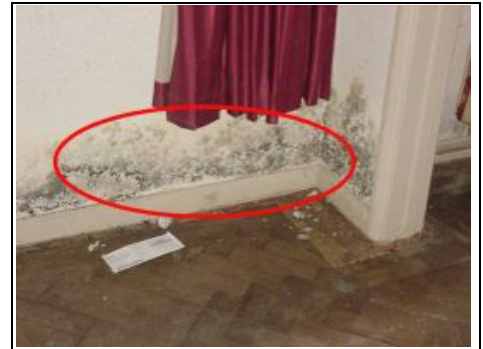
Mould caused by cold bridging
