# RESIDENTIAL BUILDING SURVEY

**XXX**  
**Streatham,**  
**London**  
**SW16 XXX**

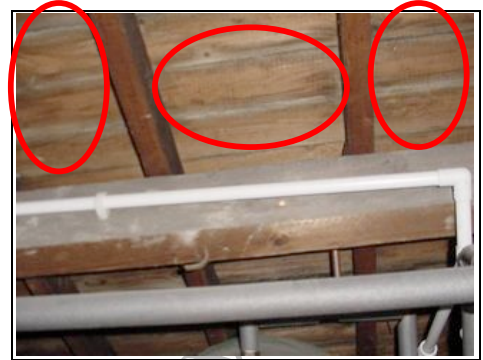
We can see that dampness is coming into the roof between the feather edged close boarding. It is fairly common in this age, type and style of roof. There can be a problem with the spalling to the nibs of the tiles, which means the tiles get displaced. We can see no obvious visual signs of this occurring (we would see the dust and crumbling of the tiles in some instances), nevertheless the roof is letting dampness in.

Dampness coming in to front left hand roof

It is a Catch 22 situation with this type of roof as to what to suggest, as although it is letting in some rainwater it is not letting in enough to make us recommend re-roofing.

**ACTION REQUIRED:** We recommend that the existing insulation is removed and a boarding with an insulation underneath it be added instead of this. This would have three benefits:

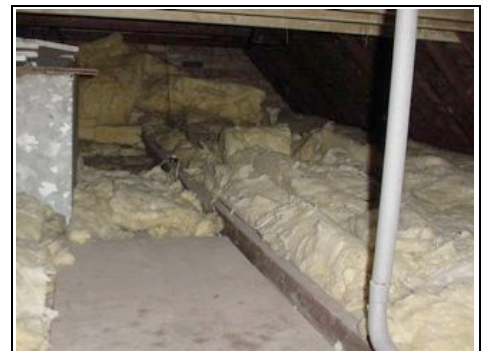
Mass of insulation

Most importantly, this type of roof would allow you to see how much rainwater is coming in and patch repair those areas of the roof.

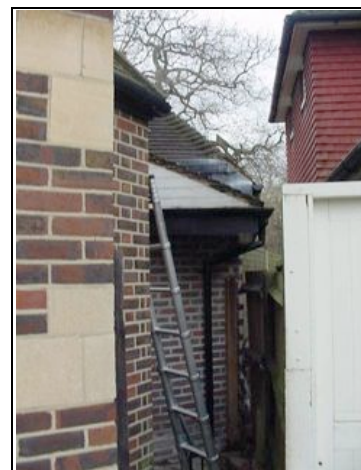
We think there may be some dampness getting in from the annexe roof into the shower room area below. It is difficult to be 100% certain as there is damp in there that is certainly due to condensation. We thought that some of that may also relate to a roof leak.

Ladder to annexe roof to investigate problems

**ACTION REQUIRED:** We recommend you do this as a two stage process. First of all carry out the work that we are recommending with regard to the condensation. If you are then still getting leaks within this area then carry out work to the roof.

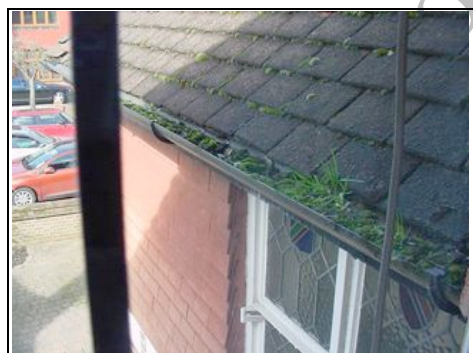
We can see that the gutters have not been cleared for some time; grass can literally be seen growing out of the gutters to the side and to the rear. This in turn has caused deterioration of the fascias and soffits and bare timber is visible in some areas.

Gutters full of grass and moss

**ACTION REQUIRED:** A handyman required for a few days to clear all gutters and moss from the roof that can easily be reached, using a soft brush so as not to damage the tiles; possibly even doing some painting during the warmer weather.

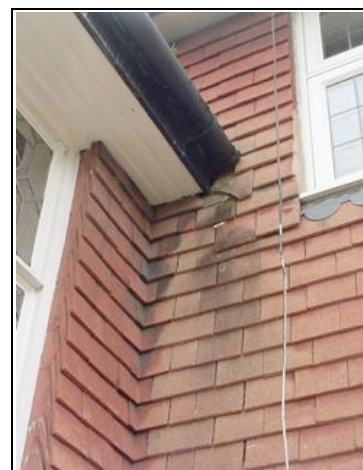
Pattern staining being caused to right hand side where gutter is overflowing down the vertical wall tiles

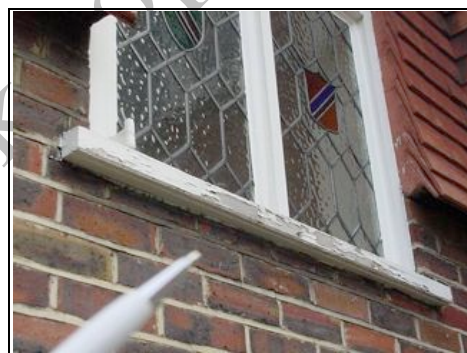
We noted the older windows have flaking paint and some bare timber is visible. The newer windows do not seem to have had a final finish as they are quite dull. We are aware that some of the new modern windows are spray painted off site and then brought to site, so this is what may have happened in this case. We like to see a good gloss finish, but you may or may not like this and it is personal preference.

Windows need painting

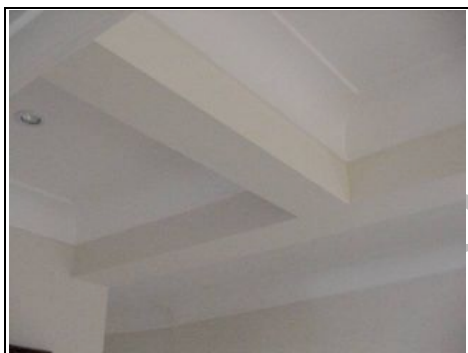
Where any building is altered over the years and there is a mixture of extensions new and old and minor alterations, such as removing walls (as there has been in this case to the kitchen area and also at first floor level) you will get some differential movement, which in turn will cause cracking, which is alright if it is hairline cracking (very fine cracking). We can see hairline cracking to the property, but our concern is that some struts may have been removed in the roof to achieve this configuration to the landing area.

Walls removed at first floor level

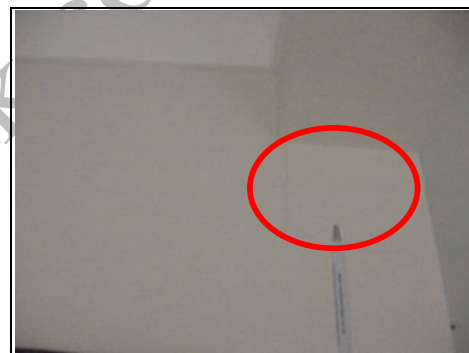
Resulting hairline cracking in hallway

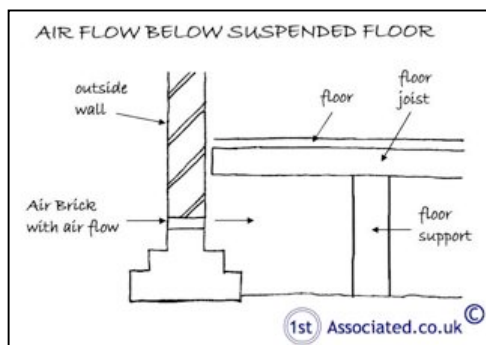
We note that the property has a suspended timber floor added, which we believe still exists but underneath the tiles which also has a heated floor system. The air vents are in place to allow a through flow of air to minimise wet and dry rot and woodworm. In addition to this, there is normally some breathing of the floor between the floorboards which cannot take place due to the area being tiled.

Suspended timber floor

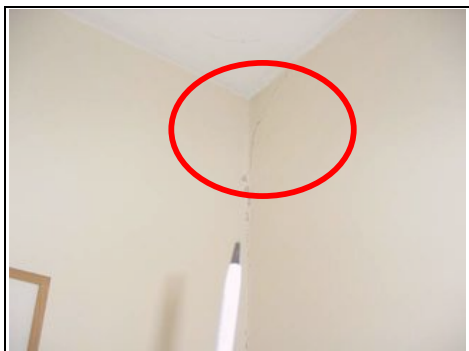
Throughout the property you have a ventilation and condensation problem. This can particularly be seen in the en-suite shower rooms; both in the main building and the shower room in the annexe. The annexe may also have a leaking roof. We would start by sorting out the condensation problems.

Sign of dampness in master bedroom en-suite

**ACTION REQUIRED:** We recommend replacing the extract fans with large humidity controlled extract fans.

**ANTICIPATED COST:** Allow the sum of £500 to £1,000 for adding in an extraction system.

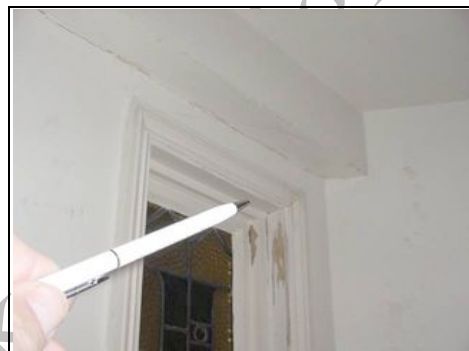
Water damage in shower room in annexe which may be partly condensation and partly a roof leak

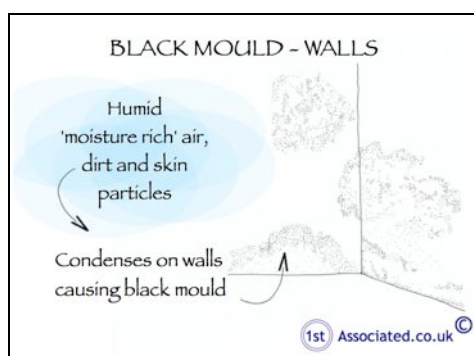
We noted in the annexe that there was black mould visible around the windows and other area. Black mould occurs where humid air carries dust, dirt and skin particles to cold areas, such as corners of buildings and around windows and deposits on these areas. From the research being carried out in the USA (due to legal cases against landlords) black mould can have a detrimental effect on health. We believe we are still in the infancy of discovering the effects of this type of mould but it is best to ventilate and be without it in our opinion.

Black mould

**ACTION REQUIRED:** We have already mentioned about adding a large humidity controlled extract fan in the shower room, we would equally add extraction in the bedsit (kitchen, lounge and bedroom), particularly around the cooking area. You also need to be aware that people will usually dry clothes during the winter months in these areas so it does need to be well ventilated.

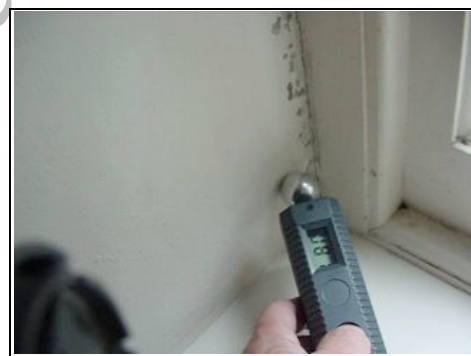
High damp readings in the annexe

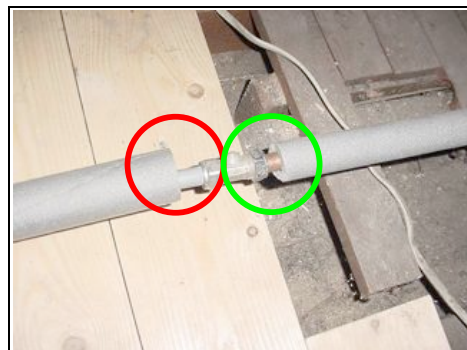
There is an above average amount of unsupported pipework in the roof space, which gives us cause for concern on the plumbing as a whole.

In addition to this, we would also mention that there is a mixture of copper and plastic pipes which we are not keen on and have experienced properties where leaks have occurred, including some work on insurance claims that have been practically new properties.

Mixture of plastic (red circle) and copper pipes (green circle)

**ACTION REQUIRED:** We would wait until the pipe leaks and support it in the meantime. Ensure that anyone that goes into the roof is well aware not to lean on it or touch it.

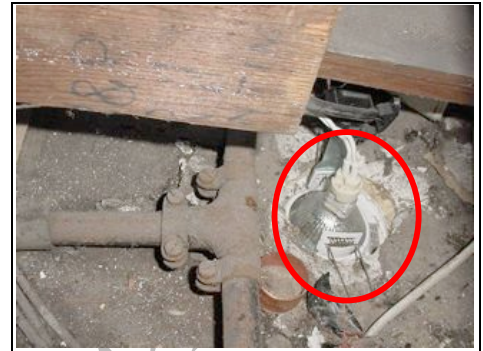
Just to reiterate our earlier comment; the ceiling lights are covered within the roof space. This is a potential fire hazard as they can become very hot.

Ceiling lights not protected

**ACTION REQUIRED:** Replace with newer modern low energy lights which give off less heat. Also carry out the recommendation to line the roof and add ventilation to these areas.

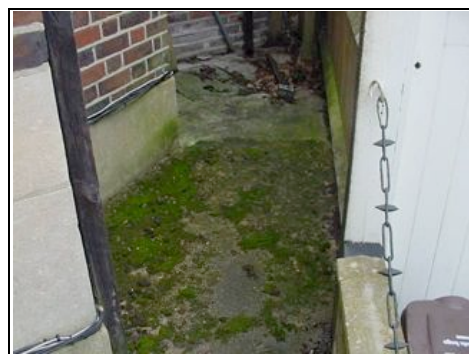
To the front right hand side the manhole cover was lifted and the drain looked to be partially blocked with earth, which would usually indicate that the drain has partially collapsed. We can see the moss on the right hand side which could be due to a leaking water supply pipe or leaking drain, or possibly rainwater being discharged off the roof and landing in this area, but further investigation needs to take place.

Area of moss on the right hand side  
indicates there is possibly a leak  
from the supply pipe/drainage and  
there is a manhole cover nearby

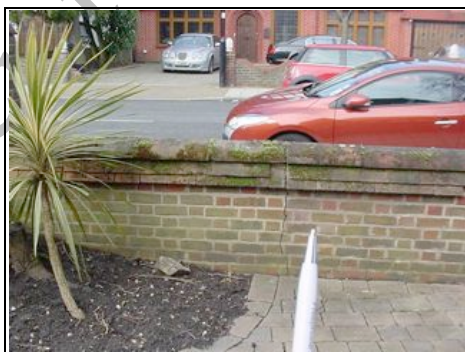
We believe that the tree roots of the removed trees to the front of the property have caused the crack in the front wall.

Crack to front wall

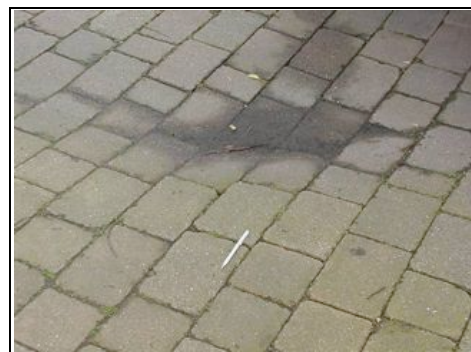
Sunken pavia slabs

We were advised by the owners that these were chopped down before the roots got as far as the property. If this is correct then this should not be a problem, however we did note that some of the parking area is sunk which can be caused by roots, either alive or dead and rotting.

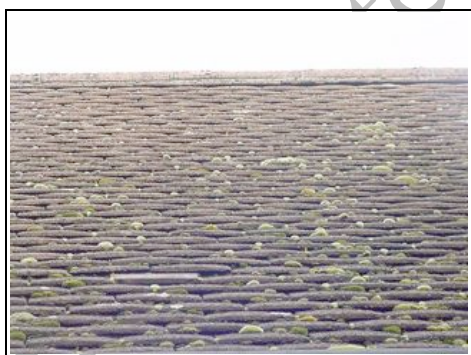
Close up of tiles with moss on – some replacement tiles which are machine cut are much flatter than the original older tiles

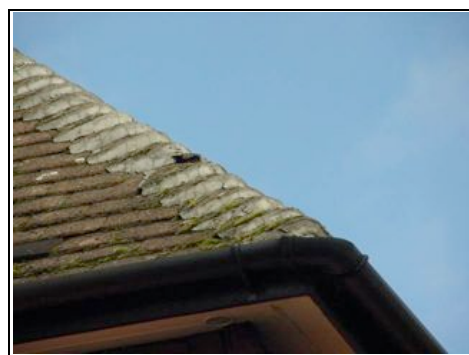
Hipped ridge has been re-bedded

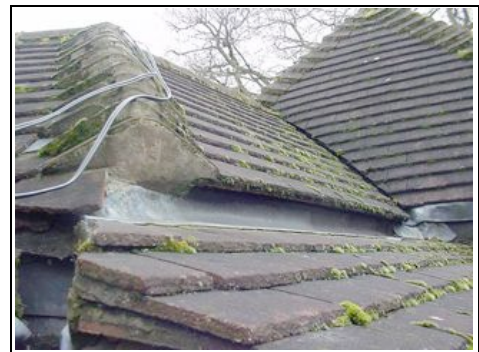
Where the roofs meet on the right hand side there is an awkward detail which we think may be leaking into the annexe shower room. This area needs reviewing; it was difficult to view with the ladders we had.

Awkward roofs to front  
right hand side

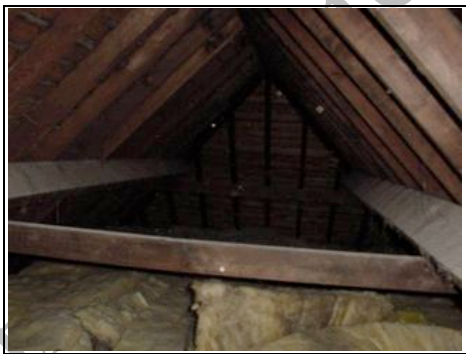
This roof is quite unusual by what is missing with regard to part of the purlin to the rear and struts that we would expect to be in place and have possibly been removed.

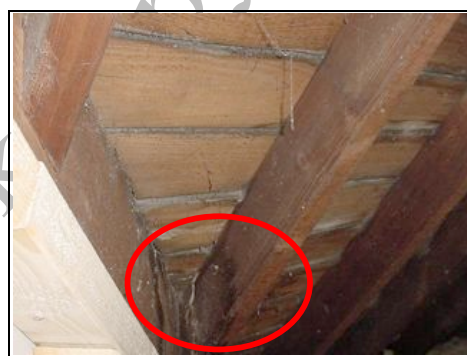
View front left hand roof with dampness coming through

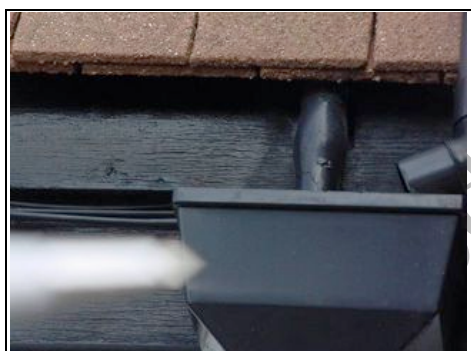
Possible lead pipework externally

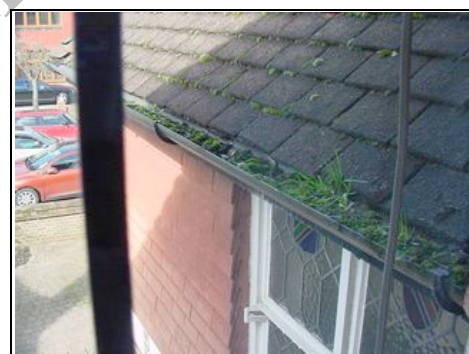
Gutters full of moss

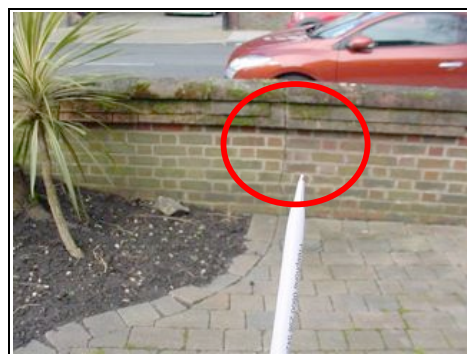
Crack to front brick wall  
where tree has been removed

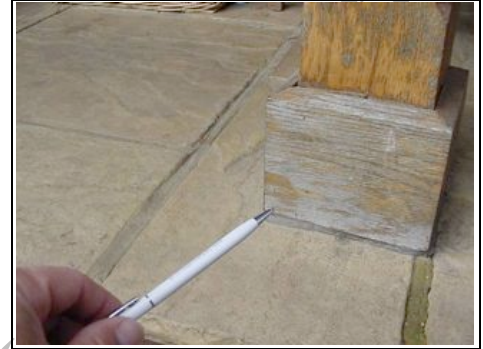
There is some staining required to the timber and, as mentioned, we believe the windows would benefit from redecoration.

Timber in need of  
work / external joinery

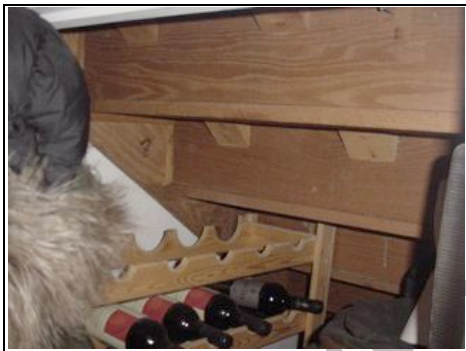
We noted that the underside of the staircase was exposed. It is more normal today to have a half hour fire barrier to stop fire spreading from the ground floor to the first floor in a worse case scenario. You may wish to take a view on whether you add this.

Underside of stairs not lined

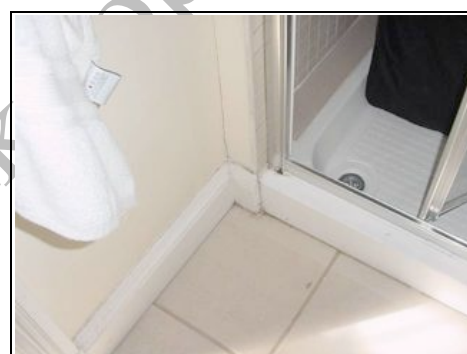
There looks to be a leak in the master bedroom en-suite shower room. It does not look to have been used for some time.

**ACTION REQUIRED:** Please see our comments in the Executive Summary.

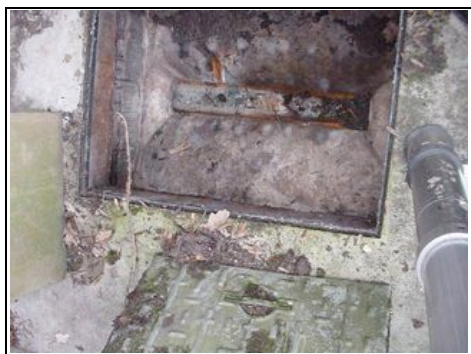
We duly lifted the cover and it appeared to be blocked at the time of our inspection and we noted an area of moss to the right hand side. It could be from the drain or water supply or overflowing of the roof, and it certainly needs investigating.

Front right hand manhole  
appears to be blocked

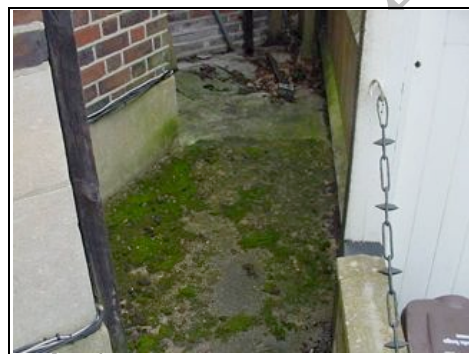
Area of moss on the right hand side  
indicates there is possibly a leak  
from the supply pipe/drainage and  
there is a manhole cover nearby

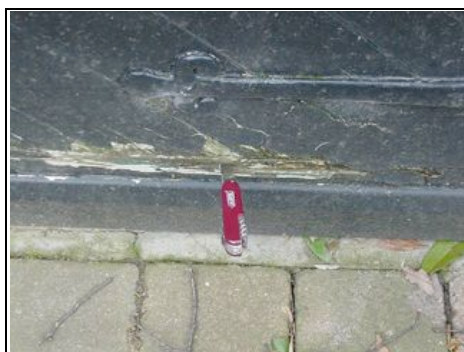
Rot to garage door

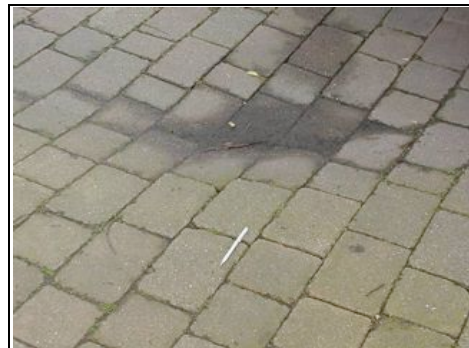
Dip in pavia slabs
