RESIDENTIAL BUILDING SURVEY

XXX

London.

SW17 XXX

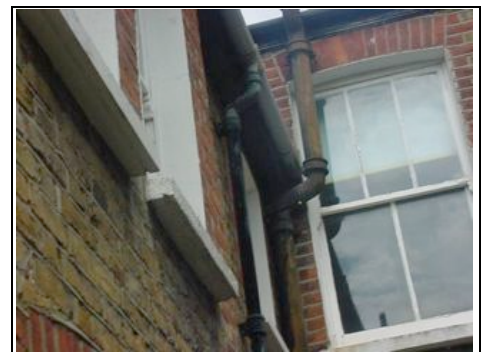
The cast iron is in need of maintenance. We much prefer cast iron than replacement plastic as it lasts longer but you do need to keep it maintained.

ACTION REQUIRED: Repair and redecorate. The opportunity should also be taken to clear all the gutters and downpipes.

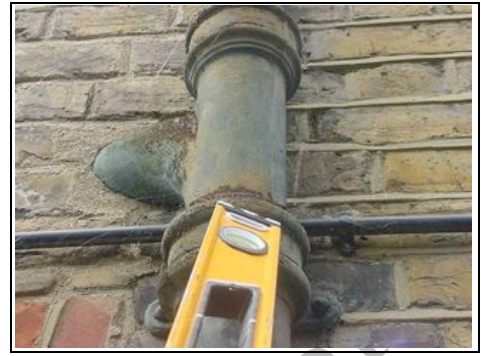
ANTICIPATED COST: In the region of £1,000 - £2,000 as some areas are badly rusted and we feel new sections of pipework may be required. In theory this should be a shared cost but you do need to have meetings with the upstairs neighbour. Please obtain quotations.

Rusting soil and vent pipe

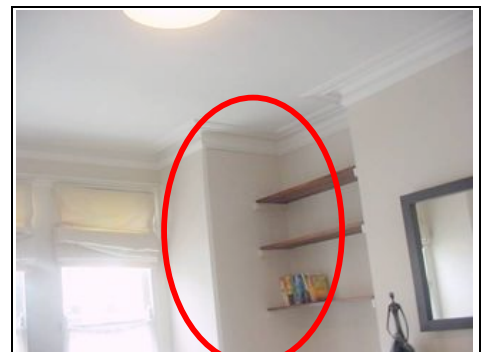
Dampness to front left side

ACTION REQUIRED: Check gutters for leaks next time it rains heavily. It may simply be a need to clear the gutters (see above) or it may well be that the edge of the coade stone detail is allowing water

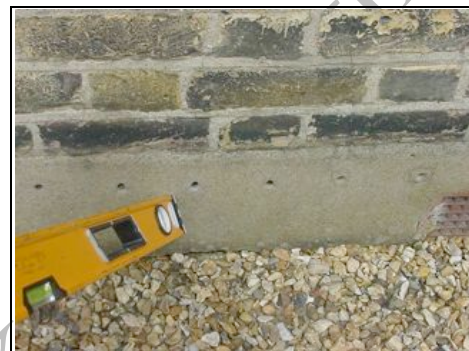
We think in the past that dampness has been blamed upon a lack of a damp proof course and that a chemical damp proof course has been inserted. We believe as mentioned above that the dampness relates to the high ground level and lack of good ventilation under the floor.

Inserted damp proof course to rear unnecessary

ACTION REQUIRED: As mentioned lower the floor and protect the airbricks. We would also recommend taking up a section of the floor to check its condition although we would add that there didn't appear to be excessive deflection compared with what we have found where the joist ends have rotted.

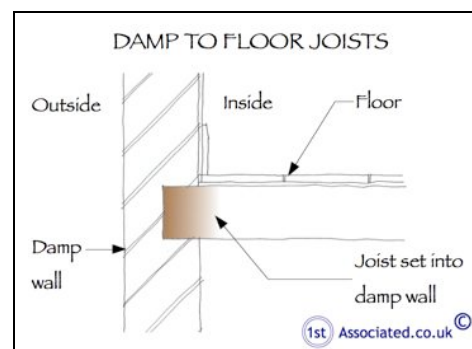
Joist ends

ANTICIPATED COST: In the region of £250 - £500 to investigate the condition of the floor; please obtain quotations.

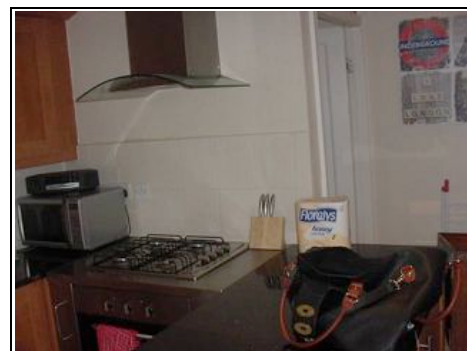
It has a filter above the hob, which simply filters air and discharges it back into the room.

Filter above hob not extractor

ACTION REQUIRED: We would recommend a large humidity controlled extract fan in the kitchen. We would also recommend a proper extract system from above the cooker.

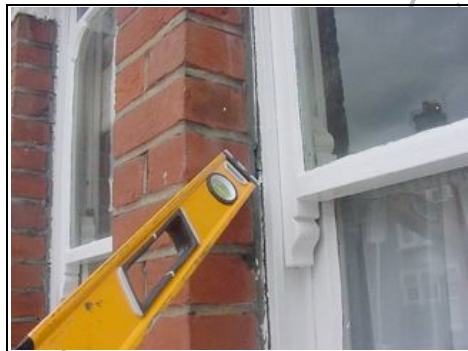
There is cracking around windows, which may be due to minor movement in the front bay window.

C Cracking around window

ACTION REQUIRED: Fill in cracks and monitor.

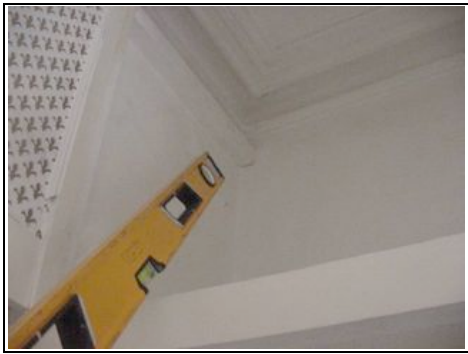
Cracking was noted internally in the middle bedroom within the built in cupboard and in the boiler cupboard. This internal cracking we believe is due to minor movement inside the property; it may be that your next door neighbour has removed their chimney for example which would cause such cracking.

Cracking in middle bedroom

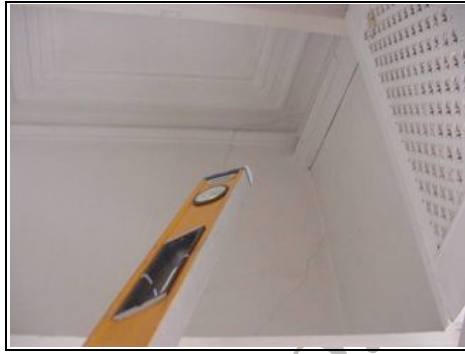
Cracks in middle bedroom

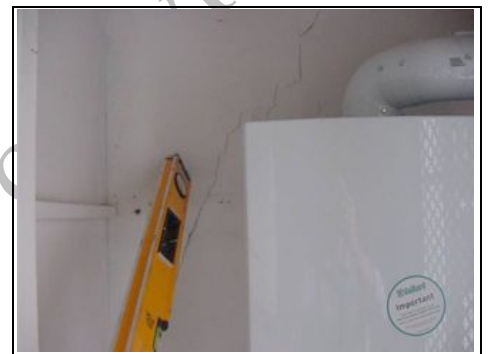
Crack in boiler cupboard

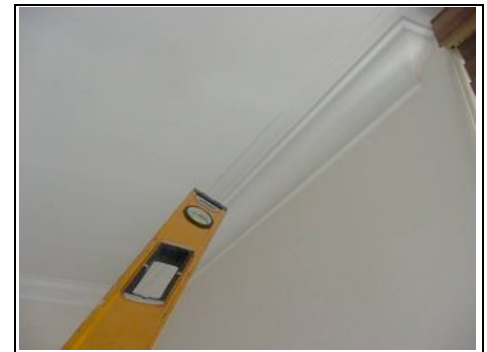
Cracking was also noted to the rear bedroom, which could be due to dampness getting in or differential movement due to the flat roof and coldness above as we suspect the roof has a cold deck flat roof.

Hairline cracks to rear part of property, which could be due to dampness

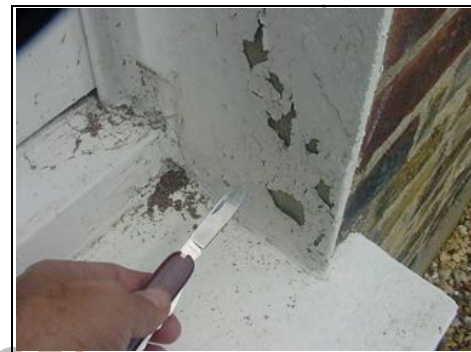
Softness to windows

Redecoration required to windows

ACTION REQUIRED: General repair and redecoration the sooner the better and no later than the summer of XXX.

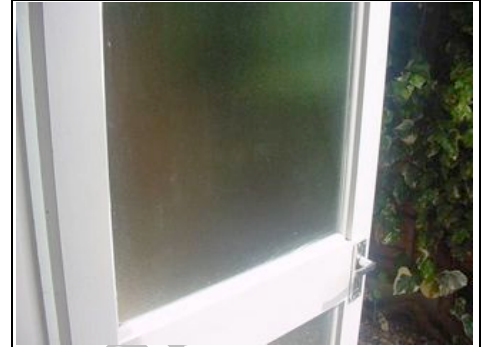
The rear door and also the door into the kitchen have got a fair amount of glass in them. We cannot see a British standard safety kite mark and we believe that this glass isn't safety glass therefore it can shatter. Having recently experienced a door like these being blown too near us we would recommend changing the glass to safety glass and in fact we would recommend for security reasons changing the rear door.

Not safety glass

ACTION REQUIRED: Replace the rear door for a more secure door with modern toughened glass. Change the glass in the internal door; it may be easier to change the door.

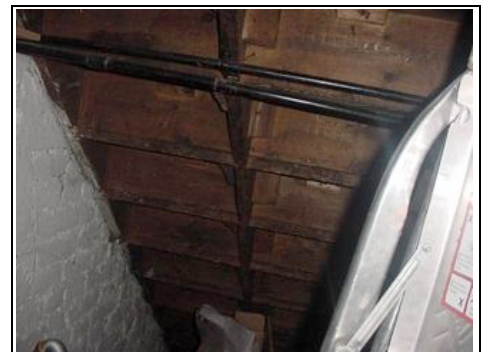
The staircase leading to the first floor apartment is not lined. We would recommend this is lined particularly as the electric fuse board is in the cupboard under the stairs. In a worst case scenario if a fire occurs in the house this is the main way that the upstairs occupants would escape.

Stairs not lined

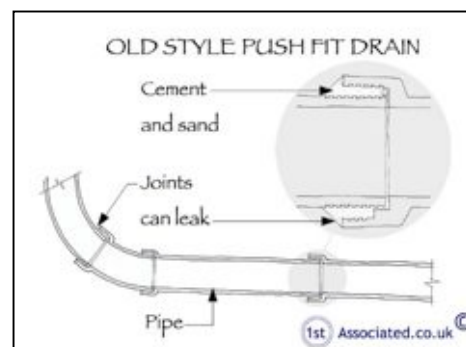
In older properties, such as this, drainage was often push fitted together rather than bonded together which means that they may leak over the years. Whilst we ran the tap for 15 minutes without any build up or blockages the only way to be 100% certain of the condition of the drains is to have a closed circuit TV camera report.

Push fit drain

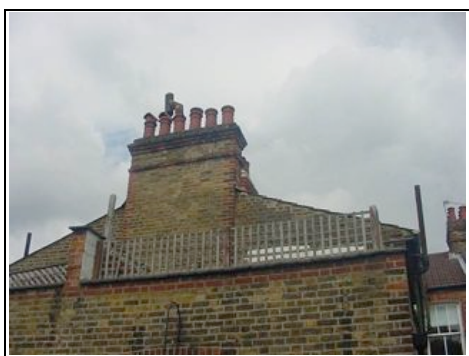
Rear chimney

This is a substantial chimney built in a similar manner to the first chimney, though we would comment that it is in need of repair; a close inspection may reveal more. This is the type of thing that would be repaired under the saving fund/sinking fund.

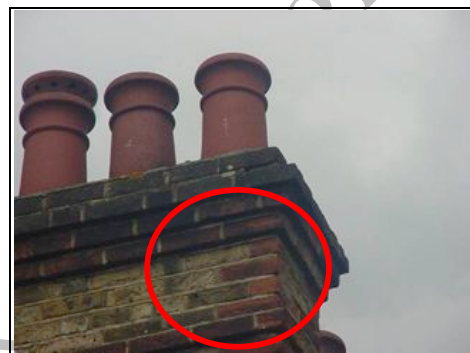
Work required to rear chimney

ACTION REQUIRED: Repair.

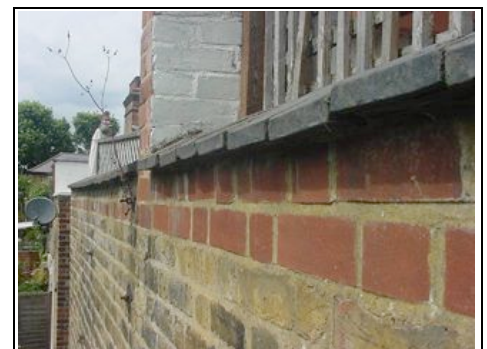
Rear parapet wall

We viewed this from a ladder, it would obviously be a lot better to view it from the balcony above. We suspect that some dampness is coming in through the parapet wall or through the roof. A close inspection from the flat roof terrace above would be the best way forward.

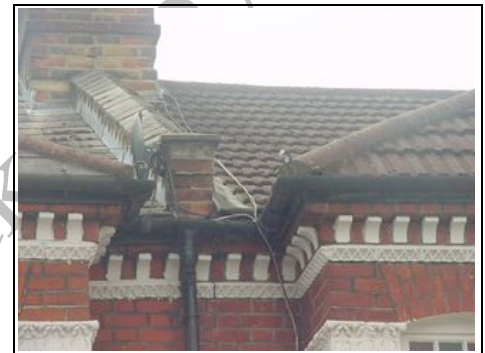
Main roof

The main roof is shallow pitched and clad with a concrete tile, and, from ground level, this looks in average condition considering the roofs age type and style.

A heavier concrete tile has replaced the original slate and therefore there should be additional roof support; in this case we have not had access into the roof.

We also noted there was a dip to the end tile which means the tilting fillet could have been missed.

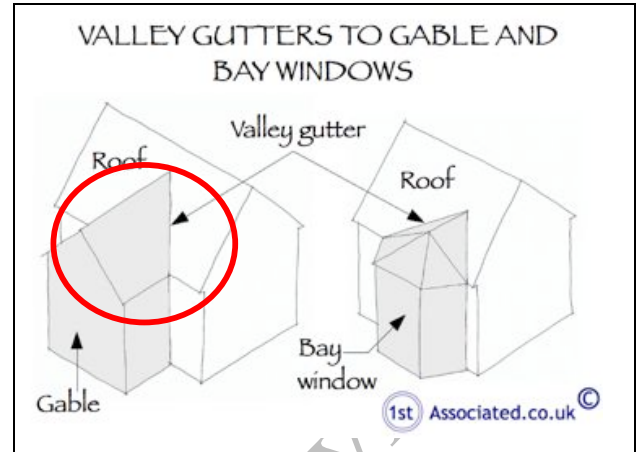
Valley gutter to front of property

This property has valley gutters which were difficult to view due to the surrounding trees. Valley gutters are formed where two roofs meet and these are generally problematic. In this case it looked to be lead and in reasonable condition although we have not had access to the roof which is where we generally find issues and see if any dampness is getting in.

ACTION REQUIRED: A close inspection of the valley gutter within the roof is recommended.

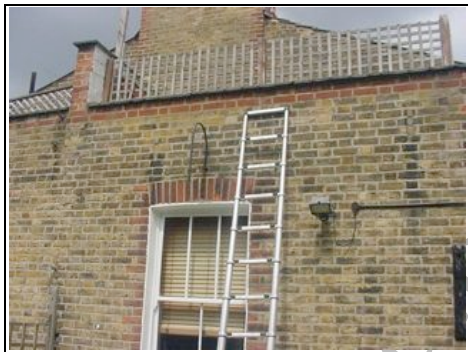
We tried to view this area via our ladders but unfortunately couldn't really see anything due to the trellis work at the top (we had knocked on the neighbour's door first of course). We believe this roof to be a cold deck roof as this would be typical for this era of property; it may even have had no insulation at all.

View of flat roof obscured by trellis

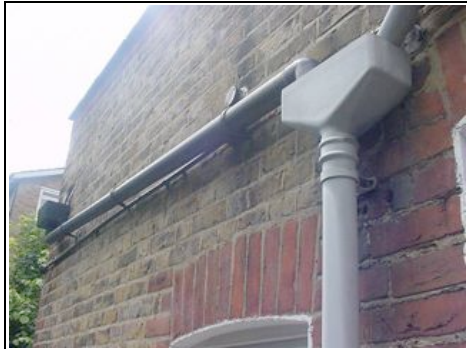
The property predominantly has replacement plastic gutters and downpipes. This looks to be the older type of plastic, which is affected considerably by ultraviolet light. There does look to be some leaks around the hopperhead, it may be because it is blocked and simply needs clearing.

Gutters and downpipes

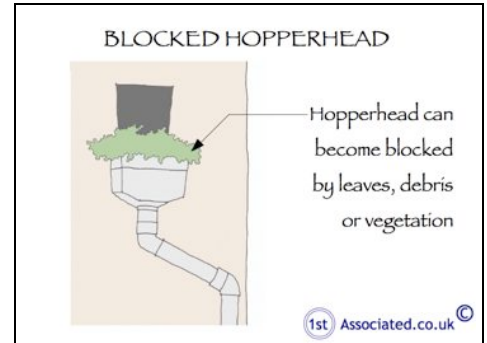
Overflowing hopperhead

Blocked hopperhead

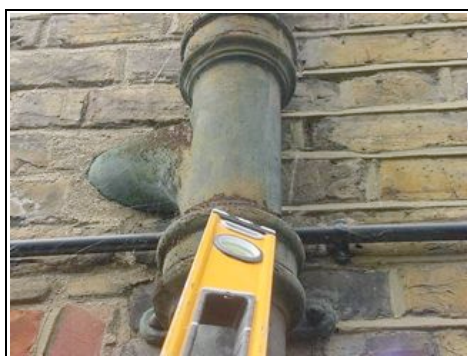
The property has cast iron soil and vent pipes, which are rusting.

Rusting soil and vent pipe

ACTION REQUIRED: Apply rust stop agent and redecorate.

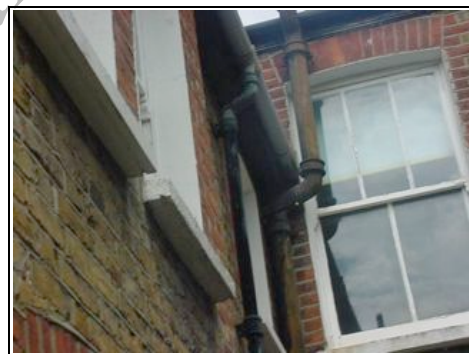
Rusting soil and vent pipe

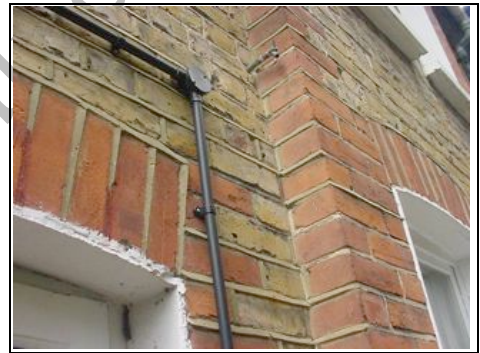
Wrongly repointed

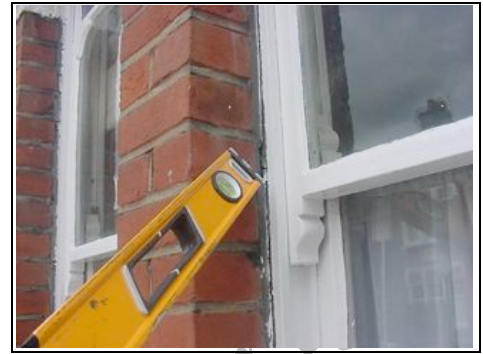
We noted missing mortar around the windows which needs to be filled.

Cracking around window

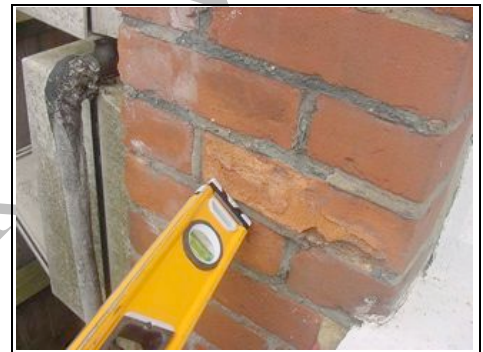
Spalling occurs often to softer red brick but also occurs where cement mortar has been used.

Spalling to brickwork

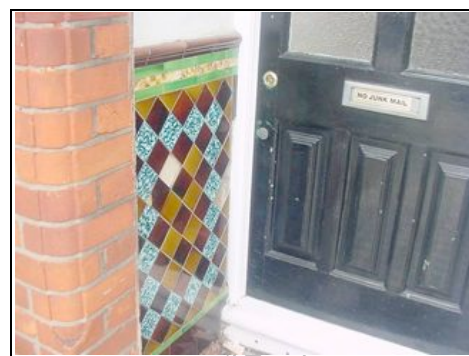
There are tiles around the front door which is fairly common. There are a few tiles missing in this case.

Decorative tile missing

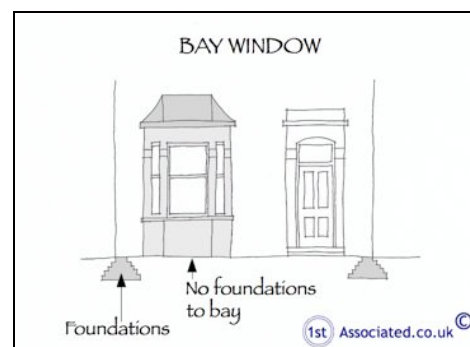
Bay windows in this era of property typically do not have foundations underneath them and have been subject to movement. We are aware that some insurance companies underpin bay windows with a modern foundation. We think this is often excessive and unnecessary and would be happy to comment further on this if you ever find yourself in this situation.

No foundations to bay

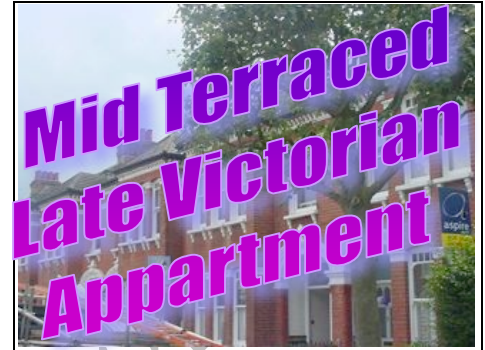
There is a tree on the public footpath within what we would term as influencing distance but you do need to speak to your insurance company as they may have a different interpretation for insurance reasons.

Tree to front

ACTION REQUIRED: You need to speak to your proposed insurance company before you commit to purchase the property to check the distance that trees can be away from properties without getting a premium or other such additional cost.

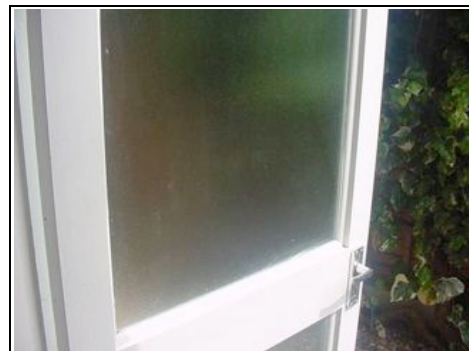
Not safety glass

ACTION REQUIRED: Replace the rear door for a more secure door with modern toughened glass. Change the glass in the internal door; it may be easier to change the door.

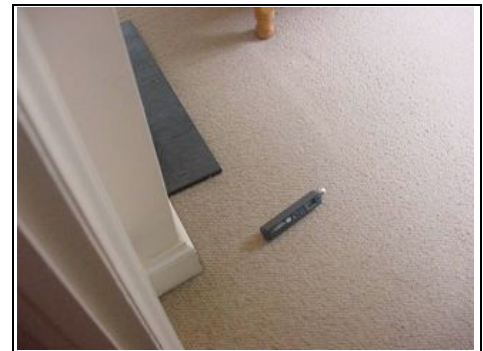
Some soft areas to the floor

ACTION REQUIRED: Open up the floor.

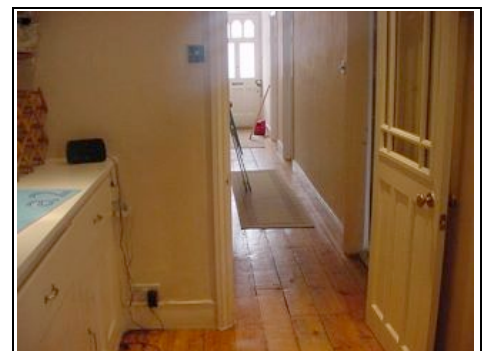
We noted where the floor had been sanded in the hallway and kitchen that a rotary sander had been used rather than a belt sander so there are marks within the floor, which you may or may not like.

Marks to floorboards

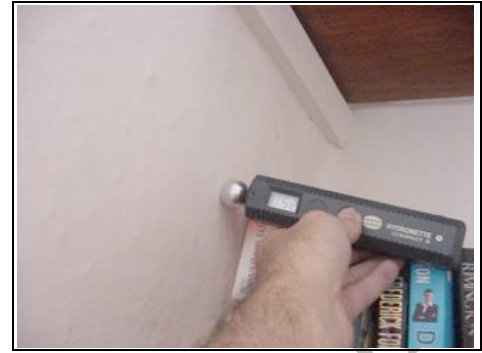
We have found significant dampness in the front left wall and suspect where the hopperheads are to the rear of the property there will be dampness after periods of heavy rainfall.

Testing for lateral dampness

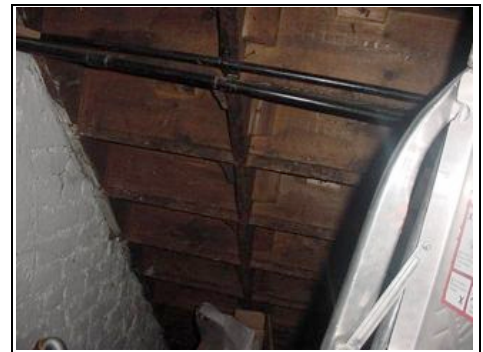
We noted that the underside of the staircase was exposed. It is more normal today to have a half hour fire barrier to stop fire spreading from the ground floor to the first floor in a worse case scenario. You may wish to take a view on whether you add this.

Stairs not lined

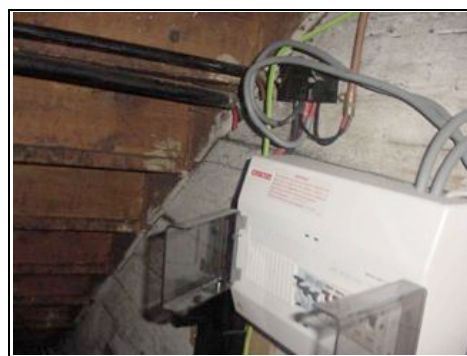
Fuse Board

The electric fuses and consumer units were located under the stairs. The fuse board was dated XXX's and better are now available; we would recommend upgrading. In multi occupied properties a defective fuse board can be particularly dangerous. Please see our earlier comments with regards to lining the staircase.

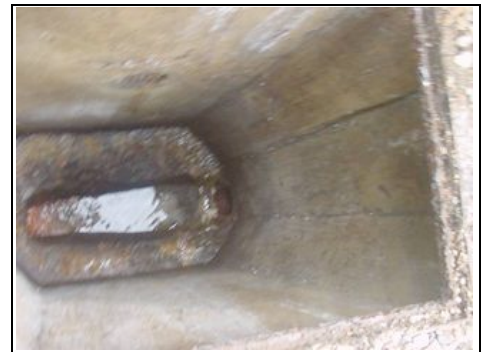
Manhole

From what we could see it is concrete built which indicates it has replaced the original brick one so there may have been drainage problems at this property.
