# RESIDENTIAL BUILDING SURVEY

XXXX  
London.  
SW17 XXX

Prepared by:  
XXXX  
INDEPENDENT CHARTERED SURVEYORS

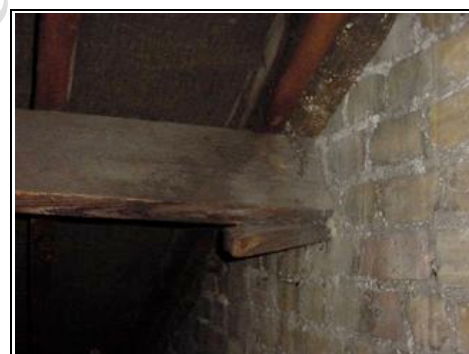
Front right hand purlin

**ACTION REQUIRED:** We recommend the purlins would benefit from having struts added whilst it could be argued that the roof has survived the test of time. We feel that a safer measure would be to have struts added.

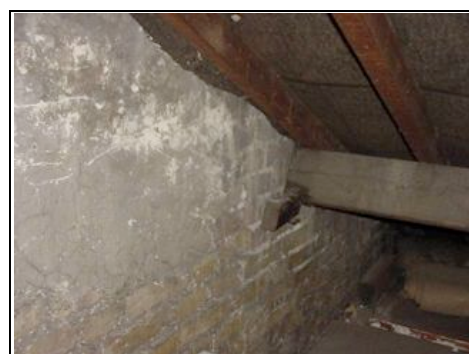
Rear right hand purlin

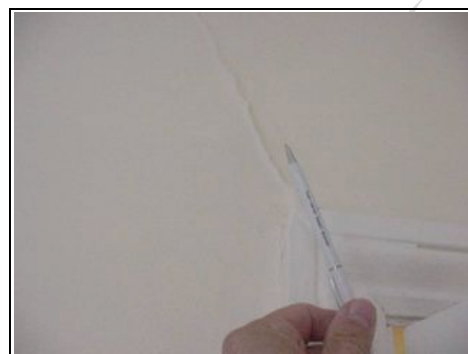
Movement visible to front bedroom above door

**ACTION REQUIRED:** As this is a terraced property the property cannot move far as it has buildings on either side however structural movement of any sort can put people off purchasing a property with the perception of problems. Ideally the existing owner should lodge an insurance claim with the insurance company monitoring the property for typically a year who will then advise in writing whether

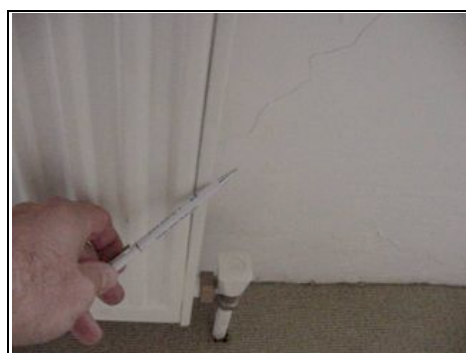
Cracking to rear bedroom wall

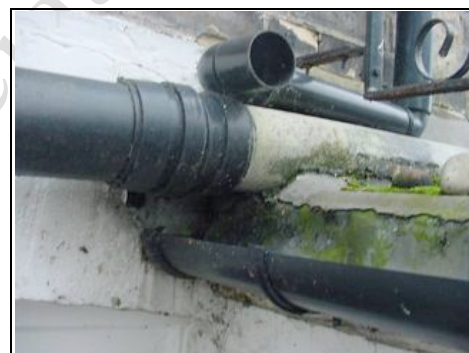
3.1) The front bay where the gutter can overflow and cause dampness to the wall.

Guttering to rear

**ACTION REQUIRED:** We would recommend a hopper head is added to catch the rainwater. You may have some dampness coming into the kitchen from this where it has been overflowing over the years.

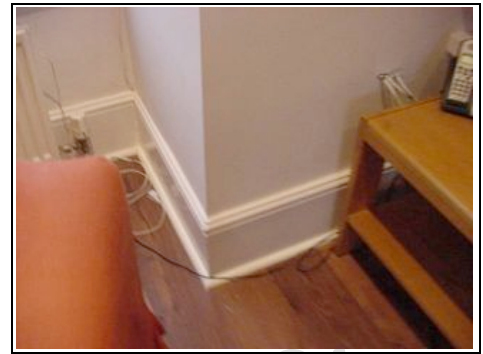
Unfortunately we could not see the condition of the floor as it is hidden by the laminate floor covering.

We do have concerns regarding the condition of the floor.

Laminate floor hiding what is beneath

**ACTION REQUIRED:** You need to add at least two airbricks to the front of the property and make sure that they cannot act as gutters. To the rear you have one airbrick which is acting as gutter and is also blocked which you need to open up; it is essential that you have airflow here. At some point in time you should open up the ground floor itself to check the condition of the timbers.

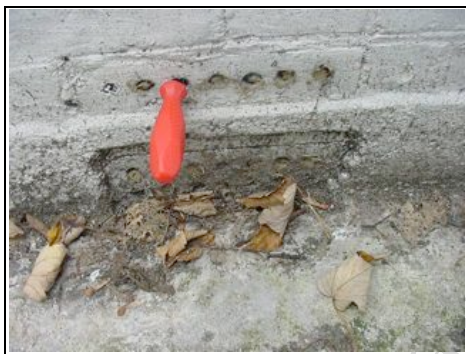
The property has a suspended timber floor which is not vented properly. This can cause deterioration to the floor the vents provide airflow to help reduce the effects of woodworm, wet rot and dry rot.

Rear airbricks acting as gutter and also blocked

**ANTICIPATED COST:** A few hundred pounds to add airbricks or expose, protect, repair and make sure airflow is going through them. The repairs to the floor can again be a few hundred pounds to a thousand or so pounds dependent upon the condition ; please obtain quotations.

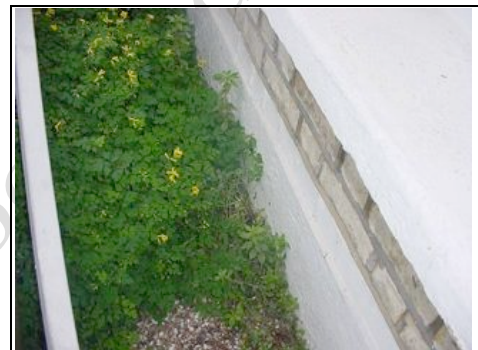
Front airbricks not visible

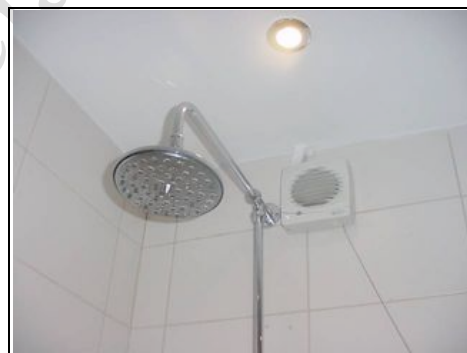
Small extract fan in bathroom

**ACTION REQUIRED:** Improve the extraction in the internal bathroom. We would recommend using an extract fan with a humidity controlled thermostat. We would also recommend adding the same in the kitchen.

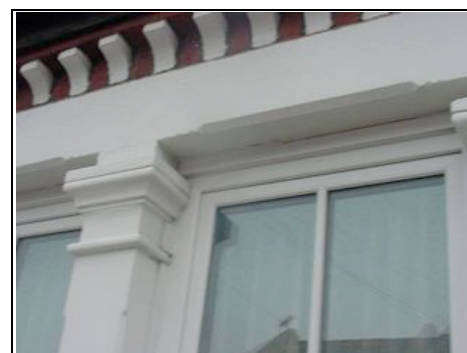
Window without trickle vent

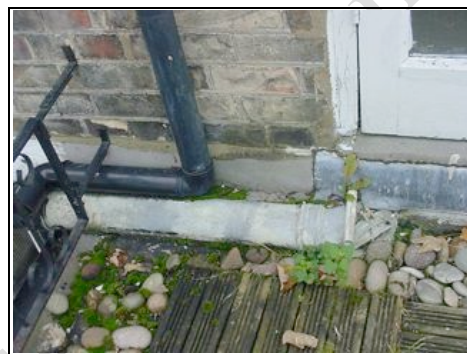
The moss that we could see on the roof indicates to us that rainwater is sitting on it so it could be in danger of leaking.

Moss sitting on terrace/balcony due to rainwater sitting on this area.

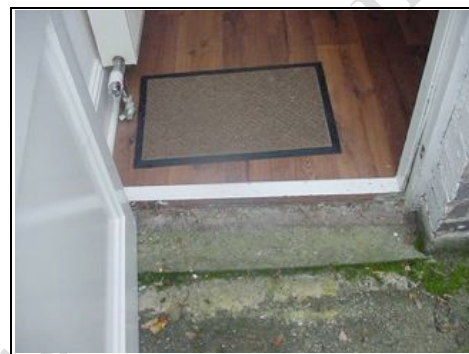
The ground level outside the property is similar to the ground level inside which indicates that there is likely to be dampness to the floor and may get in when it rains heavily as we could see moss in this area.

**ACTION REQUIRED:** You need to amend this threshold detail.

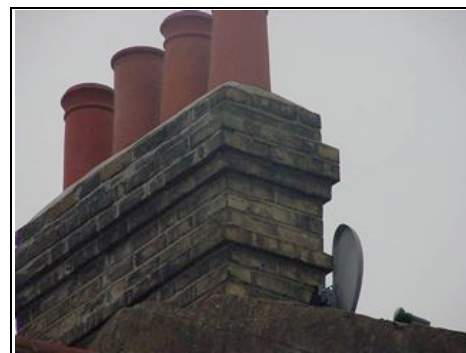
Chimney One

This chimney is brick finished with a lead flashing and four chimney pots. From what we could see from ground level it looked in average condition considering its age, type and style. Unfortunately we were unable to see the top of the chimney known as the flaunching, we therefore cannot comment upon them.

**ACTION REQUIRED:** We note that there is a satellite dish on the chimney, we do find that these can cause deterioration. There looks to be minor ad hoc re-pointing needed.

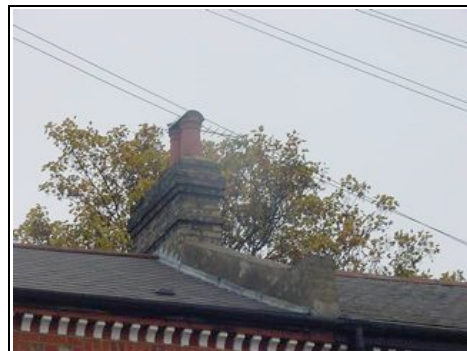
Chimney Two and parapet wall

**ACTION REQUIRED:** With both chimneys we suggest that a close up inspection is carried out in the summer of 2012 when we are recommending work to the parapet wall is also carried out. Again there looks to be minor ad hoc re-pointing needed, please see photograph labelled rear right hand side parapet wall where you can see pointing is missing on the chimney.

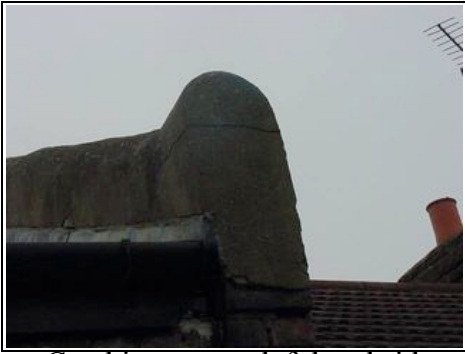
In this case there are parapet walls are built from brick with a cement render. We can see that some of the render is deteriorating, cracking or is completely missing.

Cracking to rear left hand side parapet wall

**ACTION REQUIRED:** We recommend the entirety of the parapet walls are re-rendered and the lead flashing is checked. Dampness will get into the property if this is not carried out.

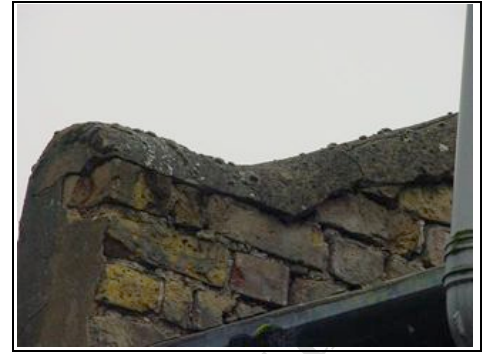
Render coming away and brickwork spalling re-rendering needed

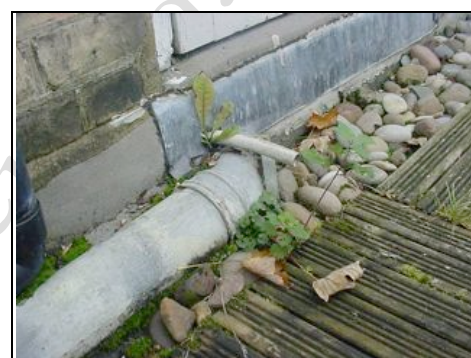
Rear roof clad in decking

**ACTION REQUIRED:** During the summer of 2012 we would recommend you lift all of the decking so that you can see the roof beneath and take photographs and email these to us and we would be happy to comment on the condition.

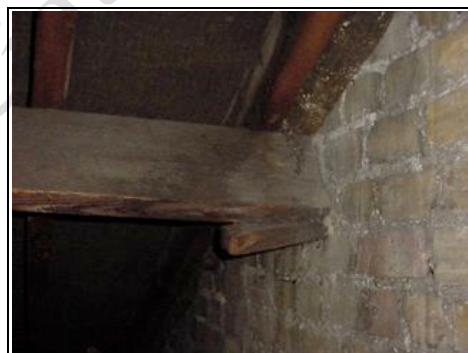
Purlin

**ACTION REQUIRED:** In this instance the sketch is not correct as there are not any struts or props in the roof. We would recommend that these are added.

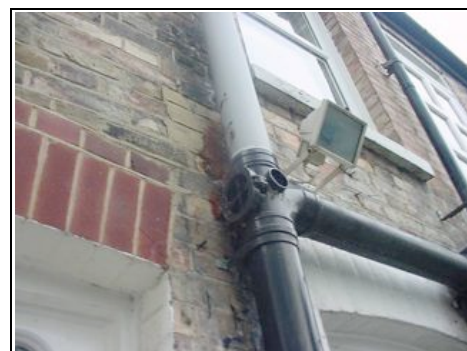
Soil and vent pipe

**ACTION REQUIRED:** We would recommend the soil and vent pipe is boxed in where it is exposed so that it does not freeze up and get damaged.

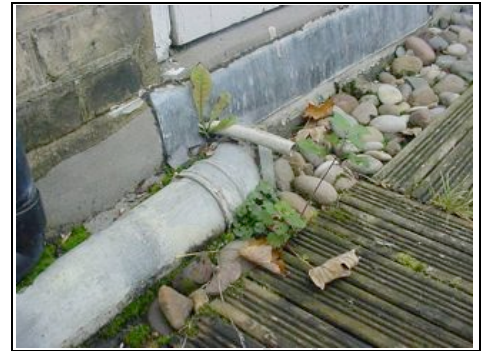
Soil and vent pipe awkward run

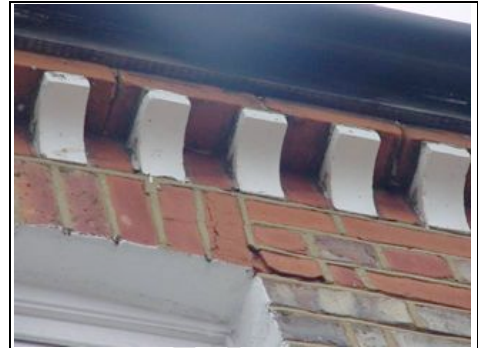
As is often the case the soft red brickwork used for detailing due to re-pointing in cement mortar is deteriorating and spalling. It is a priority that you have this re-pointed in a lime based mortar.

Spalling to soft red brickwork.

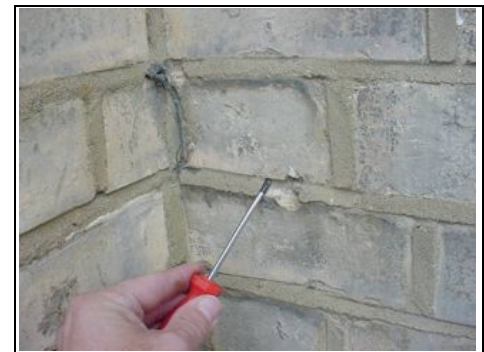
A cement mortar has been used rather than a lime based mortar. We recommend you use lime mortar in any future repairs regardless of what the builders say! Using lime mortar will limit further damage to the brickwork, which is almost impossible to repair successfully. However, we would add that many, if not most, of the properties that are re-pointed are re-pointed wrongly; it is only in recent years that we have discovered the problems that can occur from it.

Cement re-pointing

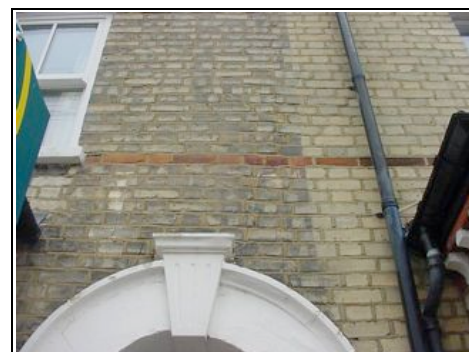
Cracking at front

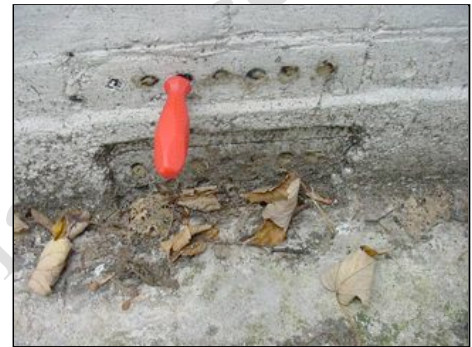
Air brick acting as gutter

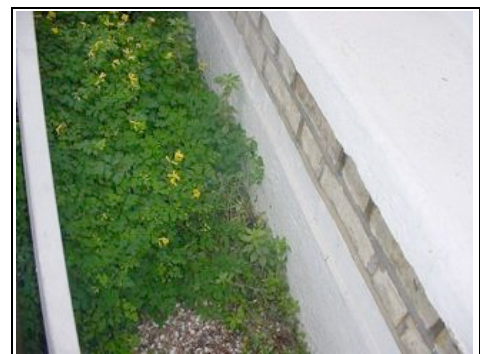
Looking for airbricks and not finding any at front of property

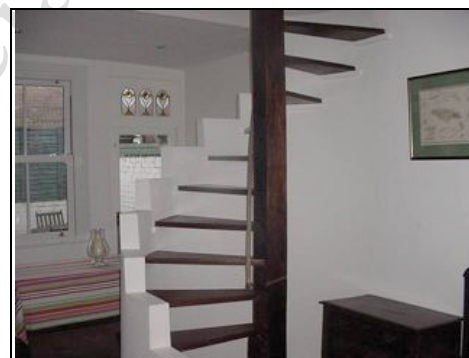
The stairs were very unusual to find in this age of property. Whilst we appreciate they are a feature they do not meet current Building Regulations as they do not have a proper hand rail but a rope. As mentioned with the terrace/balcony area the balustrade would need to be approximately 1.2m high with 100mm openings.

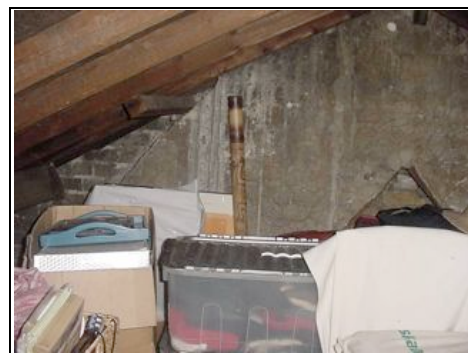
Mass of stored items in roof
