RESIDENTIAL BUILDING SURVEY

XXX
London.
SW3 XXX

Prepared by:
XXX
INDEPENDENT CHARTERED SURVEYORS

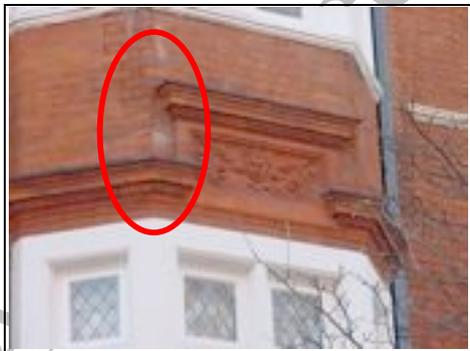
We can see pattern staining to the brickwork and areas that need repairs. We feel there should have been more repairs carried out to the external brickwork of the property.

Pattern staining;
repointing required

ACTION REQUIRED: Brickwork repairs and repointing and attention to the detailing of the brickwork.

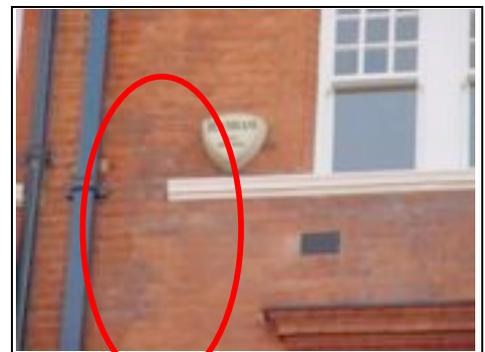
Repointing required

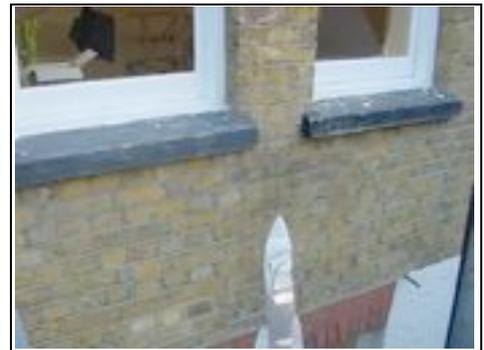
Hairline cracking can be seen to the rear bay through the brickwork in some areas.

Hairline cracking

ACTION REQUIRED: Confirmation required from the existing owners/the contractor as to whether this cracking is being monitored.

Confirmation required from the existing owners/the contractors as to whether the original timber lintels, bonding timbers and bearing timbers have been replaced. If they have not then this is a risk particularly to the bay window and there will be repair/replacement work in years to come.

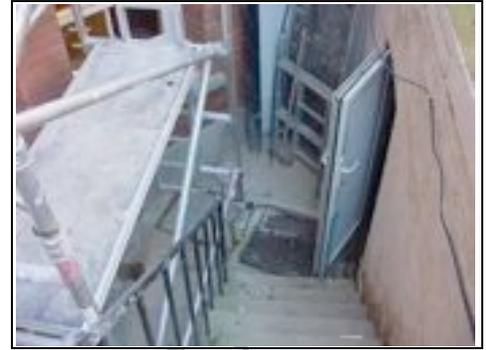
Manhole

During the course of the survey we could see that the drains were not clearing. It was noted that a tradesman was using the drains to get rid of waste material (photographic evidence available) and we feel there could be a problem with the drains.

We have been advised that a closed circuit TV camera report has been carried out previously but we feel there is a danger that the drains have been used for the disposing of material and as such may have become partially blocked. Typical materials that we have found in drains over the years include tiling grout.

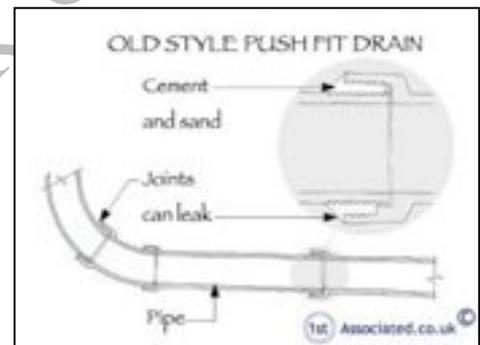
We would advise in older properties, such as this, drainage was often push fitted together rather than bonded together which means that they may leak over the years.

Push fit drain

Whilst we ran several of the taps for 15 minutes without any build up or blockages the only way to be 100% certain of the condition of the drains is to have a closed circuit TV camera report which we recommend.

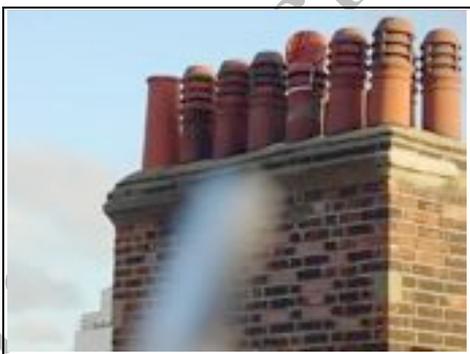
Front left hand chimney

This chimney is brick finished with a lead flashing and numerous chimney pots. From what we could see from ground level it looked in below average condition considering its age, type and style. We noted spalling brickwork which has been cement repaired. It also has a very awkward detail to the rear of it which we think will cause dampness.

ACTION REQUIRED: Generally we would recommend removal of cement repairs and replacing with a lime based mortar and an increase in the flashing where the awkward detail is and repair spalling brickwork.

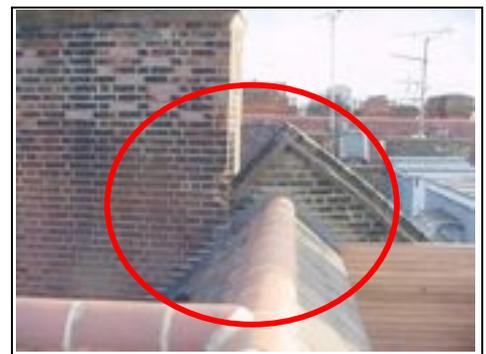
Awkward detail where chimney meets the roof

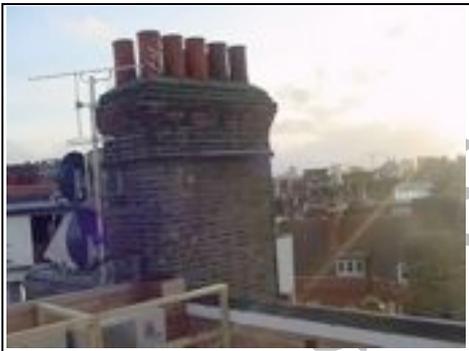
Middle left chimney

This chimney is also brick built with a lead flashing and numerous chimney pots. There are areas of spalling brickwork and areas where the cement mortar is coming away. The cement is already causing deterioration to the softer red brick.

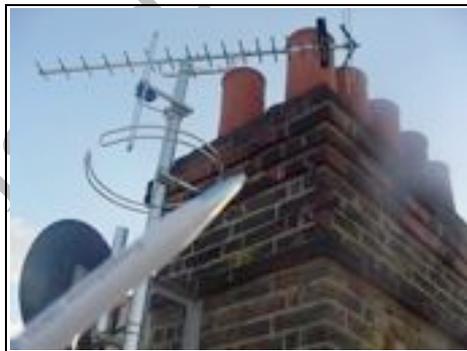
Spalling brickwork

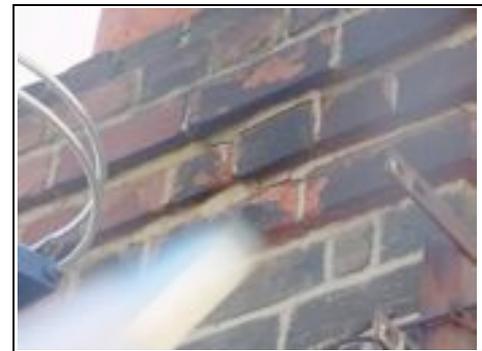
Close up of spalling brickwork

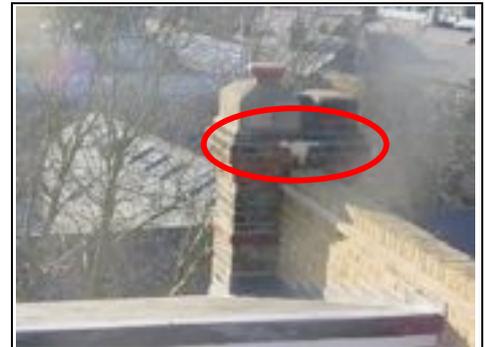
We have not been able to have a close inspection of this chimney and recommend a close up inspection. There is an area at the back of the chimney where we think dampness may come in but there is little you can do about this detail.

Cement mortar pointing

ACTION REQUIRED: We recommend a close up inspection as well as repair and repair spalling brickwork.

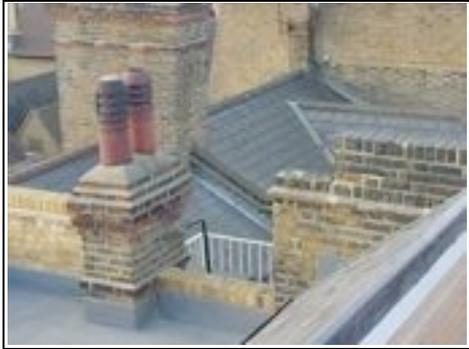
Middle rear right chimney

This chimney is brick built with two pots and a lead flashing. We would comment there is a crack to the haunching.

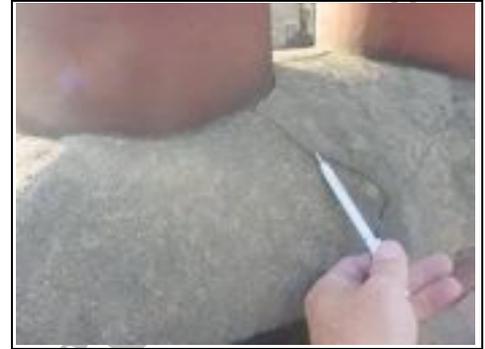
Crack to cement haunching

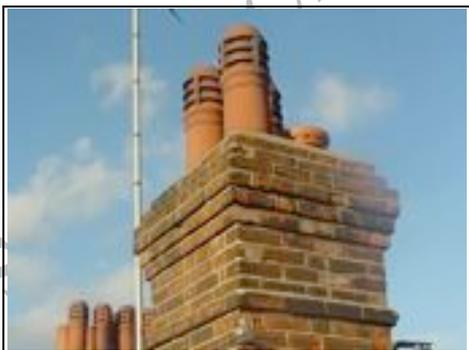
Front right hand chimney

This chimney is brick built with a lead flashing. We would comment the bricks are spalling.

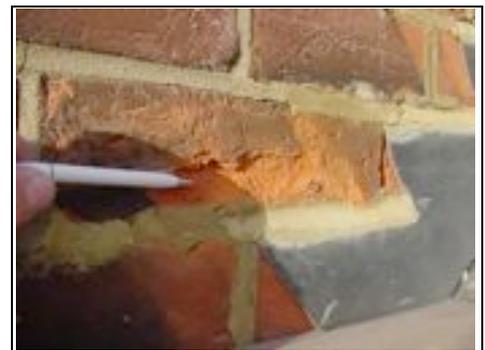
Spalling brickwork

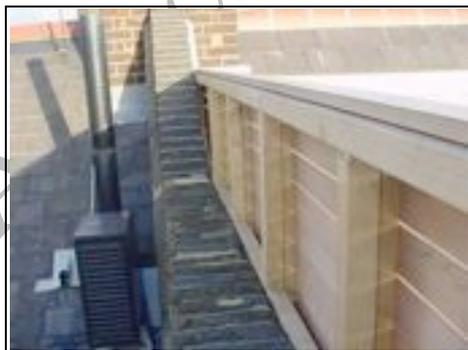
Right hand parapet wall

Additional brick built parapet wall. Some poor repointing has been carried out in cement mortar. No membrane as far as we can see to the wall and no repairs carried out before the cladding was added or we would say thought to the detailing.

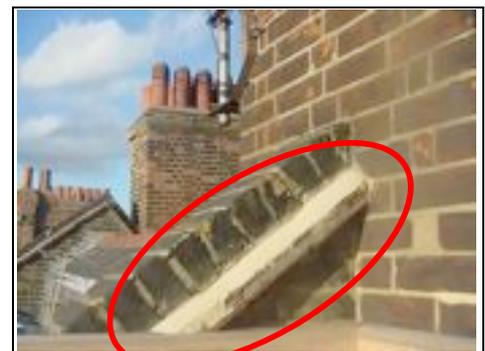
Inappropriate cement repointing

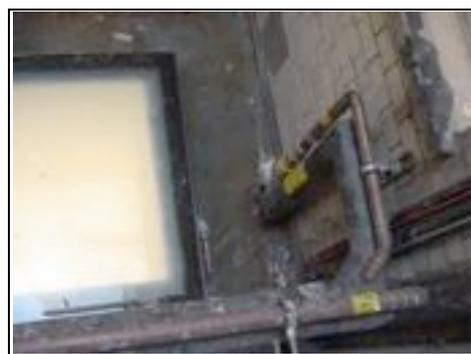
Roof window

We would add that with this sort of detailing it seems inevitable water will come in via the roof window. We do feel a better detail could have been provided.

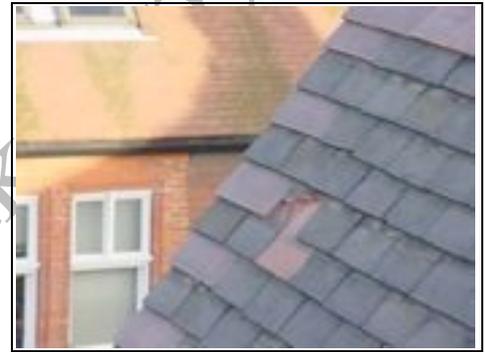
The main roof is pitched and clad with clay tiles and this looks in slightly below average condition particularly considering that this property has been newly refurbished as we can see there is a tile that's broken and some of the tiles look out of alignment. The only new work that we can see is the re-bedding of the ridge.

Broken and undulating tiles

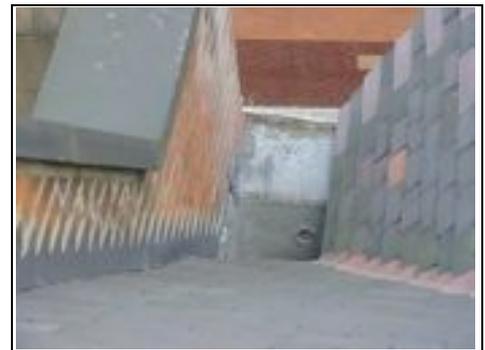
There are box gutters to the front of the property which are difficult to access. We feel these are likely to be a future area where you will get blocked gutters and thought should have taken place as to how to access these areas. This is what we would term as an original design defect (inherent defect).

Difficult to access box gutter

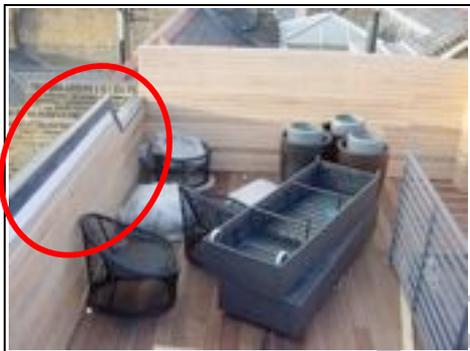
We noted around the terraced area there are areas of boarding; we feel these could have been detailed better as we feel they will suffer from pattern staining which will look unsightly.

Poor detail, allowing rainwater to drip down the cladding

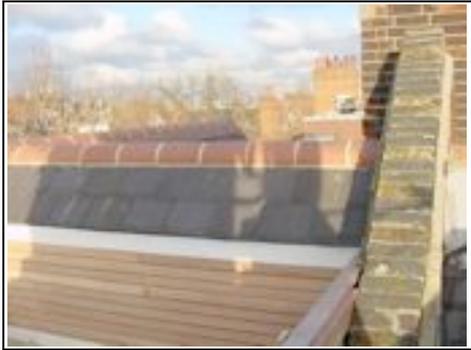
Small front slate roof

This is covered with slate tiles. It is poorly detailed and should have a guttering although this could be argued it is unsightly, equally pattern staining down the timber is unsightly.

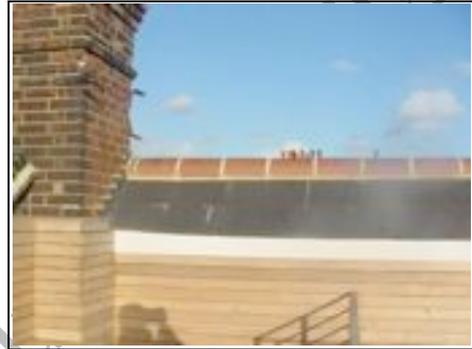
Poor detailing where water will run down the timber and cause pattern staining we believe

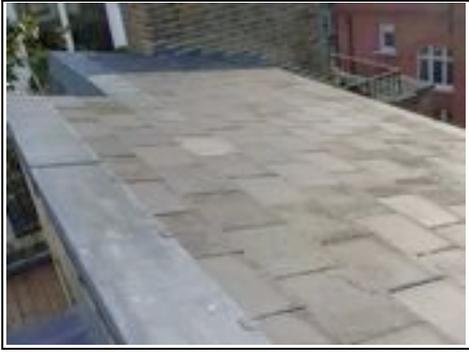
Rear slate roof

We noted an awkward detail to the left side and that there was no lead surround to the hopper head.

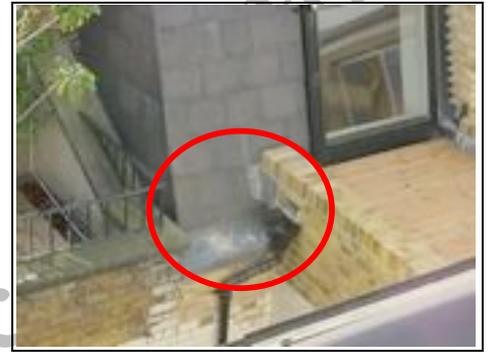
No lead surround to hopper head

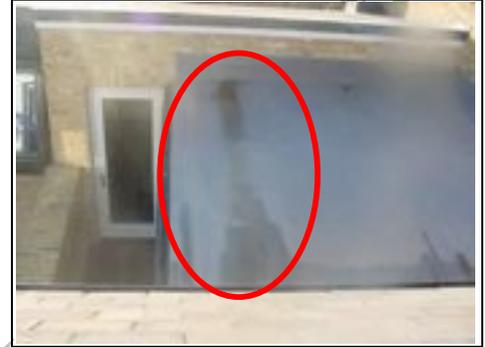
We noted there is ponding on the roof, indicating a lack of fall. The flashing does not look to be bedded in properly. Our general comment is that we find this the most economic roof that is often used by developers but it doesn't have a long term life.

Ponding on single ply roof

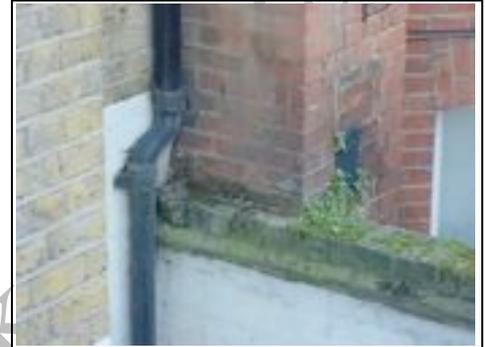
Cast iron of this age will need maintenance. If not regularly maintained it will crack and rust if it hasn't already.

Leaking downpipe

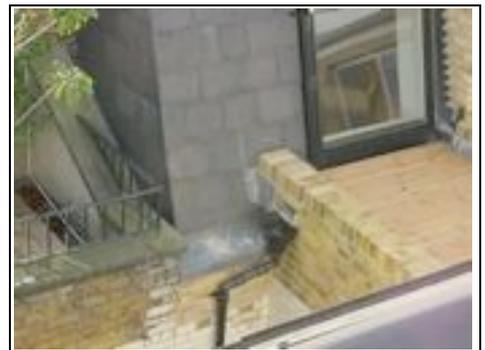
Green moss staining around hopper head indicating it is overflowing

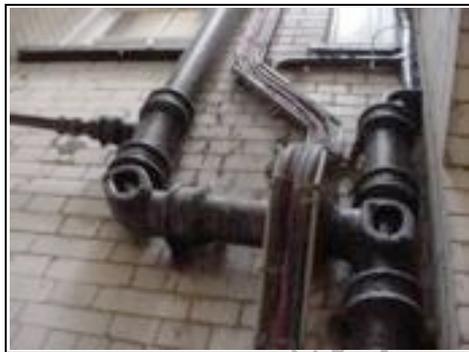
The property has internal soil and vent pipes within the central communal area, some of which are leaking.

Staining indicates soil and vent pipes are leaking

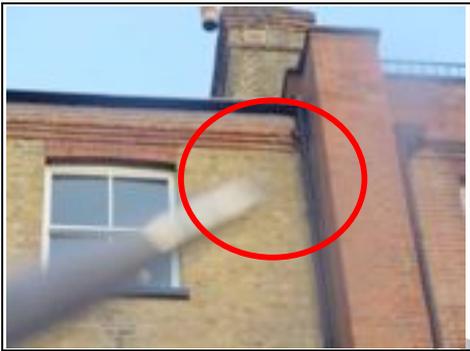
Hole at high level

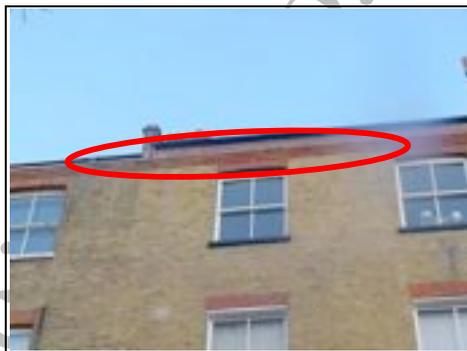
Appears to be deterioration to the red brickwork indicating that the gutter above may be leaking onto it.

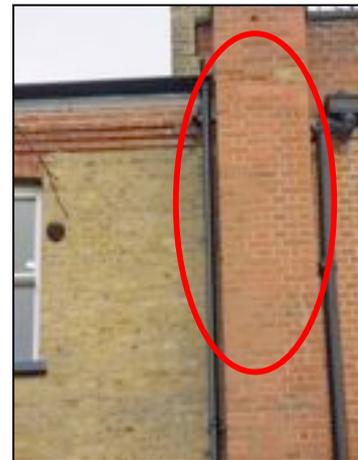
Pier needs repointing

ACTION REQUIRED:
Replace inappropriate cement mortar with lime based mortar.

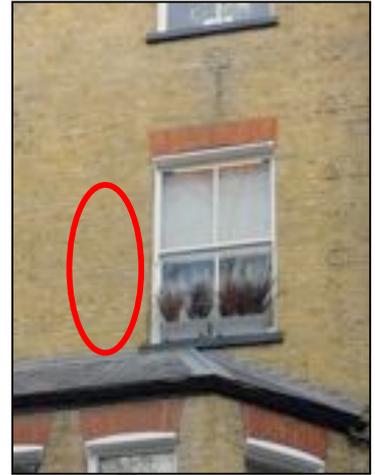
We are advised the pattern staining is to the flat areas only; no work has been carried out in these areas although we would disagree in some cases.

Pattern staining

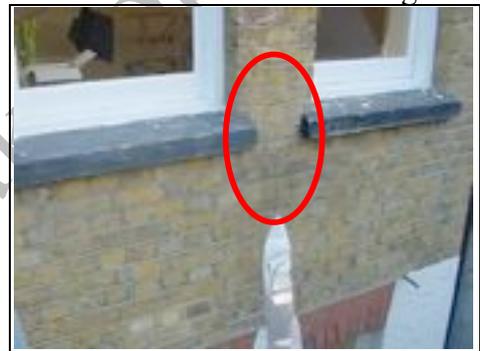
Hairline cracking

ACTION REQUIRED: The existing owners need to advise whether they have made a claim with regards to movement in the property or not.

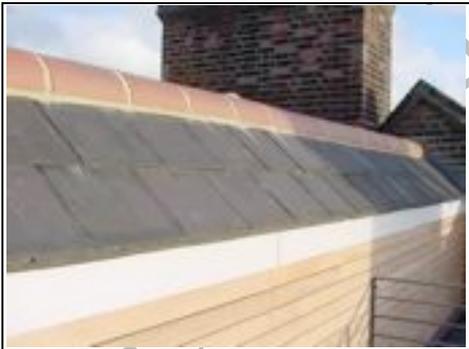
The fascias and soffits are timber. They are painted and we would comment they are in average condition for their age, type and style. There is no guttering to the fascia on the terrace; the contractor advised they didn't put one as it would look unsightly. This is something that has been raised in our snagging list as equally we believe the accelerated deterioration of the timber beneath and pattern staining will look unsightly.

Fascia on terrace has no gutter, without guttering pattern staining will occur

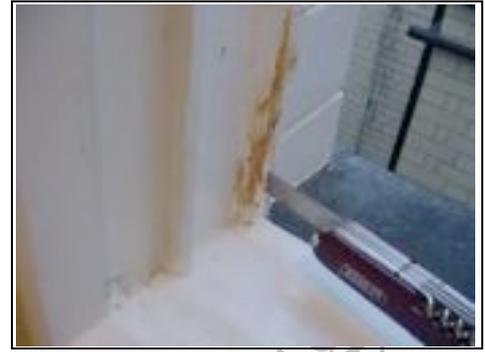
The property has mixture of timber sliding sash single and double glazed windows. We were surprised to find wet rot in one of the windows. We have been advised that all of the windows had been replaced. The windows look to have been filled poorly and rotten timber simply painted over.

Rot to windows

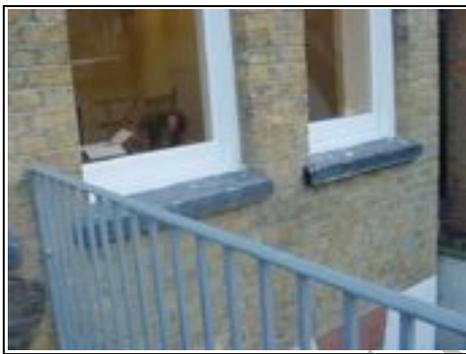
Window sills not decorated

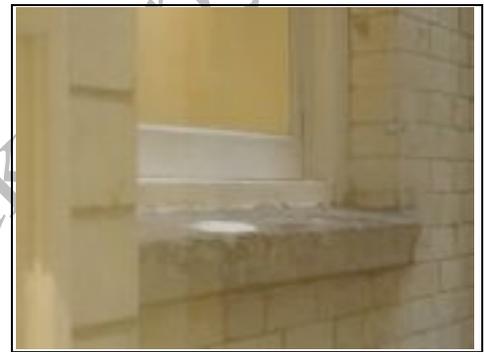
Window facing central void requires painting to window and window sill.

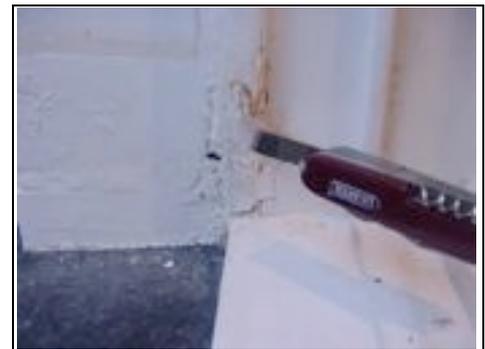
Knife test found rot

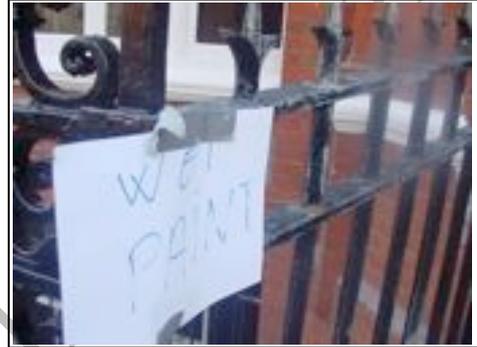
Our concerns are that the redecoration we have seen doesn't appear to be prepared correctly. Specifically we would identify the front railings where we believe rust has been painted over.

Rusting to railings

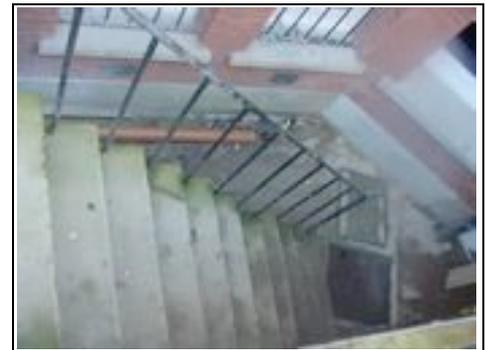
Front external area

The railings were being painted but we noted there hadn't been any preparation treatment to the rusting areas. There is dampness at the top which we are advised by the contractor that they will be dealing with. There are broken steps; we would recommend these are replaced. We couldn't see any fall to the floor or a drain that would take the water away quickly. We also noticed that one of the windows hasn't got any bars on it.

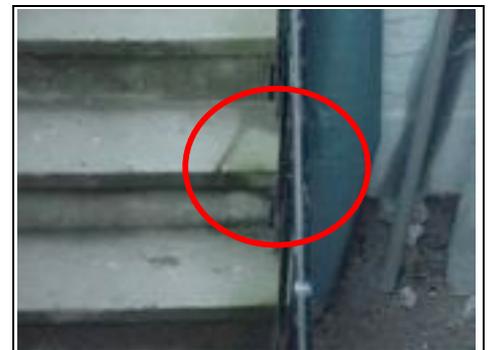
Cracked steps

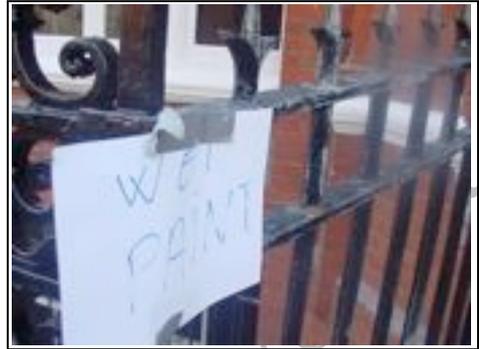
Rusting area

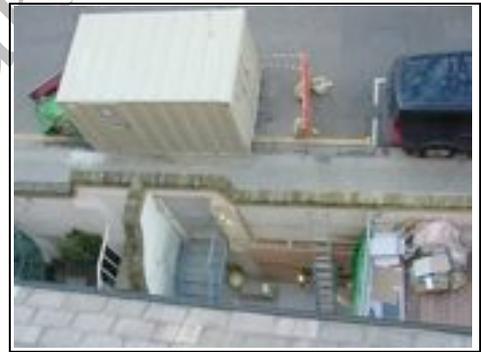
Construction still underway and building materials needed to be removed

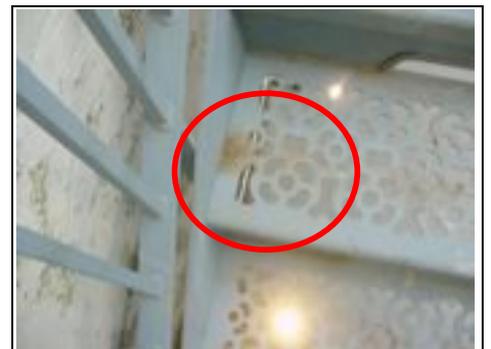
Rusting to stairs

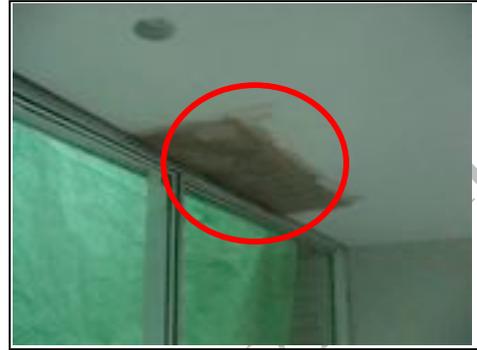
Repair carried out to ceiling

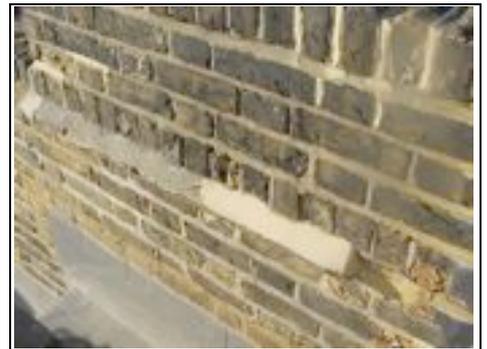
Poor workmanship
