RESIDENTIAL BUILDING SURVEY

XXX
London.
W10 XXX

FOR
Mr X

Prepared by:
XXX
INDEPENDENT CHARTERED SURVEYORS

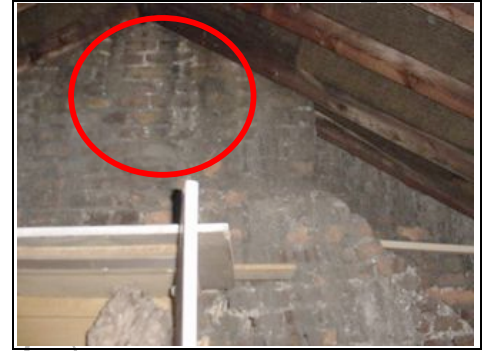
The right hand chimney is allowing some water in which isn't that unusual but we can see a crack also in the rear part of it.

Dampness coming in via front left chimney

ACTION REQUIRED: We appreciate you wish to remove the rear chimney to make the middle bedroom larger. If you do this you do need to look at repairing the chimney where the crack is. Alternatively you could look at removing the front chimney.

ANTICIPATED COST: To remove the chimney would be in the region of £500 - £1,000 as it will need support and Building Regulation approval and Party Wall Approval. It is very important you need to check next door to see if they have removed their chimney as you could cause major problems if they have already

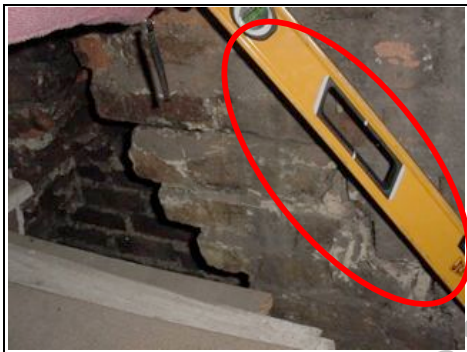
Our concern is that if you are intending to remove the front portion of this chimney to gain extra space as we discussed it may place extra weight onto the cracked chimney which could open it up and cause additional problems.

Crack to chimney

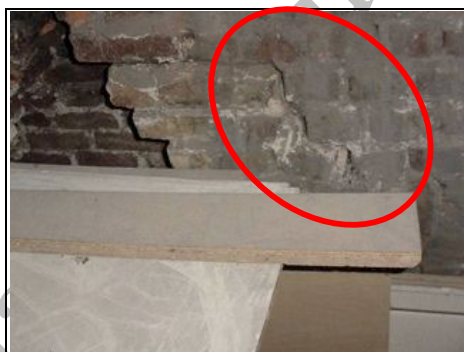
Crack in chimney

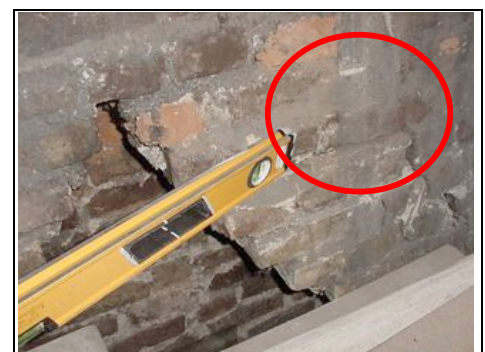
Close up of crack

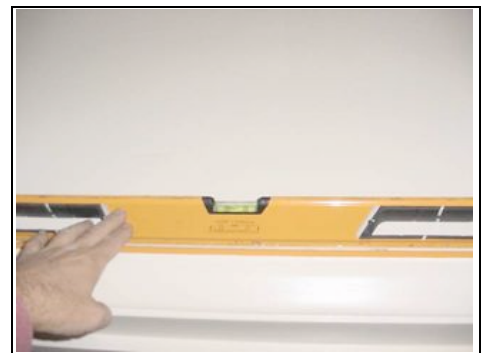
Movement has clearly taken place in this property as it has in lots of older properties particularly where London clay is involved and leaking drains from years gone by. We can see movement has taken place sideways which in turn has made the frame slightly out of square on some of the doors, for example the front bedroom door and also the stair floor is not horizontal.

Top of door out of alignment

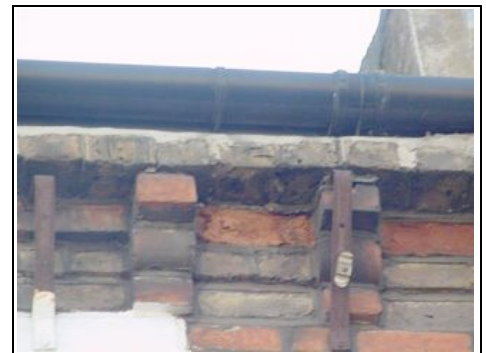
Spalling to soft red brick

The use of cement mortar causes deterioration to brickwork and does lead to the face of the bricks deteriorating, which in turn leads to dampness. This is a very important point.

ACTION REQUIRED: Ad hoc repointing during the warmer months. This will probably take a few years as other bits of cement mortar fall out. This is fairly typical of the way this type of building was wrongly repaired.

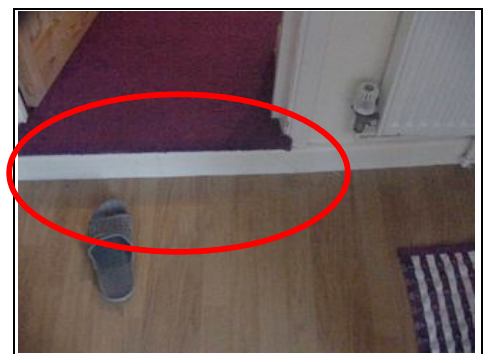
Step in kitchen where we believe vent should go

ACTION REQUIRED: We would recommend the addition of a vent in the step into the kitchen. We would also recommend that an area of the floor is opened up to check its condition underneath. This can be carried out underneath the stair area so it is not visible.

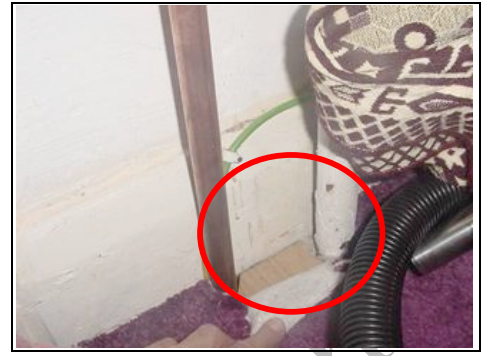
When we lifted the carpet in this area we found more laminate flooring underneath. Unfortunately laminate flooring covers floorboards and means that the timber underneath cannot breathe. In a worst case scenario you can usually prop up the floor or part replace it, very rarely does it all need to be taken up.

Laminate under carpet under stairs

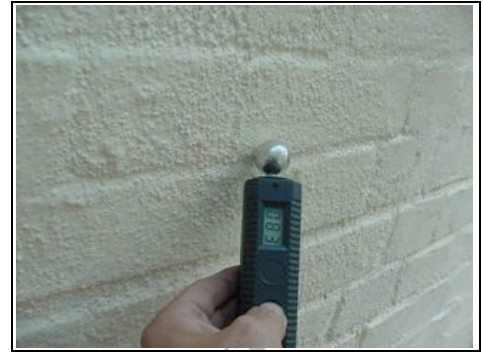
In another instance it is in the utility/outside area which as mentioned we would term as DIY standard so we are not surprised that dampness is visible in the wall and after all there is only a painted garden wall to the left hand side which is where the dampness was found.

Dampness to utility room/outside cupboard area

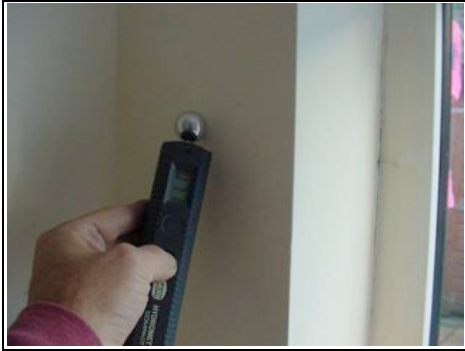
The property has a higher than average chance of getting condensation. Within the kitchen area we could see condensation and indeed got high damp meter readings to some of the walls. This, we believe, primarily is because humidity created in there during cooking, etc is not being expelled from the building.

Dampness in kitchen

ACTION REQUIRED: Add large humidity controlled extract fans to all humidity creating areas.

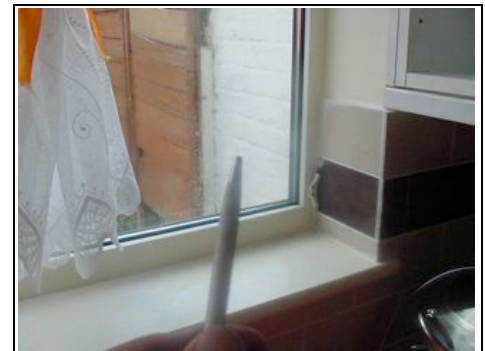
We also noted the seal has gone on the window to the kitchen meaning there is humidity and condensation within the double glazed unit.

Condensation within metal window

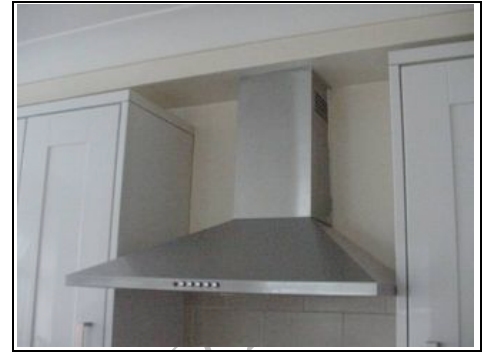
Please note there is a filter over the cooker. This is purely a filter, not an extractor and it filters the smell but the humidity stays the same.

Filter in kitchen, not an extract

ANTICIPATED COST: A few hundred pounds per extract fan; please obtain quotations.

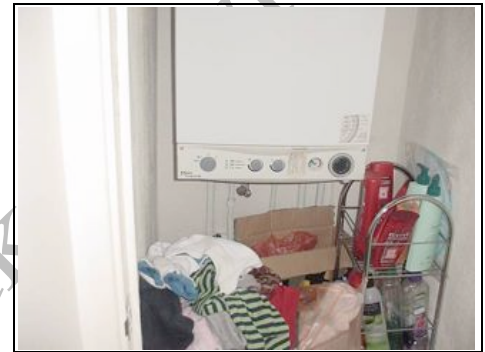
Boiler

The boiler is a Main boiler which is dated and a model we rarely come across therefore you may not be able to obtain parts. We would also comment it is more usual to have boilers located in the kitchen.

ACTION REQUIRED: Budget to replace the boiler.

ANTICIPATED COST: £2,500 - £3,500 and you may need to replace radiators as well. See our comments about internal radiators. Please obtain quotations.

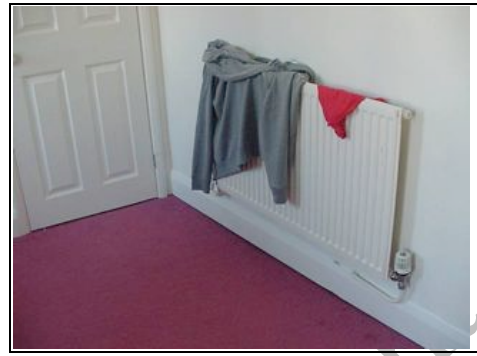
We noted the radiators are internal in some areas. This is often carried out on cheaper central heating systems to save the labour and piping costs of taking the radiators underneath the windows. However, it then reduces the air movement in the room.

Internal radiator to front bedroom

ACTION REQUIRED: We would live in the property and then if there are problems we suggest you move the radiators underneath the windows as this gives a better circulation of air and reduces the chance of condensation.

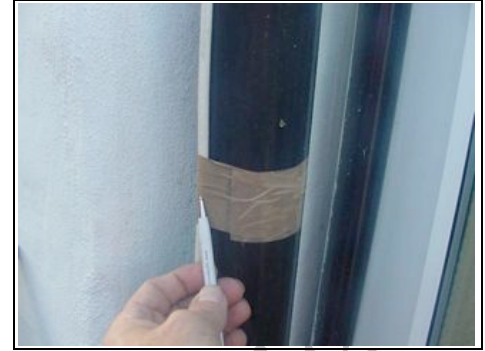
There are electrics taped to the downpipe which is not ideal and gives us concern for the whole of the electrics.

Electrics taped to wall

There are some what we would term as DIY electrics such as the wiring being attached to the downpipe which is why we would recommend an Institute of Electrical Engineers standards (IEE) test and report. This should be carried out by an NICEIC registered and approved electrical contractor or equivalent.

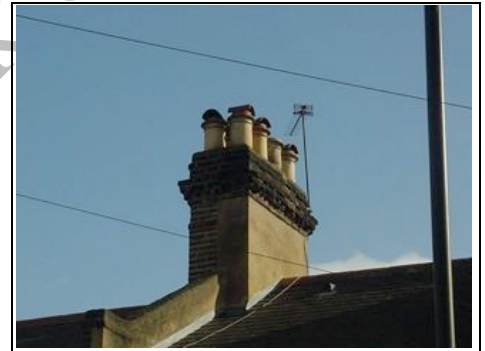
This chimney is brick built with a render finish with a lead flashing and numerous chimney pots (approximately eight). From what we could see from ground level it looked in average condition considering its age, type and style. It looks to have been rendered recently which is usually carried out where there is a damp problem which can often occur in these properties due to soft red bricks being used for detailing such as around chimneys and windows.

Chimney front left

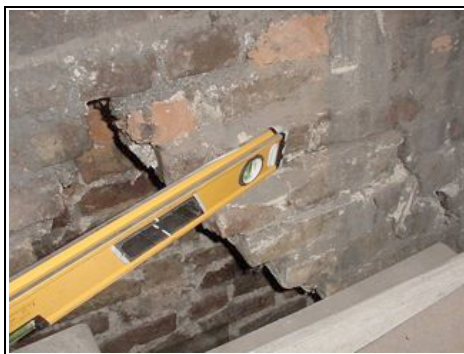
Close up of crack

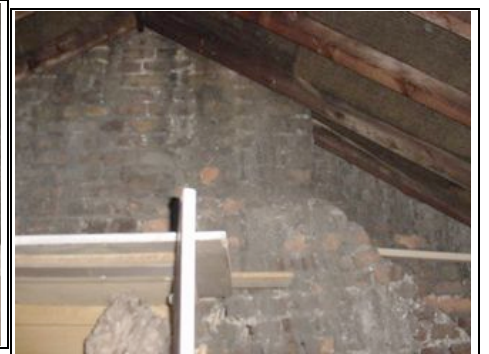
Dampness coming in via front left chimney

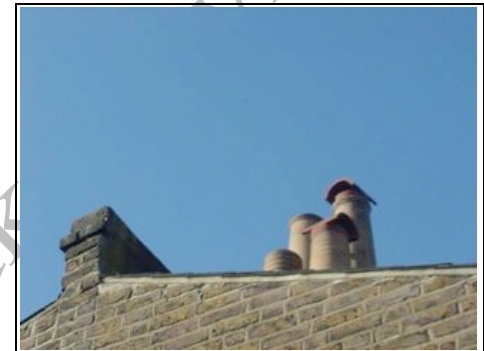
Chimney rear right

This is the best view we had of this chimney. Our concern is the condition of it because we couldn't see it.

ACTION REQUIRED: When carrying out the high level repointing work that we have mentioned have a look at the chimney and the associated parapet walls.

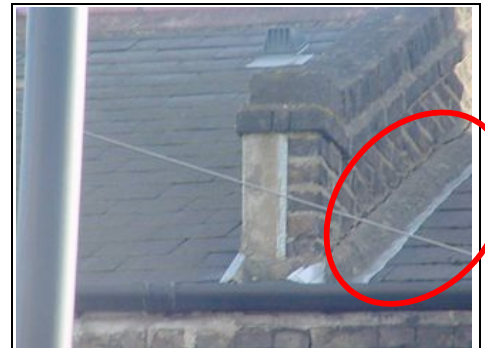
We noted a crack to next doors side which will allow dampness into your property.

Crack in next doors side which will allow dampness into your property

ACTION REQUIRED: Check condition when carrying out the high level repointing work.

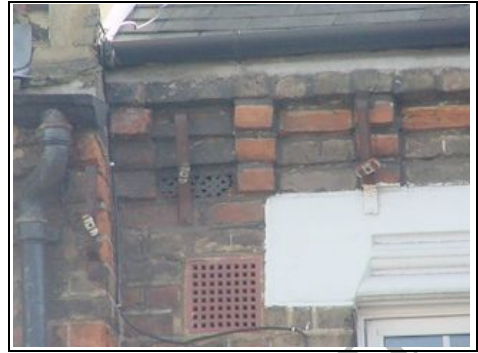
We noted a slate guard indicating the previous roof was in poor condition and had to have a slate protection guard added. This is to stop slates from slipping off the roof. Alternatively it may have been to hold electric cables.

Old Slate Guard

ACTION REQUIRED: You may wish to remove these in the future as they will just rust away otherwise.

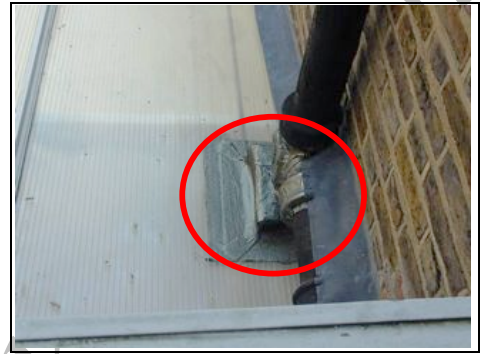
Flashband where it goes into polycarbonate

Flashband is a sticky backed felt which is best used for temporary repairs only.

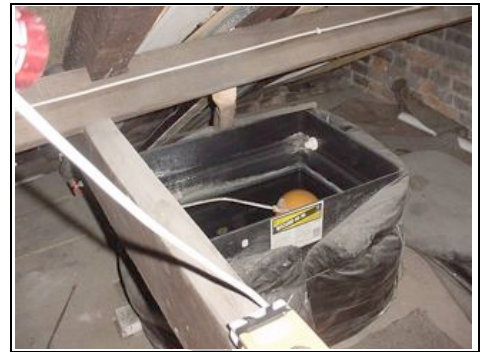
We would always recommend that water tanks be drained down and cleared of any debris etc. (we have seen dead birds and other unmentionable things in these tanks). As you are using the water it is best to be as clean as possible.

Water tank without lid

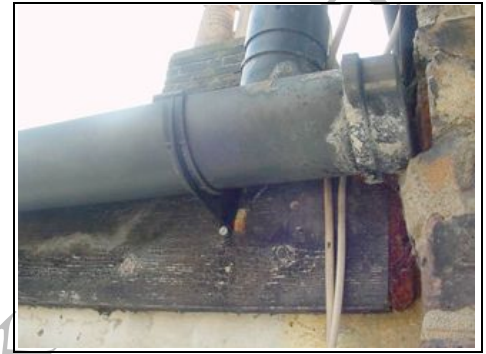
Example of leaking gutter

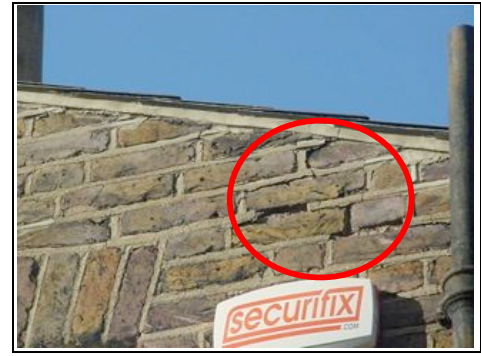
Cement mortar coming away

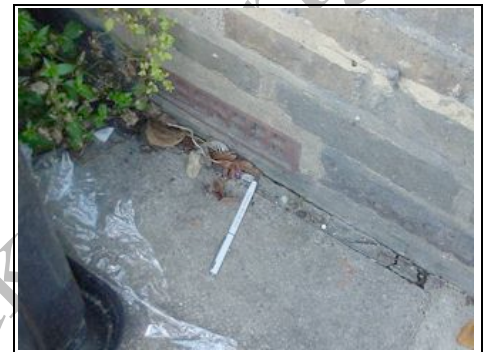
Air bricks are essential to have a through flow of air as this helps to reduce the chances of wet rot, dry rot and woodworm. In this case airflow has been blocked by both the airbrick to the rear being blocked (we can see one airbrick) and also the laminate floor being placed over the suspended timber floor.

Air brick to front

ACTION REQUIRED: Please see our comments in the Executive Summary.

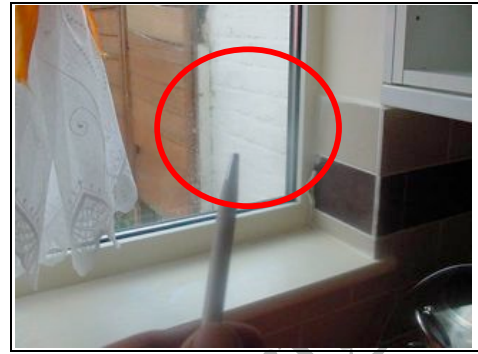
We would draw your attention to the fact that sealed double glazed units can fail, particularly as a result of poor workmanship during installation. Failure of the seal leads to condensation between the two panes of glass and simply replacing the affected units may not provide a satisfactory long-term solution. In this case we noted a broken seal to the kitchen window.

Condensation due to broken seal in kitchen

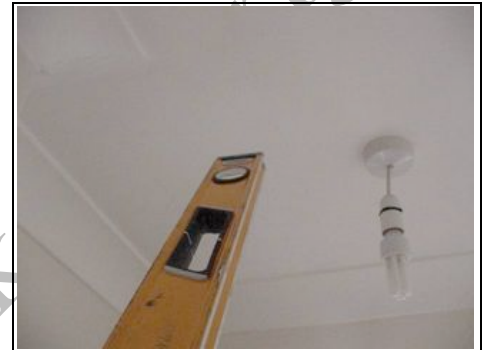
Hairline cracks in ceiling

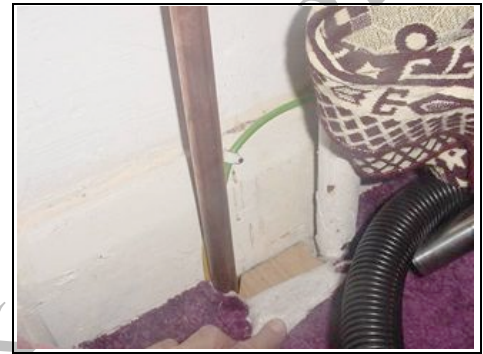
Carpet with laminate underneath under stairs

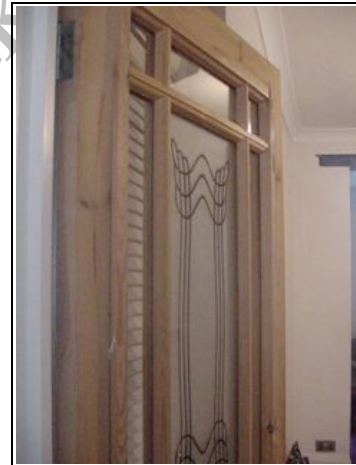
No safety glass to kitchen door

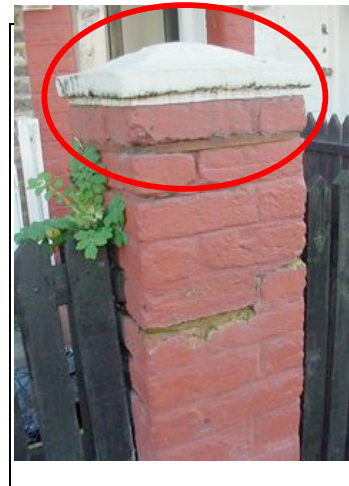
Pillar loose
