RESIDENTIAL BUILDING SURVEY

xxxxxxxxxxxxxx,
Wandsworth,
London,
SW18 xxx

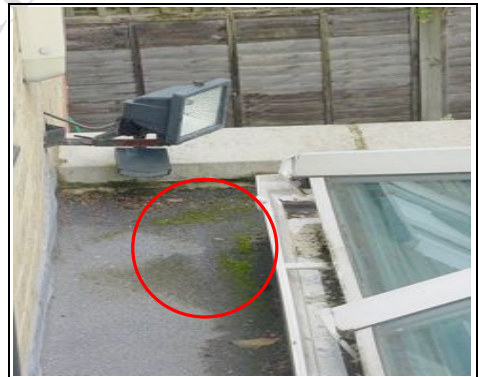
Flat areas on the roof with moss forming

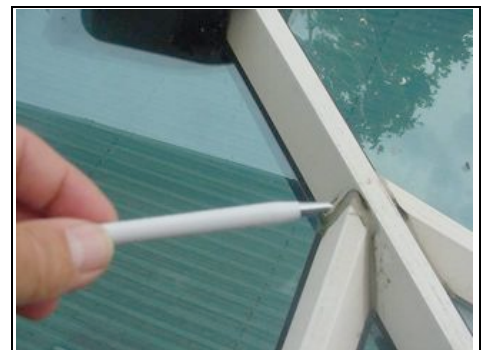
4.2) We can also see to the glazed areas that there have been some repairs over the years.

Mastic repairs

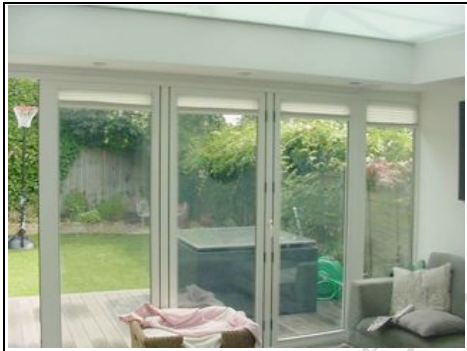
We feel that the kitchen/dining/lounge area will suffer from heat loss during the winter months due to both the glazed roof area and also the sliding doors. Although both these areas have blinds we noted that they are standard blinds with little thermal insulation that will not prevent cold coming in or heat going out.

Large area of glazing can cause heat loss

ACTION REQUIRED: We would recommend that you either replace the blinds with insulated blinds or add to the blinds with curtains or wooden shutters to keep these areas warm during the winter and cool during the summer.

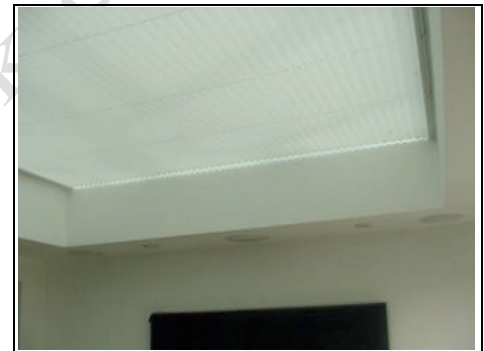
Glazed area of roof can cause heat loss in winter.

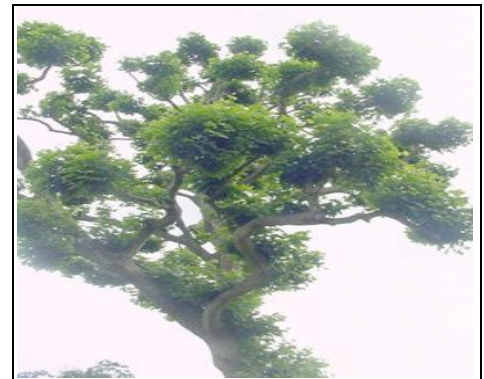
There is a large tree to the rear of the property in a neighbouring garden which we assume was taken into consideration when the property was originally built. However, with the adding of the new single storey extension to the rear of the property the tree may, or may not, have not been taken into consideration.

Large tree

ACTION REQUIRED: Your Legal Advisor to check with Building Regulations to ensure that foundations have been built adequately with consideration for the tree to the rear.

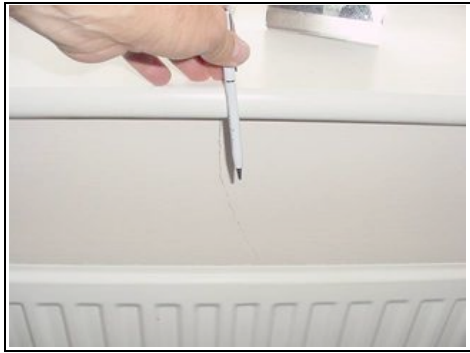
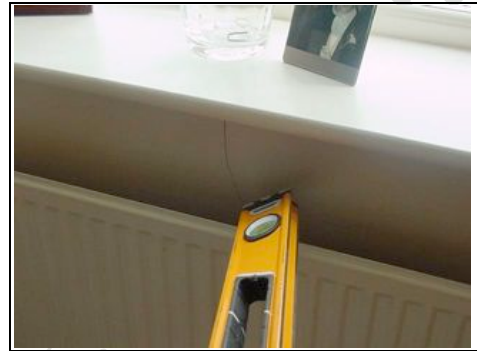
We noted a crack to the wall below the lounge window. We believe this crack may relate to the alterations to the ground floor to allow access into the new extension. If you can imagine, the ground floor wall has effectively been taken out.

Hairline crack

ACTION REQUIRED: Your Legal Advisor to confirm that full Building Regulations and Planning Permission was obtained for the extension.

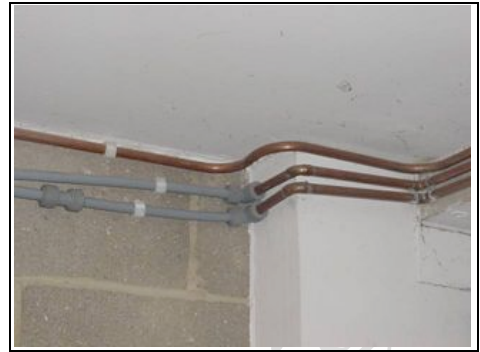
We noted a combination of copper and plastic pipework in the garage.

We have recently, in the last six months, experienced problems with this type of system which we believe relates to differential movement/expansion between the two materials. This is both during the hot weather where pipes crack and in the colder weather where the pipes contract causing leaks.

Copper and plastic pipe work

ACTION REQUIRED: We would look at converting the pipes to copper and in the meantime would also look at giving more support to the plastic pipes. We noted that the plastic pipes are now used for both cold and hot water.

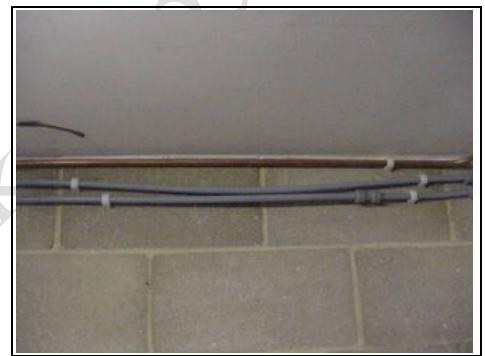
Pipe work in garage

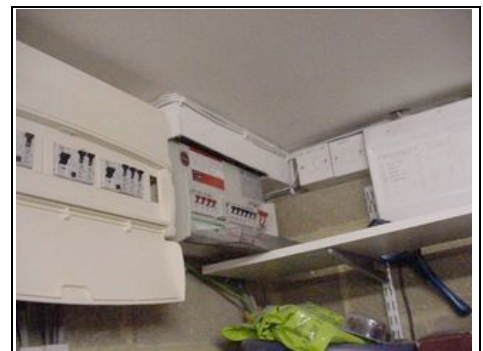
We noted two fuse boards in the garage, we are not certain why this is? One appeared to be older than the other.

Two fuse boards

ACTION REQUIRED: Your Legal Advisor to enquire in writing why there are two fuse boards.

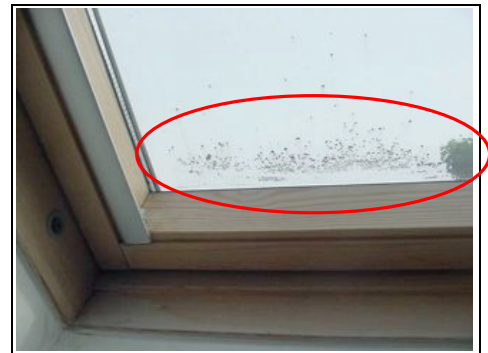
The important factor with roof lights is the flashing around them; in this instance we would comment on the roof lights that we could see by standing on ladders that there were no obvious signs of defects to the flashings. We would add that there is some mould on some of the windows which probably relates to the adjacent shower room not extracting the moist air quickly enough.

Minor signs of mould

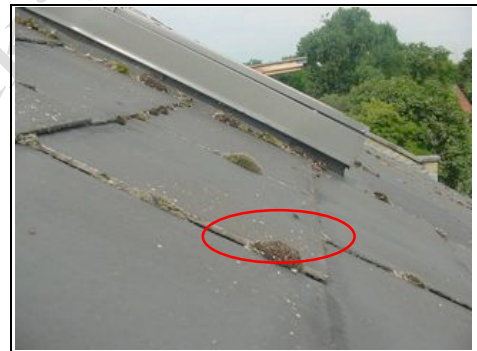
The main roof is pitched and clad with a manmade slate and, from ground level, this looks in average condition considering the roofs age type and style, although there is some minor moss.

We could see some slates that had lifted slightly but there did not appear to be any replacement slates on the roof. We have also found that manmade slates get lighter in colour/turn grey/white over time.

Manmade slate
Minor moss visible

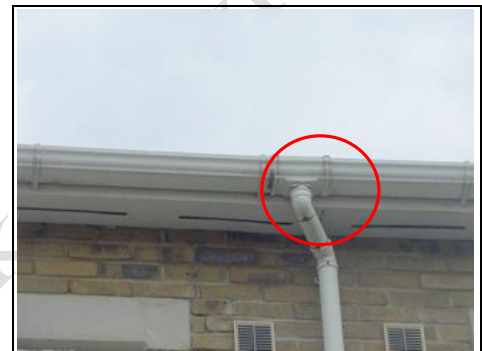
Gutter and downpipe, leaking slightly indicated by staining to the swan neck

We always recommend that the gutters and downpipes are cleaned out, the joints are checked and the alignment checked to ensure that the gutters fall towards the downpipes.

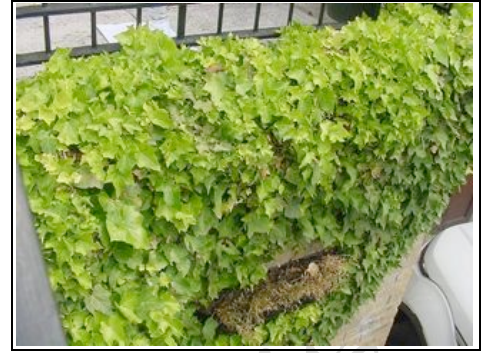
Ivy growing on brickwork

We would always recommend that Ivy is cut back and put on a trellis to prevent damage to the brickwork.

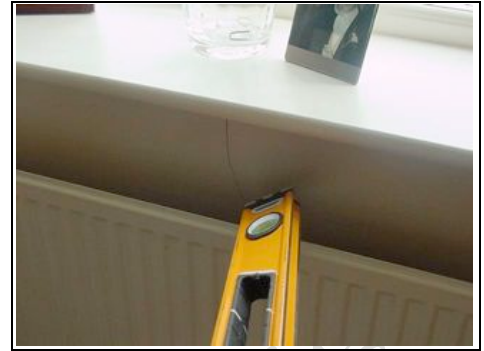
Hairline crack

ACTION REQUIRED: Please see our comments within the Executive Summary.

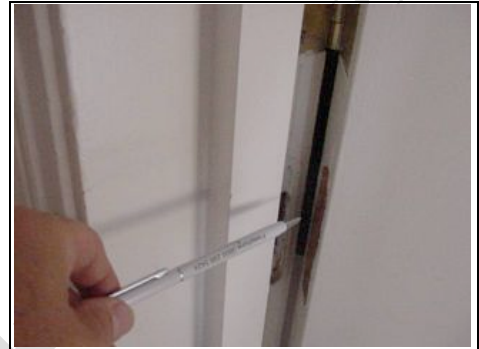
The doors to the property are modern hollow core doors and some do not have door closers.

Perko door closers missing lower ground floor

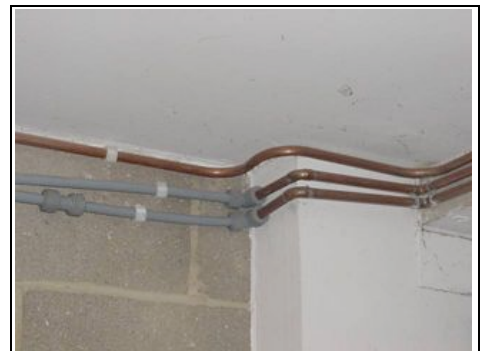
We also noted some awkward piping just as we entered the loft storage area so be careful not to tread on these as it could cause a water leak.

Plastic and copper piping
