RESIDENTIAL BUILDING SURVEY

**Leytonstone,
London.
E11 XXX**

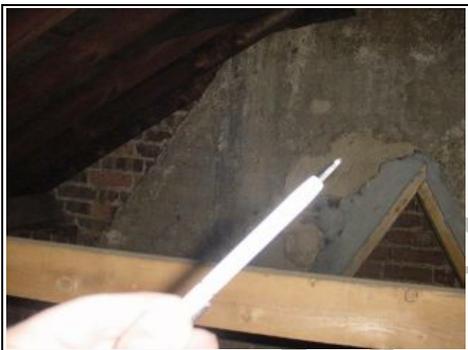
Chimney breast in roof space.
Rear chimney has crack in it
front, no support can be seen

the time of the survey but there was no response. We would recommend you advise number 156 in writing that your chimney breast has been removed if you do proceed; in theory this should also have had a party wall notice.

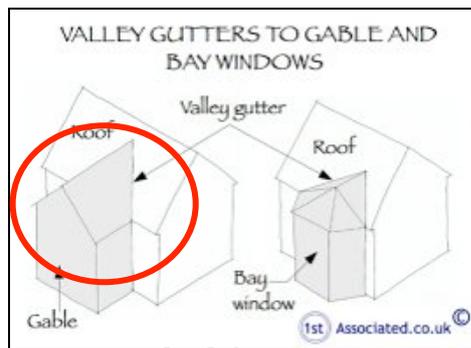
We can see within the roof space that the valley gutters are leaking. There are no obvious visual signs of where this was externally although we would say that sometimes it is the cement rendering to the side.

Valley gutter

ACTION REQUIRED: You need to put a long ladder or tower scaffold up to have a close inspection of the valley gutters and carry out repairs to make watertight.

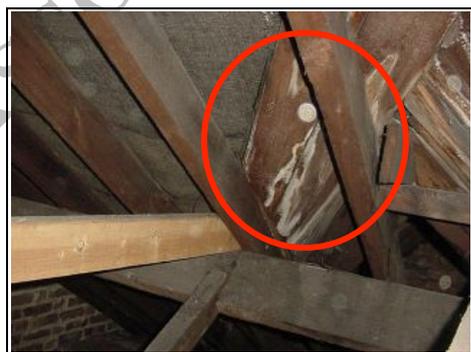
Valley gutter leaking

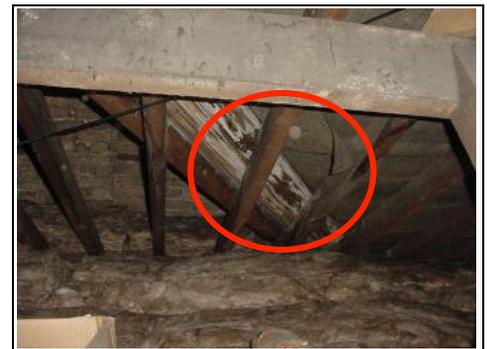
Valley gutter leaking

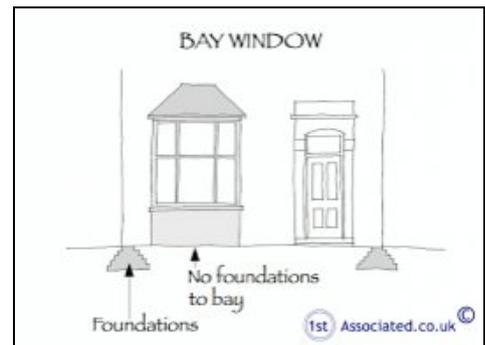
To the front of the property the cracks are over the bay window. Typically in this age of property there is a timber lintel which can deteriorate over the years and give slightly. Also we find that bay windows have little foundations underneath them which is part of how they were built.

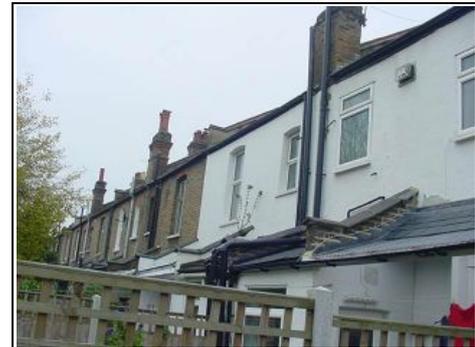
Nearby properties that have been re-rendered

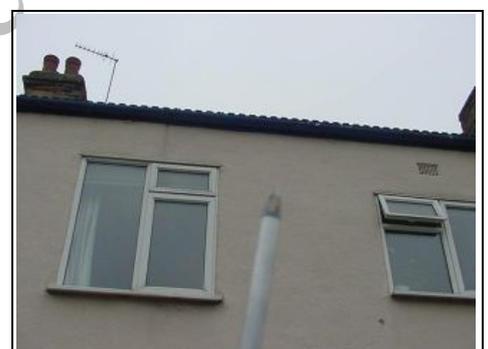
High level cracking

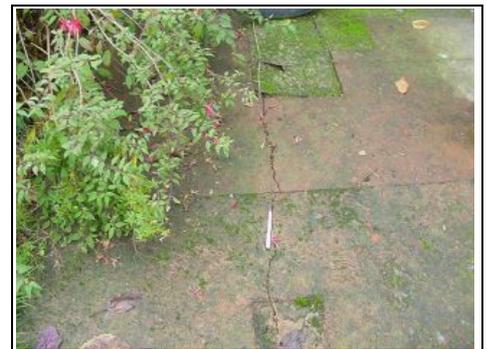
We believe there may be drainage problems with the drains leaking. Cracking was noted to the rear garden path which would be consistent with next door having cracks as well. Unfortunately we could not find a manhole to check the condition of the drains.

Cracking in rear garden path likely to be from drains

ACTION REQUIRED: Close circuit TV camera report of drains. Your legal advisor needs to specifically request in writing if there have been any structural problems with the property and you also need to write to insurance companies to see if they are aware of problems in the area. The main problem in our experience with drains is that if they are not resolved then they will continue to leak and this can affect the clay soil that we have in London as well as eroding ground.

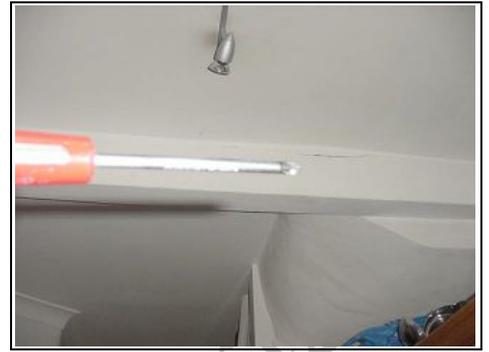
We also noted a crack to the beam in the kitchen which we believe relates to a leak in the bathroom above.

Crack in beam in kitchen

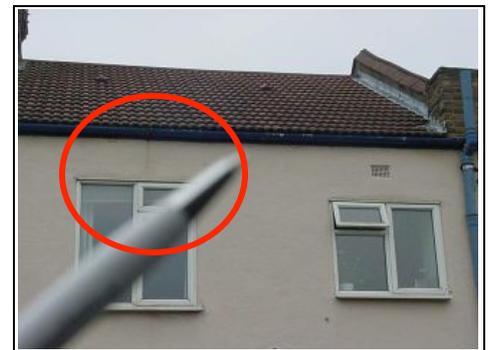
The gutters are leaking to the rear, pattern staining can be seen. We wouldn't normally comment upon leaking gutters however in this instance we feel they could be contributing to the cracking of the render as the render is soaking up the water from the drains like blotting paper.

Leaking gutters to rear

ANTICIPATED COST: £1,000 to £2,000 depending upon whether repairs or complete replacement is necessary; please obtain quotations.

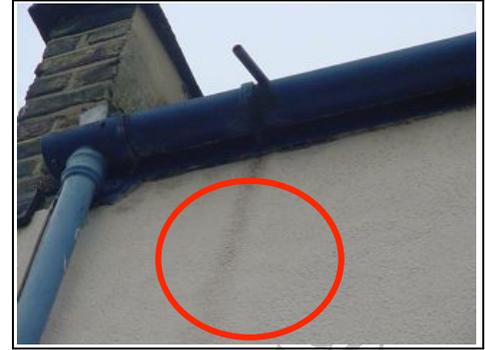
Pattern staining to rear

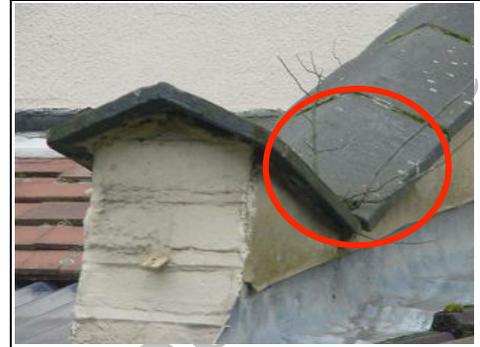
Plant growing from parapet wall

ACTION REQUIRED: Repair parapet walls.

ANTICIPATED COST: A few hundred pounds to repair the low level parapet walls. To repair the high level parapet walls will be much more expensive. We would add that we can't see any excessive dampness getting into the structure at present but it is a potential problem. Please obtain quotations.

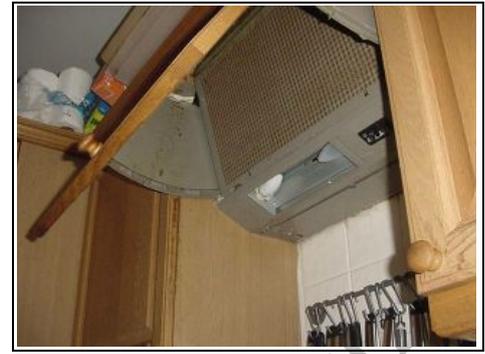
Air cleaner in kitchen needs cleaning

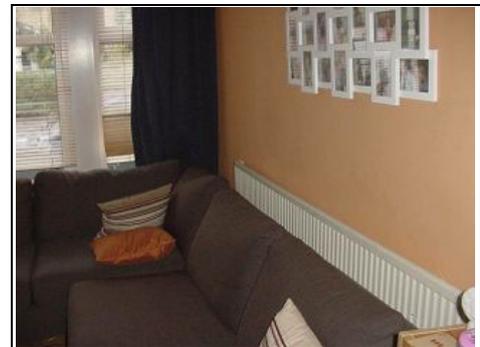
Another thing related to the higher chance of getting condensation would be that we noted the radiators are internal in some areas. This is often carried out on cheaper central heating systems to save the labour and piping costs of taking the radiators underneath the windows. However, it then reduces the air movement in the room.

Internal radiator

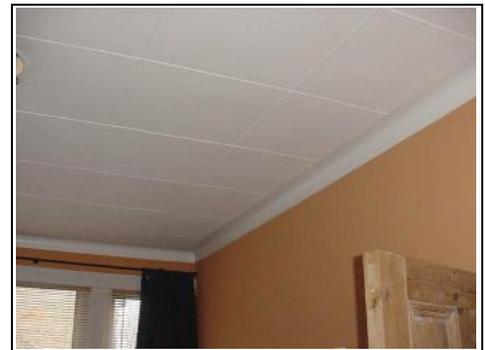
Polystyrene tiles are generally by most mortgage companies requested to be removed as they can be a fire hazard. It can also mean that the lath and plaster ceiling behind them is in poor condition as they were also used to cover things up.

Polystyrene ceiling tiles

ACTION REQUIRED: The polystyrene tiles should be removed as they are a fire hazard. You may then have a problem with the ceiling so the other option is to plasterboard over them.

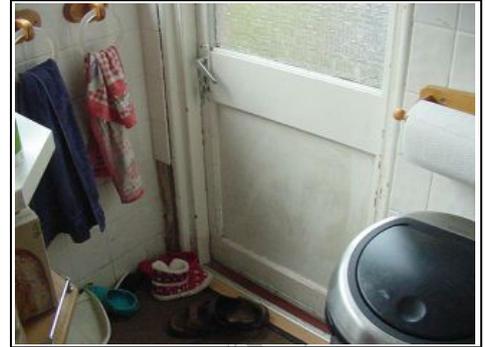
We have been unable to find a kite mark on the doors which indicates that they are not safety glass.

Not safety glass

ACTION REQUIRED: Replace with safety glass.

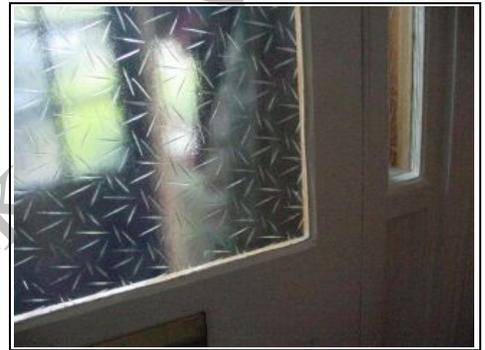
Door not safety glass

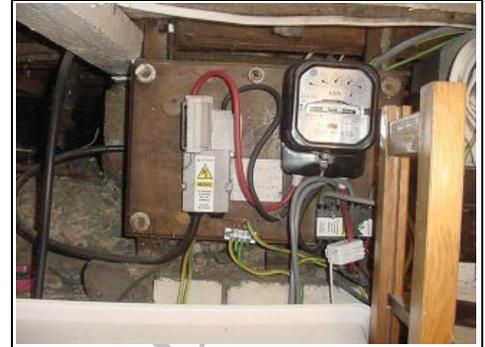
Dated electrics

ACTION REQUIRED: Replace and upgrade the electrics.

ANTICIPATED COST: In the region of £250 to £500; please obtain quotations.

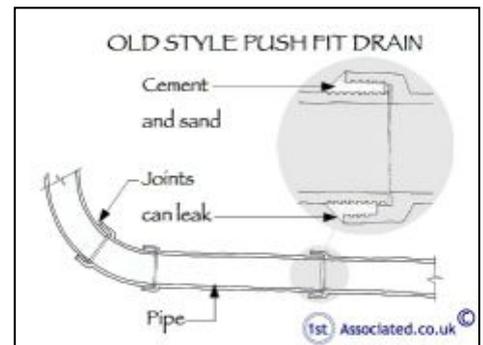
The drainage may relate to the cracking to the rear of the property. In older properties, such as this, drainage was often push fitted together rather than bonded together which means that they may leak over the years. Whilst we ran the tap for 15 minutes without any build up or blockages the only way to be 100%

Push fit drain

ACTION REQUIRED: We would recommend a closed circuit TV camera report of the drains.

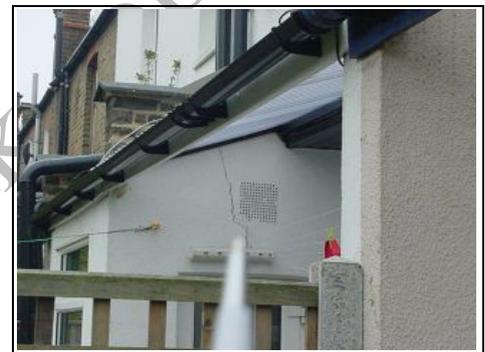
We would reiterate that we feel the cracking to the rear of the property could relate to structural movement which is likely in turn to relate to the drains. The difficulty with trying to resolve drainage problems is that the whole of the drain needs to have work carried out on it not just your section.

Cracking to next door

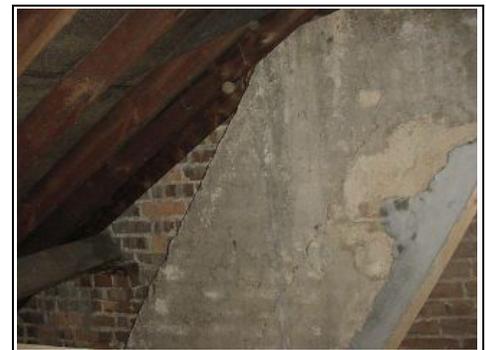
We would also refer you to our comments in the Executive Summary about the chimney beneath it being removed to the front and to the rear there being a crack present.

Crack to chimney

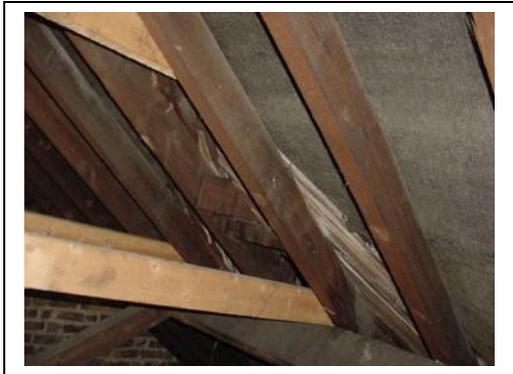
This property has valley gutters. Valley gutters are formed where two roofs meet and these are generally problematic.

Leaking valley gutter

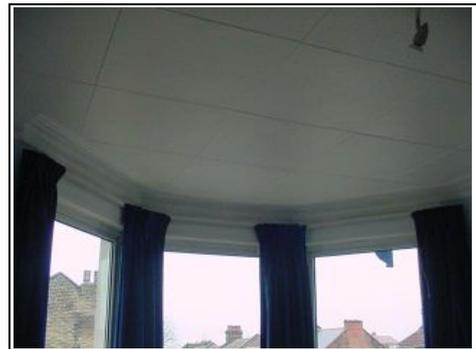
Area over bay window where leaks are

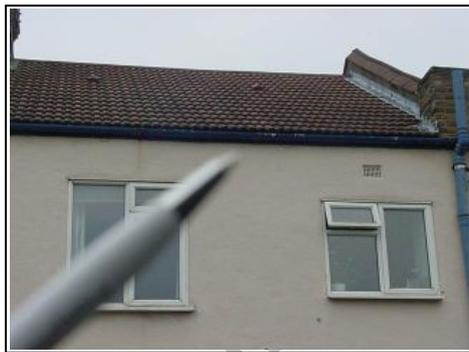
They are in below average condition for their age, type and style with pattern staining visible to the rear.

Leaking gutters

ACTION REQUIRED: Replace completely. Please see our comments in the Executive Summary.

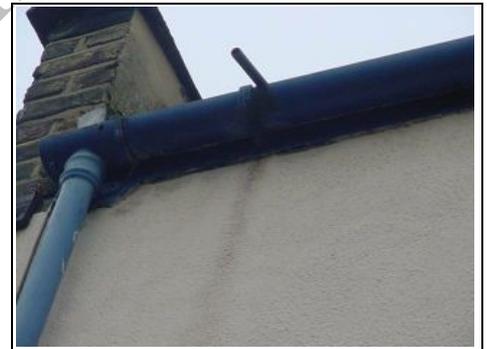
Pattern staining

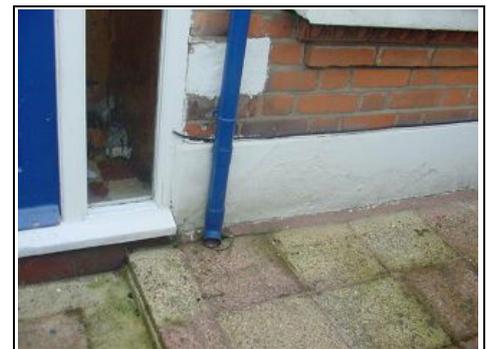
The pipe discharging onto the ground may cause dampness into the front of the property.

Downpipe discharging onto ground

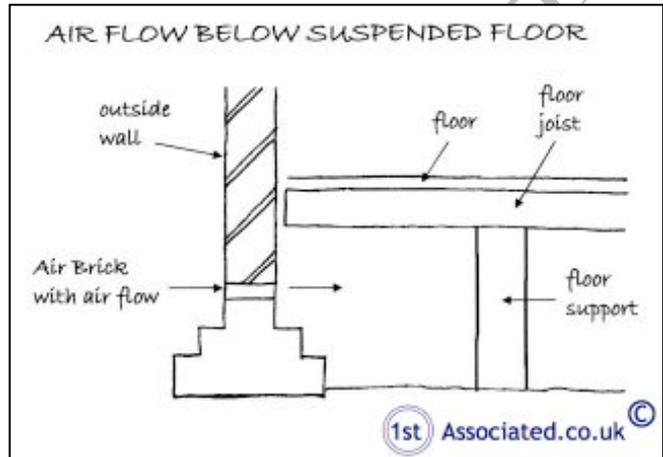
Air bricks were noted. The front air brick is acting as a gutter and water is likely to be going into the cellar area and possibly affecting the timbers in this area. Note we were not able to view the timbers in this section but we could see that they were embedded in the walls from the cellar area.

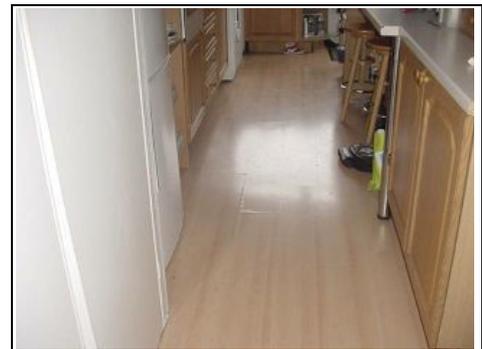
Laminate floor hides condition of floor

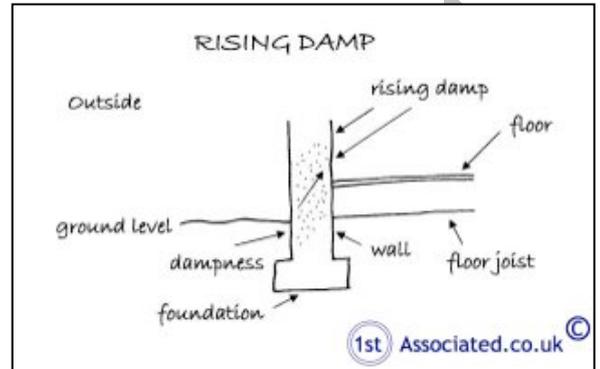
Rising damp

ACTION REQUIRED: Please see the Executive Summary.

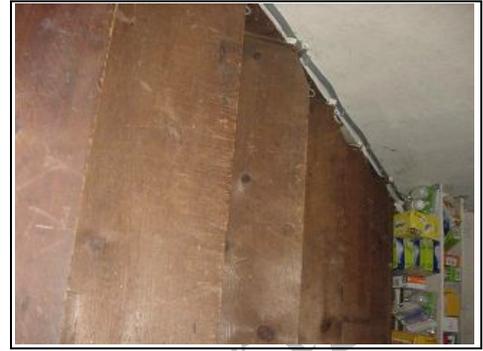
We noted that the underside of the staircase was exposed. It is more normal today to have a half hour fire barrier to stop fire spreading from the ground floor to the first floor in a worse case scenario. You may wish to take a view on whether you add this.

Understairs not lined

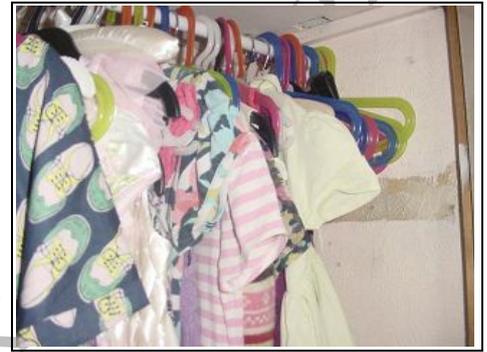
Damage within cupboard area needs redecorating

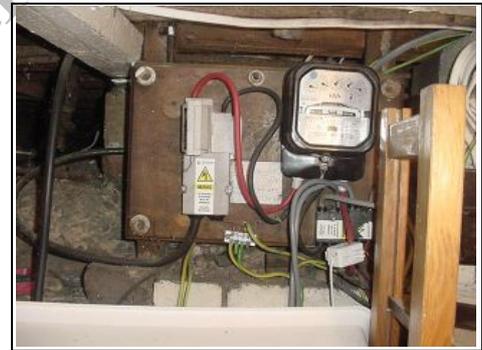
Fuse Board

ACTION REQUIRED: Replace.
Please see our comments in the Executive Summary.

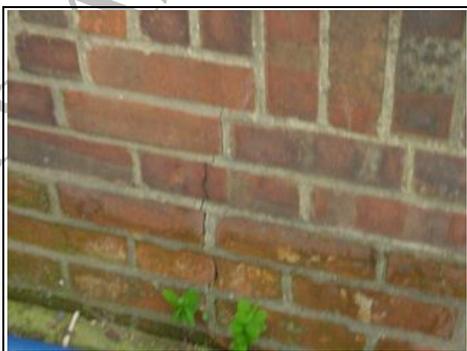
Cracking to front wall

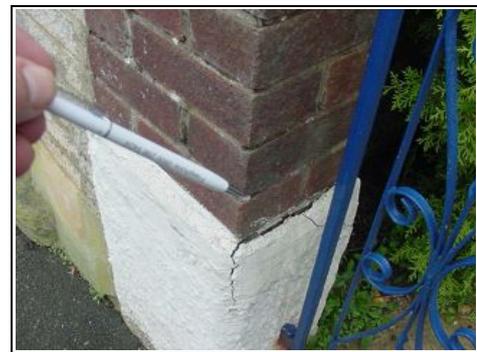
There is a small front garden. The boundary wall render is coming away and damaged and would benefit from repair.

Render coming away to front boundary wall
