JOB REFERENCE: XXXX

RESIDENTIAL BUILDING SURVEY

XXXX
London
SE14 XXX

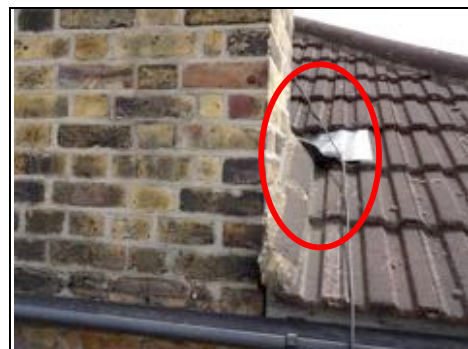
- 1.2 The chimney also has the tile on end, again we believe that dampness will be coming through sooner or later and we can see any areas that has been repaired to the rear.

Tile on end to chimney
~ Aerial View - 360 Photo ~

ACTION REQUIRED: Items 1.1 and 1.2 we recommend that all tiles on edge are replaced with a lead flashing. 1.3 where the tiles have moved, we recommend that the tiles are repositioned, in theory this should be a shared cost.

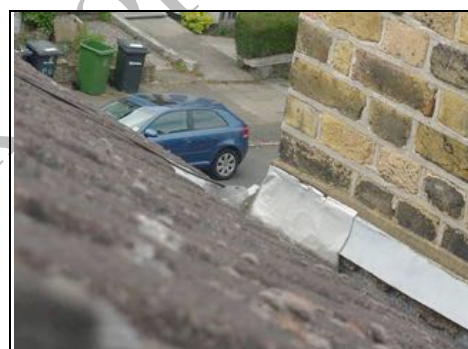
Flashband repair to rear of
chimney

- 1.3 In addition to this we can see that a tile has moved around the flue to the rear left and this is allowing dampness to come in through the roof. It has previously repaired by a product known as Flashband, which we consider a temporary repairing material.

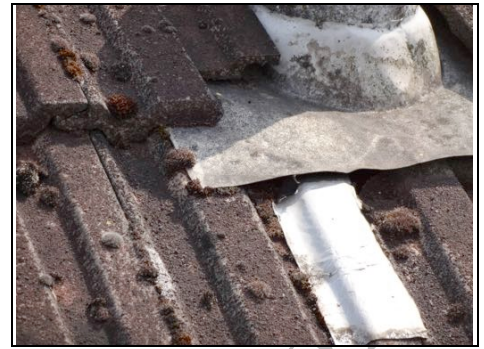
Dampness coming in at roof level where we believe the tile has come out of place

Dampness is getting in around the flue
~ Aerial View - 360 Photo ~

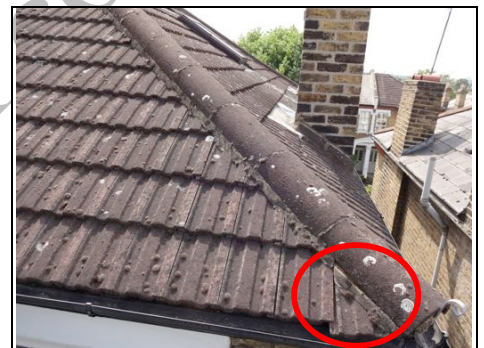
- 1.4 There are a few other areas where we noted tiles have slipped. It is difficult to get to these areas to replace the tiles and an additional difficulty that we often come across is ensuring they don't cause more damage than they repair when they carry out the work. We would always recommend that the roofer takes a photograph before and after or of the work carried out on the surrounding area. The terms "fiddler on the roof" can be very true!

A tile has moved on the corner of the property

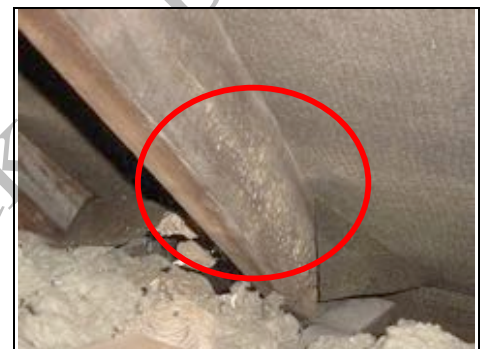
Within the rear roof (as this was the only roof we could view properly – the other roof was lined where it formed part of the front room in the roof) we found, what looks to be Frass which related to woodworm activity.

Close up of woodworm

ACTION REQUIRED: We recommend that insulation is removed in a section of the roof for the remaining timbers to be checked. We are more than happy to check any photos taken of the timbers.

We would recommend adding ventilation to the roof in the form of air bricks and roof vents. This should make the climate/environment not suitable for woodworm to breed and eradicate the problem.

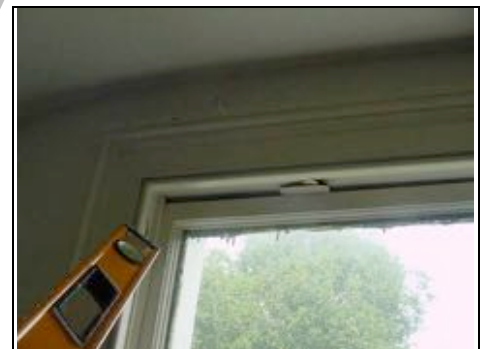
These are replacement sliding sash windows which are of a below average quality and do not fit particularly well. There are companies who carry out refurbishments to sliding sash windows adding such things as seals but at the end of the day they are still single glazed timber sliding sash windows.

Typical sliding sash window
Rear bedroom top floor

ANTICIPATED COST: To replace windows can cost a few hundred pounds to £500-£600 depending on the quality of the window in addition to the fitting and installation. Please obtain quotations.

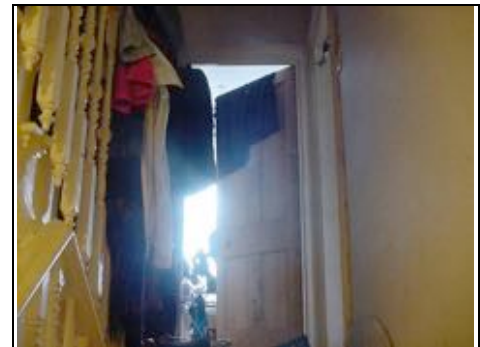
Drying clothes on doors, etc causes mould

- 1) Removal of the humid air at source from humidity generating areas such as the bathroom, the kitchen and any areas that are used for drying clothing etc. We would recommend large good quality humidity controlled extract fans.

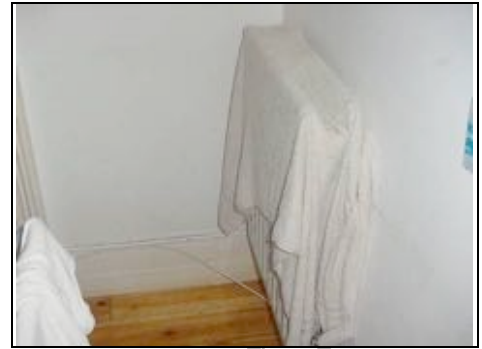
Drying washing on internal radiators, steam cooking and lots of showers. As well as wanting to have the heating as warm as possible in every month of the year.

Drying washing inside
Internal radiator

ACTION REQUIRED: There are various ways of improving the air movement and removal of humid air in the property such as adding large quality humid controlled extract fans. We also do not feel that the relatively high number of people living in the property (multi occupied property) is helping the matter. If the number of people reduced it would also reduce the humidity generated by breathing, washing, cooking etc. and may help to resolve the problem on its own.

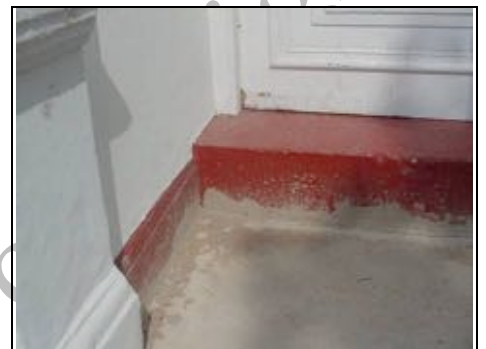
Repair at top of stairs

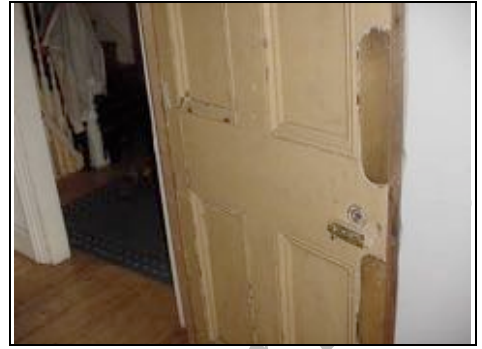
Damage and wear to doors

ACTION REQUIRED: General upgrade of the property as and when you feel necessary. From what we can see most of the things were usable though not in best condition.

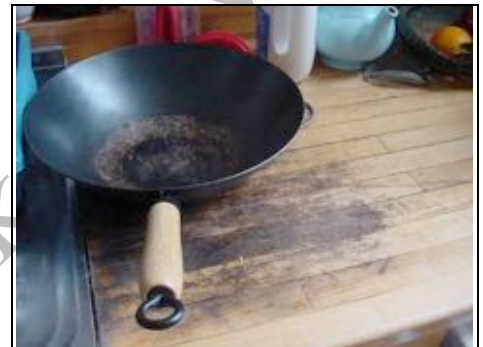
Worktop worn/burnt

ANTICIPATED COST: Worktop worn/burnt in the kitchen can be anything from replacing the worktop for a few hundred pounds to replacing the whole kitchen where you can spend as much or as little as you want on a kitchen.

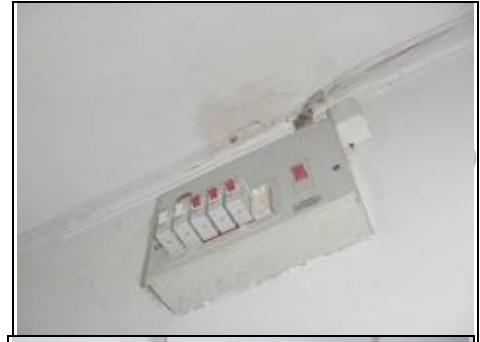
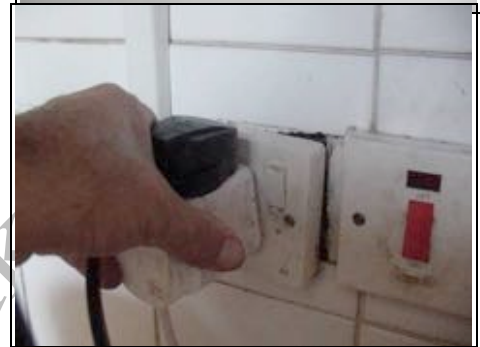
Overloaded electrics – additional socket points required

Some socket points not secured

ACTION REQUIRED: We recommend an Institution of Engineering and Technology (IET) test and report to be carried out by an NICEIC registered and approved electrical contractor or equivalent.

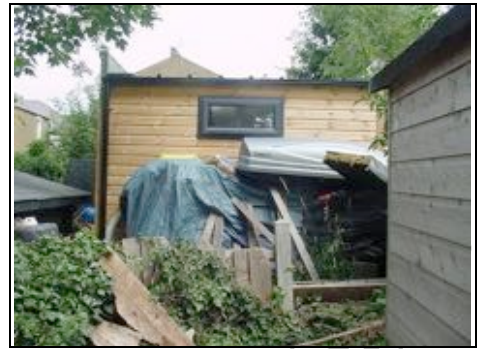
The boundary fence is in a poor condition, particularly to the rear. This needs to be upgraded.

Rear boundary fence that needs repair

ACTION REQUIRED: Both the boundary fence to the rear and the fence to the left need to be repaired or replaced. Please see our comments with regard to planned maintenance. This is the sort of item that should be included in the planned maintenance schedule as well as gardening and maintenance of the trees.

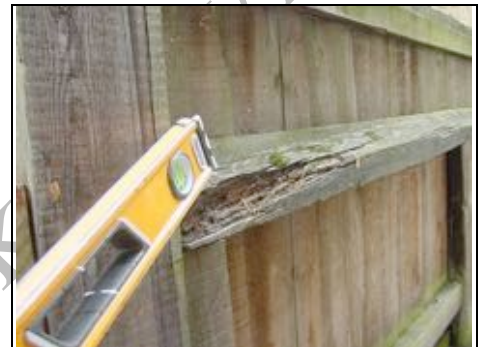
We can also see some rot to the fence on the left side. This should be a shared cost.

Fence on left side rotting

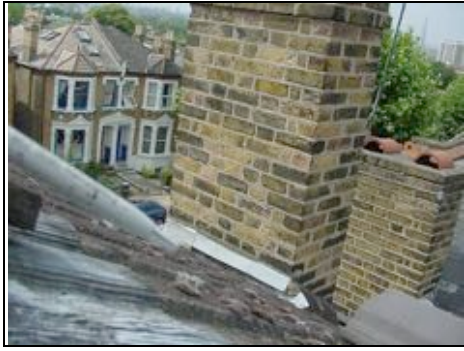
Front chimney has flashband repair to rear

ACTION REQUIRED: Replace all flashing with lead flashing

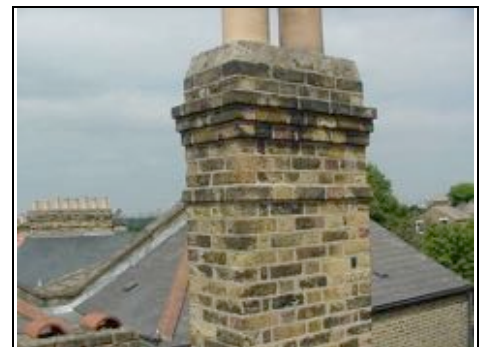
Rear left chimney

This chimney is also brick built. We would comment that the chimney is in similar condition with a variety of flashings. It is these flashings at the base of the chimney that we think will be a problem in the years to come.

ACTION REQUIRED: Replace all flashing with lead flashing

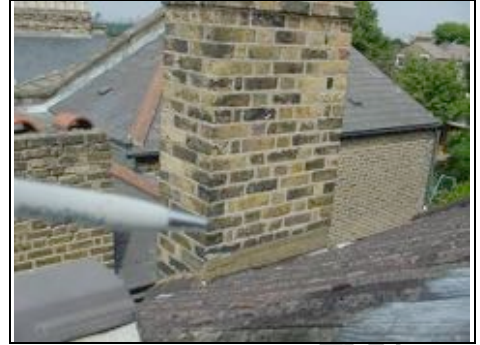
Bottom of chimney –cement flashing?

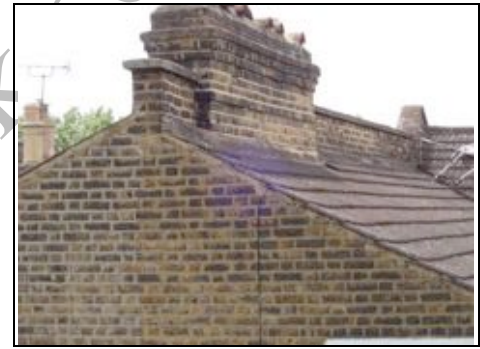
This is a substantial brick chimney to the rear right with hog back tiles to the top of it. These are used to close off chimneys which are no longer in use (sometimes known as capping) and there is tile on edge being used as flashing where we would much prefer to see a lead flashing.

Rear chimney
~ Aerial View - 360 Photo ~

ACTION REQUIRED: Recommend replacing the tile on edge with a lead flashing.

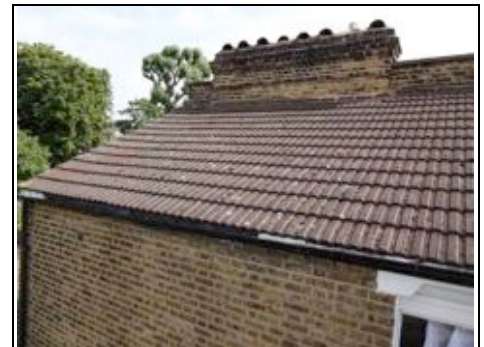
Rear chimney – replace flashing
with lead flashing
~ Aerial View - 360 Photo ~

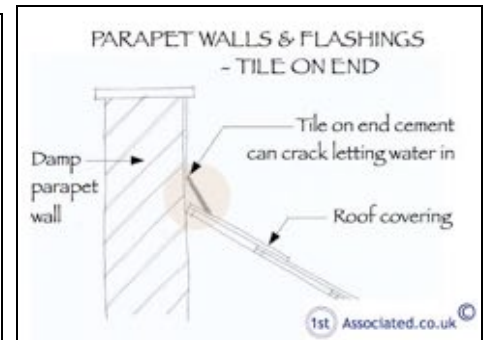
Tile on edge

ACTION REQUIRED: All the tiles need to be removed and be replaced with lead tiles. You need to carry out repairs to the front right room and repairs to the wall plate. In order to carry our repairs to the wall plate you will need to fully light the rear roof. We would also board it as well. Please see our comments in the Executive Summary.

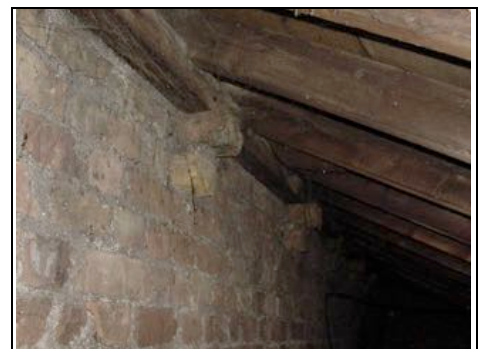
The rear right of the property is visible within the roof space and is causing rotten deterioration to the wall plate timbers.

Timber wall plate in rear right roof

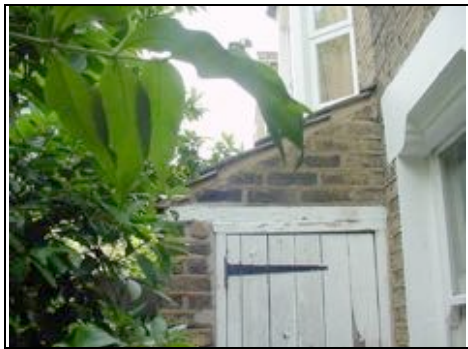
There is a concrete tile roof to the rear right which has a crack in the tiles.

Lean-to with broken tile

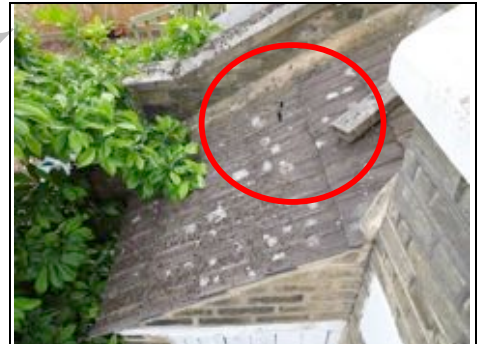
Crack in tile
~ Aerial View - 360 Photo ~

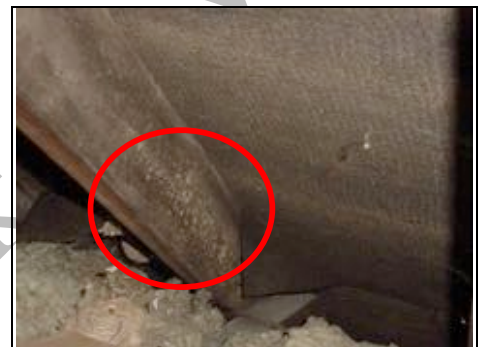
- 1) The wall plate timbers deteriorating resulting in dampness getting in, and
- 2) The woodworm with potential for more woodworm if the insulation is lifted.

Woodworm

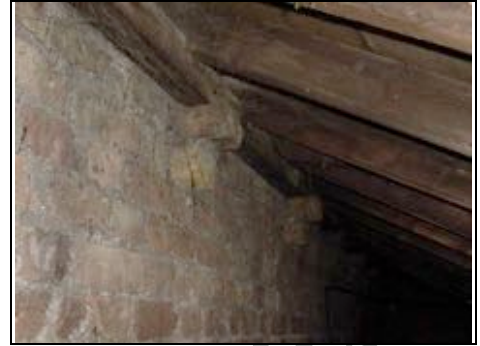
The wall plate is suffering from the dampness coming through from the parapet wall on the right side.

Wall plate deteriorating

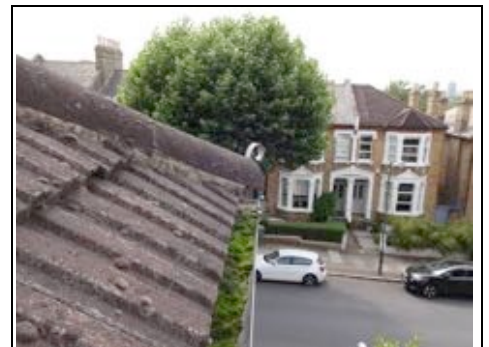
There may be some minor leaks but most people would be happy to live with these providing repairs are carried out within the next six to twelve months.

Moss in gutters
~ Aerial View - 360 Photo ~

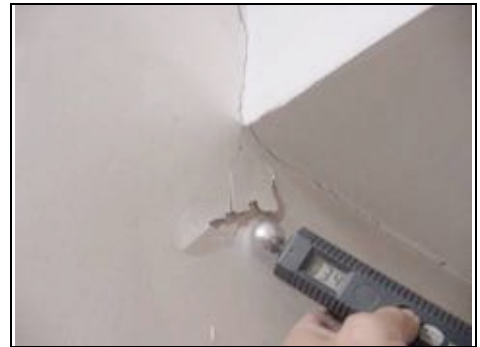
Skin coat of plaster breaking up

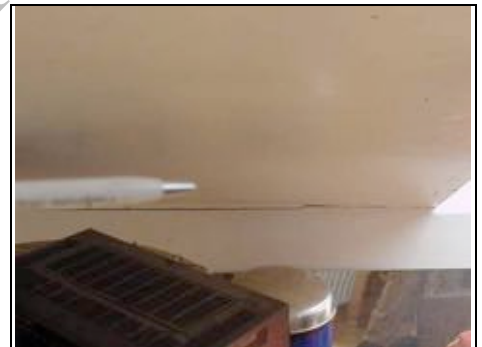
Straight line plasterboard cracking in room in the roof

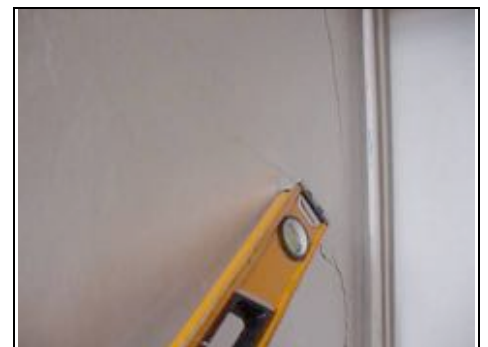
Crack at bottom of stairs

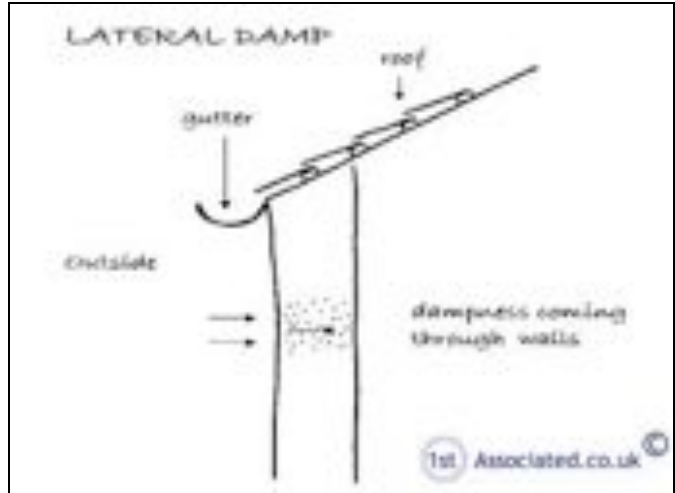
We used a resistance meter on the external walls. We have found significant dampness.

Lateral damp

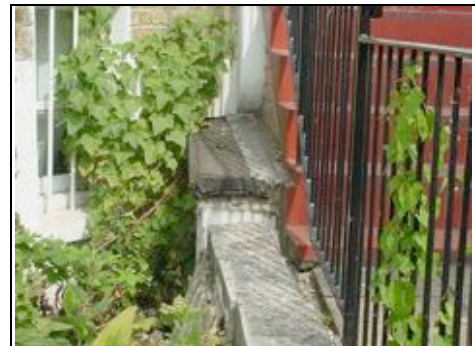
An external staircase is renowned for leaking and this looks to be leaking into the ground floor flat. We can also see some repair work has also been carried to the top step, fairly recently, there was even a sign still in the hallway.

Awkward detail that we believe is allowing dampness into ground floor flat

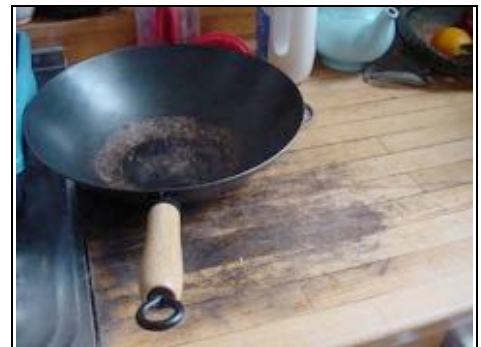
Worktop worn

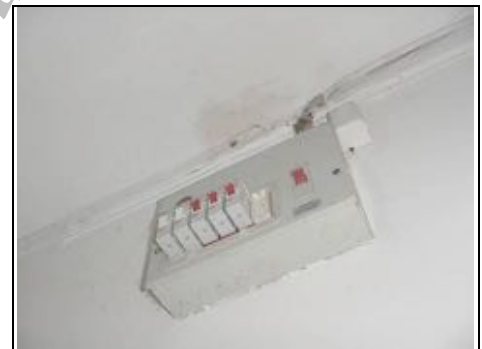
The electric fuses and consumer units were located in the entrance of the staircase to your property. The fuse board looked 1970's/1980's and better are now available. In multi occupied properties a defective fuse board can be particularly dangerous.

Fuse Board

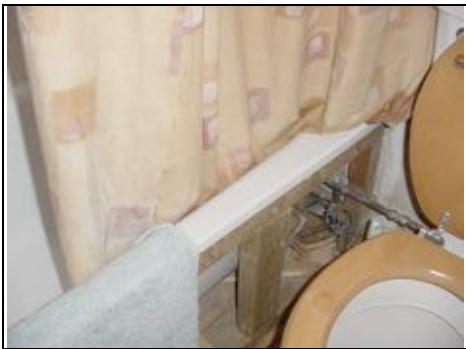
Bath panel missing

ACTION REQUIRED: Please see our comments in the Executive Summary with regards to bathroom.

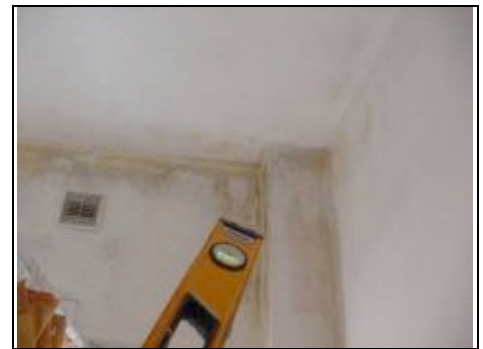
Mould in bathroom

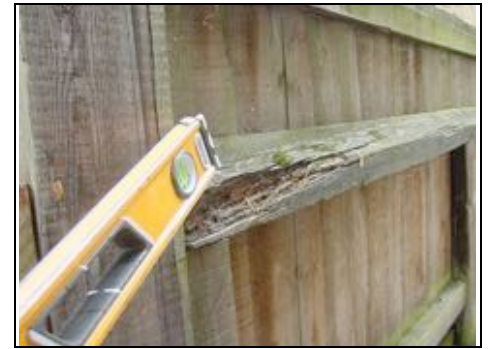
Fence on left side rotting
