# RESIDENTIAL BUILDING SURVEY

XXXXXXXXXXXXXX,  
Palmers Green,  
London,  
N13 xxx

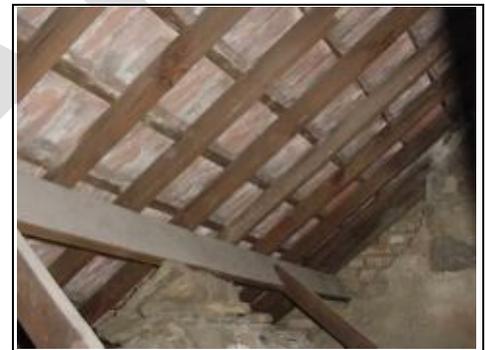
Rags filling gaps in roof

No protective underlayer

**ACTION REQUIRED:** Ultimately the property needs re-roofing but in the short term you may be able to limit the damage caused by adding a board with insulation beneath.

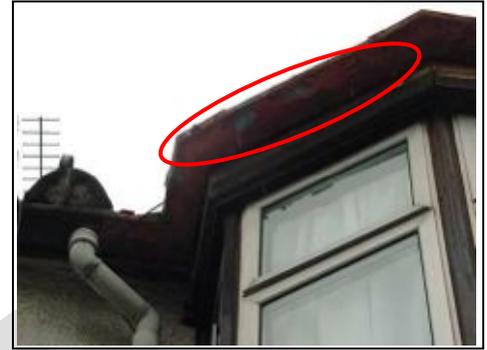
The property has predominantly cast iron gutters and downpipes. The gutters, in particular, need repair and redecoration.

Gutters need re-decoration

**ACTION REQUIRED:** Repair and redecorate the cast iron.

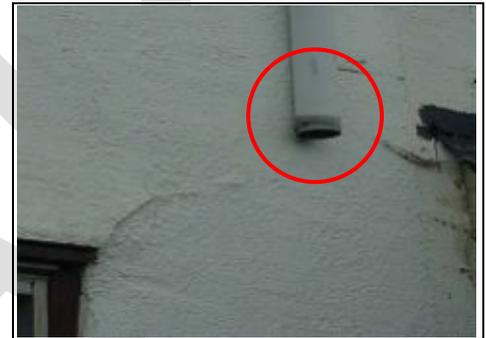
Note the downpipe to the rear of the property is currently discharging down the wall and causing dampness and does not appear to have an outlet to join into at ground level.

No outlet to join into at ground level

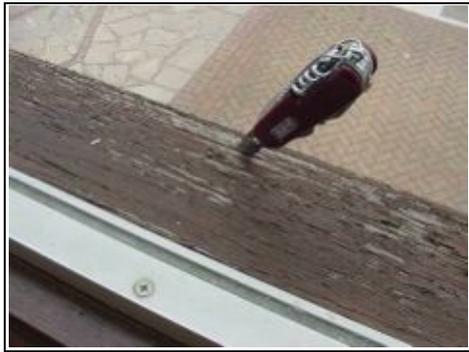
Also the timber frames and sills are in poor condition and need redecoration.

Timber is in poor condition

**ACTION REQUIRED:** We would suggest that, to help prevent condensation, you add large humidity controlled extracts to areas of high humidity such as the bathroom, kitchen and areas where clothes are dried. You will also need to repair and redecorate the timber frames and sills

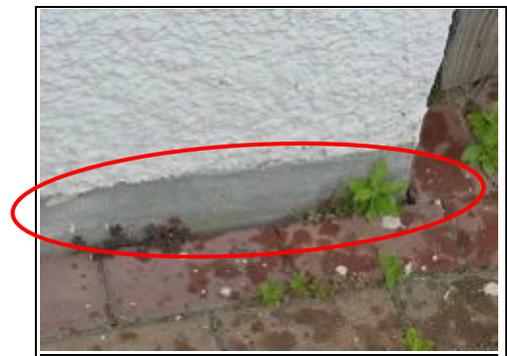
No bell mouth but this detail to the base of the render can draw water into the property

**ACTION REQUIRED:** Please see our comments within the Executive Summary regarding adding a bell mouth to the base of the render.

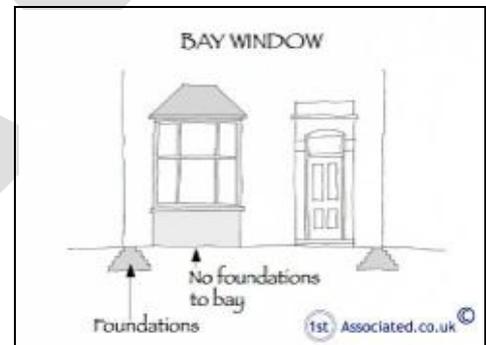
We can see there has been some potential movement to the front bay and also to your neighbours front bay. This is generally because the front bays do not have foundations and therefore some differential movement with the main building can occur. However in this instance it may also relate to the chimneys.

No foundation to bay

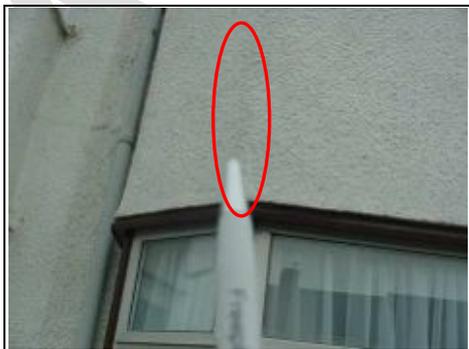
Hair line crack to the property

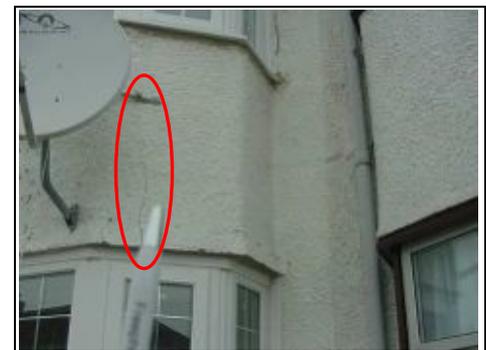
Hair line crack to the neighbouring property (left)

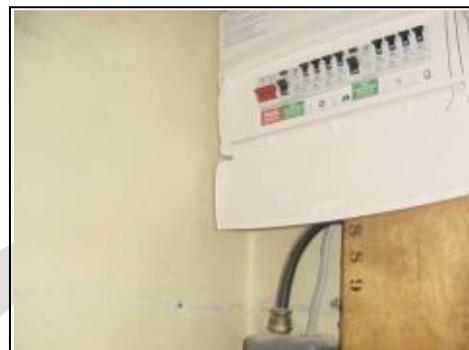
Electric fuse board

The electric fuses and consumer units were located in the cupboard under the stairs. The fuse board looked dated, circa 1970's/1980's, and better are now available.

**ACTION REQUIRED:** We suggest that this is replaced and that you may also require additional socket points adding.

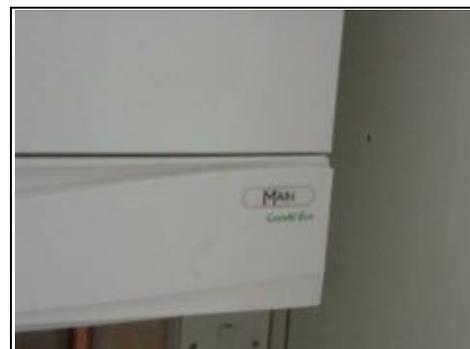
Wall mounted Main boiler

**ACTION REQUIRED:** We would budget to replace the boiler.

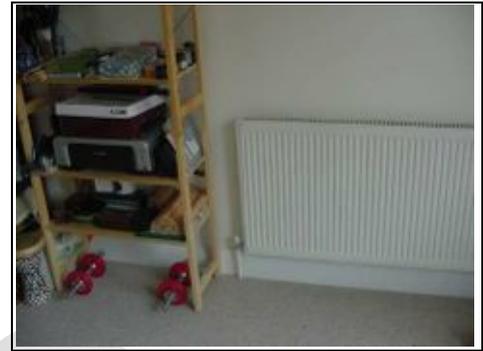
We noted internal radiators, which do not allow the flow of air around the property.

Internal radiator

**ACTION REQUIRED:** We would recommend moving internal radiators to underneath windows if possible or replacing.

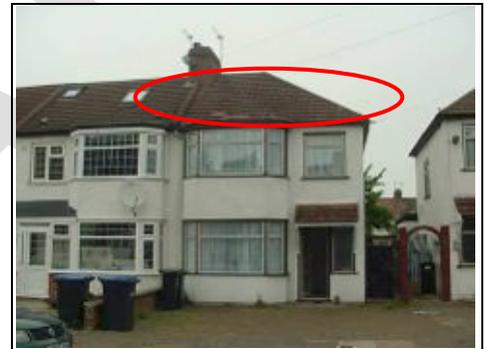
The main roof is pitched and clad with a nibbed tile and, from ground level, this looks in below average condition considering the roofs age type and style. When we viewed the roof space it confirmed that this is a problem area.

We can see that some tiles have been replaced

Main hipped roof

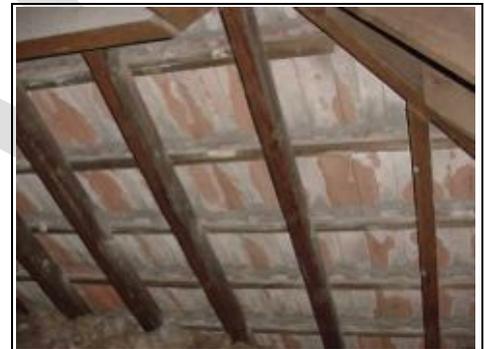
The tiles are nibbed tiles with no protective under layer. This means that wind driven rain can get underneath the tiles and indeed we can see that this is happening from the staining within the roof. We are always in a Catch- 22 with regard to this type of roof as although it is letting in some rain water it is not letting in that much. We have therefore taken guidance from the adjoining/nearby roofs which show approximately twenty per cent have been replaced and that there have also been a number of loft conversions.

This photo shows the common rafters (the ones that form the pitch of the roof). Dampness can be seen coming through due to the lack of protective underlayer

**ACTION REQUIRED:** We mentioned to you earlier that we would recommend in the short term that you board out the roof space with insulated roof board. However, this may not be sufficient in this case as we you will have to carry out work to the roof as well and so we recommend that you budget to have this roof replaced.

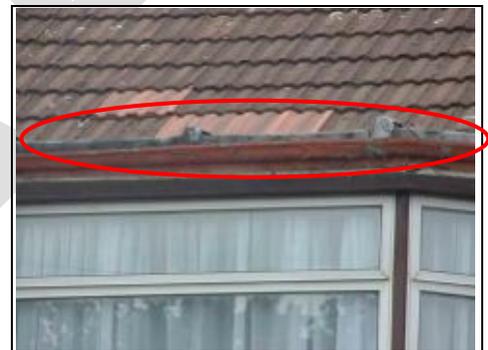
There is a flat roof over the bay window which looks to be an original metal (usually lead) roof. This area is susceptible to dampness getting into the property particularly if it is the old original roof.

Flat roof to bay window

We would set aside the sum of £450 to £500 to check the flat roof and carry out any work necessary. Also when the main roof is replaced we would recommend that this roof is replaced as well.

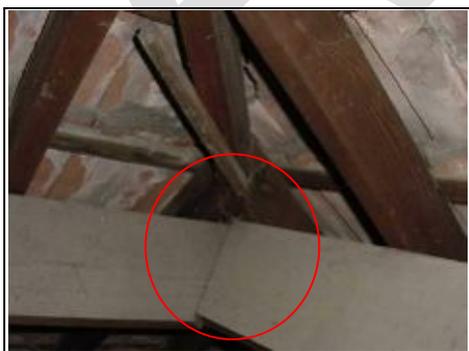
This type of roof structure has what is known as a hipped cut timber roof. This is a roof that is purpose made and hand built on site. Without the original design details we cannot categorically confirm that there are no defects. We can see there has been some slight movement in the roof and when we kicked the roof timbers these did not feel as solid as we would expect them to feel.

Slight movement in the hip

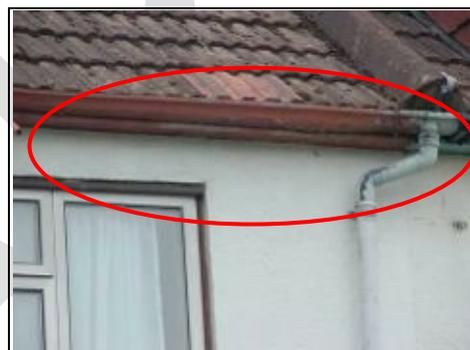
Gutters and downpipes need redecoration

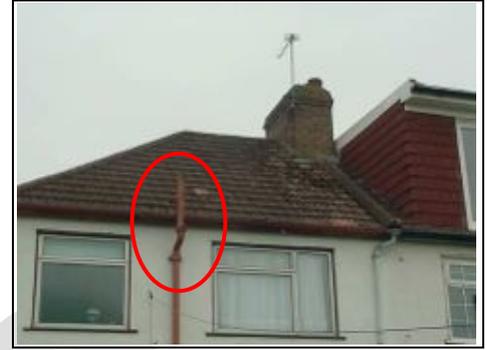
The property has cast iron soil and vent pipes which also need repainting.

Soil and vent pipe

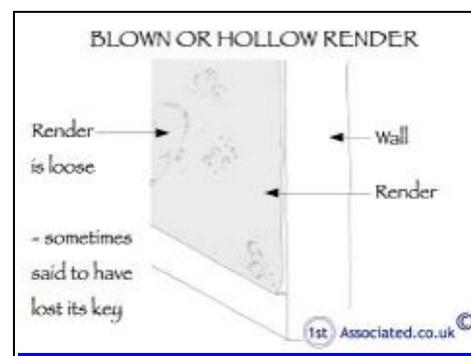
We have carried out a tap test (literally hitting the render with the back of a hammer) testing for blown or hollow render areas. We found it to be in average condition for its age, type and style. In this age of render hairline cracking can occur if it is not decorated regularly. If this cracking is not treated it allows water to get underneath and causes blistering and failure of the render.

Blown or hollow render

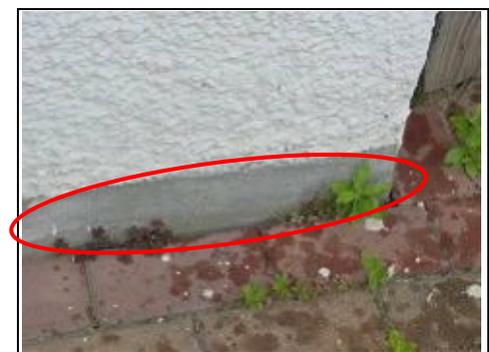
No bell mouth detail

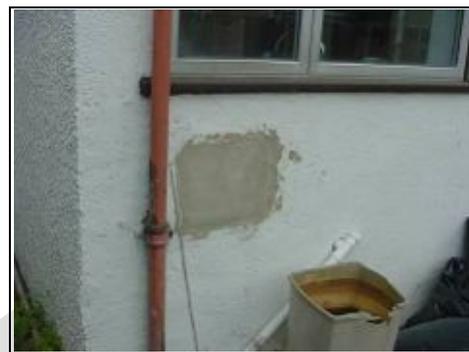
Render needs repairs and painting where the old boiler was removed

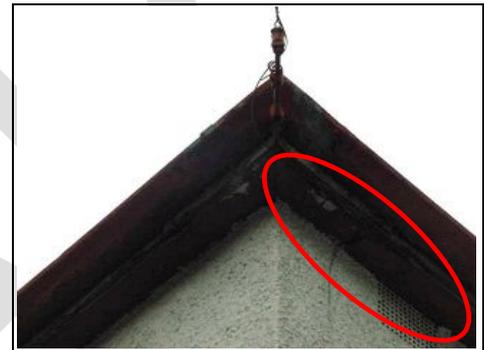
The fascias and soffits need redecoration

**ACTION REQUIRED:** Redecorate when work to the gutters is carried out.

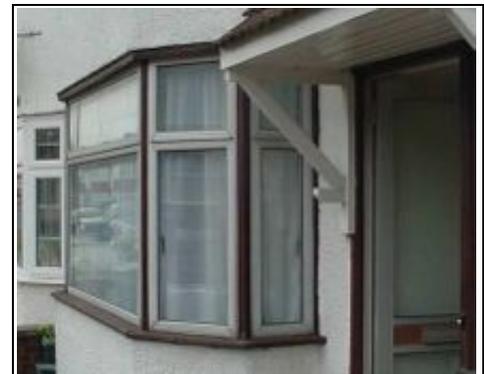
We have tested the windows by pushing a knife into a random selection. We generally tend to do the lower windows as access is easier. We noted the timber around the windows requires staining and the timber sills require repair and redecoration.

Bay window

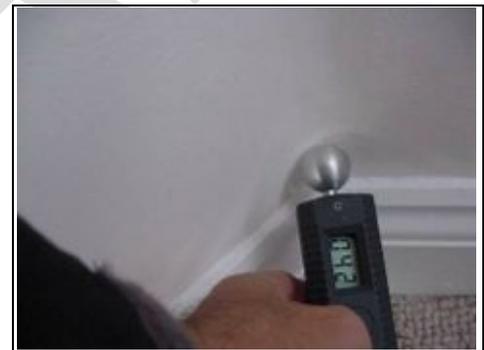
A visual inspection and tests with a moisture meter have been taken to the perimeter walls. In this particular case we have found a small amount of rising damp that we believe relates to the render.

Testing for rising damp

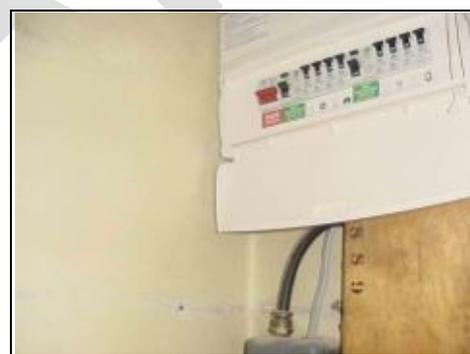
Fuse Board

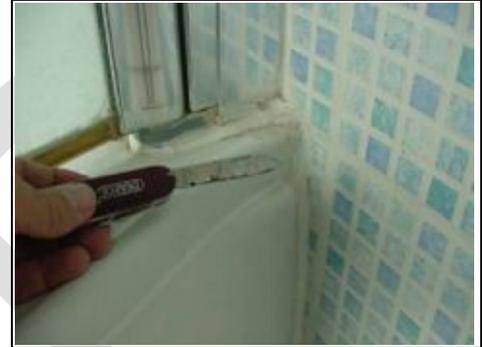
We did note that the shower was leaking slightly.

Shower is leaking
