RESIDENTIAL BUILDING SURVEY

Earlsfield,
London,
SW18 xxx

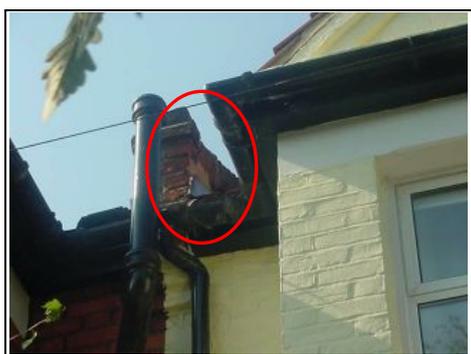
The left hand parapet wall appears to have a damp problem from what we can see from inside the roof space. However, our view has been limited both to the front of the property by the large tree and inside the roof space by the stored items.

Left parapet wall has not been repaired

ACTION REQUIRED: We would anticipate repairs to the left hand parapet wall.

ANTICIPATED COST: To repair the left hand parapet wall in the region of £3,000 to £5,000 dependent upon access scaffolding required. It may be able to be carried out via a tower scaffold access. You need to allow for a worst case scenario.

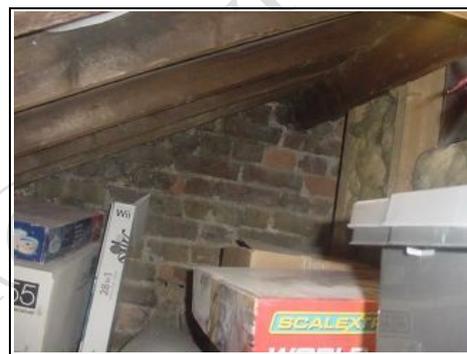
The left hand wall appears to be causing dampness

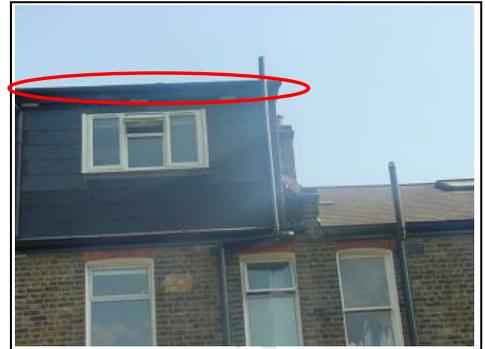
Flat roof not visible to roof conversion

ACTION REQUIRED: We are happy to return, if the roof windows can be removed, to view the roof. Or alternatively if this is not possible we would recommend that amendments are made to the roof window, preferably before you commit to purchase the property, so that the roof can be inspected.

ANTICIPATED COST: In the region of £200 to £300 for alterations to make the roof accessible, in our experience the roof window usually has to be replaced. Alternatively if the roof has an insurance backed guarantee this can be forwarded to us along with the specification of the work and we can comment on this; please obtain quotations.

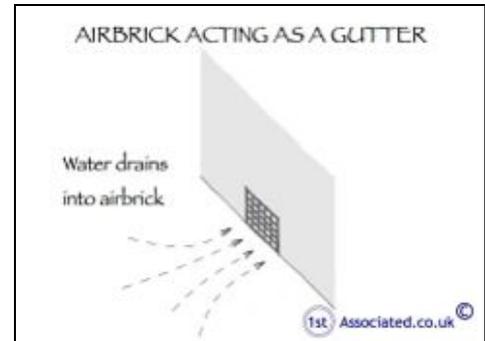
Air brick could be acting as a gutter allowing water in

Air brick acting as a gutter

ACTION REQUIRED: You will need to make sure that the air bricks are clear and that there is a through flow of air adding extra air bricks if required. Ideally an area of the flooring should be opened up so that the condition of the floor can be checked.

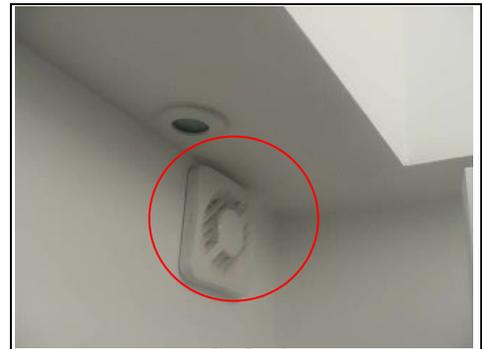
We can see that increased insulation has been added but there are no extract fans in the humidity creating areas of the kitchen, bathroom, shower room and any areas used for drying clothes.

We would enlarge this extract fan

ACTION REQUIRED: Add large humidity controlled extract fans to the kitchen, bathroom and any room used for drying clothes (rear right hand bedroom at the time of the survey). We would increase the size of the extract fan in the shower room which we think will be prone to condensation due to its design. Also ensure the roof windows are easy to open which these did not appear to be.

ANTICIPATED COST: £250 to £400 per extract fan dependent upon the existing wiring and how easy it is to wire them in; please obtain quotations.

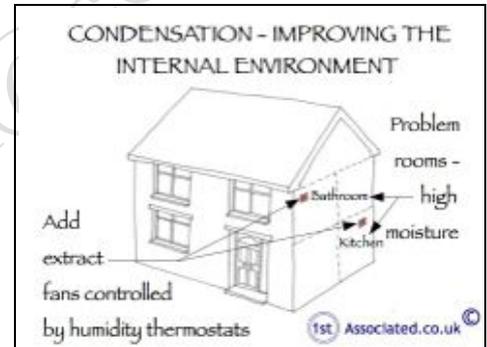
Condensation

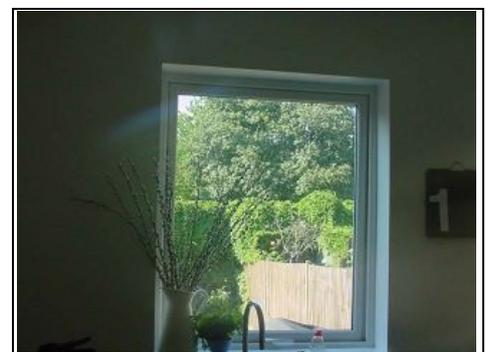
Further to the issue, with regards to air movement and the lack of ventilation that can cause condensation, we would draw to your attention the plastic double glazing to the property. This is from the cheaper end of the market and does not have trickle vents which will make the condensation situation worse.

Double glazing from the cheaper end of the market

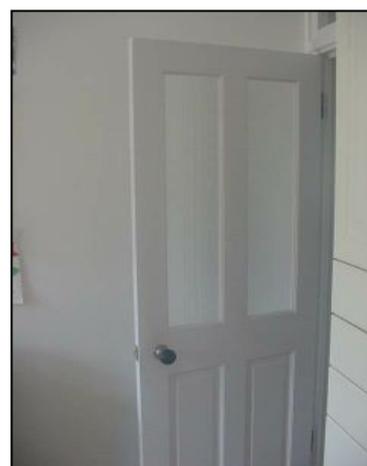
The door into the kitchen is glazed and we were surprised that it did not have a British Standard Kite mark, indicating this is not safety glass. We assumed this was part of the modern alterations.

Glazed door to kitchen

ACTION REQUIRED: If the owners cannot confirm this is safety glass then we would recommend that this is replaced with safety glass or the door replaced.

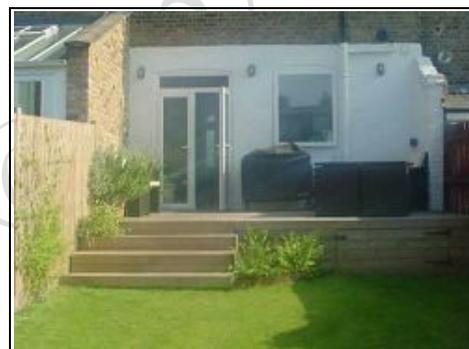
We did not locate a manhole during the course of our survey, however, this is likely to be under the decking to the rear.

Manhole may be under decking to the rear

ACTION REQUIRED: Although the water drained away when we ran the taps it may be beneficial to have a closed circuit TV camera report carried out to establish the condition of the drains. Of course the owners need to be asked if there is a manhole and if so where it is.

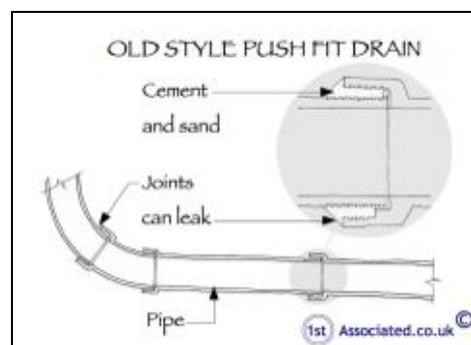
Push fit drains

Typically older properties will have older style push fit drains that will have leaked over the years.

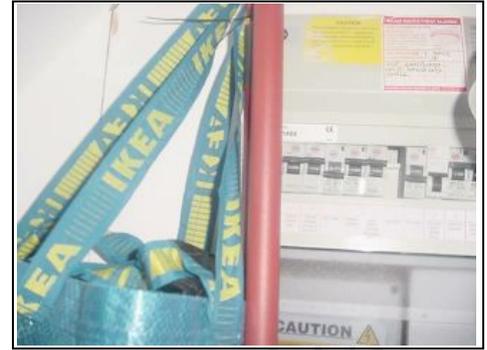
The electrics are slightly dated and we would have expected an upgrade especially where alterations have been carried out. This looks to be a 1990's/2000's fuse board?

Fuse board

ACTION REQUIRED: Replace the fuse board.

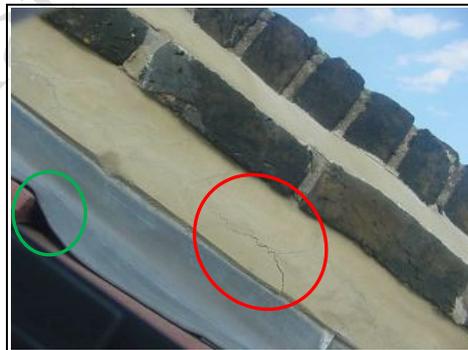
Some cracking where cement mortar has been used

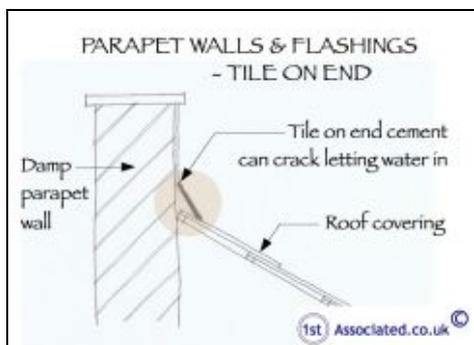
The neighbours side of the parapet wall looks to have a tile on edge flashing. This will eventually leak which could eventually lead to dampness entering your property as well.

Tile on edge flashing

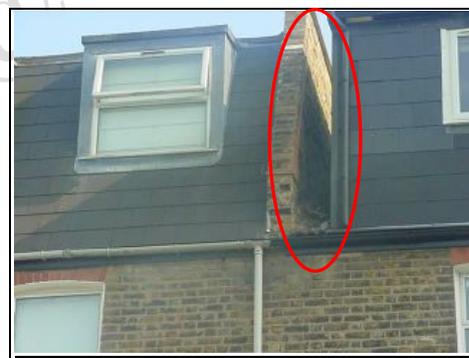
It appears as if party wall permission was agreed for the neighbouring property but not for your property

Gap between your extension and the party wall

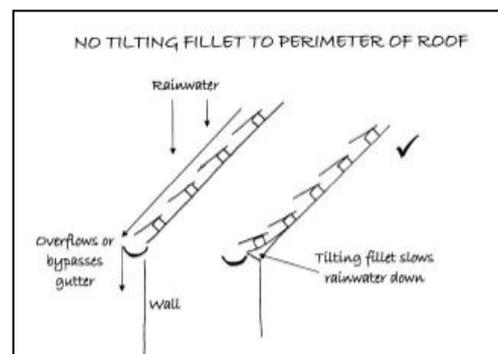
Poor tilting fillet detail to edge of the roof

No tilting fillet

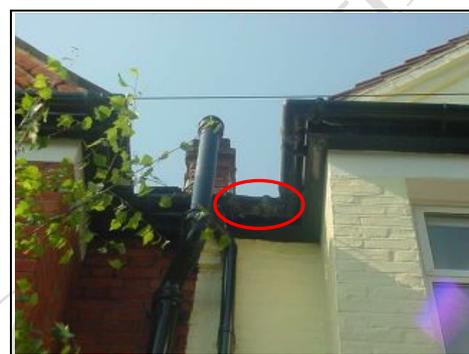
Leaking gutter

We also recommend that the gutters and downpipes are cleaned out, the joints are checked and the alignment checked to ensure that the gutters fall towards the downpipes.

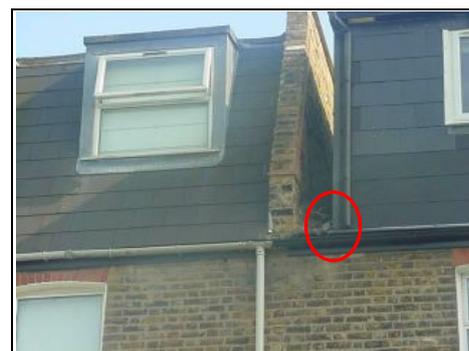
Likely to overflow where down pipe meets gutter

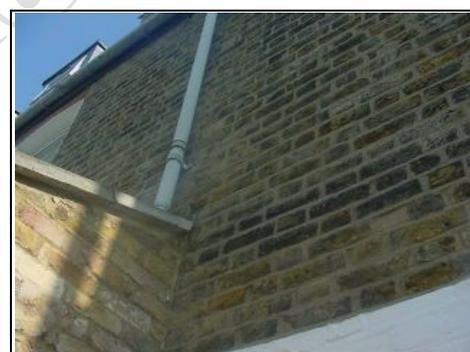
Bricks re-pointed in cement mortar

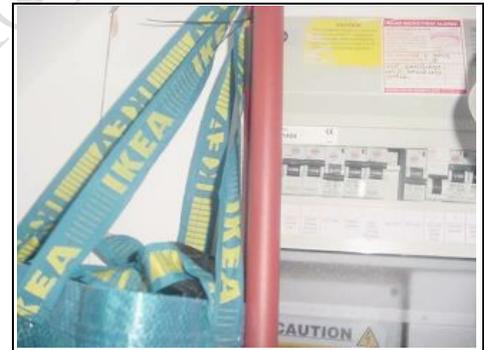
Fuse Board

ACTION REQUIRED: We recommend this is replaced. Please see our comments within the Executive Summary.
