RESIDENTIAL BUILDING SURVEY

XXXXXXXXXXXXXX,
XXXXXXXXXXXXXX,
Earls Court,
London,
SW5

**Late Victorian
Purpose Built
Apartment**

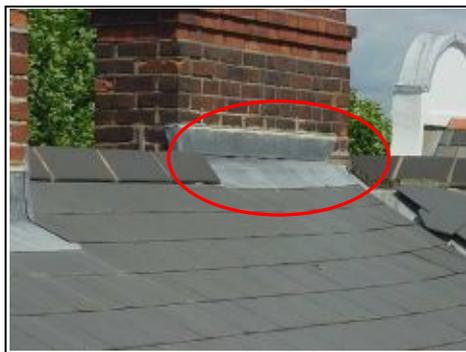
Flashings around chimneys where dampness is getting in. These look to have been replaced but the quality looks poor

ACTION REQUIRED: There should be an annual inspection of the roofs, in our opinion, and the associated elements of the chimneys and parapet walls. Repair work such as this should be logged to be carried out. Whilst the dampness getting in via the chimney would be preventative, as we cannot see dampness within the building as yet, you do need to be made aware of this.

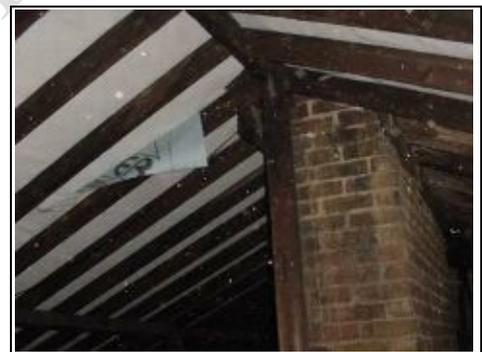
We can see some dampness coming in around the chimney in the roof space

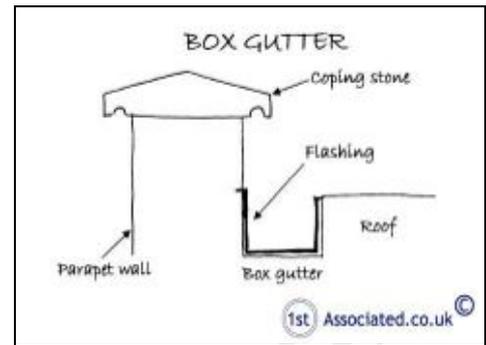
Box gutter

There are brick built parapet walls around the property. We can see these have been repaired over the years. There is a box gutter behind them and this is where we suspect the problem with the roof is but we have not been able to access this area.

We could see greening and efflorescence of the brickwork detail which again indicates dampness is getting into the property and that the parapet wall box gutter detail is not working.

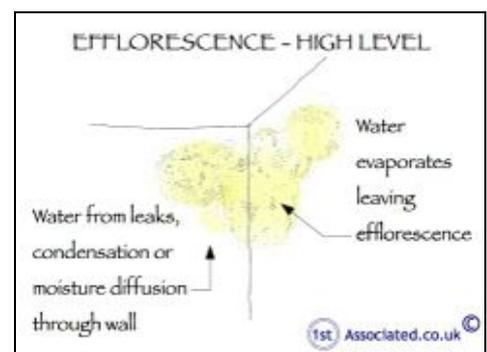
Efflorescence at high level

ACTION REQUIRED: The efflorescence, dampness and general deterioration of the parapet wall needs to be brought to the attention of the management company before you purchase the property and a written reply given as to whether the parapet wall/box gutter forms part of the planned maintenance programme.

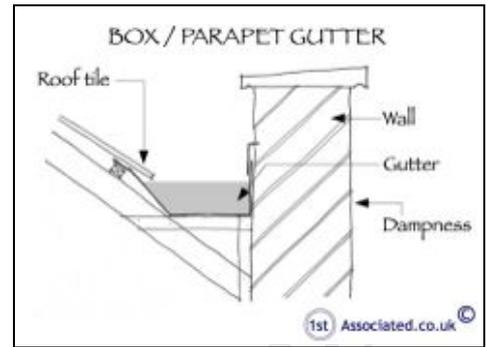
Box gutter and dampness

ANTICIPATED COST: This will be a shared cost. We would start by repairing the flashing to the box gutter and also look at the joints on the parapet wall; please obtain quotations.

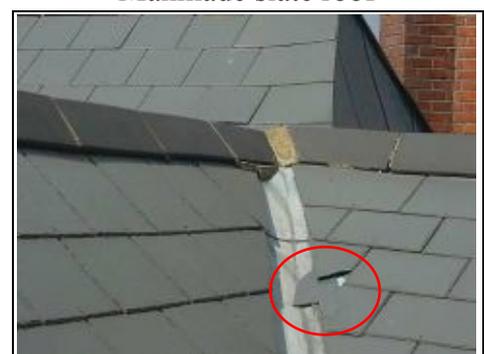
Broken slates

ACTION REQUIRED: You need to speak to the management company to establish who repairs this. We assume it's an owner's responsibility and should be taken out of the maintenance/sinking fund. We would recommend that your legal advisor specifically asks if there is an insurance backed guarantee with the roof as we have concerns with the way the roof has been fixed, as the pins restraining the slates are usually facing upwards as opposed to facing downwards as in this instance.

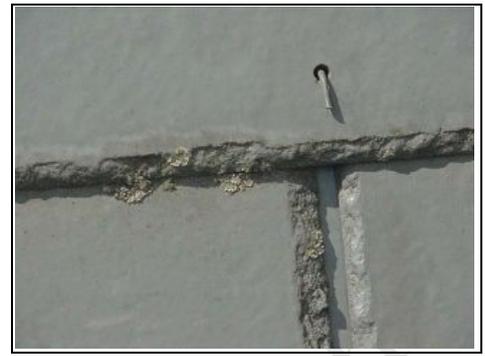
Pins facing down instead of upwards

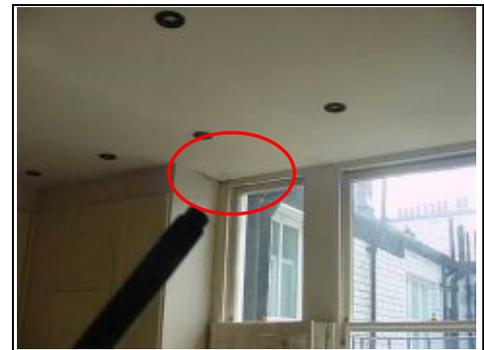
There has been a roof leak into the kitchen near the kitchen window. It is very difficult to see where the water is coming in from, as is often the case with roofs such as this.

Where roof leaked into kitchen

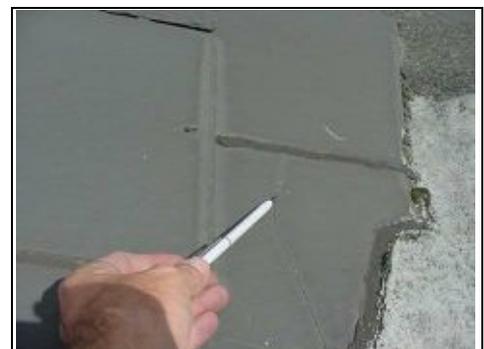
We can see that mastic has been used between the slates which is generally the practice that is used when all else has failed. It could be that this is a problem leak that is only triggered once in a while, during heavy rain or when wind driven rain occurs, and so is difficult to solve.

Mastic roof repair between the slates above the kitchen area

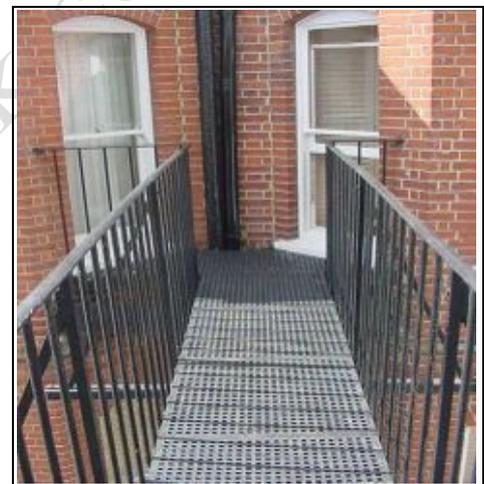
Metal walkway

1. The metal walkway that is adjacent to it is allowing water to sit against the building.
2. The building is built in a relatively soft red brick which is quite absorbent.

ACTION REQUIRED: Ideally protect the detailing around the metal walkway/fire escape, however, this problem may be very difficult to resolve without major work as it will be high level work to the walkway which will be very expensive.

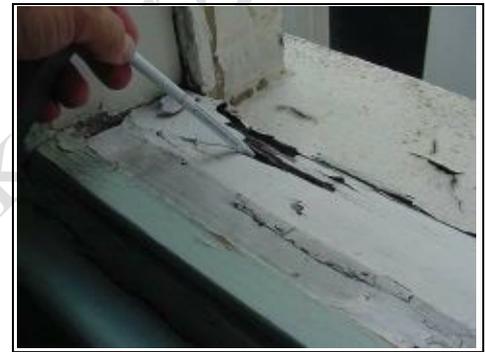
Rotting window in bathroom

ACTION REQUIRED: We would initially contact the management company of the properties to ask if this could be repaired as a special case. If this is not possible we would be of the opinion that you should carry out the work yourself. There is difficulty accessing the exterior of the window. We also noticed that there looks to have been board added to the window which should also be repaired correctly.

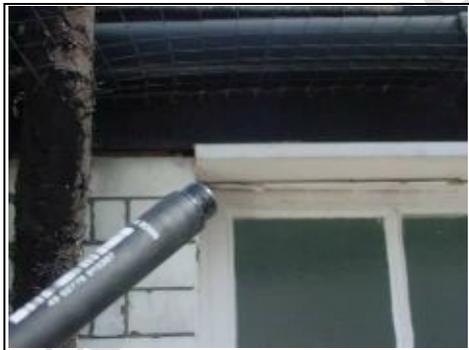
Badly repaired window

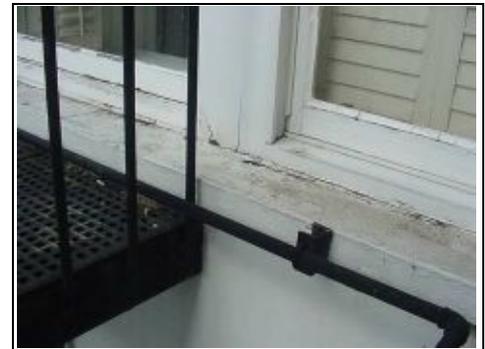
The sills allow water to sit on them and then dampness gets in

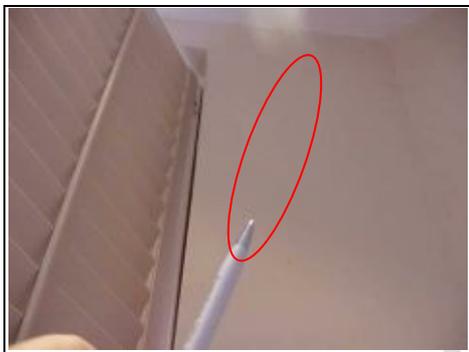
We could see hairline cracking internally to some of the rooms that we believe relates to the dampness coming in via the parapet walls and the box gutter.

Cracking in master bedroom

ACTION REQUIRED: Unfortunately whatever work you carry out the cracking is likely to reappear due to the dampness getting in through the parapet wall areas. Please see our comments above and in the parapet wall section of the main report.

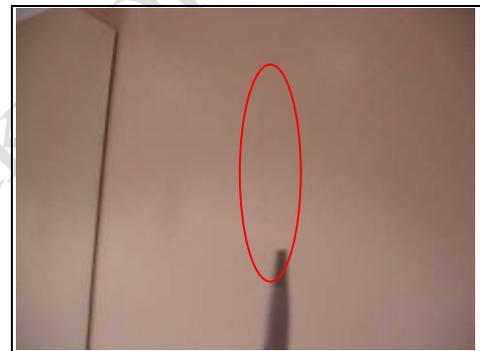
Cracking in en suite

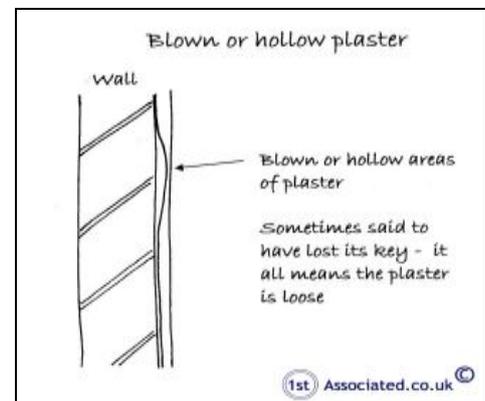
Blown/hollow plaster

ANTICIPATED COST: Likely to require some re-plastering to hollow areas; please obtain quotations.

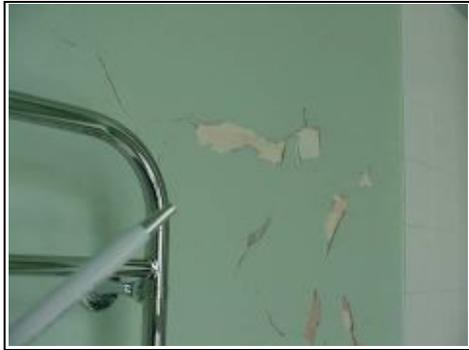
Condensation causing the paint to peel

ACTION REQUIRED: We would recommend adding large humidity controlled extract fans to the bathroom, the en suite and any other humidity generating areas.

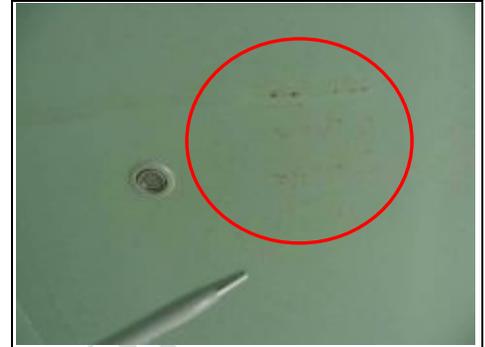
Mould and staining to the ceiling

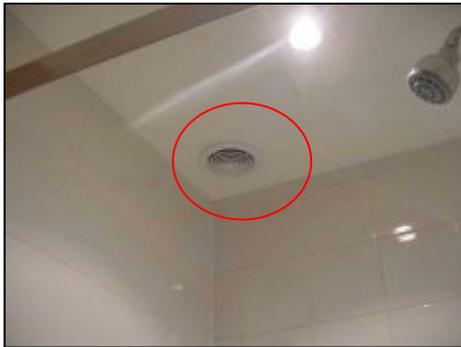
Small extract fan in en suite should be replaced with large humidity controlled extract fan

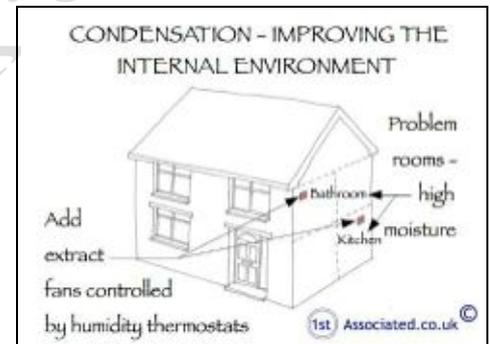
We noted condensation is occurring within the bathroom and the en suite shower room.

Condensation

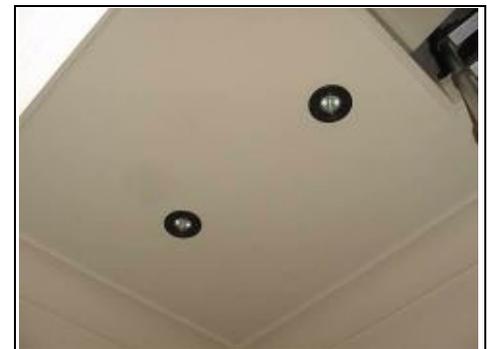
Ceiling lights have been covered with insulation which is not ideal

ACTION REQUIRED: We recommend they are replaced with LED lights.

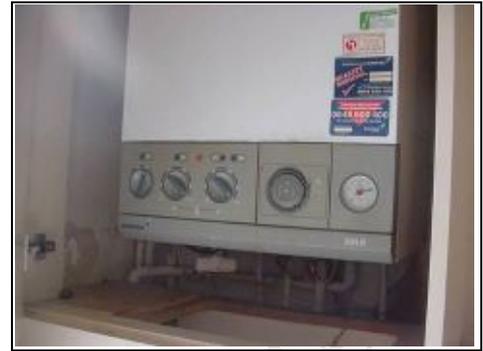
The property has a British Gas branded boiler which do not seem to last particularly well, with even British Gas no longer using their own branded boilers. We also noted that the radiators in the flat were of an older style.

British Gas boiler

ACTION REQUIRED: Budget for replacement in the future.

ANTICIPATED COST: In the region of £3,000 to £4,000 however it is likely that you also need to replace the older style radiators throughout so expect quotes from £4,000 to £7,000; please obtain quotations.

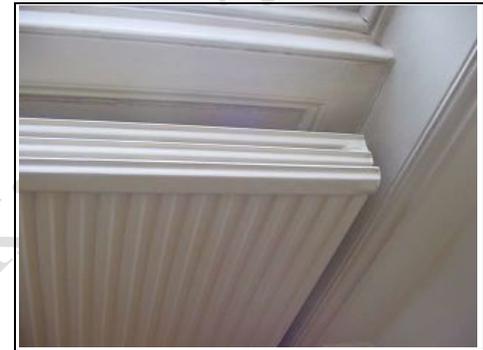
Older style radiator

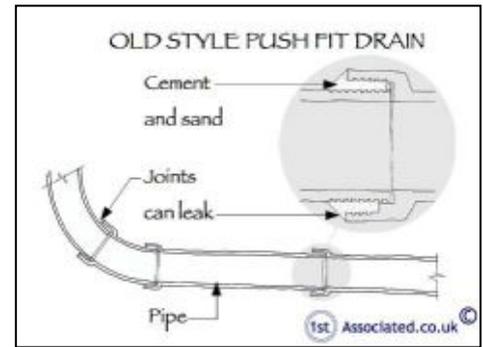
In older properties, such as this, drainage was often push fitted together rather than bonded together which means that they may leak over the years. Whilst we ran the tap for 15 minutes without any build up or blockages the only way to be 100% certain of the condition of the drains is to have a closed circuit TV camera report.

Push fit drain

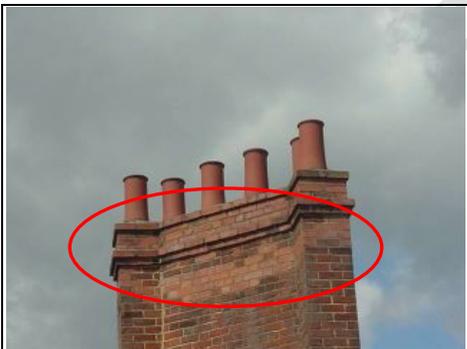
This large chimney is brick built finished with a lead flashing and many chimney pots. From what we could see it has been partially rebuilt. This chimney sits directly over your lounge which could of course be a problem if allowed to get into a poor condition.

Where we believe the chimney has been rebuilt

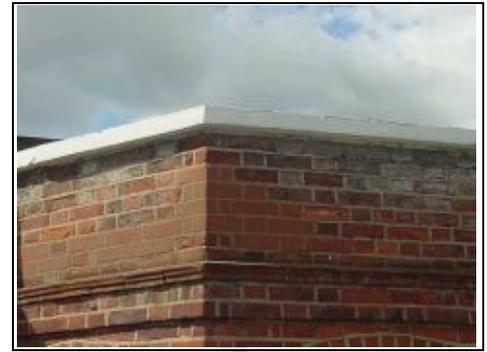
We can comment that they look to have been repaired / rebuilt. The repairs look to have been carried out with cement mortar which we would not recommend.

Parapet wall has been repaired

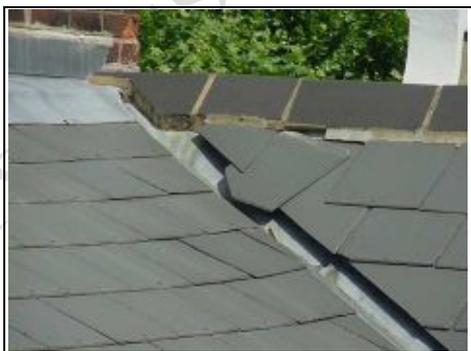
The main roof is pitched and clad with manmade slates and, from roof level this looks in slightly below average condition considering the roofs age type and style due to the broken/slipped slates.

Broken slates

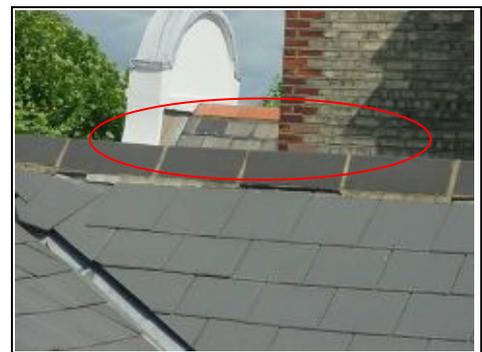
Ridge tiles need re-bedding

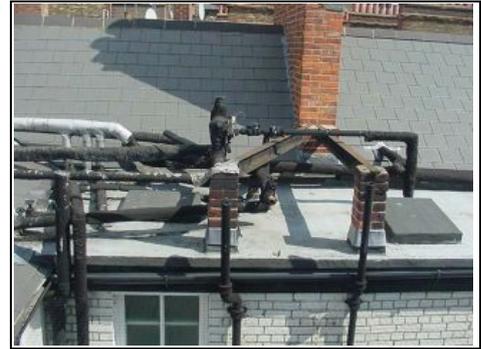
We must draw to your attention the large number of services on parts of the roof. In our experience the openings for these can cause problems.

Services on roof

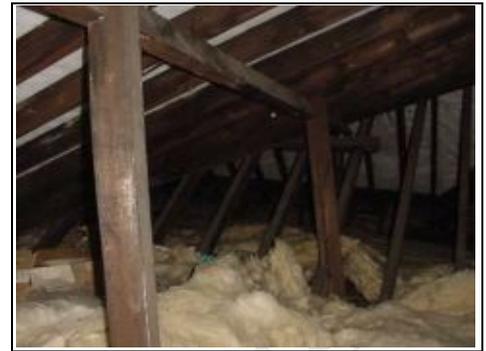
Roof above lobby in flat. We can see some staining to the timbers but we believe this to be old staining before the property was re-roofed but cannot be certain without monitoring

ACTION REQUIRED: The only way to be 100 per cent certain is to have the roof cleared and checked.

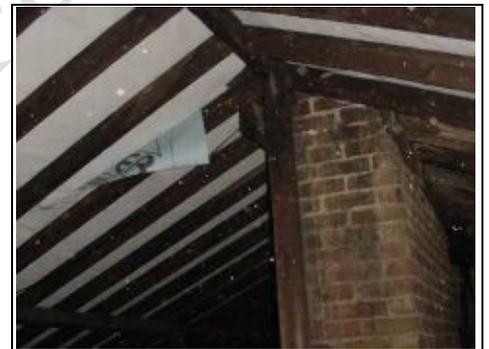
Dampness coming in near the chimney in this roof

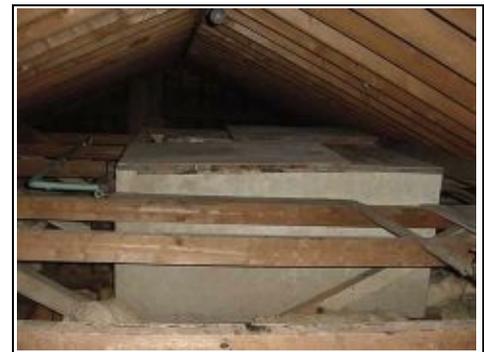
We noted an old water tank in the roof space.

Possible asbestos clad water tank

ACTION REQUIRED: Please see our comments within the Executive Summary regarding Asbestos as we believe this may be asbestos clad but cannot be certain from a visual inspection.

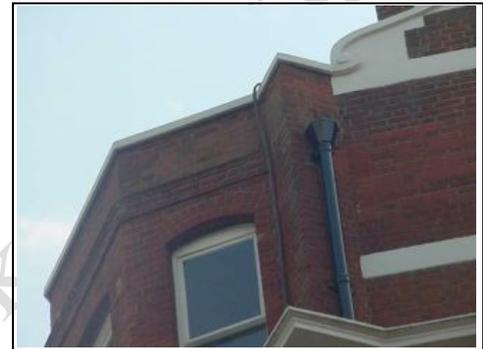
Hopper head could cause problems

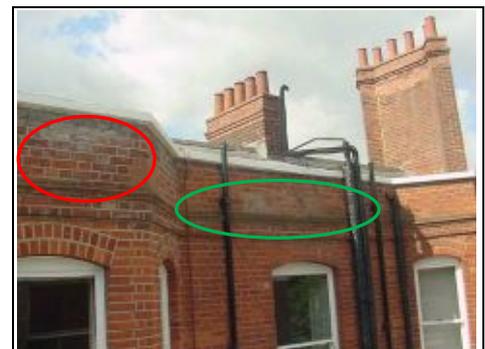
We can see that some of the re-pointing has weathered to the right hand side and we can see ad hoc re-pointing to the left hand and right hand side corners. We can also see what appear to be cement repairs.

Greening to the brick detailing and efflorescence

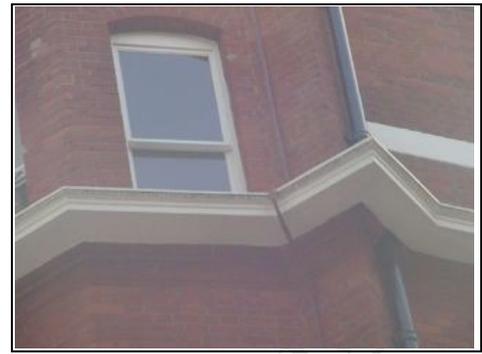
The walls appear to have been wrongly re-pointed in cement mortar instead of lime mortar which has meant deterioration to the red brick leading to replacement of the bricks with a cement mortar finish. This unfortunately is not the recommended way to repair such walls and in theory the entirety of the building should be re-pointed in a lime mortar but we are aware that this would be a very expensive project for this building particularly with high level work needing extensive scaffolding.

Pointing has weathered to the left hand side of the downpipe

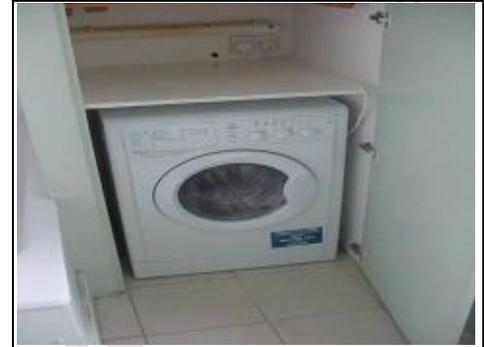
The washing machine is located in the bathroom and does not help with the humidity.

Washing machine in bathroom
