RESIDENTIAL BUILDING SURVEY

XXXXXXXXXXXXXXXXXX,
Marylebone,
London ,
W1U xxx

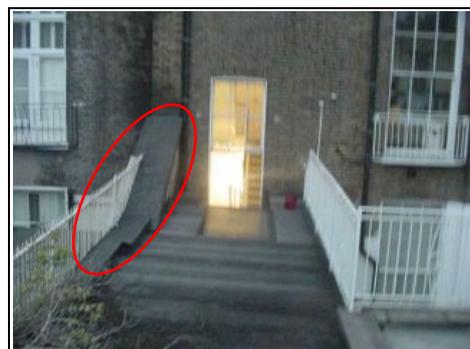
We can see that the courtyard to Apartment Two and the shared terrace to the rear of the property have a coping stone that looks to have leaked over the years. We can see that the joints of this have been tarred to the left hand side and the parapet wall has been completely tarred to the right hand side.

Rear right hand side parapet wall has been completely tarred

ACTION REQUIRED: We would recommend that lead cappings are added to the parapet walls including the one on the main roof.

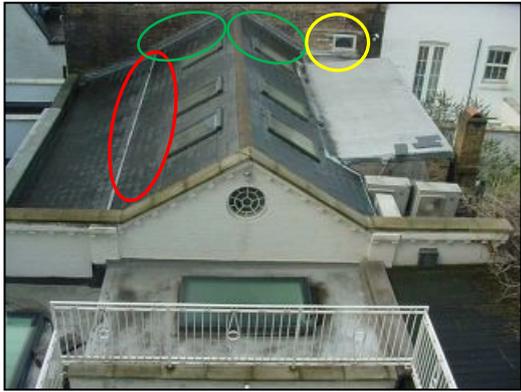
Rear of Apartment Two
Awkward valley gutter (red)
Straight lead flashings instead of stepped (green)
Gutter leaking onto property (yellow)

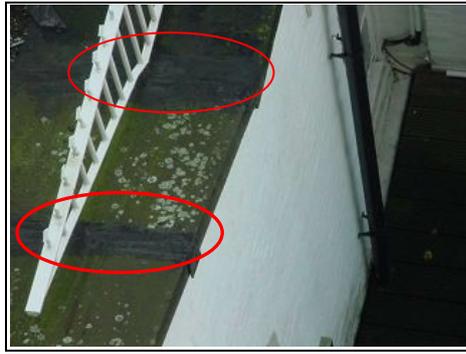
Left hand side of courtyard
Repairs to the parapet wall

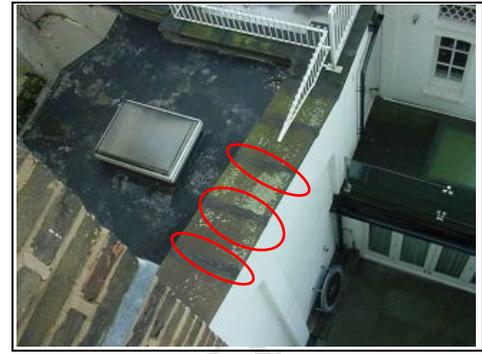
Courtyard to apartment two – repairs visible

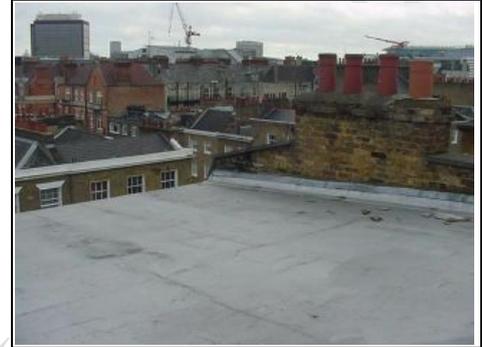
Main roof

The main roof has a shallow pitched Asphalt roof. Generally Asphalt roofs are considered to be the Rolls Royce of flat roofs and we would always recommend repairing them rather than replacing them, except for a fairly few exceptions where there are major problems and with no insulation present.

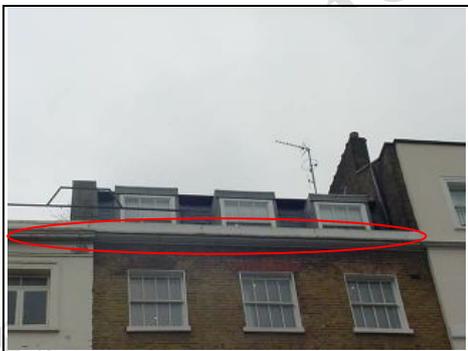
To the front of this Asphalt roof is a box gutter detail where we think rainwater is getting in. The problem may be caused by the poor detailing to the box gutter around the dormer windows, see further on in this section.

Awkward box gutter

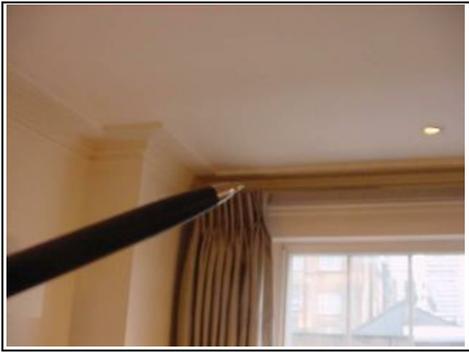
Damp staining at window

ACTION REQUIRED: There are various testing systems to use on Asphalt roofs to pinpoint the leak. The main problem with this type of roof is that where the leak is getting in is not necessarily where the staining is seen. However as said, this is the Rolls Royce of roofs and should be kept if at all possible. Adhoc repairs should be carried out and solar reflective paint added to the roof to prolong its life. In addition to this there may also be dampness coming in via the lead work. This is precarious to carry out repairs to and will require a cantilevered scaffolding to give access and to allow a full inspection.

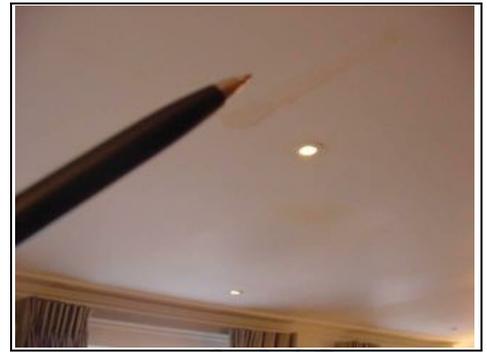
Damp staining relating to the main roof

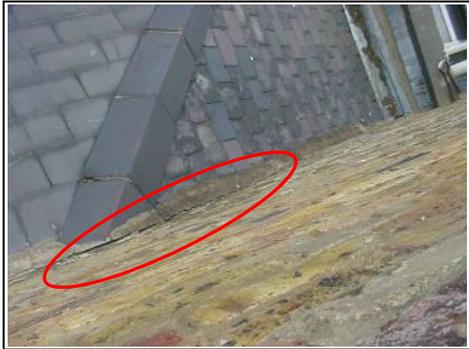
The adjoining property still has the original butterfly roof. There is cracking visible between the concrete fillet that has been used and the parapet wall of this property.

Cracking to concrete fillet

ACTION REQUIRED: Ideally this should have a lead flashing as dampness can get into the top floor apartment from your neighbour's property. We recommend speaking to the neighbour to advise them of the problem. If they are not happy to carry out the work it may well be worth you carrying out the work.

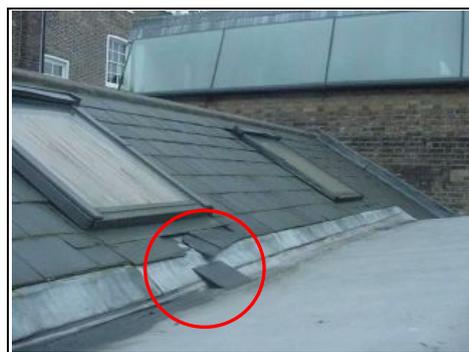
As mentioned there is a pitched roof to the rear of Apartment Two which forms the cathedral ceiling within the apartment. This has been re-roofed at some point with a manmade slate, this would typically have been during the 1990's. We noted that some slates have already been displaced to the rear right hand side.

Slates displaced

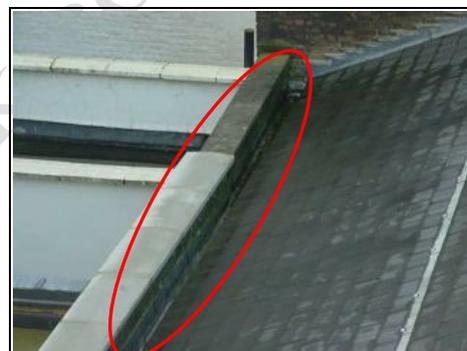
To the left hand side there is an awkward gutter that we believe is leaking. Again as with the main roof, box gutters really can be problematic particularly in this case where any water that discharges from the gutter actually goes into the walls.

Awkward box gutter that we believe is leaking

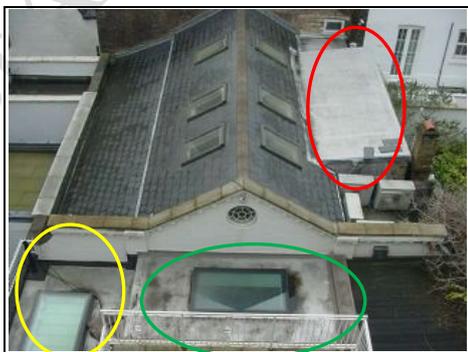
Flat roofs

There are various flat and shallow pitched Asphalt roofs to the rear and we could see that rucking and deterioration is starting to occur.

ACTION REQUIRED: Patch repairs will be required in the next few years. As mentioned Asphalt is the Rolls Royce of roofing materials as long as it maintained.

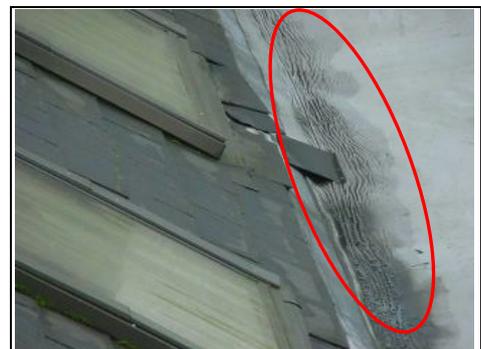
Roof to the right hand side is starting to deteriorate and ruck

ANTICIPATED COST: A few hundred pounds if carried out before the roofs leak, thousands if left; please obtain quotations.

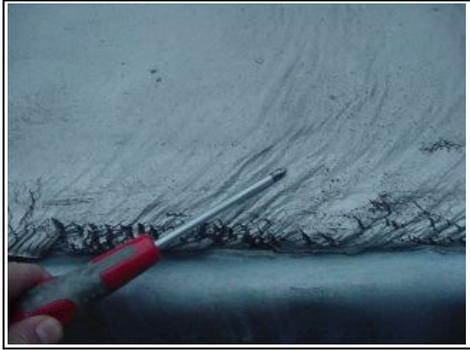
Deterioration to roof

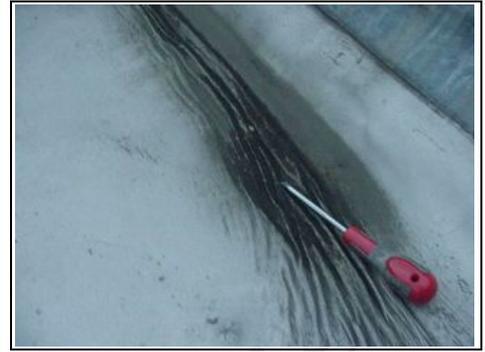
Deterioration and rucking

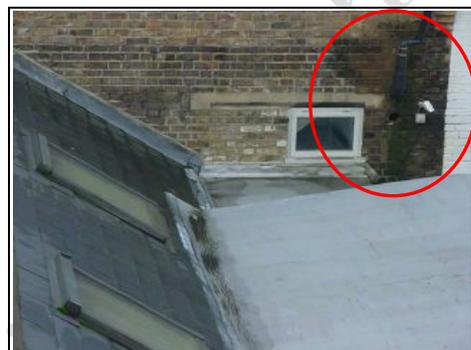
To the rear of the property, above the single storey right hand side area of Apartment Two, we can see that the adjoining property has uncoupled guttering which is allowing water to discharge down their wall and also down yours.

Neighbours gutter leaking onto your wall

ACTION REQUIRED: Speak to the neighbours but we would recommend that you repair it if you do not get any response.

ANTICIPATED COST: A few hundred pounds, this will stop dampness getting into your building; please obtain quotations.

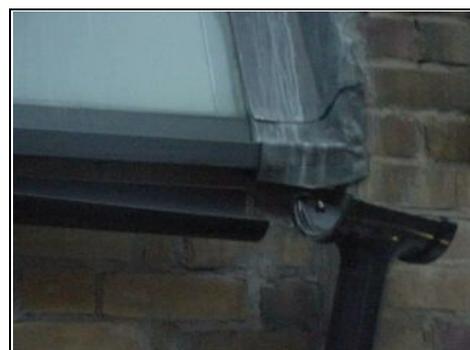
Guttering is broken

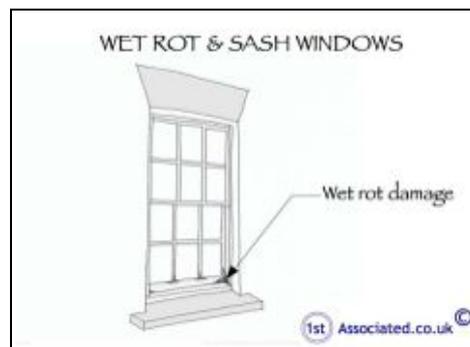
The timber is likely to be good quality and we would only recommend repair in the areas susceptible to wet rot as shown in our sketch. We do find there is a pressure to replace such windows and often, with a window of a lesser quality over the long term.

Wet rot in sash windows

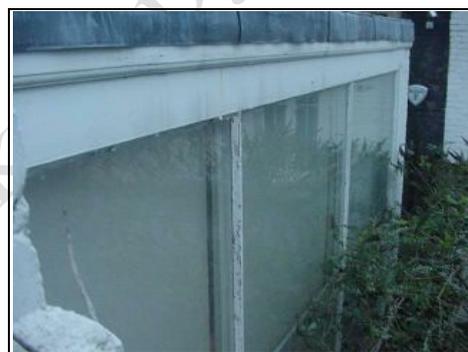
Rear windows

There are large fixed/picture windows hidden by blinds at the time of the survey. These do not look to be of good quality or condition particularly as they have thin mullions (the vertical timbers on the windows). We also think that the detailing at roof level is poor and we recommend that an up-stand is added to this area to minimise any wind driven rain coming off this section.

ACTION REQUIRED: We would recommend redecoration in the summer of 2014 and would be looking to renewing the windows dependent upon what is found during the redecoration.

ANTICIPATED COSTS: The difficulty is accessing this area which is likely to require scaffolding and we would expect costs in the region of £2,000 to £4,000.

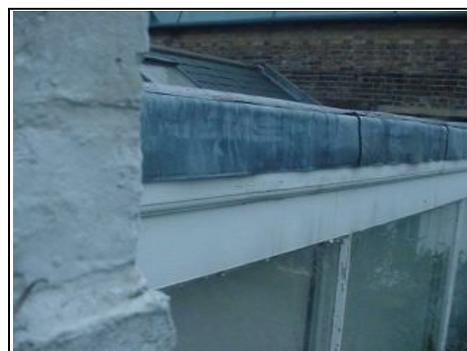
Poor detail requires a gutter, assuming it is not hanging over next doors property

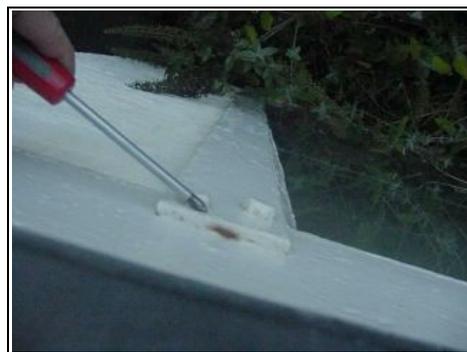
Rusting to metal work on timber windows

You could equally decide that rather than redecoration it would be worth replacing them, in which case as these are large picture windows we would replace them with large modern double glazed windows. However, the windows may have to be timber due to the listed building requirements.

Replacement costs are likely to be in the £7,000 to £15,000 market with the increase due to the scaffolding required and also because they will need to be custom made.

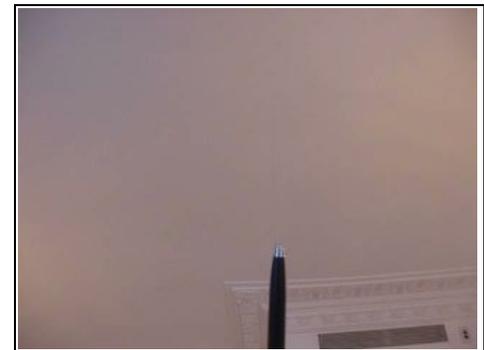
There has been some movement in the structure which is difficult to see due to the dry lining that has been used which effectively adds a false wall around the property. However, we can see hair line cracking and raking cracks around the lift shaft and the staircase area. We believe this is due to a combination of reasons.

Cracking around the lift area in Apartment Four

1. There can often be movement where there is a staircase and this could be due to the timbers being embedded into the wall and deteriorating over time.
2. The lift has been added at some point in time which will have involved structural work and adds a more solid element to buildings that were designed very differently and this can result in cracking such as this. We have inspected the property externally

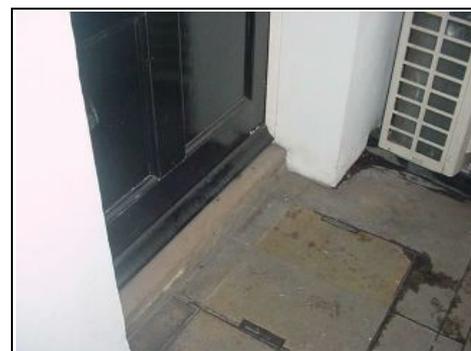
There are various manholes throughout the property. The ones we found require specialist lifting equipment and so we were unable to open them.

Manhole cover not lifted at entrance to the apartments

ACTION REQUIRED: The only way to be 100% certain of the condition of the drains is to have a closed circuit TV camera report.

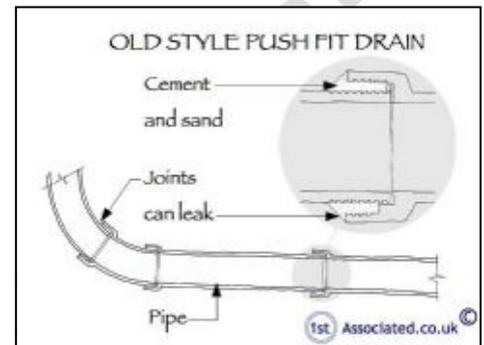
In older properties, such as this, drainage was often push fitted together rather than bonded together which means that they may leak over the years. Whilst we ran the taps for 15 minutes without any build up or blockages the only way to be 100% certain of the condition of the drains is to have a closed circuit TV camera report.

Push fit drain

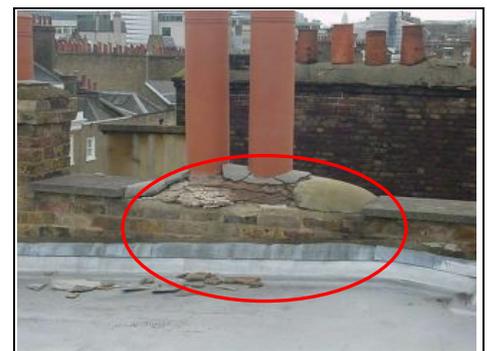
This chimney is brick built finished with a lead flashing and several chimney pots. From what we could see from ground level it looked in below average condition considering its age, type and style due to the condition of the flaunching

Left hand chimney needs repairs

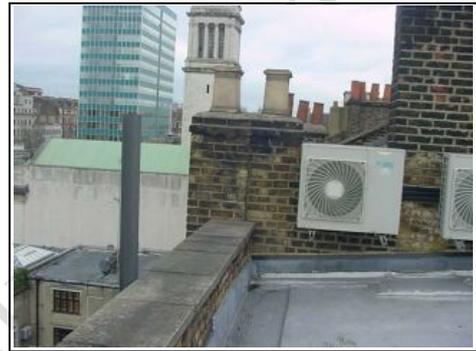
General view of rear parapet wall

ACTION REQUIRED: We are recommending that any parapet walls with coping stones should be capped using lead as this stops any dampness getting in through the joints and through the brickwork.

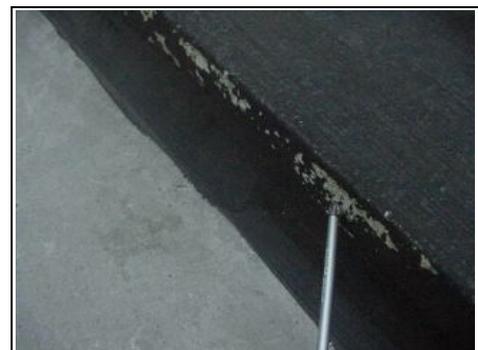
Damage to parapet wall

ACTION REQUIRED: We are recommending that all walls have lead cappings added. Please see our comments within the Executive Summary.

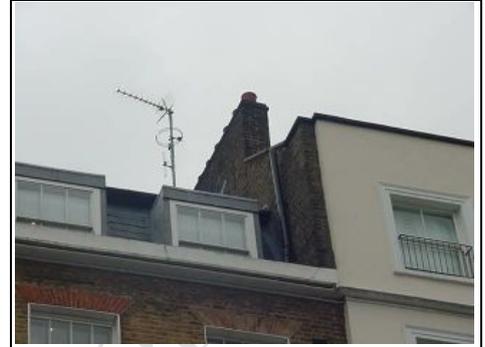
Dormer window

There are dormer windows to the front of the property which may have leaks due to the poor detailing to the box gutter. The dormer windows are lead covered. There does appear to be a leak internally.

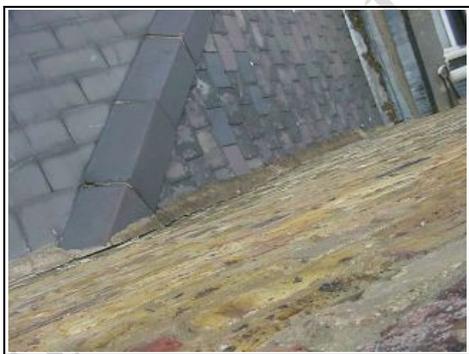
The neighbour's roof beds onto this property. Where a cement mortar has been used instead of a lead flashing hairline cracking is visible.

Neighbours roof beds onto this property. Cement mortar has been used rather than lead flashing

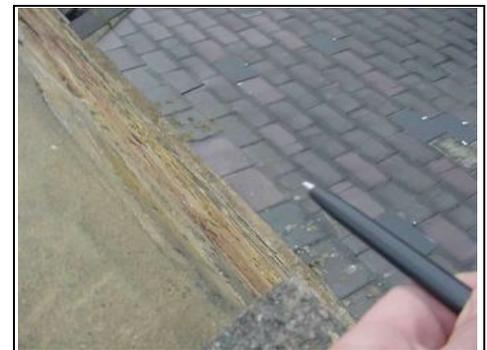
Hairline cracking.

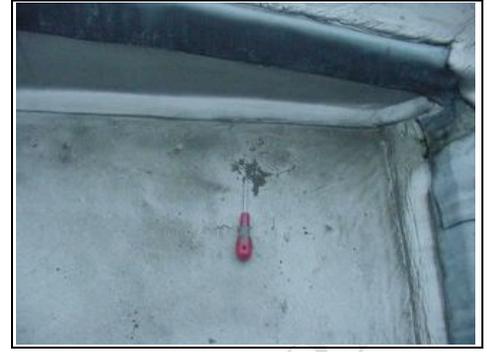
Solar reflective paint is
wearing away

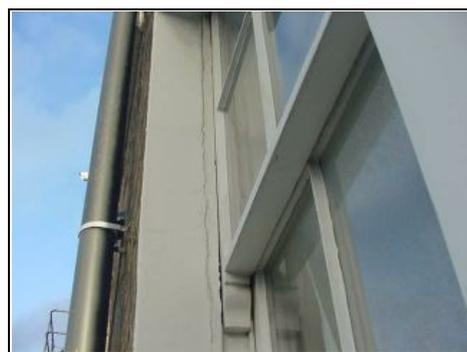
Hairline cracking to render on the reveals of the windows

We would add that any hairline cracks that appear need to be sealed as soon as possible to stop dampness and water getting in and causing blisters and hollow areas in the render.

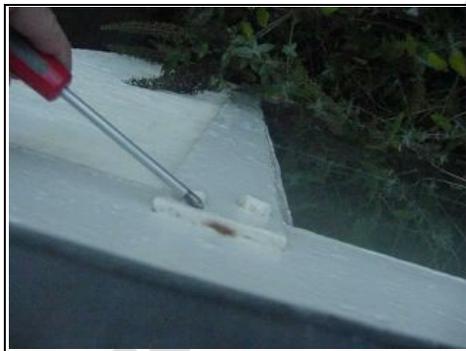
Rusting to the metal work on the timber windows to the right hand side of Apartment Two

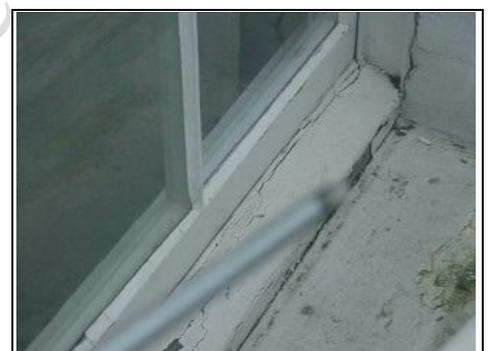
Timber windows need redecorating

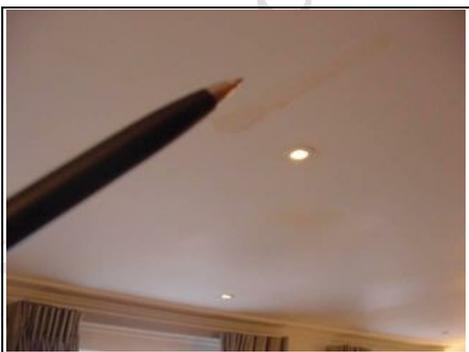
A leak has been painted over in the drawing room in Apartment Five

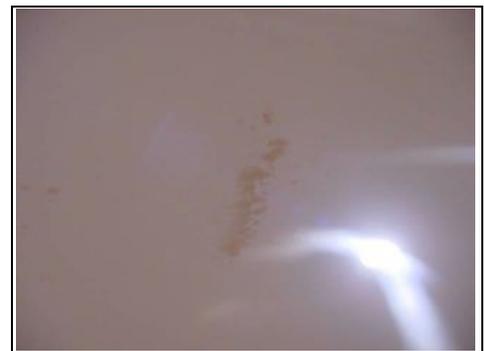
Dampness coming into the ensuite from the kitchen above in Apartment Two

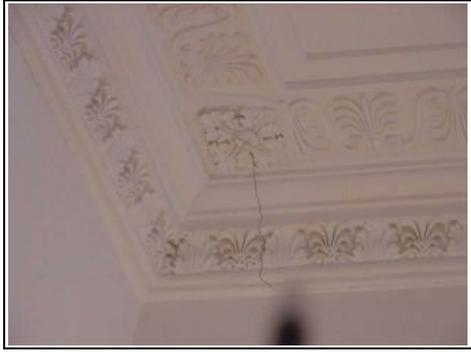
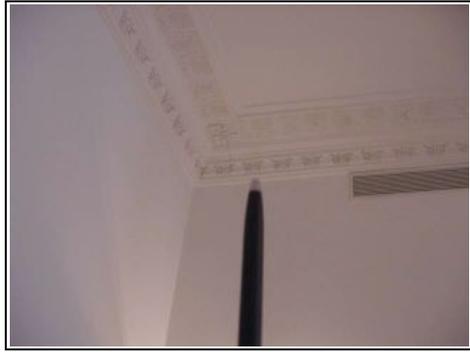
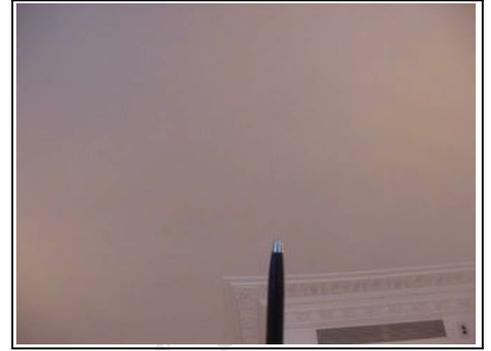
Cracking around the lift area in
Apartment Four

ACTION REQUIRED: Please see our comments within the Executive Summary.

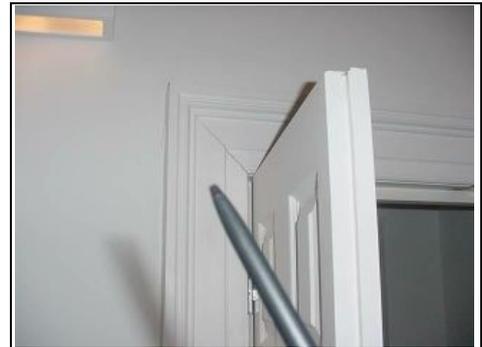
Cracking around entrance
door to drawing room,
Apartment Four

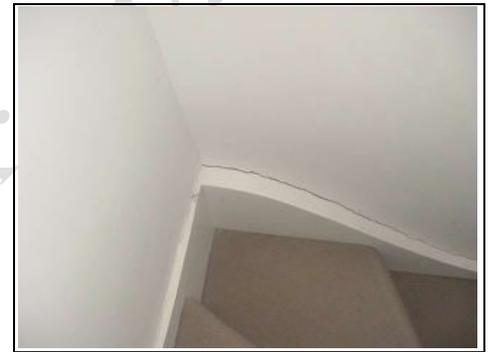
Cracking on stairs in Apartment Two leading down to bedrooms

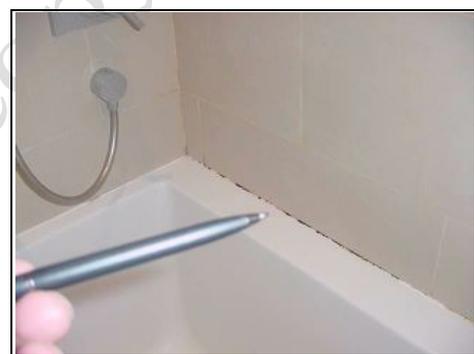
Condensation in bathroom
Apartment Three

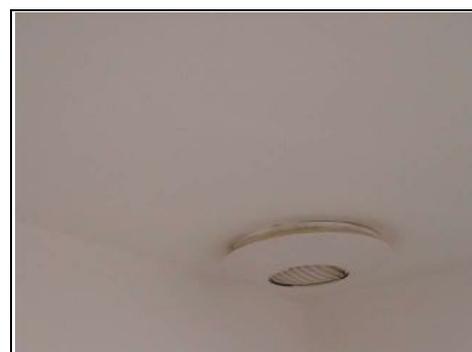
Extract fan is inadequate in bathroom of Flat Three
