RESIDENTIAL BUILDING SURVEY

**Marylebone
London
W1**

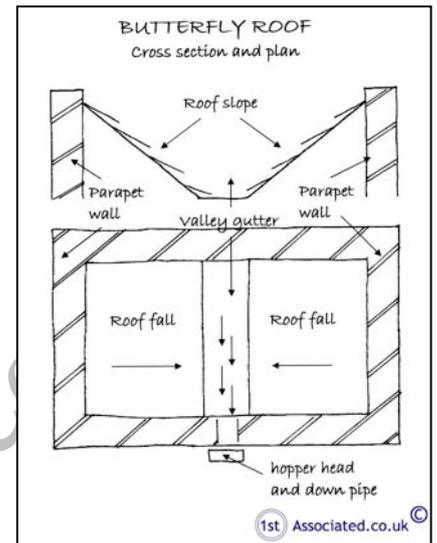
- 1.1) It is old if it has not been replaced
- 1.2) It has a central valley gutter, which can leak
- 1.3) Fairly shallow pitch, which means there is a lack of ventilation.

Butterfly roof

The reason why we believe that there are problems with this roof is that when we went onto the top floor landing where apartments 5 and 6 are to see if we could gain entry to the roof, we could see dampness coming through.

ACTION REQUIRED: Roof needs further investigation and repair. We also recommend that your solicitors obtain any information possible with regard to maintenance of the roof from the Management Company or Occupiers Management Group or Property Management Group.

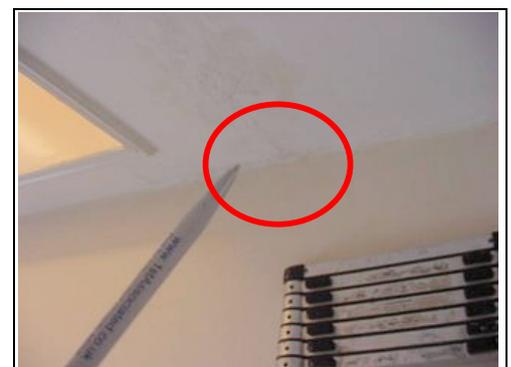
Dampness to ceiling on landing

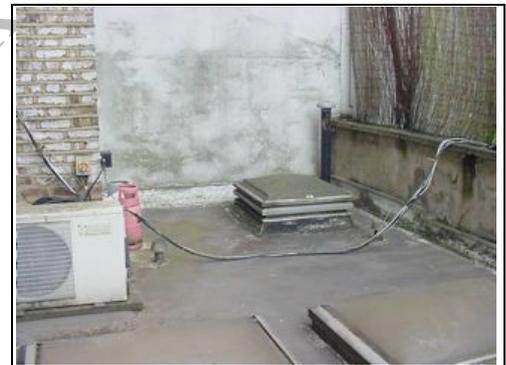
There is a rear asphalt flat roof accessed from the building. Generally we believe this to be the Rolls Royce of flat roofs however in this case there is crocodiling and splits in the roof which require repair.

Rear flat roof general view

The rear flat roof requires general maintenance.

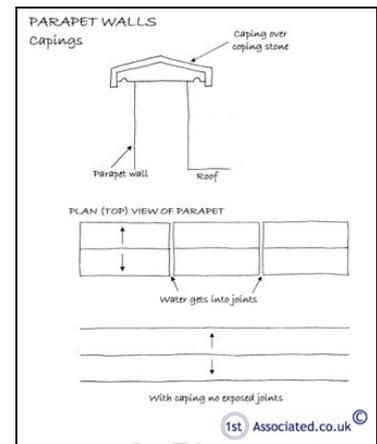
Capping of parapet wall

ACTION REQUIRED: We would recommend a coping stone or capping in lead to the parapet wall.

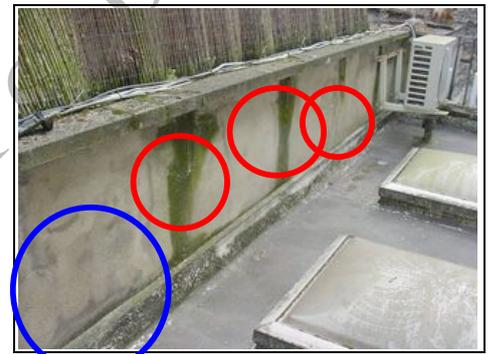
We can also see that some of the parapet walls are leaking at the coping stone joints and at the left side we believe that the parapet wall has been re-rendered.

Leaking of coping stone joints to parapet walls – red circles
Re-rendered – blue circle

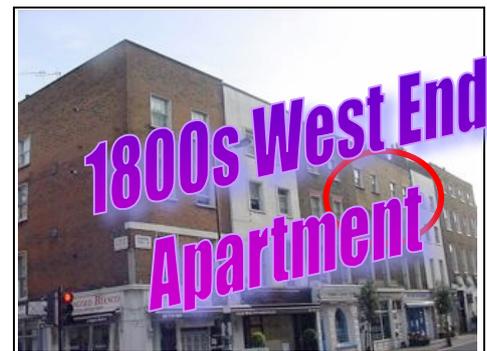
The property and the near by property has War damage/bomb damage and have been re-built in part. We could see on a neighbouring property there is a newer brick indicating complete re-build to large sections of the property.

Different coloured brickwork to top floor

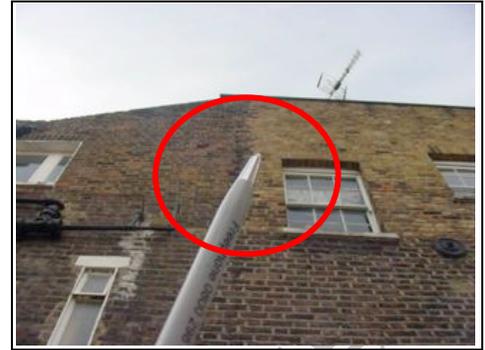
We can see a vertical crack to the front of the property in the adjoining property to the right side. To this property to the rear we can see a miss match of brickwork indicating that repair was carried out.

Mis-match brickwork to rear left side

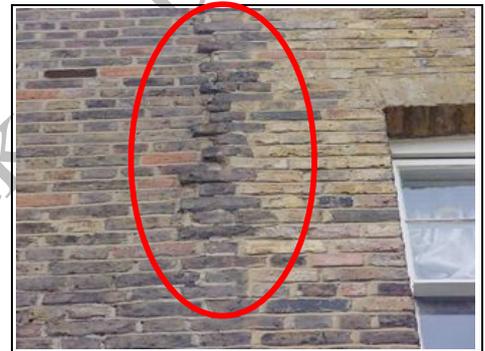
Mis-matched brickwork close up view

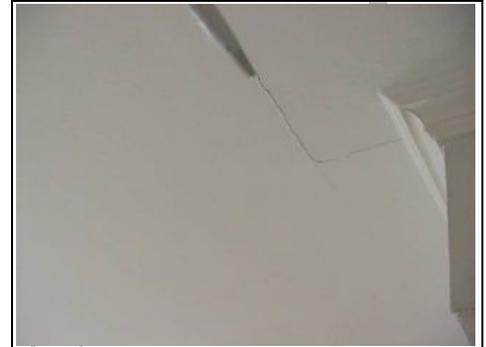
This is usually the case where modern gypsum plaster is used in older properties. We also find there tends to be less regular painting carried out where a property has been rented out, as in this case, so any hairline cracks that happen over the years are still visible many years later.

Hairline cracking in the hallway ceiling

ACTION REQUIRED: Repair and redecorate and as previously discussed get access to the roof, etc.

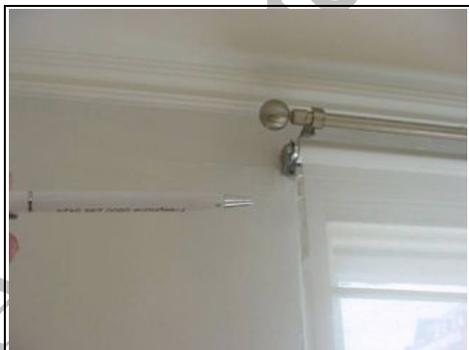
Hairline cracks in the walls

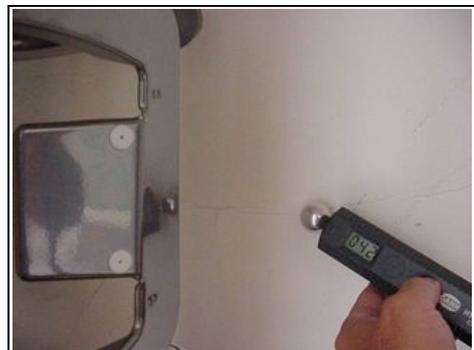
Cracking in cupboards in Bedroom

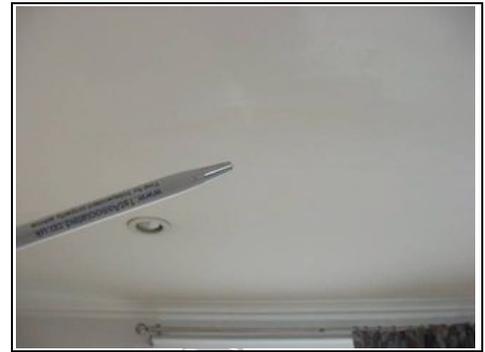
The staining to the ceiling indicates that there has been a leak from the apartment above, probably the Bathroom or the Kitchen, which is not that unusual in apartments. This is however unusual to leave the staining visible.

Staining to ceiling in Bathroom

ACTION REQUIRED: We recommend a chat with your upstairs neighbour prior to legally committing to purchase the property to ensure that the leak is no longer a problem and ideally gain access for an inspection.

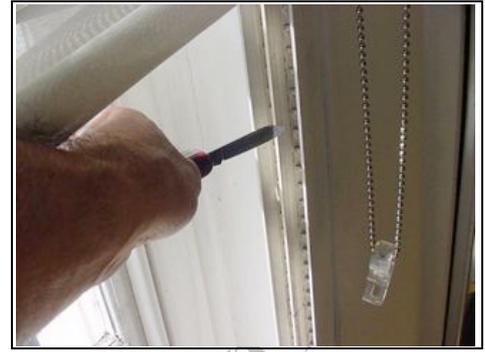
We would also draw your attention to the secondary glazing that was missing at the time of the survey. Secondary glazing is generally added to stop the cold getting in during the winter months or noise or both as we suspect is the reason in this particular case.

Secondary glazing

ACTION REQUIRED: We recommend a chat with your upstairs neighbour prior to legally committing to purchase the property to discuss noise transfer.

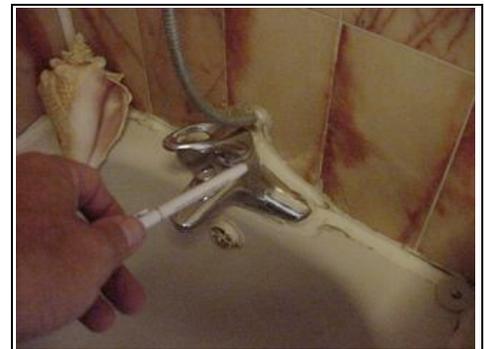
Equally it appears that you may be causing problems to the apartment below (again we have not been able to gain access) judging from the amount of mastic around the taps and bath and believe there has been a leak or still is a leak. Again, unfortunately the downstairs neighbours were not in so we cannot confirm this.

Mastic around shower taps and bath

Also with regard to the overall condition of the Bathroom we would ideally start again with a complete refurbishment.

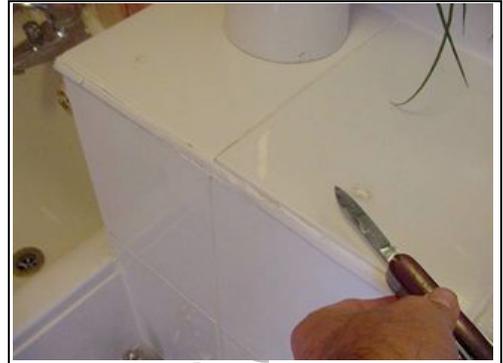
There is also damage around the WC where there is no obvious way to access the cistern; we believe this damage may have been caused when someone has been trying to carry out maintenance.

Old fixing points

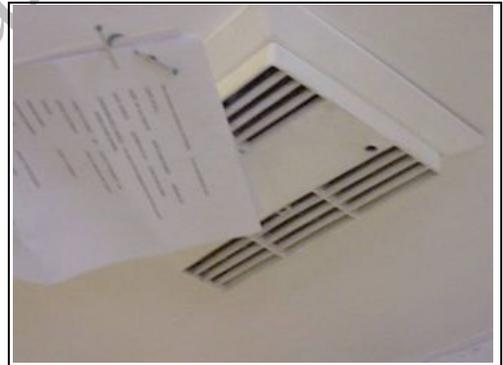
At the time of our inspection the Bathroom extract fan was not in working order. The area is likely to be a high condensation area as it is an internal Bathroom in addition there is a washing machine located in the Bedroom.

Extract fan not working in Bathroom

ACTION REQUIRED: Refurbishment recommended. Addition of a large humidity controlled extract fan in the Bathroom and Kitchen and any high humidity areas (for example where you are drying clothes) to extract to external air.

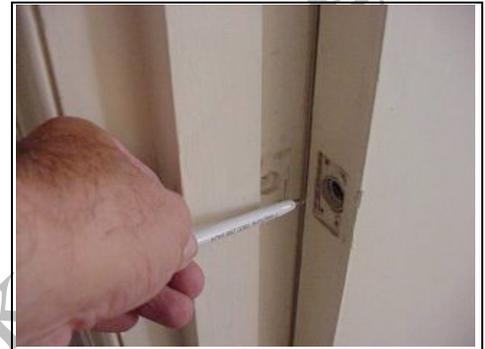
We noted that a Perco door closure was missing from the inner door, which is something we do not like to see.

Perco door closure missing

ACTION REQUIRED: Replace
Perco door closure.

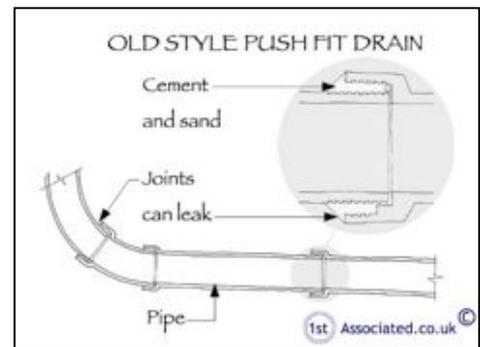
In older properties, such as this, drainage was often push fitted together rather than bonded together which means that they may leak over the years. Whilst we ran the tap for 15 minutes without any build up or blockages the only way to be 100% certain of the condition of the drains is to have a closed circuit TV camera report.

Push fit drain

Whilst we ran the tap for 15 minutes without any build up or blockages the only way to be 100% certain of the condition of the drains is to have a closed circuit TV camera report.

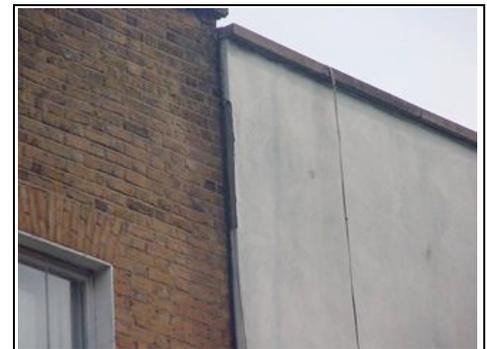
We could see a small area of render that we believe has come away which does indicate, to us, that there is possibly dampness coming in via the parapet walls.

Parapet wall, looks like render is coming away

It is relatively common to have dampness coming in via the joints to the coping stones and we generally recommend a capping is added to the parapet walls but of course we have not seen the parapet wall close up in this instance.

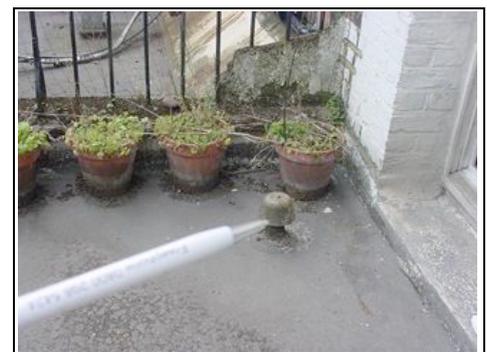
There is a flat roof to the rear extension, which is not above your property but may well have a shared liability. We could see some deterioration to the roof with crocodile cracking. Please see our comments in the Executive Summary.

Flat roof to rear extension

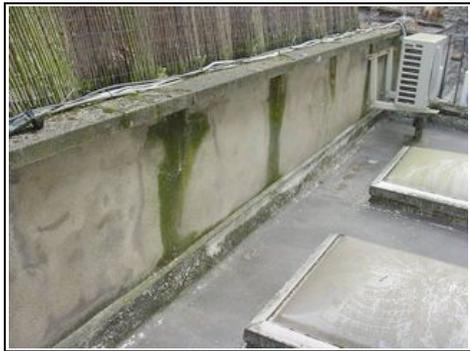
Worn kerb stone

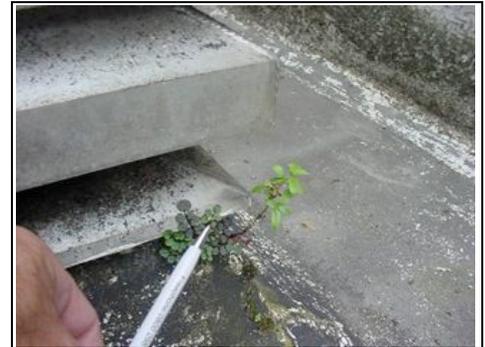
Roof lights coming to the end of their natural life with plants growing out

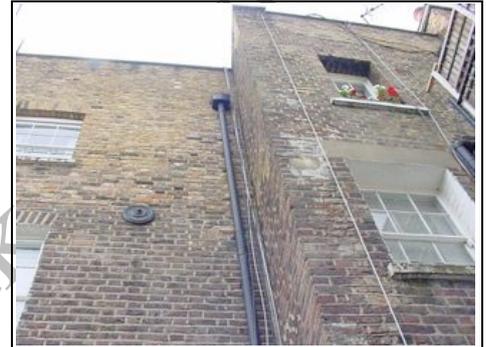
The property has plastic hopper heads and downpipes and are fairly typical of what we see; they are in average condition for their age, type and style. There is an awkward right angled bend in the pipework that we suspect will leak.

Hopperhead to the rear of the property

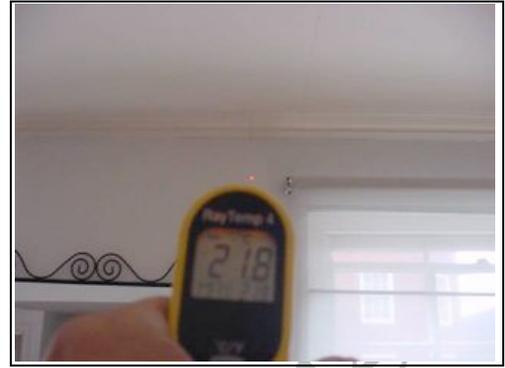
Temperature differences around lintels indicating maybe timber lintel is still present but very difficult to obtain good readings during warm weather

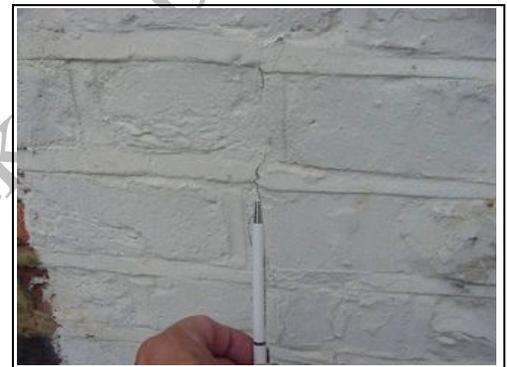
Cracking to rear of the property

ACTION REQUIRED: We recommend that any hairline cracks are sealed as soon as possible to stop dampness and water getting in and causing blisters and hollow areas.

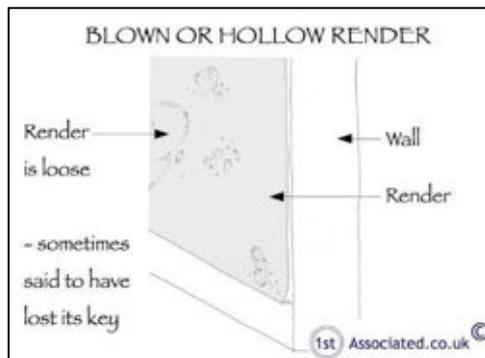
Blown or hollow render

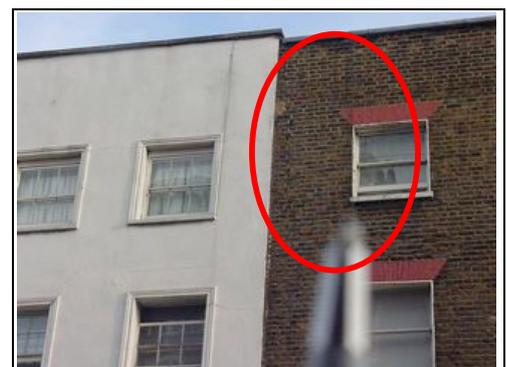
We noted some cracking to the next door properties brickwork.

Crack to next door neighbour's front wall

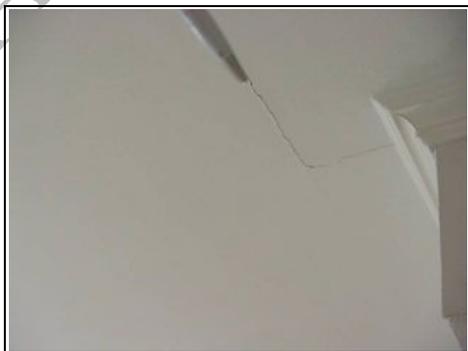
Hairline cracks in Lobby area

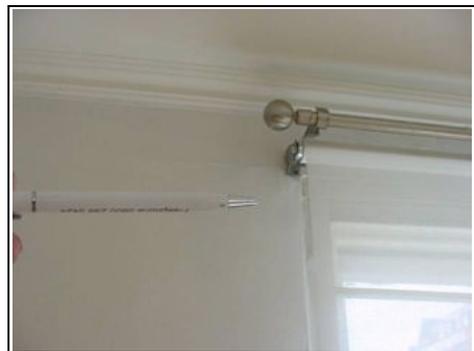
Hairline cracking in walls

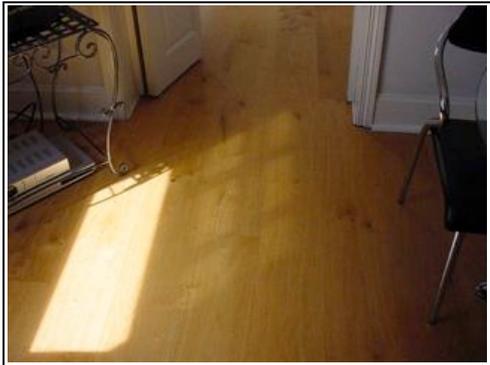
There is laminate flooring throughout the property with a slight springiness to it. We noted that there are quadrant beads to the skirting indicating that this has been fitted after and means we cannot comment on the floorboards and the construction.

Floor poorly laid

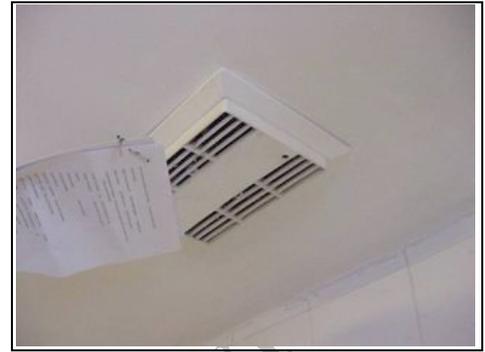
The extract fan was not working in the Bathroom at the time of our inspection. Please see our comments in the Executive Summary.

Extract fan not working in Bathroom

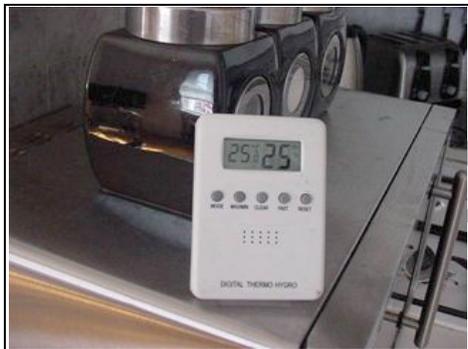
Relatively high humidity

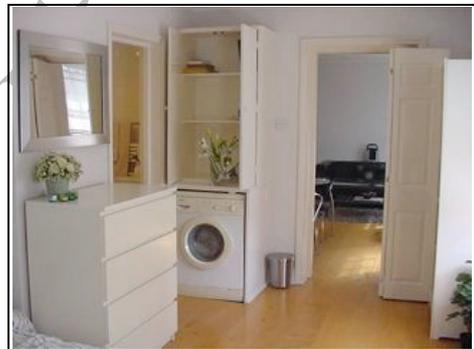
Washing machine in Bedroom

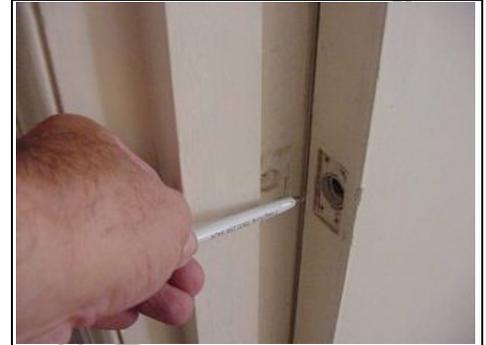
Perco door closure missing

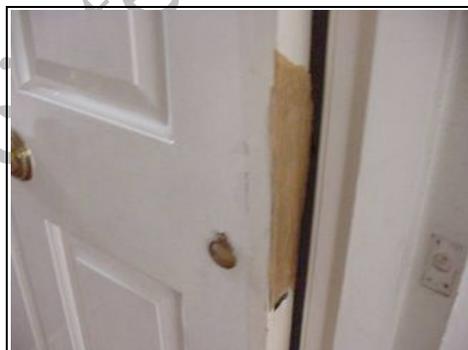
The front door appears to have been damaged. There appears to have been three locks with damage to the middle one.

Middle missing lock

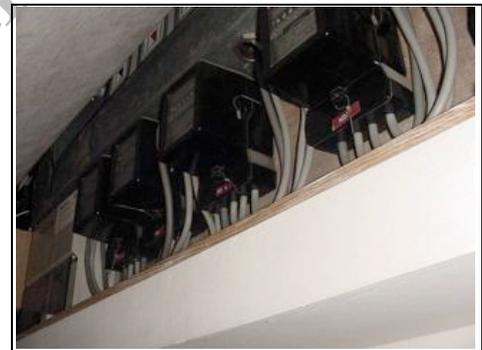
The electric fuses and consumer units were located in the Kitchen. The fuse board looked dated; it was not possible to confirm which fuse board related to this property. In multi occupied properties a defective fuse board can be particularly dangerous.

Fuse Boards

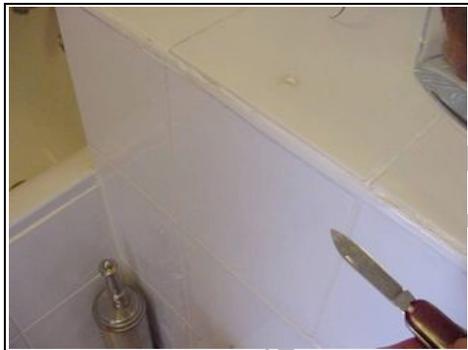
Damage where tiles have been taken out

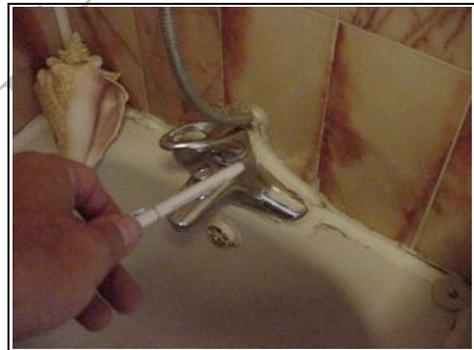
Thick mastic around bath and taps
