**TAILOR MADE  
RESIDENTIAL BUILDING SURVEY**

**XXX  
Notting Hill,  
London.  
W2 XXX**

**FOR  
Mr X**

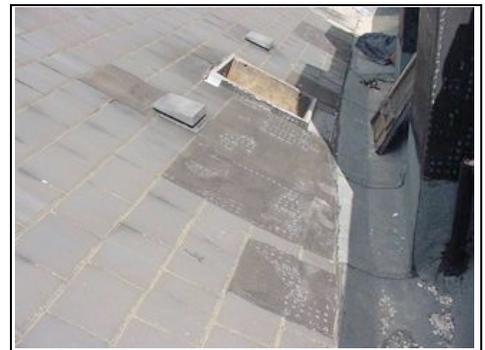
Damaged slates and poorly detailed slates have been allowing water into the property which in turn has caused deterioration to the roof timbers over the years. The full extent of this cannot be identified unless we have the roof fully lit as we have only viewed it by torchlight.

Damaged slate – felt repairs

- 1.) The felt repairs to the slate roof to be replaced with slates.
- 2.) Where the valley gutter meets the slate roof and where the box gutter meets the slate roof, these areas need to be stripped back to approximately 2ft and a timber decking put in.

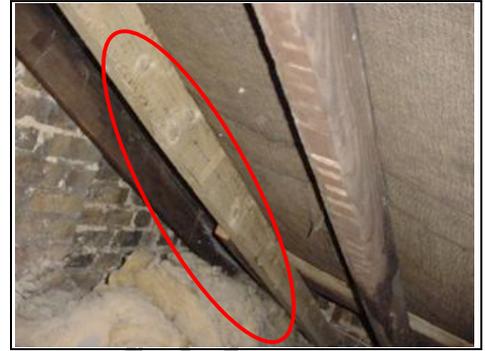
1.1.1) Replacement timbers to the right hand side of the roof

Replacement timber

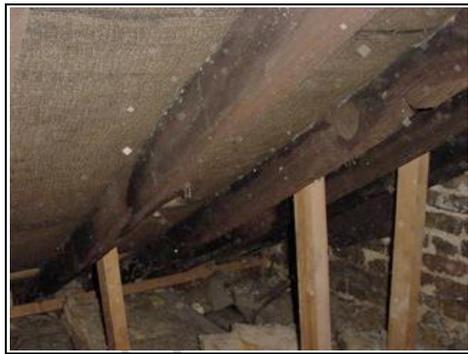
1.1.2) To the left hand side we can see that props have been added and we believe there is a bow in the roof. We also noted a split timber. There are also back to back timbers visible which are used to add strength to the timbers where problems have occurred.

We believe there is a bow in the roof

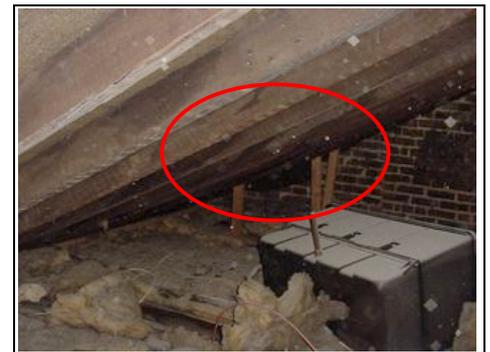
Props added

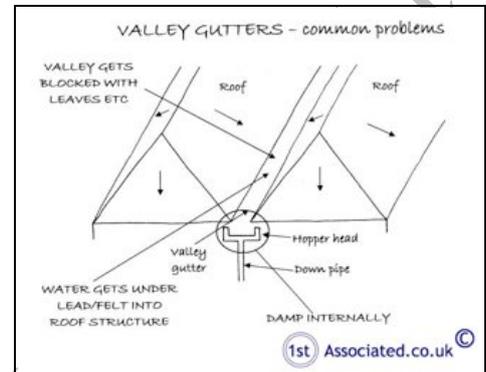
A valley gutter is where two roofs meet as shown in the adjoining sketch and they are renowned for being problem areas. This one looks to have been leaking over time.

Problems with valley gutters

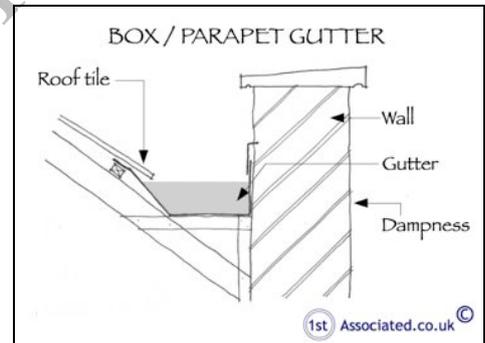
There are box gutter details to both the front and the rear of the roof. Where these are incorrectly formed there can be leaks which can cause the common rafter feet to rot.

Box gutter

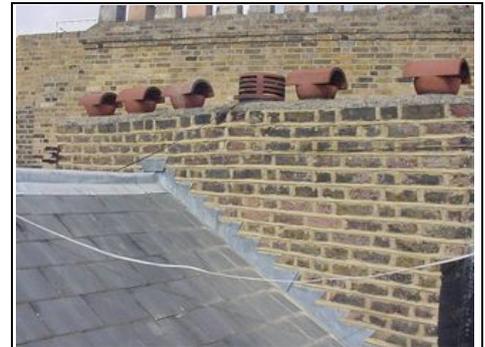
The flaunching seems to be deteriorating to the right hand chimney, which we were able to inspect properly, including a missing chimney pot which we believe is causing dampness within the chimney breast but is not visible due to the dry lining to the walls.

Right hand chimney

**ACTION REQUIRED:** Carry out repairs to the chimneys.

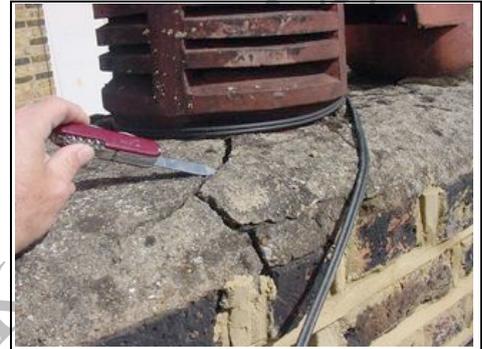
There is also general cracking and deterioration around the chimneys particularly to the top where the flaunching is.

Cracking to the top

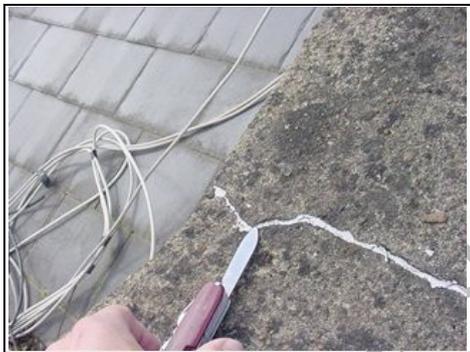
Old repair to top of parapet

**ACTION REQUIRED:** Strip back the felt, check the condition of the parapet walls, re-render the parapet walls and possibly add cappings to them.

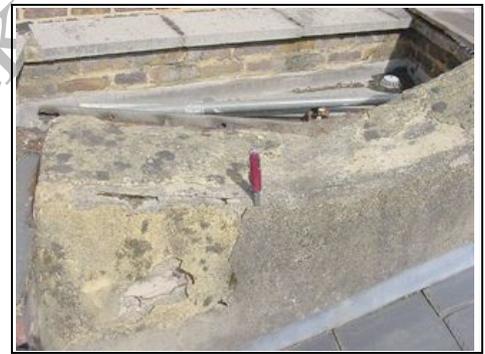
Parapet walls surround the roof to the front, sides and rear. Where we can see the parapet walls they are deteriorating and the render is coming away. In many areas they have simply been felted over, we assume to make them watertight and prevent rainwater getting in.

Deteriorating render

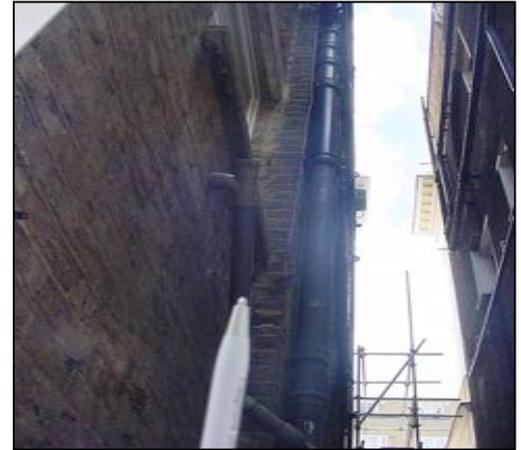
We can see there has been some cracking and movement in the left hand gable. This generally occurs where the gable ends are not bonded in to the main structure of the building.

Cracking to left gable wall

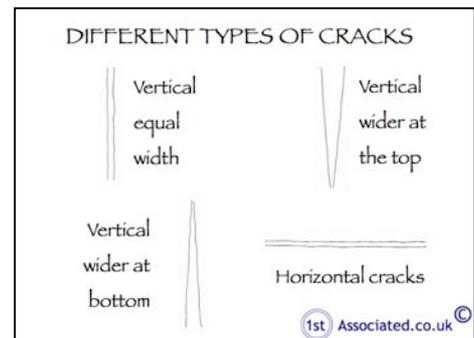
Cracking

We would add that due to the location of the crack we cannot establish what type of crack it is from ground level.

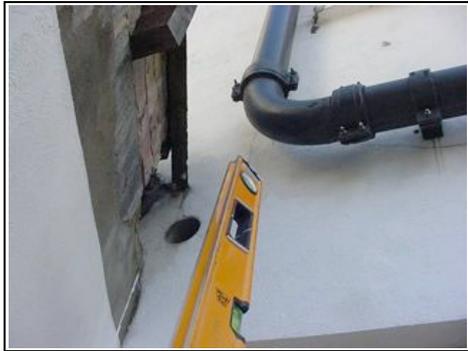
We can see vertical cracks to the render even though it has been painted over in many areas. We can also see what appears to be dampness getting into the kitchen of one of the apartments, this requires further investigation on the left gable rear.

Vertical cracking to rear of the property

**ACTION REQUIRED:** It is generally recommended to monitor any cracks for a year. Obviously within the short time scale that you have available to you this is not possible but we would be happy to discuss this further with regards to the risk of this matter.

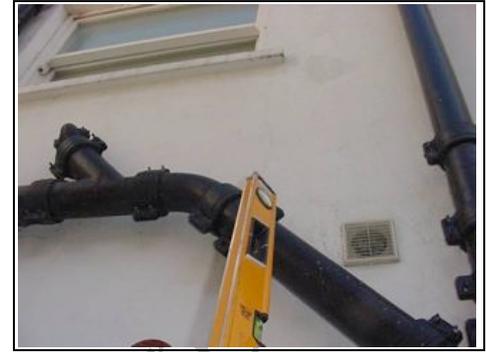
More vertical cracking to rear of property

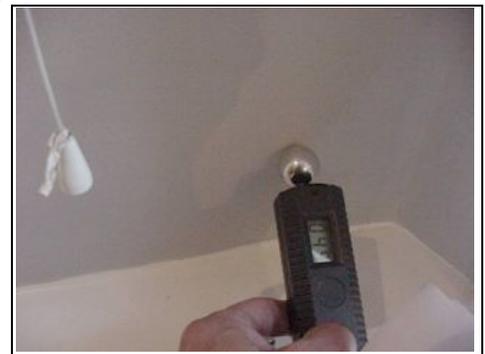
We found the damp readings to the lower ground floor to be over and above what we would expect in this standard of property.

Dampness readings

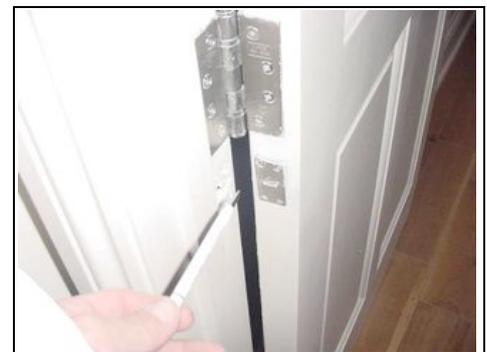
Some of the door closers are missing to the fire doors within the property.

Door closer missing

**ACTION REQUIRED:** Full check on Fire Safety of the building is required. We have not carried out any tests in relation to safety measures.

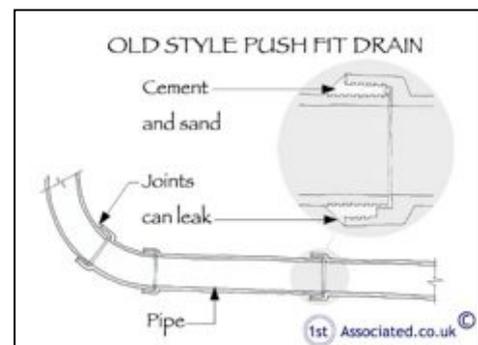
In older properties, such as this, drainage was often push fitted together rather than bonded together which means that they may leak over the years. Whilst we ran the tap for 15 minutes without any build up or blockages the only way to be 100% certain of the condition of the drains is to have a closed circuit TV camera report.

Push fit drain

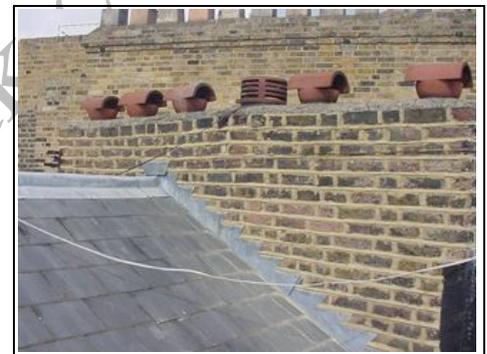
This chimney is brick finished with several chimney pots. It looked in below average condition considering its age, type and style. We could see that the chimney has been re-pointed where we could see dampness has been getting in and one chimney pot is completely missing. We also noted cracking in the flaunching.

Chimney -right

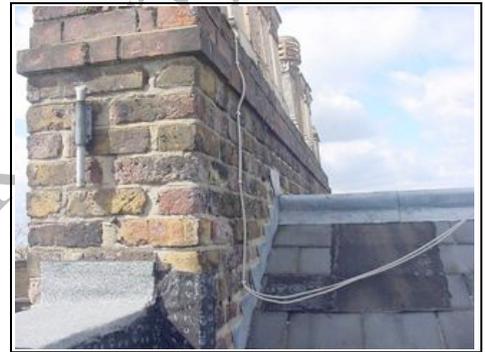
We noted that there appears to have been some patch repair work including a new flashing which may have resolved this dampness.

Patch repair and new flashing

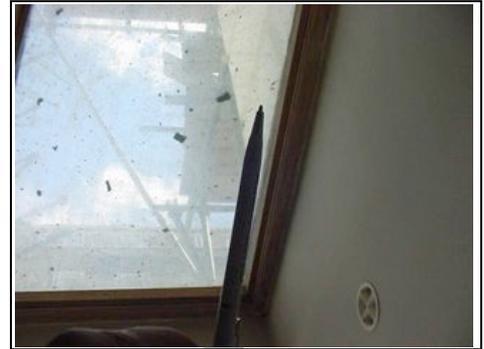
The property has a roof light to the front of the property to the lower ground floor. The glass in the window appears to be broken. We could not see the window very well because of the scaffolding surrounding it.

Roof window

**ACTION REQUIRED:** Repair roof window and consider adding security in the form of bars or video camera system.

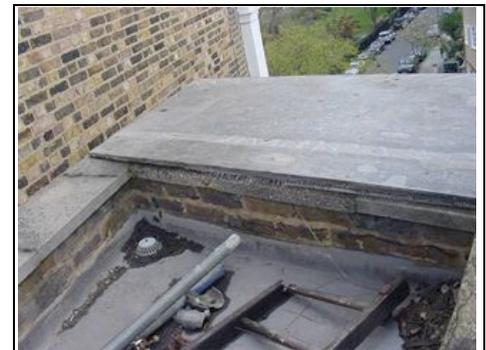
The flat Asphalt roof to the rear looks to have been patched and repaired. We could also see areas of ponding to the roof.

Flat roof -right

**ACTION REQUIRED:** Ad hoc repairs to both flat roofs

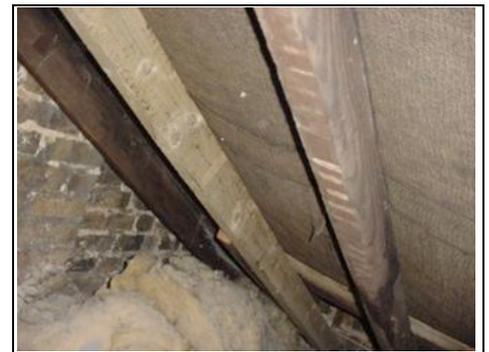
Replacement timber – right hand timbers

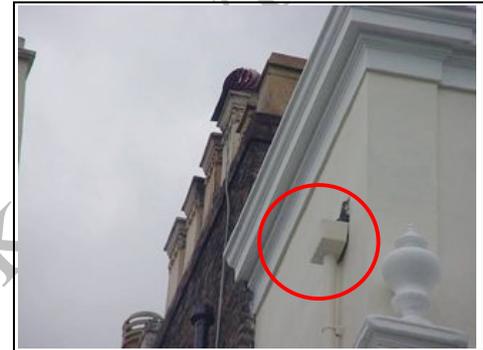
Unfortunately in this case the property has been recently painted and as such this hides any rainwater pattern staining but from what we could see the hopper heads are modern plastic hopper heads and tend to be smaller than the original hopper heads and can overflow.

Hopper head

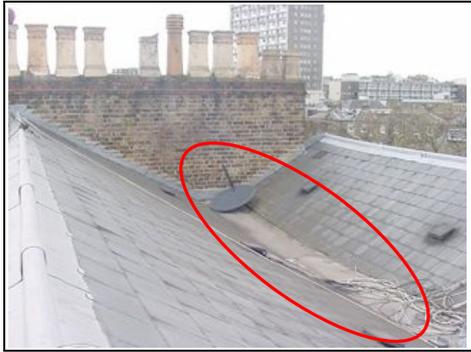
The junction between the valley gutter and the roof is important and this appears to be letting water in.

Valley gutter

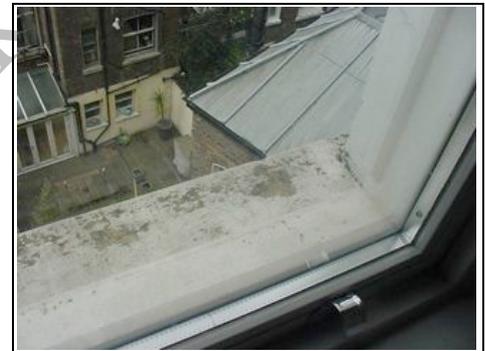
Window ledge viewed from top floor apartment needs painting

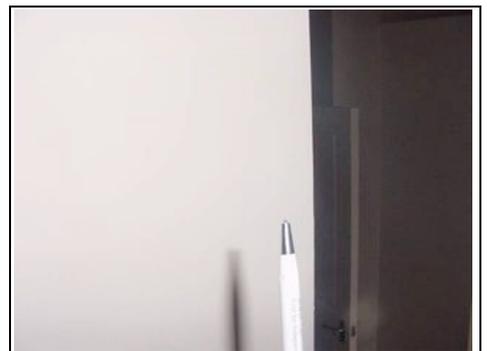
Hairline crack between bathroom and bedroom in top floor apartment – possible sign of movement to the gable end walls.

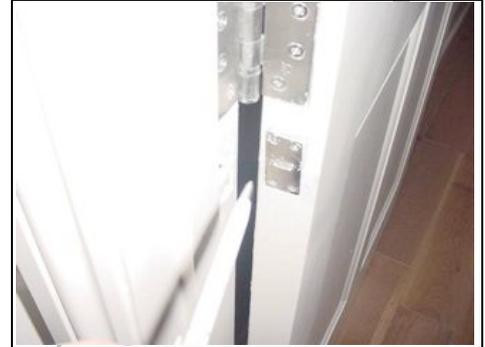
We noted that some of the fire doors did not have working door closers which we were surprised about as we were advised by the management company/selling agents that they had dealt with the management of the property. Contact details in appendices.

Door closer

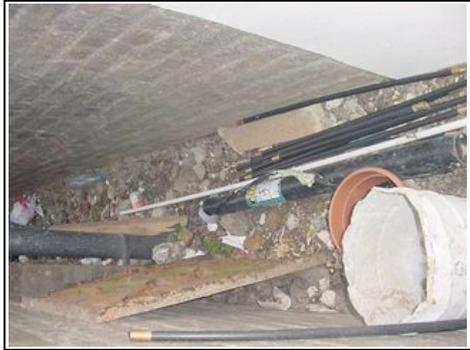
We found drain rods-  
never a good sign

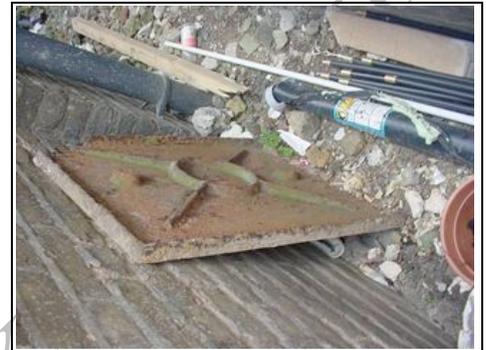
Manhole cover only – left hand side  
There may be a covered up manhole
