RESIDENTIAL BUILDING SURVEY

XXXXXXXXXXXXXX,
Wandsworth,
London,
SW18 xxx

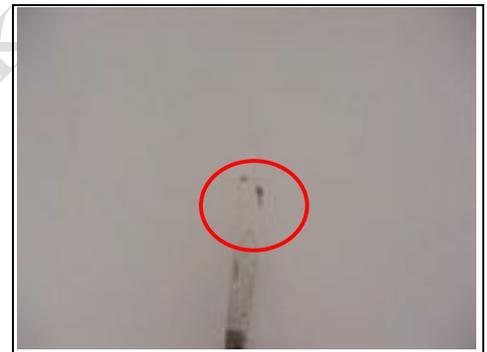
More popping centrally in the second floor bedroom

ACTION REQUIRED: We would recommend that a roof hatch is added to the roof to allow access and viewing of the roof. A decision can then be made upon the quality of the flat roof. We are more than happy to comment on this if you forward the photos to us once this work has been carried out.

ANTICIPATED COST: In the region of £250 to £500 dependent upon how difficult it is to remove the existing roof window; please obtain quotations.

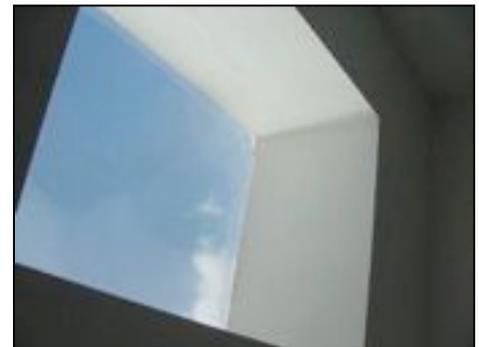
This roof window could possibly be amended to give access to the top roof

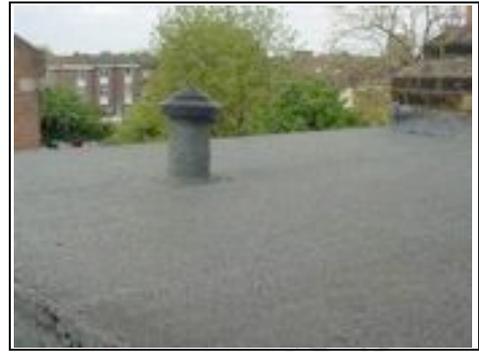
Rear flat roof

We would add that we can see the rear flat roof which although it is in average condition does look to be a very flat, flat roof. Where flat roofs do not have a fall (typically we would like to see 15 degrees) we find that they deteriorate quicker.

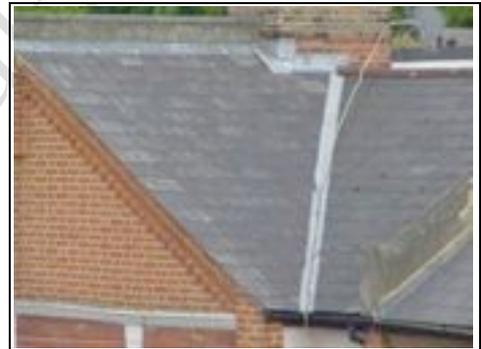
We can see that the slates are starting to deteriorate and the whiteness/greyness is starting to come through which will in due course present as a patchy coloured roof (see photo) rather than the dark grey slate roofs that are traditionally seen on this type of property. We would comment that we feel that the roof slates come from the cheaper end of the market as we rarely see discolouration like this.

Patchy roof visible to another property nearby

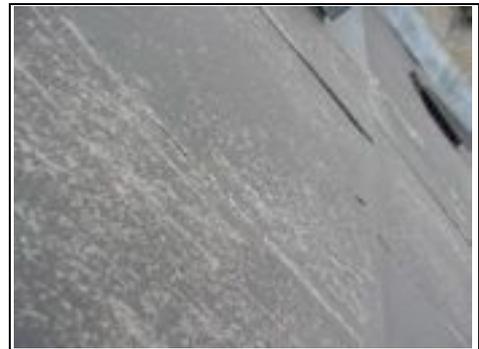
Manmade slates starting to deteriorate

Close up of deterioration on manmade slates

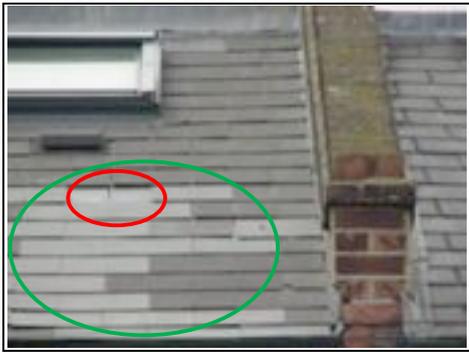
There are also missing, loose or slipped slates visible together with different coloured slates in some areas indicating a repair. We think there are likely to be some problems with this roof in years to come.

Missing slates (red)
Replacement slates (green)

ACTION REQUIRED: We would recommend that you employ a roofer for one day to overhaul the roof before the winter of 2013 to check and replace the slates as necessary.

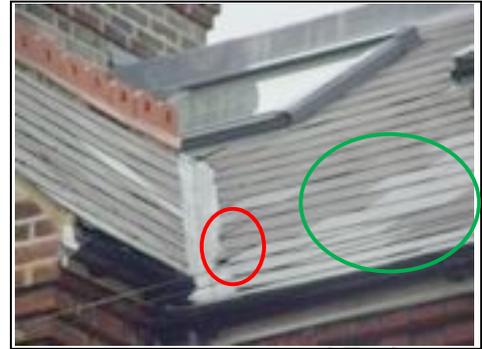
Slipped slates (red)
Replacement slates (green)

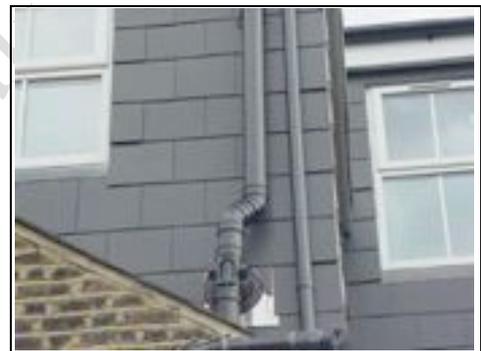
Vertical slates

We also noted vertical slates to the rear of the property to the roof extension.

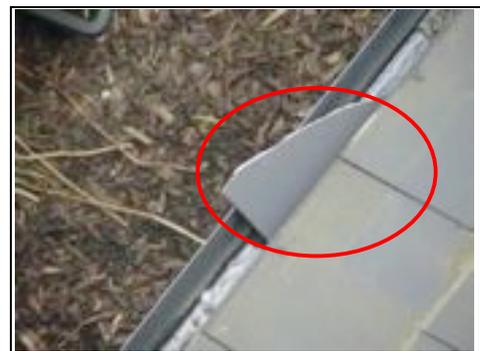
Slipped tile in gutter

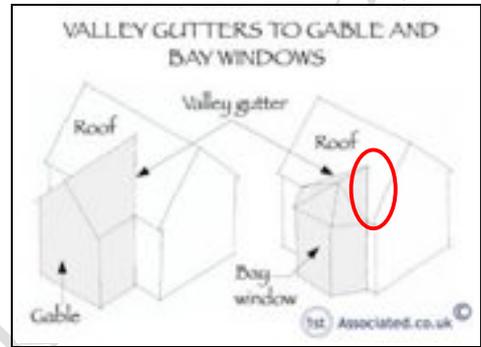
Valley gutters

To the roof we can also see that the valley gutters are deteriorating and that the left hand gutter is possibly blocked with cement mortar which has come away from the sides of the valley gutter. We can also see where there looks to have been repairs to the lead work on the valley gutter. This is all contributing to the dampness we found in the first floor bedroom.

ACTION REQUIRED: We would recommend that repairs are carried out to the valley gutter via the roof or it may need actual replacement.

ANTICIPATED COST: We have budgeted for a roofer for a day above. If this valley gutter is a problem (the others should be checked as well) we would set aside a further £250 to £1,000; please obtain quotations.

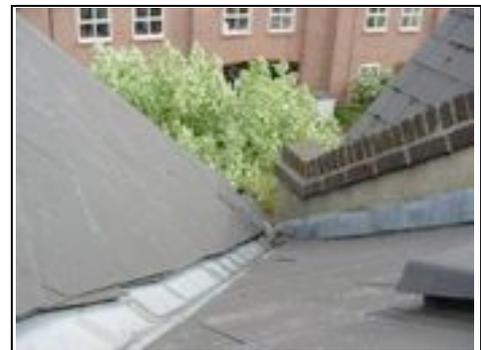
Valley gutter (front left)

We can also see that the joints have been re-masticed indicating there is a problem with the valley gutter.

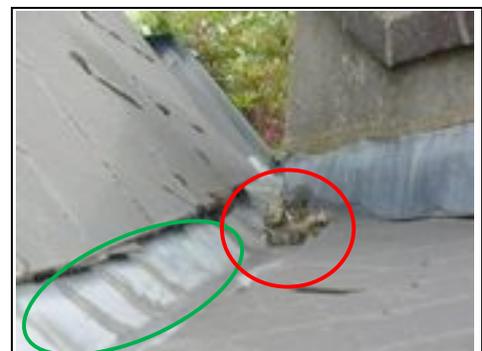
Close up showing cement mortar in the valley gutter (red)
Deterioration to valley (green)

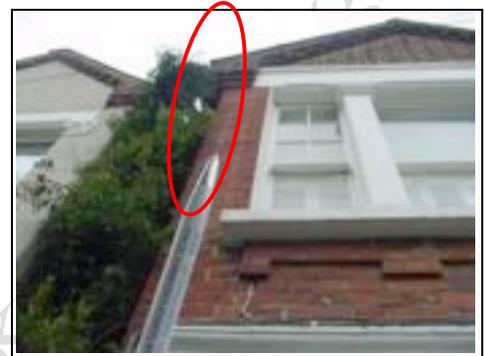
Cracking to front bay area at high level

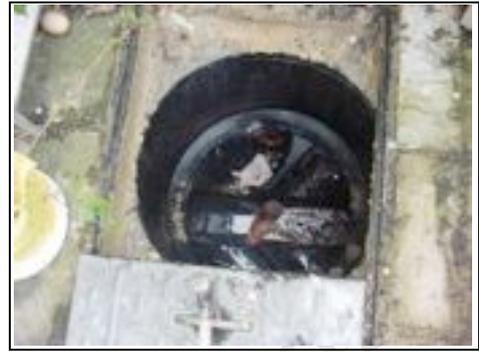
This is a fairly common problem in older properties where often a push-fit drainage system has been used and this has leaked over the years. We were advised by the owner that to the best of their knowledge the drain had been replaced either side of the house but not under the house which is fairly typical of what happens.

Manhole to the rear is not working very well

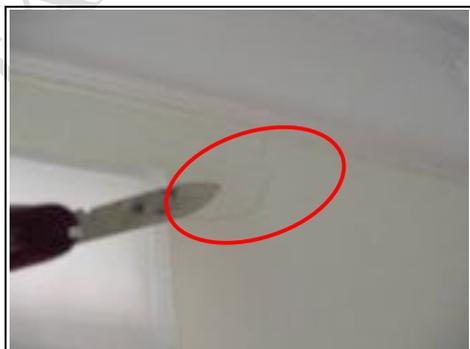
We could also see there has been movement in the structure by the way the bathroom door does not close properly and cracking to the bathroom and front bedroom on the first floor.

Cracking to the front bedroom on the first floor

ACTION REQUIRED: The only way to be one hundred per cent safe with regard to this movement, as a one off inspection cannot be conclusive, is to have it monitored. Typically monitoring takes about a year.

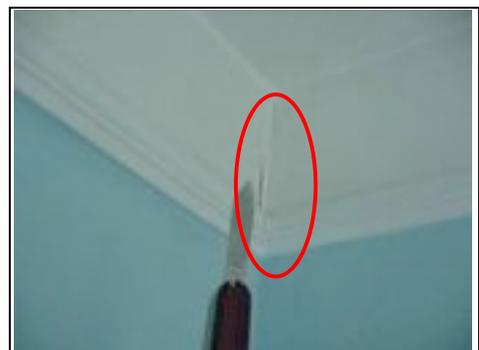
Cracking visible in the bathroom

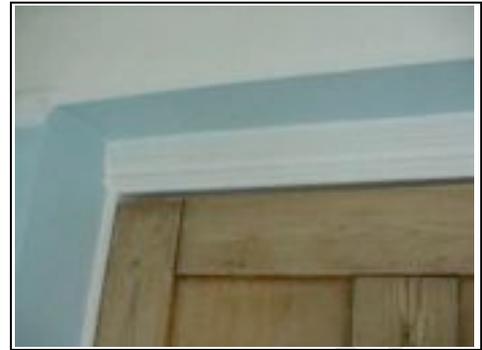
Movement visible in the door of the first floor bathroom

We would recommend that the existing owners put in place an insurance claim advising that the Surveyor noted movement in the property (this should cost them nothing other than time). You would then stay with the same insurance company and take over this insurance claim which will limit any liability to the premium costs only. Your Legal Advisor needs to confirm in writing that this is an acceptable way forward for both you and the insurance company as this would need to be one hundred per cent watertight.

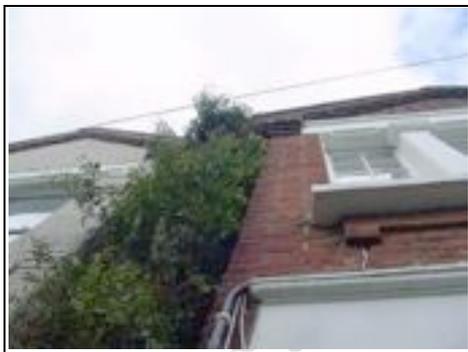
We could see that dampness is getting into the front left hand side of the property due, we believe, to the large climbing plant that is growing in the alcove/recess area. This is allowing water to sit against the wall, not allowing sunlight to get to it. This dampness also relates to the defective valley gutter above.

Climbing plant growing in the alcove between the two properties

ACTION REQUIRED: Cut back the climbing plant and/or add a trellis to keep it away from the wall. Also repair the valley gutter.

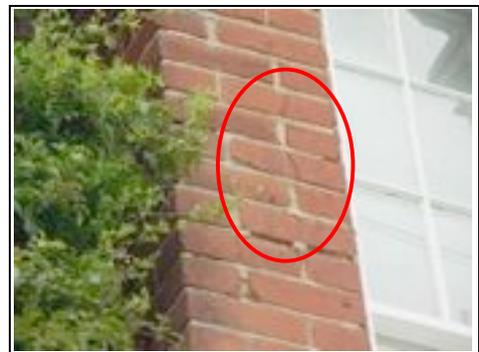
Unfortunately the cement re-pointing, whilst well meaning, is not appropriate for this type of older construction. This has been used instead of a lime based mortar. We recommend you use lime mortar in any future repairs regardless of what the builders say! Using lime mortar will limit further damage to the brickwork, which is almost impossible to repair successfully. We would add that many, if not most, of the properties that are re-pointed now are re-pointed wrongly; it is only in recent years that we have discovered the problems that can occur from it.

Deteriorating cement mortar visible in wall next to the plant

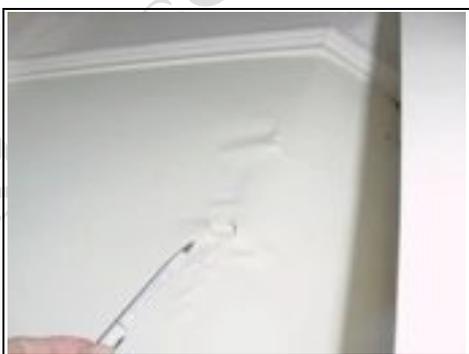
Dampness in the first floor bedroom

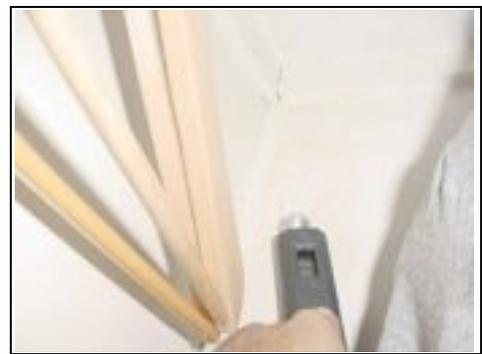
Dampness in the cupboard in the first floor bedroom

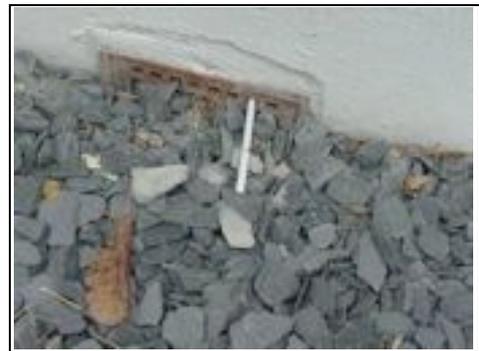
The property has a suspended timber floor. Air bricks are essential to have a through flow of air. We noted that the airbricks are acting as gutters allowing rainwater to get underneath the suspended timber floor which can cause rot and deterioration to the timbers as well as encouraging woodworm.

Air bricks to the front are too low and are acting as gutters

We recommended earlier that the entirety of the ground level is lowered, once this happens it should also reduce the problem of air bricks acting as gutters.

ACTION REQUIRED: We would recommend that a section of the floor is opened up and checked in due course. It would be ideal to carry this out prior to purchasing the property or it will have to be

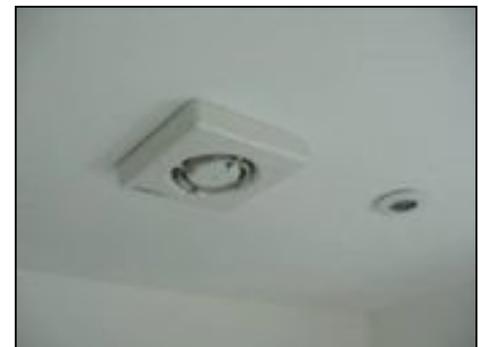
Replace small extract fan in bathroom with a large humidity controlled extract fan

ACTION REQUIRED: In our experience to date the best way to deal with this problem is to have large humidity controlled extract fans within the bathrooms, kitchens and any areas that are used for drying of clothes.

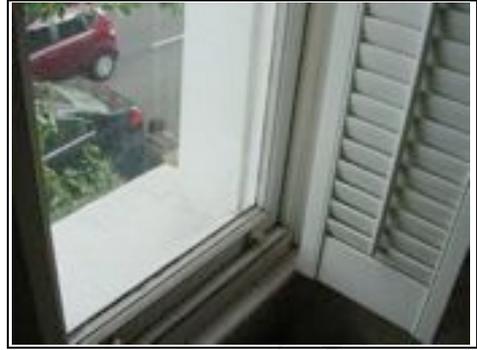
We were unable to get the sliding sash windows to open, for example, in the front bedroom. This means that you may need to ease and adjust the windows. We would add that the folding shutters that are in place throughout the property are excellent from the point of view of allowing light in and protecting privacy and also keeping heat in.

We could not open the sliding sash windows

ACTION REQUIRED: We would recommend that easing and adjustment takes place to the windows you wish to use.

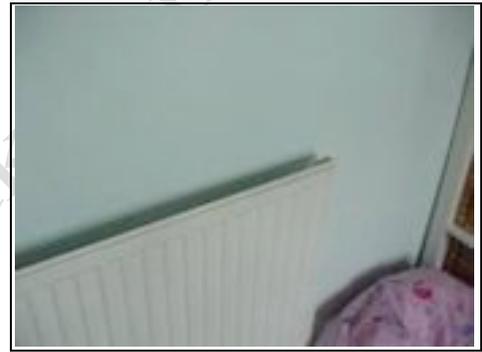
We noted the property has some single panel radiators. Single panel radiators may not warm the property as much as you would like or will struggle to reach the temperature you would like.

Single panel radiator

ACTION REQUIRED: We always recommend replacing these with double panel convection radiators.

ANTICIPATED COST: If it's as simple as replacing the radiators then a few hundred pounds per radiator; please obtain quotations.

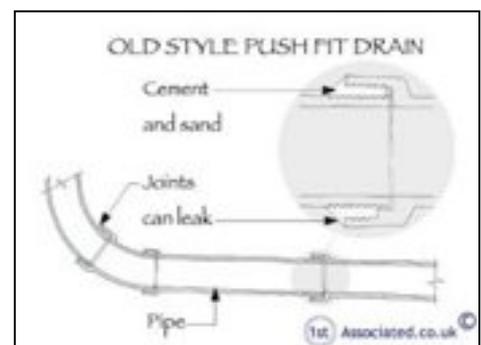
As already mentioned, in older properties such as this, drainage was often push fitted together rather than bonded together which means that they may have leaked over the years.

Push fit drain 25

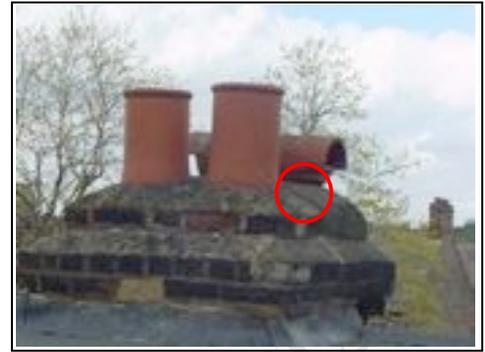
This chimney is also brick built with a lead flashing and several chimney pots. In this case we would comment that the chimney is in below average condition and that it has been poorly and inappropriately repaired for this age of property. We noted cracking to the flaunching and also that the flashing has not been finished correctly.

Chimney- rear left
Crack in flaunching

ACTION REQUIRED: Repairs to the chimney should be carried out before it allows dampness into the property.

ANTICIPATED COST: In the region of £250 to £500 to carry out repairs to the chimney; please obtain quotations.

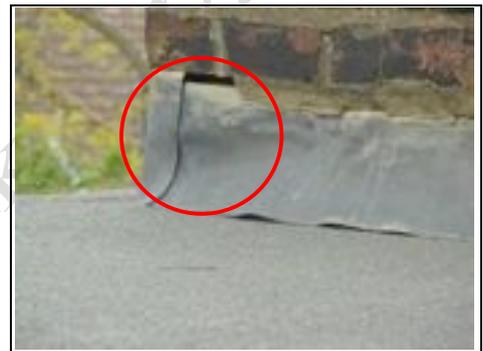
Flashing has not been
finished correctly

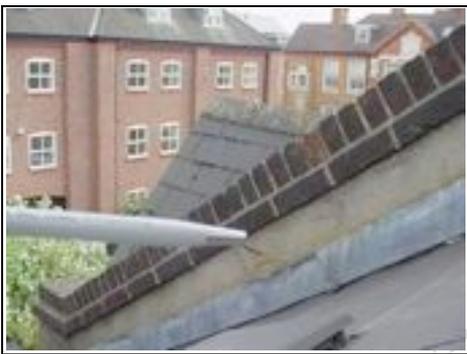
We would usually divide the left and right parapet walls and comment on them separately but in this instance our view was very limited. We can see a crack in the cement render of the parapet wall on the left hand side which may in due course allow dampness in.

Crack in parapet wall - front left

ACTION REQUIRED: When the roof work is being carried out we recommend that the parapet walls are also inspected.

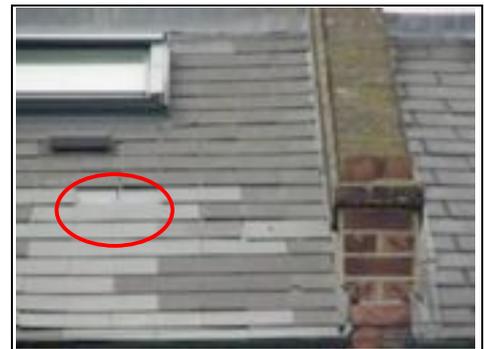
Missing slates

ACTION REQUIRED: Please see our comments within the Executive Summary.

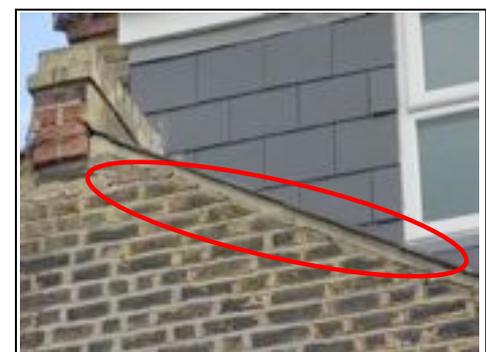
Different colours of cement mortar on rear gable

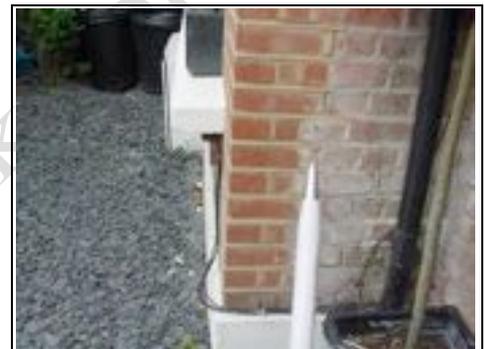
Cracks and possible re-building work

ACTION REQUIRED: Your Legal Advisor to specifically ask if any underpinning/work has been carried out to the front bay.

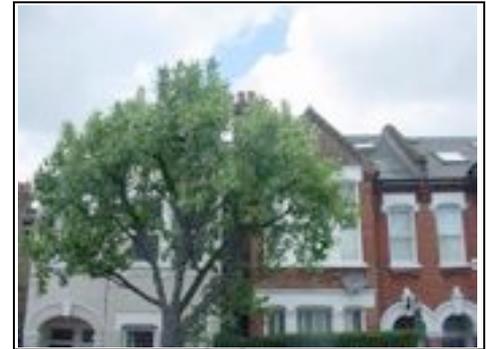
The tree is located to the front left of the property.

ACTION REQUIRED: We would recommend that you speak to the Local Authority about the tree and ensure that it is maintained advising them about the problems to the bay window.

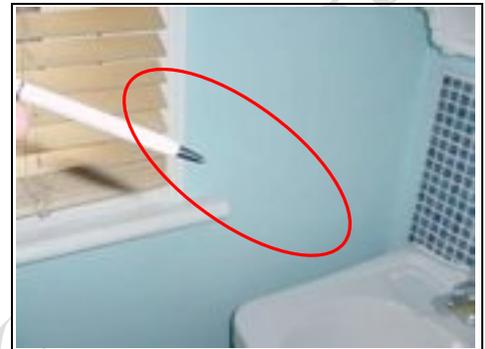
Crack in rear bathroom wall

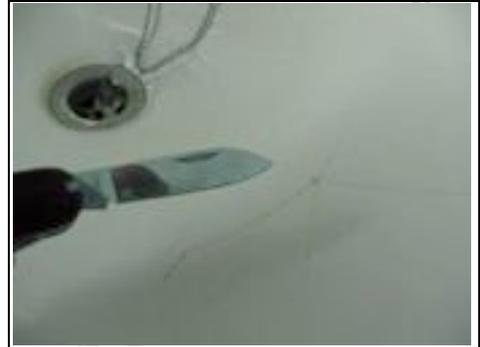
Damage to the wash hand basin

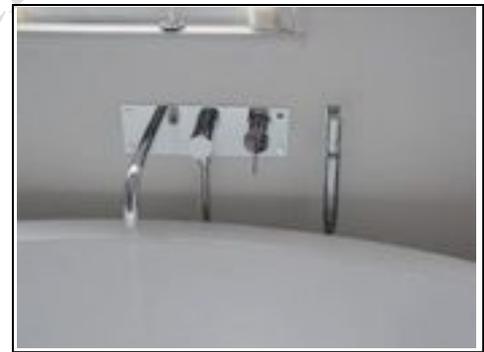
We tend to find this type of shower can leak
