RESIDENTIAL BUILDING SURVEY

London Borough of Ealing

Mr & Ms W

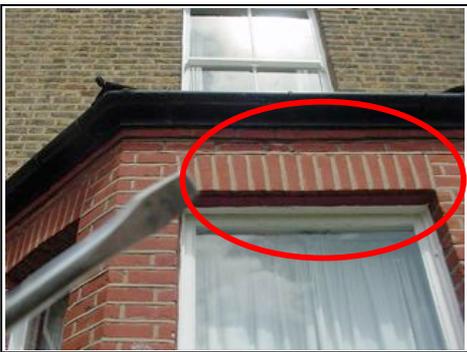
We found cracking to several areas; most notably the rear bay where we could also see a steel lintel has been added to the central window.

Metal lintel being used under central window of bay

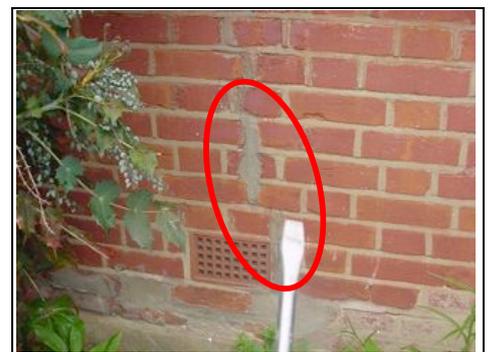
Soldier course above window has moved

Cracking to rear bay window

ACTION REQUIRED: Your solicitor needs to check and confirm if there has been underpinning carried out to any part of this property as considerable work has been carried out (relatively speaking) to the bay. Bay windows such as this often do

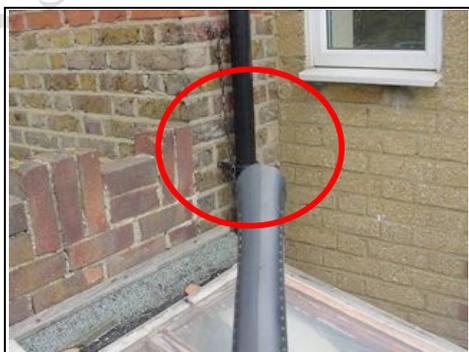
The other main area we could see cracking is to the rear two storey extension.

Crack between original building and rear bay

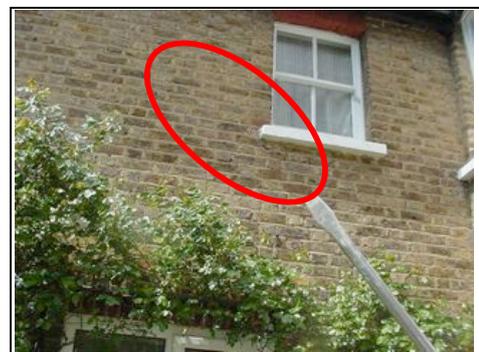
Raking crack to wall indicating that the main building and the rear building are moving separately

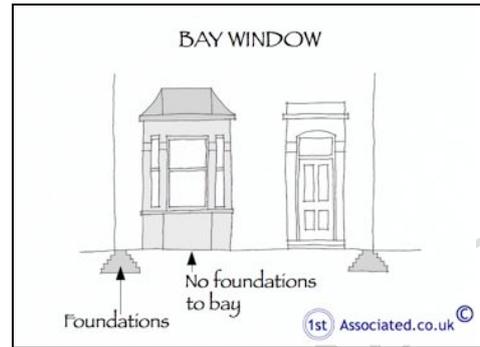
No foundations to bay window

move as there was no or limited foundations under the bays and it is a fairly common thing to see however the jury is still out as to the best way to resolve the problem. We are aware that many insurance companies put foundations underneath bay windows but this in turn we have come across problems with where the extra weight has caused further movement. We feel the best course of action is probably to monitor the bay. The Building Research Establishment (known as the BRE) recommend a year. Existing owner to place an insurance claim which you then take over using the same insurance company which would limit your risk to any premium. Your legal advisor to check and confirm this liability is legally transferred.

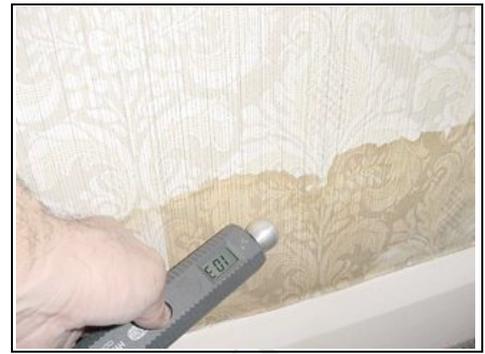
We found dampness internally. We can see that over the years they have tried to resolve the problem by injecting a damp proof course into the property. We don't feel this type of liquid injected damp proof course works on this type of older property. We feel the problem is likely to relate more to the cement mortar that is being used and the higher ground levels.

High damp meter readings on right hand side of property

ACTION REQUIRED: Reduce ground levels and use a soft brush to brush away the cement mortar and replace with a lime based mortar to allow the walls to breathe. The problem with the high ground is particularly to the rear of the property.

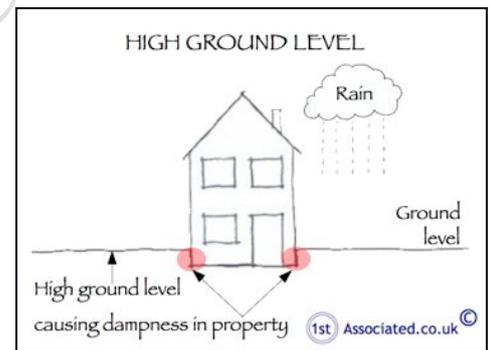
High ground level

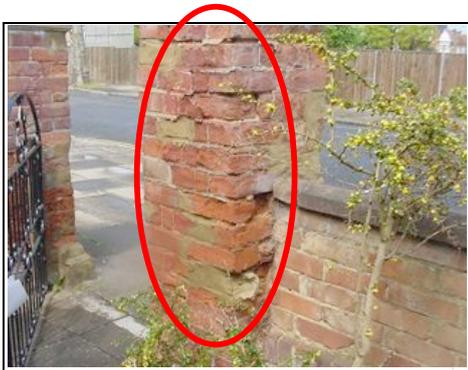
With older properties such as these you need to allow the property to breathe and as such the cement mortar stops this from happening.

Boundary wall in poor condition, repaired with cement

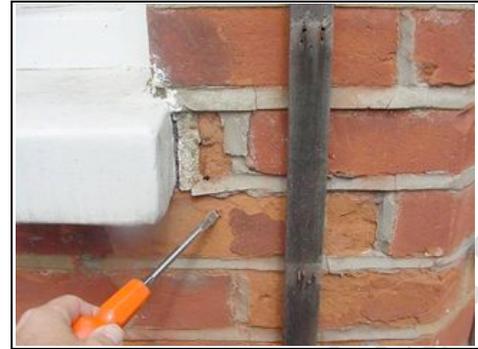
Spalling to brickwork caused by cement mortar

The use of cement mortar causes deterioration to brickwork and does lead to the face of the bricks deteriorating, which in turn leads to dampness. This is a very important point.

ACTION REQUIRED: We would recommend that a time served older bricklayer is employed to gradually repoint your apartment and the property as a whole in a lime mortar which will allow the building to breathe.

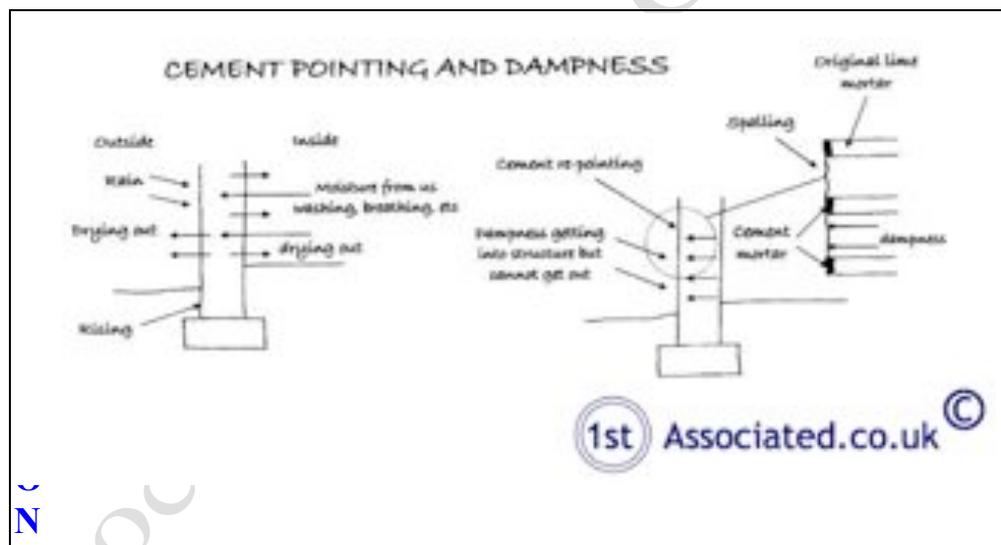
Cement pointing and dampness

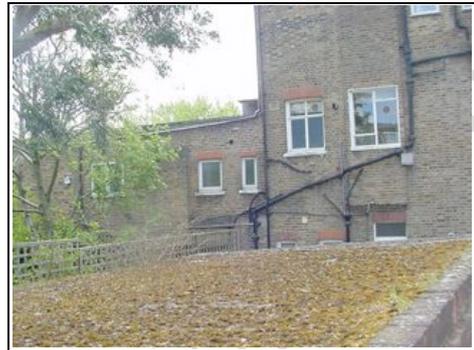
An asbestos roof was found to the garage block, including your garage, which is starting to deteriorate.

Deterioration to all the asbestos garage roofs

ACTION REQUIRED: We would recommend that your solicitor talks to the landlord/management company to see if they have an asbestos report and if they have a plan already in place and if they have a sinking fund/planned maintenance budget for this type of work.

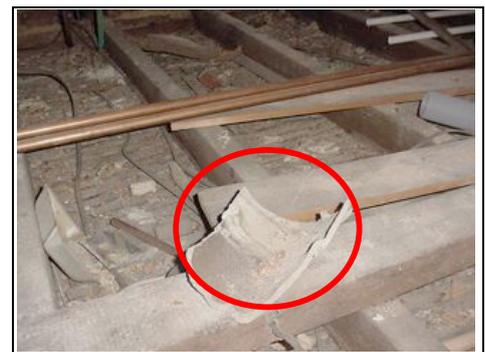
We also noted an old section of an asbestos pipe had been left in the ceiling above the kitchen which indicates to us that other asbestos may be elsewhere within the property.

Asbestos in kitchen roof

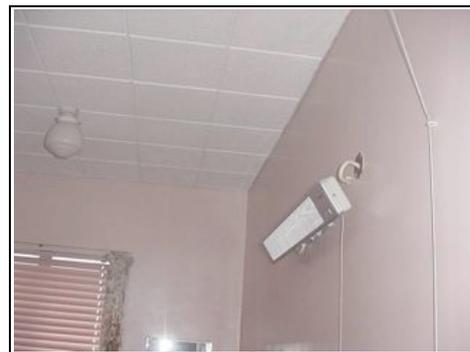
There are ceiling tiles in several of the rooms including the kitchen and the toilet which need to be removed as generally they are considered a fire hazard.

Bathroom tiled ceiling

ACTION REQUIRED: Remove tiles and repair ceilings as appropriate.

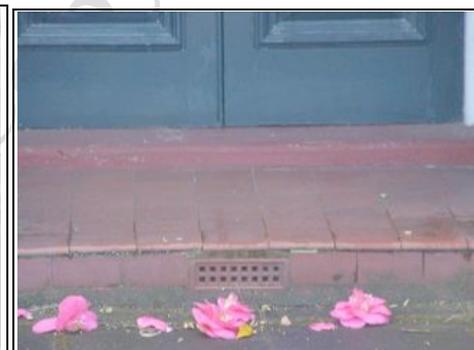
Airbrick acting as gutter at front door

ACTION REQUIRED: This needs to be amended as soon as possible to stop the rainwater getting in and in addition to this you need to open up a section of the floor and check the condition of the timbers particularly around the perimeter of the building/the bay window areas.

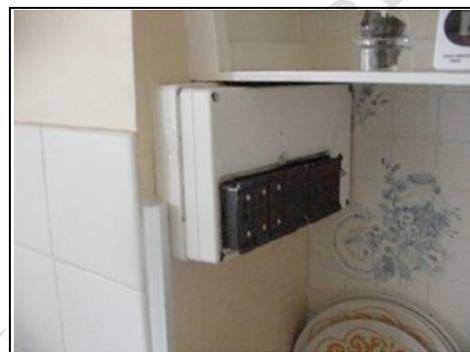
Dated fuse board

ACTION REQUIRED: Replace with a new fuse board. The Institute of Electrical Engineers standards (IEE) recommend a test and report whenever a property changes occupancy. This should be carried out by an NICEIC registered and approved electrical contractor or equivalent.

ANTICIPATED COST: In the region of £300 - £600 for a new fuse board; please obtain quotations.

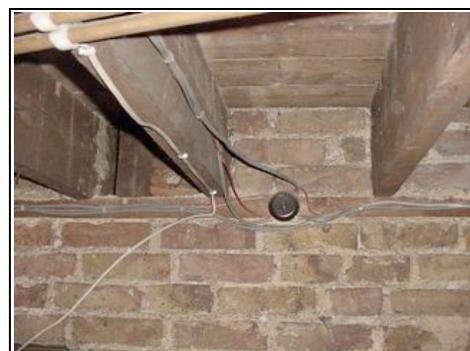
Ultimately a complete re-wire is needed. We also noted older dated wiring and socket points which need to be upgraded. You predominantly have single socket points throughout the property.

Dated electrics

ACTION REQUIRED: The initial step is to replace the fuse board to make the circuit as safe as possible subject to the electrician agreeing. We would then suggest that a re-wire is carried out replacing single sockets with double sockets and locating them where you wish them to be. It is best to redecorate after this work.

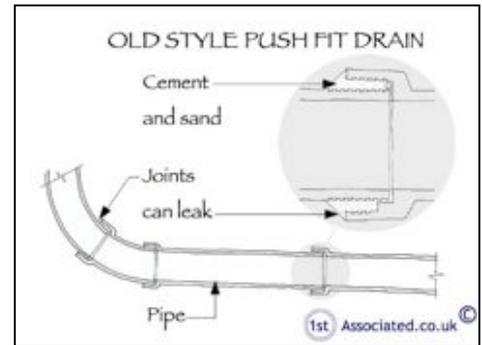
In older properties, such as this, drainage was often push fitted together rather than bonded together which means that they may leak over the years. Whilst we ran the tap for 15 minutes without any build up or blockages the only way to be 100% certain of the condition of the drains is to have a closed circuit TV camera report.

Push fit drain

ACTION REQUIRED: Again, as part of a sinking fund/ planned maintenance we would expect a close circuit TV camera report of the building to establish condition and future work.

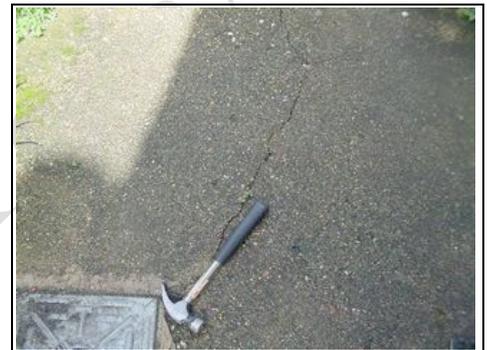
We noted some cracks in the footpath indicating there may be some minor leaks in the push fit drainage.

Crack

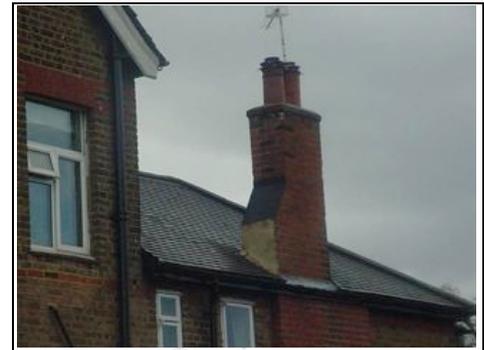
Chimney two

This is a substantial red brick chimney with two chimney pots and a lead flashing. We can see some cement mortar to the side. This type of detail normally gets dampness in it however as we haven't viewed the top floor flat we cannot comment.

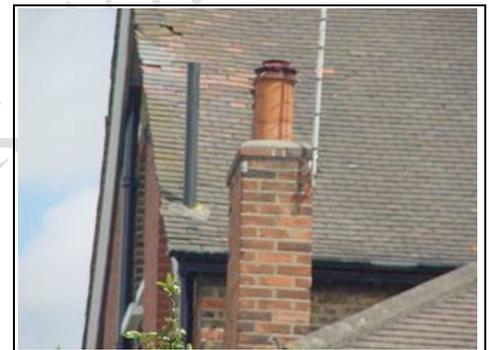
We noted that there are aerials on this chimney which can cause damage and cut into it like a cheese wire into cheese. Our main concern is that this chimney is built in a softer red brick which can deteriorate and the weathered pointing. Again a sinking fund/planned maintenance fund should have comments and views with regards to how soon this type of work needs doing.

Aerial to chimney

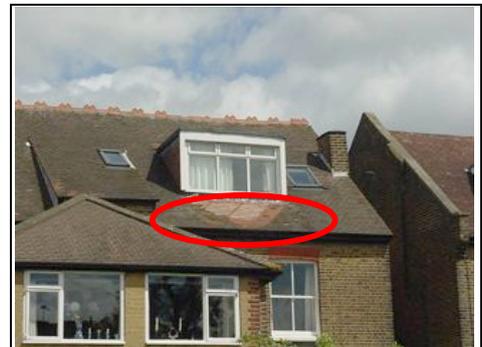
Tiles replaced to base of rear dormer

With regards to the rear dormer window we noticed a lot of tiles have been replaced underneath it which indicates there has been a problem.

ACTION REQUIRED: Your legal advisor to specifically request further information with regard to sinking fund/planned maintenance, whether the dormers are included and what the repair works relate to with regard to the tiling.

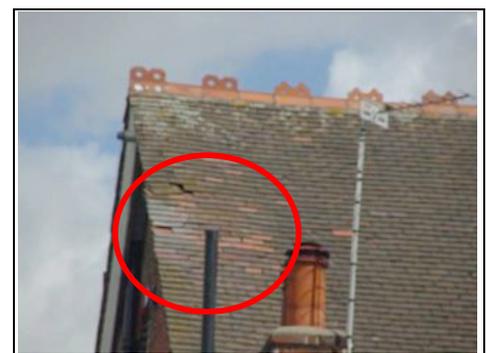
Perimeter tiles that are missing are often caught by the wind and lifted

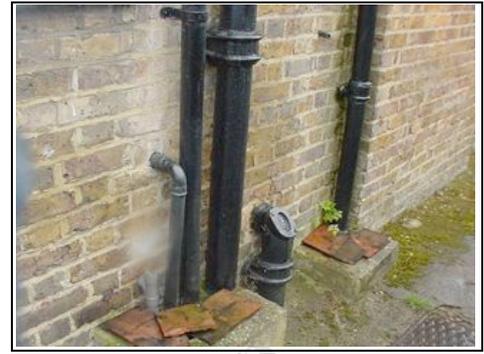
The property has cast iron soil and vent pipes. We would comment that it needs a grill where it goes into the property. Cast iron of this age will need maintenance.

Soil and vent pipe

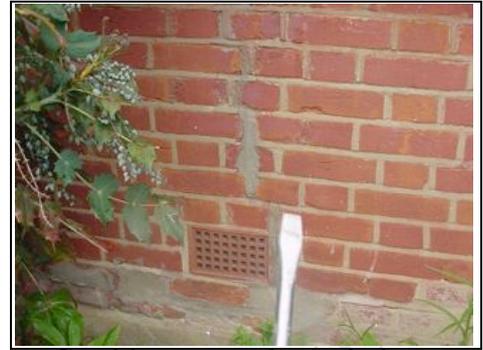
Cracking to rear bay window

ACTION REQUIRED: Please see our comments in the Executive Summary.

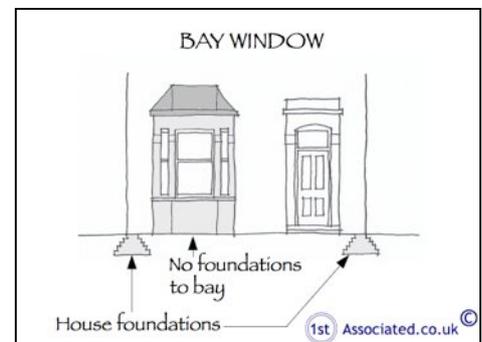
Bay windows in this era of property typically do not have foundations underneath them and have been subject to movement. We are aware that some insurance companies underpin bay windows with a modern foundation. We think this is excessive and unnecessary.

No foundations to bay window

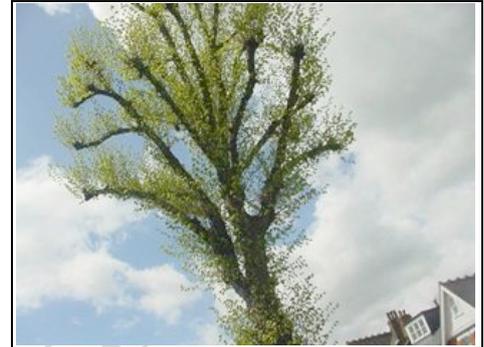
There is a tree which presumably is a local authority tree (your legal advisor to confirm) which may affect the boundary wall and also the house given the height of it. The local authority should maintain this tree, it may be worth having a chat with them prior to purchasing the property; it is certainly within influencing distance of the wall.

Tree contributing to pushing wall

ACTION REQUIRED: Your legal advisor to check and confirm with regards to the tree. Trim back the plants so the condition of the wall can be seen properly. We would be happy to return and comment further or you could send us photographs.

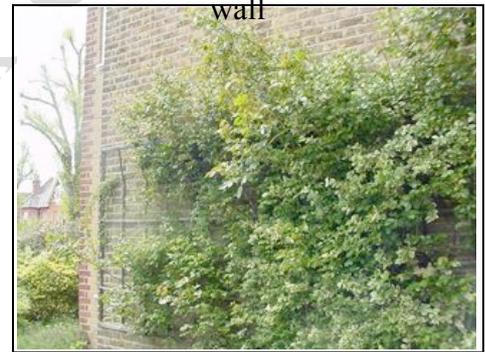
In addition there are plants growing on the garden wall which need maintenance. We have found that where plants grow on the wall such as this, even with trellis work, it can lead to dampness in the property due to the water sitting on the plant and there being no air circulation and no sun getting to the wall.

Plant growing on wall which needs maintaining

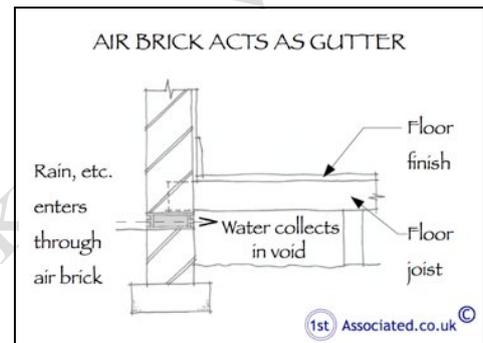
Airbrick acting as gutters

ACTION REQUIRED: Please see our comments in the Executive Summary.

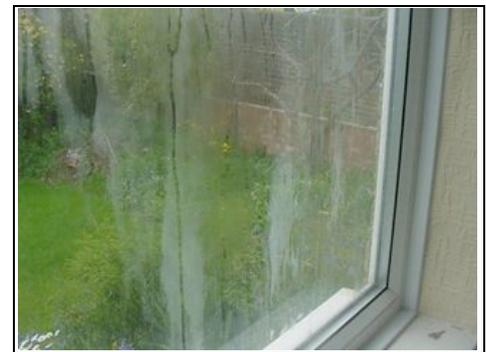
There are double glazed windows in some areas of the property. We noted misted up windows to the rear which we personally would recommend are replaced. From a chartered surveyors point of view it can also mean there is some minor movement in the rear part of the property if the seals are broken.

Misted window to rear bay in lounge

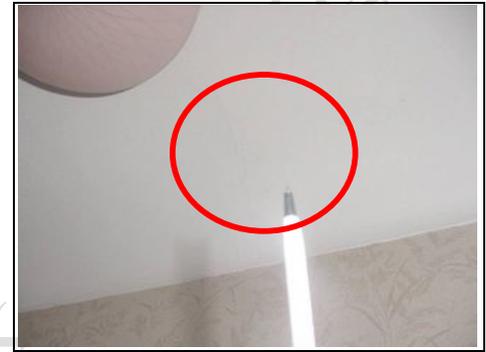
Hairline crack to lath and plaster in hallway

ACTION REQUIRED: Please see our comments in the Executive Summary.

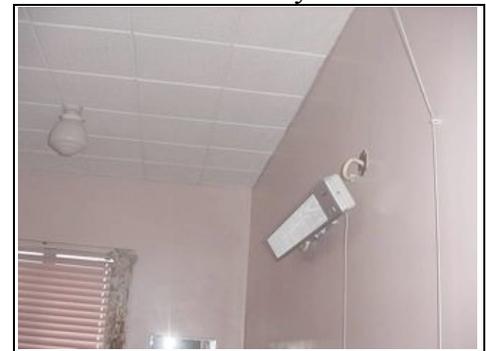
Tiles in bathroom ceiling that need removing

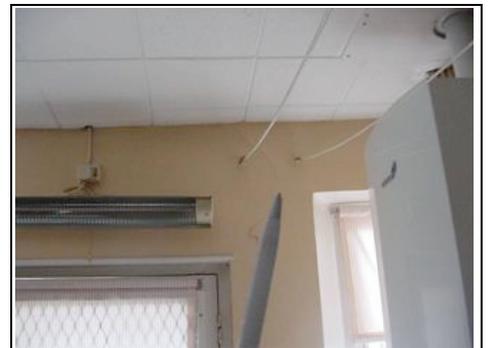
Crack in kitchen wall

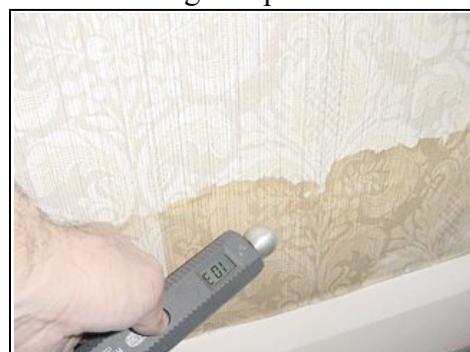
High damp meter readings on right hand side of property

ACTION REQUIRED: Please see the Executive Summary.

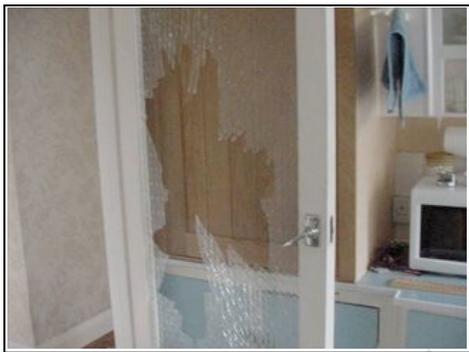
Some of the doors are glazed and some of them are not. As you are aware the wind caught the glass door and smashed it which should be resolved by the time you read this report. As I mentioned on the phone message we removed all the glass from the door completely.

How the door initially cracked

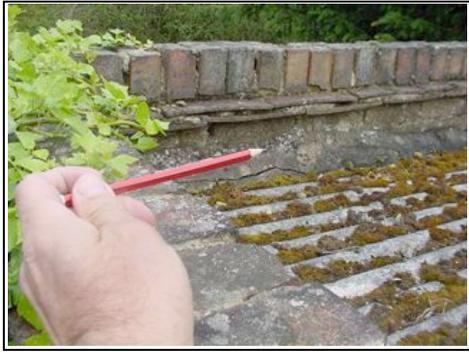
Cracking to the cement flashing surrounding asbestos

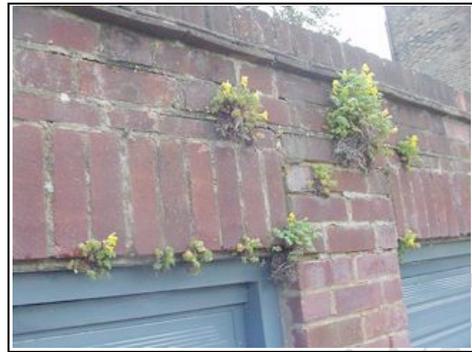
Plants growing from garage wall
