JOB REFERENCE: JXXXX

RESIDENTIAL BUILDING SURVEY

XXX
London.
E11 XXX

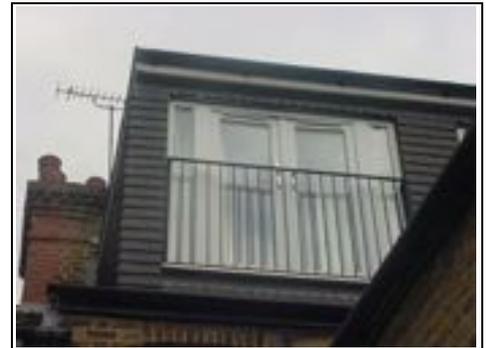
Hidden flat roof

ACTION REQUIRED: We recommend a roof light is added to give access to view this roof. If a roof access is added we would be more than happy to return and inspect.

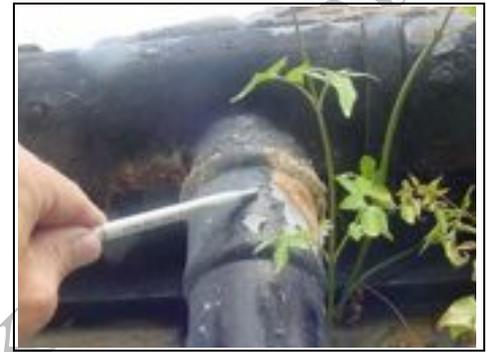
Metal gutter and downpipe to rear deteriorating

ACTION REQUIRED: General repairs recommended and perhaps replacement of the gutters and downpipes.

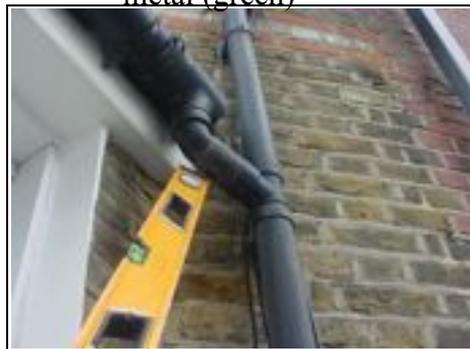
Leaking downpipe to front

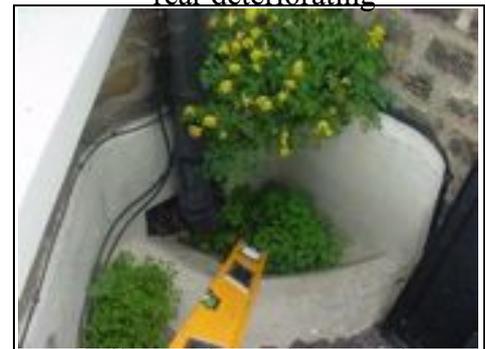
Gulley to downpipes needs clearing

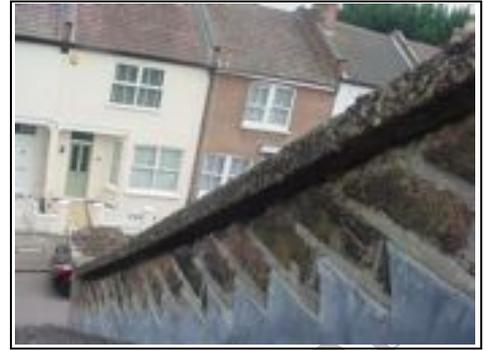
The parapet wall to the front left hand side we can see that the coping stones have not been bedded and that mortar has been missed in some areas.

Parapet wall has mortar missing

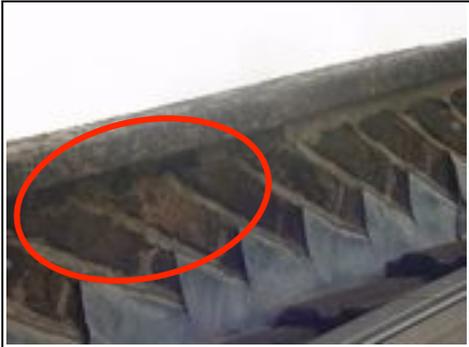
Mortar missing under coping stones

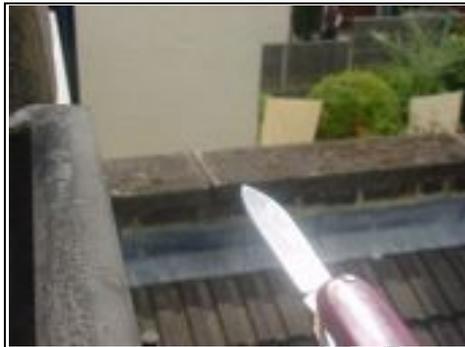
Mortar missing between coping stones

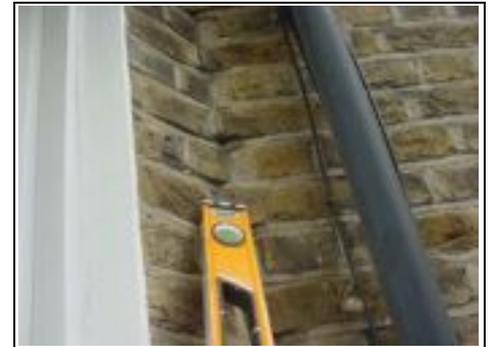
This, together with the unusual joint on the front bay window leads us to believe there may have been considerable rebuilding carried out on this property.

Unusual joint to front canted bay

ACTION REQUIRED: Your legal advisor to specifically, in writing, ask the existing owners are they aware of any building work to the property. We would also recommend that you speak to insurance companies to check and confirm whether there have been any issues with this building.

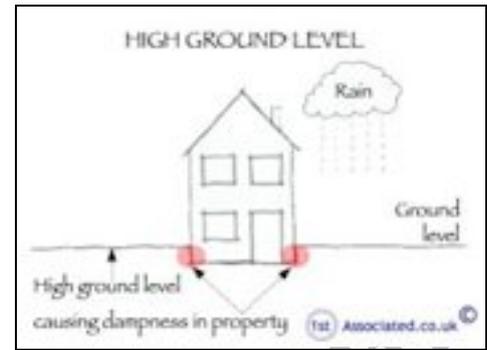
We were surprised that the property did not have rising damp due to the high ground levels which may be because of the dry weather, but we would also recommend the lowering of the ground level around the property.

ACTION REQUIRED: Lower ground level and add French drain.

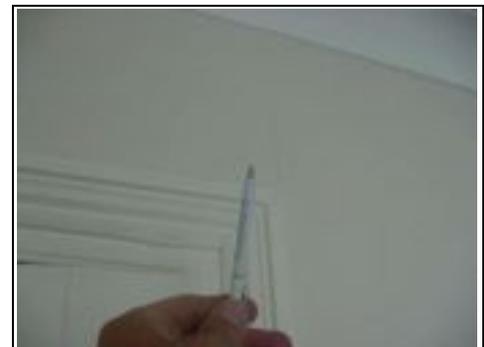
We did note some hairline cracks around the doors. Where an extension like this has taken place we would advise there will be some initial settlement for many years. Also see

Hairline cracking in the loft
bedroom around door

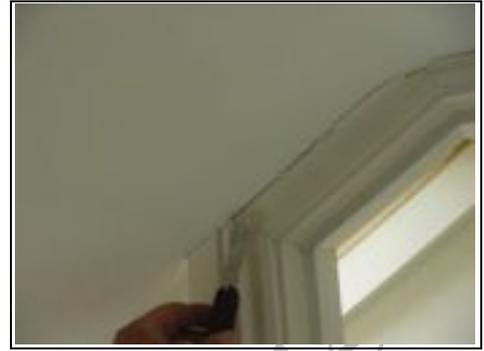
Often where new and old are added and built together there can be some differential movement. This is caused by the different characteristics of the material.

Differential movement

ACTION REQUIRED: You will need to fill, possibly tape any openings up and redecorate. In our experience although this is meant to eventually stop, we have found that it keeps re-occurring.

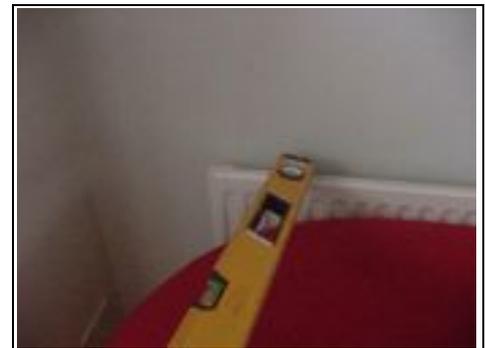
We noted the radiators are internal in some areas. This is often carried out on cheaper central heating systems to save the labour and piping costs of taking the radiators underneath the windows. However, it then reduces the air movement in the room.

In addition we noted that there are a fair number of single panel radiators. These may not warm the property to the heat that you desire. In most modern installations double panel radiators are used and often double panel convection radiators, which are more efficient, are utilised.

Single panel internal radiators

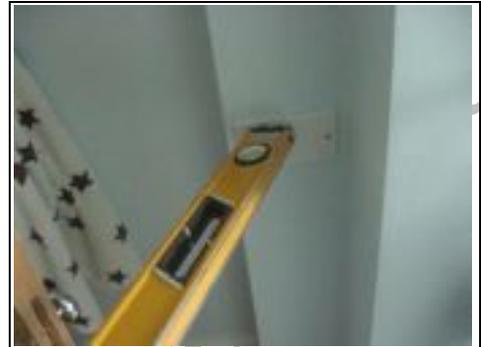
Blanked off socket plate within bathroom

ACTION REQUIRED: We would recommend you have an Institute of Electrical Engineers test and report carried out by an NICEIC approved electrician or equivalent.

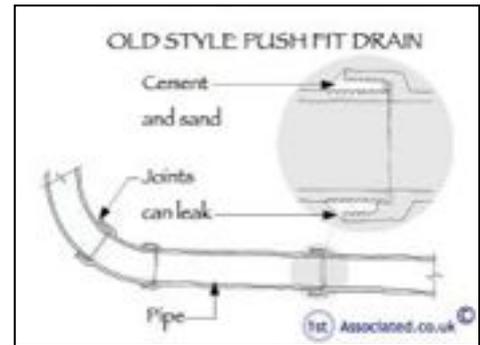
In older properties, such as this, drainage was often push fitted together rather than bonded together which means that they may leak over the years. Whilst we ran the tap for 15 minutes without any build up or blockages the only way to be 100% certain of the condition of the drains is to have a closed circuit TV camera report.

Push fit drain

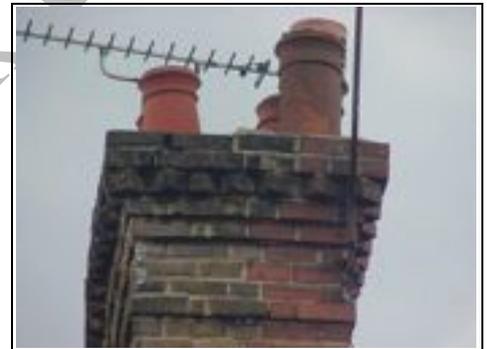
This chimney is brick finished with a lead flashing and four chimney pots. From what we could see from ground level it looked in slightly below average condition considering its age, type and style with deteriorating chimney pots.

Chimney pot deteriorating which can lead to dampness getting into the property

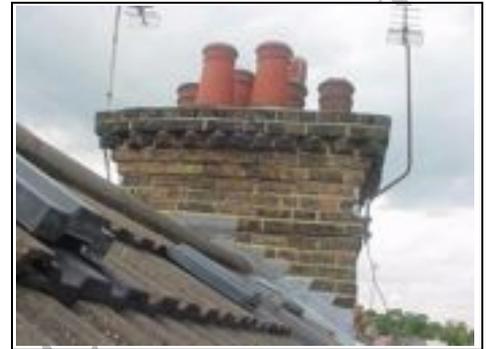
This chimney is also brick built with a lead flashing. This chimney is in below average condition and in need of repointing.

Rear chimney

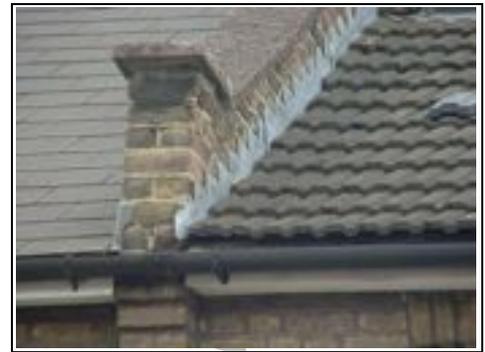
In this case there are parapet walls to the front left built from brick with a coping stone of concrete. We can comment that generally they are in below average condition with areas of missing mortar.

Left parapet wall

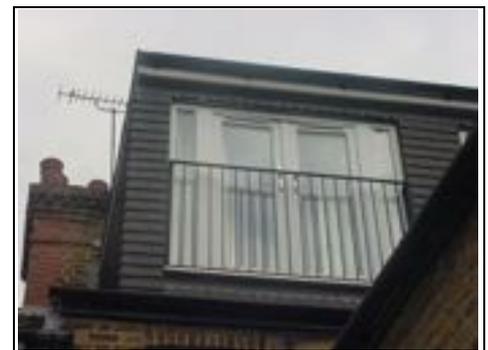
It was not possible to view the flat roof to the dormer; access hatch recommended. This roof should have been to the latest building regulations.

Hidden flat roof to dormer

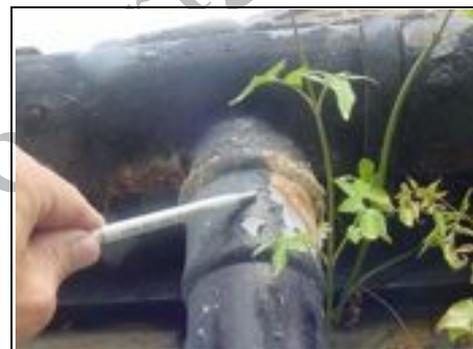
Metal gutter and downpipe to rear deteriorating

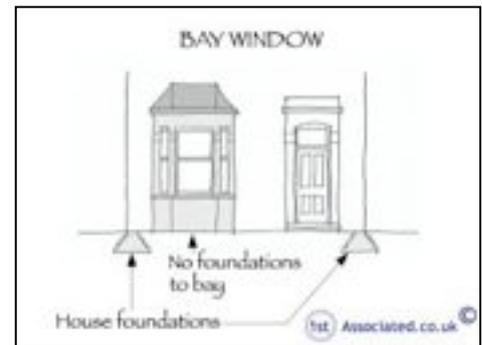
Bay windows in this era of property typically do not have foundations underneath them and have been subject to movement. We are aware that some insurance companies underpin bay windows with a modern foundation. We think this is often excessive and unnecessary and would be happy to comment further on this if you ever find yourself in this situation.

No foundations to bay window

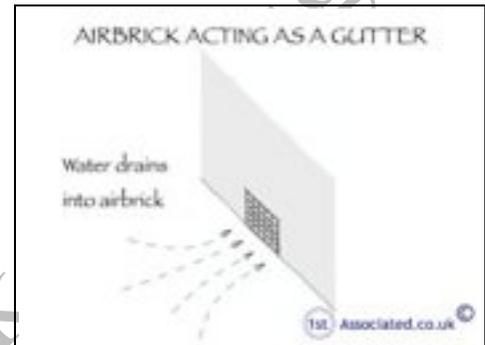
Air bricks are essential to have a through flow of air as this helps to reduce the chances of wet rot, dry rot and woodworm. In this case the airbricks are acting as gutters.

Airbrick acts as gutter

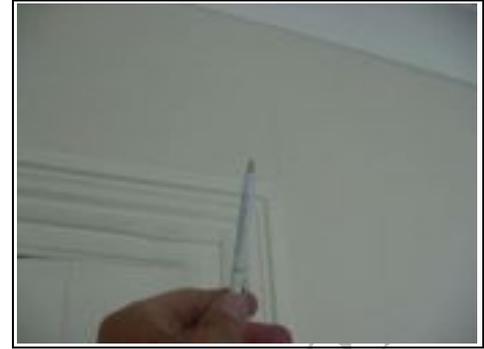
Hairline cracking in master bedroom around door

ACTION REQUIRED: Please see our comments in the Executive Summary.

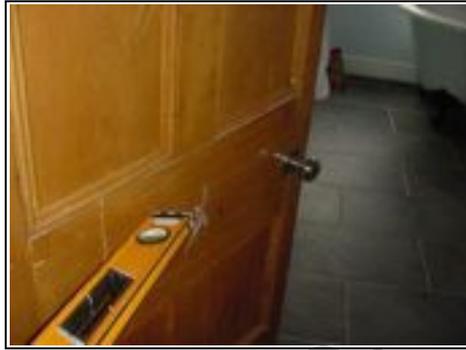
The property has a mixture of panel doors some of which are painted or stained and newer modern pressed doors. There is damage to some of the doors.

Damage to doors

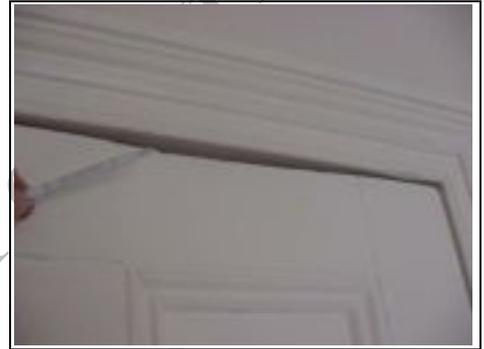
Damage to door

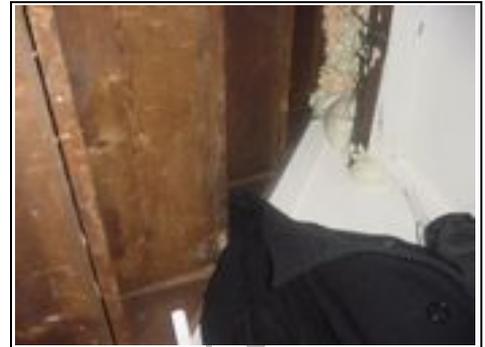
Stairs not lined under staircase to top end

ACTION REQUIRED: We would recommend the staircase is lined at the top. Please see our comments in the Executive Summary.

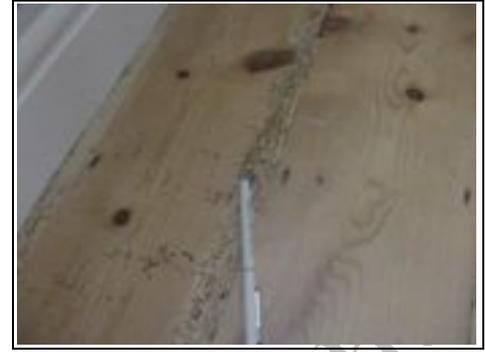
There are perfect conditions for woodworm under the floor with the current airbricks acting as gutters.

Old woodworm to floor

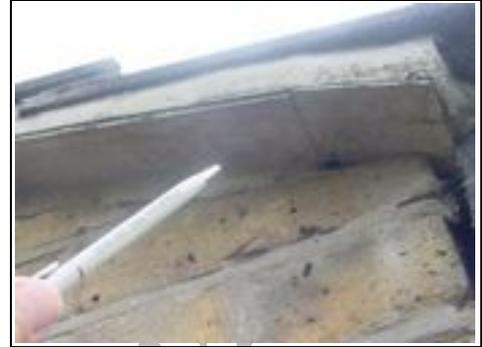
Possible asbestos

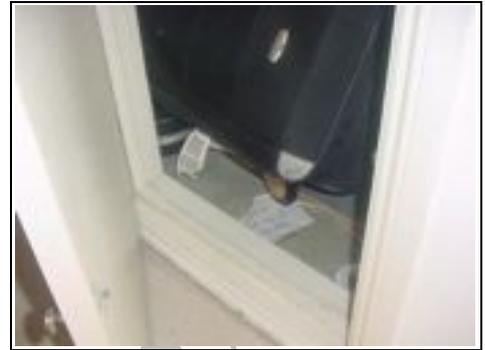
Roof space full of stored items
