RESIDENTIAL BUILDING SURVEY

London Borough of Camden

NW6

**Victorian
Apartment**

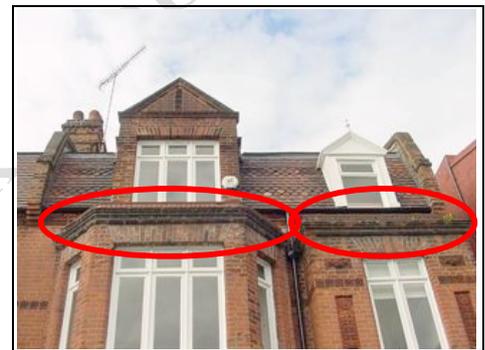
You have two flat roofs to the front bay windows. Whilst we can't see any obvious visual signs of dampness getting in, we would add that the property does look to have been recently decorated, you do need to know the condition of these flat roofs. We can only base our thoughts on the flat roofs that we can see such as the rear of the property which are in poor condition so we would anticipate these would also be (see communal/shared issues items).

We can see that the bay window ceiling to the lounge looks to have been replaced which may indicate there has been problems with the flat roofs.

Flat roofs to front bay windows

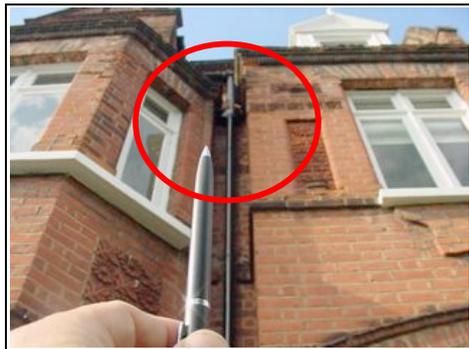
We can see cracking and movement to the front bay. The only way to be 100% certain that there aren't any problems with the front bay is to have it monitored for a year as recommended by the Building Research Establishment.

Crack

ACTION REQUIRED: We would recommend that the existing shared freehold owners make an insurance claim with regards to the cracking to the front of the property. This then will be monitored by the insurance company over a period of about a year and if there are problems it will then be at the cost of the premium of the insurance and if there aren't then you will receive confirmation of this from the insurance company.

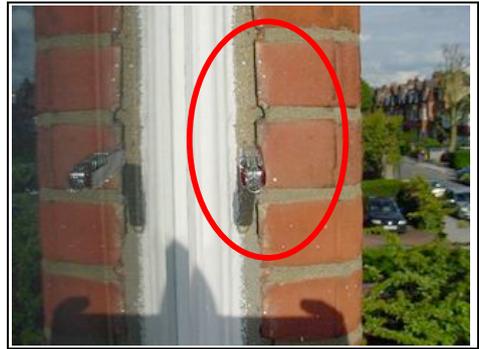
Slight movement to front of bay window which is bowing out a fraction

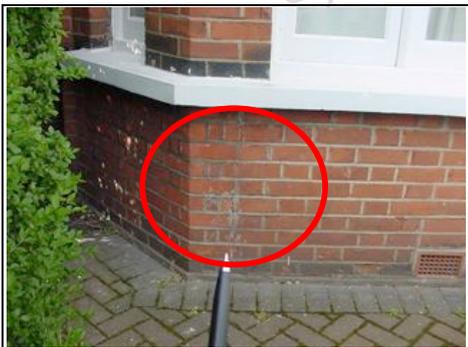
Cracking to front bay

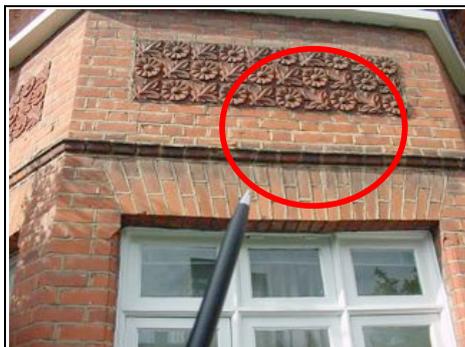
Cracking above bay window

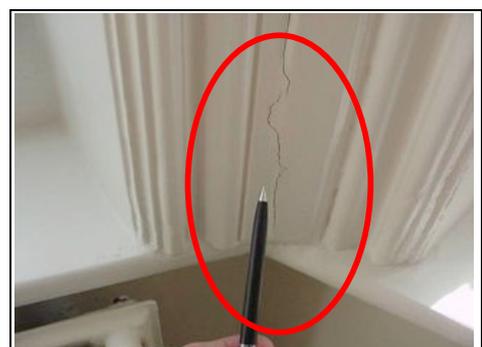
Cracking to front bay

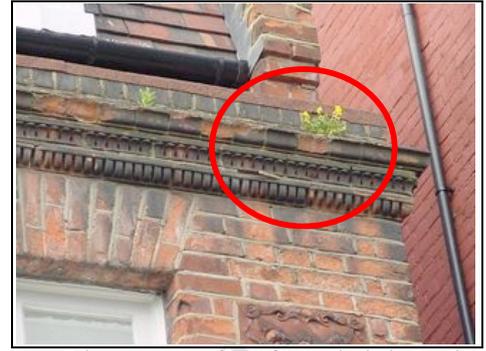
Plants growing from brickwork which is never a good thing

ACTION REQUIRED: We would recommend that a time served older bricklayer is employed to repair the damage caused, removing cement mortar with a soft brush and repointing in a lime mortar which will allow the building to breathe.

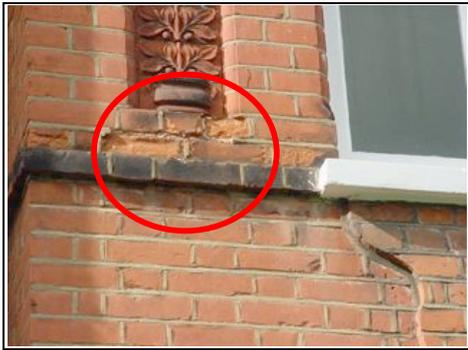
The brickwork is spalling due to the use of cement mortar. This has caused deterioration to the surface of the relatively soft red brick.

Spalling brickwork

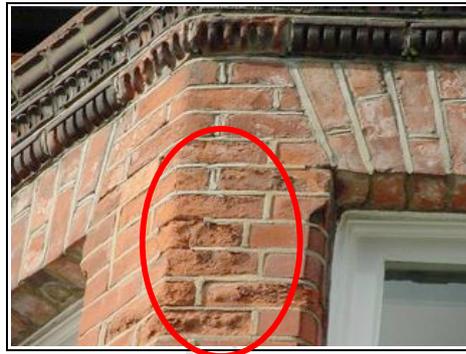
Spalling brickwork

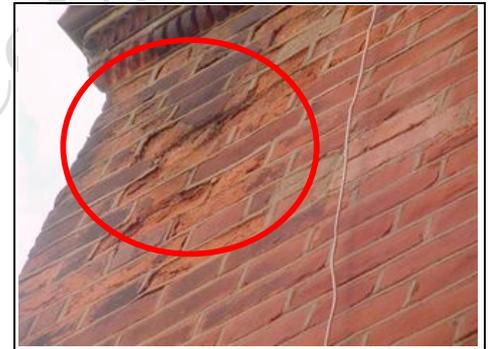
Spalling brickwork at high level

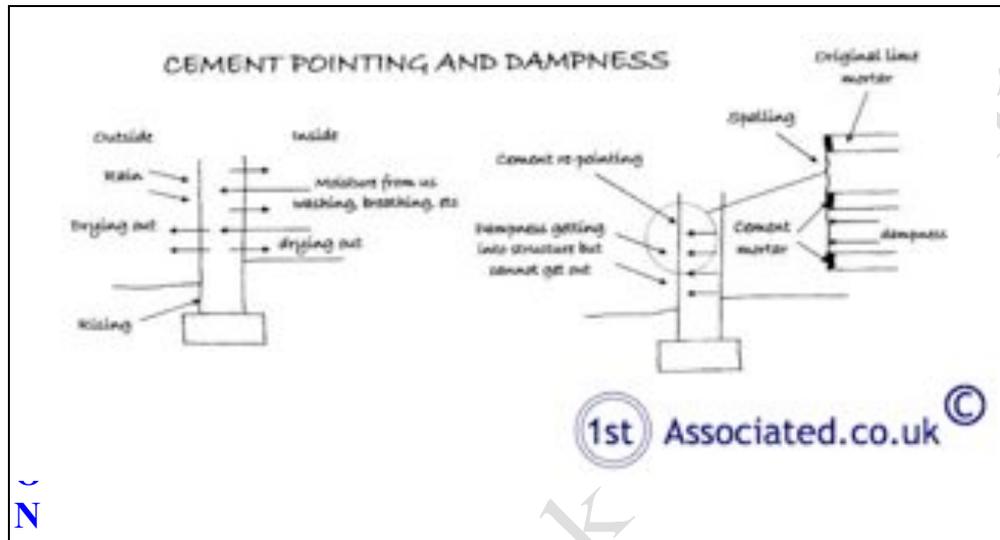
The use of cement mortar causes deterioration to brickwork and does lead to the face of the bricks deteriorating, which in turn leads to dampness. This is a very important point.

Cement pointing and dampness

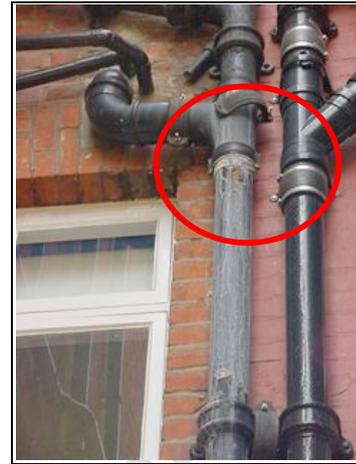
Sewerage pipe leaking

ACTION REQUIRED: The sewerage leak needs to be stopped. You also need to look at replacing the entirety of the pipes or maintaining it.

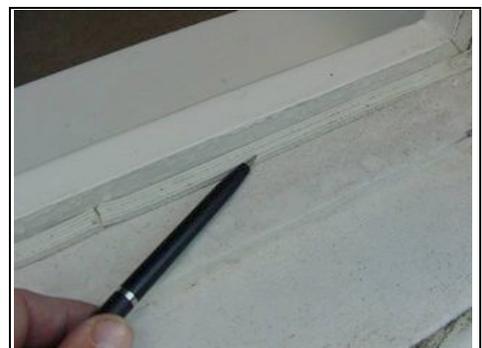
Only seal we found on windows¹⁷
for sealing draughts

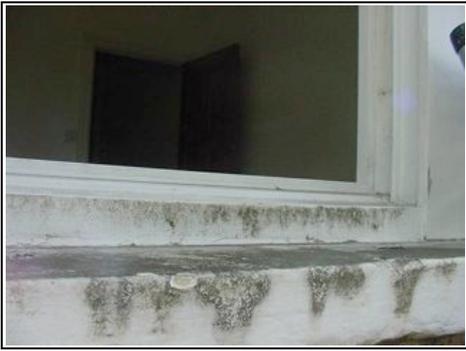
The sliding sash windows externally are in need of repair and redecoration with paint flaking and rust spots to the handles.

Window sills need painting

ACTION REQUIRED: Generally properties such as this are repainted as a whole. However it does very much depend upon the arrangements made between each party. Either way we would recommend redecoration in the summer of 2013 to limit any further deterioration.

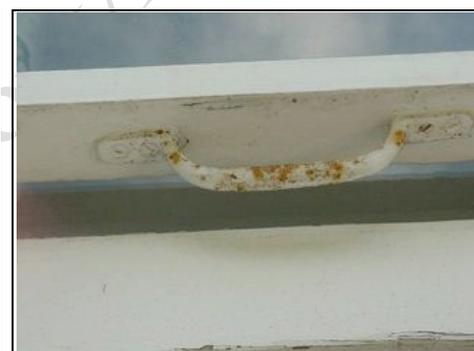
Rusting handle

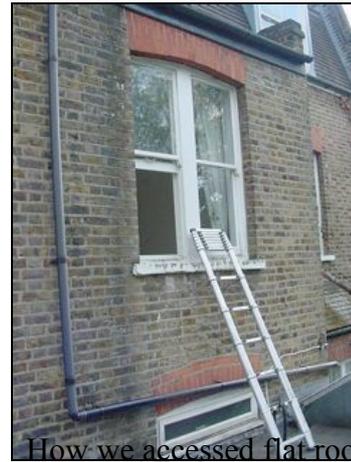
The photograph shows how we accessed the flat roof. From a security point of view it would be fairly easy to get into the property.

How we accessed flat roof.

ACTION REQUIRED: We would recommend an upgrading of the security system in the building as a whole.

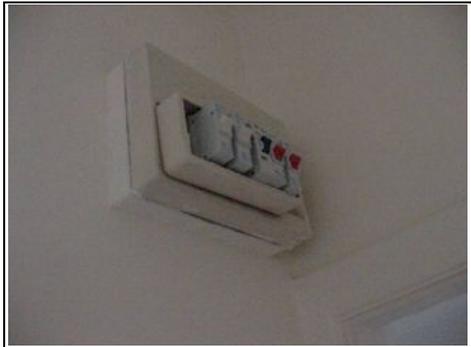
The electrics looked dated and better are now available. In multi occupied properties a defective fuse board can be particularly dangerous.

Fuse Board

ACTION REQUIRED: Replace with new fuse boards. The Institute of Electrical Engineers standards (IEE) recommend a test and report whenever a property changes occupancy. This should be carried out by an NICEIC registered and approved electrical contractor or equivalent. Again this is the sort of thing that would be covered by a sinking fund/planned maintenance.

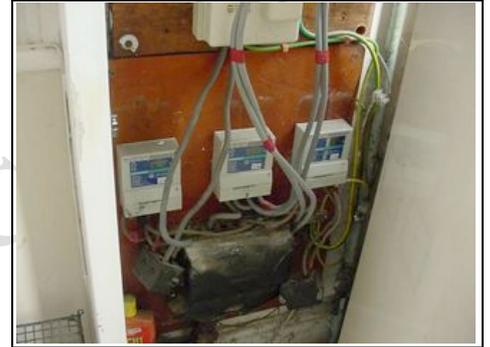
Electrics

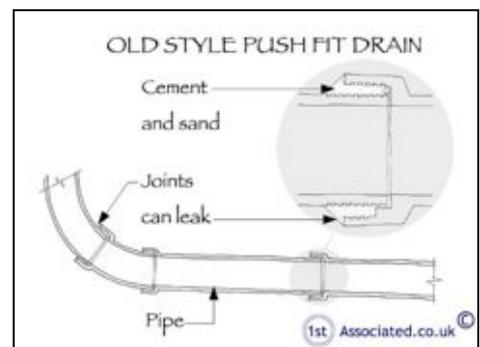
Rather unusually we didn't find a manhole at the property. We do like to find manholes as they show where the drains are. In drains of this age of property there can often be leaks as they are push-fit drains.

In older properties often there were no manholes. Drainage was a relatively new invention that has been added at a later date.

ACTION REQUIRED: We would recommend a closed circuit TV camera report of the drains.

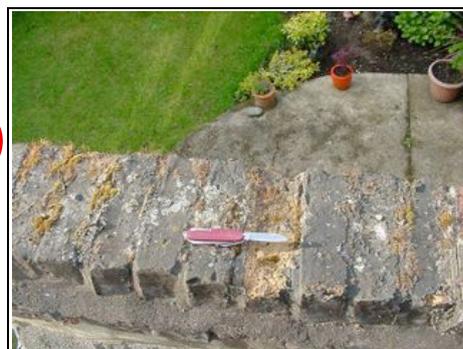
Deterioration to parapet wall

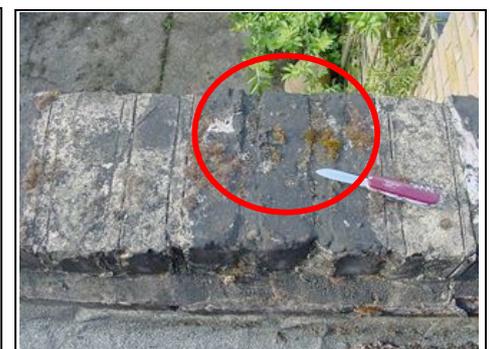
Parapet wall tarred

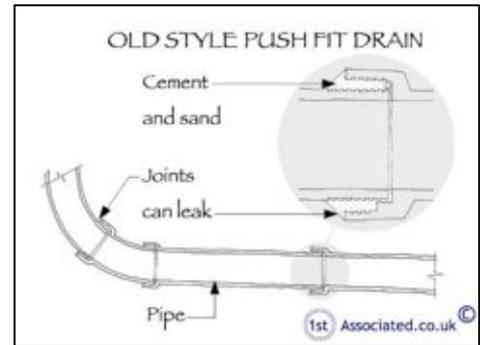
In older properties, such as this, drainage was often push fitted together rather than bonded together which means that they may leak over the years. Whilst we ran the tap for 15 minutes without any build up or blockages the only way to be 100% certain of the condition of the drains is to have a closed circuit TV camera report.

Push fit drain

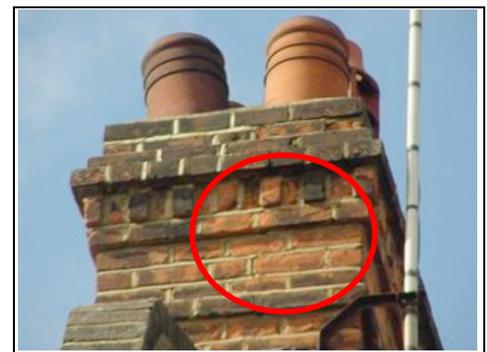
This chimney was difficult to view and we were unable to see all of the chimney. What we could see had spalling brickwork and we assume it has been repointed in a cement mortar. We couldn't see the flashing at the base but there is lead flashing on the parapet walls so it would seem reasonable to assume it is also on the chimney. We noticed that the chimney pots were not all straight, this generally means that the flashing is deteriorating.

Spalling brickwork to chimney one

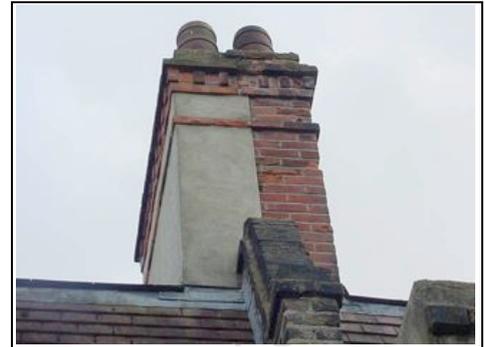
This chimney is built in brickwork which again looks to have been repointed in cement and is badly deteriorating and spalling.

Rear view of Chimney two

ACTION REQUIRED: We would recommend repointing in a lime mortar as soon as possible. We noticed that the adjoining chimney has been rendered which was probably due to it being in such a poor condition that they had no choice.

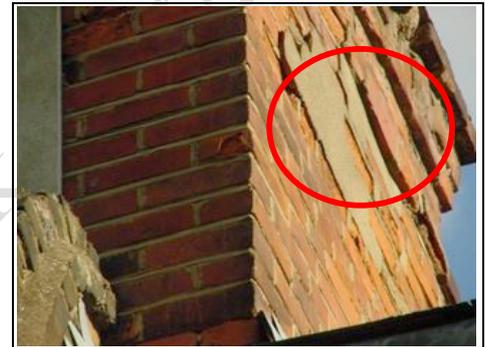
Spalling repaired

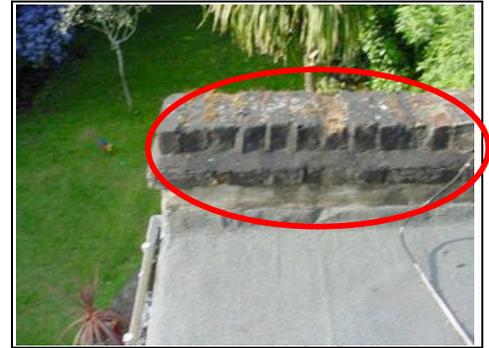
These are deteriorating and are letting damp in to the ground floor flat.

Parapet wall which is causing problems to flat below

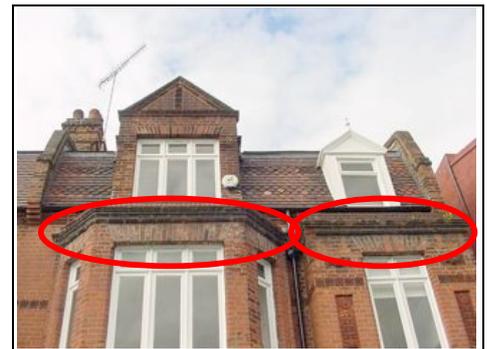
Traditionally these would have been a lead roof or similar. Often this is replaced over the years with felt.

Flat roofs to front bay windows

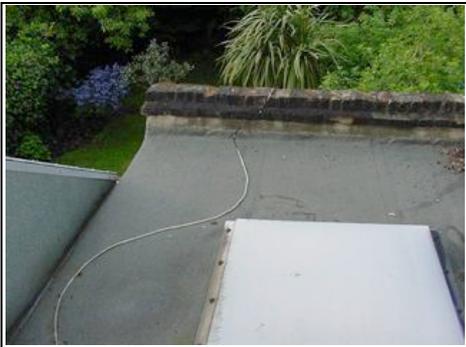
Having been in the apartment below we could see that the flat roof, the conservatory and the box gutter are all leaking into the kitchen and breakfast room area below.

Rear flat roof

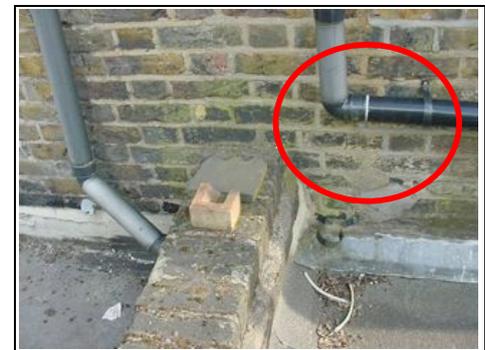
Sharp bend on the rear rainwater downpipe which we tend to find

We would also recommend that the gutters and downpipes are cleaned out, the joints are checked and the alignment checked to ensure that the gutters fall towards the downpipes.

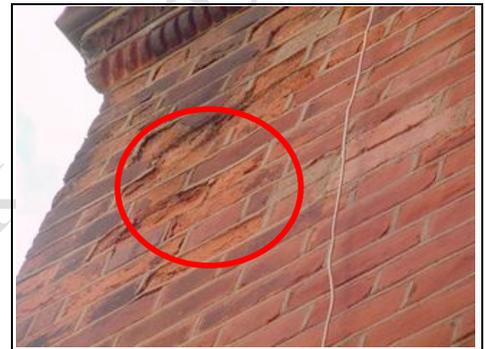
The property is built in a brick predominantly in a soft red brick to the front and a yellow stock brick to the rear, originally in a lime mortar in what is known as Flemish bond brickwork which has been wrongly repointed in a cement mortar which is causing spalling.

Spalling brickwork at high level

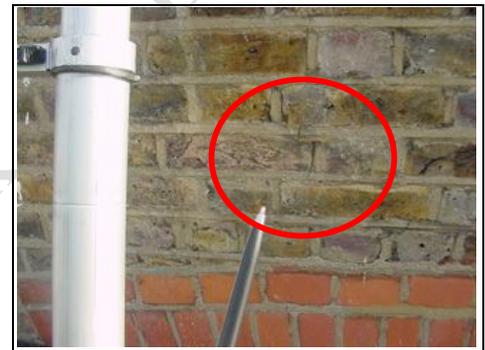
Cracking to rear

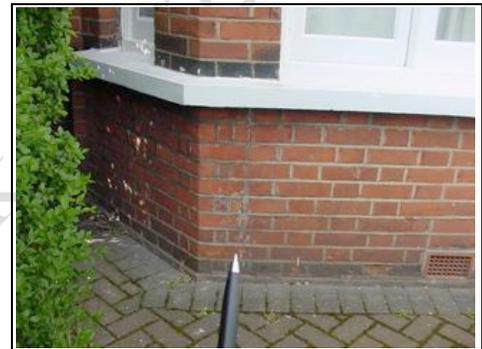
No DPC

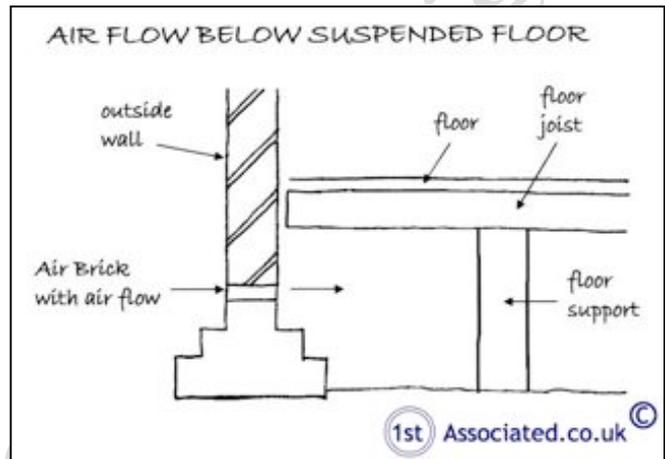
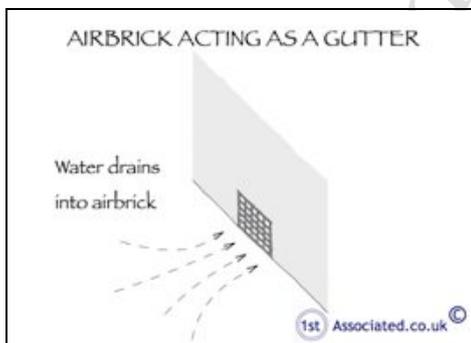
There are airbricks to the ground floor apartment. Due to the brick paving these airbricks are acting as gutters. Air bricks are essential to have a through flow of air as this helps to reduce the chances of wet rot, dry rot and woodworm. In this case the airbricks are very low and are what we would term as acting as gutters.

Airbrick acting as gutter

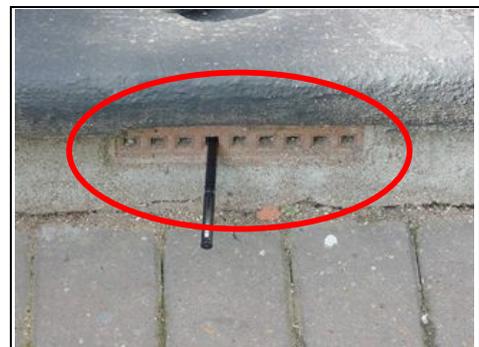
Air brick too low

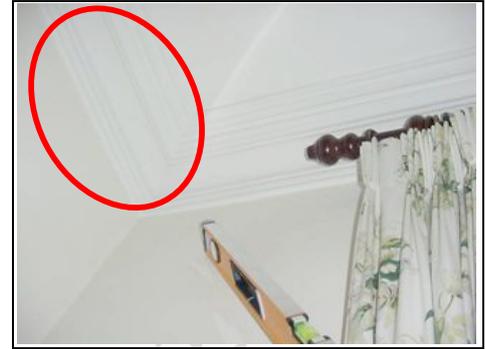
We noted cracking to the rear right bedroom which is possibly due to the rear extension that has been added at a later date putting weight and stress onto the building. We have mentioned that the rooms look to have been fairly recently redecorated so this may well be seasonal movement.

Cracking to rear right bedroom

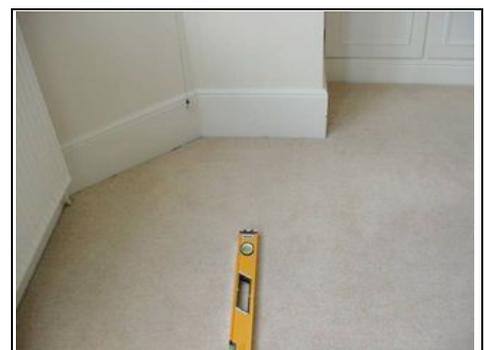
The ridge in the carpet where the bay window is does to us indicate that there has been some movement in the bay as well as of course the cracking that we have mentioned earlier.

Ridge in carpet to bay window area in the lounge

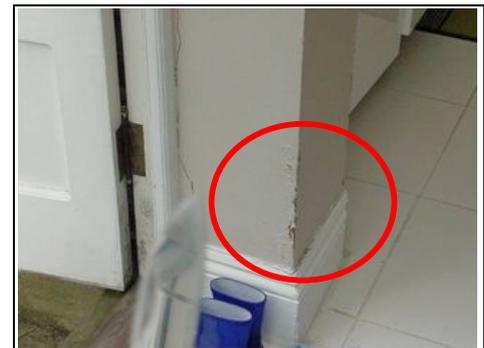
As this property is on the first floor rising damp normally does not affect it as rising damp travels to about a metre high from ground level. However you may have a shared responsibility for dampness in the property. Dampness was found within the ground floor apartment. Please also see our comments about the airbricks acting as gutters.

Rising damp to ground floor apartment

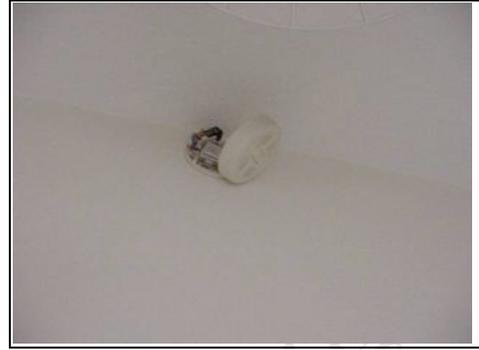
We found one battery operated smoke alarm. We would much prefer to see hardwired alarms in this property.

Smoke alarm

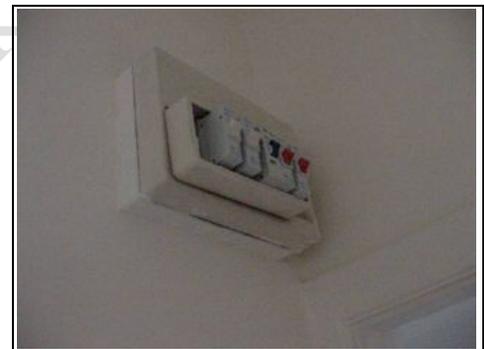
The electric fuses and consumer units were located in the hallway. The fuse board in the apartment looked to be 1980's – 2000 which we would recommend has an hour half fire resistant box around it. The ground floor electrics looked 1960's/1970's. We would recommend all fuse boards are updated. In multi occupied properties a defective fuse board can be particularly dangerous.

Fuse Board in apartment
