# RESIDENTIAL BUILDING SURVEY

Apartment

West Kensington, London. W14

Mr X

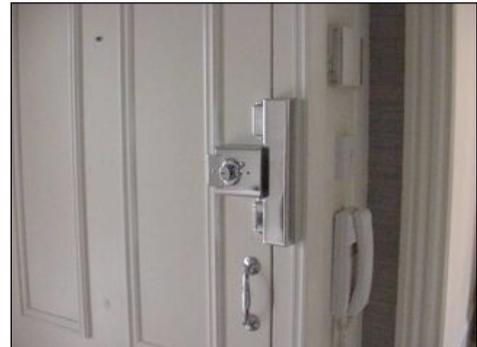
Add a London bar to the apartment entrance door

**ACTION REQUIRED:** Add video entry system and London bar

**ANTICIPATED COST:** Between £3000-£6000 or less if carried out the same time as the fire alarm system; quotations required. This should be a shared cost that is paid by everyone but you will need agreement.

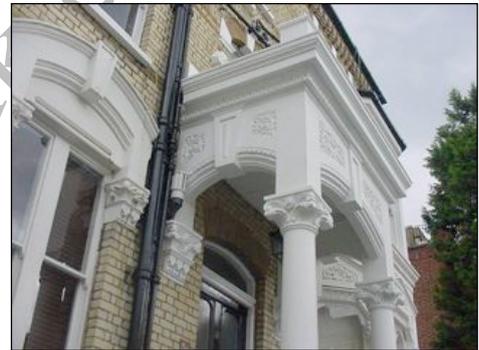
Entrance

There is a shared entrance area with the associated roof this roof is adjacent to your family shower room and we noted that it had a new roof on it which is asphalt, ideally this should have a reflective paint added to it, we also noted a small drainage outlet, in our experience these typically get blocked. Additionally during our question and answer session we spoke to the present owners about this and were advised that they had literally seen it full of water and they do keep an eye on it and regularly clear the roof.

Small outlet (hidden behind the leaf)

**ACTION REQUIRED:** You will need regular maintenance to stop the small drainage outlet from getting blocked by clearing it of leaves etc. The only way we know of resolving this matter long term is to make the outlet much larger.

**ANTICIPATED COST:** To make the outlet larger we would expect costs to be in the region of £500 as you may need scaffolding it should be something you can raise with everyone as a shared cost; quotations required.

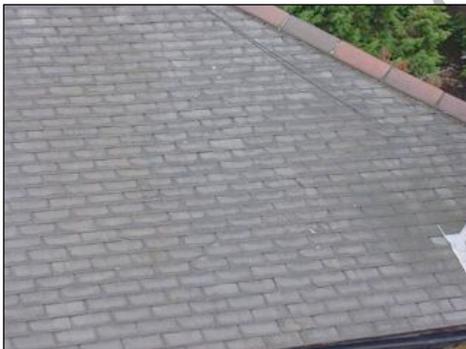
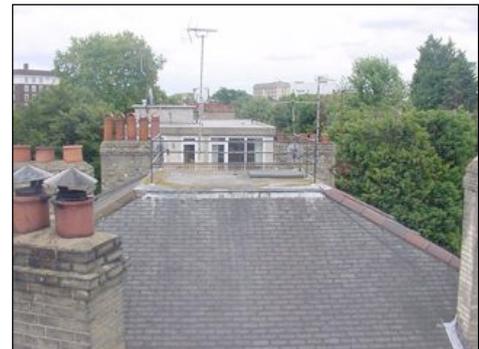
Main roof

We were able to see the left hand side of the roof clearly from the adjoining neighbours property and we had limited view on the rest of the roof. From this we would comment that the roof is pitched and clad with quarried slate. The slates sit fairly true and are generally in average condition considering the property's age, type and style.

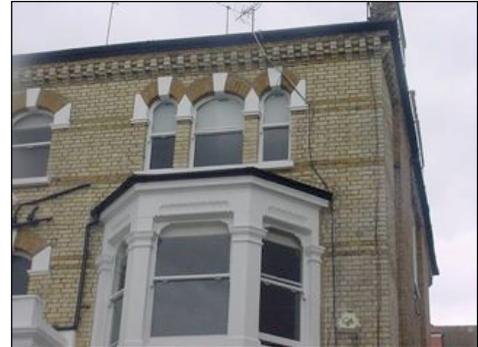
Bay window

Bay Window roofs can often have problems but unfortunately we could not see it but during our question and answer session we spoke about it with the present owner who advised it had been repaired recently.

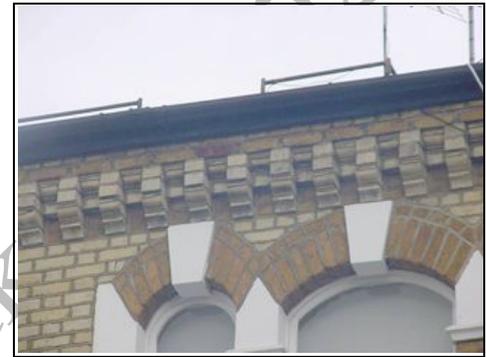
Close up of brick corbelling

We have a nice decorative brick course sometimes know as dragon teeth. We believe there may be a fascia above the brick course although this is difficult to see due to the height of the building and the guttering hiding it.

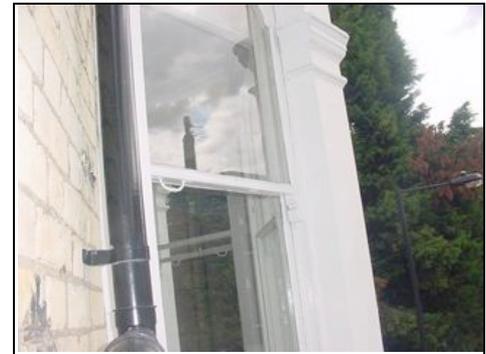
Close up of window

This property has sliding sash windows, they have a painted timber finish and are in reasonable condition although we would add we were only able to inspect them via opening the windows internally. During our question and answer session with the present owners they advised that refurbishment had been carried out on the windows therefore latent defects may be being hidden

**ACTION REQUIRED:** Sliding sash windows commonly need some easing and adjusting by a carpenter who is use to dealing with this type of work. Please see our comments with living with sliding sash windows as they can be cold and draughty if you have not experienced them previously.

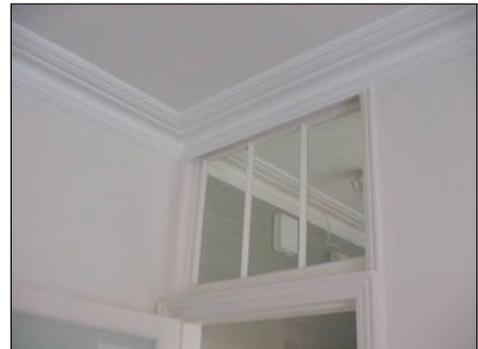
In the eightieth century ornamental plaster ceilings came into vogue, many beams disappeared from view, encased in boarding or plaster which is the case with this building. You certainly have a decorative coving, the skill required for these is considerable and adds to the overall feel of the property.

Ornamental plaster ceiling and coving

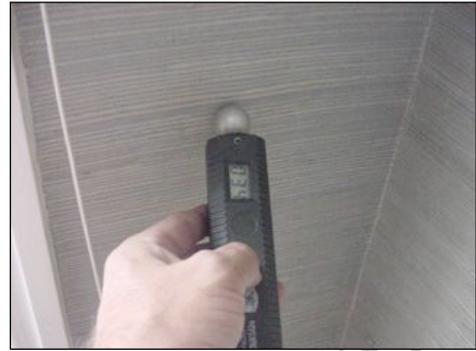
Dampness test

Tests were taken with a moisture meter at random points to internal walls, floors and other surfaces. Our readings were in line with what we would expect for this age of property, i.e. minor dampness. No evidence of any significant penetrating/lateral dampness was detected.

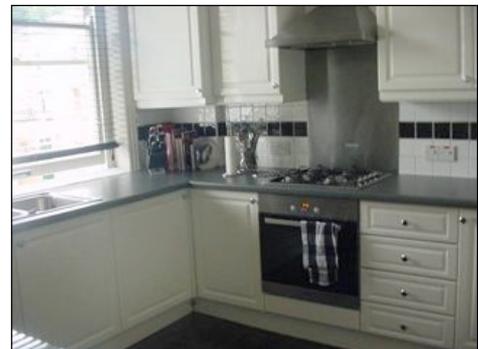
Kitchen

From our cursory visual inspection the kitchen looked in reasonable condition, although it has suffered from some general day-to-day marks. We have not tested any of the kitchen appliances.

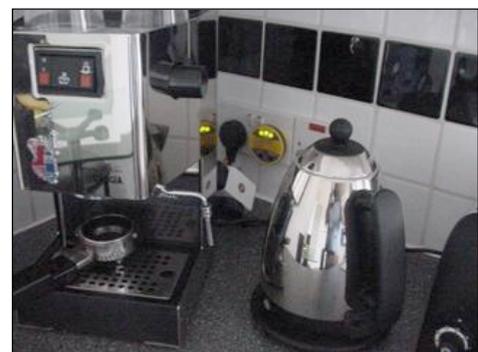
Earth Test

We carried out an earth test in the kitchen area to the socket point that is normally used for the kettle and this proved satisfactory.

**ACTION REQUIRED:** We would add that you do need to obtain a copy of the last electrical inspection the property has had as a whole. If there is no record of an electrical test having been undertaken within the last five years, it is recommended that the installation be tested by a competent electrician (NICEIC registered) and all recommendations implemented. Thereafter, the installation should be re-tested every five years.

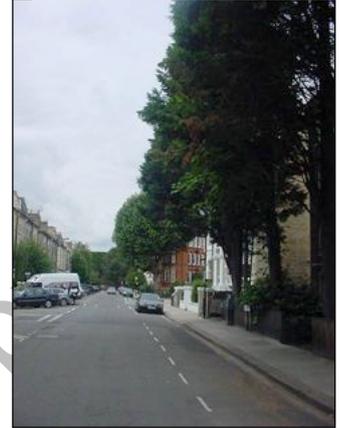
Parking is on roadside on a first come first served basis with permit control and there was parking available at the time of the survey.
