RESIDENTIAL BUILDING SURVEY

XXXXX

Ealing

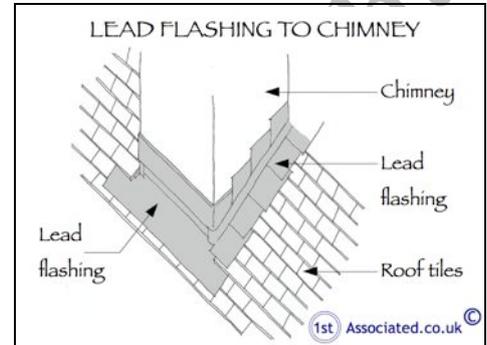
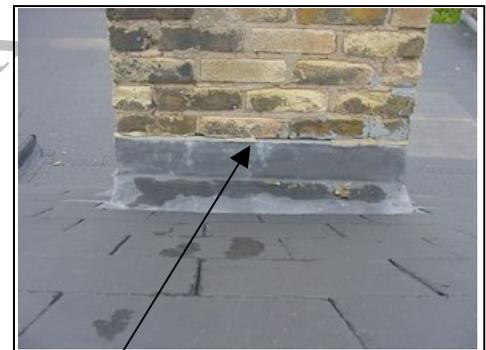
Joint failing to middle chimney

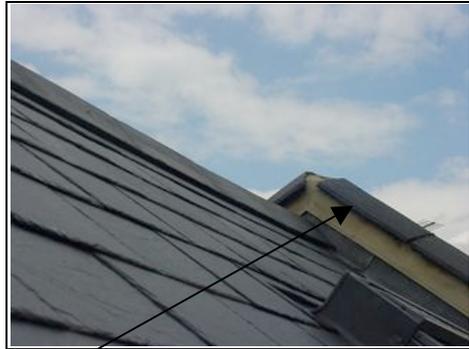
2.0) Parapet wall problem

The parapet wall has coping stones which have not been bedded correctly and the walls require work.

Slipped coping stone to left hand side parapet wall

ACTION REQUIRED: Re-bed coping stones and check parapet walls are watertight.

ANTICIPATED COST: In the region of £1000 to £2000, again assuming that the work can be carried out without scaffolding ; please obtain quotations.

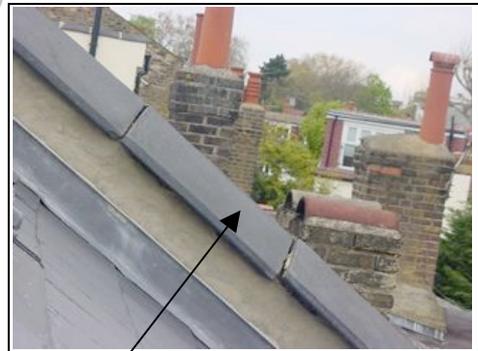
The grey coping stones are literally just sitting on the roof

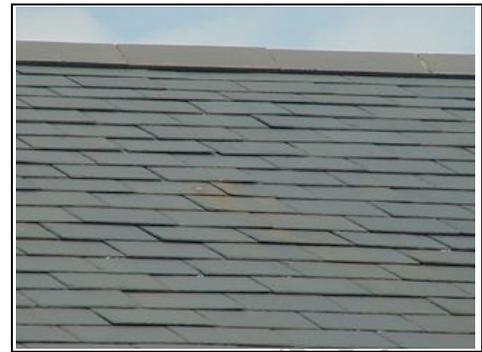
Slates to main roof undulate

ACTION REQUIRED: You need to monitor the roof carefully.

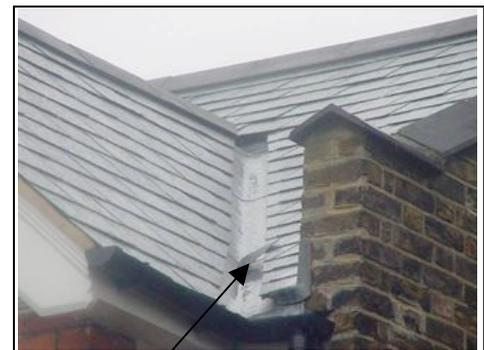
3.1) Roof slate loose

There is a roof tile which is loose at the front of the property and will allow wind driven rain to get into the property if not secured.

Manmade slate coming off the main roof in the valley gutter

Investigate where the slipped slate has come from. Secure roof slate.

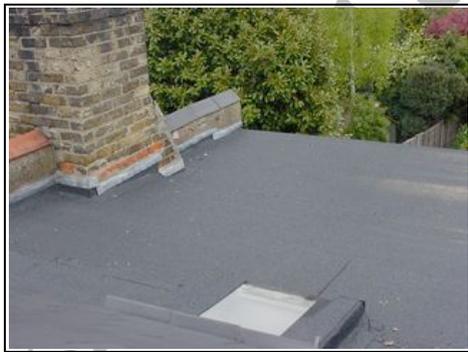
We were pleased to see that the rear roof had a modern mineral felt. It is likely to be a third of the way through its natural life and as flat roofs are problematic we would recommend that you reinstate the roof light which is currently felted over.

Roof Light partly felted over

ACTION REQUIRED: Alter the roof light so that it is also an access to the roof.

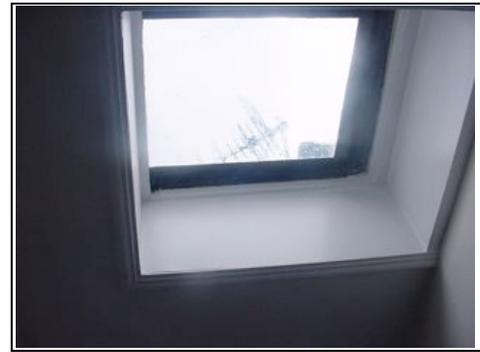
Roof Light partly felted over viewed inside the property

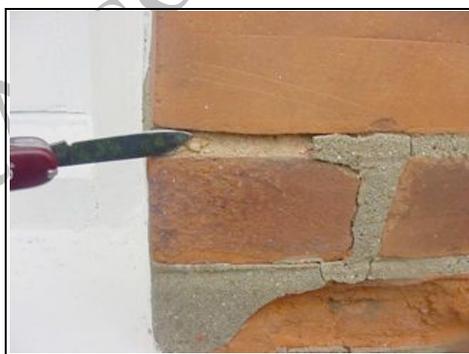
The property has Flemish Bond brickwork which has been incorrectly re-pointed using a cement mortar as opposed to a lime based mortar. Cement mortar smothers the building not allowing it to breathe whereas traditional lime mortar used on properties of this age, type and style allow the property to breathe.

Cement re-pointing

ACTION REQUIRED: Gradual re-pointing in a lime mortar, the good thing about cement mortar is that it falls off on its own, particularly when helped with a soft brush. We would recommend yearly visits by an experienced, time served bricklayer who knows how to work in lime mortar which will gradually allow the building to breathe and reduce the dampness within the building.

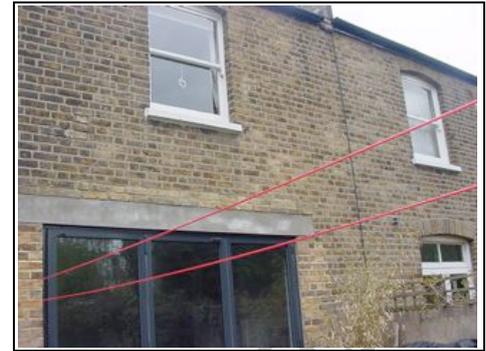
There is a rear sliding, folding door which we have concerns about the adding of these types of modern doors to a property such as this as there is a considerable span which needs to be supported. As such Local Authority Approvals should have been obtained.

Sliding, folding doors to rear

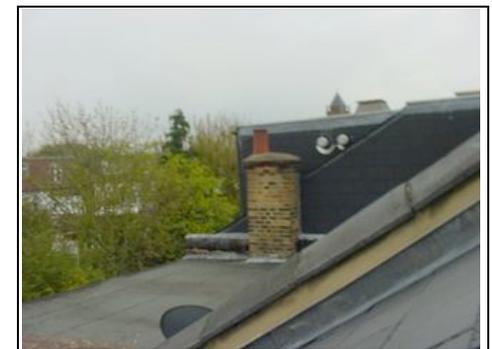
Next door but one's rear extension, extending over the top of the flat roof area.

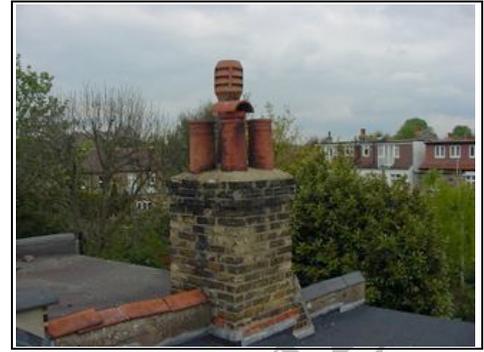
Chimney Two

This chimney is brick finished with a lead flashing and numerous chimney pots. From what we could see from the roof light it looked in average condition considering its age, type and style. However we believe a close up look is necessary.

Unfortunately we were unable to see the top of the chimney known as the flaunching, we therefore cannot comment upon them.

ACTION REQUIRED: Carry out a close inspection particularly to the flashings. Re-point if necessary. Periodically inspect the chimney.

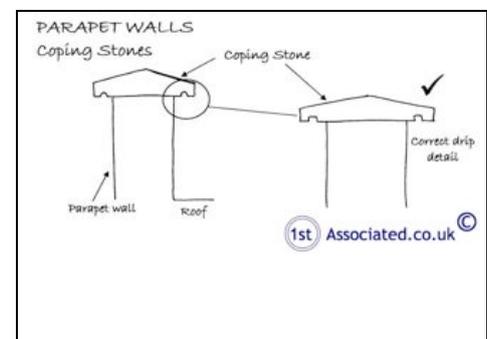
In this case there are parapet walls to the main roof and also to the rear flat roof. We can see that the coping stones are coming away to the flat roof side.

ACTION REQUIRED: Re-bed parapet wall coping stone and check the parapet walls as a whole as it looks like it is relatively new work.

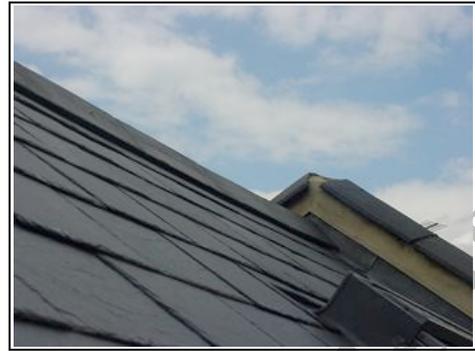
Slipped tile to left hand parapet wall

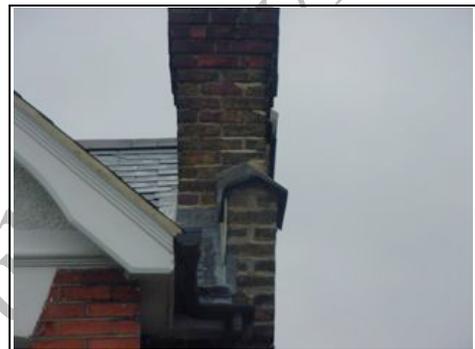
Right hand parapet wall

Finally, we were only able to see approximately forty percent of the parapet wall, therefore we have made our best assumptions based upon what we could see. A closer inspection may reveal more.

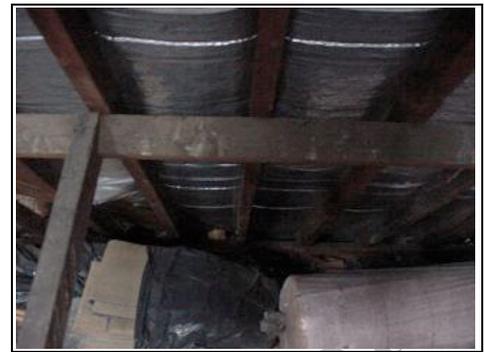
Often an older roof will have no protective underlayer at all unless it has been re-roofed post war and then it will have a Hessian base bitumen membrane. In this case we found quite unusually a modern foil protective underlayer which does indicate along with the manmade slates that this roof has been carried out fairly recently probably in the 1970s/1980s.

This photo shows the common rafters (the ones that form the pitch of the roof) and the silver area between is the protective underlayer.

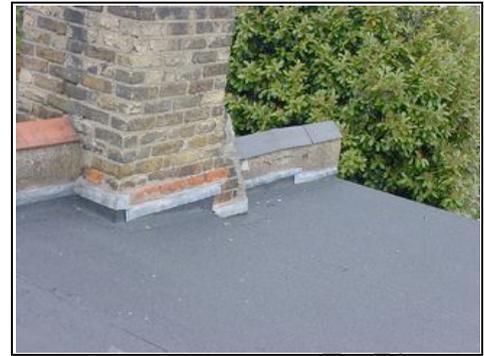
Flat roof

The rear roof is a flat felt roof. Typically flat roofs have a fall of approximately 15°; what we can see of the flat roof it does have a reasonable fall.

What we do find is that sometimes if the rear gutters are not cleared to a large flat roof such as this which also takes the rainwater from the rear pitched roof the gutters to the rear can overflow and discharge rainwater down the walls.

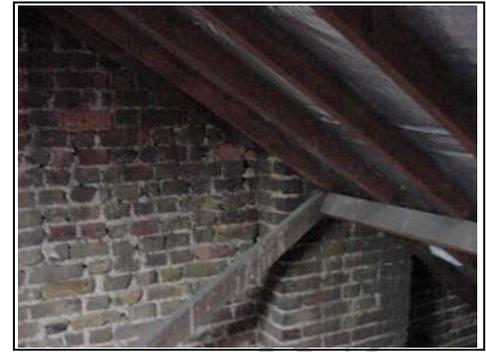
Our examination was limited by the general configuration of the roof. What we could see was generally found to be in average condition for its age, type and style. It is, however, feasible that there are problems in the roof that are hidden.

General view of inside of roof showing common rafters (ones that form the pitch of the roof) purlins, cross brace and brace to the central wall.

ACTION REQUIRED: The only way to be 100 per cent certain is to have the roof cleared and checked.

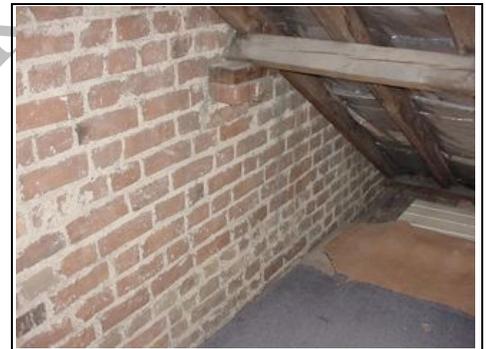
Bigger than usual splits in the purlins

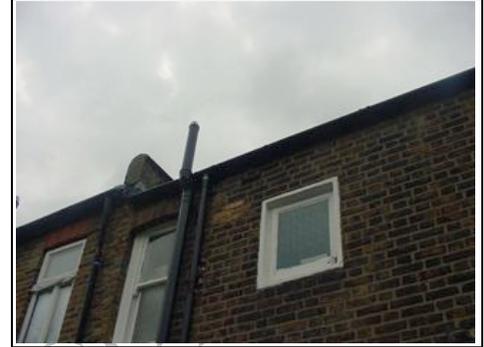
Soil and vent pipe

The soil and vent pipes are plastic.

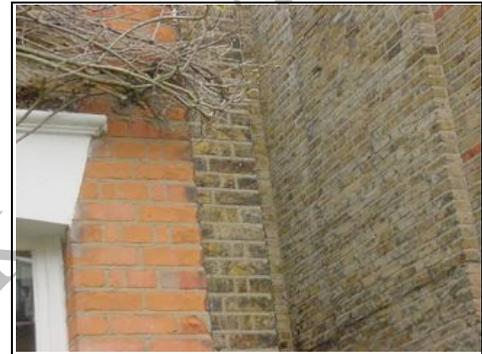
Brickwork to the front of the property

The use of cement mortar causes deterioration to brickwork and does lead to the face of the bricks deteriorating, which in turn leads to dampness. This is a very important point.

The property is built in a mixture of yellow stock bricks and soft red bricks; the soft red bricks in particular deteriorate due to the cement mortar pointing.

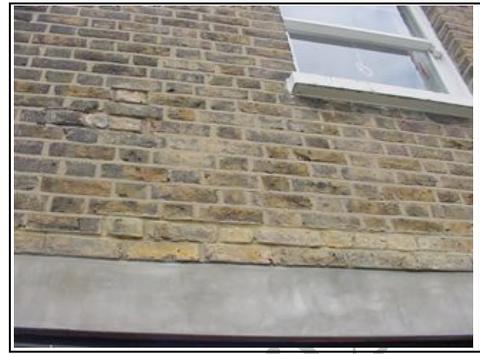
There is a very large opening made for the sliding, folding doors to the rear of the property.

Large opening for sliding, folding doors to the rear

ACTION REQUIRED: Your Legal Advisor needs to check and confirm that Local Authority Approval has been obtained and there are calculations for the lintel.

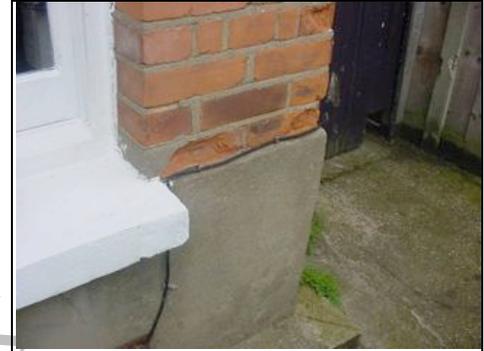
All modern properties should incorporate a damp proof course (DPC) and good building practice dictates that a differential of 150mm (6 inches) should be maintained between the damp proof course and ground levels. In this case, we cannot see a DPC as it may be covered by a rendered plinth. This was the era when damp proof courses were starting to be added but does not necessarily mean you have one, they were often originally slate.

The render plinth may be hiding a damp proof course

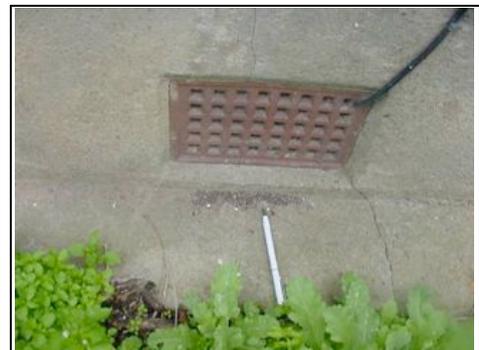
Air brick

There are low level air bricks to the property which look to have been enlarged than the original brick size to double this which is good. You do however need to make sure that they are kept clean to allow and air flow underneath the building.

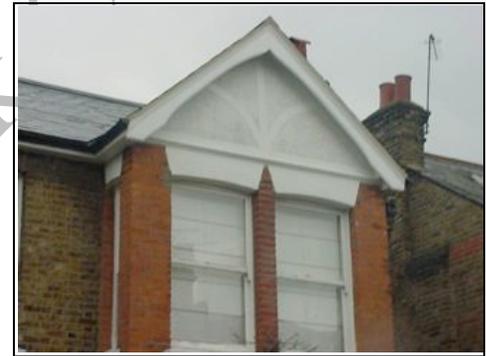
Fascias and soffits

The fascias and soffits are timber. They are painted and we would comment they are in average condition for their age, type and style. It is feasible that the front area is similar to the front windows which look in good condition however when knife tested are not.

ACTION REQUIRED: When work is being carried out to the front windows also have a re-check of the fascias and soffits. Make sure gutters and downpipes are watertight before carrying out any work on fascias and soffits.

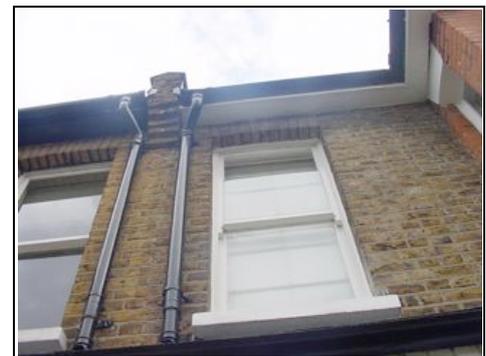
Sliding sash window

The property has single glazed timber sliding sash windows.

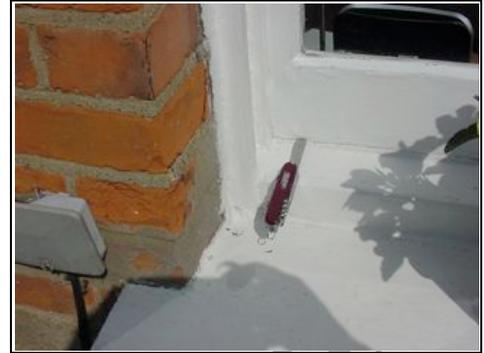
Knife test to window

ACTION REQUIRED: We would recommend repairs to the windows are carried out during the summer of 2012.

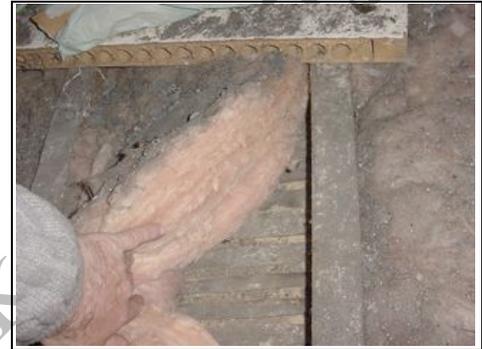
Where we could see the ceilings from within the roof space this property has lath and plaster ceilings however we are aware that the modern alterations have no doubt been carried out with a modern plasterboard.

Lath viewed within roof space

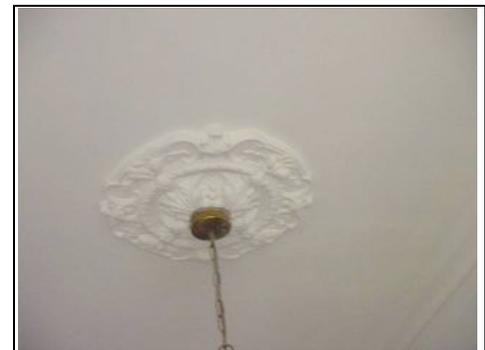
Ceiling rose

The property has some ceiling roses, whether they are original or not we are not certain but we do believe that they are a pleasant detail in the property although this is up to personal taste.

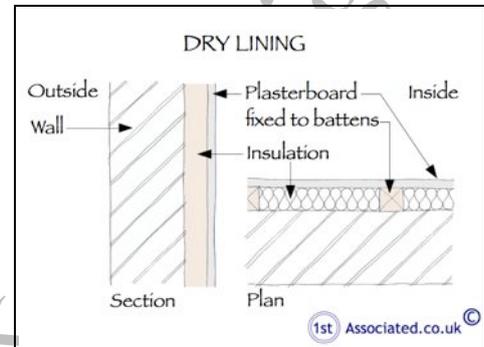
We believe that some of the perimeter walls have had a skim coat of modern gypsum plaster and to the rear of the property there is what is known as a dry lined wall which could be due to hiding dampness; please see our comments with regard to the flat roof and the rear of the pitched roof possibly discharging rainwater down the rear wall.

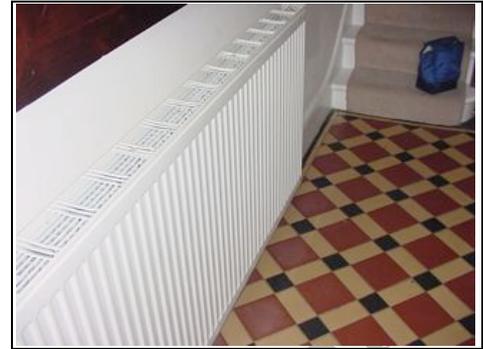
There is a tiled floor to the entrance hallway which, in our opinion, is a pleasant feature.

Tiled floor to entrance hallway

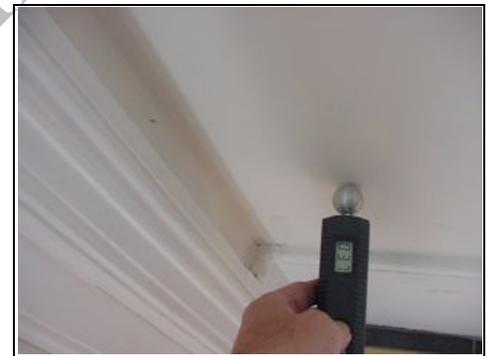
A random visual inspection and tests with a moisture meter have been taken to the perimeter walls and some internal walls. In this particular case we have found no rising damp.

Testing for rising damp

ACTION REQUIRED: Please see the Executive Summary regarding the kitchen rear wall being dry lined.

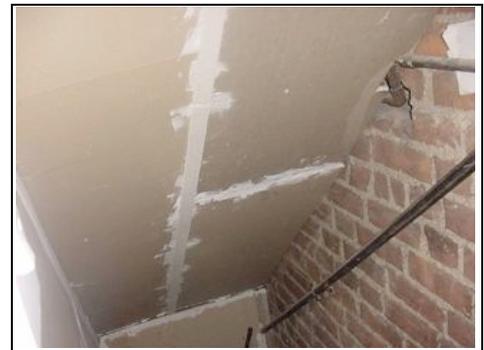
We were unable to examine the underside of the stair timbers due to it being lined, which precluded our inspection, so we cannot comment further upon the stair structure. We can, however, say that the lining gives a resistance to the spread of fire if such circumstances were to occur.

Staircase lined

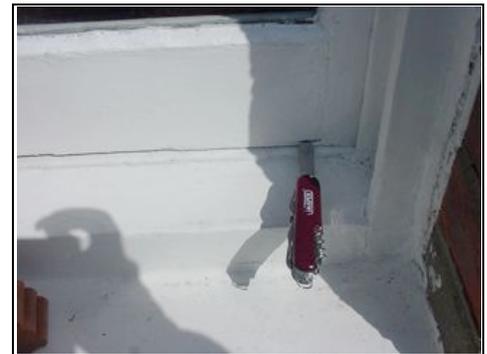
We noted wet rot in the front windows and we would expect to find wet rot to the fascias and soffits. There is also a possibility that wet rot is in the suspended timber floor.

Knife test to window

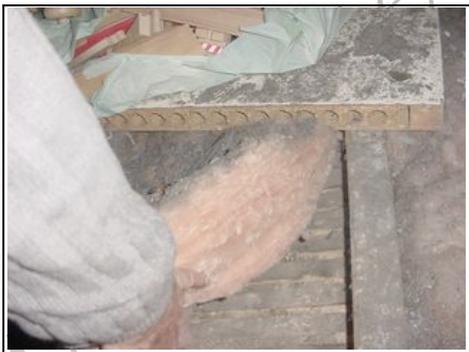
There was approximately 200mm of insulation present in the roof, current Building Regulations requirements are of 300mm.

Insulation

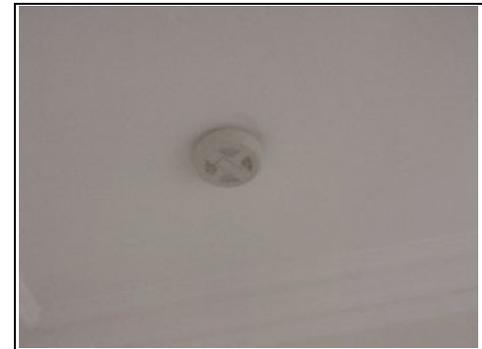
Some smoke detectors were noted. The current Building Regulations require that they be wired into the main power supply. Obviously in a property of this age this is difficult, as it would mean having surface mounted wires or cutting wiring into the plaster.

Smoke alarm

ACTION REQUIRED: We would recommend, for your own safety, that smoke detectors be installed. We would always recommend a hard wired fire alarm system and are also aware that some now work from a wireless signal which may be worth investigating. Whilst fire is relatively rare it is in a worst case scenario obviously devastating.

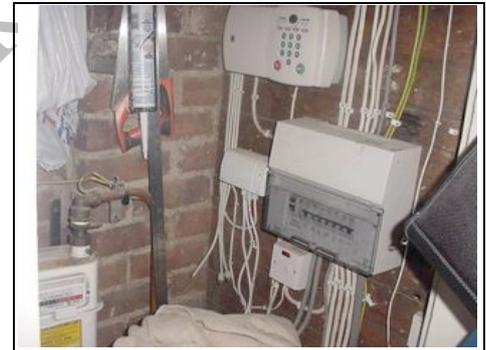
The electric fuses and consumer units were located under the stairs. The fuse board looked newish and better are now available.

Fuse Board

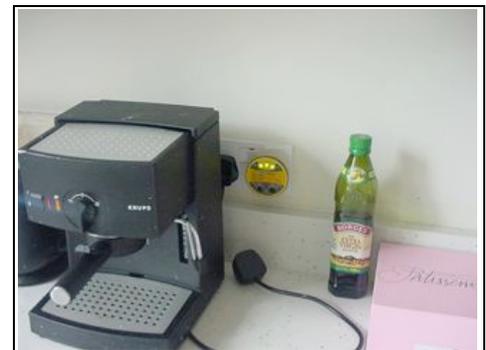
Earth Test

We carried out an earth test in the kitchen area to the socket point that is normally used for the kettle, this proved satisfactory.

ACTION REQUIRED: As the property is changing occupancy an Institute of Electrical Engineers (IEE) test and report should be carried out by a NICEIC registered and approved electrical contractor or equivalent.

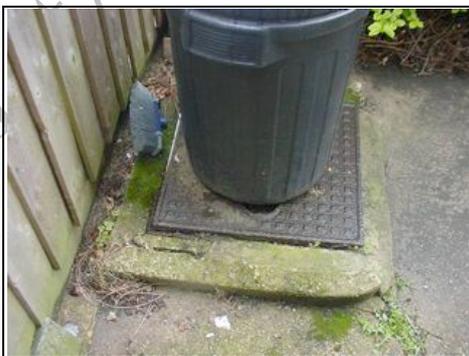
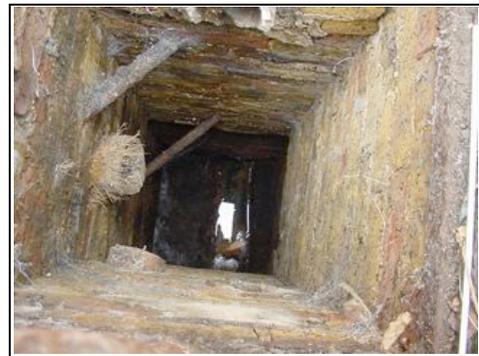
Manhole one

The manhole was inspected to the front of the property using our 15 minute tap test (running water for 15 minutes). No obvious problems were seen. Water was free flowing.

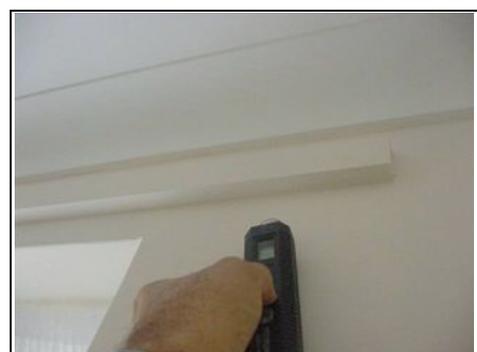
Dampness and condensation around the concrete window lintel
