# RESIDENTIAL BUILDING SURVEY

## Ealing

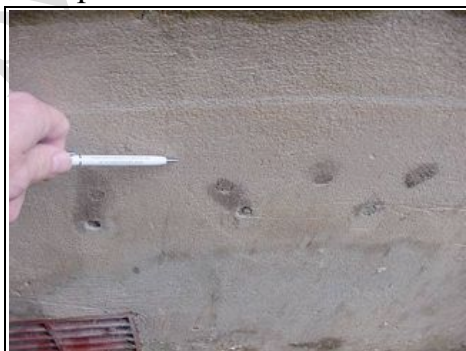
We can see to the left hand side and also to some of the right hand side, that there have been numerous previous attempts at inserting a damp proof course. We believe the problem to be on the right hand side and rear due to the high ground level and on the left hand side we believe is due to the render bridging the damp proof course, this requires a bell mouth to the render.

Damp proof course has been inserted on the left hand side

**ACTION REQUIRED:** It is important that both these works are done correctly as unless this happens, the dampness will remain.

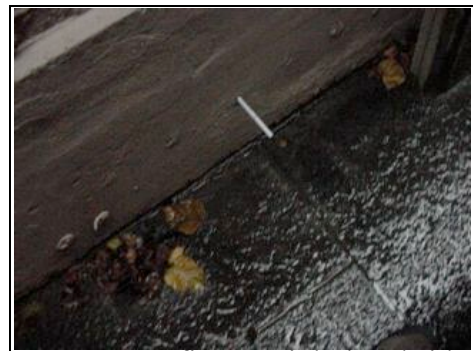
Damp proofing on right hand side

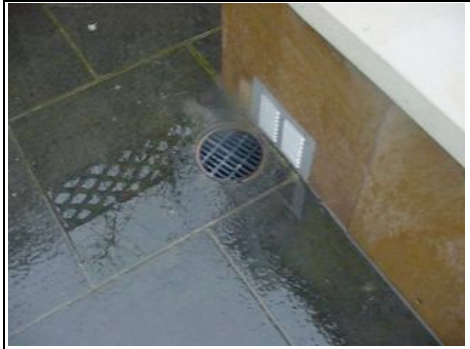
We suspect that additional airbricks were originally to the rear but these have been covered up by the decorative paving slabs that have been added.

Airbricks acting as a gutter to the rear

**ACTION REQUIRED:** You need to ensure that all the current air vents are clear and allow a flow of air. You need to open up a section of the floor to check the condition of the timber underneath. If there is any dampness or deterioration then we would recommend additional airbricks are added to the rear.

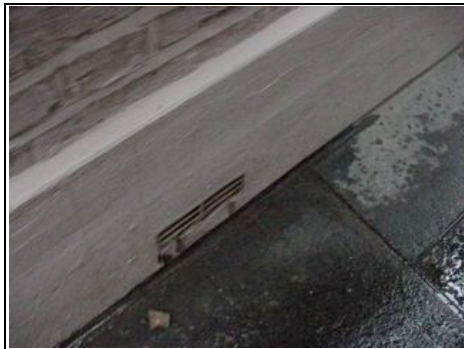
Airbrick acting as a gutter on the right hand side

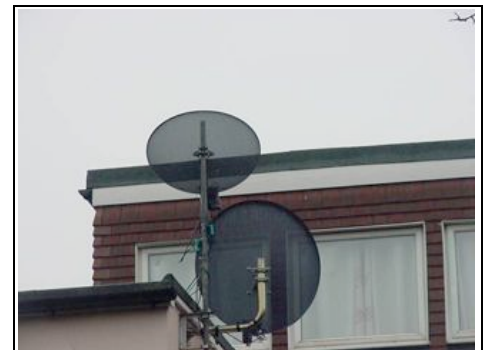
Dormer window

To the rear of the property a dormer window has been added as part of the loft conversion. There is a flat felt roof which we were unable to see, the cheeks of the dormer are clad in tiles and the windows are plastic double glazed. Generally we could comment for its age, type and style it is in average condition.

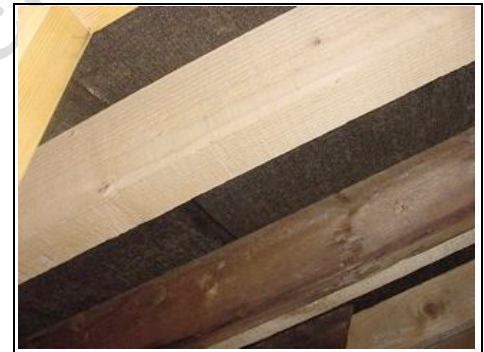
We were only able to see a very small area of the protective underlayer. This we found to be a Hessian base Bitumen membrane. We could only see approximately five percent of the underside of the roof. The Hessian based membrane has been used since the 1960s. We generally found the little we could see to be in average condition.

This photo shows the common rafters (the ones that form the pitch of the roof) and the dark area between is the protective underlayer

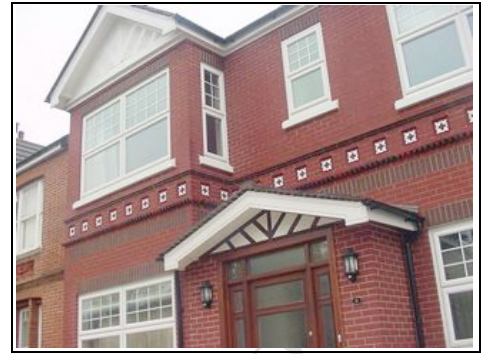
Porch roof

There is a shallow pitched roof over the porch that we assume has been put at that pitch to miss the decorative band of brickwork running across the property. We can see that the flashing has been added poorly. Rather than stepping the brickwork which is traditional with this age of property, it has been cut into the brickwork.

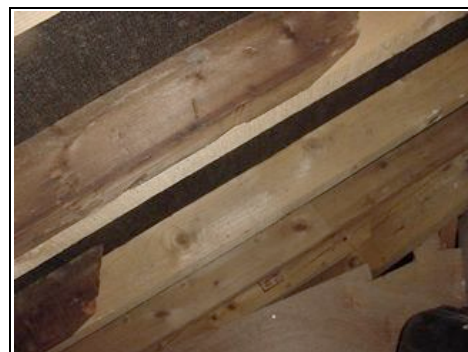
Roof viewed in rear right hand cupboard space on the top floor

Our examination was very limited due to the loft conversion. The timbers we could see were newer timbers and were thinner and smaller in profile than we expected but without seeing the whole roof we cannot be certain of how it is constructed. It may, for example, have a metal frame within it which would allow the size of the timbers to be reduced.

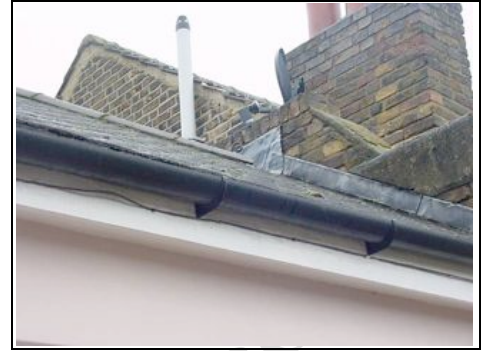
Cast iron of this age can crack and rust and needs regular maintenance.

Soil and vent pipe

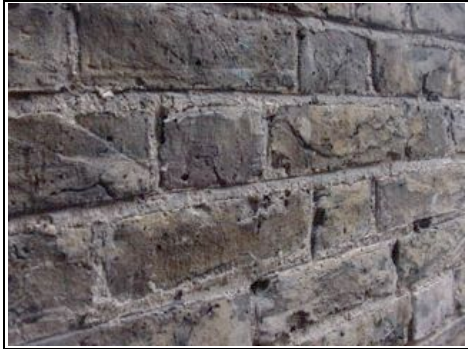
Flemish Bond

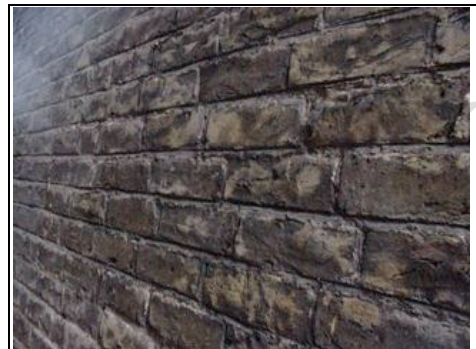
Flemish garden wall bond

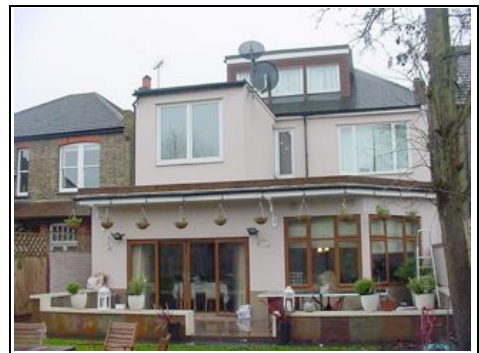
The external walls to the rear are finished in a smooth faced painted render. We are always wary when we see rendered properties as it usually means they have been rendered for a particular reason.

In this particular case we believe it has been added at a later date as we cannot see it on adjoining properties. It looks a new style cement render.

Render to the rear

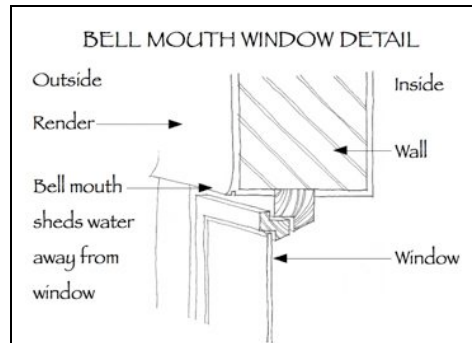
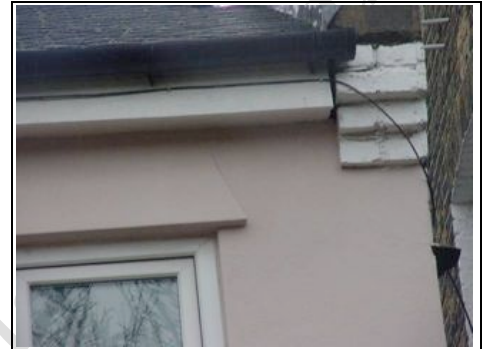
Drip details over the window on the render to the rear

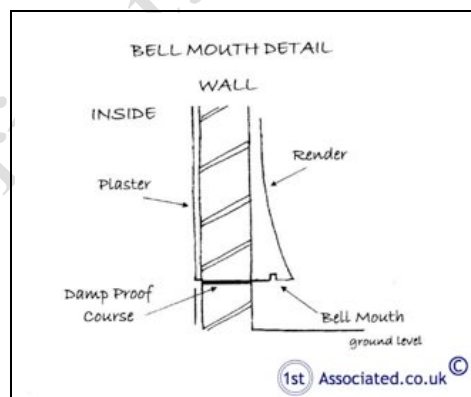
However to the base where we would expect to find a drip detail, there is no detail.

No bell mouth

**ACTION REQUIRED:** Please see our comments within the Executive Summary with regards to adding a bell mouth.

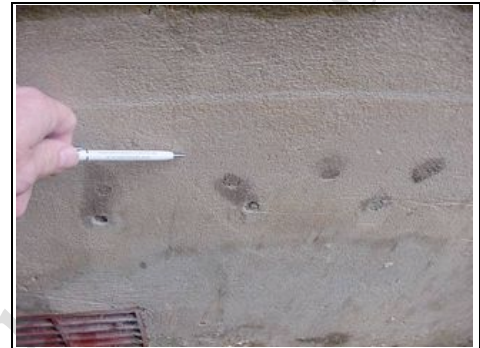
Damp proof course has been inserted on the left hand side

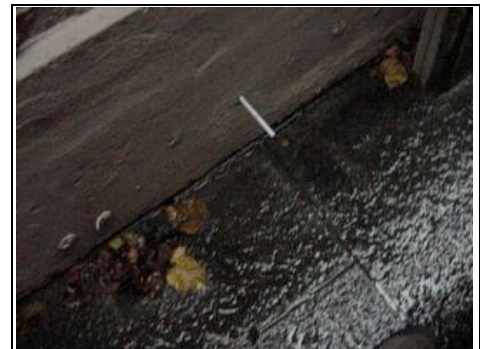
Damp proofing on right hand side

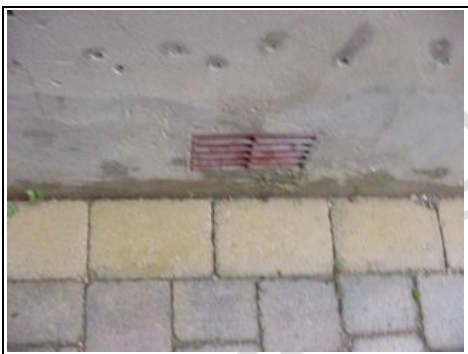
Left hand airbrick

**ACTION REQUIRED:** Please see our comments within the Executive Summary.

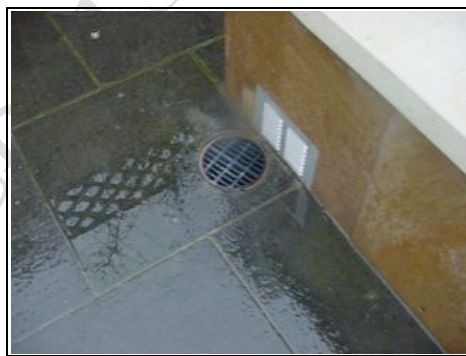
Airbrick acting as a gutter

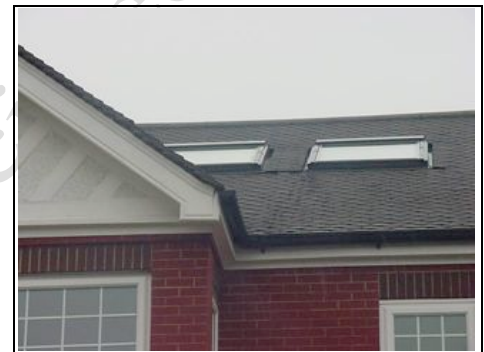
The fascias and soffits are timber. They are painted and we would comment they are in average condition for their age, type and style.

Fascias and soffits

**ACTION REQUIRED:** Make sure gutters and downpipes are watertight before carrying out any work on fascias and soffits.

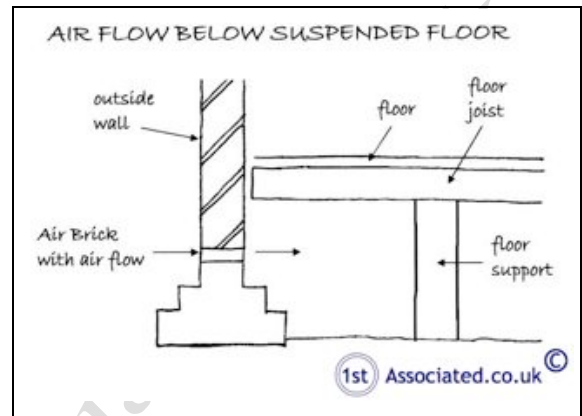
The floors to the property are suspended timber floors which are covered with ceramic tiles and wood flooring which has limited our inspection.

Tiles to wooden floor with a step on the ground floor

**ACTION REQUIRED:** Please see our comments within the Executive Summary with regards to the problems that can occur where ceramic tiles are laid over timber floors.

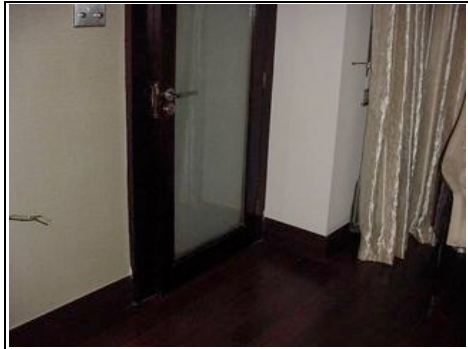
There is a variety of modern doors. Some of them are glazed, these should have a British Standards kite mark to ensure that they are safety glass; we couldn't see it in this instance.

Glass doors

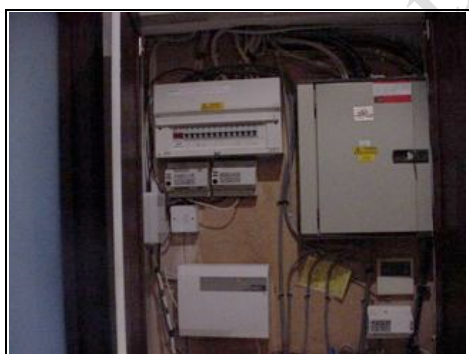
Quite unusually this property has two electric fuse boards. One is located in a cupboard on the ground floor next to the entrance door, the other one is at first floor level. This may have been added due to the under floor heating being electric.

Circuit board on ground floor

**ACTION REQUIRED:** You need to specifically ask the owner why two fuse boards are present. We would add that we were pleased to see that the fuse boards were relatively modern.

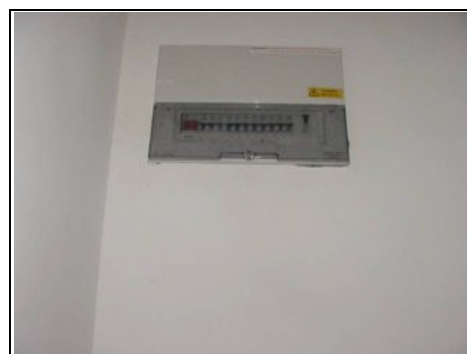
Fuse Board on first floor

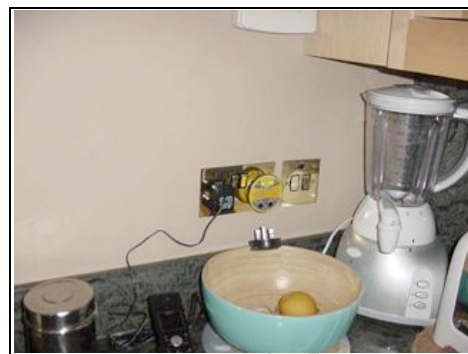
We carried out an earth test in the kitchen area to the socket point that is normally used for the kettle, this proved satisfactory.

Earth Test

**ACTION REQUIRED:** As the property is changing occupancy an Institute of Electrical Engineers (IEE) test and report should be carried out by a NICEIC registered and approved electrical contractor.

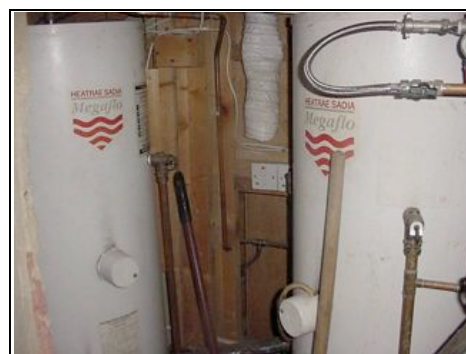
There are two modern Megaflo hot water cylinders. In our experience we have found these to be very good. This type of cylinder hasn't been in existence for that long.

Megaflo Cylinders

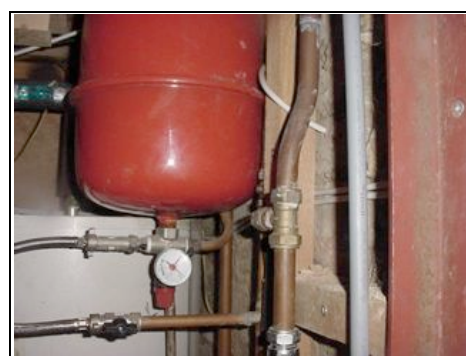
We noted that the system is pressurised which means that pressure is added to enable the water supply to reach all the parts of the building. These need regular maintenance.

Pressurised cylinder

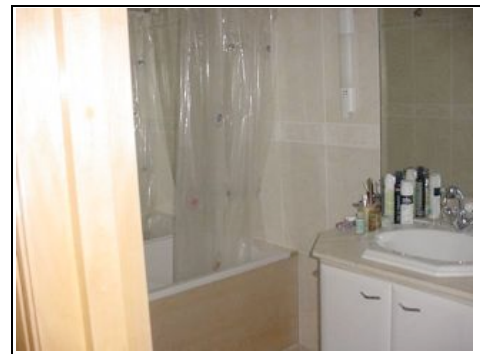
En-suite bathroom to front left hand bedroom

This comprises a three piece bathroom suite, consisting of a bath, shower, wash hand basin and WC, which looks in average condition. The shower mastic needs checking.

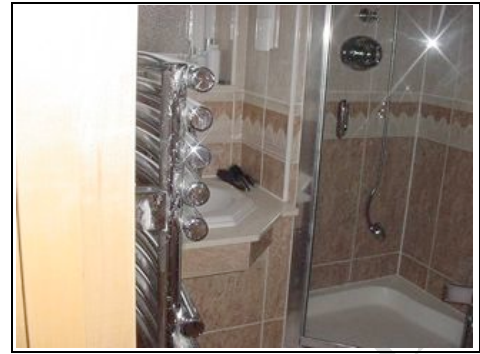
En-suite shower room to front right hand bedroom

This comprises a three piece bathroom suite, consisting of a shower, wash hand basin and WC, which looks in average condition. We would recommend you check the seals around the shower.

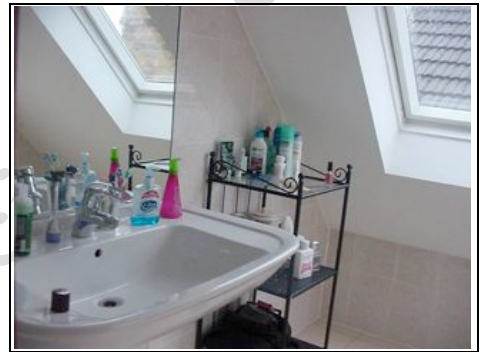
Bathroom to top floor

This comprises a three piece bathroom suite, consisting of a shower, wash hand basin and WC, which looks in average condition. Again, we would recommend you check the seals around the shower.

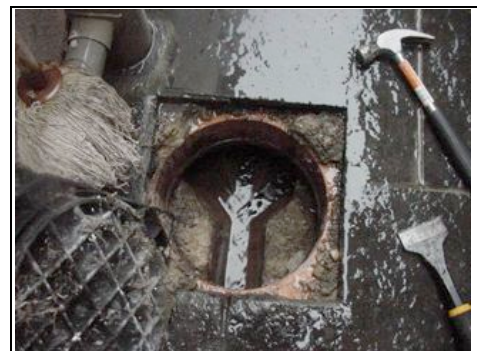
Manhole one

We duly lifted the cover and found it to be free flowing at the time of our inspection.

From what we could see it is plastic.

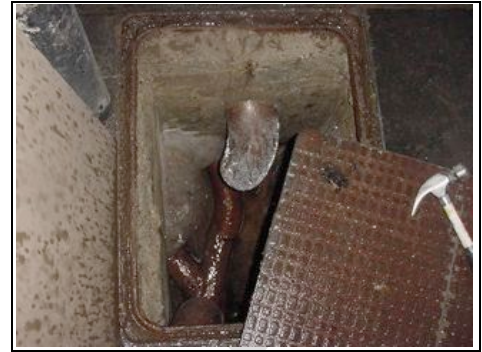
Manhole two

We duly lifted the cover and found it to be free flowing at the time of our inspection.

From what we could see it is concrete built.

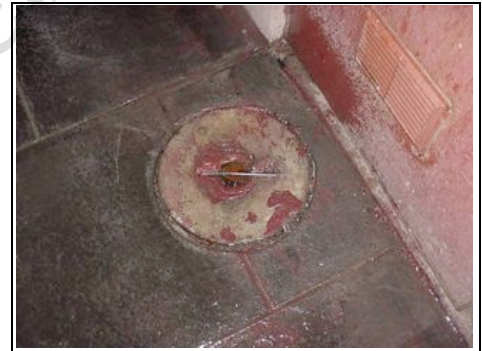
Manhole three

**Inspection Chamber / Manhole Three –located in the middle**

We were unable to lift this manhole. It is known as a modern inspection chamber.

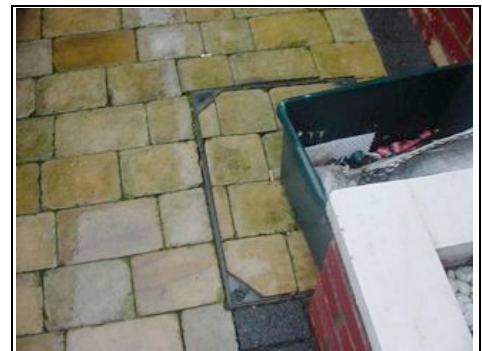
Manhole four

**Inspection Chamber / Manhole Four – located to the front right hand corner**

We were unable to lift this manhole.

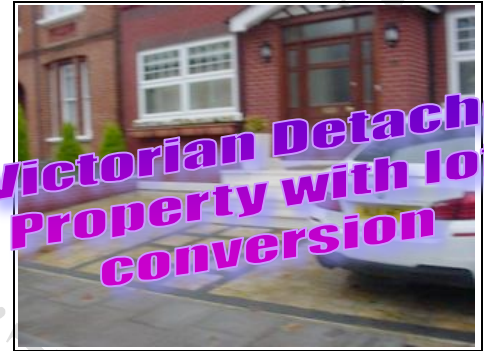
There is a car parking area to the front of the property.

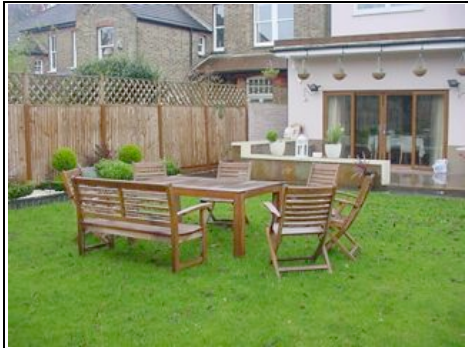
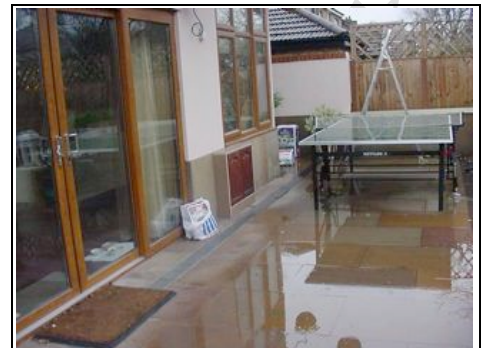
The rear garden has a patio area and a grassed area. Please note our comments on the tree in the Trees Section, which could affect your insurance and could be affecting the rear of the property.
