DEFECTS REPORT AND BUILDING SURVEY

XXX
Hackney,
London.
E8 XXX

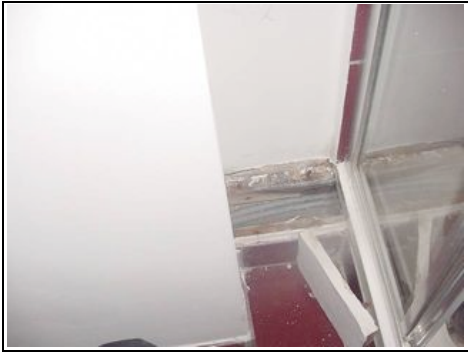
We would also add that we could see that plastic piping had been used throughout: we are finding problems can occur with the joints with this type of piping. We have experienced problems a few times now, for example, once where the vibration from the pump/saniflo worked joints loose and another where the joints had not been carried out properly.

Plastic pipes in lower ground floor

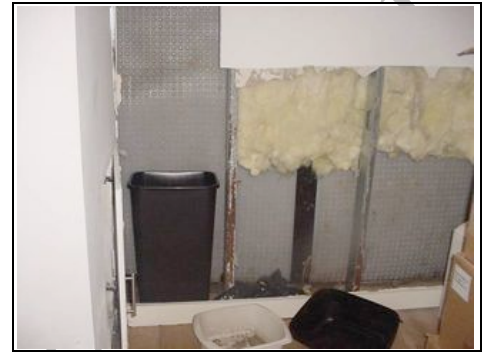
We can see the tanking/damp proof membrane in place.

It would appear that, from our visual investigations, there is a defect possibly in the tanking.

ACTION REQUIRED: Most tanking will have a guarantee. You do need to ensure that the plumbing is not leaking so that this cannot be blamed by the tanking contractor.

Again we believe this should be brought to the attention of the NHBC informing them that the tanking appears to be leaking, again with a time frame set before legal advice is sought if no progress is made.

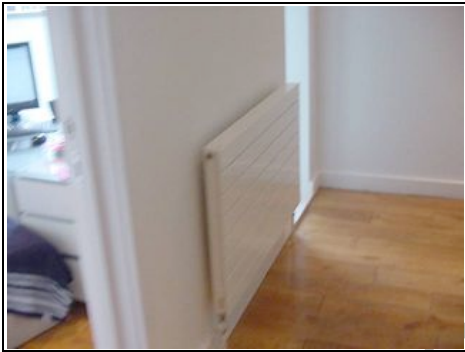
There is a lack of air circulation in the property. In theory, radiators situated underneath windows provide a better air circulation rather than on internal walls as this allows the warm air to hit the cool air from the window and circulate around the room (please see the adjoining sketch). The lack of air movement/circulation could be contributing towards the problems

Internal radiators should be moved underneath windows

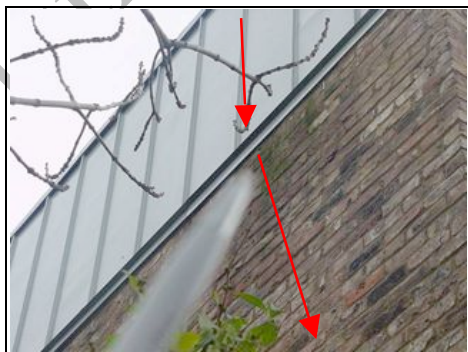
Another concern we have with the roof is that the detailing to the perimeter is poor and we believe is allowing water to discharge down the metal cladding and then onto the brickwork which is not satisfactory. It is more usual for the detailing to throw the water away from the building.

Water discharges onto the brickwork

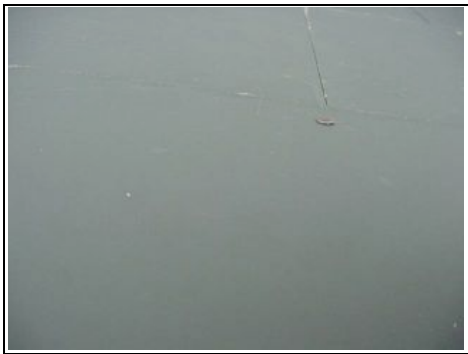
We have not had a close inspection of the vertical slates on the right hand side but they look to have been nailed in place. It needs to be checked that the correct nails have been used (non-ferrous).

Slates have been nailed on

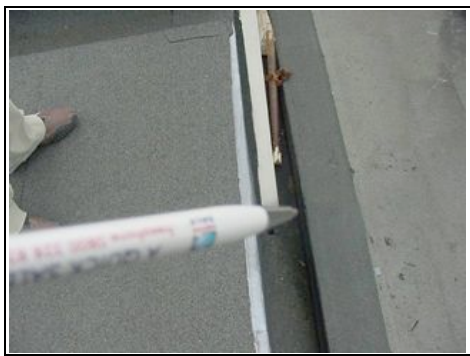
Box gutter on flat roof

ACTION REQUIRED: Please see our comments within the Executive Summary

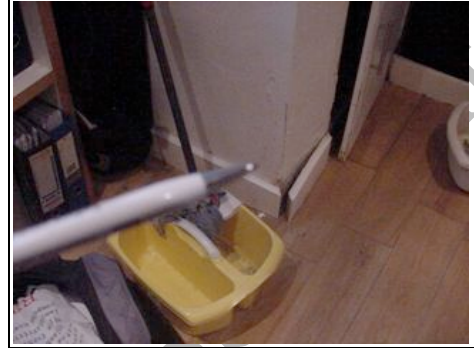
Store room (front)

Adjoining wall affected by damp

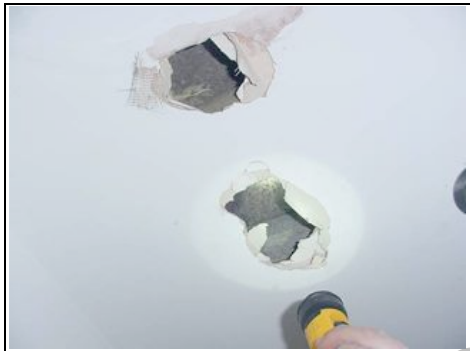
Shower Room

Opening up ceiling to resolve problems with traps

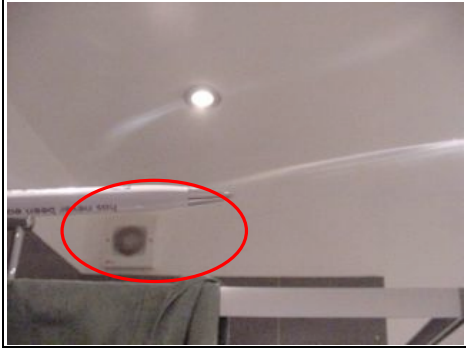
Bathroom

Extract fan is too small
