RESIDENTIAL BUILDING SURVEY

XXXXXXXXXXXXX,
South Tottenham,
Haringey,
N15 xxx

**Victorian
Terraced
Property**

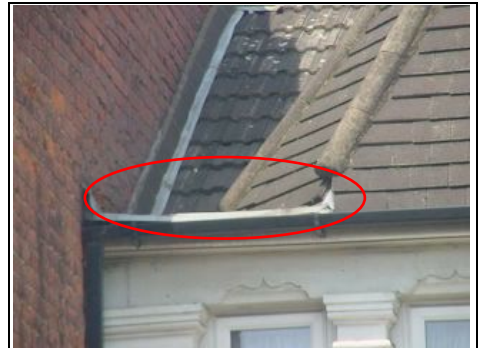
The property has been re-roofed with a concrete tile, this work is from the poorer end of the market with an unusual flat roof section to the left hand side. In addition to this the detailing is below average using tiles on edge instead of a lead flashing.

Flat roof section

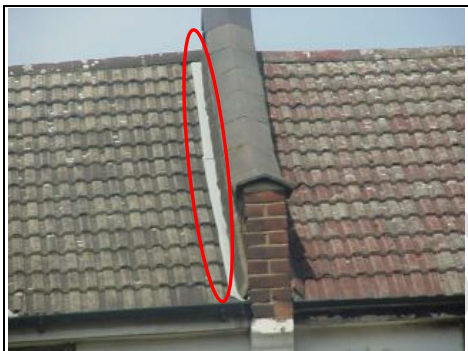
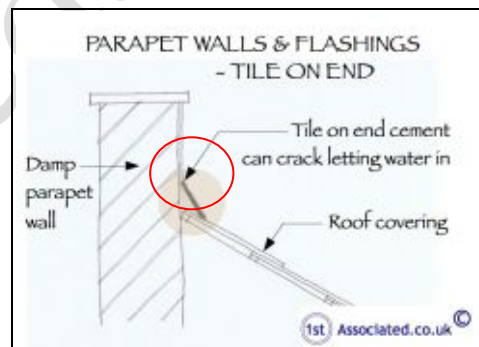
Tiles on edge

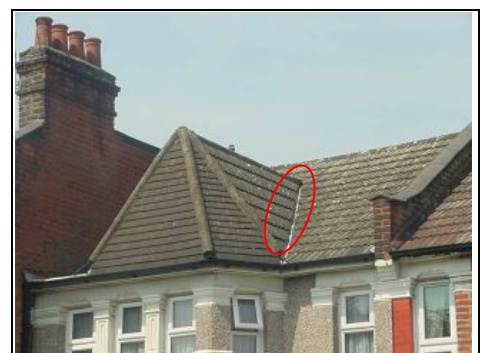
We noted very narrow valley gutters to the roof which tend to become blocked.

Narrow valley gutters

ACTION REQUIRED: In years to come these areas will need replacing. We would also comment that it may be difficult to access due to the high level of the roofs which could double if not treble the cost, far exceeding the cost of the roofing work.

ANTICIPATED COST: £2,500 to £5,000. It may be possible to use a tower scaffold to carry out some of the work; please obtain quotations.

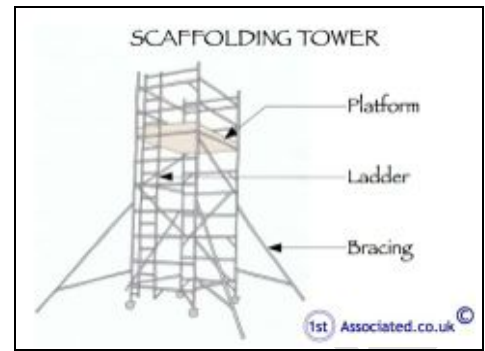
Tower scaffold

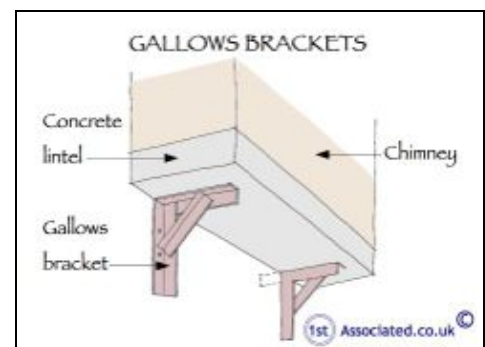
Having said that, the chimney alterations have stood the test of time, however, it may mean in the future that this will devalue the property slightly due to this defect in the property.

Gallows bracket

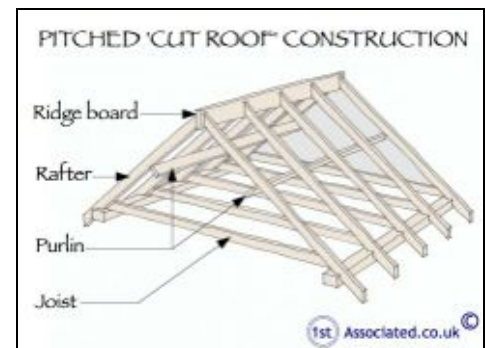
This would originally have been a slate roof but it has now been re-roofed with a concrete tile. The rear roof appears to have once been in a poor condition as the common rafters have been replaced and there also appears to be a replacement purlin.

Purlins in cut timber roof

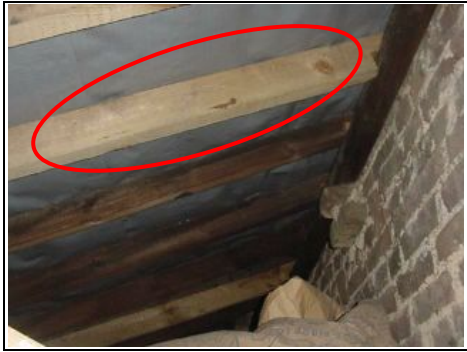
New common rafters
have been added

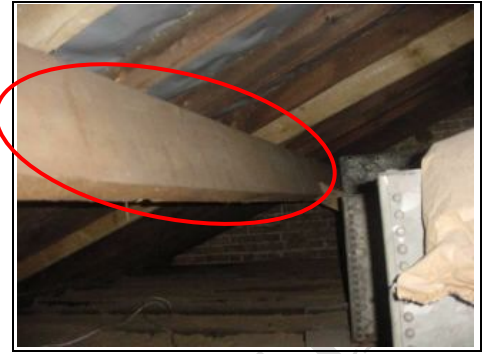
New purlin added

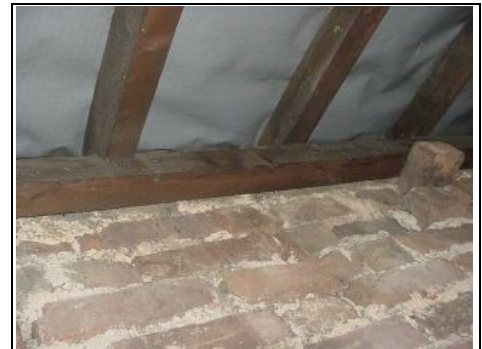
We are particularly concerned that the new timbers have been incorrectly cut to approximately half their width where they meet the wall plate; typically it should be much less than this. In fact, we noted that some older timbers have not been cut at all and others only up to a third of their width.

Older timbers show minimal cuts

ACTION REQUIRED: We cannot see anything specifically wrong with the roof at the moment but you need to be aware of the problems within it. Please also note the next section.

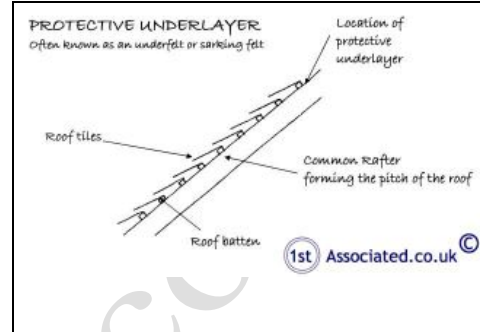
Protective underlayer

This plastic underlayer was used for some years before it was realised it helped promote condensation. We could see some dampness within the roof which we believe to be condensation; however it is possible the roof is leaking.

ACTION REQUIRED: We would recommend that ventilation is added in the form of vented roof tiles to reduce the chance of timber deterioration.

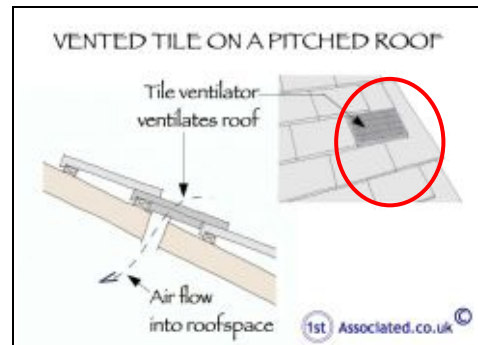
Vented tile

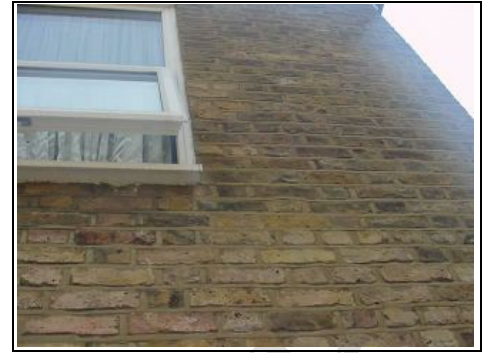
We could see that the brick work has been re-pointed in cement mortar that will reduce the breathability of the property. Older properties such as this were originally built with a lime mortar that would allow them to breathe. This also meant that any dampness getting into the building was dissipated out.

Bricks re-pointed in cement mortar

ACTION REQUIRED: The cement mortar should be removed (it will eventually fall out on its own but a soft brush will help it). We recommend you find a time served brick layer who is able to carry out the re-pointing in lime mortar and gradually replace sections of the cement mortar with lime mortar.

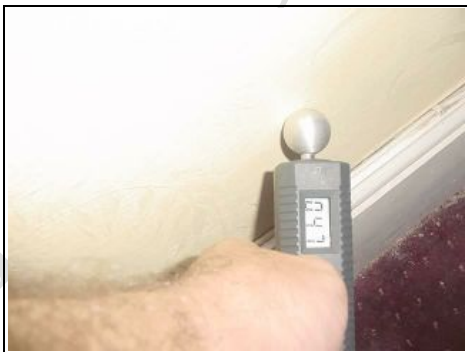
Damp reading is what we would expect to the front wall

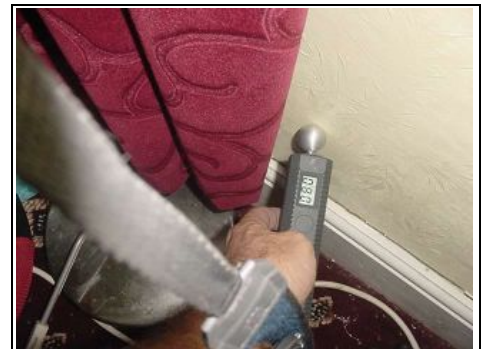
There was dampness evident to the rear of the property in the lounge. We believe this dampness to be caused by a lack of airflow under the suspended timber floor, partly caused by the concrete floor to the kitchen and also due to the re-pointing in a cement mortar.

High damp readings to the rear wall

ANTICIPATED COST: £200 to £400, possibly more, you will need to open up the floor to check. The amount of work will depend upon the condition of the timbers / floor. Additional work would be to repair / replace floor joists and supporting timbers and possibly floor boards although this is a worst case scenario and felt unlikely from the deflection in the floor; please obtain quotations.

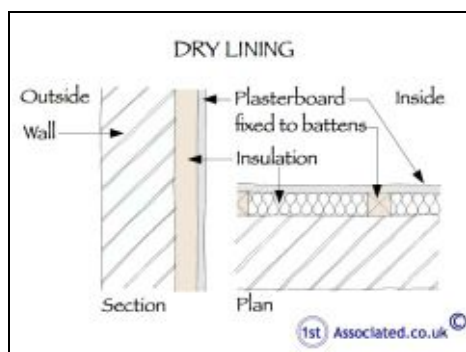
We believe there may also be dampness to the kitchen area. However this is partly hidden by the dry lining. You may discover this dampness when you are refurbishing the kitchen. We will be more than happy to return and comment once the kitchen units and dry lining have been removed.

Dry lining

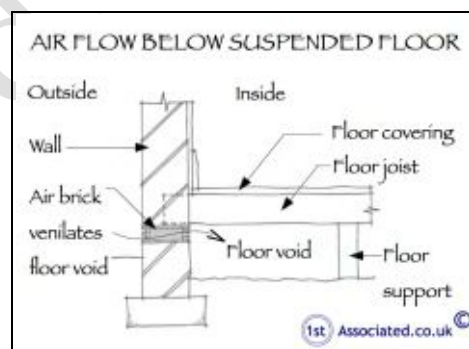
Airflow to suspended floor

ACTION REQUIRED: Add additional air bricks to the suspended timber floor.

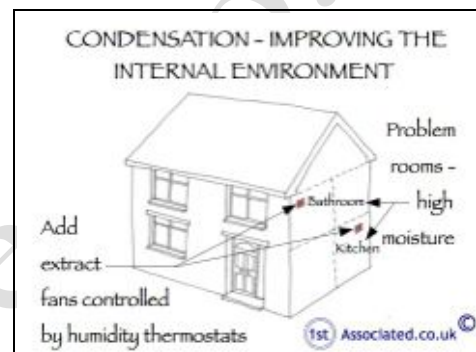
Improving the internal environment

ACTION REQUIRED: We would recommend that large humidity controlled extract fans are installed in the bathroom, kitchen and any rooms used for laundry/drying of clothes.

ANTICIPATED COST: Approximately £200 to £400 per extract fan dependent upon wiring required; please obtain quotations.

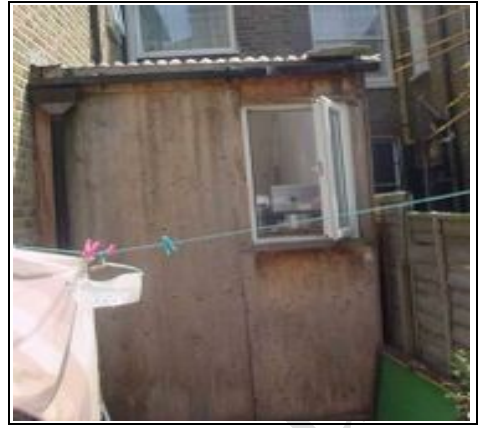
We would term the standard of the lean-to as DIY and as discussed with you we would expect it to be replaced in the not too distant future.

Lean-to

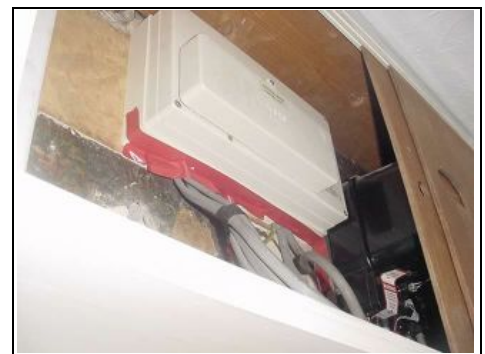
The electrics are located in the high level cupboard to the right hand side of the entrance to the property. They are circa 1960's and better are now available.

We would also add that there appears to be a general lack of socket points throughout the property, you may wish to add more.

Electric fuse board

ACTION REQUIRED: Budget to expect a complete re-wire in this type of property. We would recommend that the fuse board is replaced and that extra socket points are added where required.

ANTICIPATED COST: Expect costs for a full rewire to be in the region of £3,500 to £5,000. A partial re-wire can cost from £1,000 upwards. To replace the fuse board, £150 to £400; please obtain quotations.

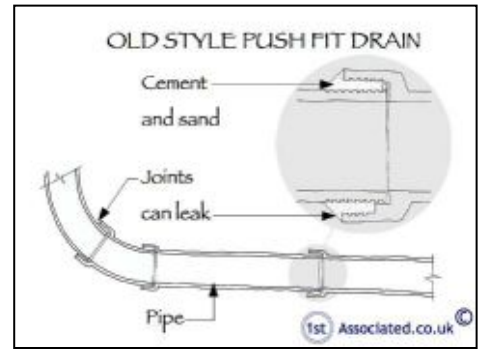
In older properties, such as this, drainage was often push fitted together rather than bonded together which means that they may have leaked over the years. Whilst we ran the tap for 15 minutes without any build up or blockages the only way to be 100% certain of the condition of the drains is to have a closed circuit TV camera report.

Older style drainage pipes

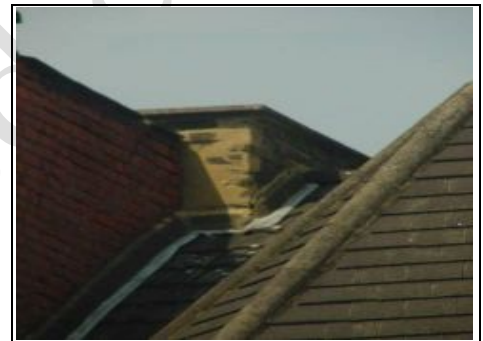
This chimney is brick finished with a tile on edge flashing and no chimney pots. We can see that it has been lowered and re-pointed badly, we assume due to dampness getting into the property. We can also see from within the roof that the front section of the chimney has been removed and gallows brackets added.

Chimney (front left)

ACTION REQUIRED: Please see our comments within the Executive Summary.

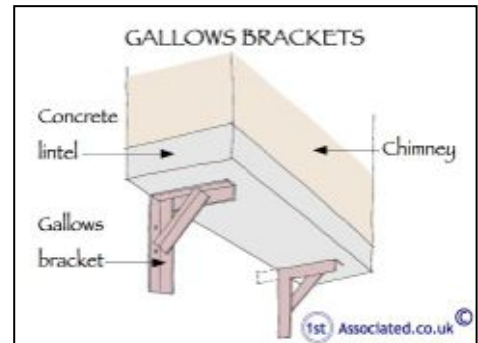
Gallows brackets

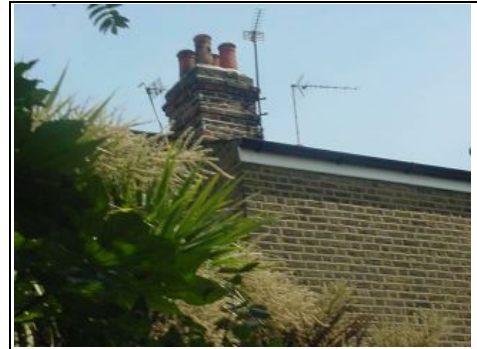
This chimney is brick finished with four chimney pots. Externally we had a poor view of this chimney but what we could see from ground level looked to be in average condition considering its age, type and style.

The chimney appears to have been removed internally at kitchen/ground floor level.

Chimney (rear)

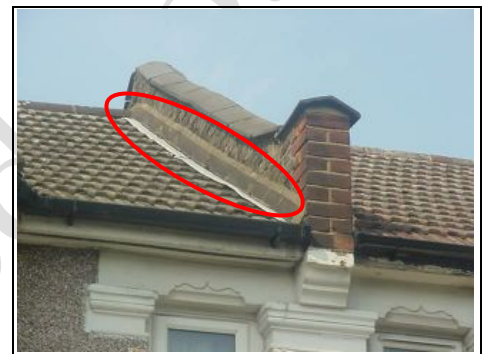
In this case there are parapet walls built from brick with a tiled coping stone and a tile on edge flashing. We can comment that generally these flashings do eventually leak although in this case there does look to be metal underneath them but this does not appear to be lead.

Front right parapet wall with tile on edge flashing

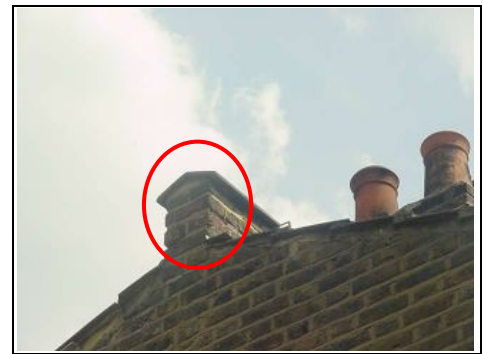
Rear parapet wall

Finally, we would add that we were only able to see approximately five per cent of the parapet wall to the rear of the property, therefore we have made our best assumptions based upon what we could see. A closer inspection may reveal more.

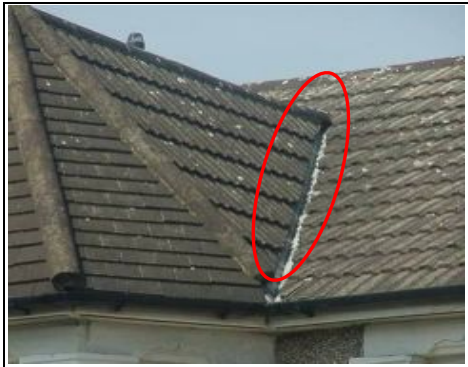
Thin valley gutter

Please see our comments within the Executive Summary.

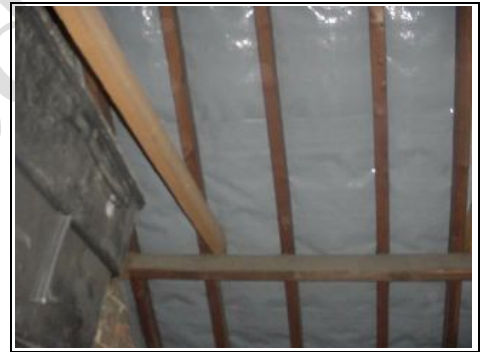
When we inspected the loft space we found a plastic underlayer which in our experience will cause condensation to occur.

ACTION REQUIRED: Please see the Executive Summary regarding ventilation.

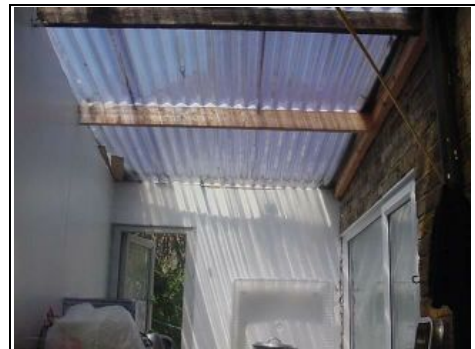
We have termed this lean-to as being to a DIY standard. The roof is a relatively thin, corrugated plastic and may well leak during the winter months or heavy wind driven rain.

Plastic lean-to roof

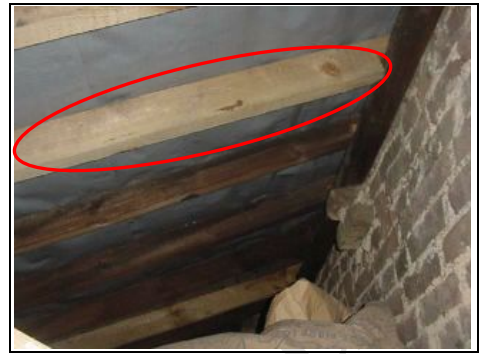
In the rear roof we can identify the new timbers by the difference in colour indicating that they have been added at a more recent point in time. Please see our comments within the Executive Summary.

New timbers added in rear roof

ACTION REQUIRED: Please see our comments within the Executive Summary.

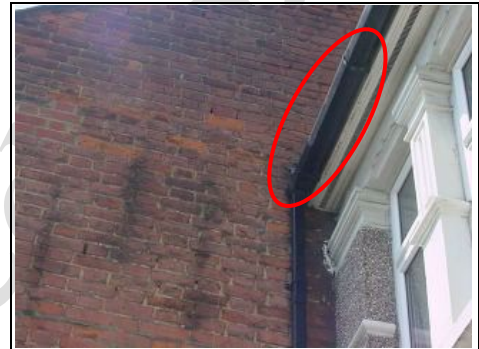
We feel there may be problems to the front gutter that may be discharging down the brick wall of the neighbouring property on the left hand side.

Overflowing gutter and downpipe

We would advise that you speak to the neighbour and ask if the gutter is causing dampness in their property. We did knock on the door on the day of the inspection but no one answered.

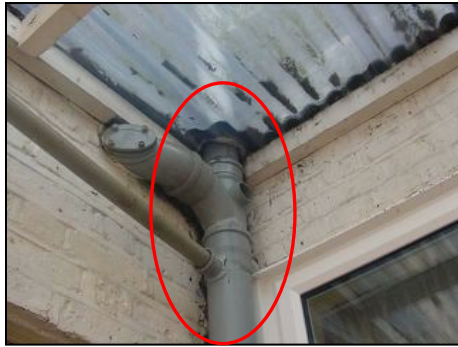
We believe the soil and vent pipes are plastic and part of this is internal within the DIY lean-to. This is not ideal and we feel, at the very least, it should be boxed in.

Soil and vent pipe in lean-to

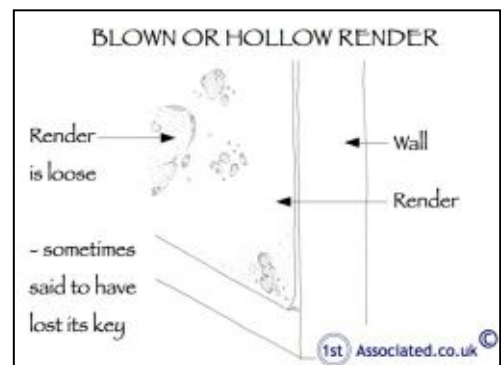
You can get hairline cracking within the pebbledash render which can be very difficult to see but can lead to sections of the pebbledash coming away. Any cracks that do appear need to be sealed as soon as possible to stop dampness and water getting in and causing blisters and hollow areas.

Blown or hollow render

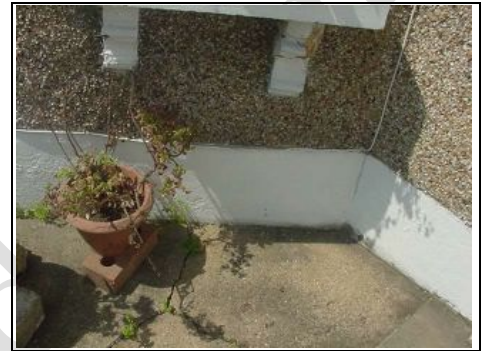
All modern properties should incorporate a damp proof course (DPC) and good building practice dictates that a differential of 150mm (6 inches) should be maintained between the damp proof course and ground levels. In this case, we cannot see a DPC because of the plinth. However, a plinth normally indicates that it would be a slate damp proof course, if a DPC was put in at all.

DPC is hidden

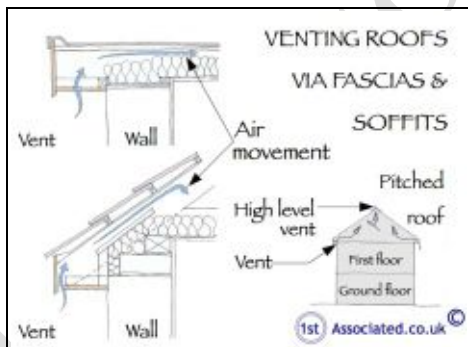
The fascias and soffits to the front look to be plastic from ground level as they have a vent in them but do not appear as shiny as we would expect plastic soffits to look. However where we can see them to the rear we note that they are plastic.

Vents to roofs via fascias and soffits

ACTION REQUIRED: Make sure that the insulation in the roof is not blocking the air from venting the roof, with this type of roof it is very important that it is ventilated adequately. As mentioned earlier we would recommend adding more ventilation.

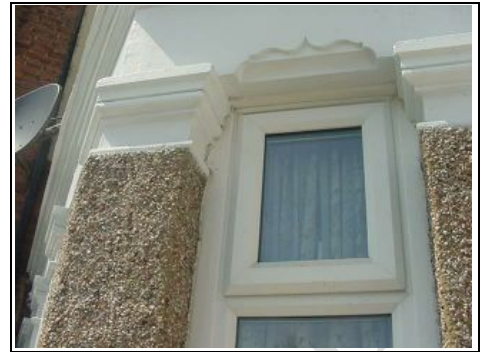
Windows without trickle vents

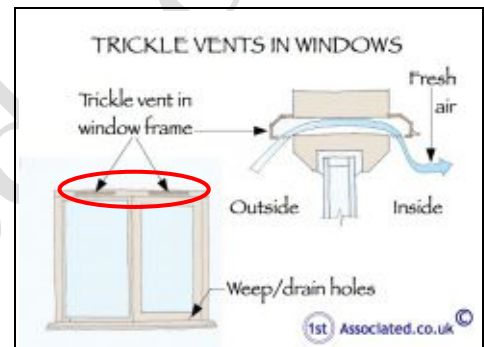
Plastic double glazed windows without trickle vents

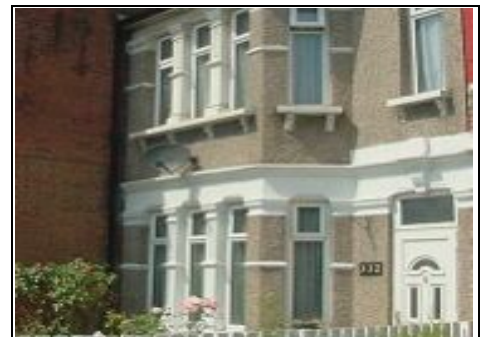
Bay windows

We would draw your attention to the fact that sealed double glazed units can fail, particularly as a result of poor workmanship during installation. Failure of the seal leads to condensation between the two panes of glass and simply replacing the affected units may not provide a satisfactory long-term solution.

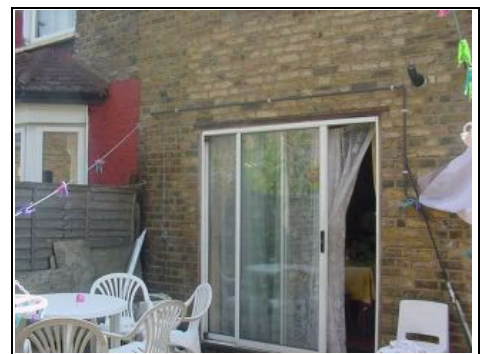
Rear patio doors

We noted a timber lintel to the rear of the property. Whilst a timber lintel is not unusual in this age of property it is relatively unusual where alterations have taken place, such as where sliding doors have been added and where typically they would have transferred over to a metal or concrete metal. This does point out to us that there have been a fair amount of DIY alterations to this property.

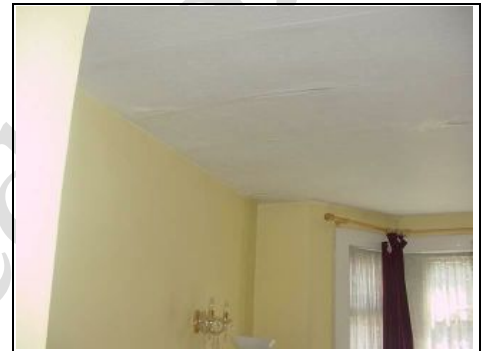
Lounge ceiling

We noted the paper is coming away to the ceiling in the lounge and in other rooms indicating to us that redecoration will be required almost immediately.

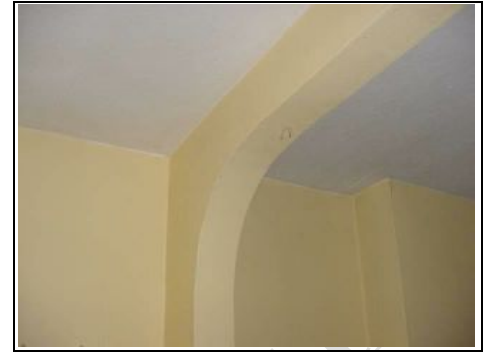
The central wall has been opened up considerably in the lounge to make a through lounge. Generally the other walls within the property remain in their original form with the exception of the kitchen where we believe a cloakroom has been added.

Wall removed in lounge

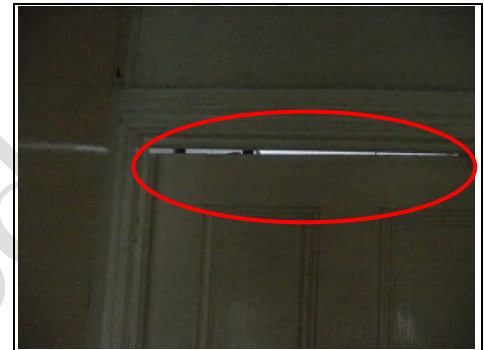
In older properties such as this often structural movement can be seen in the way the door frames and the doors have moved over the years (assuming that the doors are not new).

Gap showing movement above the front bedroom door

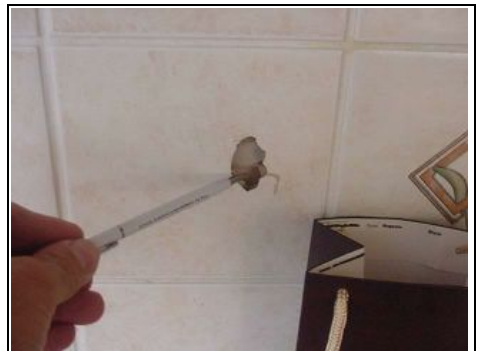
We believe they are generally an older style lime plaster with the exception of the kitchen where we noted what appears to be an area of dry lining to the central wall.

The walls in the kitchen have been dry lined

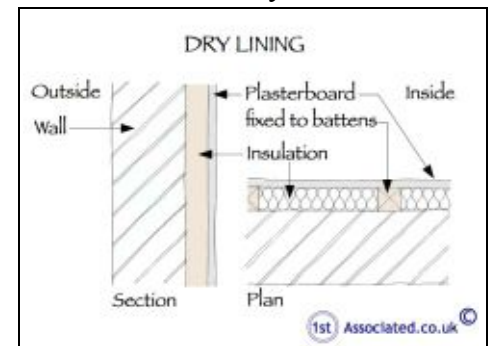
Dry lining

We would expect that there may be some central wall dampness. Unfortunately we cannot get to the actual wall because of the dry lining.

ACTION REQUIRED: When you carry out the refurbishment you will need to inspect the main kitchen walls

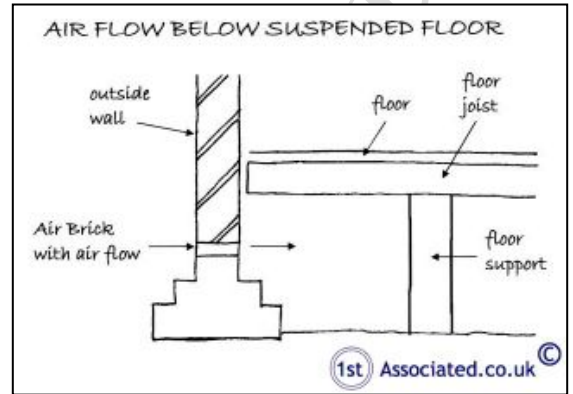
There is a mixture of a suspended timber floor to the front of the property, which requires air movement underneath to minimise wet rot, dry rot and woodworm and a concrete floor to the rear.

As mentioned we suspect that there is dampness being hidden by the kitchen units etc. which unfortunately you may discover when you look at refurbishing the property.

Suspended timber floor

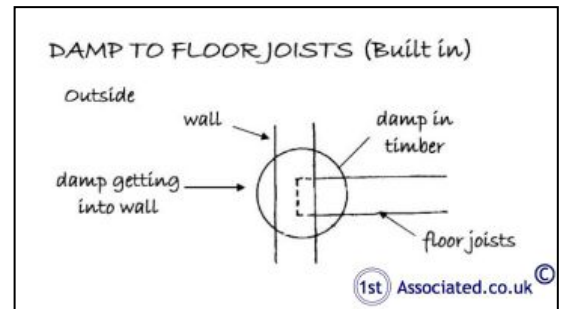
Embedded timbers

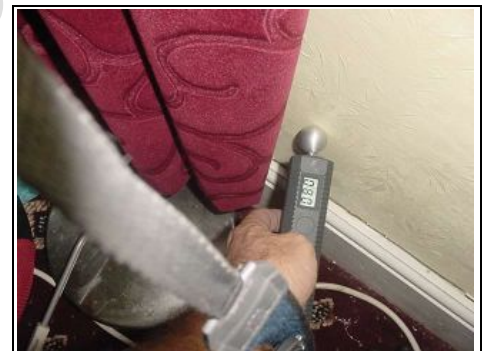
A random visual inspection and tests with a moisture meter have been taken to the perimeter walls. In this particular case we have found rising damp to the rear of the property.

Testing for rising damp

ACTION REQUIRED: Please see the Executive Summary regarding more air vents required.

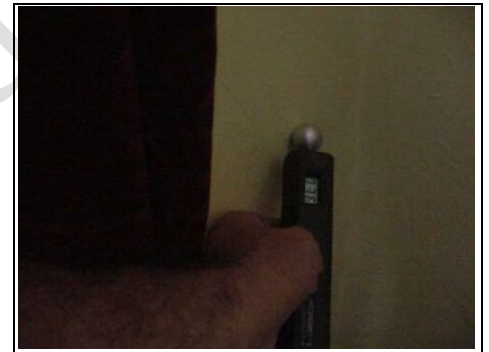
We used a damp meter on the external walls. We have not found lateral dampness.

Testing for lateral dampness

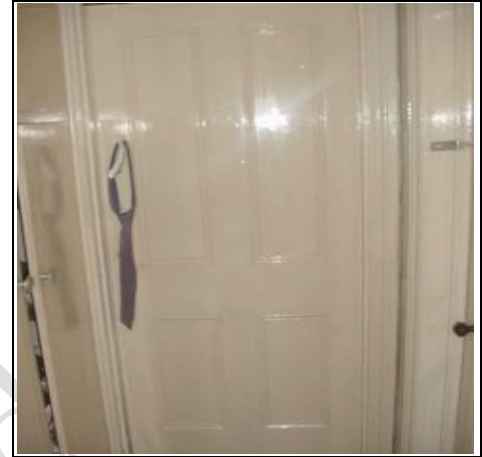
The doors are predominantly painted panel doors. There are also some 1960's/1970's glazed doors that do not have safety glass. Please see our comments within the Executive Summary.

Panel door

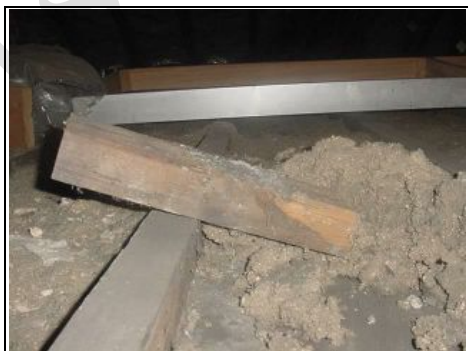
Some roof insulation was present although not to current Building Regulations requirements of 300mm. In this instance the main roof had an older style insulation of about 100mm. This would benefit from extra insulation being added but ventilation must be provided. The rear roof has traditional fibreglass insulation. Only add more insulation if you ventilate appropriately and check the soffit vents are working.

Main roof has older style insulation

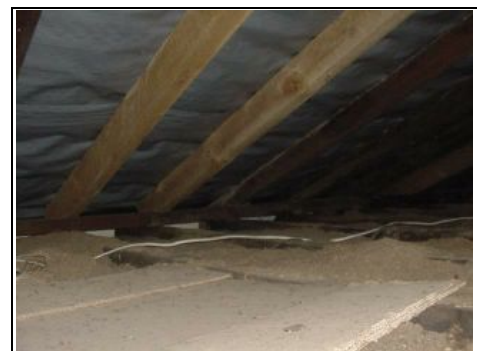
Fibreglass insulation in the rear roof

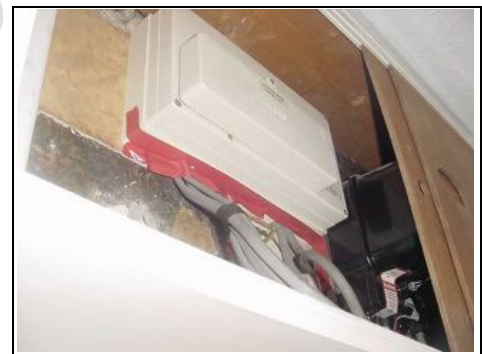
Fuse Board

The electric fuses and consumer units were located in a cupboard near the entrance door. The fuse board looked dated.

ACTION REQUIRED: We would recommend the fuse board is replaced. Please see our comments within the Executive Summary.

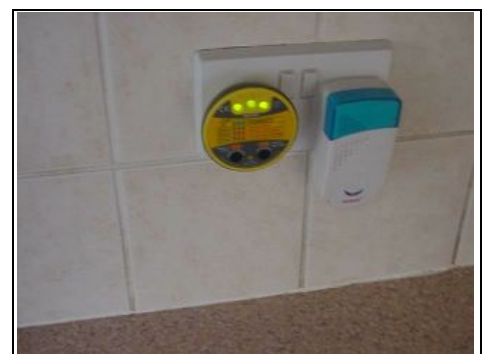
Earth Test

We carried out an earth test in the kitchen area to the socket point that is normally used for the kettle, this proved satisfactory.

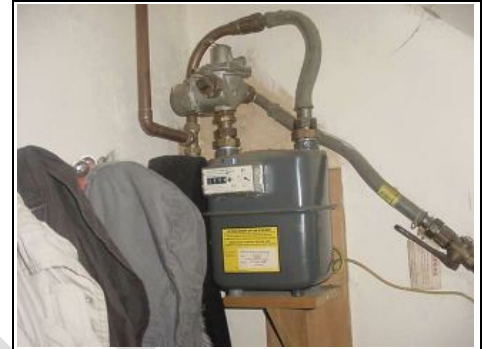
We are advised that the property has mains gas. The consumer unit is located under the stairs.

ACTION REQUIRED: As a matter of course it is recommended that the entire gas installation is inspected and made good, as necessary, by a Gas Safe registered contractor. Thereafter the installation should be serviced annually.

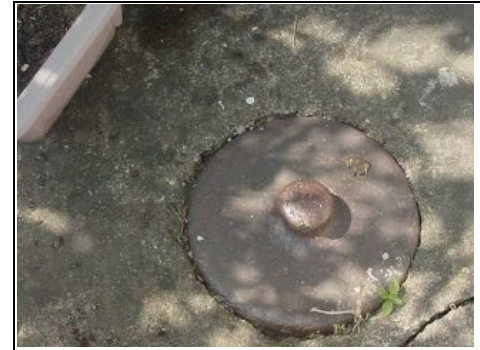
Possibly an old coal chute
