## RESIDENTIAL BUILDING SURVEY

XXXXXXXXXXXX,  
Winchmore Hill,  
London  
N21 xxx

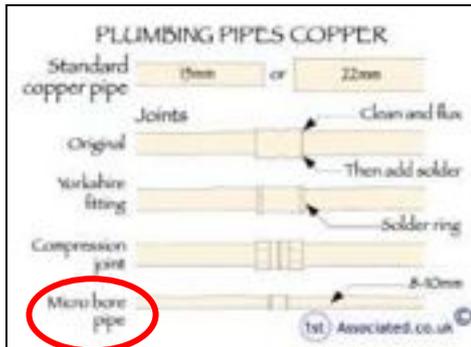
**ACTION REQUIRED:** The heating needs to be looked at and switched on before exchange of contracts or assume that it is not working and that you will need to modify it. We also noted it had micro bore pipes which do tend to block.

Microbore pipes

**ANTICIPATED COST:** We would set aside the sum of £1,000 to £2,000 for pressure jetting the system and repairing the damaged pipe.

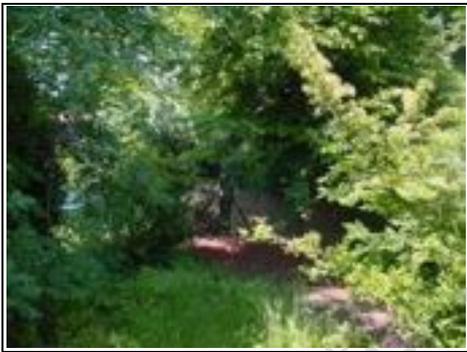
The garden is overgrown. It is particularly important that the ivy is taken off the rear of the property as it looks to be damaging the walls, the fascias and getting into the gutters.

Overgrown garden/jungle

**ACTION REQUIRED:** The garden needs clearing. Cut back plants, particularly the ivy where it is on the wall and in the gutters.

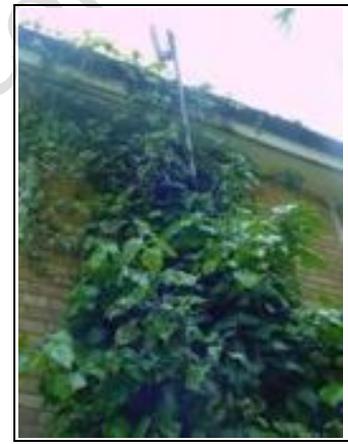
Ivy growing out of gutters and down the walls

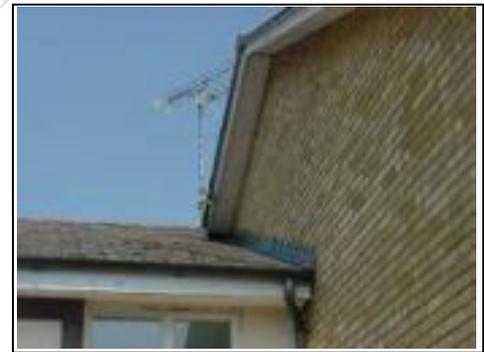
The main roof is pitched and clad with a concrete tile and from ground level, this looks in average condition (with the exception of where the ivy is growing over it to the rear) considering the roofs age type and style. There is also some light moss on it.

Main roof

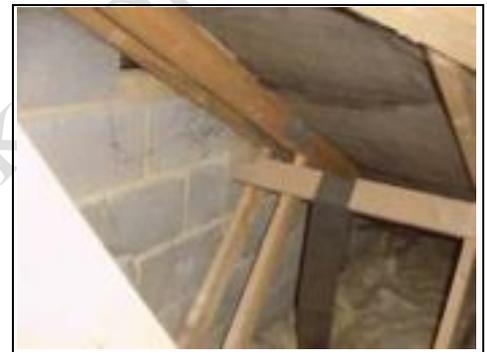
When we inspected the loft space we found a Hessian base Bitumen membrane. This type of membrane has been used since the 1960s. We generally found it to be in average condition, with damage in some areas which is what we typically find.

This photo shows the common rafters (the ones that form the pitch of the roof) and the dark area between is the underlayer

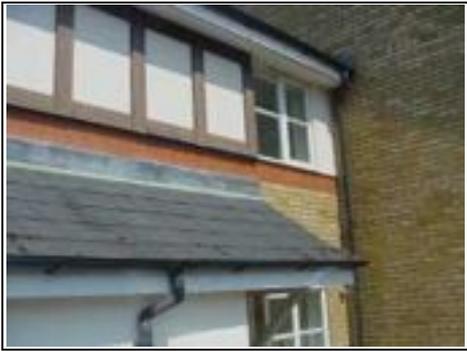
This roof is pitched and is covered with a manmade slate. To the base of it is some moss, for which there does not appear to be an explanation for unless the gutter above is blocked. We were pleased to see a lead flashing where the roof meets the main building. Normally we find with newer buildings such as this that the lead flashing does come away over time.

Porch roof

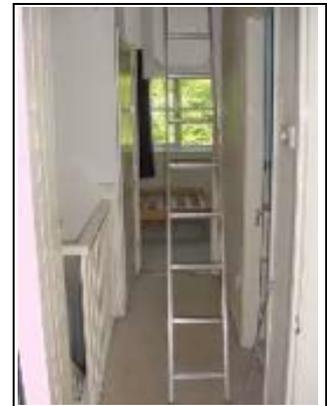
Ladder to loft

The main roof is accessed via the loft hatch located on the landing. There is a loft ladder, an electric light and some secured floorboards. We recommend that secured floorboards are added throughout (preferably with insulation), as it will make the loft space safer and easier to use.

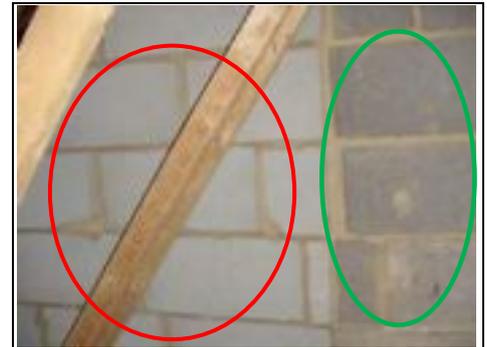
The property has two blockwork firewalls which are located one to the left side and one to the right side (all directions given as you face the property). The firewalls are also Party Walls. They are slightly unusual as they are in different blocks.

Blockwork firewall – note the different blocks

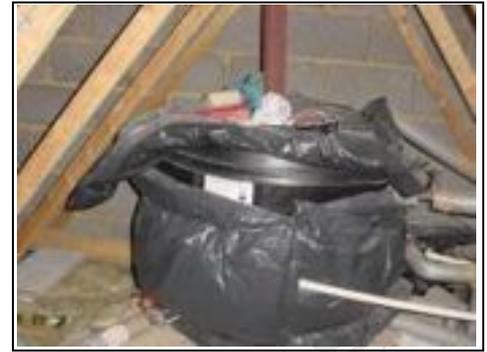
Water tank

We noted an insulated plastic water tank. We would always recommend that water tanks be drained down and cleared of any debris etc. (we have seen dead birds and other unmentionable things in these tanks). As you are often cleaning your teeth with this water it is best that it is as clean as possible!

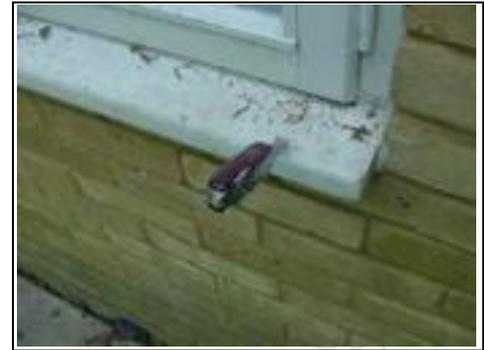
Knife test on window sills

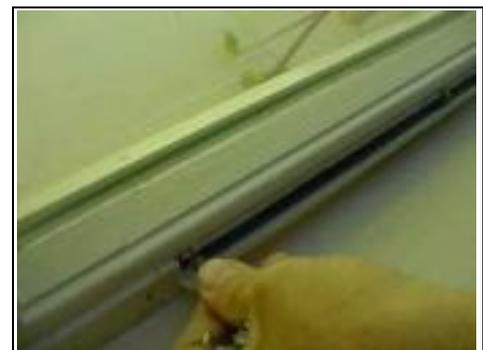
Trickle vents

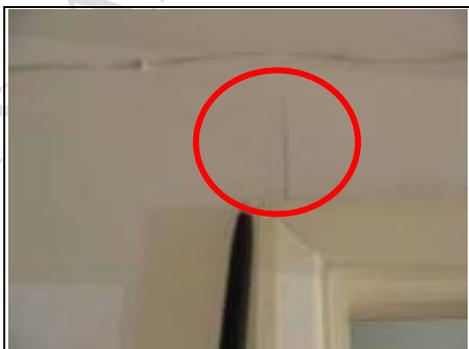
Hairline cracks internally indicate some movement to the property which can be initial settlement but as mentioned it may relate to the drains in this particular era of property.

Hairline cracks inside are not normally a problem

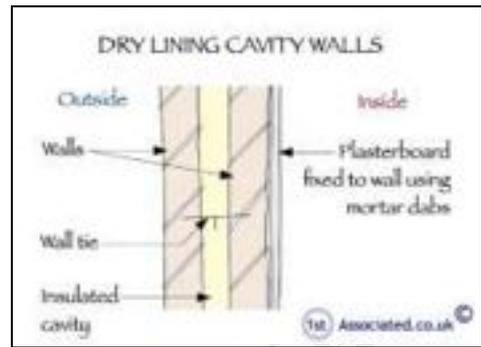
Cavity dry lining

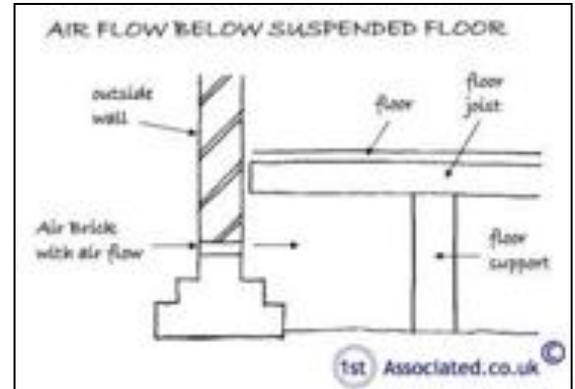
The ground floors of the property are suspended and are likely to be concrete.

Suspended floor

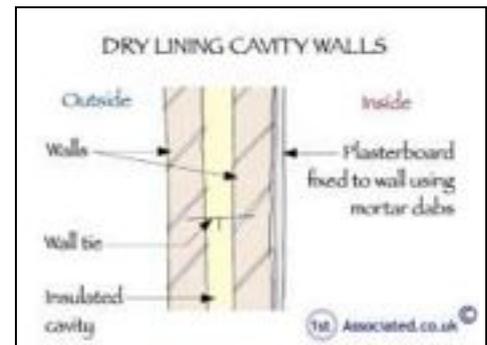
A random visual inspection and tests with a moisture meter have been taken to the perimeter walls. In this particular case we are unable to test for rising damp as the walls are dry lined.

Walls are dry lined

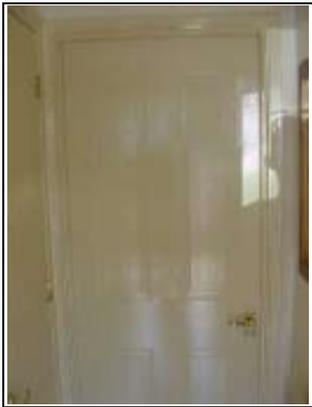
The property has modern hollow egg box construction doors. We noted some damage to the doors and some of the ironmongery needs repairing or replacing.

Modern door

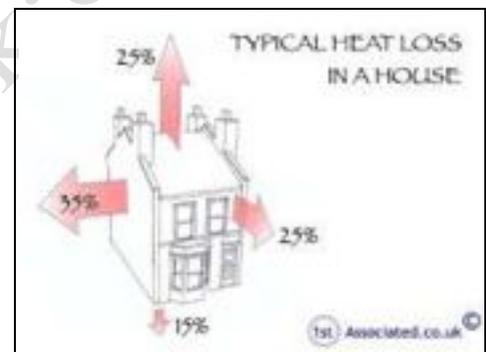
Some roof insulation was present although not to current Building Regulations requirements of 300mm. In this instance there is about 200mm.

Typical heat loss

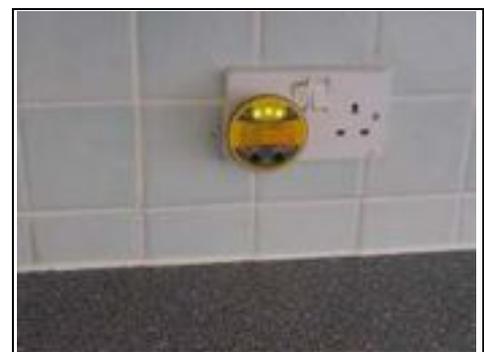
We carried out an earth test in the kitchen area to the socket point that is normally used for the kettle, this proved satisfactory.

Earth Test

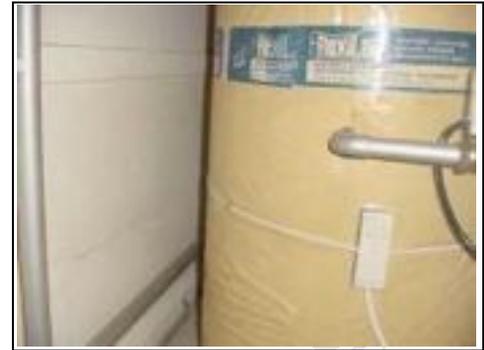
There is a factory insulated hot water cylinder located within the airing cupboard on the first floor. This cylinder will therefore have a good thermal efficiency, although not as good as the more modern hot water cylinders.

Hot water cylinder

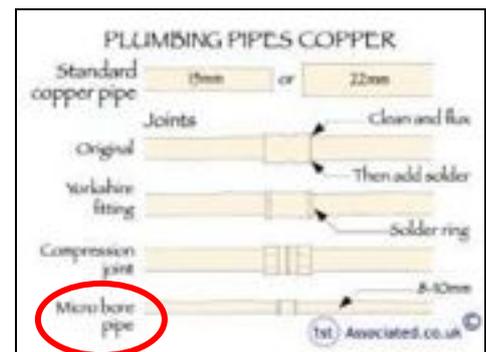
Micro bore pipe

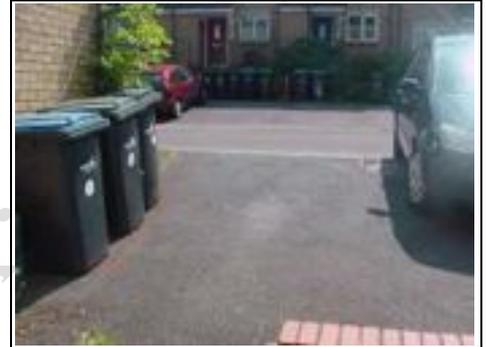
The property has a parking space to the front but the bins may need to be moved as it is a slightly tight space definitely aimed at the smaller car.

Front parking space

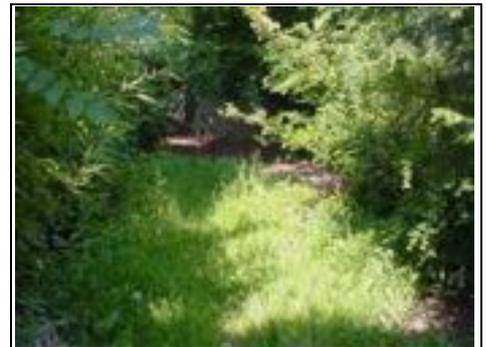
The rear garden is very overgrown.

Rear Garden

**ACTION REQUIRED:** Please see our comments in the Executive Summary.
