RESIDENTIAL BUILDING SURVEY

XXX

Wood Green,
London.
N22 XXX

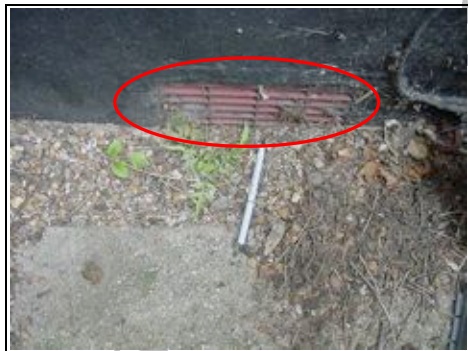
The air bricks to the front of the property are acting as gutters allowing water into the property particularly under the suspended timber floor.

Air brick acting as a gutter

You can protect the air bricks from acting as gutters by surrounded them with brickwork as shown in the sketch. It is the effect that the rainwater/dampness has had on the floor over the years that is our main concern.

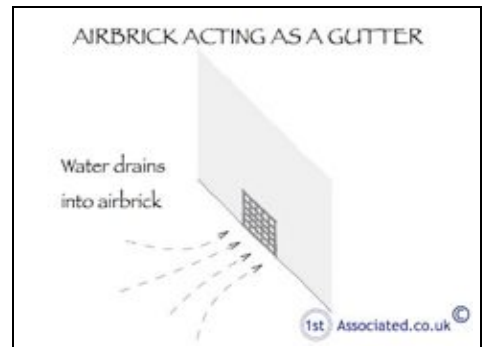
Air brick, acting as a gutter

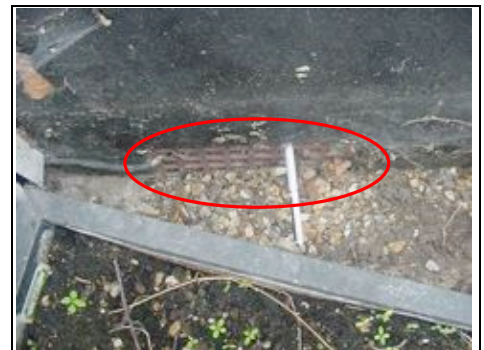
In addition to this some of the air bricks were covered with planters/pots all of which mean there is a lack of airflow underneath the suspended timber floor.

Hidden air brick

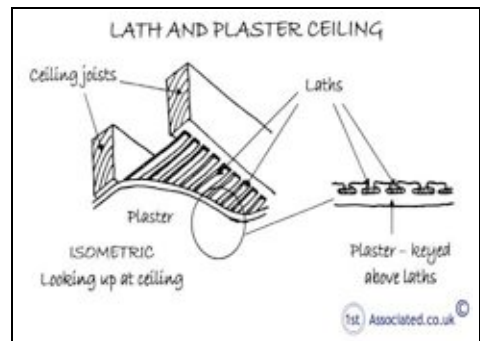
We noted hairline cracking to the front lounge in the lath and plaster ceiling and also to the plasterboard within the kitchen area. Both cracks are acceptable for the age of the property and indicate there may have been a slight twist in the building. This is nothing unusual for a terraced property built in clay soil near to a tree.

Lath and plaster

ACTION REQUIRED: Fill the cracks and redecorate. However it is very likely the cracks will reappear.

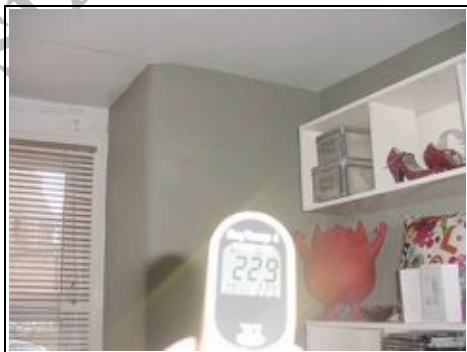
A characteristic of this property is that it will suffer from cold bridging due to the era it was constructed in and elements within it. For example, within the kitchen and bathroom there are no extract fans to remove moisture which then tends to cause condensation.

Taking surface temperature readings, 22.9

ACTION REQUIRED: We would recommend that large humidity controlled extract fans are added.

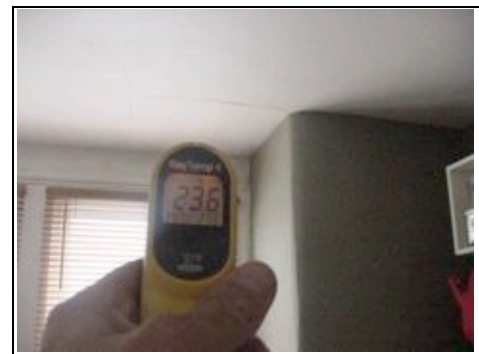
Surface temperature, 23.6
The difference in readings indicates cold bridging

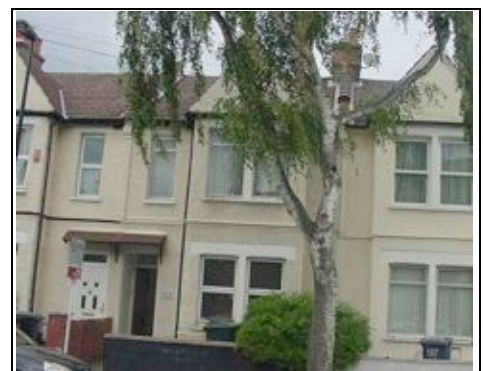
Although it is almost unavoidable in the London area there is always an increased risk when you buy a property built on London clay in close proximity to a tree. We have included an article of the properties of clay within the appendices.

Tree in front of property

ACTION REQUIRED: We would recommend that you speak to your

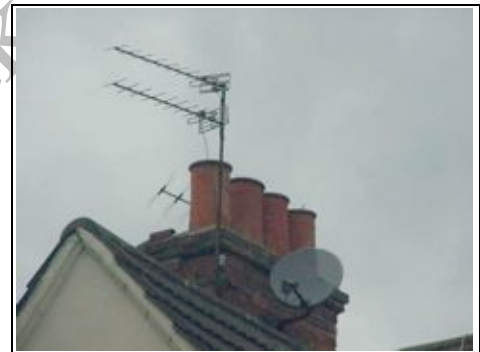
This chimney is brick built but is unfortunately difficult to view properly. It originally had eight chimney pots, four of which are still standing and four that have been closed or partially closed, we cannot see for certain. From ground level we could see approximately thirty per cent of the chimney which looked in average condition.

Chimney - right

Unfortunately we were unable to see the top of the chimney known as the flaunching, we therefore cannot comment upon them.

ACTION REQUIRED: Periodically inspect the chimney.

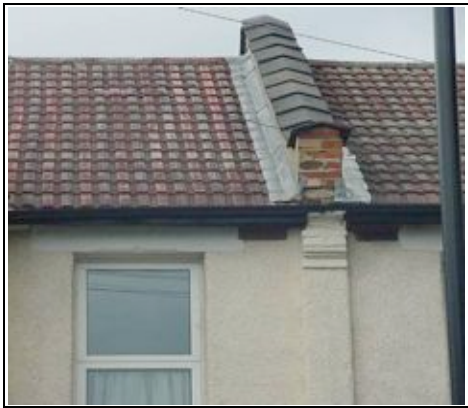
In this case there are parapet walls to the left and right hand side built from brick with a coping stone and a lead flashing. We would comment that generally the wall to the left hand side is in average condition, however, the neighbours poor repairs on the right hand side may affect the upstairs of this property which may in turn mean you have to pay a contribution towards the costs.

Parapet wall (left)

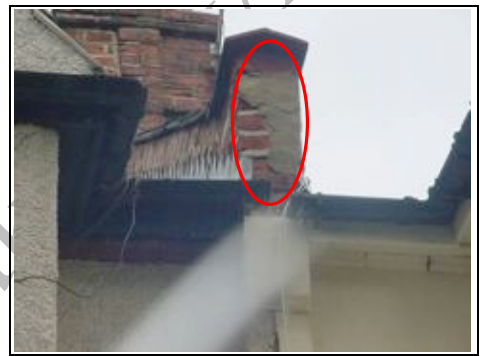
Parapet wall (right)

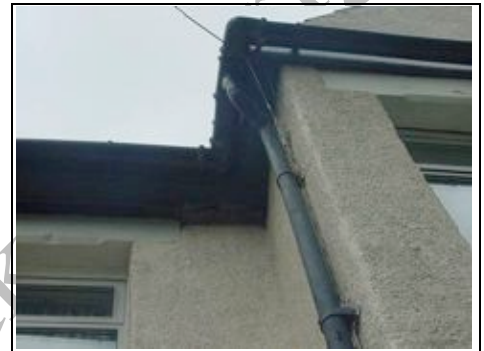
Plastic gutters and downpipe

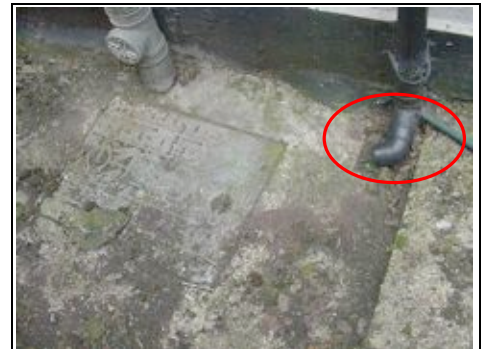
Downpipe discharging into partially blocked drain

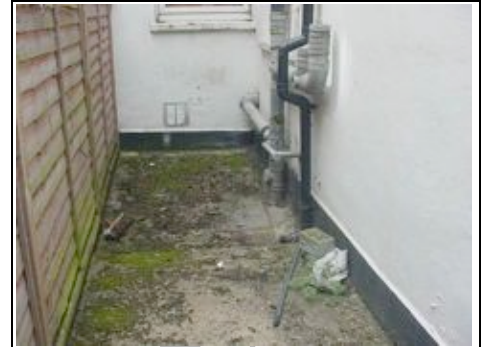
The soil and vent pipes and wastepipes are plastic. We noted they were discharging sewerage.

Soil and vent pipe

ACTION REQUIRED: Please see our comments within the Executive Summary.

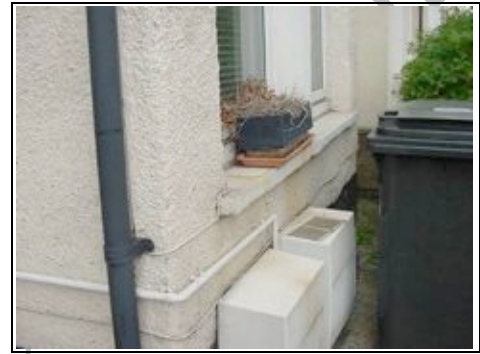
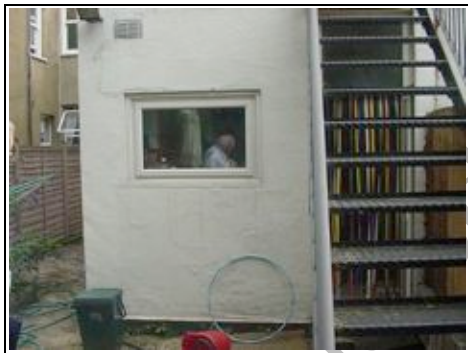
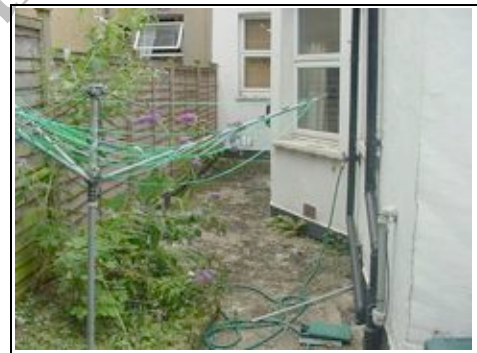
We are always wary when we see rendered properties as it usually means they have been rendered for a particular reason. In this particular case we believe that the render has been added to help make the building water tight.

Render - front

Render - rear

ACTION REQUIRED: We would recommend in the summer of 2014 that the whole of the render on both this ground floor flat and the upstairs neighbours flat is tap tested and checked for hollow areas and then work carried out.

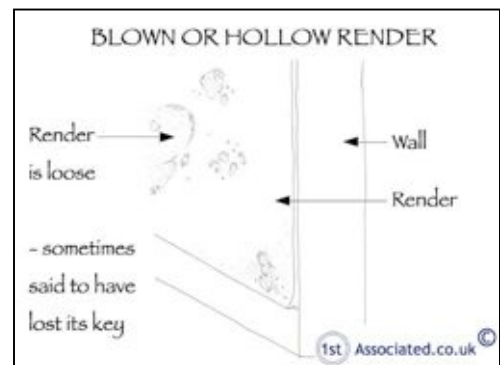
We have carried out a tap test (literally hitting the render with the back of a hammer). We found it to be in below average condition for its age, type and style with about ten to twenty per cent of hollow areas.

Blown or hollow render

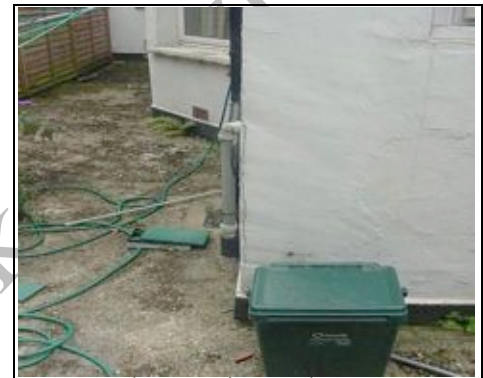
Render repairs to the rear right corner

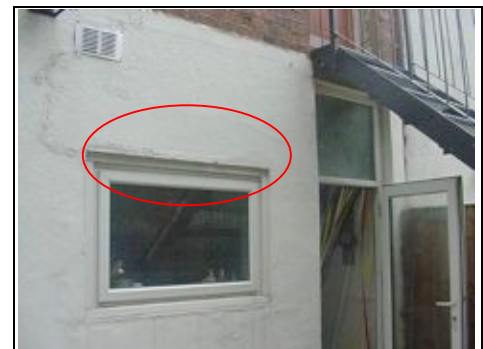
In this case we found no drip detail to the windows.

No window drip detail

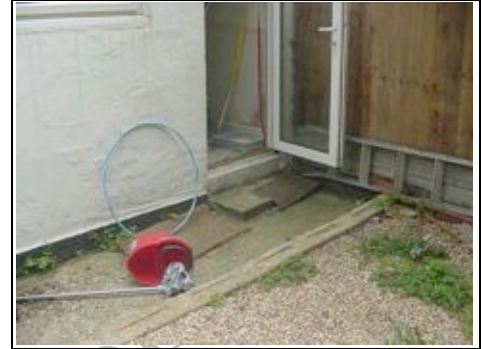
Whilst the render is cut short of the ground there is not a bell mouth detail as such.

No bell mouth

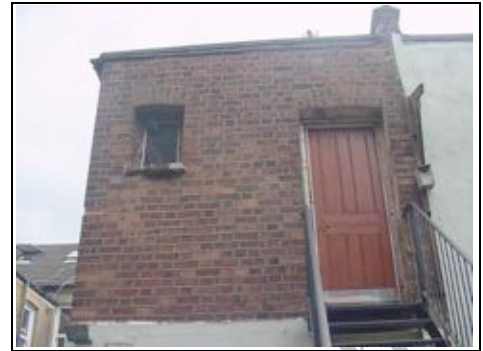
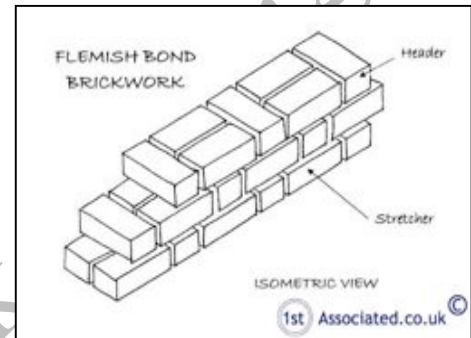
We could see Flemish Bond Brickwork to the rear at high level. This is in poor condition and we would recommend that this is rendered to match the property.

Brickwork at first floor level

Flemish Bond brickwork

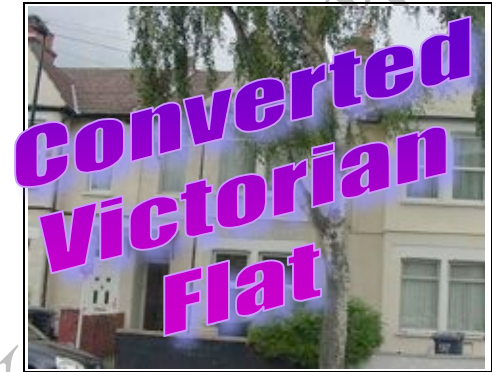
There is a tree within what insurance companies would term as influencing distance of the property.

Tree to the front of the property

ACTION REQUIRED: Please see our comments within the Executive Summary.

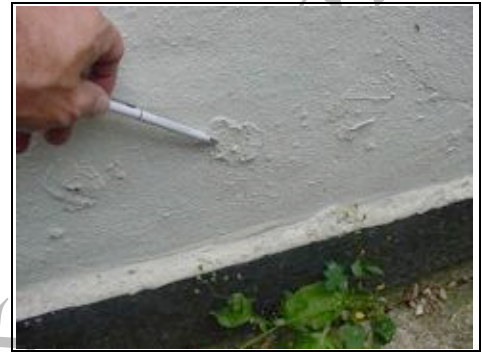
All modern properties should incorporate a damp proof course (DPC) and good building practice dictates that a differential of 150mm (6 inches) should be maintained between the damp proof course and ground levels. In properties of this age it is unlikely that a damp proof course would have been built in originally, however, often they have had damp proof courses added at a later date as in this case. We can see where the DPC has been inserted but are unable to see the DPC itself due to the render.

DPC added

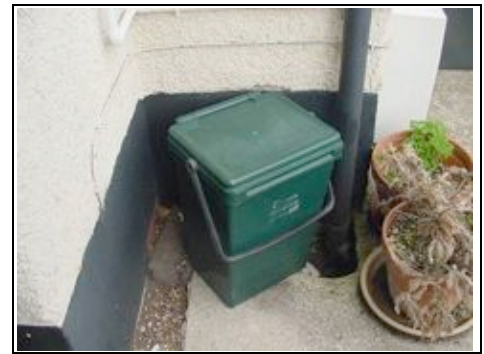
Is there a DPC behind this render?

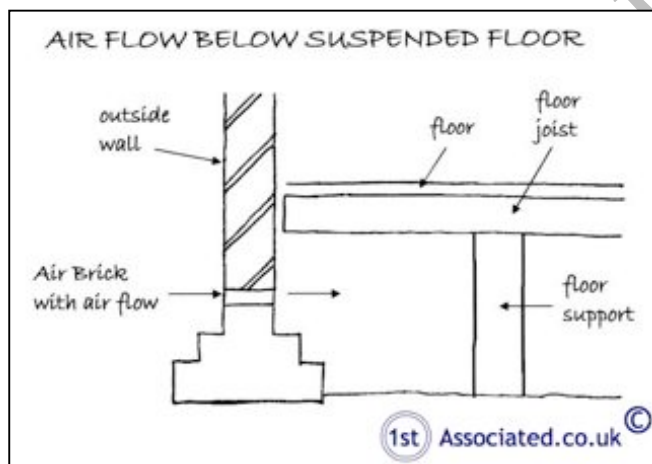
In this case we can see the airbricks to the front are acting as gutters and/or have been concealed.

Air brick acting as a gutter

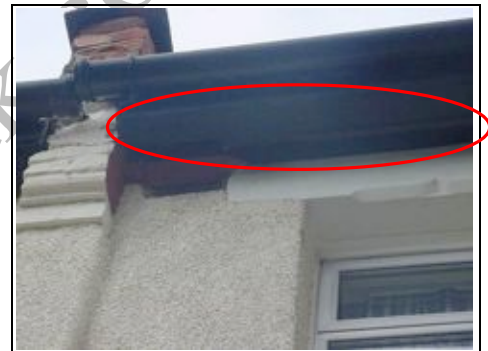
The fascias and soffits are timber. They are painted and we would comment they are in average condition for their age, type and style.

Timber fascias and soffits

ACTION REQUIRED: Make sure gutters and downpipes are watertight before carrying out any work on fascias and soffits.

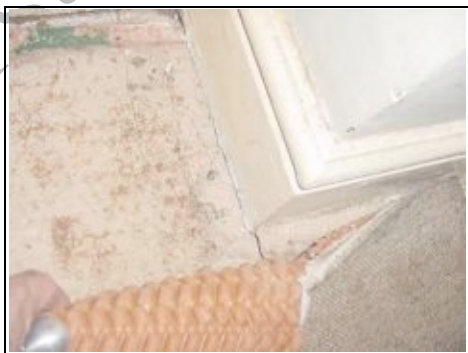
Loose carpet

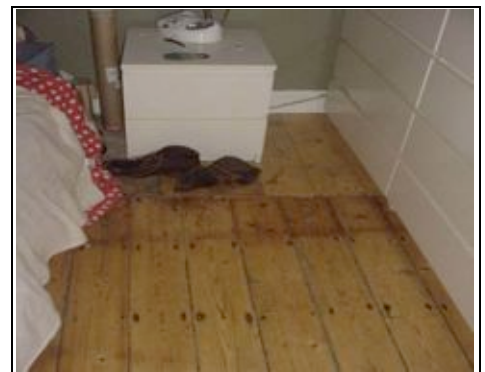
Exposed floor boards 54

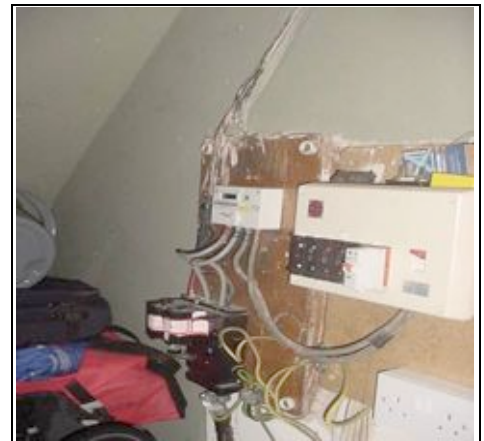
We were unable to examine the underside of the stair timbers due to it being lined, which precluded our inspection, so we cannot comment further upon the stair structure. We can, however, say that the lining helps with fire resistance if in a worst case scenario a fire breaks out on your floor.

Under the stairs

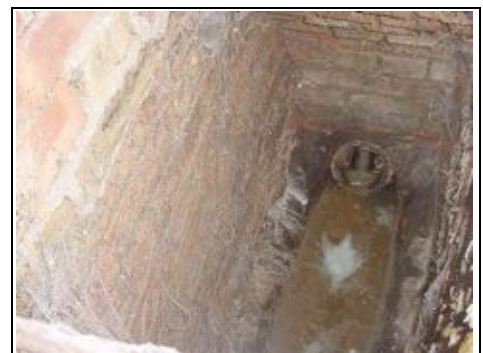
Manhole One

From what we could see it is brick built.

ACTION REQUIRED: Please see our comments within the Executive Summary.

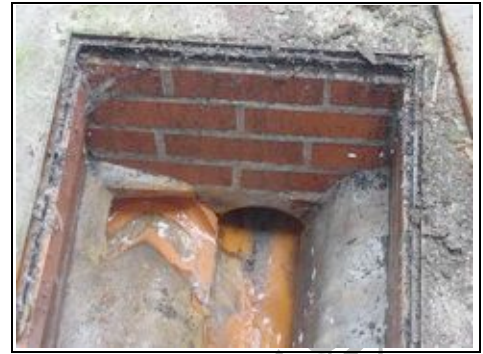
Manhole two (rear)

We duly lifted the cover and found it to be free flowing at the time of our inspection.

From what we could see the brickwork shows that it has been rebuilt. This brick was used from about the XXX onwards.

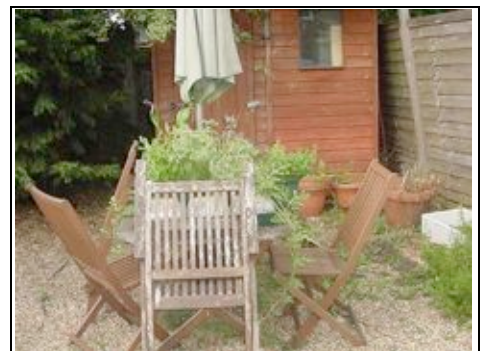
The property has a small courtyard style garden to the front and also a garden to the rear. The rear garden would benefit from some form of boundary to divide its use.

Rear garden
