# RESIDENTIAL BUILDING SURVEY

XXXXXXXXXX,  
Stroud Green,  
Finsbury Park,  
N4 xxx

Firstly, may we thank you for your instructions of xxxxxxxxxxxx; we have now undertaken a Building Survey (formerly known as a Structural Survey) of the aforementioned property. This Survey was carried out on xxxxxxxxxxxx.

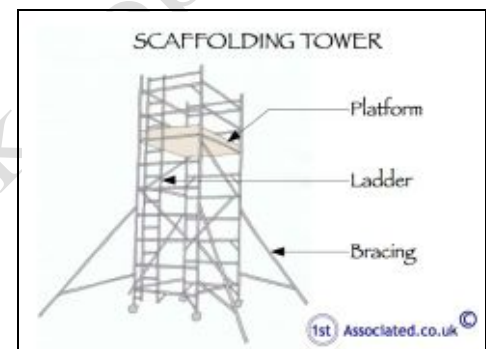
It should be noted that boilers have been added to the property and we could see to the rear, where the flues protrude, that these have not been bricked in and sealed properly. This, we would suggest, is due to the expense of carrying out high level work externally as it requires scaffolding.

Scaffolding tower

**ACTION REQUIRED:** At some point there should be a shared cost with regard to carrying out repairs to the flues. It may be possible to gain access to carry out the work via a scaffolding tower.

**ANTICIPATED COST:** A few hundred pounds, plus the cost of the tower scaffolding; please obtain quotations.

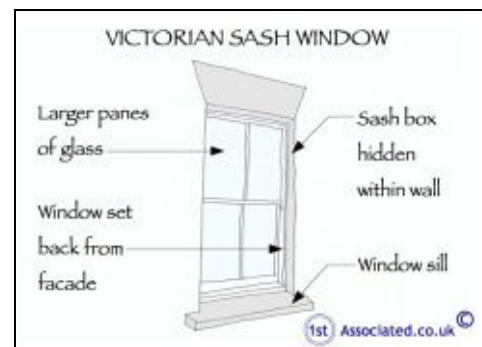
When we carried out our knife test on the timber windows we found them to be softer than expected.

Sliding sash window

**ACTION REQUIRED:** It appears as if the windows have been filled over the years and they may require timber splicing in the next time they are repaired.

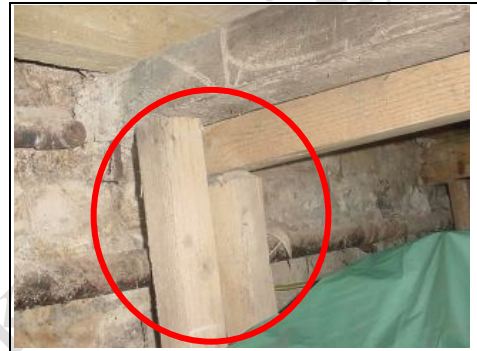
From within the basement we could see that the ground floor has been propped up, in part, underneath where the shared entrance hallway is. We can see both additional props from the ground have been added and also props with joist hangers that are embedded into the wall.

Propped up floor

**ACTION REQUIRED:** Propping of the floor is not an ideal solution. Some of the work is DIY standard and other work looks to have been carried out professionally where joist hangers are in place, although the timber does seem very thin. To some extent this area is not our main concern as it is accessible and therefore repairable. It will of course be necessary that everyone in the building has a share in the cost of this repair. We would recommend a meeting with the owners of the other flats in the building to explain the problems that have been found.

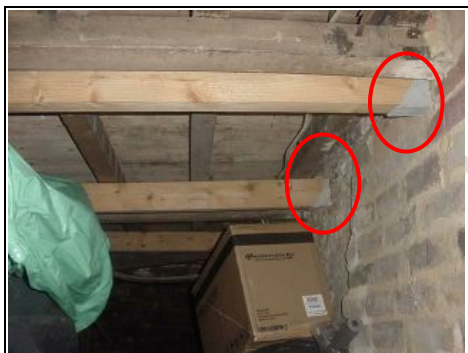
New timber beams supporting the floor with joist hangers on the right hand side

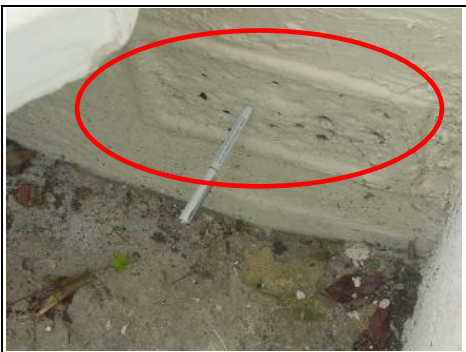
Airbrick to the front needs unblocking to allow airflow under the suspended timber floor

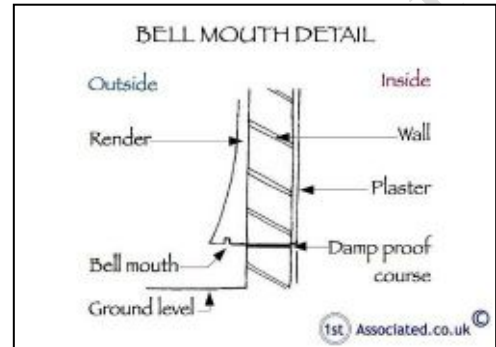
Bell mouth detail

**ACTION REQUIRED:** Add a bell mouth detail to the base of the render.

**ANTICIPATED COST:** £2,000 to £3,000; please obtain quotations.

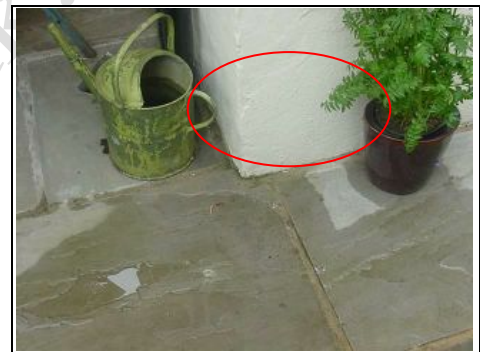
No bell mouth

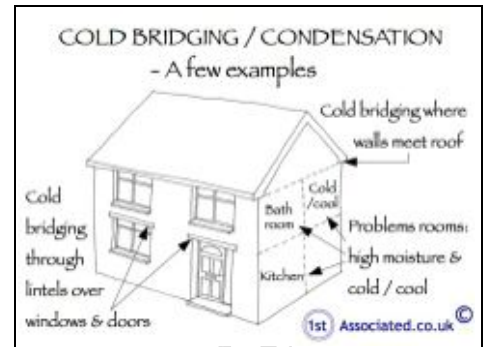
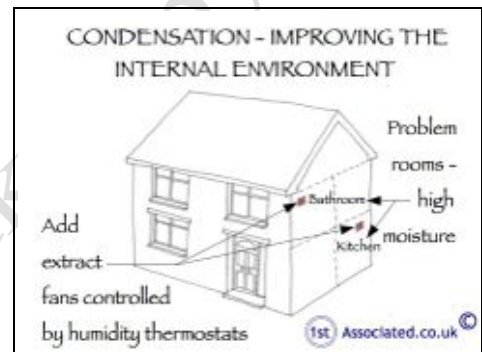
Cold bridging is caused by a colder element in the structure allowing coldness to pass through the structure much quicker when warm moist air is present in the property. Cold bridging is often caused by things like having a shower or a bath, cooking or washing, particularly if you are drying washing on the radiators. This is also caused by the general climate which results in condensation on the element.

Cold bridging

**ACTION REQUIRED:** We would recommend that the present extract fan is replaced with a humidity controlled extract fan. As discussed, there should be an over run on the extract fan which, at present, there isn't. We also think that bigger and better are now available such as these humidity controlled extract fans. At the same time we would also add a fan to the kitchen/breakfast room to reduce humidity in this area.

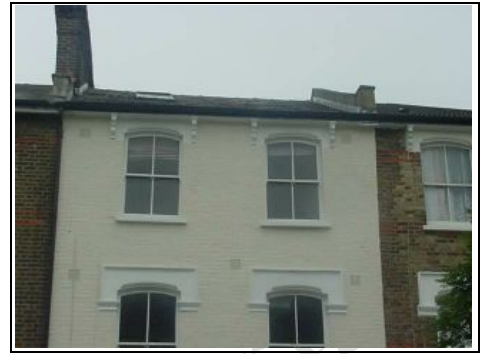
Unfortunately the neighbours were not at home at the time of the survey as we would have liked to have gained access into the roof.

Upper flats, no one was home so we could not view the roof

**ACTION REQUIRED:** We would recommend a cup of tea meeting to discuss access into the roof. We will be happy to return to check this if you do gain access. You should also enquire as to whether the other properties are owner occupied or tenanted. You can then look into whether they would want to buy the shared freehold (further in the report).

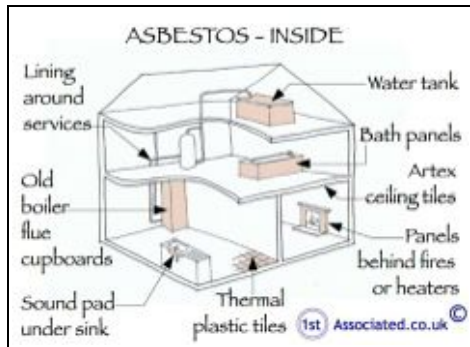
= Asbestos internally

**ACTION REQUIRED:** A property such as this should have an Asbestos report (shared cost) on it as well as a report on the drains.

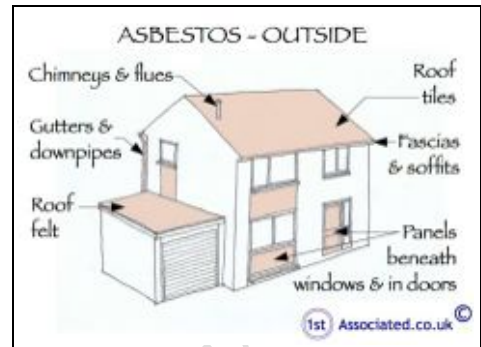
Asbestos externally

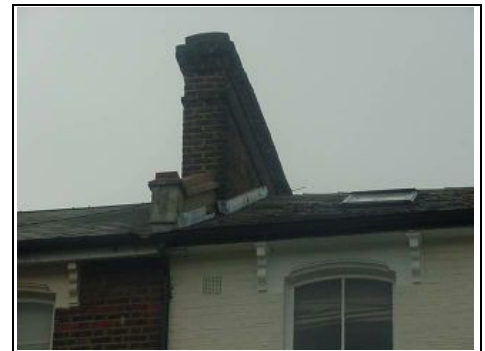
This chimney is brick built with a lead flashing, we could not see any chimney pots. From what we could see from ground level it looked to be in average condition considering its age, type and style, however, this is a substantial chimney and may require some re-pointing. From looking at how the flashing has come away we would comment that the quality of work was not to a high standard.

Chimney ( Left )

**ACTION REQUIRED:** Periodically inspect the chimney and a close inspection when the lead work is carried out.

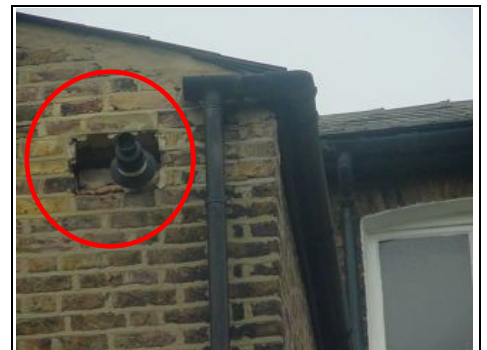
The property has metal flues visible from the boilers that have been installed. These have not been bricked and sealed correctly.

Flue from a boiler

**ACTION REQUIRED:** These should be bricked up and sealed no later than 2014. Please see our comments within the Executive Summary.

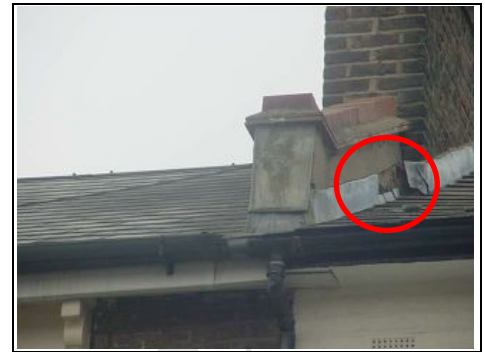
The lead flashing to the parapet wall to the front left of the property looks to be coming away. We cannot see the parapet wall to the rear properly. Please see our comments within the Executive Summary.

Parapet wall- lead flashing has come away (front left)

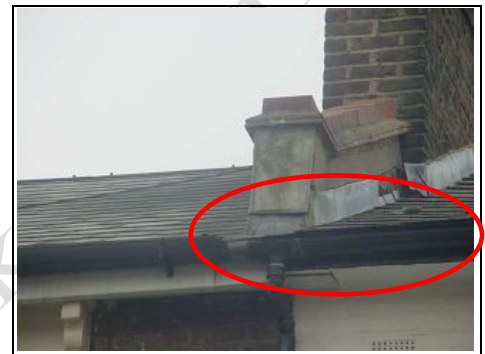
We would usually say there may be some minor leaks but most people would be happy to live with these providing repairs are carried out within the next six to twelve months. However, in this case, we think they may be leaking as we can see the fascias and soffits have come away.

Gutter and downpipe

**ACTION REQUIRED:** We would always recommend you stand outside the property next time it rains heavily and see how well the drains cope with the rainwater particularly looking at the guttering and the joints.

We would also recommend that the gutters and downpipes are cleaned out, the joints are checked and the alignment checked to ensure that the gutters fall towards the downpipes.

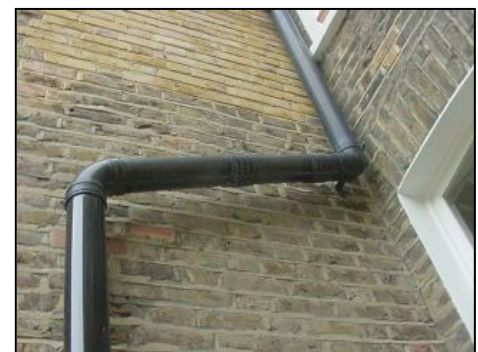
The property has plastic soil and vent pipes with fairly sharp swan neck bends.

Plastic Soil and vent pipe

**ACTION REQUIRED:** Please see our comments within the Executive Summary.

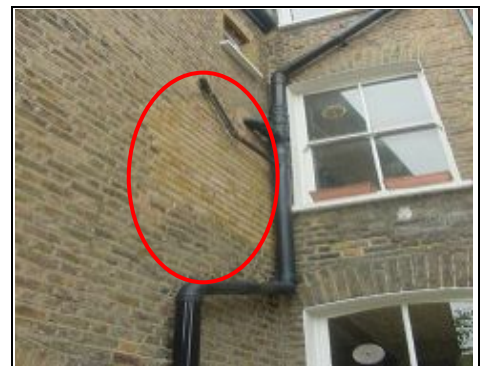
Flemish bond brickwork with an area of patched brickwork

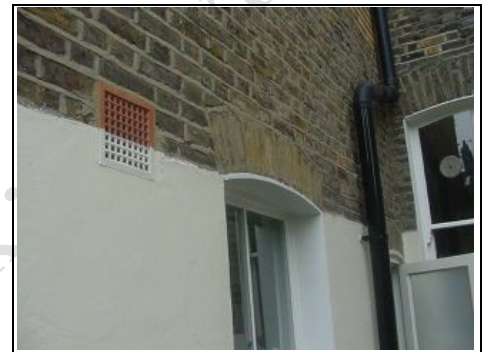
Low level external walls of the property are rendered. We are always wary when we see rendered properties as it usually means they have been rendered for a particular reason, often because dampness is getting into the property.

Rendered wall

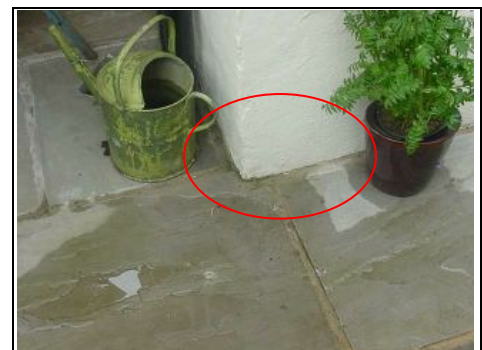
To the base of the render there was no bell mouth detail allowing dampness to get into the property.

No bell mouth

**ACTION REQUIRED:** We would recommend a bell mouth detail is added. Please see our comments within the Executive Summary regarding dampness in the property.

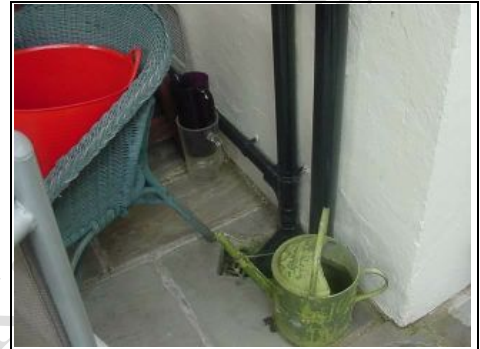
All modern properties should incorporate a damp proof course (DPC) and good building practice dictates that a differential of 150mm (6 inches) should be maintained between the damp proof course and ground levels. In this case, we cannot see a DPC to the rear because of the render and to the front it is not obvious because of the paintwork. Given that dampness is getting into the property it seems likely that the damp proof course is not working well.

Render may be hiding the DPC

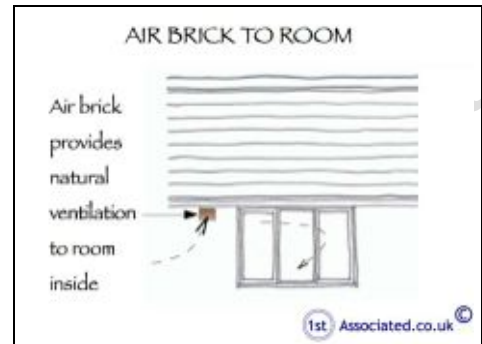
Air brick

**ACTION REQUIRED:** Ensure the air bricks are clear.

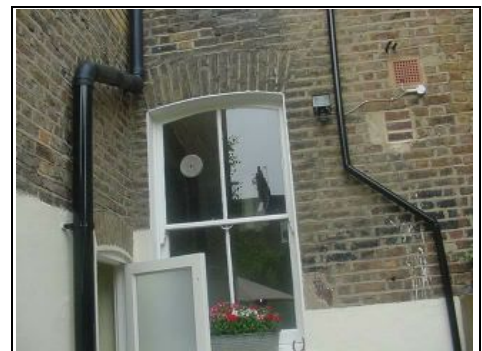
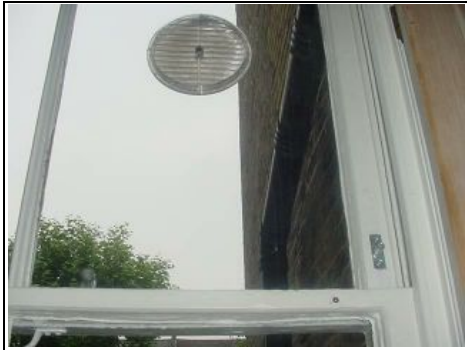
The property has single glazed timber sliding sash windows. We would specifically comment that they look relatively old and are softer than expected in the areas that we carried out our knife test. Also note the tiling has been carried out in front of the kitchen window.

addition of a plastic tube draught sealer (available from most DIY stores) and regular redecoration is the best option to minimise the draughtiness of the windows in this case.

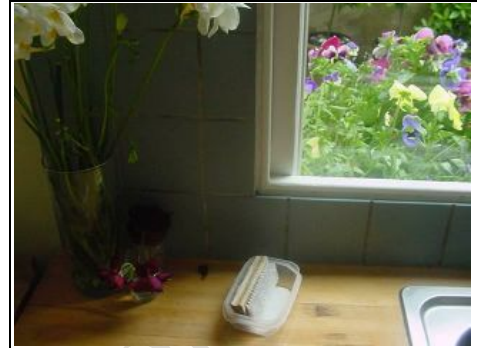
Tiling in front of part of the window

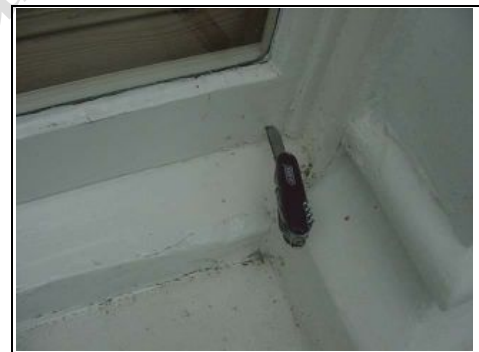
We carried out our knife test and found them to be softer than expected.

Knife test to window

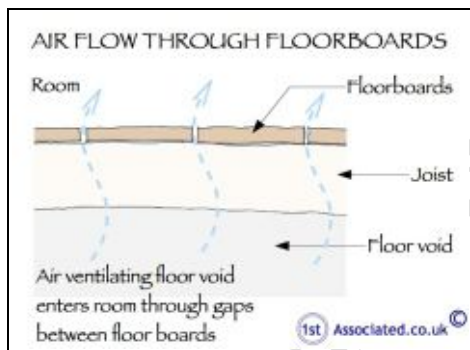
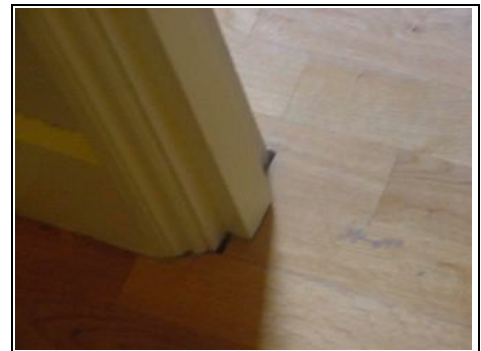
The laminate flooring does not allow the timber floor to breathe.

Laminate flooring prevents air flow through the floorboards underneath

Laminate flooring over the suspended timber floor. This does not have the best quality finish

**ACTION REQUIRED:** Please see our comments within the Executive Summary.

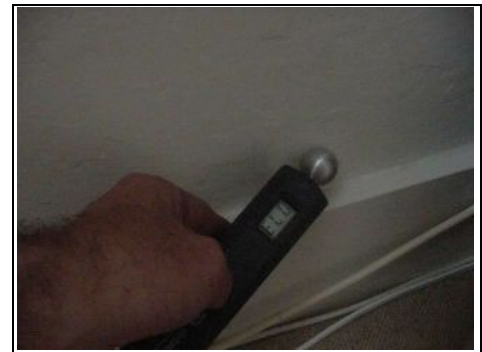
A random visual inspection and tests with a moisture meter have been taken to the perimeter walls. In this particular case we have found rising damp.

Testing for rising damp

**ACTION REQUIRED:** Please see the Executive Summary.

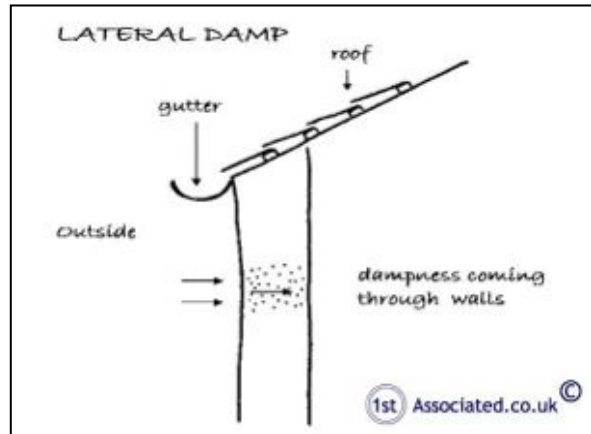
We used a damp meter on the external walls. We have not found lateral dampness.

Lateral dampness

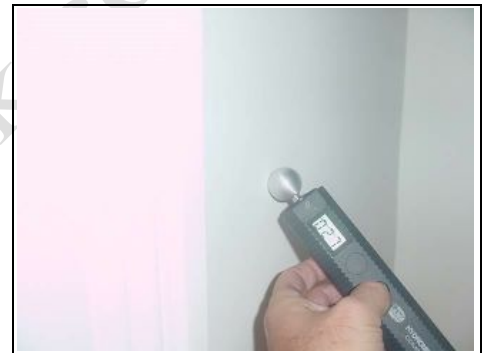
We would add that we were surprised not to find lateral dampness given that the property has been re-pointed in a cement mortar.

Testing for lateral dampness

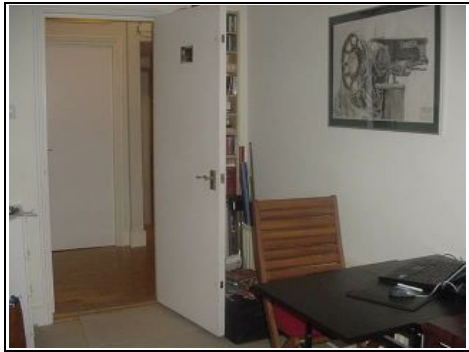
The doors are painted hollow core doors / panel doors.

Door

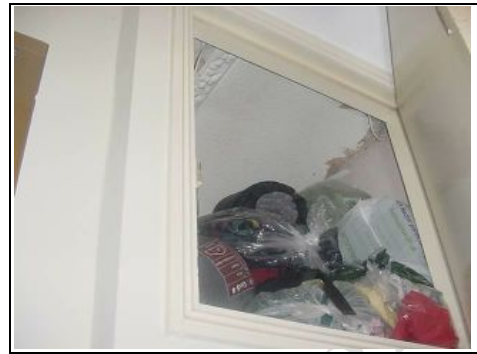
We were happy to see built in cupboards, particularly in the bedroom which is relatively small.

Cupboard in hallway

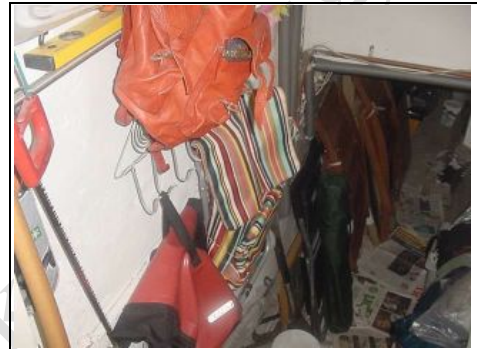
The cellar floor seemed solid under foot so we have assumed it is concrete or unmade ground. This could have been the coal store at one time.

Looking down into the cellar

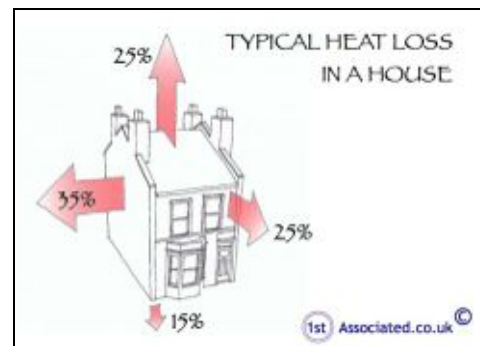
The walls to this property are solid in the sense that they do not have a cavity as a modern property would have. Also they are unlikely to have any substantial insulation, However, unfortunately it is generally very difficult to improve the insulation without affecting the external or the internal appearance of the property.

Heat loss from a house

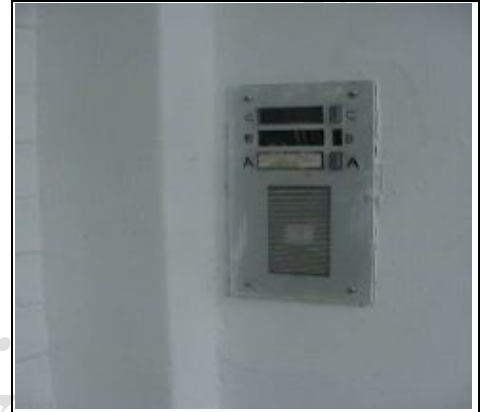
We did note a voice entry system but would prefer to see a video system in place.

We would prefer to see a video entry access system door

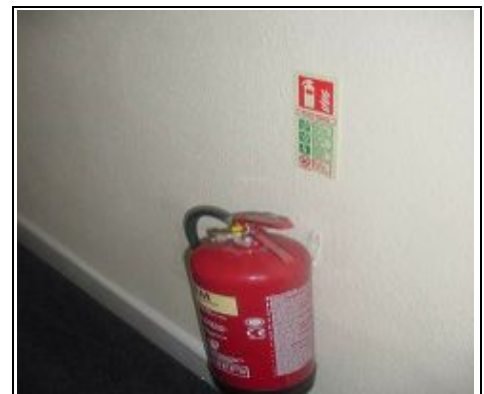
We were pleased to see the fire extinguisher as these are rarely seen

In addition to this there should be regular fire alarm drills.

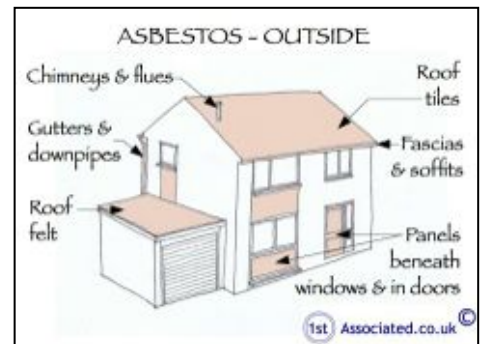
In a property of this age there may well be some asbestos. In this case we have possibly noted asbestos to the cupboard door in the hallway. Please see our comments within the Executive Summary.

Asbestos externally

We are Building Surveyors and not Asbestos Surveyors and as such the only way to be a hundred per cent certain with regards to Asbestos in a property is to have an Asbestos report carried out

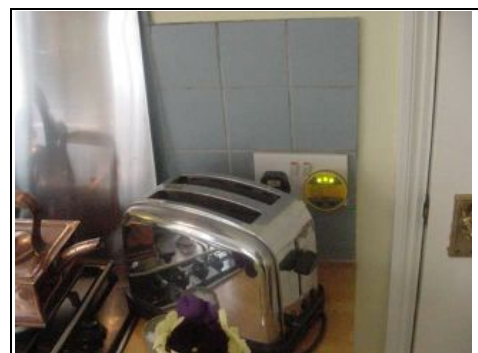
We carried out an earth test in the kitchen area to the socket point that is normally used for the kettle, this proved satisfactory.

Earth Test

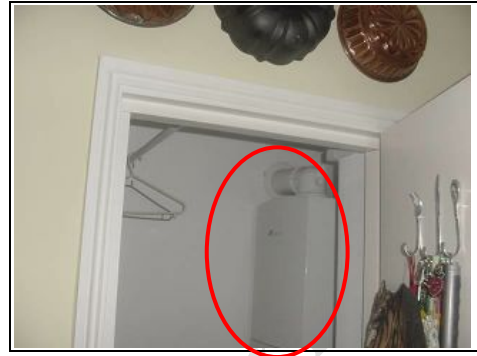
The boiler was located in the service cupboard/utility area, it is manufactured by Worcester.

Our limited inspection of the hot water and central heating system revealed no evidence to suggest any serious defects but we would nevertheless recommend that the system be tested and overhauled before exchange of contracts and that a regular maintenance contract be placed with an approved heating engineer.

Worcester boiler in the service cupboard/utility area

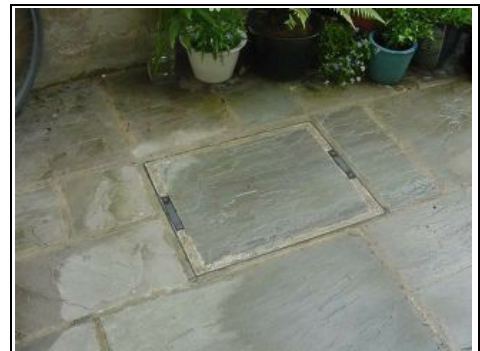
We have not lifted the cover because of the style of manhole.

Manhole (rear)

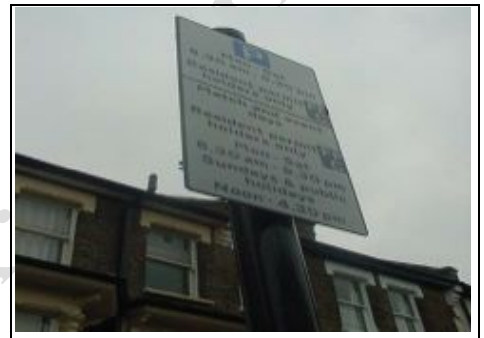
Parking is usually at the roadside on a first come first serve basis. There is a parking permit system in operation.

Parking sign to the front

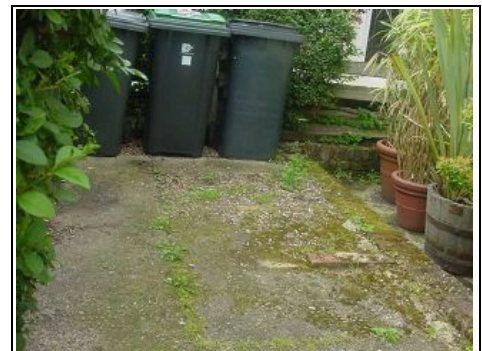
We assume that the garden to the front of the property is communal.

Front garden (assumed shared)

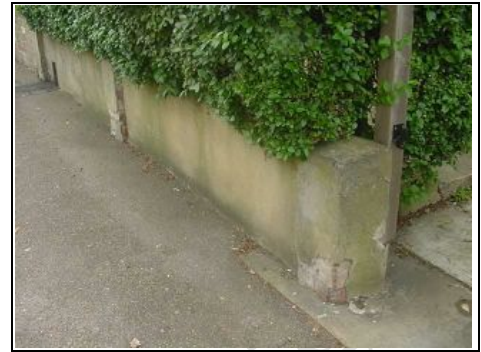
Front garden wall

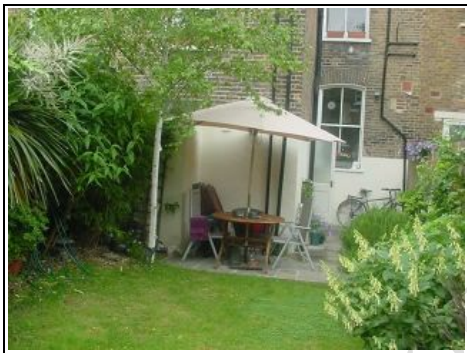
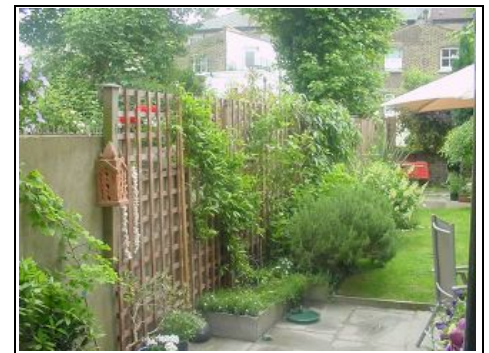
There is a garden to the rear of the property laid predominately to lawn with various shrubs and plants shrubs and a patio area. You need to confirm that you have sole access to this as we very recently came across a case where the ground floor assumed they had sole access to the garden when in fact it was shared.

Rear garden
