RESIDENTIAL BUILDING SURVEY

**Dulwich,
London.
SE22 XXX.**

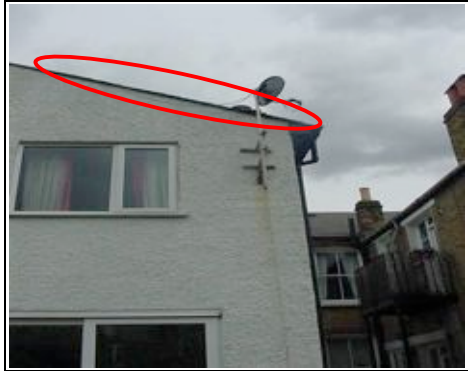
We cannot see the rear roof, however it appears to be a slate roof from what we could see from within the roof space.

Rear roof

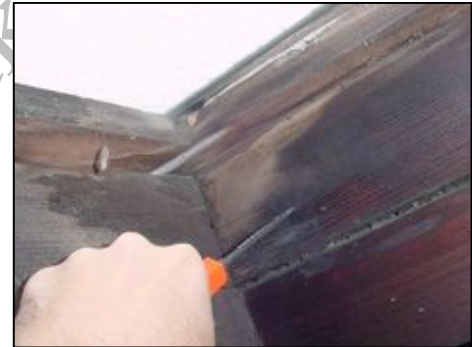
There is a roof window to the roof but unfortunately we were unable to open this window to view the roof. The window has a metal mechanism that opens it but this has rusted. We can see some dampness coming in via the window and is probably the reason the mechanism has rusted over.

Roof window is allowing dampness in

ACTION REQUIRED: We would recommend that the window mechanism is eased and adjusted to get this in working order. It would be a shame to have to replace it as it has an almost antique value! This would then allow a proper view of the rear roof, parapet walls and rear chimney.

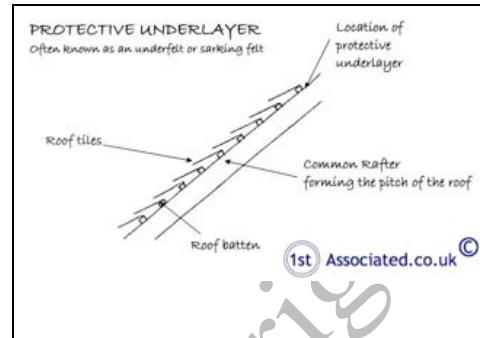
The roof has one of the earliest types of protective underlayers known as building paper; this is deteriorating more than we would usually expect to see. Without the secondary protective underlayer the roof is more prone to leaking.

Protective underlayer

ACTION REQUIRED: To replace all of the underlayer is almost as expensive as re-roofing the property as it would require scaffolding which is a major cost. It would also require removing all of the roof tiles and battens then adding the protective under layer and then re-battening and re-tiling. We would therefore recommend patch repairs are carried out. We would also recommend adding ventilation to the roof.

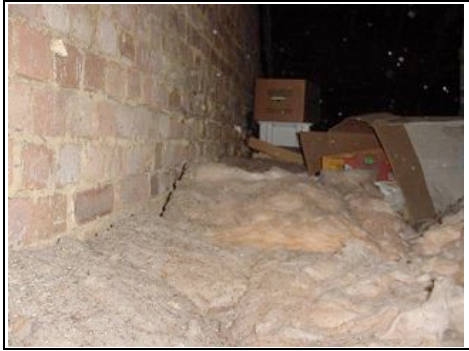
There is a mass of insulation within the roof and also bundles of excess insulation. This combined with the lack of ventilation in the roof may have caused condensation in the roof space which could explain why the building paper has deteriorated.

Mass of insulation

ANTICIPATED COST: To patch repair the roof in the region of £2,000 to £4,000. To add ventilation will be in the region of £250 to £1,000 dependent upon whether this can be carried out from within the roof or the outside of the roof; please obtain quotations.

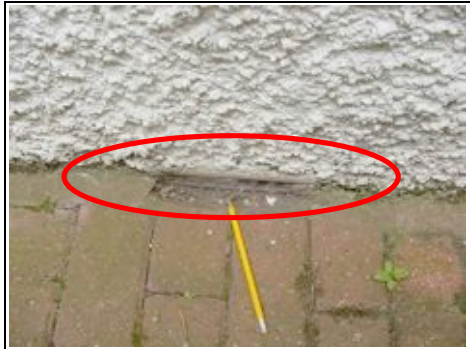
The property has a suspended timber floor which needs airflow underneath it via airbricks to prevent deterioration. We can see that the airbricks to the rear of the property are too low.

Air brick is too low (rear left)

ACTION REQUIRED: A worst case scenario will mean replacing floorboards due to wet rot, dry rot or woodworm. You need to open up all the airbricks and ensure they are protected from acting as gutters allowing water into the property. We would suggest lifting a section of floor beneath the staircase to check the condition.

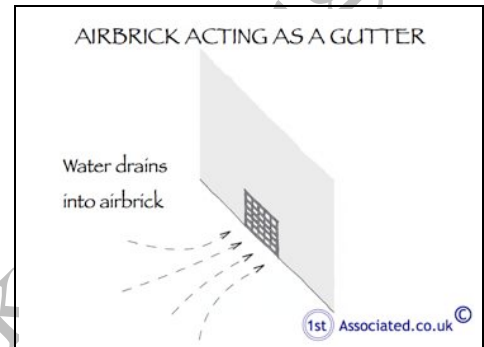
Air brick acting as a gutter

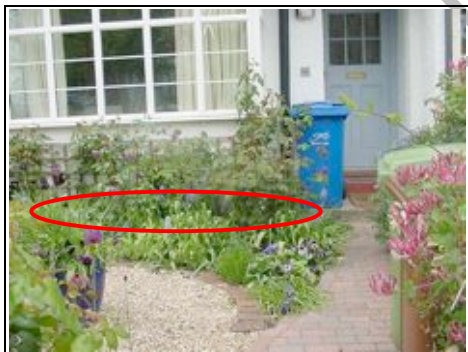
We simply cannot see the air bricks to the front of the property at all.

High ground level, the airbricks have been covered over

This means that the floor may have problems with wet rot or in a worst case scenario dry rot and wood worm. We simply cannot see this to advise as the top of the floor has then been covered with a laminate flooring, this stops the floor from breathing and seals in any dampness problems.

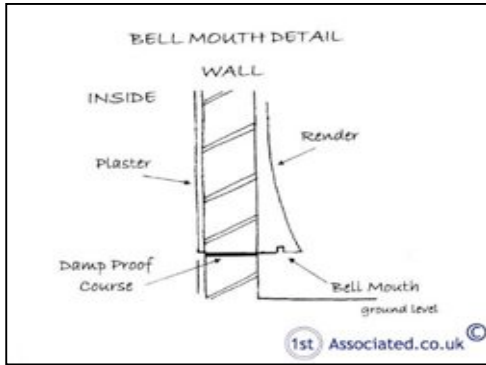
Bell mouth detail

ACTION REQUIRED: We would recommend that a bell mouth is added to the base of the property to reduce dampness.

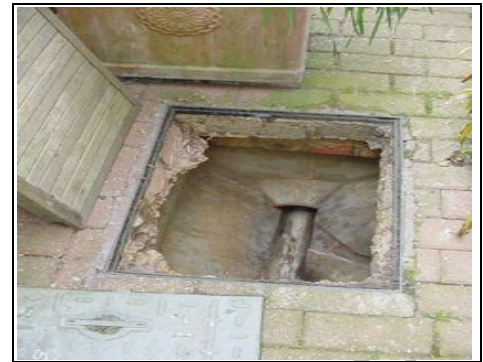
Drain is concrete, which can indicate work has taken place to the drains

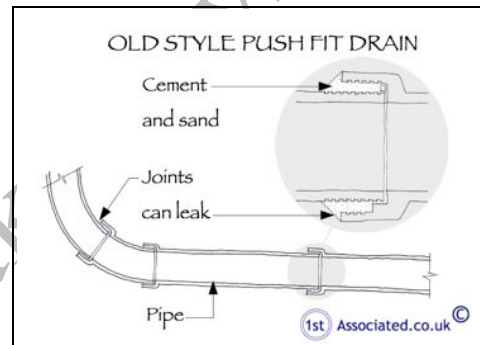
Push-fit drain

In older properties, such as this, drainage was often push fitted together rather than bonded together which means that they may leak over the years.

to find out the condition of the drains is to have a closed circuit TV camera report to establish the condition of the drains.

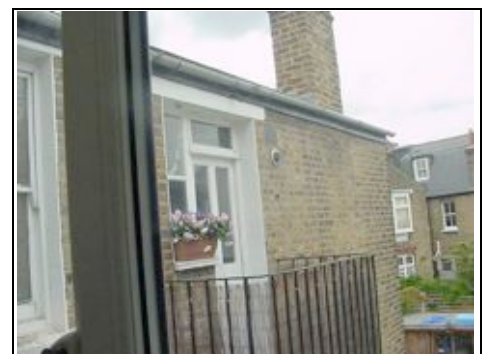
The neighbouring property has a balcony that practically overlooks the rear bedroom, rear bathroom and the rear garden.

Neighbours balcony

ACTION REQUIRED: You need to consider this as a characteristic of the building and ensure you are happy with it before you proceed to purchase.

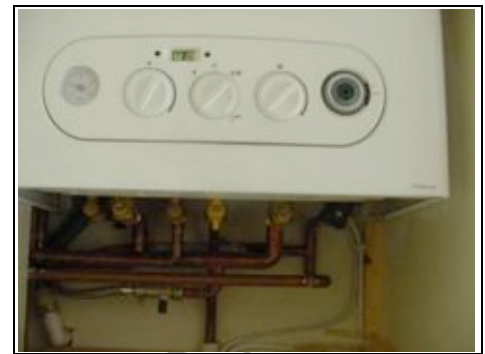
Pro boiler

We rarely come across this make of wall mounted boiler and as such it may be difficult to obtain parts for.

ACTION REQUIRED: We would recommend that you have the boiler serviced and be advised with regards to parts. If the owners have had the boiler serviced recently (we are not party to information on this) we would recommend that you discuss the availability of parts with them.

ANTICIPATED COST: A few hundred pounds for a service. Replacement boilers are usually in the region of £2,500 to £3,500 dependent upon size and installation costs; please obtain quotations.

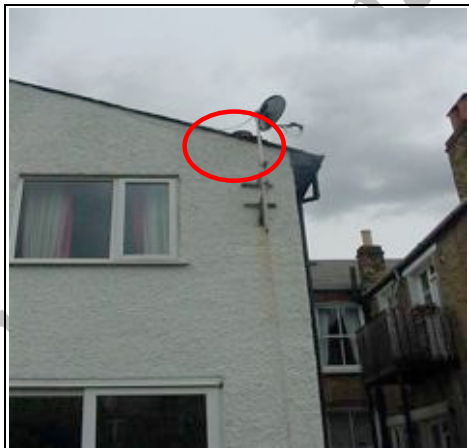
Rear chimney

Unfortunately we were able to view very little of this chimney. We were expecting to be able to see it via the roof window but as mentioned we could not open this.

ACTION REQUIRED: Once the roof window is opened we would recommend that the chimney is checked.

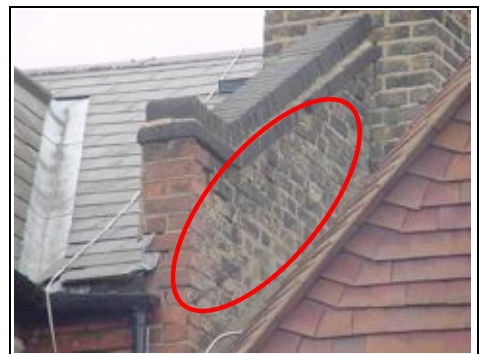
The left parapet wall is built of brick and needs re-pointing.

Left parapet wall needs re-pointing

ACTION REQUIRED: We noted that the parapet wall was weathered and needs re-pointing so we would check the chimney when the work to the parapet wall is being carried out.

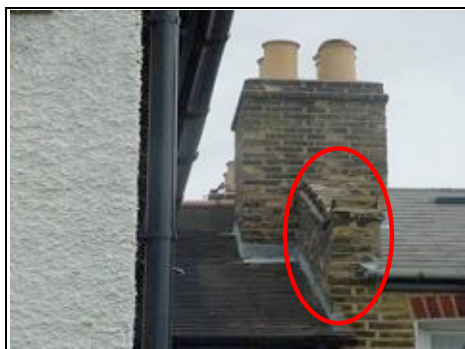
Rear left parapet wall is difficult to see

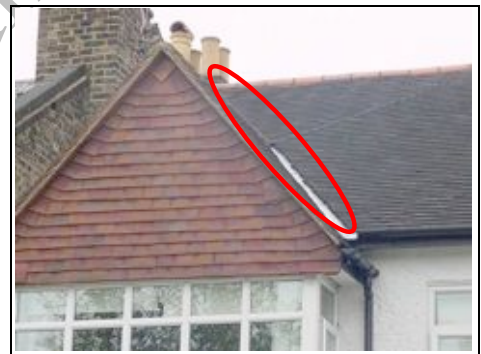
Main roof with valley gutter where it meets the bay window

With this age of roof there will usually be a few missing or displaced tiles and which there is in this case, this is nothing unusual. Our concern with the missing tiles is that the secondary protective underlayer also known as sarking felt is deteriorating.

ACTION REQUIRED: Carry out periodic inspections and maintenance of the roof, as required. The protective underlayer is deteriorating which means you do not have secondary protection. Please see the following section.

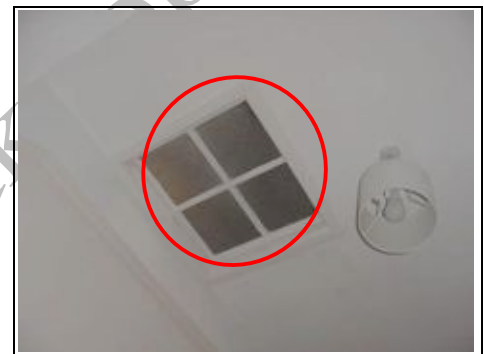
The main roof is accessed via a glass loft hatch located on the landing. There is no loft ladder, electric light or secured floorboards. We recommend that these be added, as it will make the loft space safer and easier to use.

Be careful when opening this glass hatch!

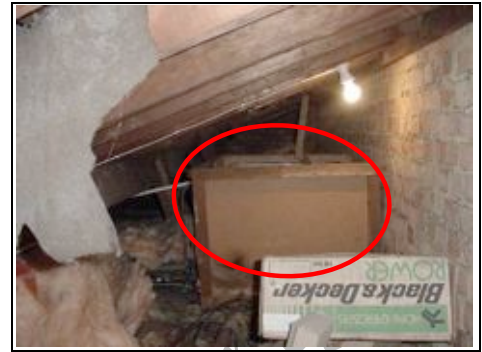
Water tank

We noted a water tank in the roof space. This looks to be a glass reinforced plastic tank and does not appear to have a lid.

We would always recommend that water tanks be drained down and cleared of any debris etc. (we have seen dead birds and other unmentionable things in these tanks). As you are often cleaning your teeth with this water it is best that it is as clean as possible!

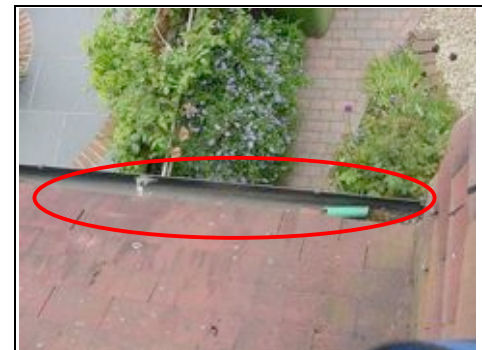
Clear the gutter. We are always mystified by what ends up in the gutters

We also recommend that the gutters and downpipes are cleaned out as we can see what looks to be a piece of pipe in the gutter. The joints also need to be checked and the alignment checked to ensure that the gutters fall towards the downpipes.

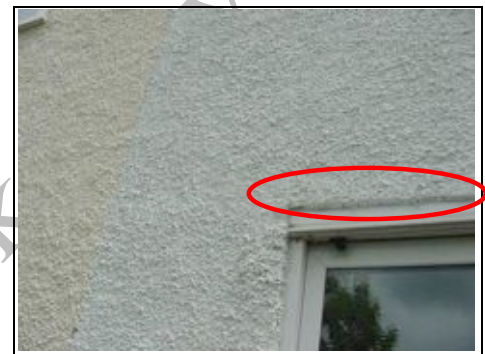
No window drip

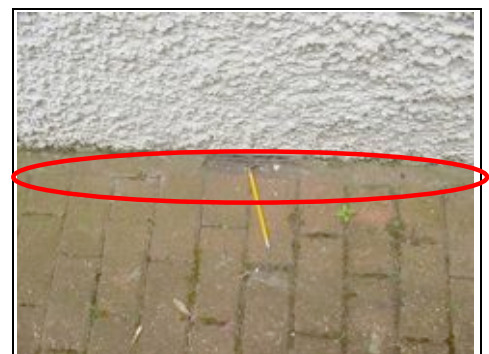
To the base of the render there is no bell mouth detail.

No bell mouth to render

ACTION REQUIRED: Please see our comments within the Executive Summary.

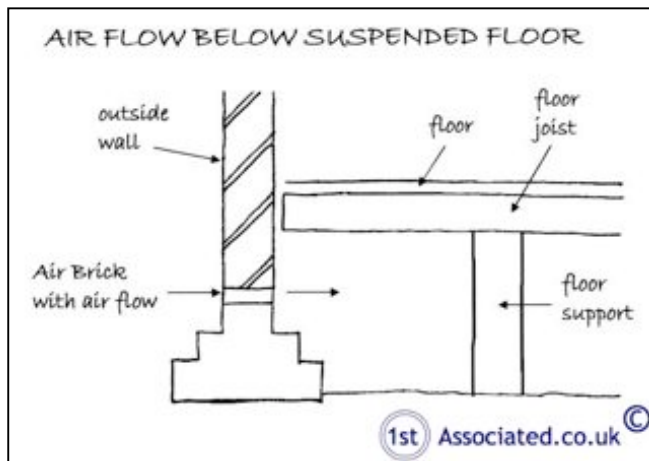
The property has a suspended timber floor and air bricks are essential to have a through flow of air as this helps to reduce the chances of wet rot, dry rot and woodworm. In this case the air bricks are too low or almost covered up (we suspect some are completely covered up).

Air brick to the rear is too low

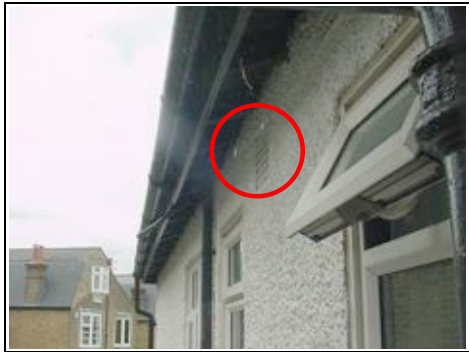
Air brick

There are vents at high level. High level air bricks are to help air circulation within the property. We noticed airbricks in the bathroom which we were pleased to see giving natural ventilation. However we do prefer mechanical ventilation in the form of large humidity controlled extract fans.

ACTION REQUIRED: Add humidity controlled extract fans to bathroom, en suite, kitchen and any rooms used for laundry/drying of clothes.

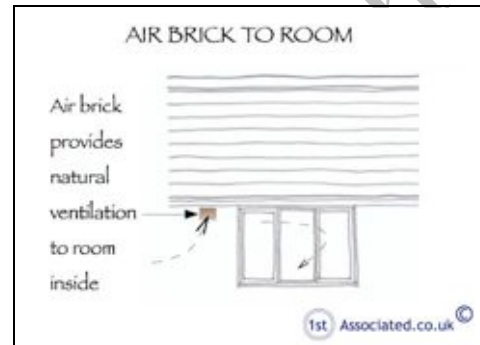
Air brick to room

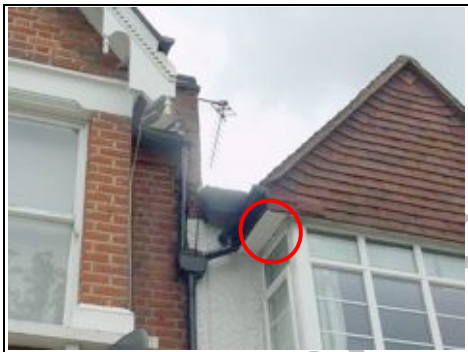
Fascias and soffits

The fascias and soffits are timber with exposed rafter feet in some areas which are sometimes difficult to paint and often get neglected. We would comment they are in average condition for their age, type and style.

ACTION REQUIRED: Make sure gutters and downpipes are watertight before carrying out any work on fascias and soffits.

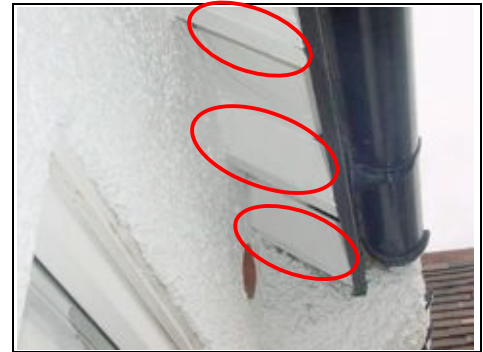
Exposed rafter feet

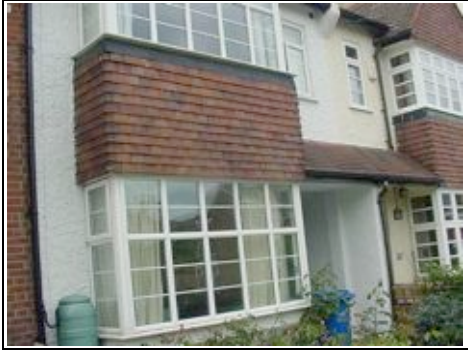
Two storey bay window

Generally they look to be of an average quality for their age, type and style. In this case there is a two storey bay window that is unlikely to have foundations underneath it and so there can be some movement particularly when the original windows have been replaced with double glazing.

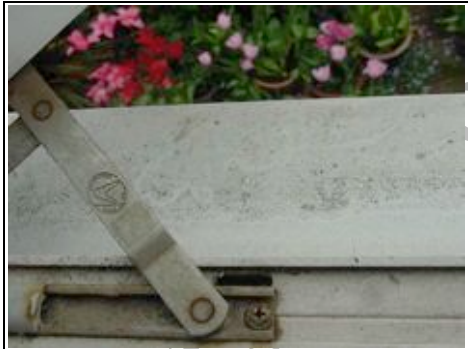
Ingrained dirt to plastic windows

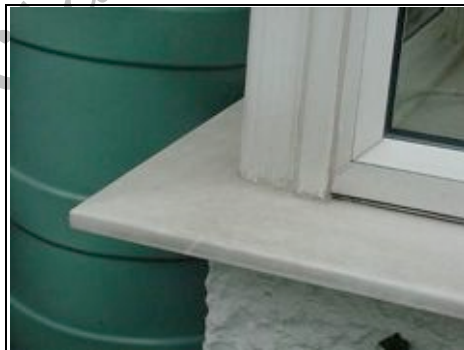
Ingrained dirt

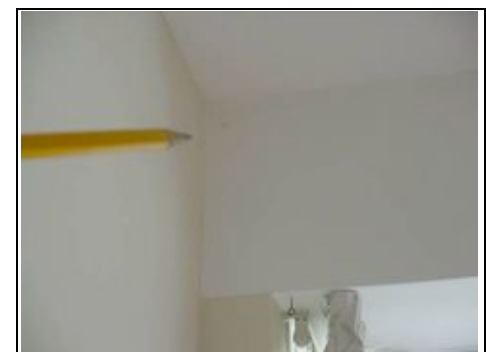
Slight mark under where the valley gutter is near the bay window and may be the first sign of dampness getting in

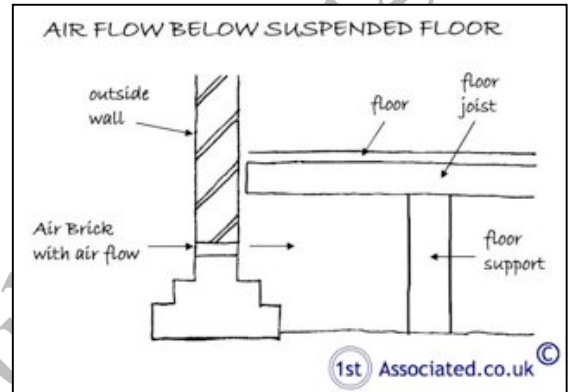
Suspended timber floor

We can see the suspended timber floor, in this instance, by going into the cellar. The timbers we could see look relatively new and many are not original. We could only see a small area to the right hand side of the property and as mentioned the lack of airbricks and the blocking of air bricks means that there is no air flow through this part of the floor which could have caused wet rot, dry rot or woodworm.

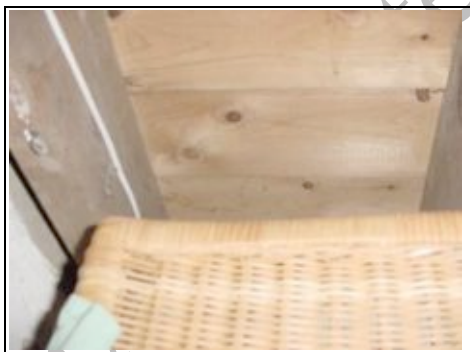
Timbers look fairly new, by this we mean twenty to thirty years

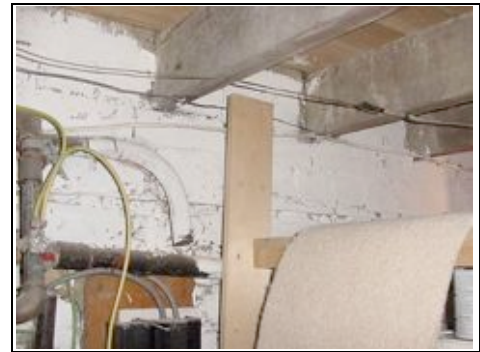
Timbers embedded in the walls

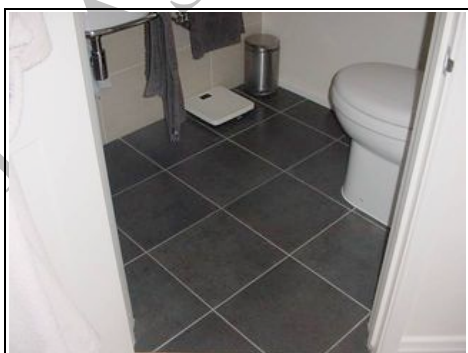
We noted that tiles have been laid in the en suite bathroom. We tend to find that over time, where tiles are put over a wooden floor, the grout becomes loose and comes out. Although in our opinion the tiled floors look good you will have to re-grout from time to time.

Tiles laid on a timber floor

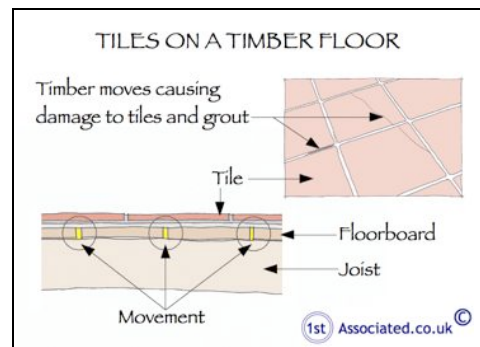
Tiles on a timber floor

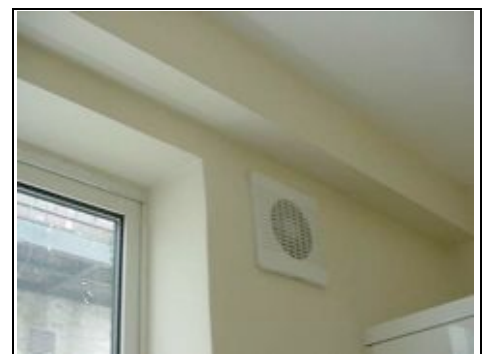
Extract fan in kitchen

ACTION REQUIRED: We noted an extract fan in the kitchen but would recommend this is replaced with an large humidity controlled extract fan, and also the bathroom, en suite shower room and drying areas.

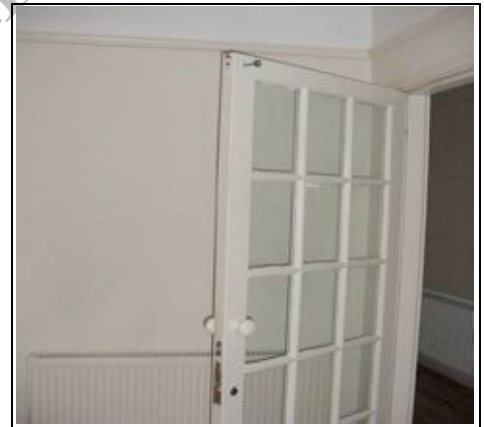
We have recently seen one of these doors caught by the wind resulting in the glass smashing. We did not notice any British Standard safety kite marks on the glass.

Glass door without kite marks to glass

ACTION REQUIRED: Your Legal Advisor to enquire if this is safety glass or not.

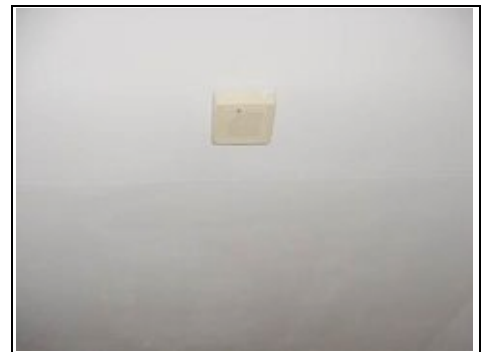
Smoke alarm

Some smoke detectors were noted. The current Building Regulations require that they be wired into the main power supply. Obviously in a property of this age this is difficult, as it would mean having surface mounted wires or cutting wiring into the plaster.

ACTION REQUIRED: We would recommend, for your own safety, that smoke detectors be installed. We would always recommend a hard wired fire alarm system and are also aware that some now work from a wireless signal which may be worth investigating. Whilst fire is relatively rare it is in a worst case scenario obviously devastating.

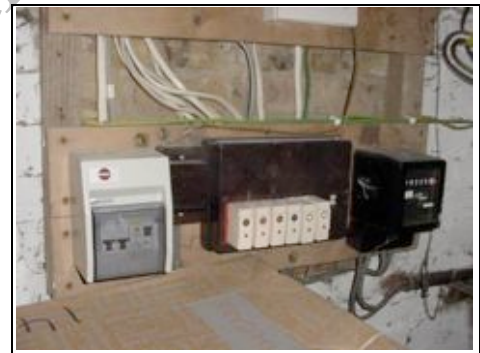
Fuse Board

The electric fuses and consumer units were located in the cellar. The fuse board looked dated, circa XXX, and better are now available. Please see our comments within the Executive Summary.

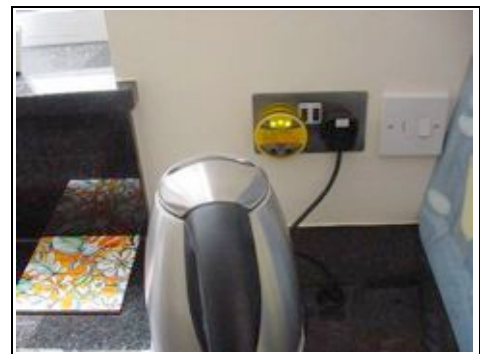
Earth Test

We carried out an earth test in the kitchen area to the socket point that is normally used for the kettle, this proved satisfactory.

ACTION REQUIRED: As the property is changing occupancy an Institute of Electrical Engineers (IEE) test and report should be carried

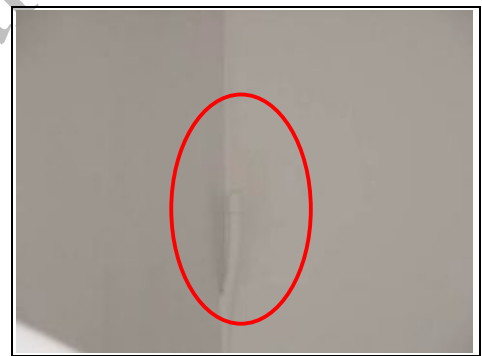
We can see a pipe to the landing area but we cannot be certain if this is a gas pipe or not. It would be more usual to have a pipe leading to the water tank in this location and this looks to have been cut off.

Gas pipe in landing area on rear wall

ACTION REQUIRED: As a matter of course it is recommended that the entire gas installation is inspected, including the cut off pipe, and made good, as necessary, by a Gas Safe registered contractor. Thereafter the installation should be serviced annually.

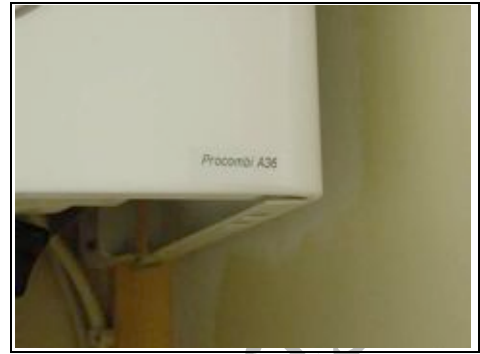
Procombi A36 boiler

Our limited inspection of the hot water and central heating system revealed no evidence to suggest any serious defects but we would nevertheless recommend that the system be tested and overhauled before exchange of contracts and that a regular maintenance contract be placed with an approved heating engineer.

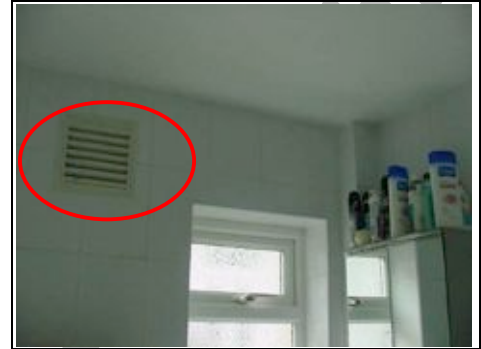
The property has a two piece bathroom suite, consisting of a bath and wash hand basin which looks in average condition, subject to some day-to-day wear and tear, as one would expect.

Air vent at high level

ACTION REQUIRED: You may wish to add large humidity controlled extract fans in the bathrooms.

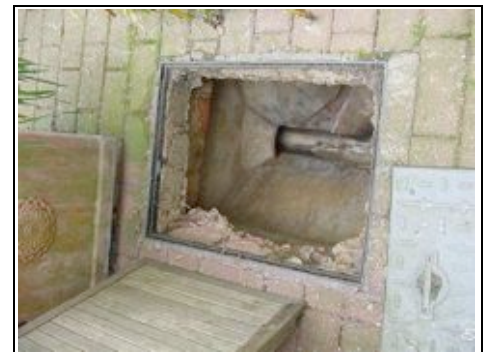
Manhole one- rear left

We duly lifted the cover and found it to be free flowing at the time of our inspection.

From what we could see it is concrete built. This is unusual as we would expect to see brick built manholes in this age of property. However this could have been added in for the kitchen extension.

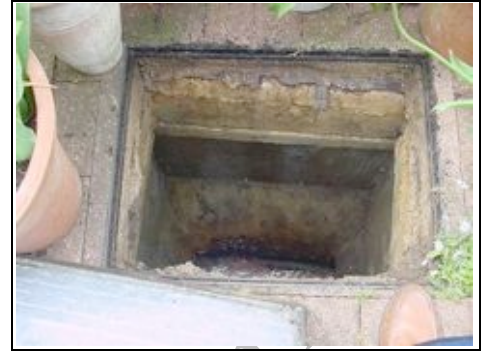
Manhole two- rear

We duly lifted the cover and found it to be free flowing at the time of our inspection.

Again from what we could see this is also concrete built.

ACTION REQUIRED: Please see our comments within the Executive Summary regarding the drains.
