JOB REFERENCE: XXX

# RESIDENTIAL BUILDING SURVEY

**XXX**  
**Camberwell,**  
**London.**  
**SE5 XXX**

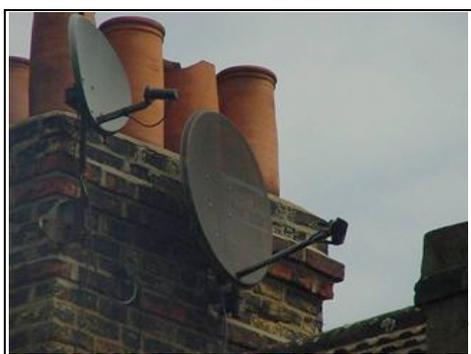
We could see the front left chimney (all directions given as you face the property) was weathered with some signs of dampness getting in (as viewed from within the roof space).

Chimney to front left

**ACTION REQUIRED:** High level inspection is recommended to the roof areas, particularly the rear. It may be possible to access the area using a tower scaffold.

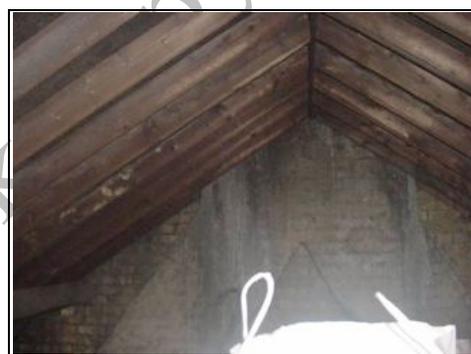
Dampness getting in around chimney within roof space

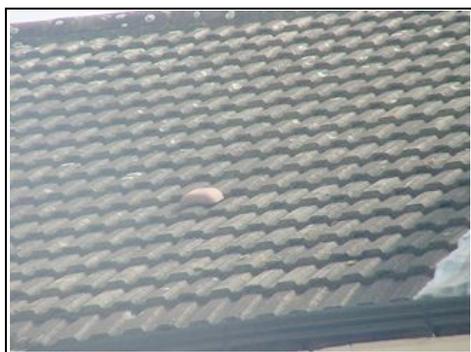
Originally this roof would have had slate tiles, these have been replaced probably in the XXX with concrete tiles which are heavier than the original slate tiles. Today you require Building Regulations Approval from the Local Authority to carry out such work to avoid causing problems with the building, particularly what is known as roof spread.

In our experience, Building Regulations Approval nearly always recommends additional strengthening of the timbers, which we cannot see in this case.

Concrete tiles

**ACTION REQUIRED:** If you want a belt and braces approach we would recommend adding in additional strengthening timbers in the form of horizontal purlins, possibly extra supports to the existing purlins.

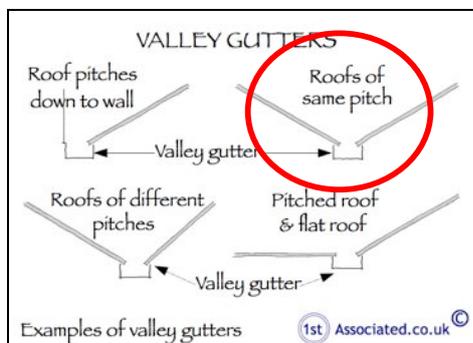
There is dampness coming in via the rear valley gutter. This could be an indication of future problems to come with the valley gutter.

Valley gutters

**ACTION REQUIRED:** You will need a tower scaffold to access to this area as we simply cannot see it.

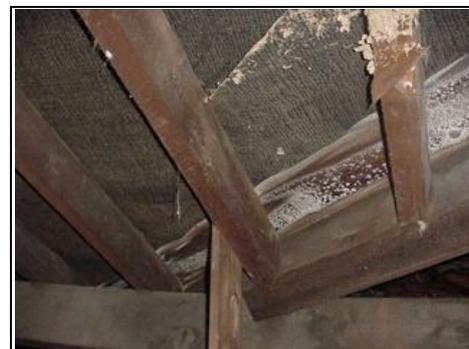
Dampness coming from rear valley gutter

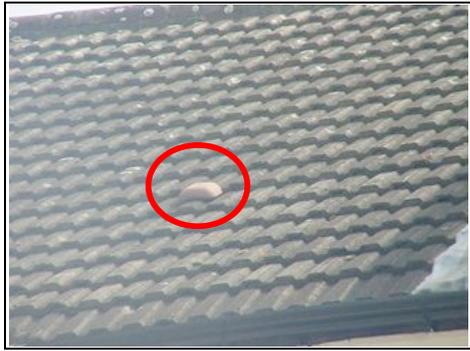
Mushroom air vents not sufficient

**ACTION REQUIRED:** We suggest that more vents are added and the existing ones are checked to ensure that they are working.

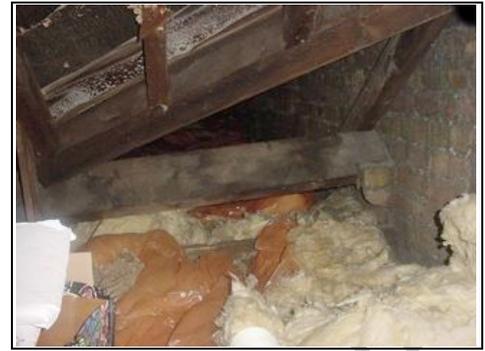
Looking towards rear roof  
Discolouration on joists which we think is from condensation

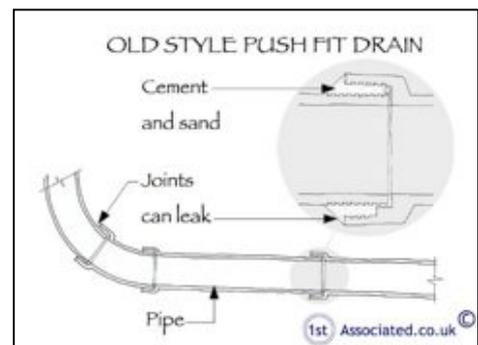
There has been movement, as is relatively common on this Era of property, and we suspect this relates to the drains which often leak over the years, as they were the older style push fit drains. Unfortunately in this instance we have not been able to check the drains, other than running the water for 15 minutes, as there is no manhole to the rear of the property.

Push fit drains

**ACTION REQUIRED:** Have a closed circuit TV camera report to establish the condition of the drains. Please see Executive Summary.

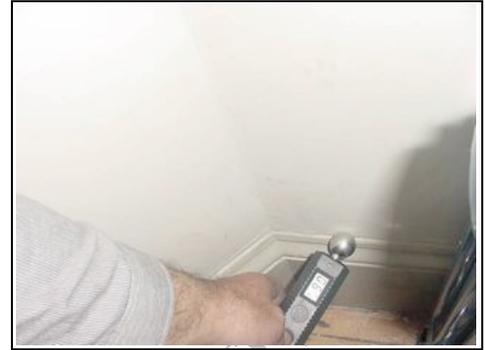
Considering the warmth of the day we were still getting slightly higher readings with our resistance meter (for measuring dampness) than we would have expected. We believe this is a combination of the air vents being blocked under the main floor and to the rear kitchen area the ground level being higher than it should be.

Finding minor dampness

**ACTION REQUIRED:** Ensure the air vents give a free flow of air underneath the property and lower the outside floor level if necessary, although this will be fairly difficult. The problem seems to have occurred because the paving and landscaping that has been carried out has been put on top of the original earth, which is common but it does make a higher ground level.

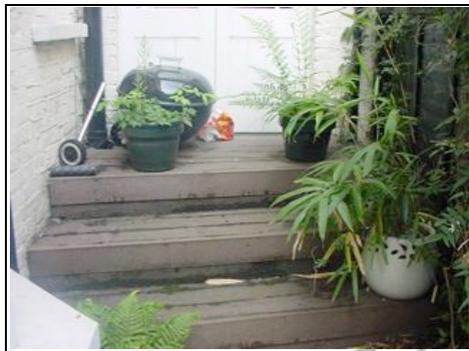
Steps blocking air vents to rear

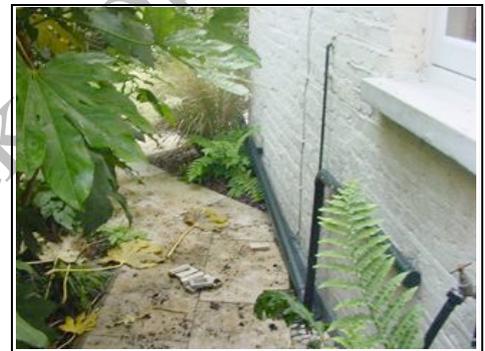
High ground level

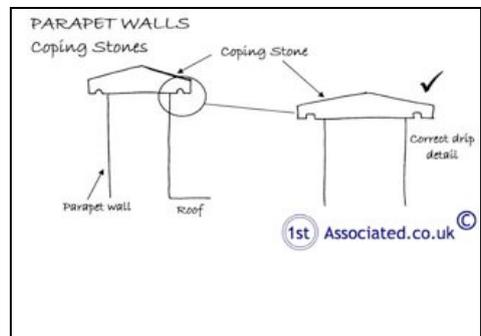
Coping stone is not large enough and there is no drip detail

Parapet wall and coping stones

**ANTICIPATED COST:** To replace the coping stones, re-bed and add a damp proof course underneath we would expect costs in the region of £750 to £1,500, plus you will of course have to re-decorate. Please obtain quotations.

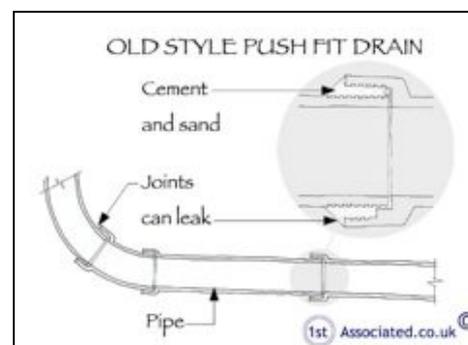
We were unable to locate any manholes at the property which is always a concern, please see our comments with regard to drainage. It is likely to be a push fit drain.

Push fit drain

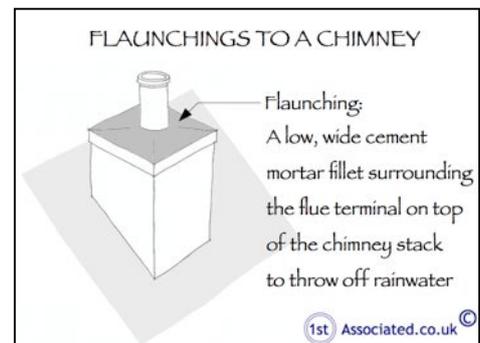
Flaunchings

This chimney is brick finished with a lead flashing and numerous chimney pots. From what we could see from ground level it looked in slightly below average condition considering its age, type and style.

Periodically inspect the chimney.

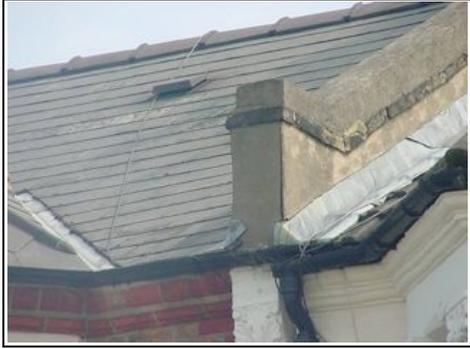
Parapet wall to front left side

The parapet walls are render finished with a brick capping and lead flashings. We noted some of the render is coming away. The parapet wall to the rear of the property is our area of concern as we could see some vegetation on the very small bit we can see to the rear.

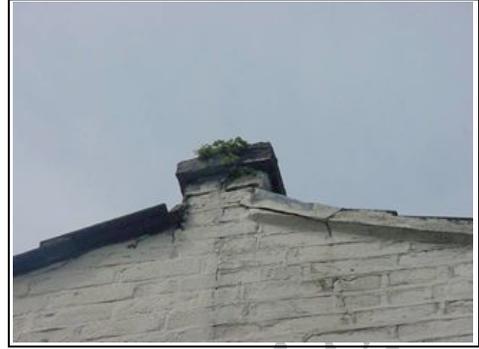
Growth of vegetation to rear parapet

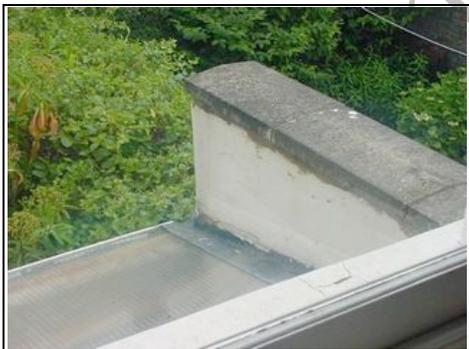
Rear parapet wall

This is a painted brickwork parapet wall surrounding the polycarbonate roof to the rear. We believe this is taking in water. The coping stone is not big enough and it is poorly detailed with a lack of drip detail, which is causing dampness into the brickwork. It looks like the coping stone has been re-bedded wrongly.

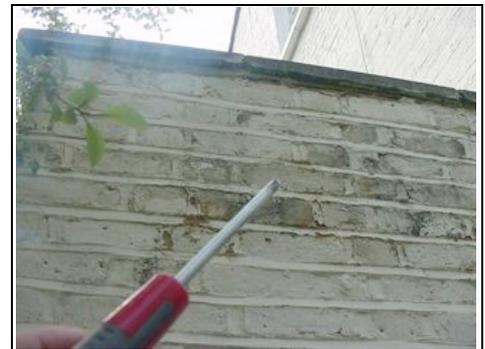
Dampness to rear of property in parapet wall

**ACTION REQUIRED:** Please see our comments in the Executive Summary.

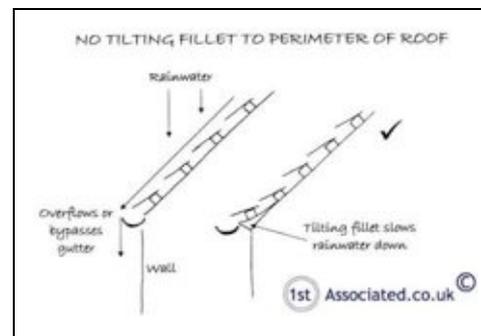
We noted minor moss, which is not unusual, but it also it does look like the tilting fillet has not been added. The idea of a tilting fillet is to flow down the speed of rain, but there are often problems with re-roofing where a thicker concrete tile is used in this instance, it then means that the tiles do not align with the gutter. In this particular, case with a sit on gutter, this can make a dampness problem where the tiles effectively tip the rainwater down behind the guttering.

No tiling fillet

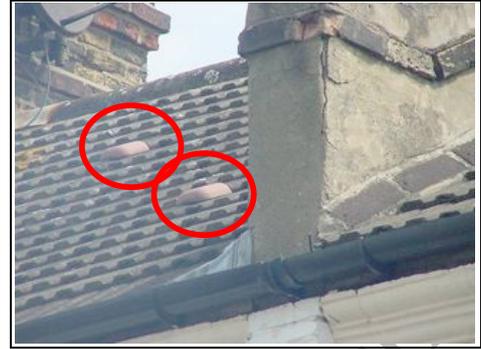
Mushroom air vents

We also noted some mushroom air vents, however having been in the roof void we do not believe these are working very well.

**ACTION REQUIRED:** Add more ventilation and close up periodic inspections of the roof.

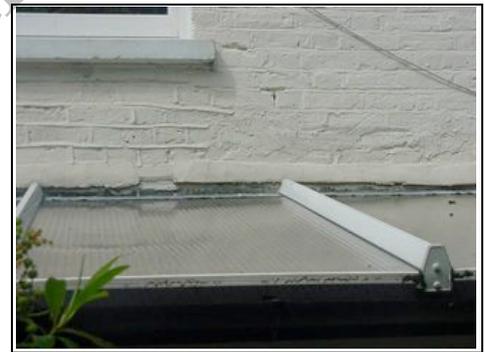
Polycarbonate roof to rear

There is a polycarbonate (plastic) lean-to roof to the rear. The main problem relating to this is the dampness coming through the parapet wall, but we also noticed part of the cement around the flashing has come away.

**ACTION REQUIRED:** We spoke about improving this entire detail and this is what we would recommend.

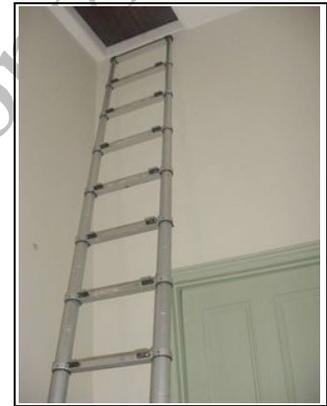
Loft hatch on top floor landing

The main roof is accessed via the loft hatch located top floor landing. There is no loft ladder, electric light or secured floorboards. We recommend that these be added, as it will make the loft space safer and easier to use and you will need a long ladder for this particular loft access.

**ACTION REQUIRED:** We recommend a long loft ladder is installed as soon as possible, plus the adding of electric lighting and secure floorboards.

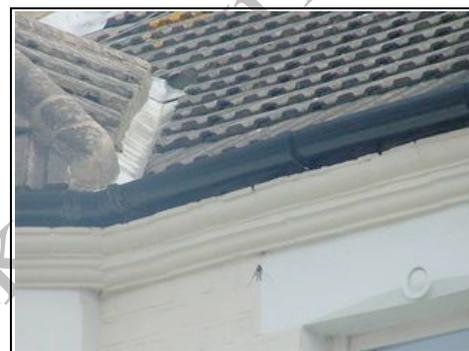
Sit over guttering with tile on edge

This does have the potential for being a big problem if it is not resolved. It may be worth you buying your own tower scaffolding to allow you and contractors to gain access to the sit on guttering.

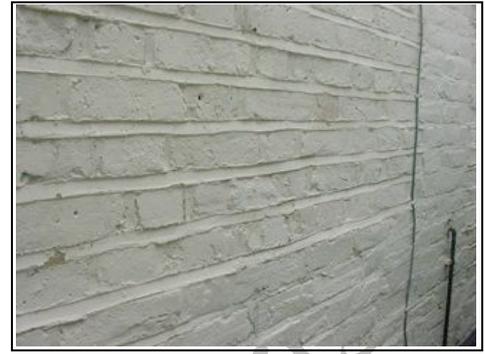
Cement mortar pointing

We noted the original lime mortar has been replaced with cement mortar, which means the building has been sealed and cannot breathe, which is a fundamental way in which this building dries out.

The use of cement mortar causes deterioration to brickwork and does lead to the face of the bricks deteriorating, which in turn leads to dampness.

Lime-based mortar should be used for any re-pointing in the future.

**ACTION REQUIRED:** Replace cement mortar with lime mortar over time. Ultimately we would recommend that any cement mortar that comes away is replaced with lime mortar over time, this will then allow the building to breathe as it was originally designed to do. They often say that an older construction is like an overcoat as it takes on the dampness but then dries out, rather than a modern construction which is like a raincoat.

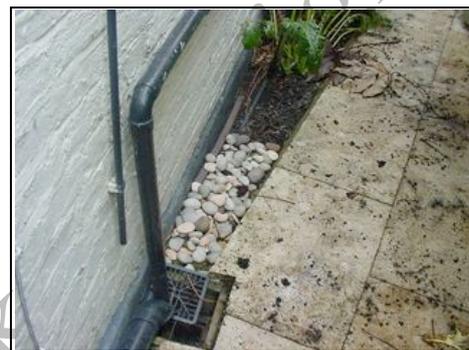
Plinth

All modern properties should incorporate a damp proof course (DPC) and good building practice dictates that a differential of 150mm (6 inches) should be maintained between the damp proof course and ground levels. In this case, we can see a plinth and hidden behind the plinth is usually a DPC. Our concern is that the ground level is high which in turn has allowed capillary action and dampness to get into the property.

**ACTION REQUIRED:** Lower the ground level.

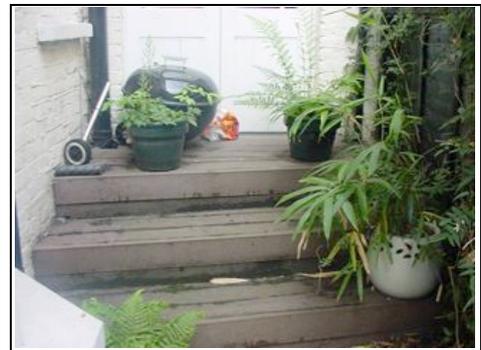
Steps blocking air vents to rear

**ACTION REQUIRED:**  
Ensure the air bricks are cleared to the front of the property and also amend the steps to the rear of the property to allow air flow through, assuming there are vents underneath. If there are not then vents need to be added.

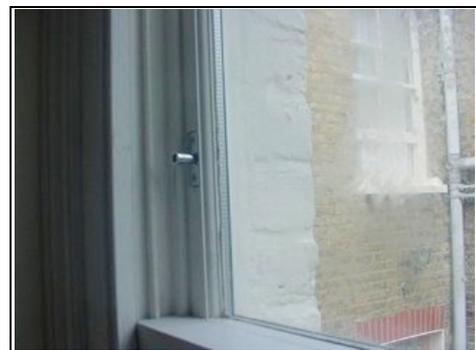
The property has sliding sash timber windows with double glazing. This is what we would term as thin double glazing and we noticed in the study that it had started to mist.

Misted over window in study

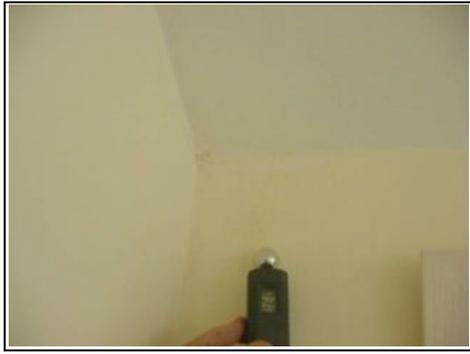
Damp areas which we believe relate to cold bridging

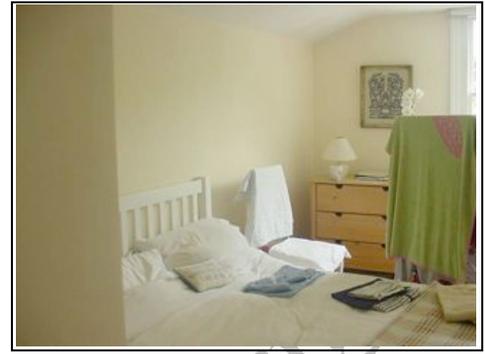
Mould is formed partly within the roof

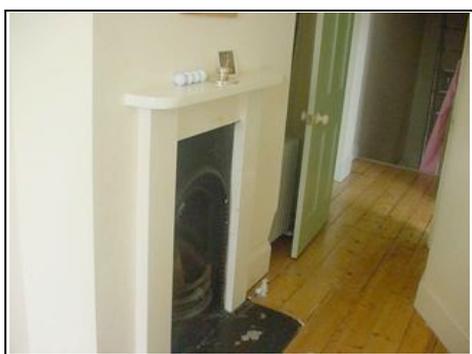
Fire place on top floor

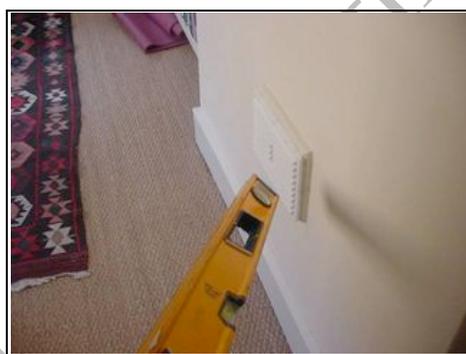
Some chimney breasts had vents some did not

At the time of the survey no chimneys were in use. Any chimneys that you do not propose to use should be capped and ventilated to prevent dampness. We would comment that in this case we cannot see any structural problems in relation this.

It is strongly recommended that flues be cleaned and checked for obstructions prior to use to minimise the risk of hazardous fumes entering the building. Please also see the Chimney Stacks, Flues Section of this report.

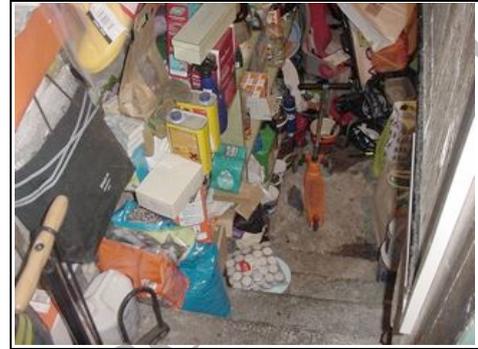
The cellar was extremely crowded with stored items, but what we could see of the floor was concrete.

Concrete floor only just visible under the stored items

We do like to have a sump pump within cellars as they do tend to flood more often than not.

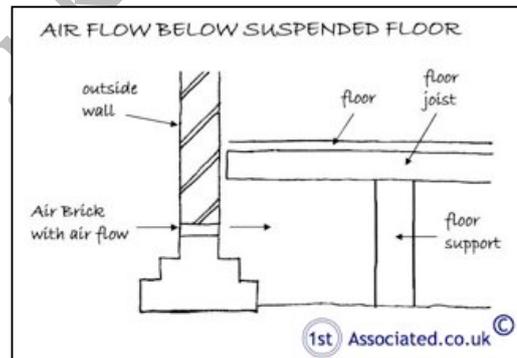
Suspended timber floor

There is damp staining visible from within the cellar to the timber floor where the hallway is, which may relate to a leaking radiator pipe, either from your side or your neighbour's side. When we checked for dampness at the of our inspection in this area it was relatively dry.

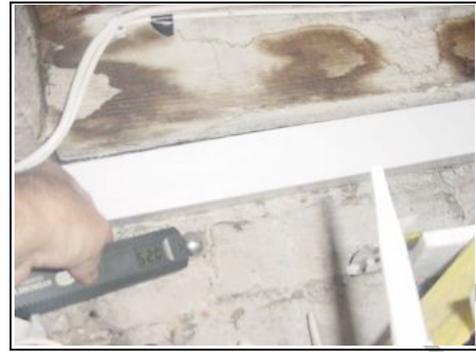
Checking for dampness in the cellar

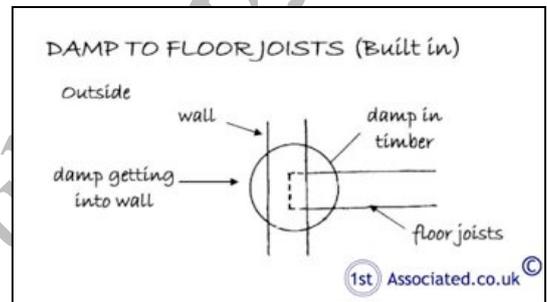
We have assumed that the first and second floor construction is joist and floorboards with embedded timbers, as this is typical in this age of property.

Embedded timbers

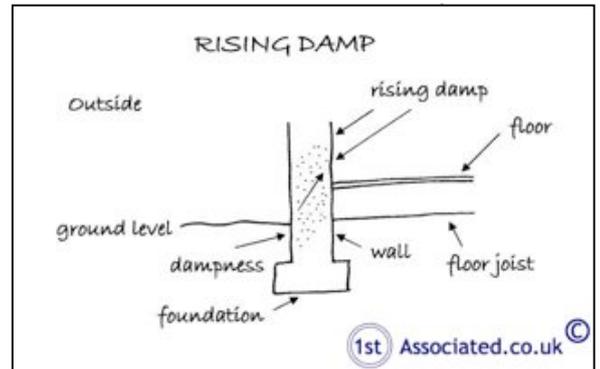
Rising damp

A random visual inspection and tests with a moisture meter have been taken to the perimeter walls. The majority of the property had no significant rising damp but there were slightly higher readings than we would expect in the kitchen area. This may relate to condensation but we think it is more likely to relate to high ground level.

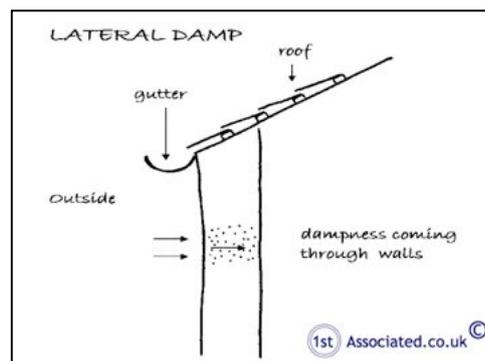
We used a resistance meter on the external walls. We have found dampness in line with what we typically see for this age, type and style of property, with the exception of the dampness coming through in the master bedroom which we believe relates to the sit on gutters, possibly the parapet wall.

Lateral dampness

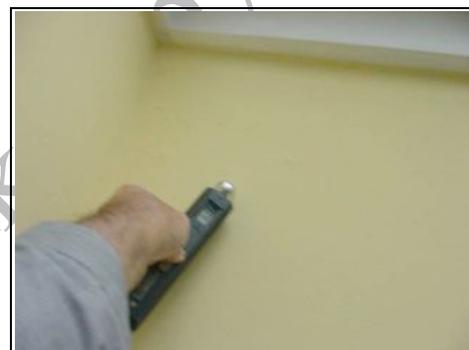
Testing for lateral dampness

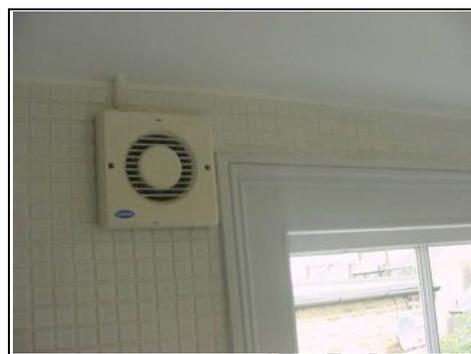
Small extract in first floor bathroom

**ACTION REQUIRED:** We would recommend large humidity controlled extract fans be added to kitchens, bathrooms and drying areas.

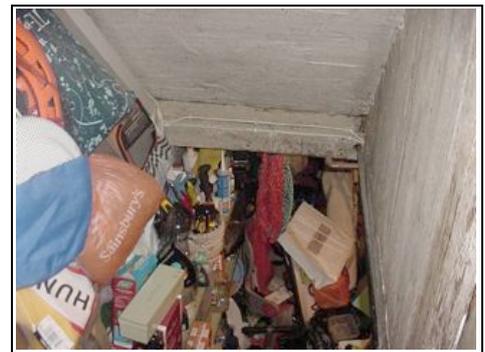
We were unable to examine the underside of the stair timbers due to it being lined, which precluded our inspection, so we cannot comment further upon the stair structure. We can, however, say that the lining gives a resistance to the spread of fire if such circumstances were to occur.

The stairs are lined

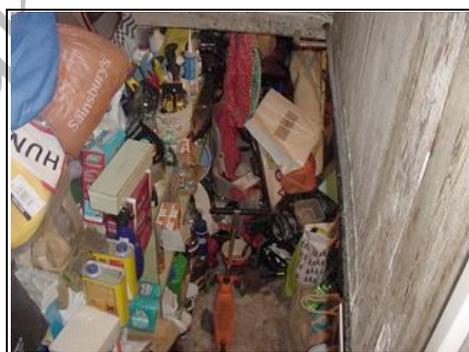
Mass of stored items in cellar

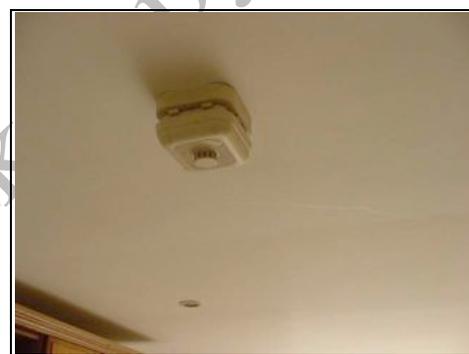
Some smoke detectors were noted. The current Building Regulations require that they be wired into the main power supply. Obviously in a property of this age this is difficult, as it would mean having surface mounted wires or cutting wiring into the plaster.

Smoke alarm

**ACTION REQUIRED:** We would recommend, for your own safety, that smoke detectors be installed. We would always recommend a hard wired fire alarm system and are also aware that some now work from a wireless signal which may be worth investigating. Whilst fire is relatively rare it is in a worst case scenario obviously devastating.

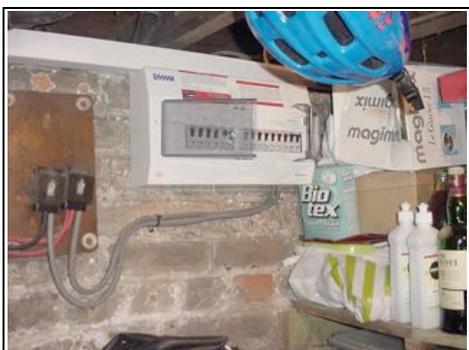
The electric fuses and consumer units were located in the cellar. The fuse board looked to be from the XXX and far better are now available.

Fuse Board

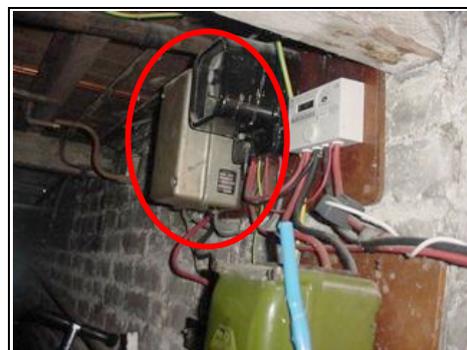
Older part of electrics

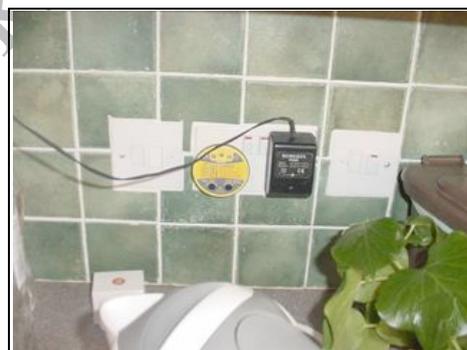
We carried out an earth test in the kitchen area to the socket point that is normally used for the kettle, this proved unsatisfactory and tripped the electrics.

Earth test

**ACTION REQUIRED:** Have the electrics checked. Please see our comments in the Executive Summary.

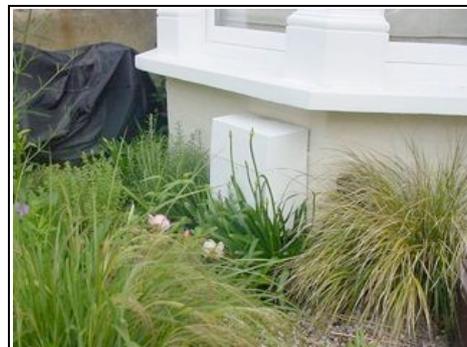
Gas to front of property

**ACTION REQUIRED:** As a matter of course it is recommended that the entire gas installation is inspected and made good, as necessary, by a Gas Safe registered contractor. Thereafter the installation should be serviced annually.

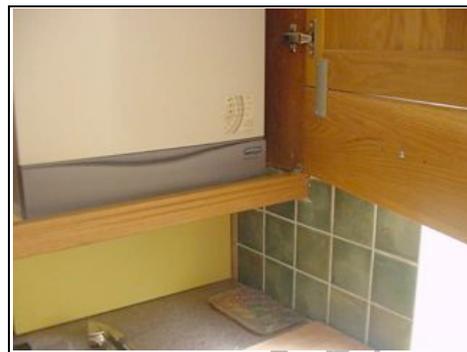
The wall mounted older style Potterton boiler was located in the kitchen. Generally these are not as energy efficient to run as a modern one.

Older style Potterton boiler

Our limited inspection of the hot water and central heating system revealed no evidence to suggest any serious defects but we would nevertheless recommend that the system be tested and overhauled before exchange of contracts and that a regular maintenance contract be placed with an approved heating engineer.

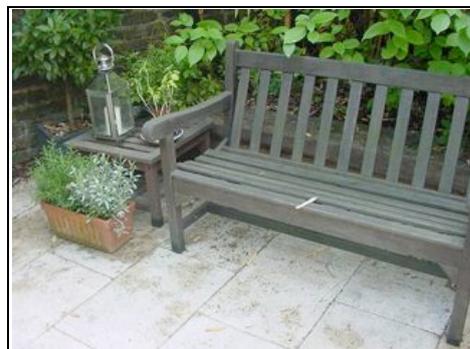
Patio area

**ACTION REQUIRED:** Please see our comments about the ground level being too high.

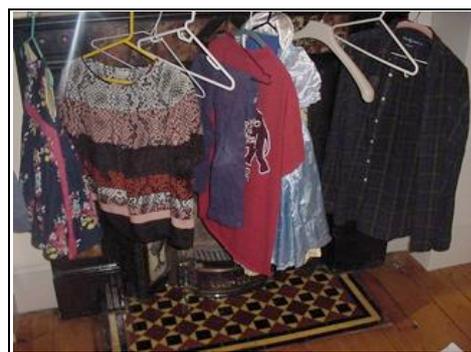
- 1) We did not have full access to the roof.
- 2) We didn't open up the floors as we could not see a way of doing so without damaging the floor.
- 3) The property was generally difficult to view due to the mass of day to day items of running a family.

Limited view due to day to day items in the property

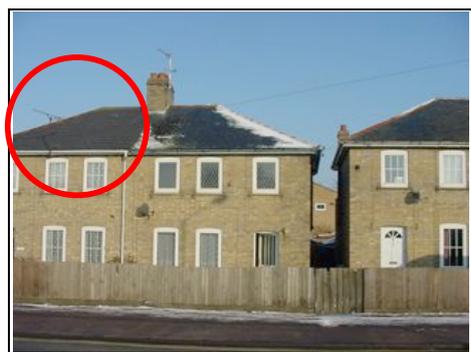
Inappropriate double glazed windows change the look of the property  
Red circle is insulated roof indicated as snow is not visible

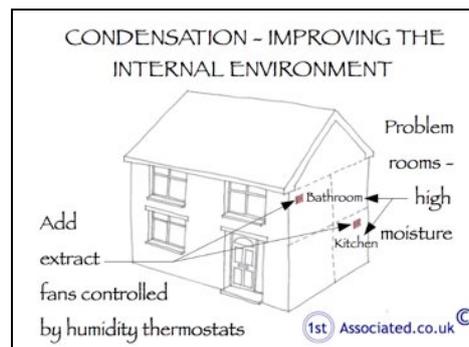
Condensation

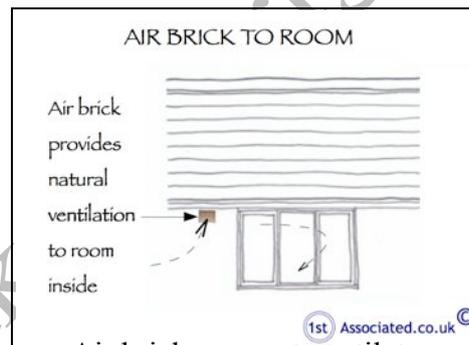
Air brick may not ventilate room enough
