# RESIDENTIAL BUILDING SURVEY

xxxxxxxxxxxxx,  
Streatham,  
London,  
SW16

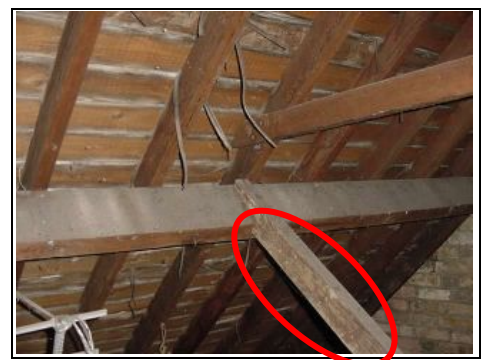
Thin strut supporting purlin

**ACTION REQUIRED:** We would recommend that the purlins are supported properly and also that the thickness of the struts are increased to the brick supports that are built in around them.

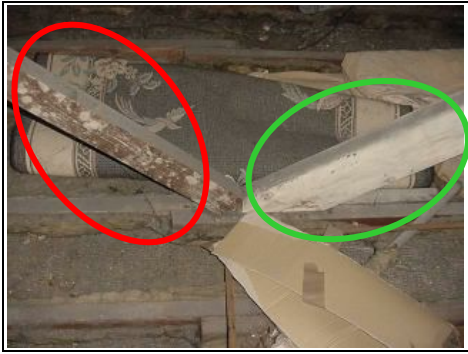
Difference in thickness of struts,  
red circle indicates thin strut

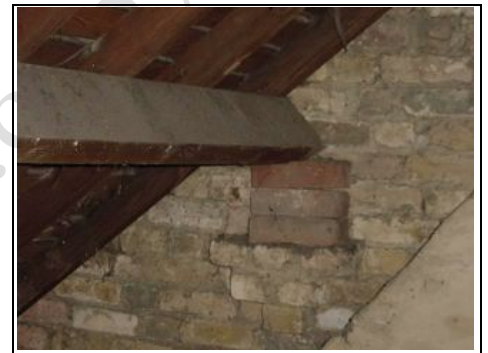
Purlins balanced on bricks  
to the rear

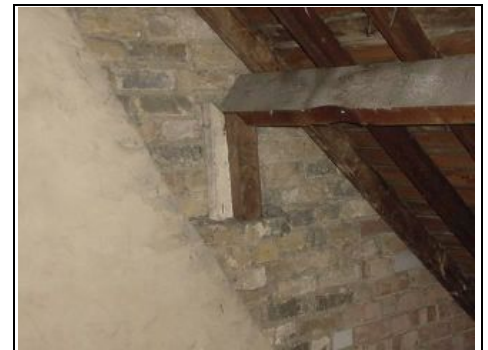
Purlins balanced on timber  
to the front

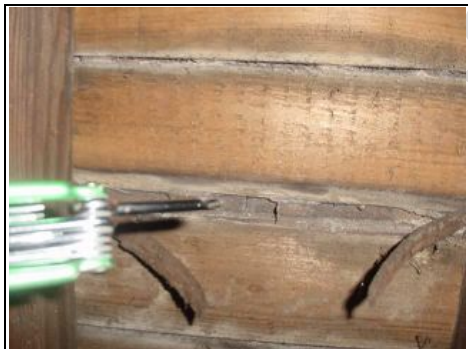
We can see that dampness is coming in internally by the damp, close boarded timbers (in the loft/roof space). Over the years this dampness tends to cause deterioration to the nibs on the tiles which then slide off the roof.

Close up of dampness

**ACTION REQUIRED:** If you are having major works carried out then it will be worth considering replacement of the roof. We would recommend that this is carried out in the summer of 2014.

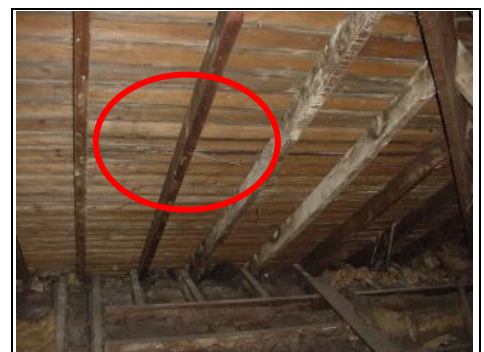
Dampness coming through

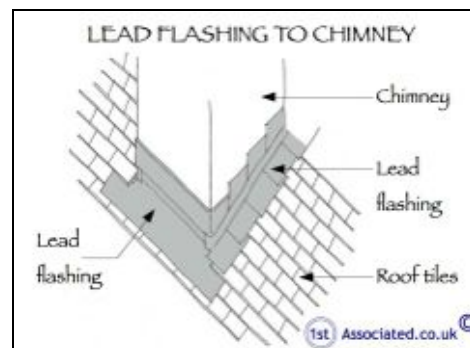
Although there do not look to be any problems with the chimney from the outside (remember we could only see the front of the chimney) from within the loft/roof space we could see damp staining.

Flashing to chimney

**ANTICIPATED COST:** If this repair is carried out as part of the roofing work with scaffolding already in place then it is likely to cost in the hundreds of pounds range but if this is specifically carried out on its own then scaffolding on its own is likely to be £1,000 plus. We would recommend this is carried out in the summer of 2014; please obtain quotations.

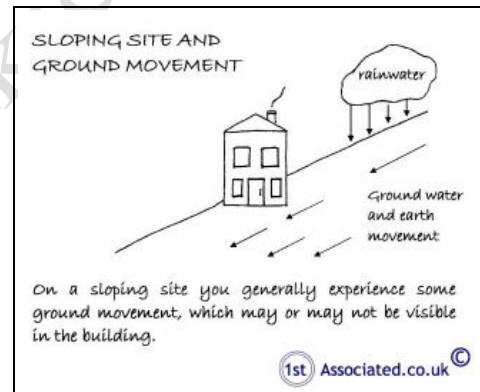
This property sits on a sloping site and as such water will travel from the top of the site to the bottom via the house which will affect it causing deterioration to timber elements and metal lintels. These all need to be checked when you carry out your refurbishment project.

Sloping site

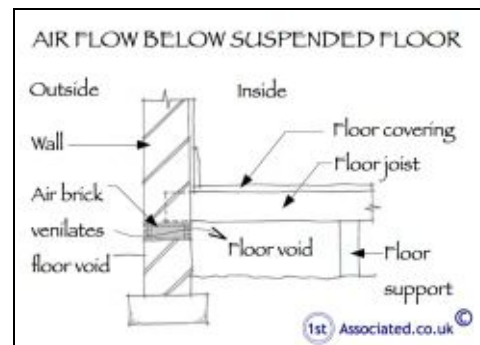
As you are aware there is a large void underneath the suspended timber floor. This may mean that the timber floor is not adequately supported. We cannot comment further without opening up this area which we are happy to return and do if you so wish (of course you will need the owner's permission).

Suspended timber floor

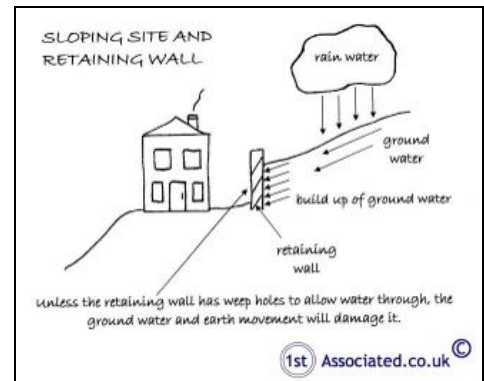
The property sits on a site that slopes both from the front of the house to the back and also from the left to the right. There is a retaining wall on the left hand side which we believe needs weep holes adding to it. We are surprised how well it has remained in place considering the amount of water pressure and earth pressure we believe this will have on it.

Sloping site

**ACTION REQUIRED:** Either rebuild the wall with anchors into the ground, we have no way of knowing if this has taken place, or you can add buttresses/ angled brick piers to it to give additional support as well adding weep holes.

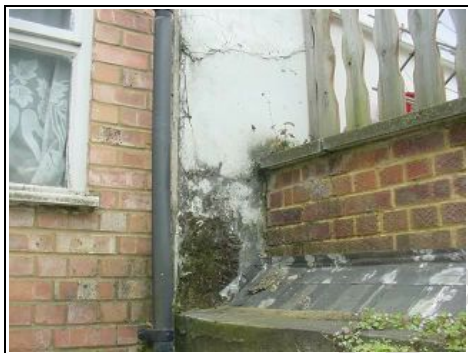
We would much prefer to see a brick buttress / angled brick piers on this height of retaining wall when it's this close to a building

Left hand boundary/retaining wall

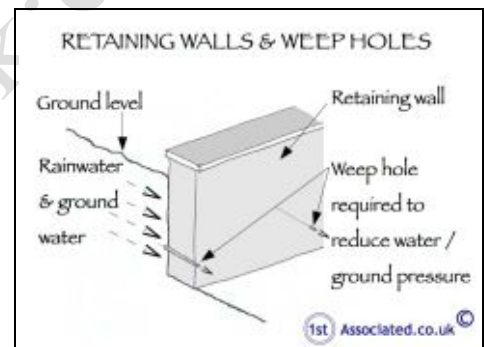
Weep holes to retaining wall

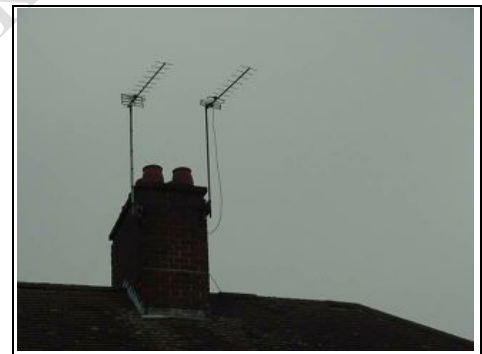
This chimney is brick, finished with a lead flashing and a few chimney pots. From what we could see from ground level it looked in average condition considering its age, type and style but we can see from within the loft/roof space that there is a leak around it. This maybe to the rear of the chimney (we could not see this clearly) or it may be too small to see from ground level.

Brick chimney

**ACTION REQUIRED:** Periodically inspect the chimney.

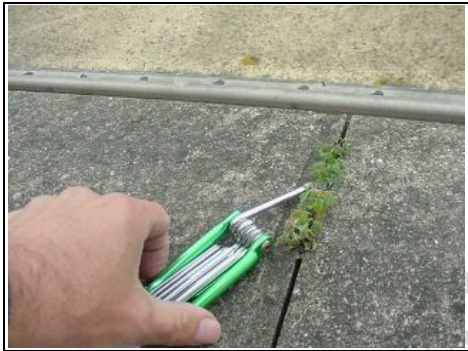
In this case there is a parapet wall to the flat roof of the garage. We can see that the coping stone to the top of the wall is leaking.

Parapet wall is letting water in

**ACTION REQUIRED:** We would lift the coping stone and check to see if there is a damp proof course. It may also be that dampness is getting in via the flashing on the roof.

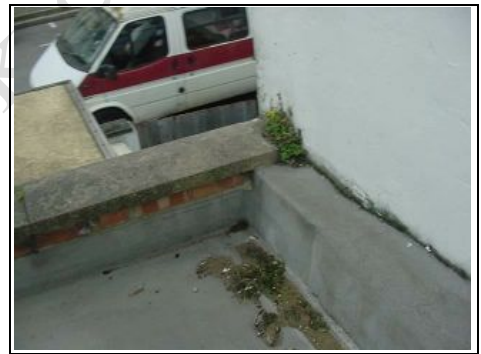
Parapet wall to garage roof

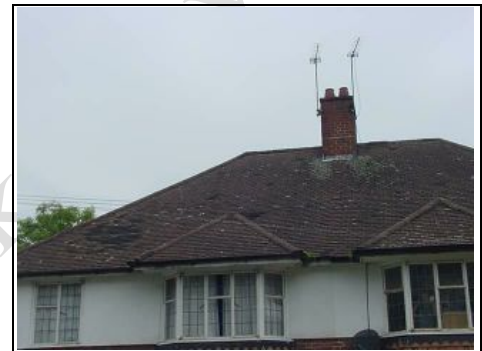
Main roof

The main roof is hipped and clad in nibbed tiles and, from ground level, this looks in slightly below average condition due to the tiles that we can see that have been replaced and also where some are lifting.

**ACTION REQUIRED:** Please read our comments within the Executive Summary. This roof we believe is worse than it initially looked. Until repairs are carried out, recommended in the summer of 2014, then periodic inspections and maintenance of the roof, should be carried out, this is be dependent on the weather.

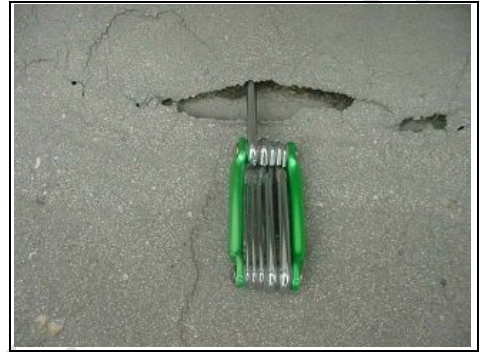
Holes to asphalt roof

**ACTION REQUIRED:** Please see our comments in the Executive Summary.

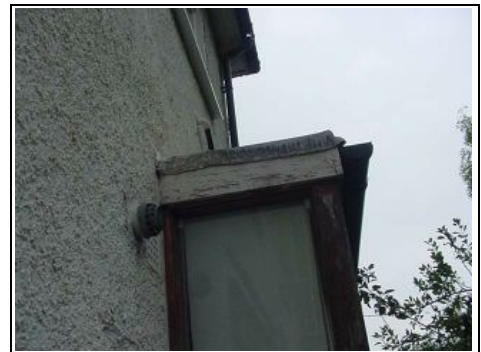
Flat roof to rear

Whilst we can see no dampness coming into the property this roof does look to be dated. We assume that if you are carrying out major alterations then it will be best to replace this.

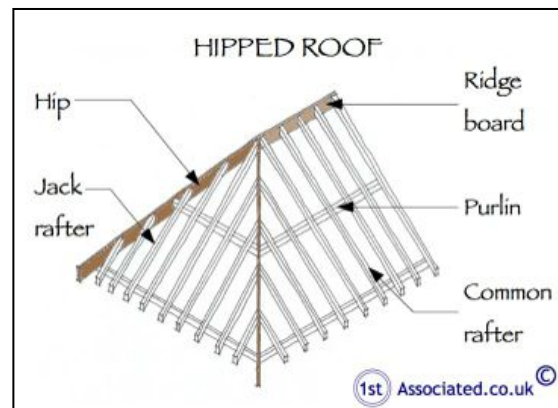
Cut timber roof

This type of roof structure has what is known as a hipped roof. Without the original design details we cannot categorically confirm that there are no defects but it is not in line with what we typically see. The struts that are supporting the purlins (not shown in sketch) look to have been repaired and replaced. We would add that our other concern is the way the purlins are balanced in place.

Finally due to the construction of hipped roofs, they are prone to slipping or to dropping which can, in extreme cases, push the walls out of vertical.

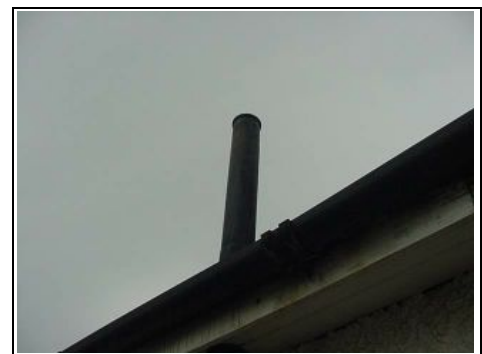
Soil and vent pipe

The property has cast iron soil and vent pipes. Cast iron of this age will need repair and maintenance.

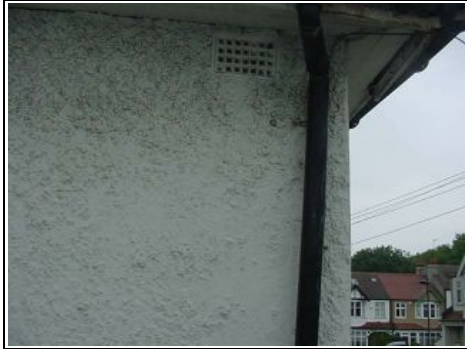
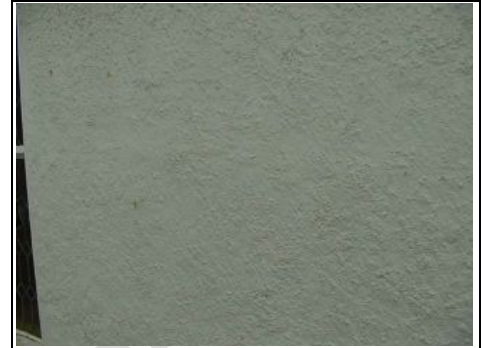
There is a lot of painted roughcast render to the property. It is deteriorating as does render of this age and era.

Roughcast render with patches of repair

**ACTION REQUIRED:** Please see our comments in the Executive Summary.

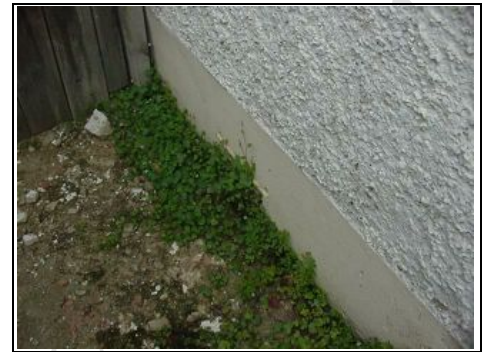
To the base of the render there was no bell mouth detail. We would always recommend that one is added although some would argue that with rough cast render you do not need a bell mouth.

No bell mouth

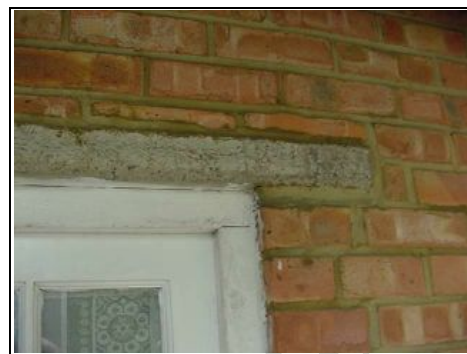
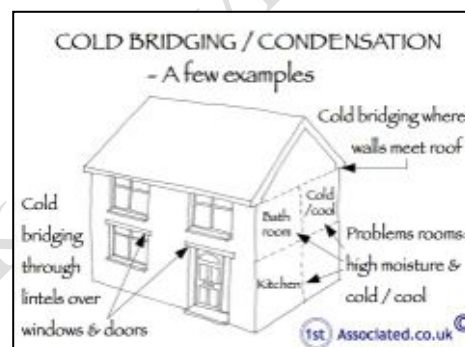
We noted concrete lintels. These may cause cold bridging. Please see our article in the Appendices at the back of the report.

Cold bridging is caused by a colder element in the structure allowing coldness to pass through the structure much quicker when warm moist air is present in the property.

Concrete lintels

Cold bridging/thermal bridging

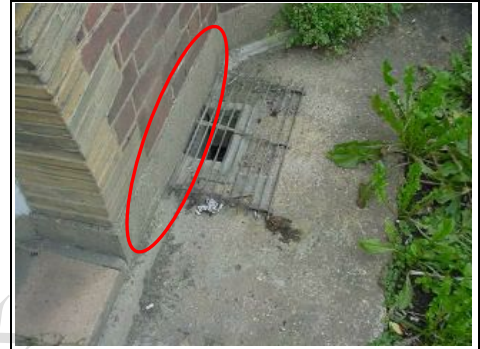
All modern properties should incorporate a damp proof course (DPC) and good building practice dictates that a differential of 150mm (6 inches) should be maintained between the damp proof course and ground levels. In this case we cannot see a DPC due to the plinth. We would expect one to be present behind the plinth and this is likely to be slate or tar.

Plinth to base of property,  
hiding DPC.

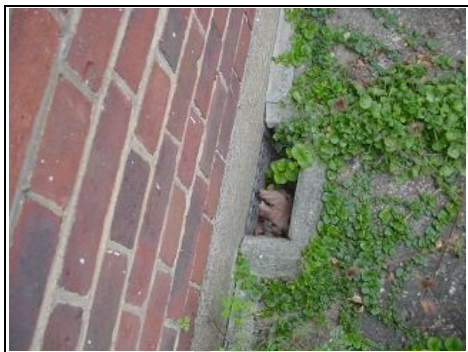
Air vent to front.  
High ground level

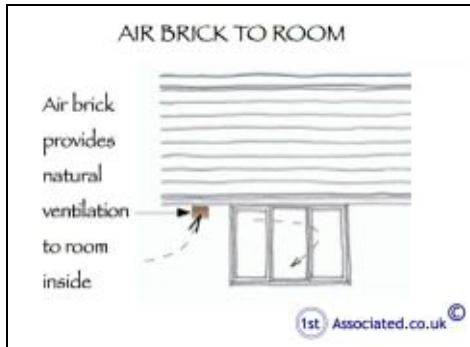
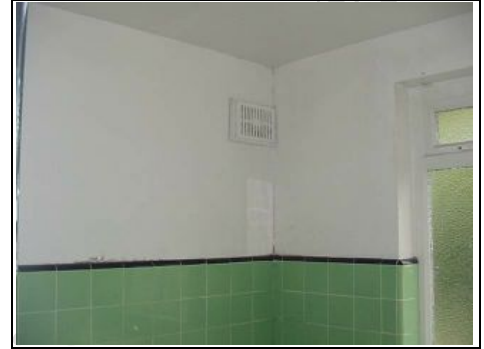
There are vents at high level. High level air bricks are to help air circulation within the property. These were often added in the 1950's/1960's when there was a lot of condensation caused by the metal windows. This does possibly indicate that the property may have been built a bit later than we originally thought.

Ventilation via air bricks

High level vent

**ACTION REQUIRED:** Ensure the air bricks are clear.

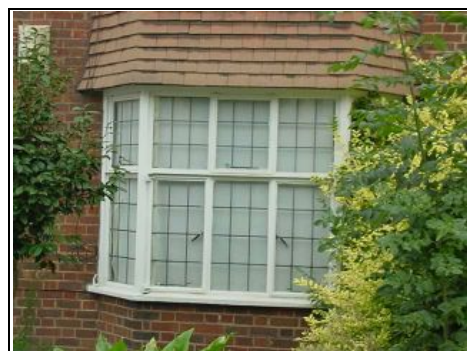
The property has metal windows in timber frames. Metal windows are often known by their generic name of Crittal windows which was one of the main manufacturers. Typically these windows warp and rust and become difficult to close which in turn makes them draughty. In this instance they are rusting and have cracked glass.

**ACTION REQUIRED:** Please see our comments in the Executive Summary.

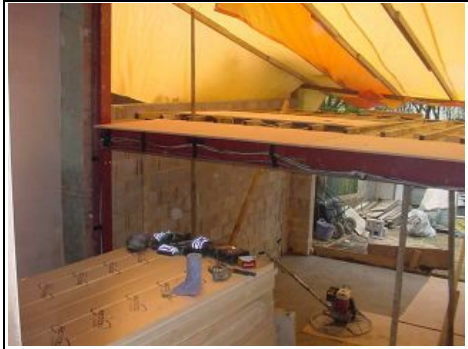
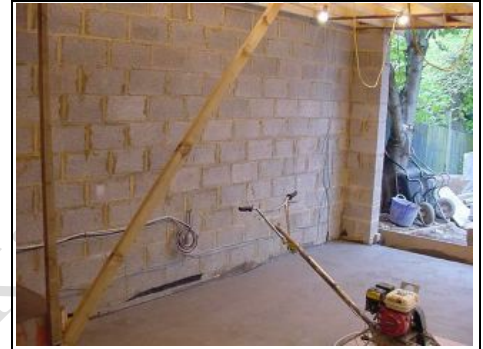
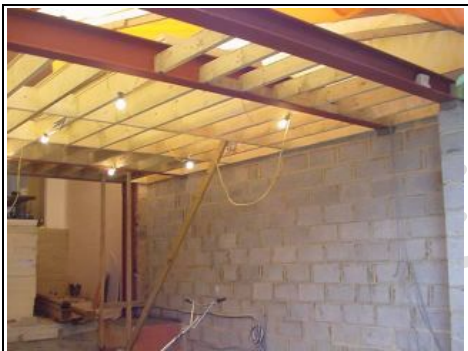
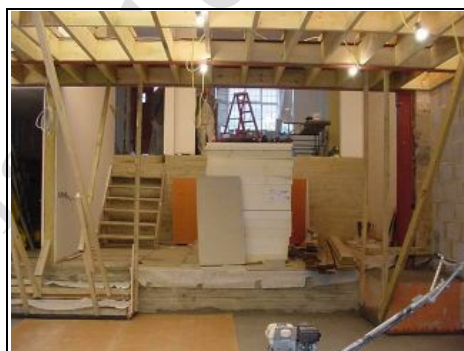
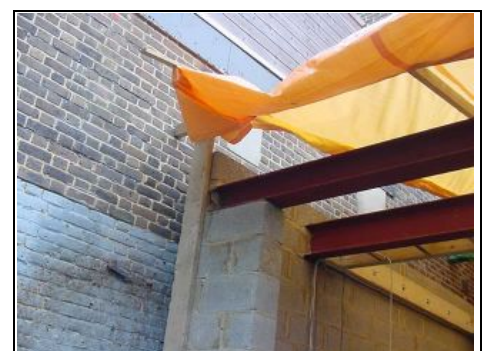
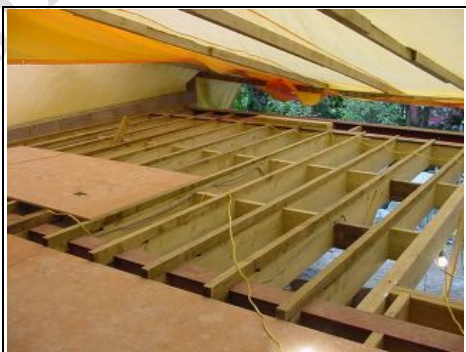
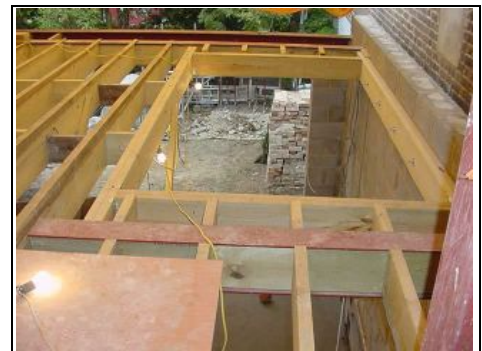
Your property is a semi-detached property and there is building work being carried out next door. We have viewed this briefly and there are major structural alterations being carried out. This work should have Building Regulations and Planning Permission together with a Party Wall notice advising of exactly what is being carried out.

New floor and roof to next door

**ACTION REQUIRED:** Your Legal Advisor to check and confirm this.

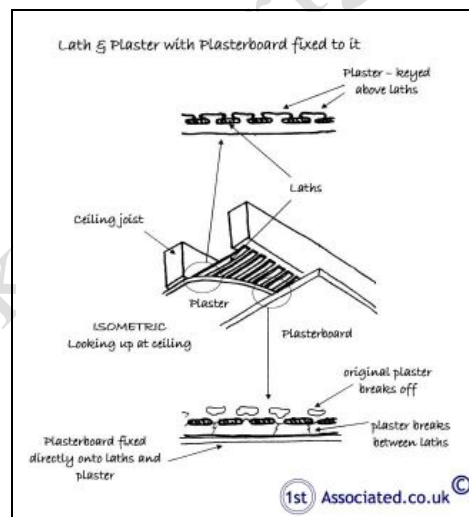
It will be an important factor in the refurbishment costs as to whether new ceilings are required. You do need to check the extent of the original lath and plaster and the extent of new plasterboard. Sometime plasterboard is tacked over the original lath and plaster.

Plasterboard tacked over lath and plaster ceiling

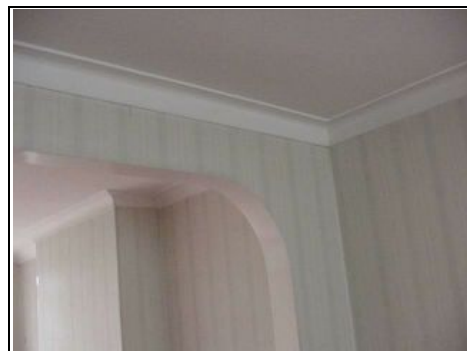
The central wall to the through lounge has been removed, possibly part of the original construction. There is a curved arch which was common in years gone by and may even come back into fashion one day!

Central wall removed, curve was common years ago

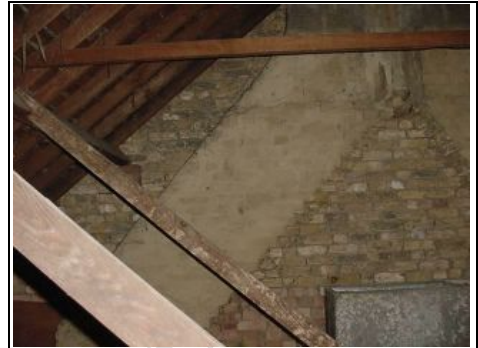
Chimney shows no signs of movement from next door

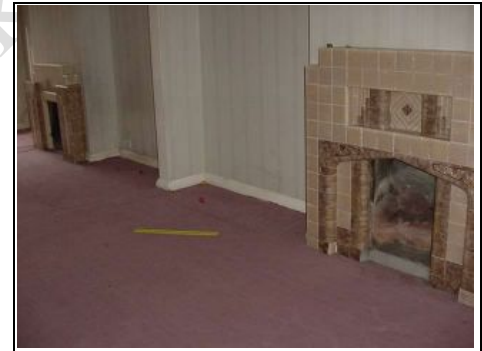
Two chimney breasts in lounge

Your Legal Advisor needs to specifically check with the Local Authority for removed chimneys and associated chimney breasts and Building Regulations Approvals and advise by e-mail immediately if chimney breasts are found to have been removed. We would recommend opening up the structure to check the condition. If we are not advised we will assume the relevant Building Regulations Approval has been obtained.

- It is strongly recommended that flues be cleaned and checked for obstructions prior to use to minimise the risk of hazardous fumes entering the building.

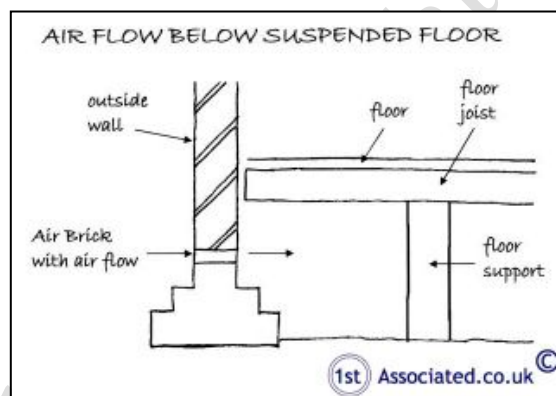
The floors of the property are suspended timber floors which require air movement underneath to minimise wet rot, dry rot and woodworm. We noted deflection to the ground floor.

Suspended timber floor

**ACTION REQUIRED:** Please see our comments in the Executive Summary.

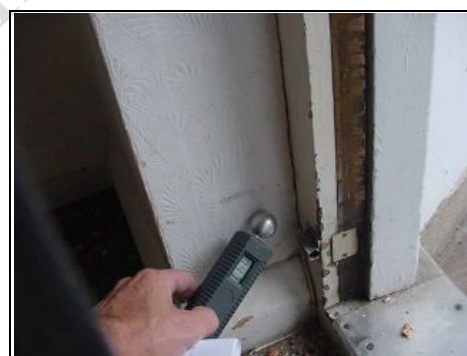
A visual inspection and tests with a moisture meter have been taken to the perimeter walls. In this particular case we have found minor dampness which has probably been brought on by the property being empty and the weather turning colder.

Testing for rising damp

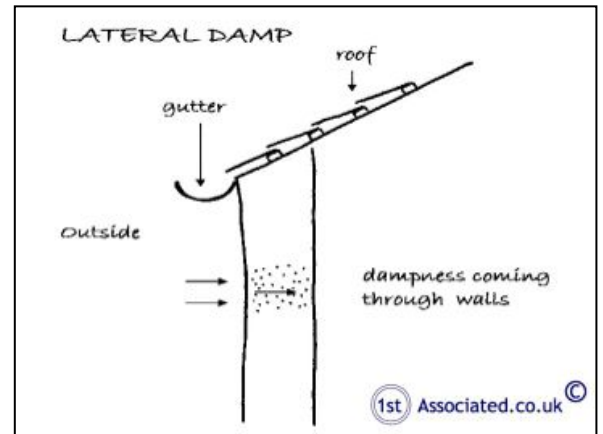
We used a damp meter on the external walls. We have found dampness in line with what we typically see for this age, type and style of property. As mentioned the render that gives the property a protective coat is starting to deteriorate.

Lateral dampness

**ACTION REQUIRED:** Please see our comments in the Executive Summary.

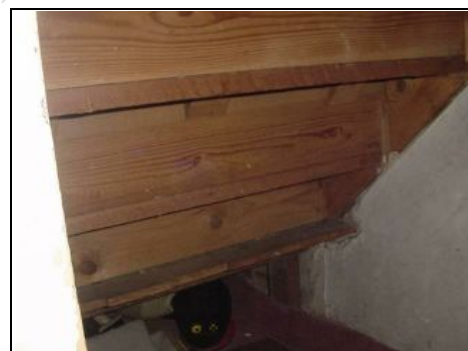
We noted that the underside of the staircase was exposed. It is more normal today to have a half hour fire barrier to stop fire spreading from the ground floor to the first floor in a worse case scenario. You may wish to take a view on whether you add this.

Stairs not lined

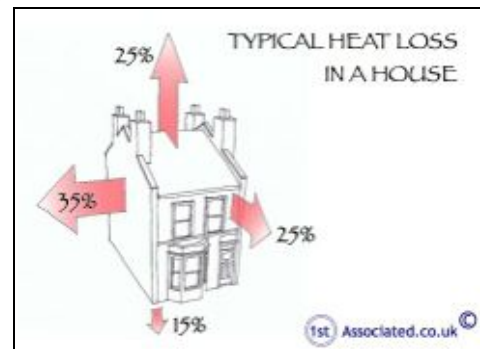
Some roof insulation was present although not to current Building Regulations requirements of 300mm. In this instance there is about 100mm in the roof which was the standard back in the 1970's.

Typical heat loss

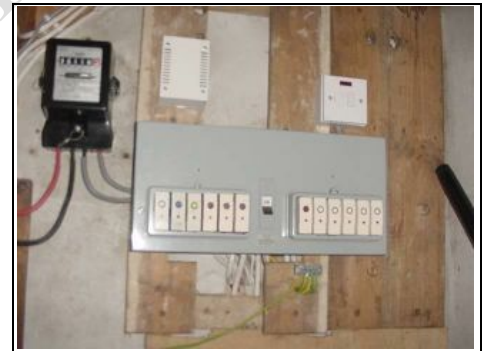
The electric fuses and consumer units were located under the stairs. The fuse board looked 1980's/1990's and better are now available.

Fuse Board

**ACTION REQUIRED:** If you are looking to refurbish the whole property then it makes sense to upgrade the electrics. Please see our comments within the Executive Summary.

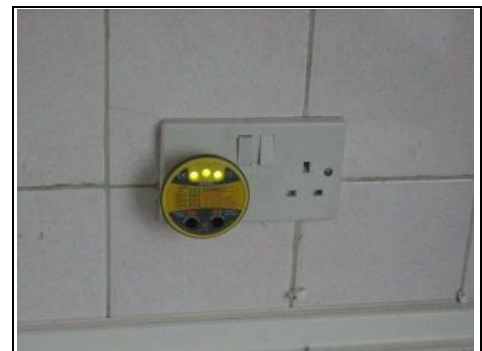
We carried out an earth test in the kitchen area to the socket point that is normally used for the kettle, this proved satisfactory.

Earth test

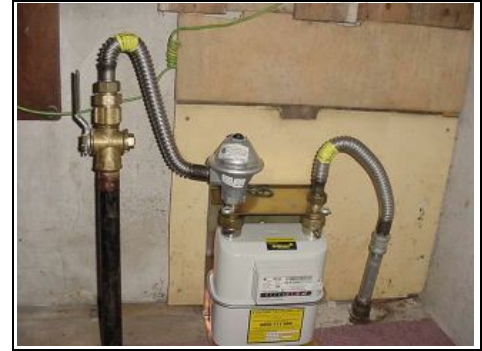
The property has mains gas. The consumer unit is located under the stairs.

Gas

**ACTION REQUIRED:** As a matter of course it is recommended that the entire gas installation is inspected and made good, as necessary, by a Gas Safe registered contractor. Thereafter the installation should be serviced annually.

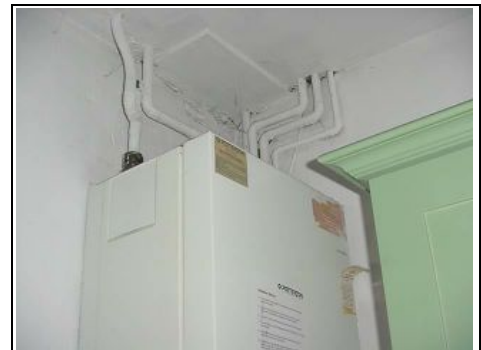
The older style wall mounted boiler was located in the kitchen, it is manufactured by Potterton.

Dated potterton boiler

Our limited inspection of the hot water and central heating system revealed no evidence to suggest any serious defects but we would nevertheless recommend that the system be tested and overhauled before exchange of contracts and that a regular maintenance contract be placed with an approved heating engineer.

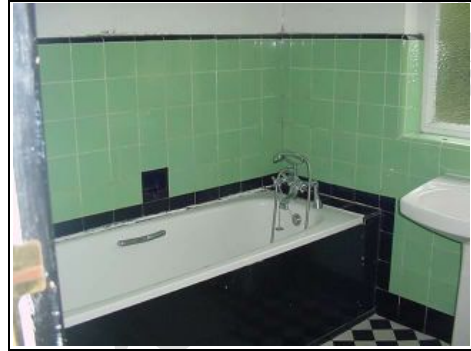
The property has a two piece dated bathroom suite, consisting of a bath and wash hand basin and a separate WC, which look in below average condition.

Bathroom

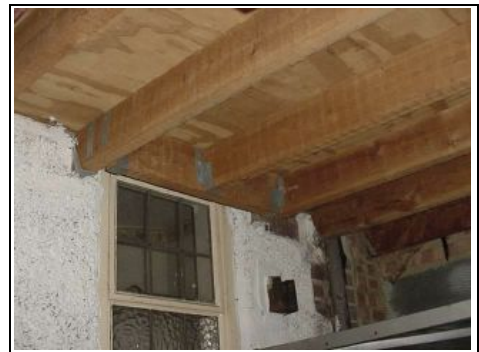
Joist hangers to underside of garage roof indicating it is relatively new

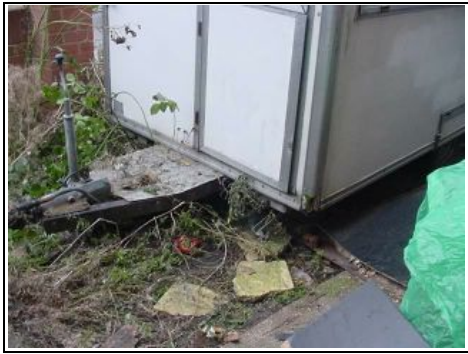
At the time of the survey rubbish was being removed from the property and there is a storage unit at the front of the garage which also needs removing.

Trailer parked to left side in front of garage

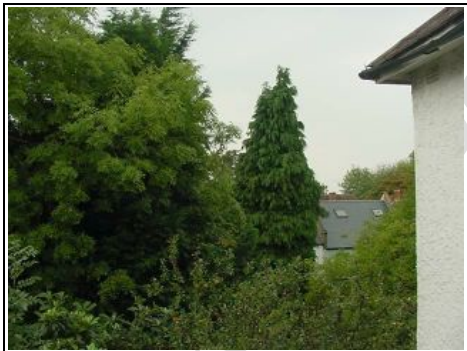
Trees to rear will restrict light in garden

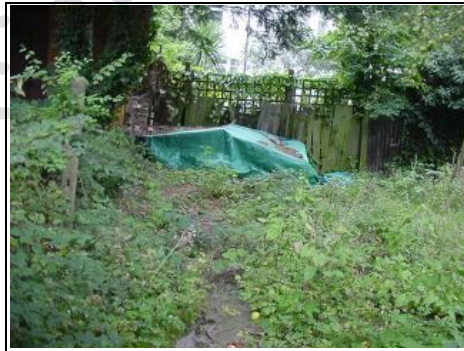
The rear garden is over grown and needs clearing.

Rear garden
