# RESIDENTIAL BUILDING SURVEY

**XXX**  
**Streatham,**  
**London**  
**SW16 XXX**

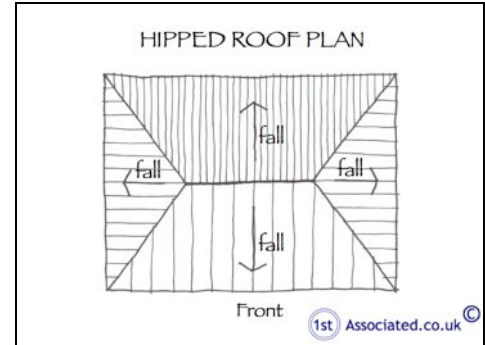
Hipped roof

You have an older style constructed roof, which consists of a hipped roof construction, which would have been cut and purpose made on site (which was the common method of this time). It has a feather edge board attached to the roof structure, with a nibbed tile hooked on to it.

Hipped roofs can be what we would describe as integrally problematic as they sit upon themselves. Some movement is not unusual in this age, type and style of property.

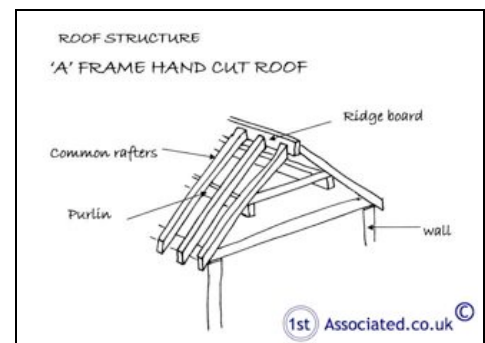
A-frame roof

We would advise that within both the main roofs there looks to have been some alterations and amendments over the years. These include additional supports in the left hand side of the roof; if you recall we mentioned about an A-structure where horizontal collars have been added, and to the right hand side of the main roof we can see the purlins are in an unusual configuration and unsupported in some areas and cut in other areas.

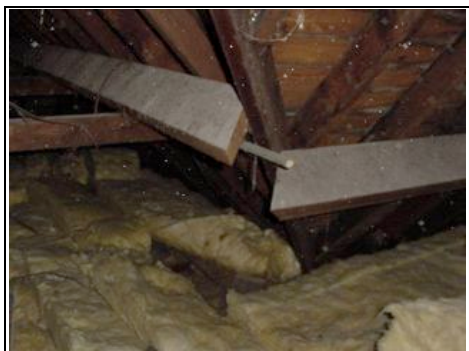
We would have expected support, particularly to the right hand purlin

There is no obvious reason why the purlin has been cut or why the other purlins have not got any supports (if they ever did have supports). Unfortunately, the mass of insulation in the roof does not allow us to see if timbers have been cut on the ceiling joists (although there is no indication they have).

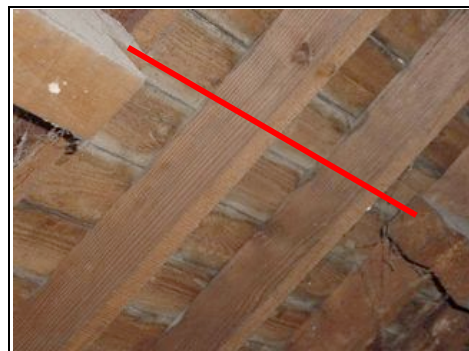
Cut purlin – the red line shows where the purlin should be

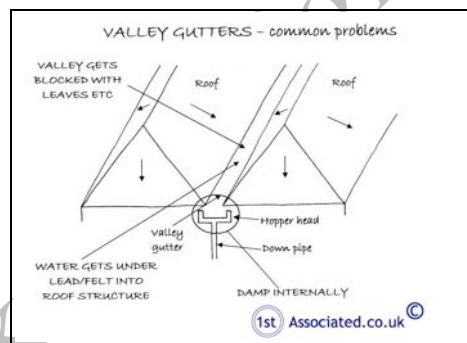
Valley gutters

From within the roofs we could see some dampness on the left hand side; we simply could not get a good view of the right hand side but we do think there is a leak in the valley gutter.

**ACTION REQUIRED:** We recommend that a roof window is added to allow this hidden area to be viewed and cleared without having to resort to expensive scaffolding to gain access.

Once the roof window is in place then clear the valley gutter and carry out any repairs.

**ANTICIPATED COST:** In the region of £1,500 to £3,000 to add a roof window and sort the problem. Please obtain quotations.

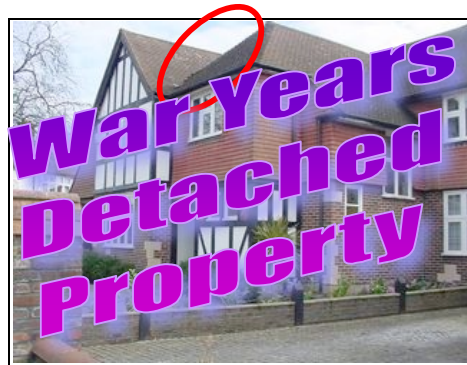
Valley gutter – where one pitch of the roof meets the other

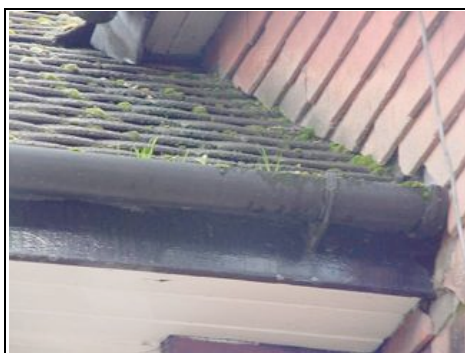
We can see that the gutters have not been cleared for some time; grass can literally be seen growing out of the gutters to the side and to the rear. This in turn has caused deterioration of the fascias and soffits and bare timber is visible in some areas.

Grass growing out of gutter

**ACTION REQUIRED:** A handyman required for a few days to clear all gutters and moss from the roof that can easily be reached, using a soft brush so as not to damage the tiles; possibly even doing some painting during the warmer weather.

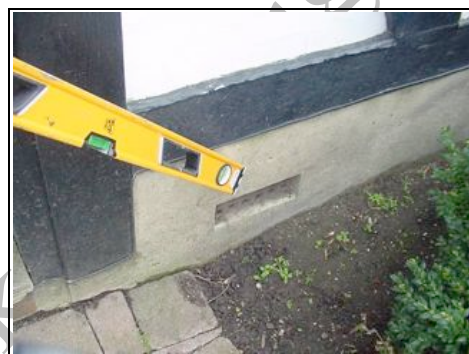
Air brick

We note that the property has a suspended timber floor added, which we believe still exists but underneath the tiles which also has a heated floor system. The air vents are in place to allow a through flow of air to minimise wet and dry rot and woodworm. In addition to this, there is normally some breathing of the floor between the floorboards which cannot take place due to the area being tiled.

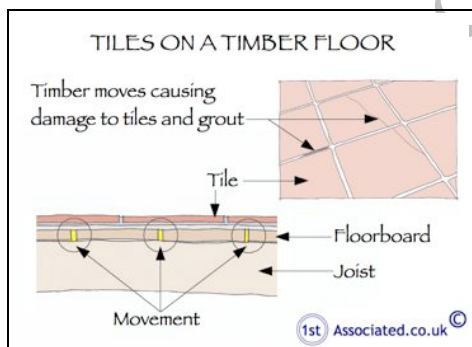
Tiles on timber floor

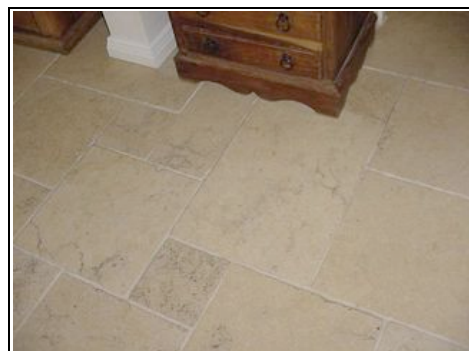
Floor tiles

**ACTION REQUIRED:** Ensure that air vents are clear to the front and rear. This is a handyman type job.

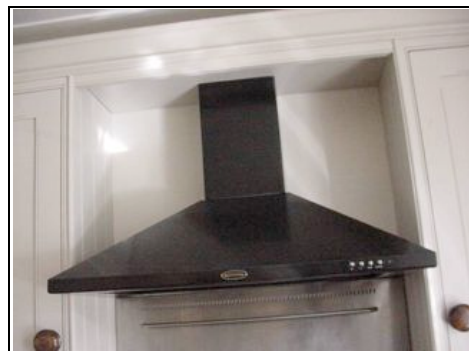
Filter in kitchen – not the air extractor

**ACTION REQUIRED:** We recommend replacing the extract fans with large humidity controlled extract fans.

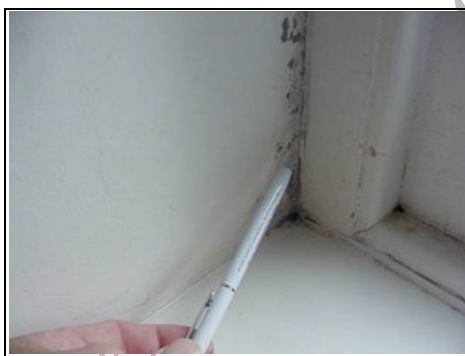
We noted in the annexe that there was black mould visible around the windows and other area. Black mould occurs where humid air carries dust, dirt and skin particles to cold areas, such as corners of buildings and around windows and deposits on these areas. From the research being carried out in the USA (due to legal cases against landlords) black mould can have a detrimental effect on health. We believe we are still in the infancy of discovering the effects of this type of mould but it is best to ventilate and be without it in our opinion.

Black mould in annexe

**ACTION REQUIRED:** We have already mentioned about adding a large humidity controlled extract fan in the shower room, we would equally add extraction in the bedsit (kitchen, lounge and bedroom), particularly around the cooking area. You also need to be aware that people will usually dry clothes during the winter months in these areas so it does need to be well ventilated.

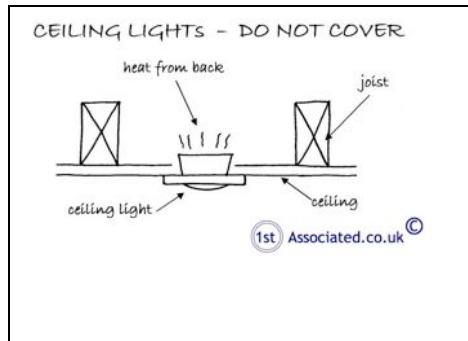
Just to reiterate our earlier comment; the ceiling lights are covered within the roof space. This is a potential fire hazard as they can become very hot.

Ceiling lights should not be covered

**ACTION REQUIRED:** Replace with newer modern low energy lights which give off less heat. Also carry out the recommendation to line the roof and add ventilation to these areas.

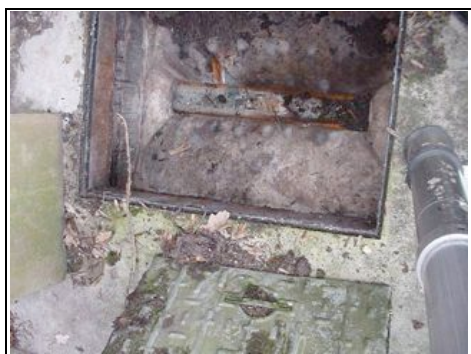
To the front right hand side the manhole cover was lifted and the drain looked to be partially blocked with earth, which would usually indicate that the drain has partially collapsed. We can see the moss on the right hand side which could be due to a leaking water supply pipe or leaking drain, or possibly rainwater being discharged off the roof and landing in this area, but further investigation needs to take place.

Front right hand manhole  
appears to be blocked

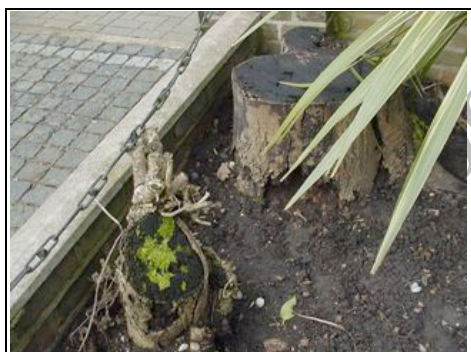
We believe that the tree roots of the removed trees to the front of the property have caused the crack in the front wall.

Tree stumps of removed  
trees to front

We were advised by the owners that these were chopped down before the roots got as far as the property. If this is correct then this should not be a problem, however we did note that some of the parking area is sunk which can be caused by roots, either alive or dead and rotting.

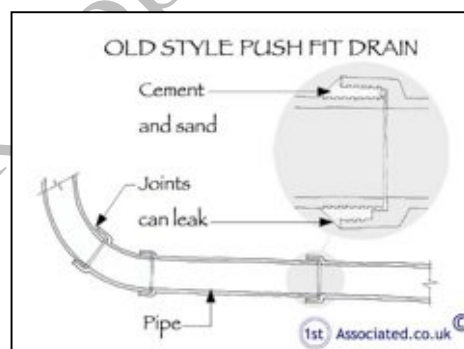
We must also advise that in older properties, such as this, drainage was often push fitted together rather than bonded together which means that they may leak over the years. Whilst we ran the tap for 15 minutes without any build up or blockages the only way to be 100% certain of the condition of the drains is to have a closed circuit TV camera report.

Push fit drain

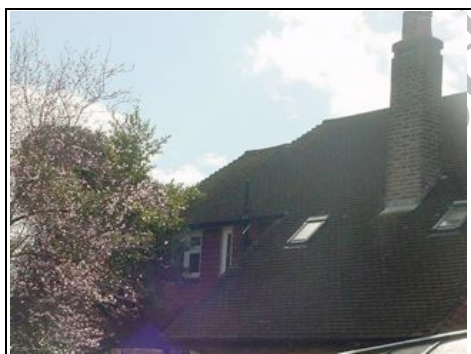
This chimney is brick finished with a lead flashing and two chimney pots. It was difficult to view due to the way the sunlight was on the day of our inspection but from what we could see from ground level it looked in average condition considering its age, type and style.

Front left hand chimney

**ACTION REQUIRED:** Periodically inspect the chimney.

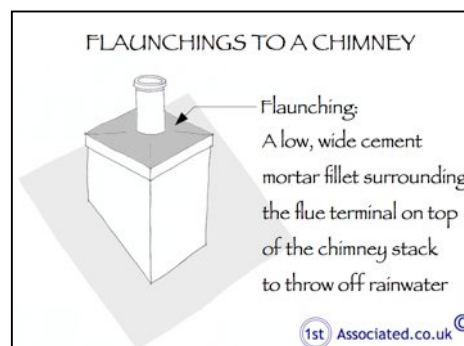
Unfortunately we were unable to see the top of the chimney known as the flaunching, we therefore cannot comment upon them.

Flaunchings

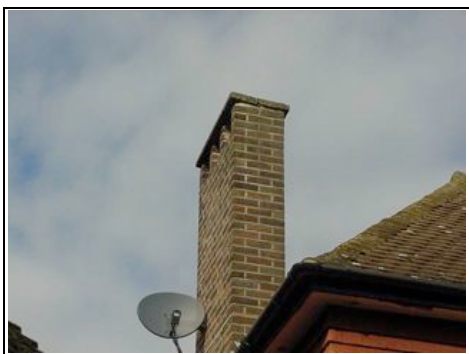
This chimney is also brick built with a lead flashing. It looks in average condition for its age, type and style.

Front right hand chimney,  
(taken from rear of property)

**ACTION REQUIRED:** Periodically inspect the chimney.

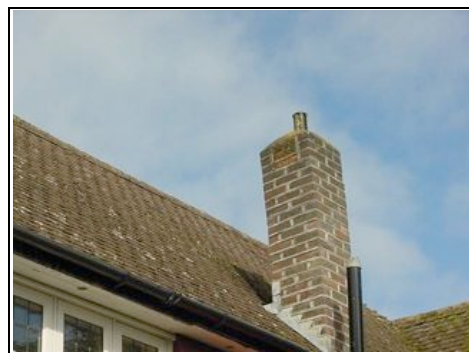
This chimney is a smaller chimney that is again brick built with a lead flashing and one flue and is also in average condition for its age, type and style.

Rear chimney

**ACTION REQUIRED:** Periodically inspect the chimney.

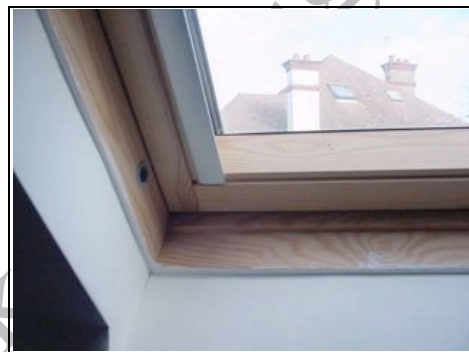
The property has two roof windows; one to the rear bathroom and one to the front en-suite. We had a limited view from a distance away. Internally we could see that there was no obvious signs of major water leaks. We could see some untidy paint that has got on to the timber.

Roof window internally

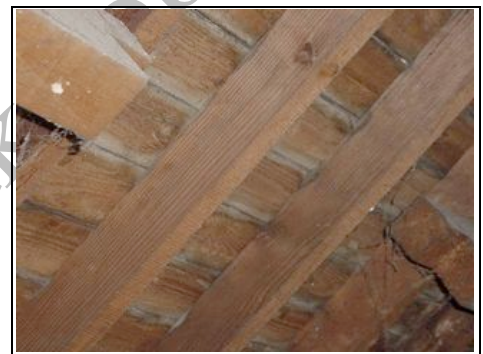
In this case the roof is feather edge and close boarded and does not have a protective underlayer. It simply has the tiles protecting the property.

We can see that dampness is getting in. Equally, these roofs are relatively well ventilated.

Feather edge and close boarding

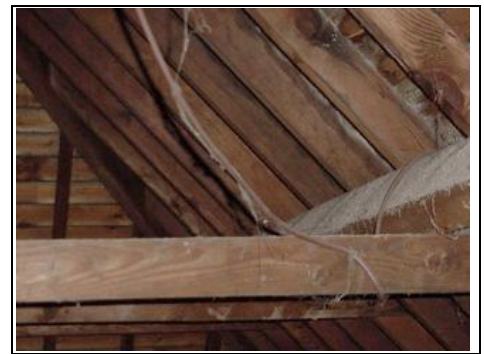
This roof is quite unusual by what is missing with regard to part of the purlin to the rear and struts that we would expect to be in place and have possibly been removed.

Dampness coming into the roof on the timbers

**ACTION REQUIRED:** The only way to be 100 per cent certain is to have the roof cleared (for example the insulation) and checked.

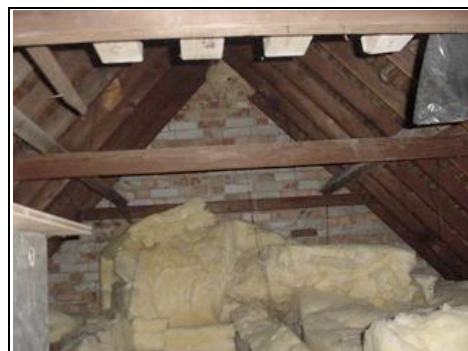
Our examination was limited by the general configuration of the roof, the insulation and stored items. What we could see was generally found to be in below average condition for its age, type and style. This is due to the alterations that have taken place which appear to be lacking to the right hand roof and the dampness that is getting in. The alterations to the roof could of course be explained by the appropriate documentation from the seller's solicitor.

Right hand side of main roof

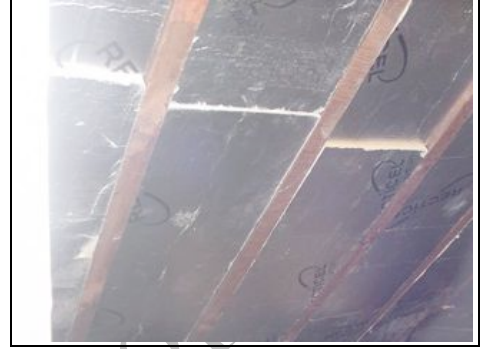
The side roof is accessed from the front left hand bedroom en-suite. It has had insulation added between the joists. This is not generally recommended as any dampness that is coming through this roof can no longer dry.

Well insulated

**ACTION REQUIRED:** We would suggest that you take out sections of the insulation, flatten it to allow air movement and then re-fix it.

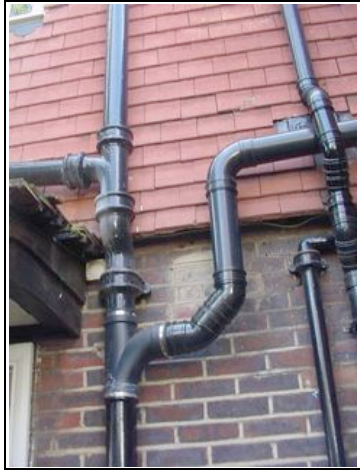
The property has a mixture of cast iron and plastic soil and vent pipes. Cast iron of this age can crack and rust and needs regular maintenance.

Left hand side cast iron and plastic soil and vent pipe

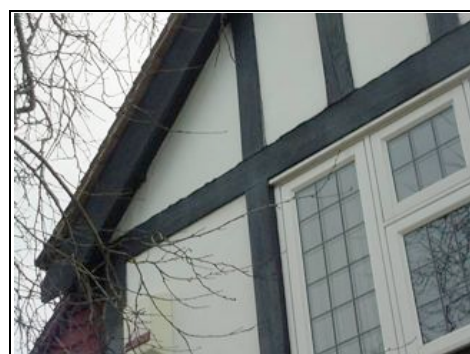
The top of the front of the property is finished with painted render with mock Tudor style timbers. They are slightly dull in appearance and would benefit from redecoration the sooner the better and no later than the summer of XXX.

Render with mock Tudor style timbers

**ACTION REQUIRED:** Redecorate before summer of 2015.

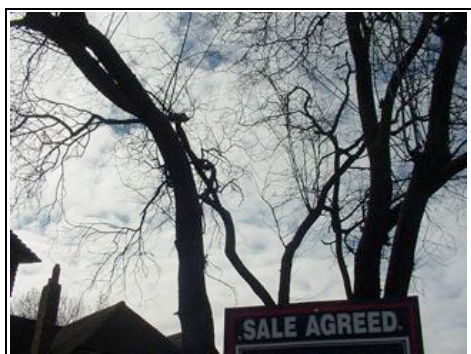
There are trees within what insurance companies would term as influencing distance of the property.

Tree to front garden

**ACTION REQUIRED:** We would recommend an arboriculturalist (not a tree surgeon) is asked to view the property and give a ten year plan for maintenance.

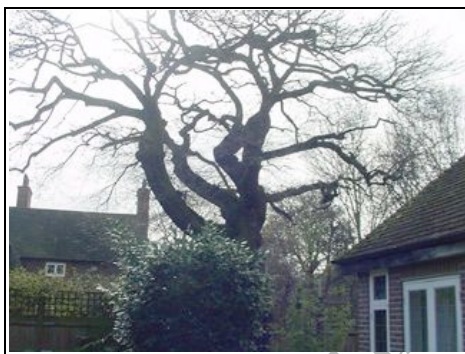
Tree in rear garden

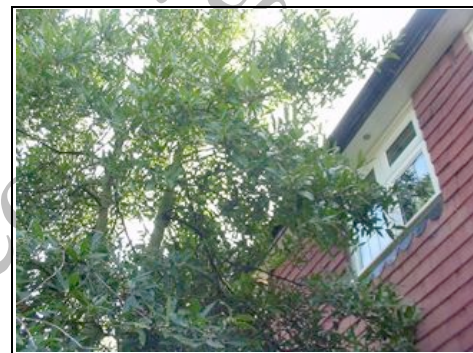
Tree to left side

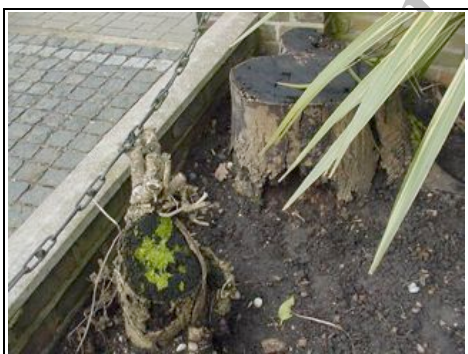
Tree stump from old tree

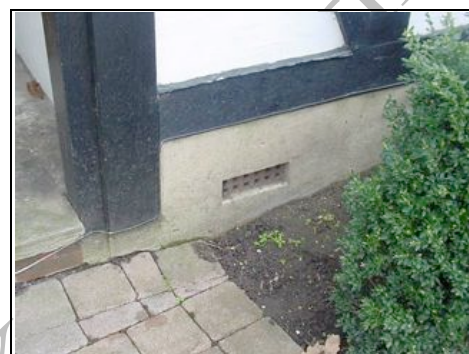
All modern properties should incorporate a damp proof course (DPC) and good building practice dictates that a differential of 150mm (6 inches) should be maintained between the damp proof course and ground levels. In this case we cannot see a DPC due to the plinth at the front.

Plinth to front where slate DPC could be hidden behind it

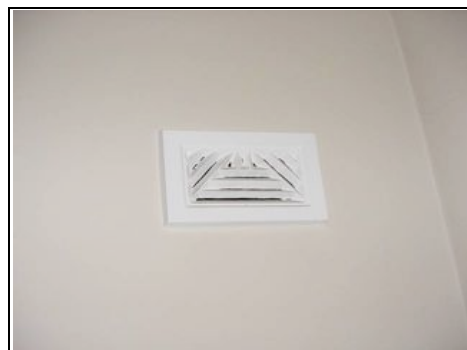
There are Art Deco style high level air vents internally. Condensation is common in this era of property which is why these vents were added.

Original vents with an Art Deco style

**ACTION REQUIRED:**  
Ensure these are clear.

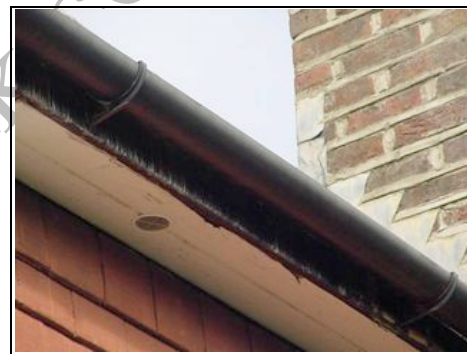
The fascias and soffits are painted timber and we would comment they are in average condition for their age, type and style. We noted vents in some of them.

Fascias and soffits with vents

**ACTION REQUIRED:** Make sure gutters and downpipes are watertight before carrying out any work on fascias and soffits.

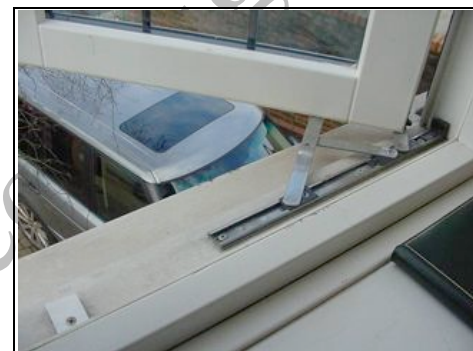
Close up of weathered windows

There is some staining required to the timber and, as mentioned, we believe the windows would benefit from redecoration.

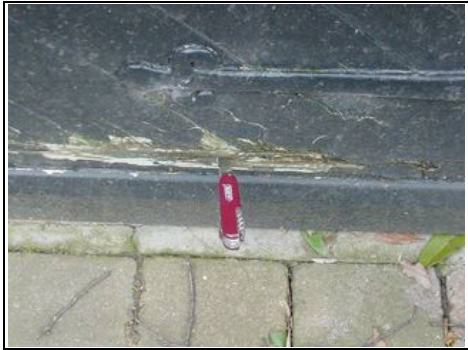
Knife test to garage door

We have found minor wet rot to the windows, garage door and possibly under the floor. There may also be some to the fascias and soffits where the gutters are blocked and have been overflowing for a while. Again, we would advise that we have not opened up the floors and we had a limited view of the roof.

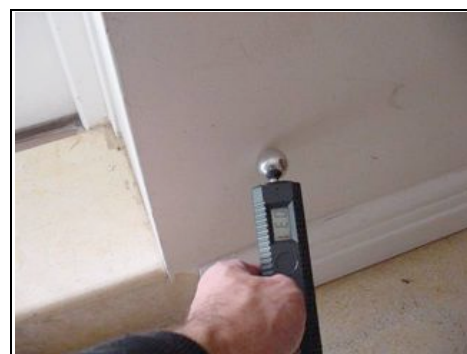
A random visual inspection and tests with a moisture meter have been taken to the perimeter walls. In this particular case we have found no significant rising damp. We must admit that we were surprised at this given the dampness of the floor and what we would say were high ground levels outside, particularly to the front of the property.

Testing for rising damp

**ACTION REQUIRED:** You do need to make sure that the bedding soil does not get too high against the property.

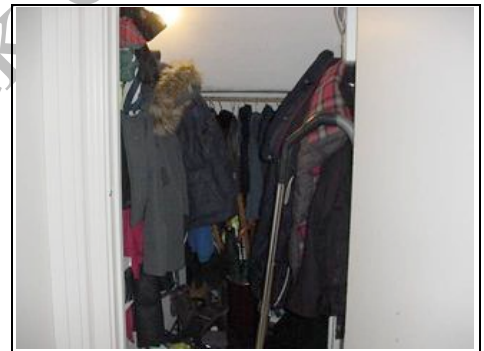
We noted that the underside of the staircase was exposed. It is more normal today to have a half hour fire barrier to stop fire spreading from the ground floor to the first floor in a worse case scenario. You may wish to take a view on whether you add this.

Under stairs lots of stored items

**ACTION REQUIRED:** Line the underside of the stairs.

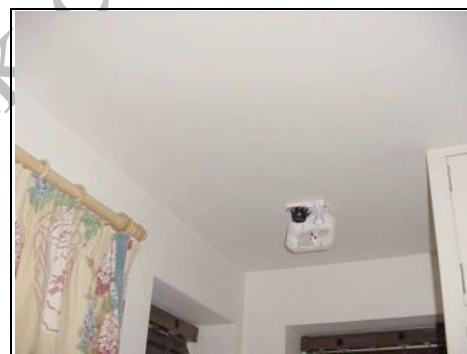
Some smoke detectors were noted. The current Building Regulations require that they be wired into the main power supply. Obviously in a property of this age this is difficult, as it would mean having surface mounted wires or cutting wiring into the plaster.

Smoke detector

**ACTION REQUIRED:** We would recommend, for your own safety, that smoke detectors be installed. We would always recommend a hard wired fire alarm system and are also aware that some now work from a wireless signal which may be worth investigating. Whilst fire is relatively rare it is in a worst case scenario obviously devastating.

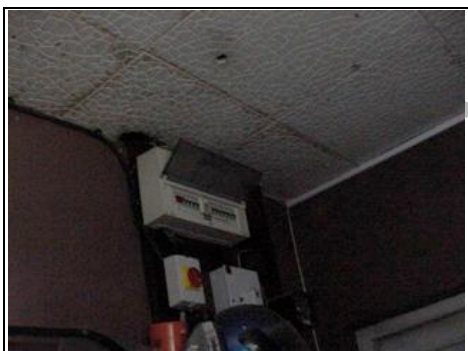
The electric fuses and consumer units were located in the garage and one in the annexe. The fuse boards looked dated and better are now available.

Fuse board in garage

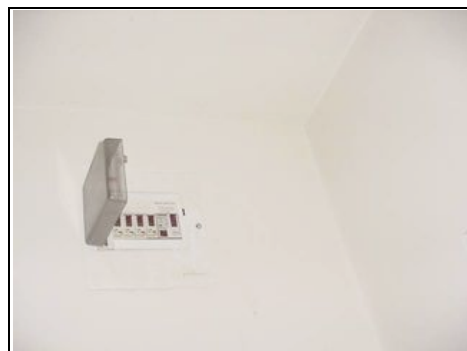
Fuse board in annexe

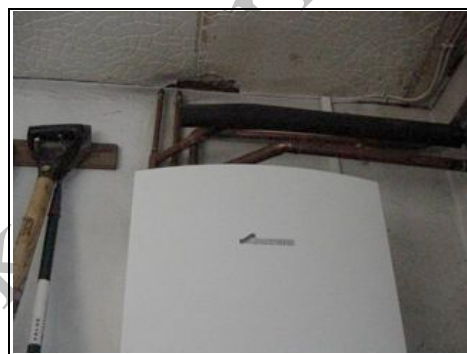
Our limited inspection of the hot water and central heating system revealed no evidence to suggest any serious defects but we would nevertheless recommend that the system be tested and overhauled before exchange of contracts and that a regular maintenance contract be placed with an approved heating engineer.

Worcester boiler

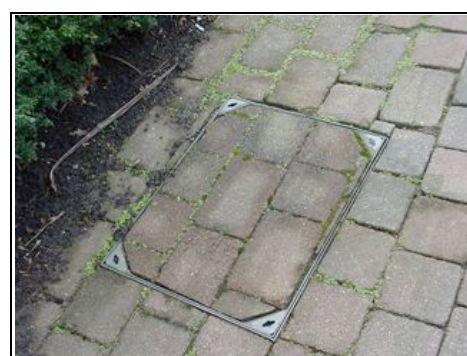
### Inspection Chamber / Manhole One, located to front

We were unable to lift this manhole due to the paving slabs and therefore cannot comment on its condition.

Manhole to front

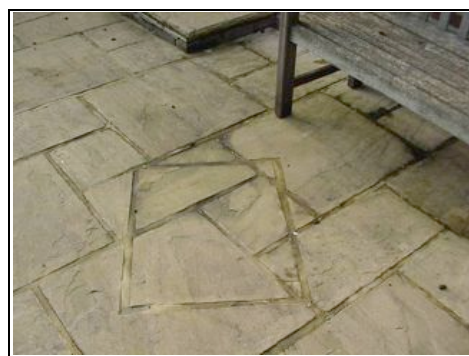
**Inspection Chamber / Manhole Three, located to the rear,  
opposite the annexe**

We were unable to lift this manhole and could not comment on its condition.

Rear manhole

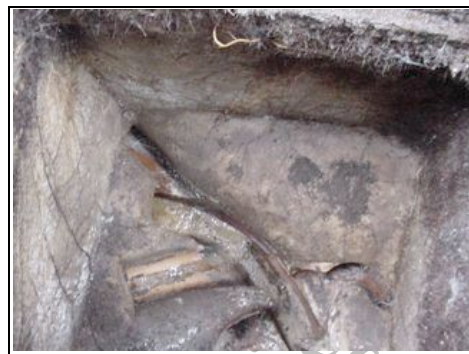
We duly lifted the cover and found it to be free flowing at the time of our inspection. However we did note some roots in there.

Manhole to left side

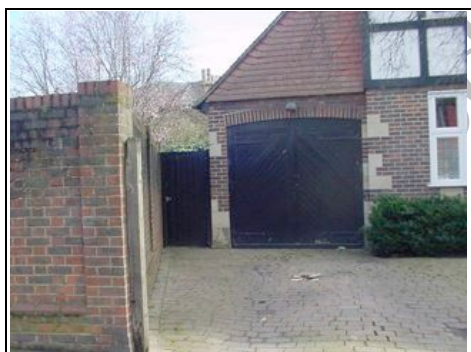
Garage

The door is rotting and internally we noted polystyrene tiles to the ceiling.

**ACTION REQUIRED:** Regular check of garage door. Remove polystyrene tiles.

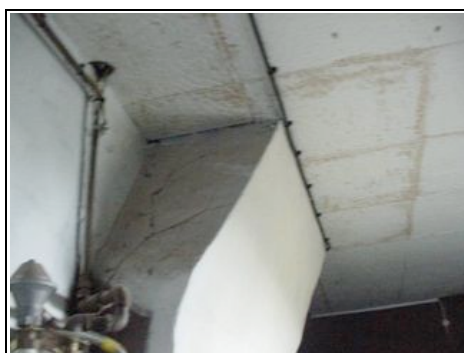
Polystyrene tile to ceiling in garage which needs removing

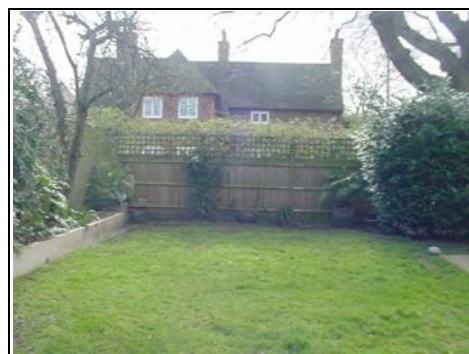
There is a reasonable sized rear garden. It was waterlogged at the time of our inspection due to recent excessive rainfall.

Rear Garden

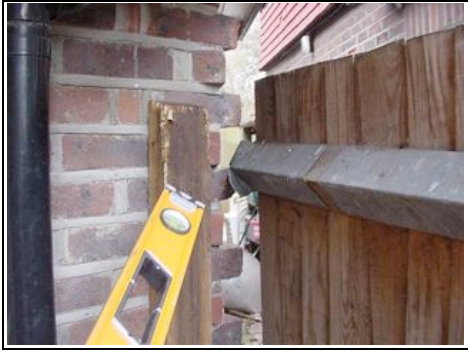
Fence right hand side where there appears to be problems
