RESIDENTIAL BUILDING SURVEY

XXX

London.

SW17 XXX

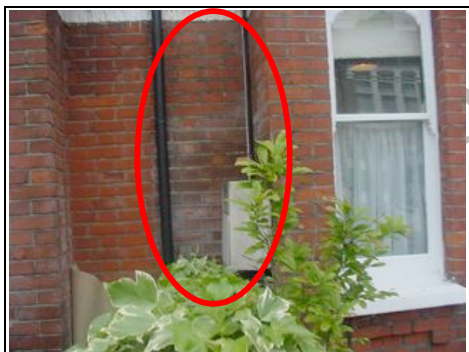
3.1) Dampness to front lounge

Dampness is coming in through the brickwork in the front lounge. We believe that this is where the brickwork meets the coade stonework. There has been a felt detailing added in this area which suggests that a lead detailing may be better as well as repointing in the area with an appropriate lime mortar.

Dampness to brickwork

ACTION REQUIRED: Check gutters for leaks next time it rains heavily. It may simply be a need to clear the gutters (see above) or it may well be that the edge of the coade stone detail is allowing water

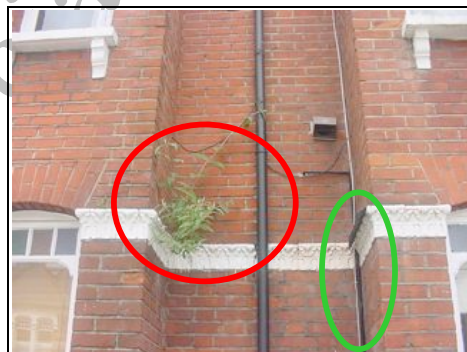
Plant growing the top of the coade stone (red), felt detailing added (green)

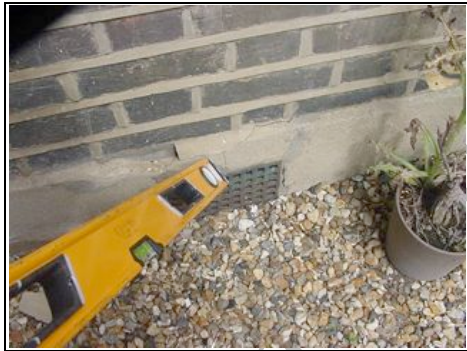
There is minor rising damp to the front and to the rear where the ground level is high. We also believe the dampness relates to the airbricks that are acting as gutters particularly to the rear of the property. These need protecting by lowering the ground and adding a brick protection.

Airbrick acting as gutter

ACTION REQUIRED: Protect airbricks and lower ground level. In theory this should be about two brick courses from the ground level to the damp proof course. In this case the damp proof course is likely to be slate and be behind the render so take the approximate height as the top of the airbrick (unless you take the render off you will not be certain).

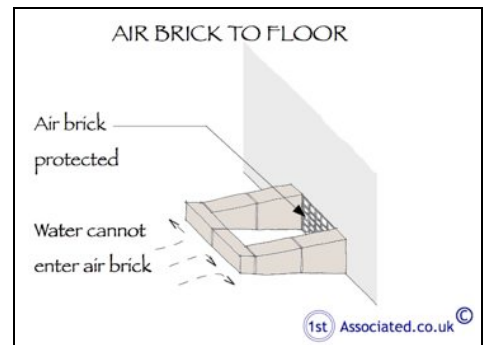
Protect airbrick

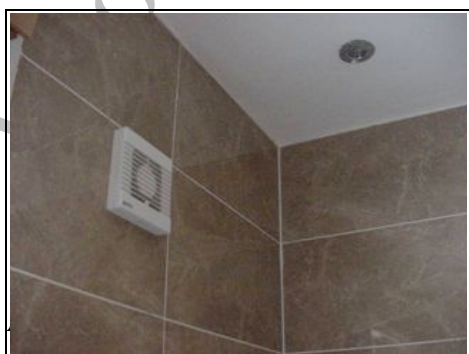
In the bathroom there is a small extract, which has not been finished properly externally.

Small extract in bathroom

ACTION REQUIRED: We would recommend a large humidity controlled extract fan in the bathroom.

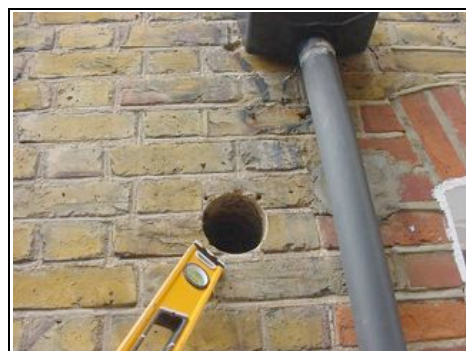
Bathroom extract fan not finished correctly

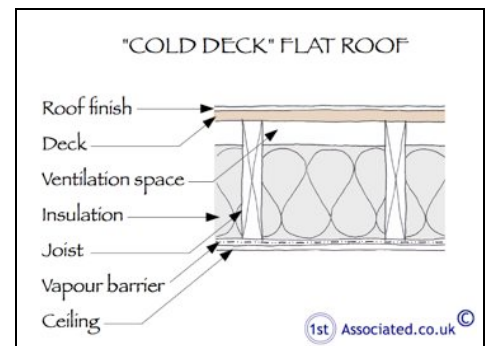
Cracking was also noted to the rear bedroom, which could be due to dampness getting in or differential movement due to the flat roof and coldness above as we suspect the roof has a cold deck flat roof.

Cold deck flat roof

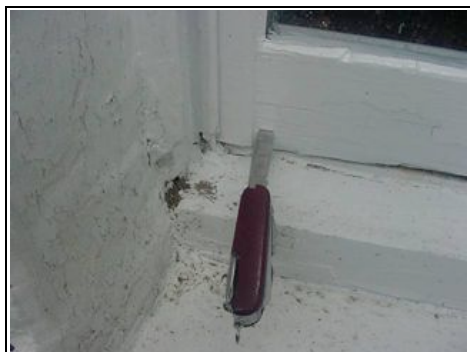
There is minor softness to the windows particularly to the rear and they are generally in need of redecoration.

Softness to rear window

ACTION REQUIRED: General repair and redecoration the sooner the better and no later than the summer of XXX.

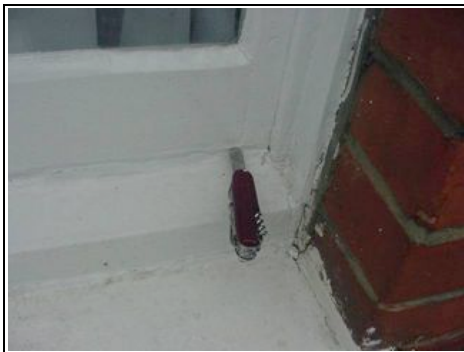
Softness to windows

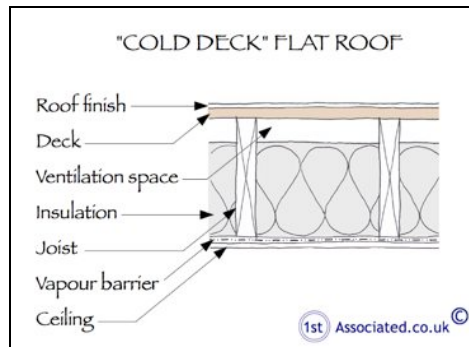
The rear bedroom will be relatively cold as it has two external walls and a flat roof and it is likely this flat roof is uninsulated (known as a cold roof). It has been fairly common for a long time to put a warm roof. This can be carried out but it will need consent of the neighbours above.

Cold roof

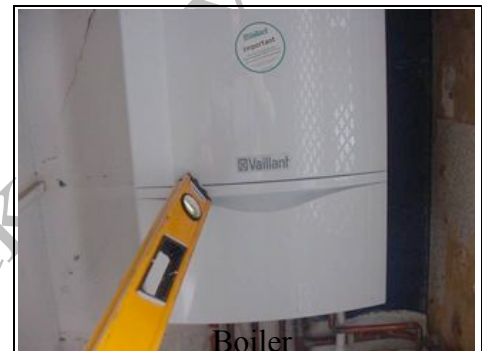
The boiler is located in the middle bedroom. As far as we are aware, this is allowed in the UK providing that they are appropriately ventilated however we do agree with you that they are noisy and would be best relocated to the kitchen.

ACTION REQUIRED: Relocate boiler to kitchen.

ANTICIPATED COST: £750 - £1,000; please obtain quotations.

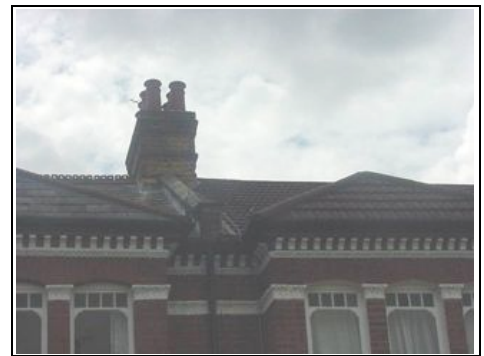
This chimney is brick finished with a lead flashing and chimney pots. From what we could see from ground level it looked in slightly below average condition considering its age, type and style. The view was obstructed slightly by the surrounding trees.

Front left chimney

ACTION REQUIRED: Periodically inspect the chimney.

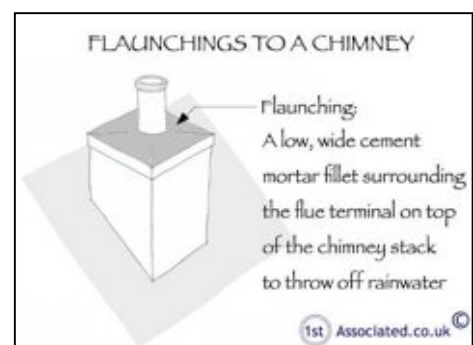
Flaunching

Unfortunately we were unable to see the flaunching, we therefore cannot comment upon them.

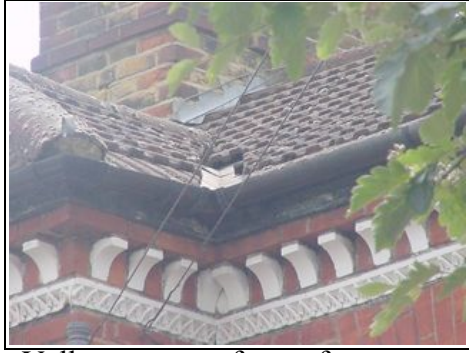
This property has valley gutters which were difficult to view due to the surrounding trees. Valley gutters are formed where two roofs meet and these are generally problematic. In this case it looked to be lead and in reasonable condition although we have not had access to the roof which is where we generally find issues and see if any dampness is getting in.

Valley gutter to front of property

ACTION REQUIRED: A close inspection of the valley gutter within the roof is recommended.

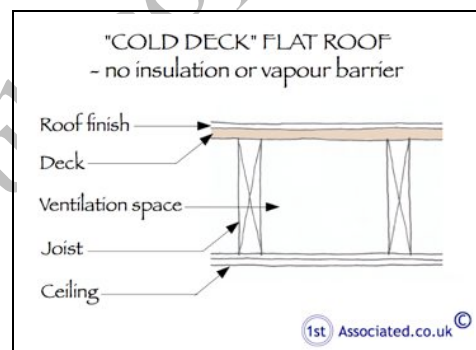
Cold deck flat roof with no insulation

Also it could not be established if there is insulation within the roof or a vapour barrier, without the vapour barrier and combined with inadequate ventilation there will be an increase in the risk of wet or dry rot.

ACTION REQUIRED: Please see our comments in the Executive Summary.

Building Regulations require flat roofs to be ventilated. Building Regulations are not retrospective but the reason for the requirement is to make sure that any moisture that enters the roof construction is dispelled by way of ventilation. We would suggest that if the opportunity arises ventilation should be provided.

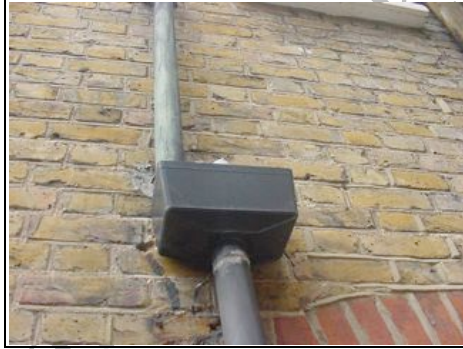
The property predominantly has replacement plastic gutters and downpipes. This looks to be the older type of plastic, which is affected considerably by ultraviolet light. There does look to be some leaks around the hopperhead, it may be because it is blocked and simply needs clearing.

Overflowing hopperhead

ACTION REQUIRED:. We would always recommend you stand outside the property next time it rains heavily and see how well the drains cope with the rainwater particularly looking at the guttering and the joints.

We would also recommend that the gutters and downpipes are cleaned out, the joints are checked and the alignment checked to ensure that the gutters fall towards the downpipes.

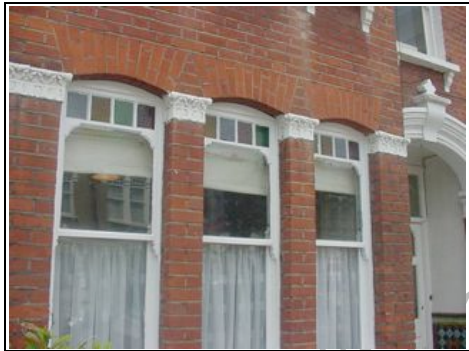
The property is built in a brick originally in a lime mortar in what is known as Flemish bond brickwork, which has been wrongly repointed in cement mortar.

Brickwork and coade stonework

We would draw your attention to the cement mortar re-pointing that has been carried out on the exterior of the property that we feel is not appropriate to this building. Originally it will have been built with a lime-based mortar and this is what should be used for any re-pointing in the future.

The use of cement mortar causes deterioration to brickwork and does lead to the face of the bricks deteriorating, which in turn leads to dampness. This is a very important point.

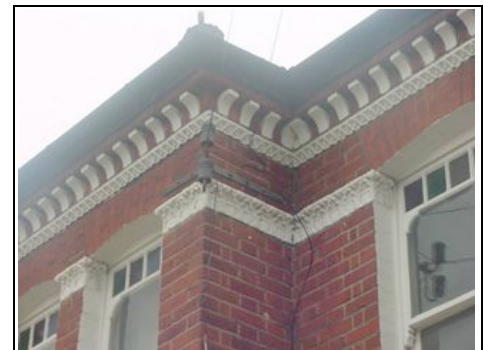
Coade stone

The property has high level detailing in coade stone. This is a type of concrete moulding that was used extensively in years gone by. This is decorative but can also allow dampness into the property.

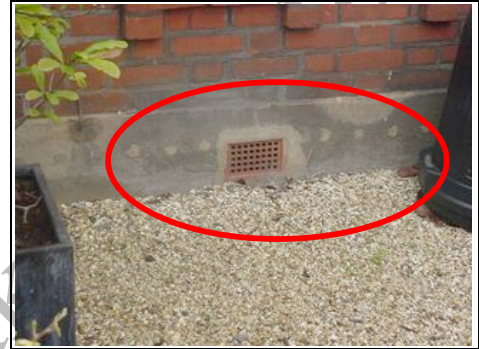
In properties of this age it is likely that a damp proof course would have been built in originally which is behind the concrete plinth. We can also see in some areas a chemical damp proof course has also been inserted.

The dots represent the inserted DPC. The plinth probably hides the original slate damp proof course

ACTION REQUIRED: Please see our comments in the Executive Summary.

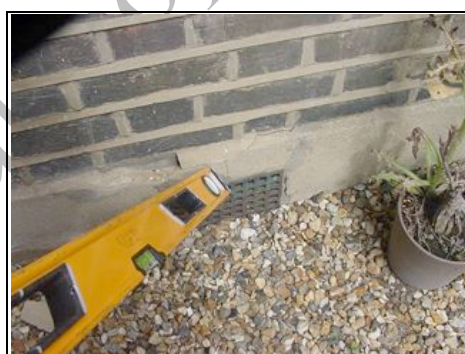
Air bricks are essential to have a through flow of air as this helps to reduce the chances of wet rot, dry rot and woodworm. In this case some of the airbricks are acting as gutters.

Air brick acting as a gutter

ACTION REQUIRED: Please see our comments in the Executive Summary.

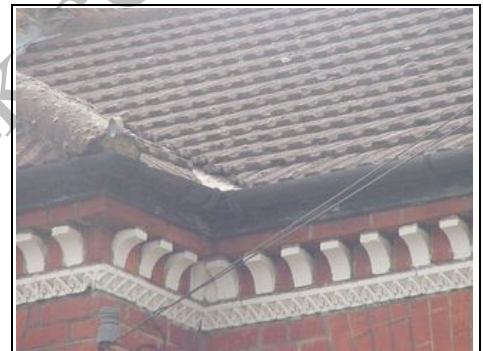
There is a very decorative fascia and soffit detail, which includes coade stonework corbelling as well as brickwork and a timber fascia. We have recommended elsewhere within this report that the gutters and downpipes are looked at; at the same time we would recommend that once they are made watertight the fascias are redecorated.

Coade stonework and decorative corbelling

ACTION REQUIRED: We recommend redecoration no later than the summer of XXX.

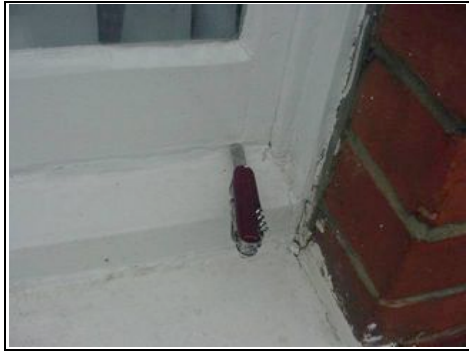
We would specifically comment that we found softness to some of the windows and they are in need of redecoration. Some of the reveals around the windows would also benefit from redecoration.

Softness to windows

ACTION REQUIRED: Redecorate by the summer of XXX. Please see our comments in the Executive Summary.

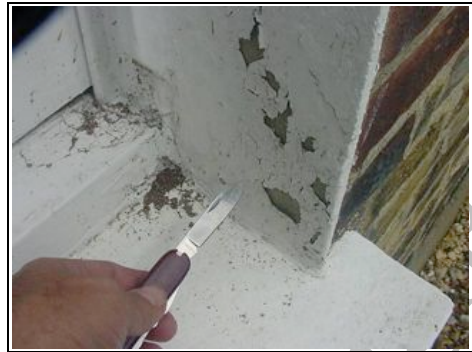
Redecoration required to reveals
around windows

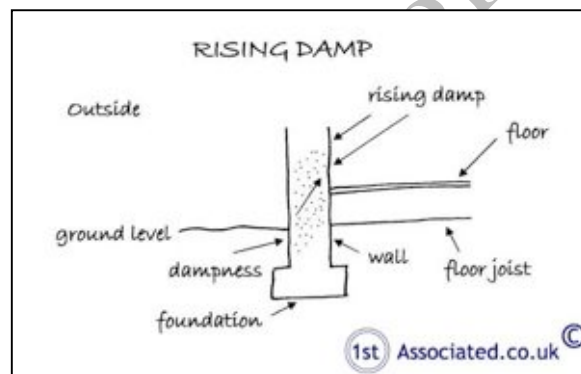
Rising damp

A random visual inspection and tests with a moisture meter have been taken to the perimeter walls. In this particular case we have found minor rising damp.

ACTION REQUIRED: Please see the Executive Summary.

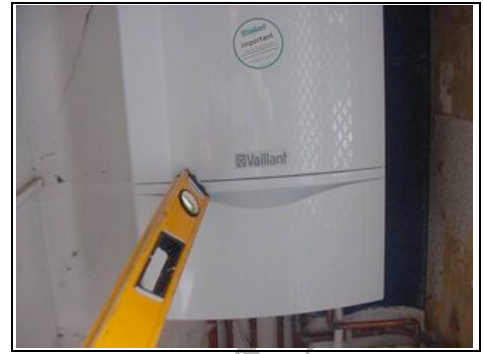
Our limited inspection of the hot water and central heating system revealed no evidence to suggest any serious defects but we would nevertheless recommend that the system be tested and overhauled before exchange of contracts and that a regular maintenance contract be placed with an approved heating engineer.

Vaillant boiler

ACTION REQUIRED: Please see our comments in the Executive Summary with regards to relocating the boiler.

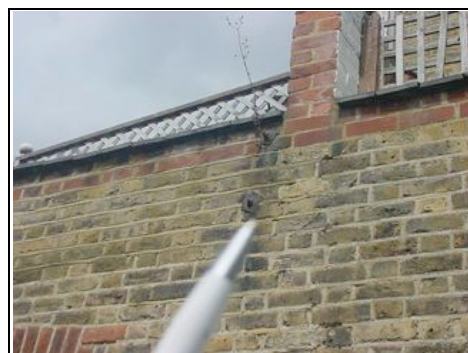
Wall ties indicate that there has been some movement in the property, without gaining access to the property we cannot comment further. We would be more than happy to view the property and comment further if access can be arranged and agreed.

Wall ties to next doors property
Right side view from the rear
