# RESIDENTIAL BUILDING SURVEY

XXXX  
London.  
SW17 XXX

Prepared by:  
XXXX  
INDEPENDENT CHARTERED SURVEYORS

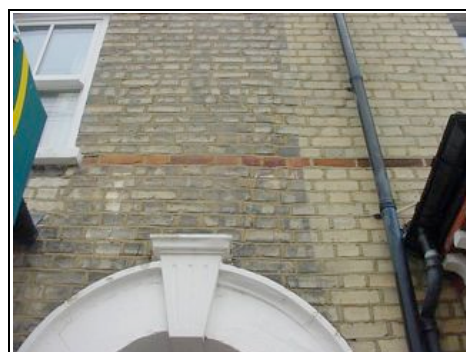
2.3) Hairline cracking in some of the walls.

We would comment that most movement in this age of property is historic but we do suggest in addition to this when the property was altered with walls being removed and moved additional weights and loadings were put on the property which has affected it and caused the additional movement.

Movement visible to front wall

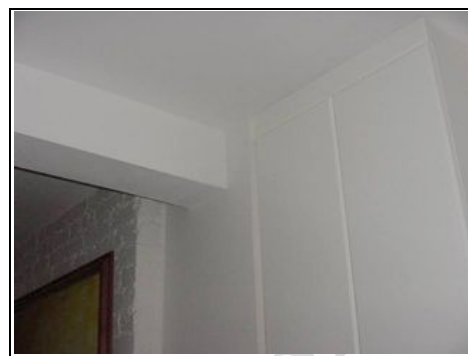
In theory the removal of the wall on the ground floor should have Building Regulations Approvals however we often find that they do not. We would also add that this is becoming a greater problem with solicitors rightly wanting all the paperwork to be in place.

No purlin nib added to alteration internally

**ACTION REQUIRED:** Your Legal Advisor to request the documentation if not available we believe insurance is available for unauthorised Building Regulation repairs. Our concern is that the end of the structural support (known as a lintel or RSJ) cannot be seen as it has been boarded around and we cannot therefore comment if there are any stress marks around it. We would be happy to return if the structure is opened up or comment on photographs of the structure opened up.

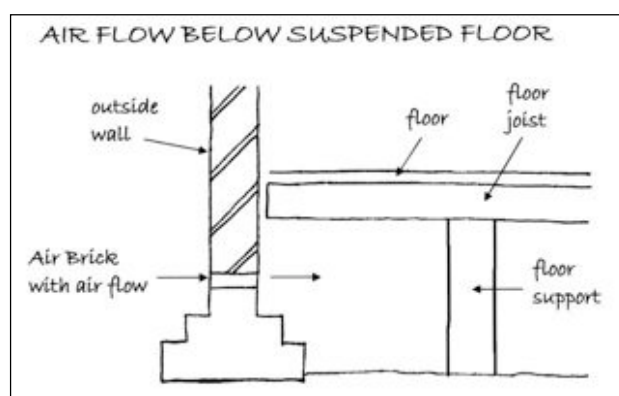
The property has a suspended timber floor which is not vented properly. This can cause deterioration to the floor the vents provide airflow to help reduce the effects of woodworm, wet rot and dry rot.

Unfortunately we could not see the condition of the floor as it is hidden by the laminate floor covering.

We do have concerns regarding the condition of the floor.

**ACTION REQUIRED:** You need to add at least two airbricks to the front of the property and make sure that they cannot act as gutters. To the rear you have one airbrick which is acting as gutter and is also blocked which you need to open up; it is essential that you have airflow here. At some point in time you should open up the ground floor itself to check the condition of the timbers.

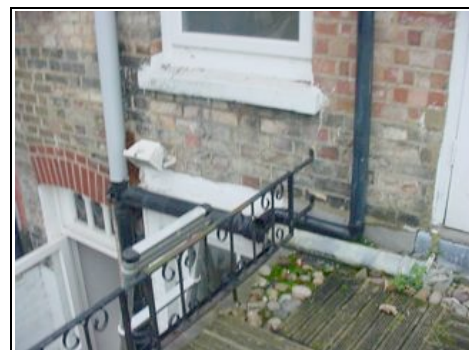
Low rail around terrace/balcony

**ACTION REQUIRED:** Your Legal Advisor to specifically request if Local Authority approvals have been obtained for the terrace/balcony.

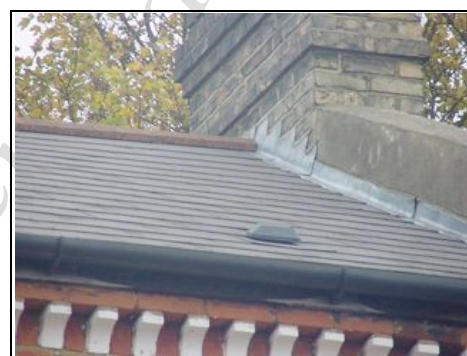
The main roof is pitched and clad with a manmade slate, and, from ground level, this looks in average condition considering the roofs age type and style. With this age of roof there will usually be a few missing or displaced slates, this is nothing unusual.

Main roof

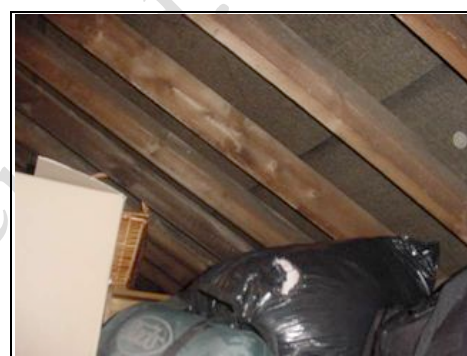
When we inspected the loft space we found a Hessian base Bitumen membrane. This type of membrane has been used since the 1960s. We generally found it to be in average condition, it is damaged in a few more places than we normally find.

This photo shows the common rafters (the ones that form the pitch of the roof) and the dark area between is the protective underlayer.

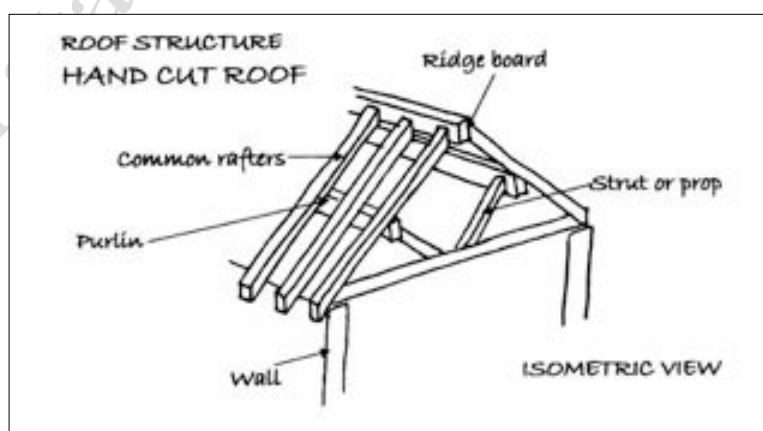
This type of roof structure has what is known as a cut timber roof. This is a roof that is purpose made and hand built on site. Without the original design details we cannot categorically confirm that there are no defects; however it is in line with what we typically see.

**ACTION REQUIRED:** In this instance the sketch is not correct as there are not any struts or props in the roof. We would recommend that these are added.

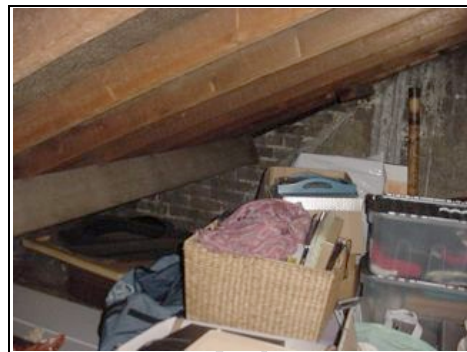
General view of inside of roof

Our examination was limited by the general configuration of the roof, the insulation and stored items. What we could see was generally found to be in average condition for its age, type and style apart from the way that the purlin is supported. It is, however, feasible that there are problems in the roof that are hidden.

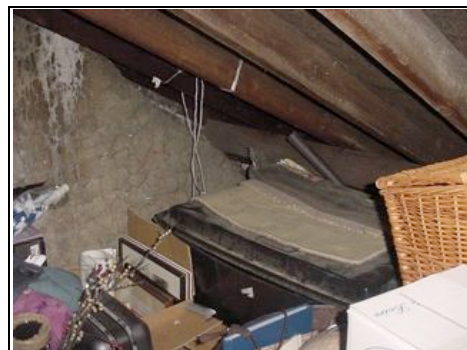
Water tank

There is relatively modern plastic water tank hidden amongst all the many stored items in the roof.

We would always recommend that water tanks be drained down and cleared of any debris etc. (we have seen dead birds and other unmentionable things in these tanks). As you are cleaning your teeth with this water it is best that it is as clean as possible!

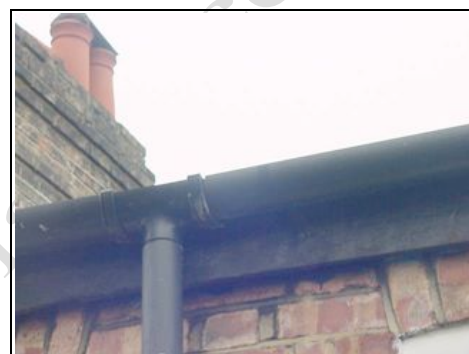
From what we could see there is predominately plastic gutters and down pipes however we believe there may be some cast iron remaining to the front of the property. The condition of the gutters and downpipes that we could see is in average condition for their age, type and style although we do feel there is a problem with regard to rainwater being discharged to the rear of the property.

Gutter and downpipe

**ACTION REQUIRED:** Please see our comments in the Executive Summary.

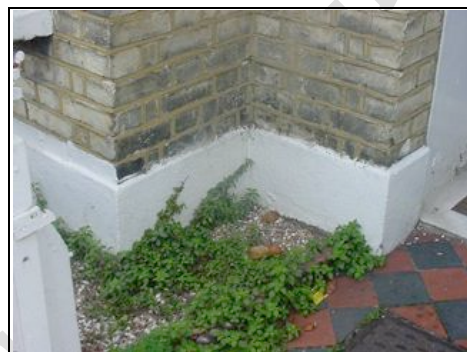
All modern properties should incorporate a damp proof course (DPC) and good building practice dictates that a differential of 150mm (6 inches) should be maintained between the damp proof course and ground levels. In this case, cannot see a damp proof course due to the render plinth but in this age of property it is likely a slate damp proof course is present.

Damp proof course cannot be seen due to render plinth.

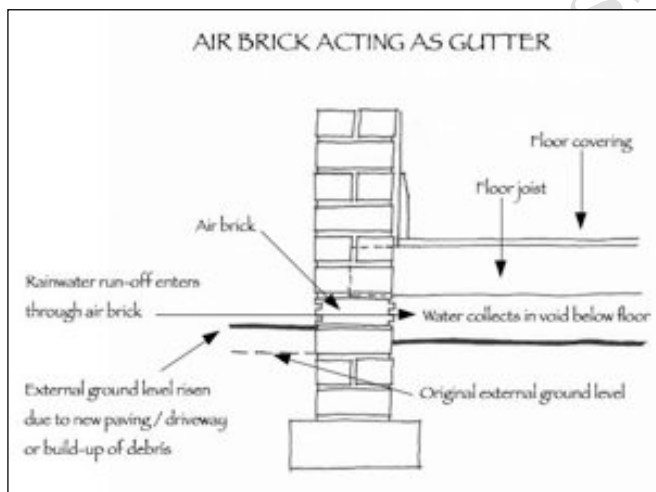
Looking for airbricks and not finding any at front of property

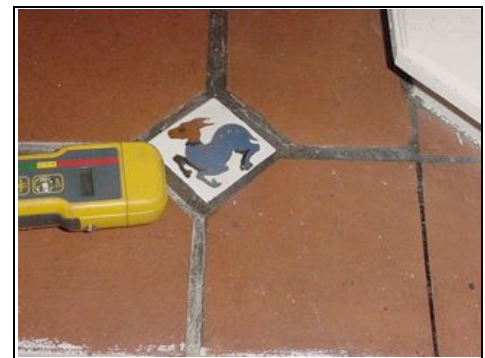
Testing for rising damp

A random visual inspection and tests with a moisture meter have been taken to the perimeter walls and some internal walls. In this particular case we have found no rising damp but we think there is likely to be condensation in the kitchen due to the tiled floor but this we would not normally consider a problem as it is not a habitable room.

The main area of dampness that we would draw to your attention is due to the similar ground levels to the rear where we feel dampness may get in in this area and the lack of ventilation underneath the suspended timber floor.

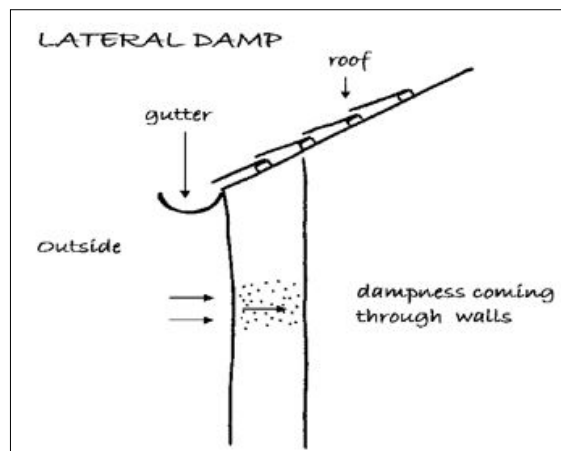
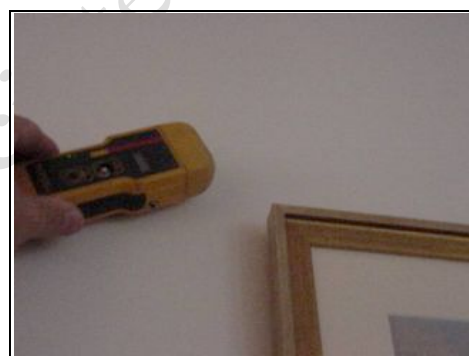
Testing for lateral dampness

We used a damp meter on the external walls. We have not found dampness.

**ACTION REQUIRED:** Please see our comments in the Executive Summary.

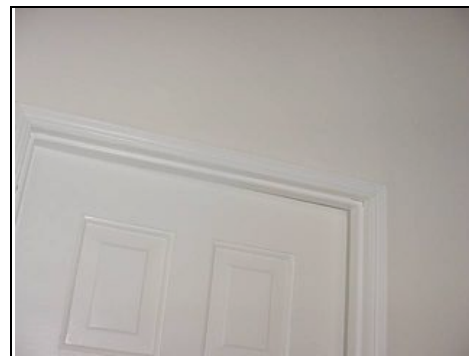
Panelled door

The doors are painted panelled doors.

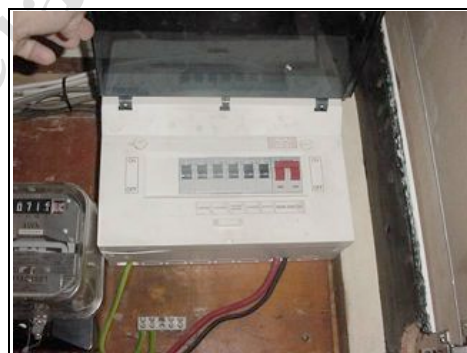
Fuse Board

The electric fuses and consumer units were located in the lounge. The fuse board looked fairly new 1980s/1990s possibly later.

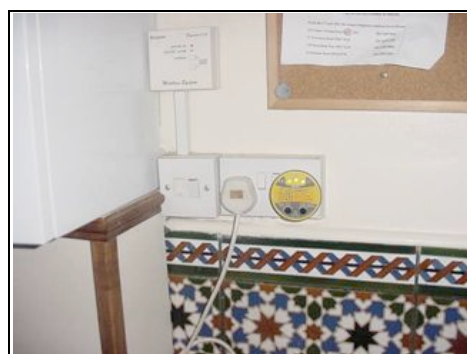
Earth Test

We carried out an earth test in the kitchen area to the socket point that is normally used for the kettle, this proved satisfactory.

**ACTION REQUIRED:** As the property is changing occupancy an Institute of Electrical Engineers (IEE) test and report should be carried out by a NICEIC registered and approved electrical contractor.

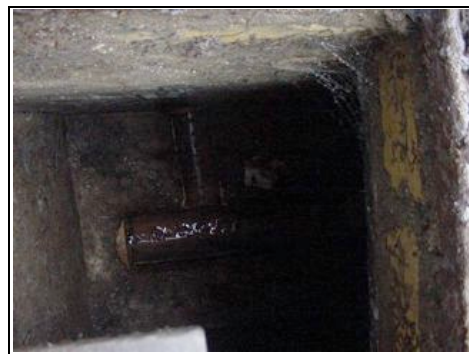
Manhole one

We duly lifted the cover and found it to be free flowing at the time of our inspection.

From what we could see it is brick built.

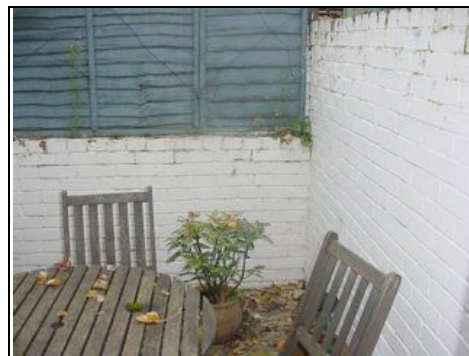
Rear Garden

The garden to the rear is small and paved.
