RESIDENTIAL BUILDING SURVEY

XXX
London.
SW3 XXX

Prepared by:
XXX
INDEPENDENT CHARTERED SURVEYORS

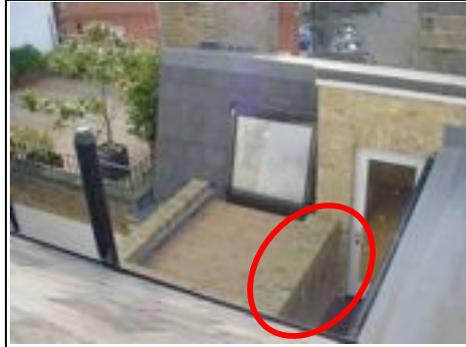
Central dividing wall

Recently built in brick as part of the project. Efflorescence visible. We do not believe that they are watertight although we can see some damp proof courses in some areas these may have not been lapped correctly.

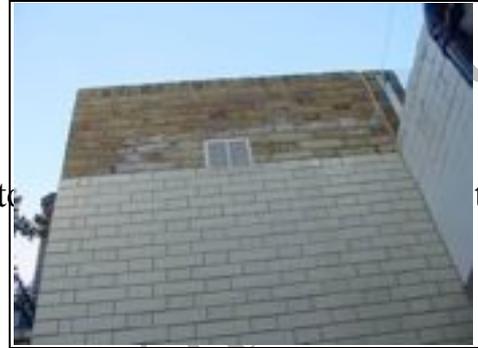
Signs of dampness to central parapet walls

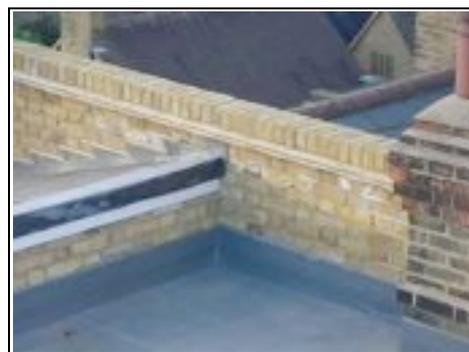
Rear right hand parapet wall

The rear right parapet wall is new. We can see efflorescence on it which does concern us as to whether it is watertight.

ACTION REQUIRED: Again monitor and carry out work to make watertight such as add a capping if required.

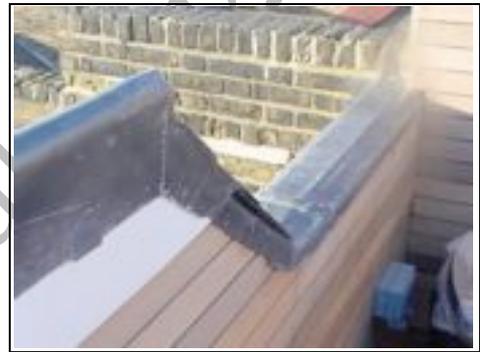
Poor detailing on terrace roof

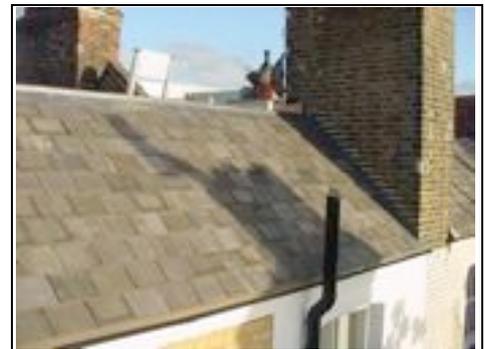
Small middle slate roof

This is covered with slate tiles. We believe the slates may discharge over the guttering during periods of moderate to heavy rainfall.

ACTION REQUIRED: This area needs to be monitored and guttering amended if surcharging (overflowing) the guttering.

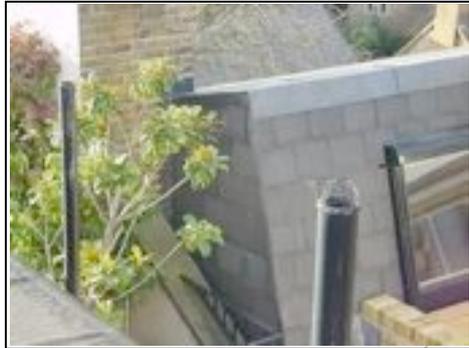
Awkward detail to left side

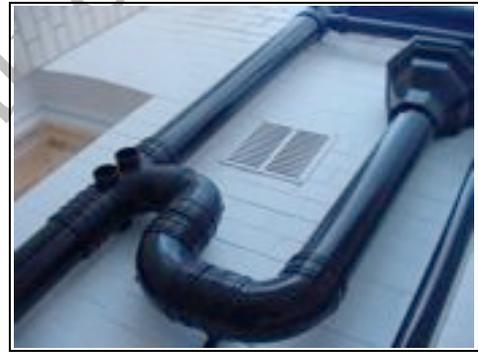
New plastic soil and vents pipes and guttering

ACTION REQUIRED: There looks to be some leaks on the cast iron soil and vent pipes. These may be old leaks but you do need to be aware of them and your maintenance man/handyman needs to check to see if they are still leaking.

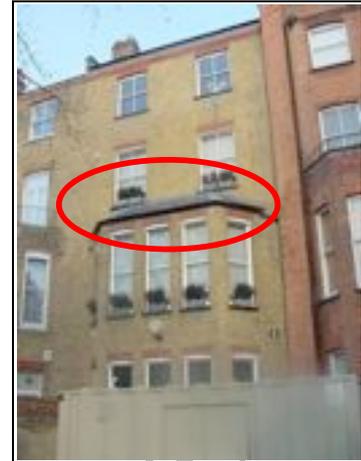
Bay window to rear

Hairline cracking can be seen to the rear bay through the brickwork in some areas.

Before the 19th Century, the practice of building timbers into external walls was almost universal. These were known as bonding timbers. They are of course prone to rot as solid walls allow dampness through. Unfortunately, without opening up the structure, we are unable to confirm if this is the case particularly to the bay window areas.

Confirmation required from the existing owners/the contractors as to whether the original timber lintels, bonding timbers and bearing timbers have been replaced. If they have not then this is a risk particularly to the bay window and there will be repair/replacement work in years to come.

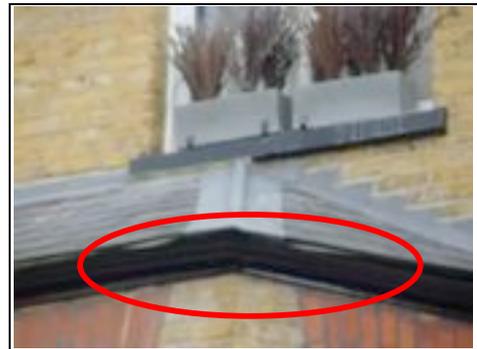
Fascia to rear bay window

ACTION REQUIRED: See Snagging List.

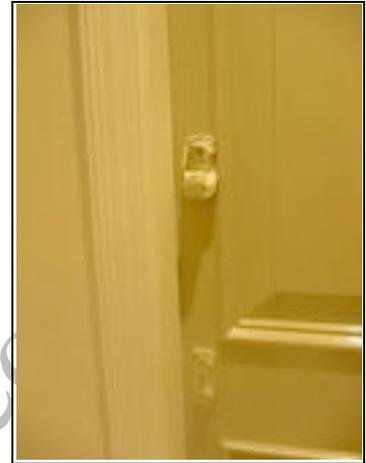
We assume all internal doors are as new. They were being painted at the time of our penultimate visit.

Door being painted

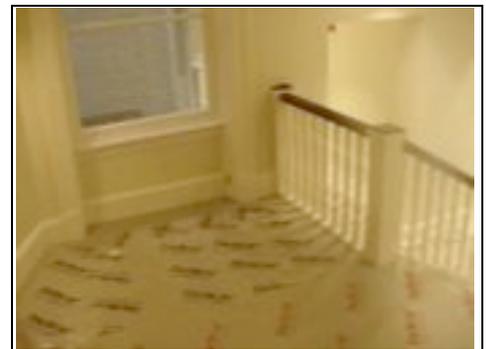
Materials were stored on the shared stairs during the course of our initial visits but later on the areas were cleared. They do need a final check for any contractor's damage that has taken place.

Shared stairs

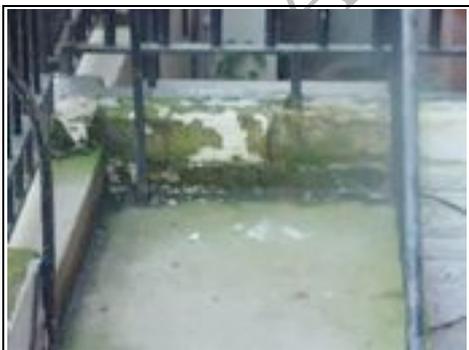
Dampness at top of external area

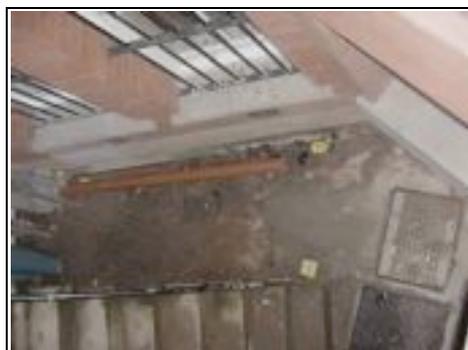
Lack of fall in area

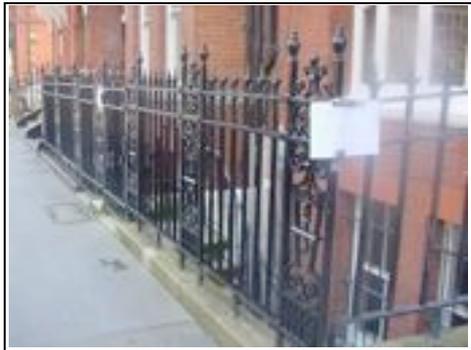
Railings to front

Our concerns are that the redecoration we have seen doesn't appear to be prepared correctly. Specifically we would identify the front railings where we believe rust has been painted over.

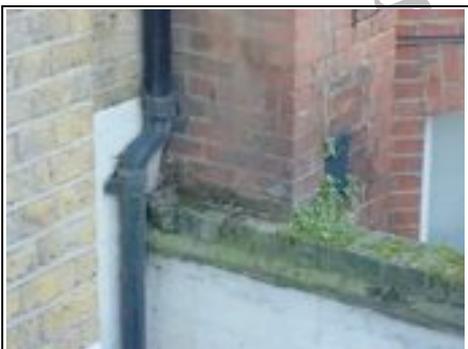
Moss and growth to top of wall

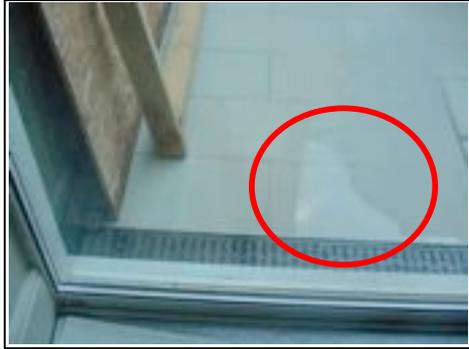
Water sitting out on paved area
