RESIDENTIAL BUILDING SURVEY

XXX
London.
W10 XXX

FOR
Mr X

Prepared by:
XXX
INDEPENDENT CHARTERED SURVEYORS

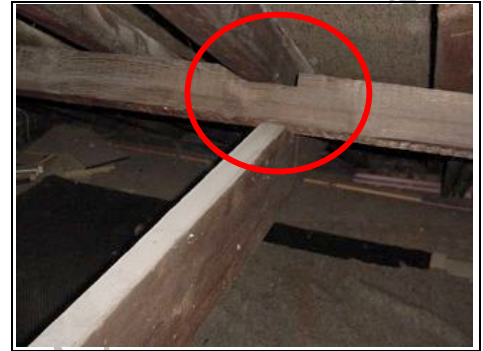
Purlin cut

ACTION REQUIRED: The roof has stood the test of time although originally it would have had a lightweight slate on it and it now looks to have a manmade slate. It is always difficult to be certain without a close up inspection.

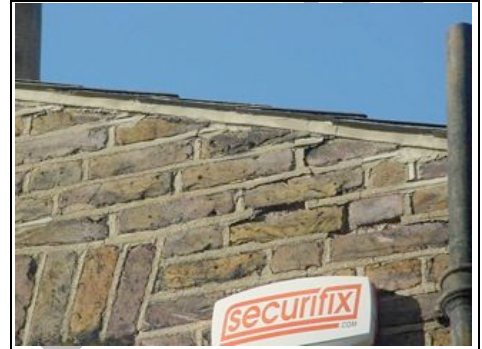
There is some work to the brickwork required, we can see at high level some of the cement pointing that has been carried out at a later date has come away.

We can also see that some of the softer red brick is being affected by the cement pointing. Ideally in a building of this age pointing should be lime mortar which is what was originally used.

Ad hoc repointing required to rear of property

ACTION REQUIRED: Ad hoc repointing during the warmer months. This will probably take a few years as other bits of cement mortar fall out. This is fairly typical of the way this type of building was wrongly repaired.

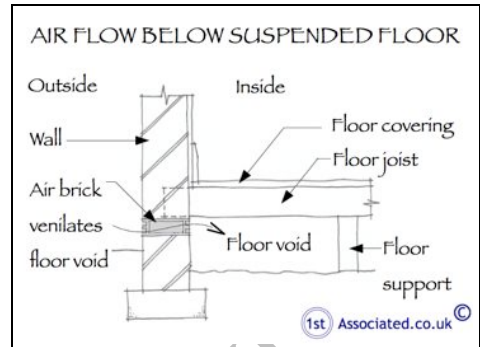
Suspended timber floors require airflow underneath them. In this case airflow has been blocked by both the airbrick to the rear being blocked (we can see one airbrick) and also the laminate floor being placed over the suspended timber floor.

Suspended timber floor

ACTION REQUIRED: We would recommend the addition of a vent in the step into the kitchen. We would also recommend that an area of the floor is opened up to check its condition underneath. This can be carried out underneath the stair area so it is not visible.

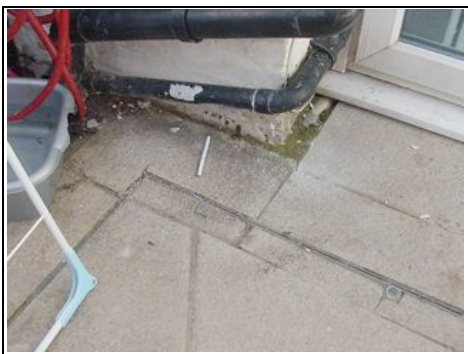
Air brick

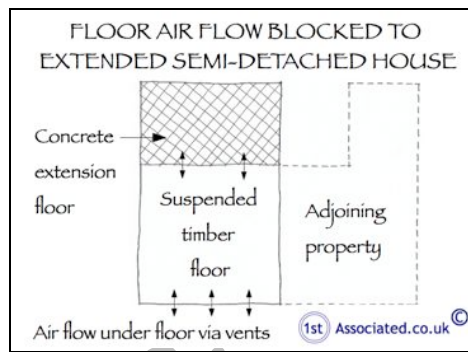
Airflow blocked by concrete floor

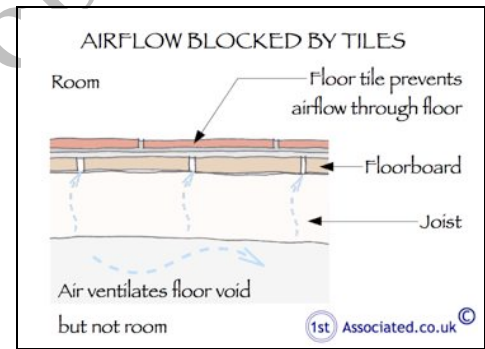
Airflow blocked by laminate floor similar to our sketch of tiles blocking airflow

When we lifted the carpet in this area we found more laminate flooring underneath. Unfortunately laminate flooring covers floorboards and means that the timber underneath cannot breathe. In a worst case scenario you can usually prop up the floor or part replace it, very rarely does it all need to be taken up.

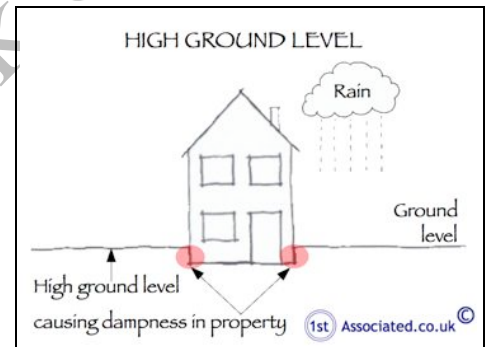
ACTION REQUIRED: Carry out venting of the floor as mentioned to get an airflow underneath it; this should help dry the building. There is however often still some dampness particularly to the rear around the step area and we suspect in this instance also to the end of the kitchen where we can see a high ground level. It could be argued that kitchens aren't habitable areas but you are intending to carry out alterations in the kitchen so it may be worth carrying out damp proofing at the same time.

High ground level

ANTICIPATED COST: In the region of £500 - £2,500. This would be a long term requirement when you are carrying out the work to the kitchen. Please obtain quotations.

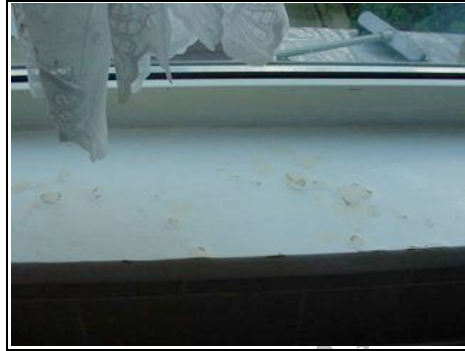
The property has a higher than average chance of getting condensation. Within the kitchen area we could see condensation and indeed got high damp meter readings to some of the walls. This, we believe, primarily is because humidity created in there during cooking, etc is not being expelled from the building.

Flaking of paint to window sill in kitchen

ACTION REQUIRED: Add large humidity controlled extract fans to all humidity creating areas.

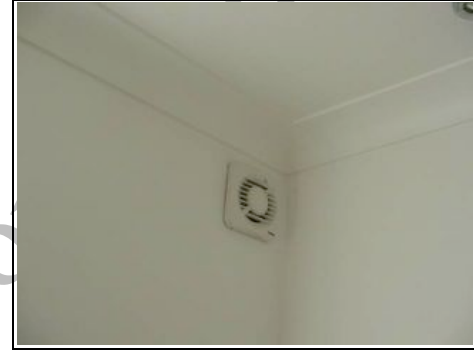
Small extract in bathroom needs to be bigger

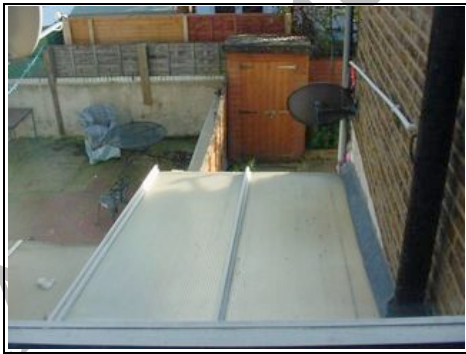
There is a very lightweight/DIY constructed rear area which has a plastic polycarbonate sheet roof which looks like DIY quality timber.

Polycarbonate roof

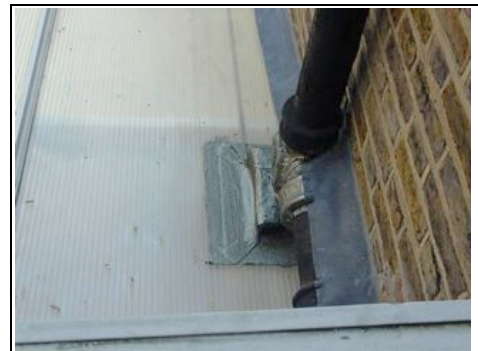
Flashband where it goes into polycarbonate

Flashband is a sticky backed felt which is best used for temporary repairs only.

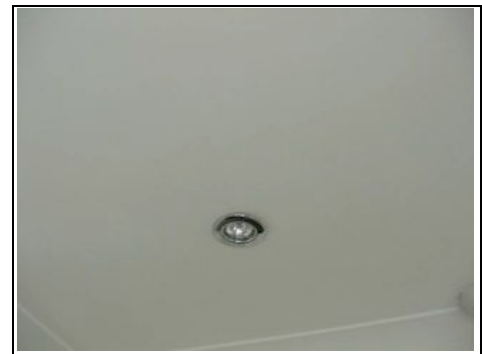
The property has electric lights to the ceiling. In some instances these can cause problems as the heat given off has in some cases lead to outbreaks of fire; these tend to be in the older type of ceiling lights and we recommend that where ceiling lights are used that the rear of the light is not covered; this is particularly the case in rooms with a loft space above it where stored items are placed in it.

Ceiling lights

ACTION REQUIRED: Change to LED low heat lights.

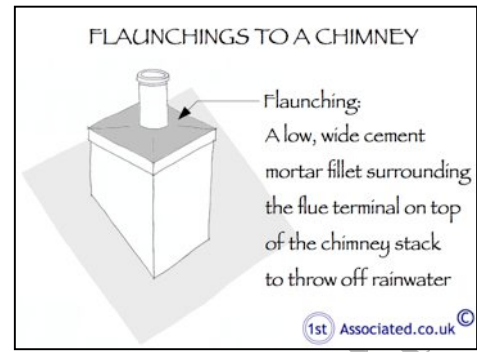
Unfortunately we were unable to see the top of the chimney known as the flaunching, we therefore cannot comment upon them.

Flaunchings

ACTION REQUIRED: Please see our comments in the Executive Summary.

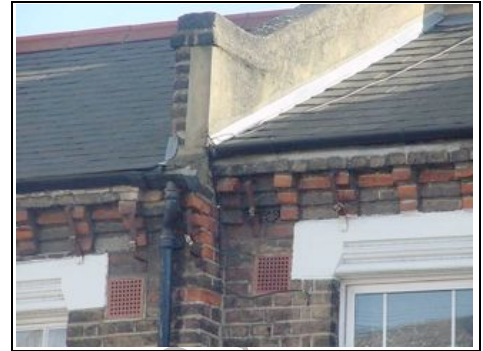
Front left hand parapet wall

In this case there are parapet walls to the left and right both to the front and rear of the property built from brick and finished with render with a brick on edge. We find brick on edges do let dampness in particularly as in this case where your half is rendered and next

doors is still in brick as this will still allow water in. We assume the rendering was carried out when the property was re-roofed.

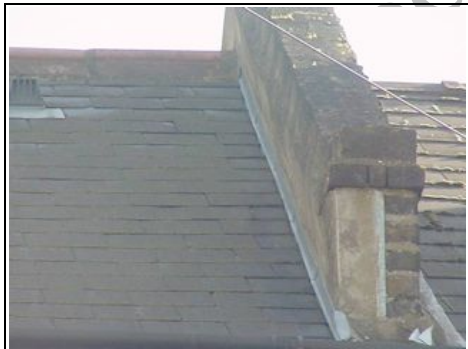
Right hand parapet wall

We noted a crack to next doors side which will allow dampness into your property.

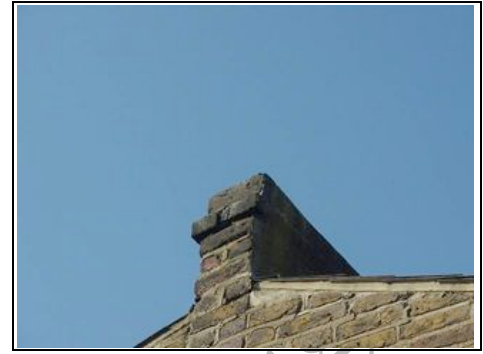
Rear parapet wall

We had very limited visibility of this wall.

ACTION REQUIRED: Check condition when carrying out the high level repointing work.

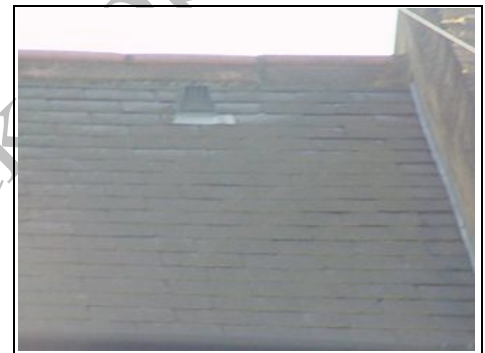
The main roof is pitched and clad with we believe manmade slates but it is very difficult to confirm from ground level. It looks in average condition considering the roofs age type and style. We were pleased to see it was vented which means that the roof was probably carried out between the 1970's and 1990's as we now use what is known as a breathable protective underlayer/felt which doesn't require a vent.

Man made slate roof with vent

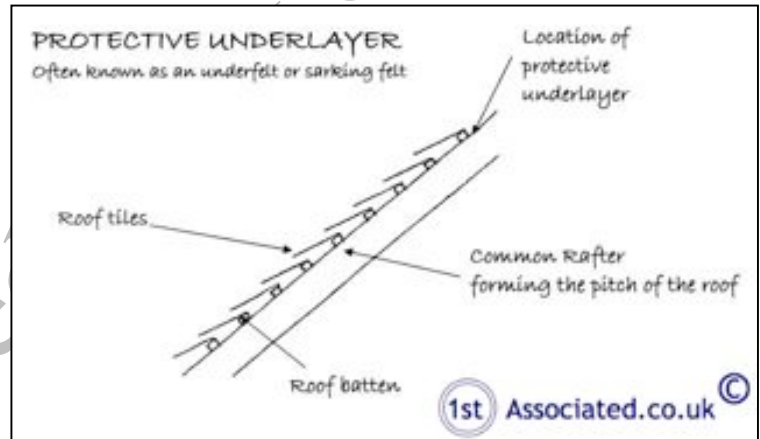
Protective underlayer

When we inspected the loft space we found a Hessian base Bitumen membrane. This type of membrane has been used since the XXX. We generally found it to be in average condition, with damage in some areas which is what we typically find.

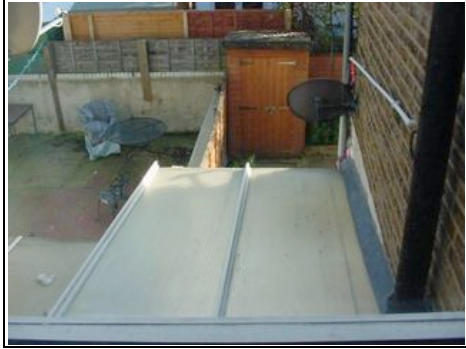
Polycarbonate roof

There is a very lightweight/DIY constructed rear area which has a plastic polycarbonate sheet roof which looks to be DIY quality timber. We are assuming all of this area will be replaced sooner or later so won't comment further.

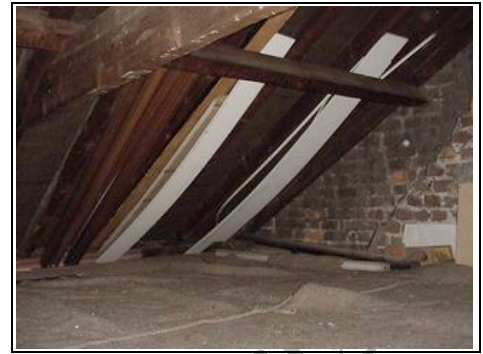
Roof structure

Our examination was limited by the general configuration of the roof and the lining to the floor. What we could see was generally found to be in slightly below average condition for its age, type and style due to the size of the purlins. It is, however, feasible that there are problems in the roof that are hidden.

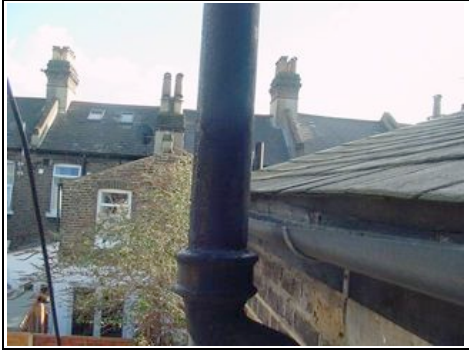
Cast iron soil and vent pipe

The property has cast iron soil and vent pipes. The cast iron soil and vent pipes to the rear are very old, you will need to watch closely as this may leak. Cast iron of this age can crack and rust and needs regular maintenance. Generally we find this age of cast iron has now been replaced.

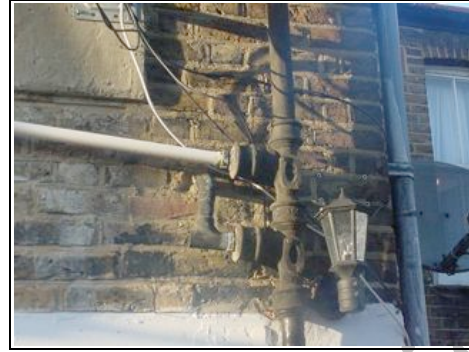
Cast iron soil and vent pipe very old

ACTION REQUIRED: Redecorate in the summer of XXX.

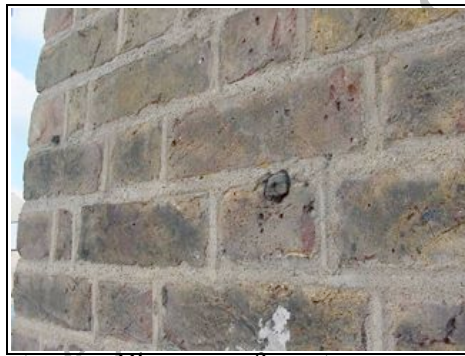
Close up of mortar

The property is built in a brick originally in a lime mortar in what is known as Flemish bond brickwork wrongly repointed in a cement mortar in many areas.

Generally Flemish Bond brickwork is liable to penetrating dampness internally, dependent upon the condition of the brickwork and the exposure to the weather. It is essential that external faces be kept in good condition. In this case cement mortar is falling out and causing damage to the red softer brick.

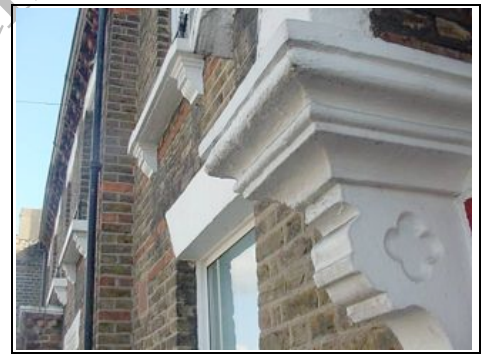
Corbel detailing

There is some nice corbelling which needs to be painted white regularly, every three to five years.

Redecorating required to the corbelling, etc. It is surprising how keeping the corbelling and other painted areas makes the building look a lot smarter particularly if dirt and dust can affect it from the road as well. We always recommend painting as often as you can.

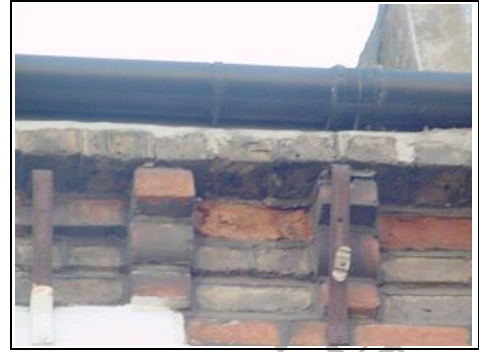
There is a large satellite dish on the back of this building and a number on the adjoining properties. We noted what could be slate guard brackets or possibly electric cable brackets on the brickwork which don't look to be in use any longer.

Are these slate guard brackets or electric cable brackets.

ACTION REQUIRED: You may wish to remove these in the future as they will just rust away otherwise.

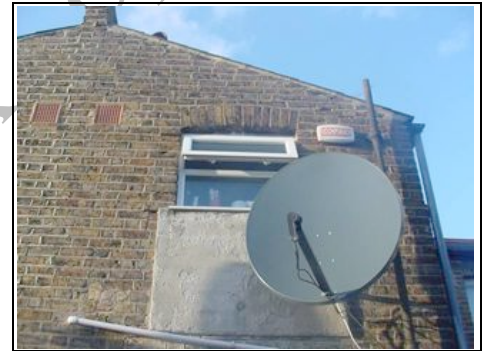
Rendered panel to rear

There is a rendered panel to the rear of the property which is quite unusual (hidden behind the satellite dish).

ACTION REQUIRED: We would recommend redecorating this in the summer of 2014.

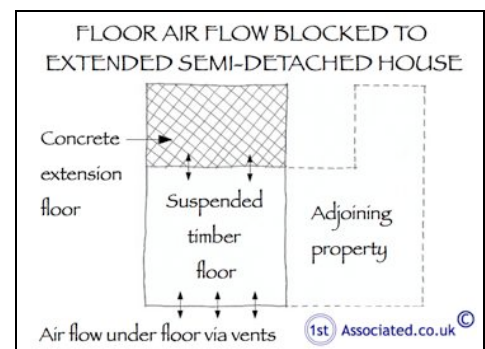
Air bricks are essential to have a through flow of air as this helps to reduce the chances of wet rot, dry rot and woodworm. In this case airflow has been blocked by both the airbrick to the rear being blocked (we can see one airbrick) and also the laminate floor being placed over the suspended timber floor.

Airflow blocked by concrete floor

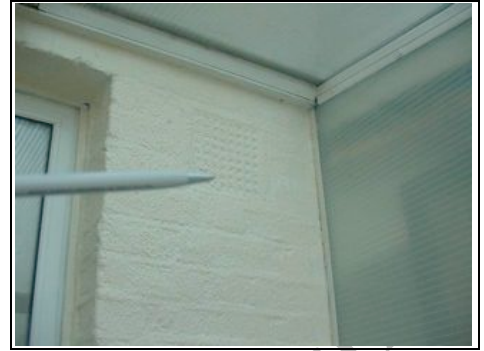
There are vents at high level, one of which is blocked.

Blocked high level vent

ACTION REQUIRED: Ensure the air bricks are clear.

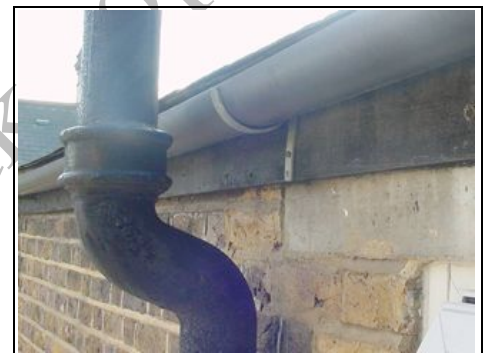
The fascias and soffits are timber. They are painted and we would comment they are in slightly below average condition for their age, type and style.

Painted fascias, replacement plastic gutters and older cast iron soil and vent pipe

ACTION REQUIRED: Redecorate in the summer of XXX. Make sure gutters and downpipes are watertight before carrying out any work on fascias and soffits.

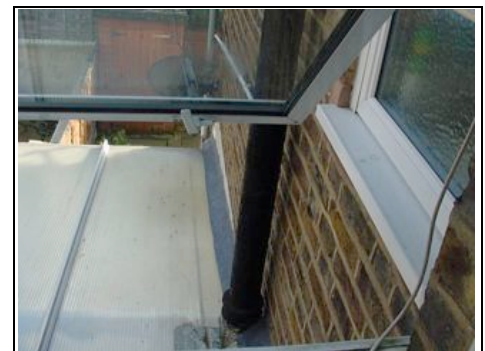
The property has a mixture of metal and plastic double glazed windows without trickle vents which unfortunately will add to the chances of condensation in the property. Please see our earlier comments.

Metal double glazed windows

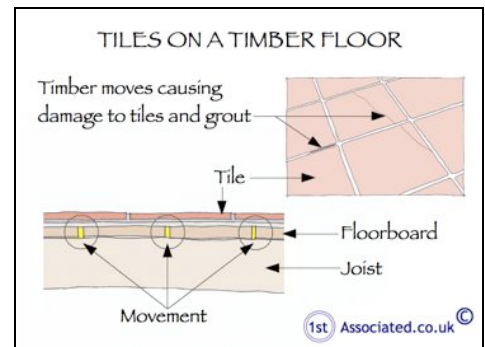
Airflow blocked by laminate floor similar to our sketch of tiles blocking airflow

ACTION REQUIRED: Please see our comments in the Executive Summary.

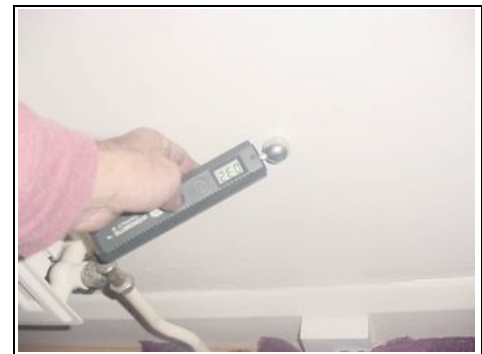
Testing for rising damp

A random visual inspection and tests with a moisture meter have been taken to the perimeter walls. In this particular case we have found rising damp slightly above what we would normally expect which we believe may be due to the lack of ventilation under the floor or the number of people that are living in the property at the moment. It may also be because the property is unlikely to have originally had a damp proof course due to the date it was built.

ACTION REQUIRED: Please see the Executive Summary.

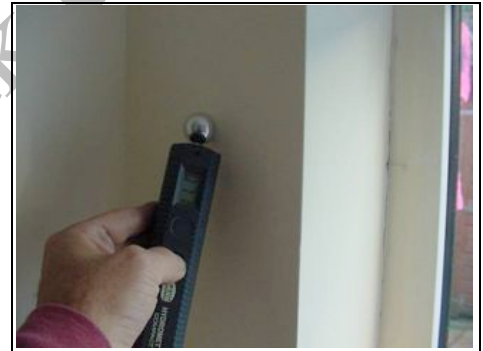
Testing for lateral dampness

We used a resistance meter on the external walls. We have found significant dampness in the kitchen which is a humidity area. We expect the same will be true in the bathroom.

ACTION REQUIRED: Please see our comments in the Executive Summary.

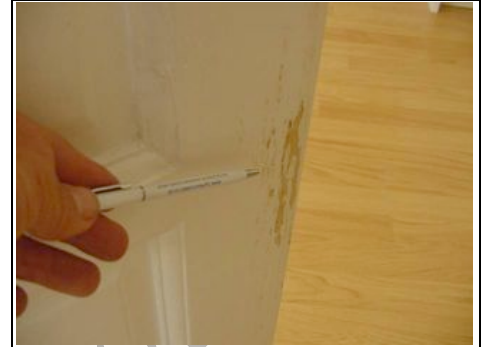
The doors were mainly painted timber panel doors; some will need work such as the kitchen door.

Looks like kitchen door has been attacked by a dog at some point

We have been unable to find a kite mark on the glazed kitchen door which indicates that it is not safety glass.

ACTION REQUIRED: Replace with safety glass.

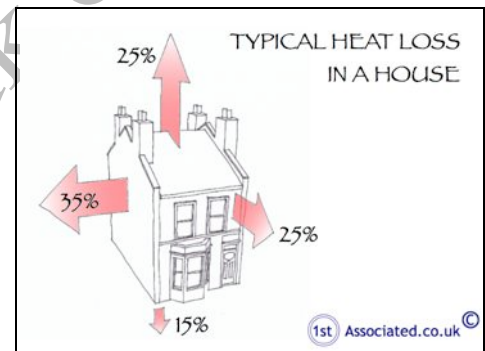
Some roof insulation was present although not to current Building Regulations requirements of 300mm. In this instance it looks to be about 200mm where we could see it with a board over the top.

Typical heat loss

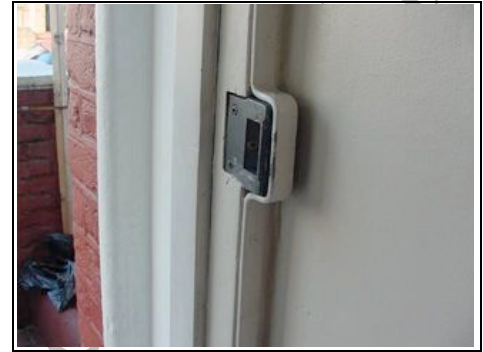
The property has a London bar. We also noted a security box to the rear of the property which is unusual.

London bar to front door

ACTION REQUIRED: Further information should be obtained from the vendor and the installer.

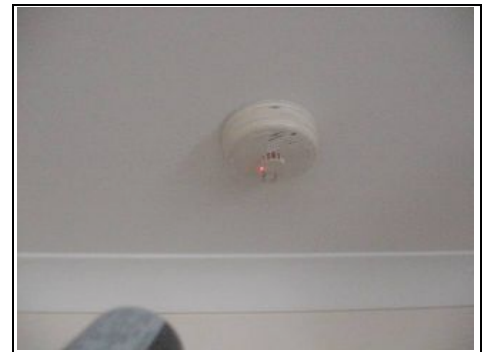
Smoke alarm

Some smoke detectors were noted. The current Building Regulations require that they be wired into the main power supply. Obviously in a property of this age this is difficult, as it would mean having surface mounted wires or cutting wiring into the plaster.

ACTION REQUIRED: We would recommend, for your own safety, that smoke detectors be installed. We would always recommend a hard wired fire alarm system and are also aware that some now work from a wireless signal which may be worth investigating. Whilst fire is relatively rare it is in a worst case scenario obviously devastating.

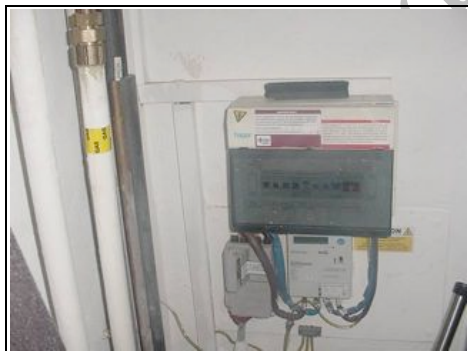
Fuse Board

The electric fuses and consumer units were located under the stairs. The fuse board looked newish. We noted DIY electrics to the downpipe.

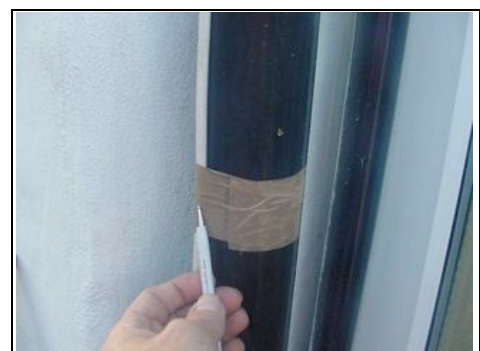
Electrics taped to wall

ACTION REQUIRED: Please see our comments in the Executive Summary.

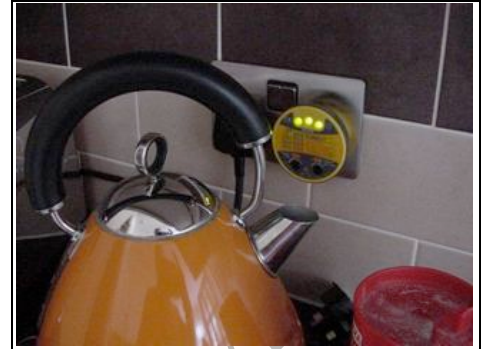
Earth test

We carried out an earth test in the kitchen area to the socket point that is normally used for the kettle, this proved satisfactory.

ACTION REQUIRED: As the property is changing occupancy an Institute of Electrical Engineers (IEE) test and report should be carried out by a NICEIC registered and approved electrical contractor or equivalent.

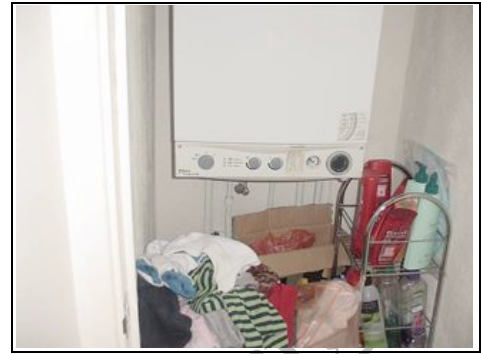
Boiler

The boiler was located in a cupboard on the first floor. It is manufactured by Main which is a model we rarely come across therefore you may have difficulty obtaining spare parts.

ACTION REQUIRED: Please see our comments in the Executive Summary.

Our limited inspection of the hot water and central heating system revealed no evidence to suggest any serious defects but we would nevertheless recommend that the system be tested and overhauled before exchange of contracts and that a regular maintenance contract be placed with an approved heating engineer.

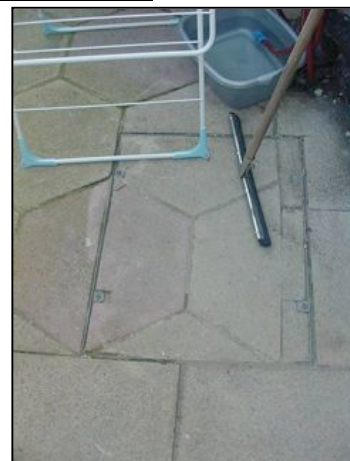
Manhole to rear

We were unable to lift this manhole therefore are unable to comment.

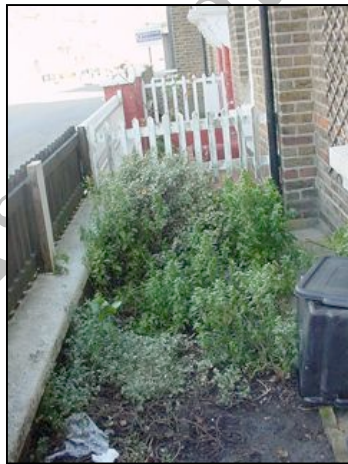
Front garden

There is a small front garden. The top of the pillar to the front wall is completely loose.

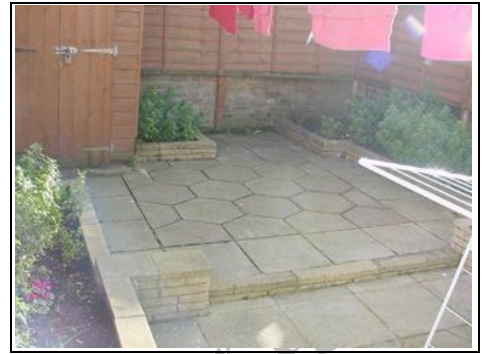
Rear garden

The rear garden has a small paved area.
