RESIDENTIAL BUILDING SURVEY

xxxxxxxxxxxxxx,
Wandsworth,
London,
SW18 xxx

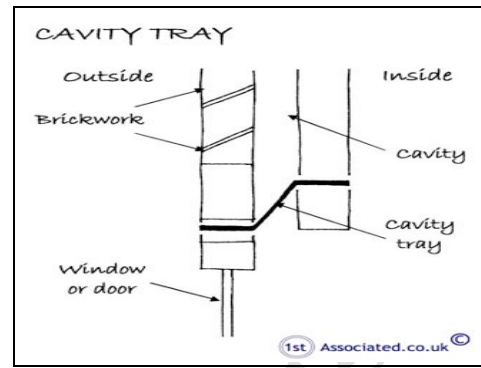
Cavity tray

What we have found quite a few times with modern timber framed properties that have been extended in this way is that the builder has not understood the construction of the building and as such has not added a cavity tray where the extension meets the main building.

ACTION REQUIRED: It is essential that your Legal Advisor checks and confirms that the Building Regulations have been complied with including the adding of a cavity tray. We are more than happy to comment on any drawings that you provide for us electronically.

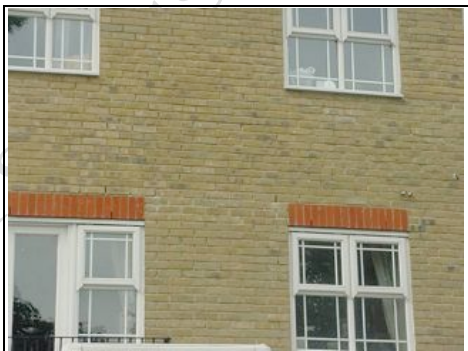
We find it fairly common for efflorescence to be visible on timber framed properties to the brickwork. This can appear in white powder form in patches or large areas.

White powdery effect known as efflorescence

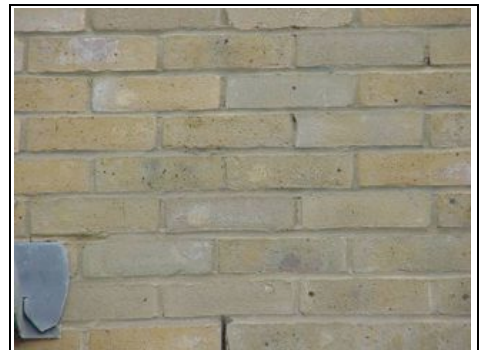
Efflorescence generally to the rear of the property

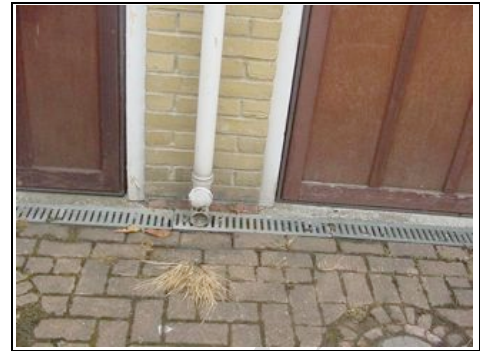
Running gulley

There is a slope towards the garage ending with a running gulley. In our experience this will need regular cleaning if not the water will end up in the garage which can be a problem if you store valuable or perishable goods in the garage.

ACTION REQUIRED: Next time it is raining check that the running gulley works sufficiently.

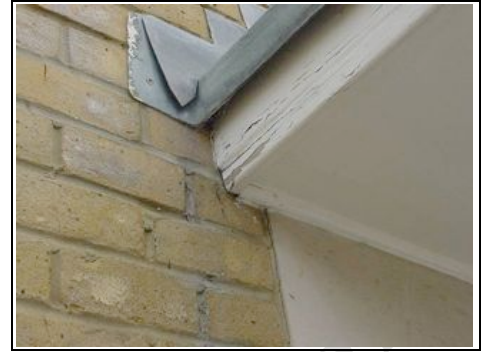
The property has timber double glazed windows in a mock sliding sash style, timber fascias and soffits and railings which would all benefit from re-decoration in the summer/warm dry weather of 2013 or the summer/warm dry weather of 2014.

Timber to porch

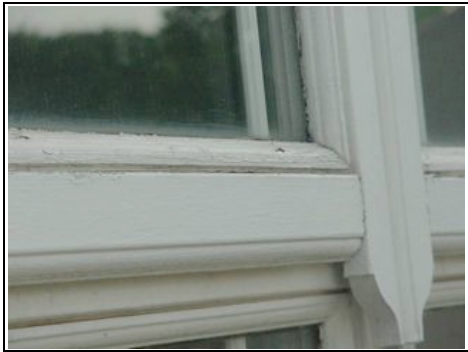
Timber windows

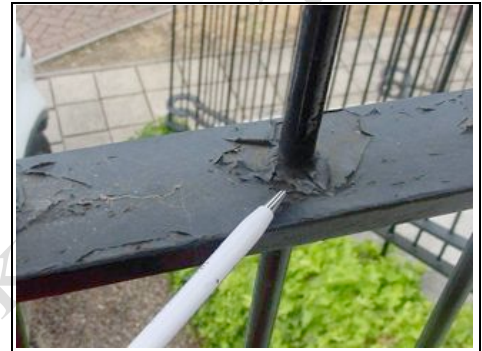
Railings need re-decoration

ACTION REQUIRED: Re-decorate all external joinery including windows, fascias and soffits and any metalwork such as the railings to the stairs.

ANTICIPATED COST: In the region of £2,000 to £3,000, possibly more due to the fact that it is high level work that may need scaffolding. This work could possibly be carried out utilising a tower scaffold; please obtain quotations.

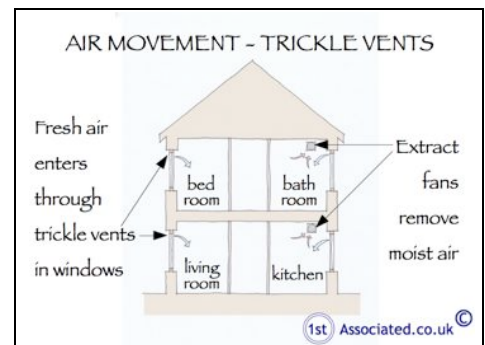
Air movement via trickle vents in windows

We noted that although the windows have trickle vents they appeared to be quite small. Also the way that the windows open any heat in the property cannot leave that easily as it effectively hits the window. Having said that if it was a problem we believe that residents in the area would have changed the style of the windows, please see the next section.

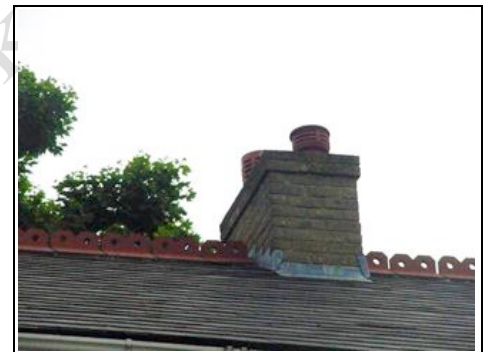
Chimney (right)

This chimney is brick built finished with a lead flashing and two chimney pots/flues. From what we could see from ground level it looked in average condition considering its age, type and style. We were pleased to see the lead flashing on a modern construction.

Unfortunately we were unable to see the flaunching, we therefore cannot comment upon them.

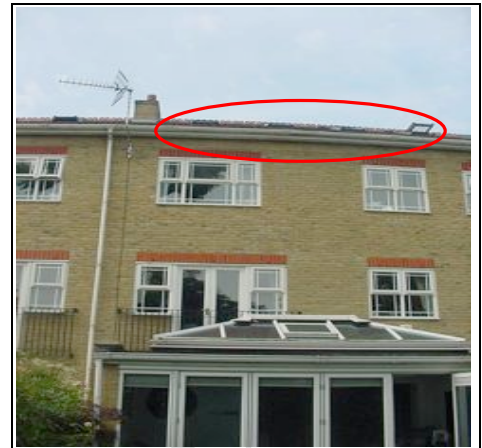
The roof windows are difficult to see externally due to the angle of the roof. They are purpose made roof lights as we would expect in this era of property and looked to be in average condition with some slight staining on them. We believe this may relate to condensation.

Roof windows are difficult to see

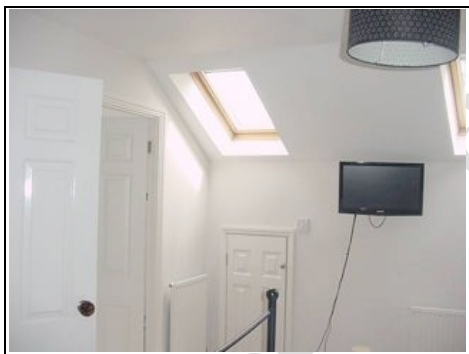
The important factor with roof lights is the flashing around them; in this instance we would comment on the roof lights that we could see by standing on ladders that there were no obvious signs of defects to the flashings. We would add that there is some mould on some of the windows which probably relates to the adjacent shower room not extracting the moist air quickly enough.

Roof window in bedroom,
on second floor

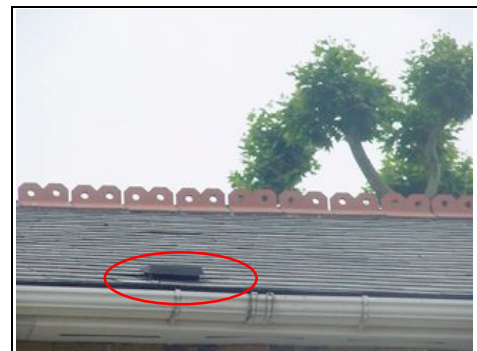
The main roof is pitched and clad with a manmade slate and, from ground level, this looks in average condition considering the roofs age type and style, although there is some minor moss.

We could see some slates that had lifted slightly but there did not appear to be any replacement slates on the roof. We have also found that manmade slates get lighter in colour/turn grey/white over time.

Main roof, manmade slate
with tile vent

ACTION REQUIRED Carry out periodic inspections and maintenance of the roof, as required. When these roofs do eventually require work it will be slightly difficult due to their high level. The new extension to the rear also adds a new dimension to carrying out roof work.

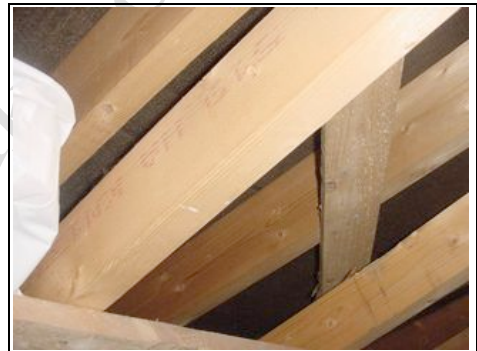
We could see the protective underlayer to the rear of the property and above the shower room. We noted a Hessian base Bitumen membrane. This type of membrane has been used since the 1960s. We generally found it to be in average condition, with damage in some areas which is what we typically find.

This photo shows the common rafters (the ones that form the pitch of the roof) and the dark area between is the underlayer.

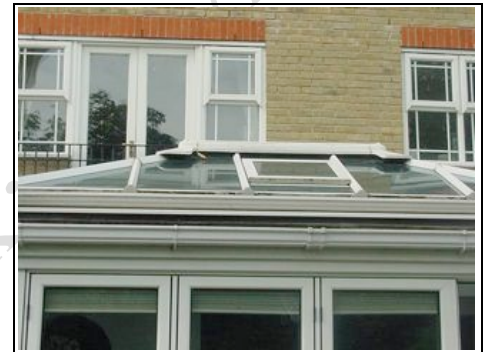
Rear extension roof

Our other concern is we do not believe it has been thought through properly with regard to heat gain and heat loss although we were pleased to see that there are windows that can be opened in the roof.

ACTION REQUIRED: Please see our comments within the Executive Summary as we do not believe the construction is particularly good.

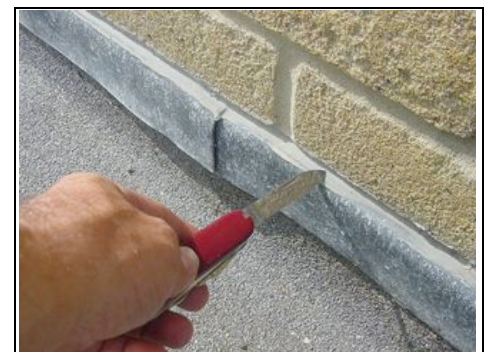
We were pleased to see that Mastic has been used to bed in the lead which is our preferred method for this age, type and style of property

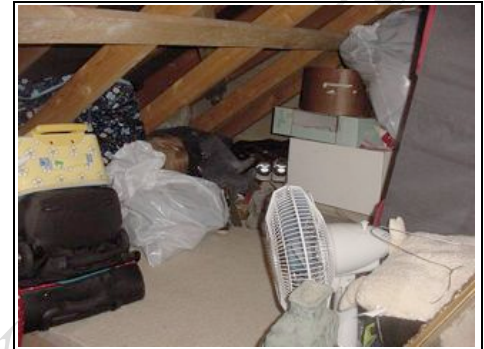
General view of inside of the rear area of the roof

Our examination was limited by the general configuration of the roof, the rooms formed in the roof, the insulation and stored items in the rear part of the roof. What we could see was generally found to be in average condition for its age, type and style. We could see approximately only thirty percent of the roof timbers and our comments are based upon this. It is, however, feasible that there are problems in the roof that are hidden.

ACTION REQUIRED: The only way to be 100 per cent certain is to have the roof cleared and checked.

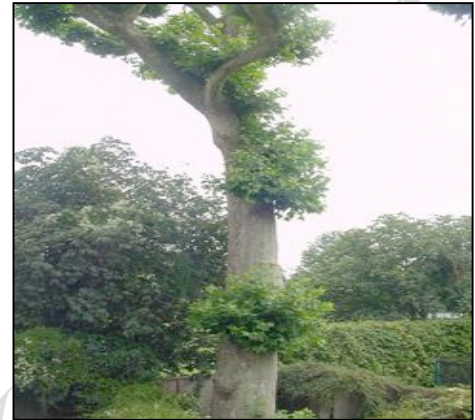
There is a tree within what insurance companies would term as influencing distance of the property.

Large tree

ACTION REQUIRED: Please see our comments within the Executive Summary.

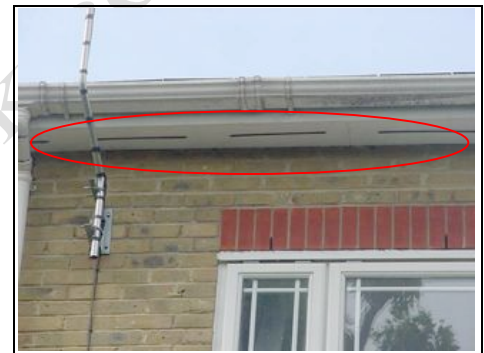
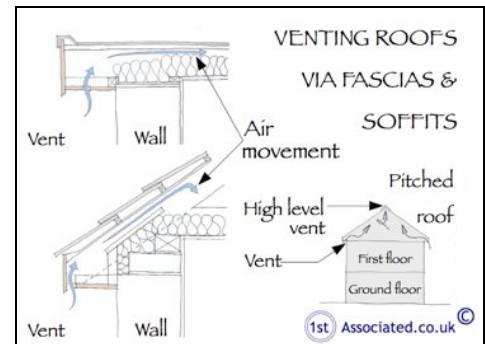
The fascias and soffits are timber. They are painted and we would comment they are in slightly below average condition for their age, type and style.

Vented soffit board

ACTION REQUIRED: Please see our comments within the Executive Summary regarding redecoration in the warmer months of 2013 or 2014. Make sure gutters and downpipes are watertight before carrying out any work on fascias and soffits.

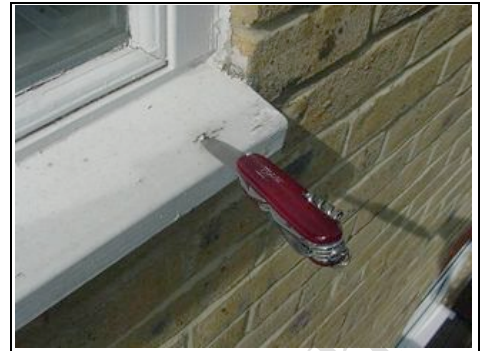
We have tested the windows by pushing a knife into a random selection. This was satisfactory apart from the paintwork that was weathered and in need of redecoration.

Knife Test

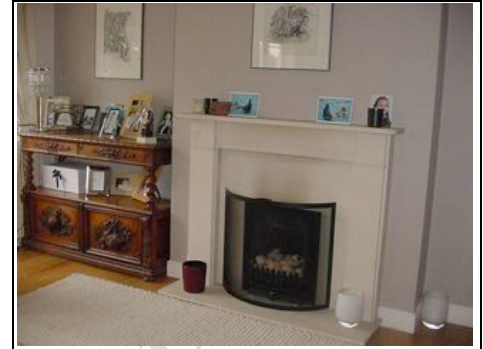
Fireplace in lounge

ACTION REQUIRED: Ask the owners/Estate Agents to show you the fire in operation.

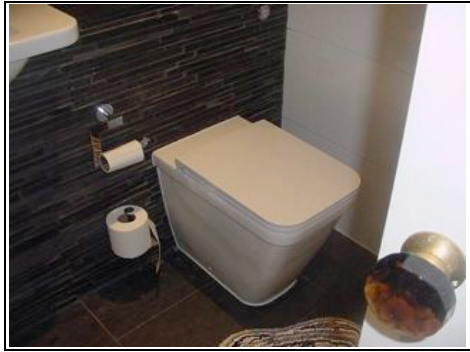
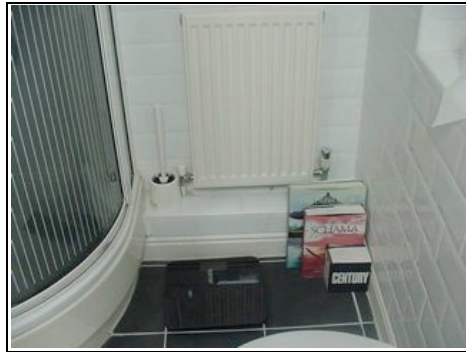
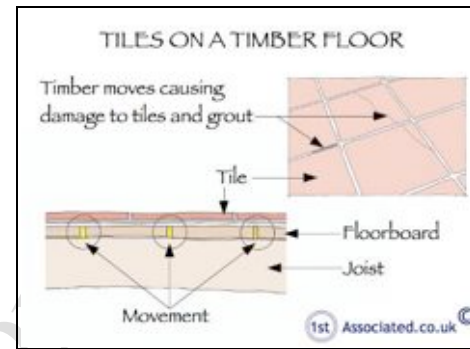
We noted tiles onto a timber floor in the bathrooms/shower room. With a wooden floor you will always get some movement/deflection, however minor. This movement/deflection in the floor will ultimately mean that the tiles will need re-grouting or may crack.

Tiles in the en suite bathroom
First Floor

Tiled floor ,en suite shower
room, second floor

Tiles on timber floor

ACTION REQUIRED: Re-grout when necessary.

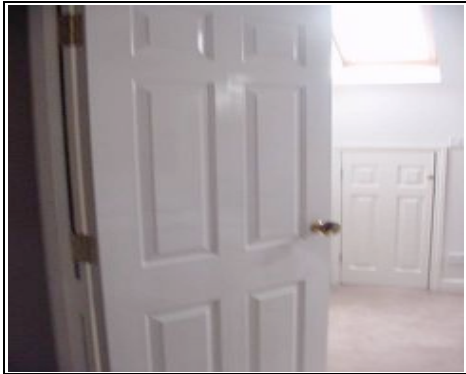
The doors to the property are modern hollow core doors and some do not have door closers.

Hollow core door

ACTION REQUIRED: We would recommend a door closer is added to the top floor door. Please see our comments in the Executive Summary regarding fire safety.

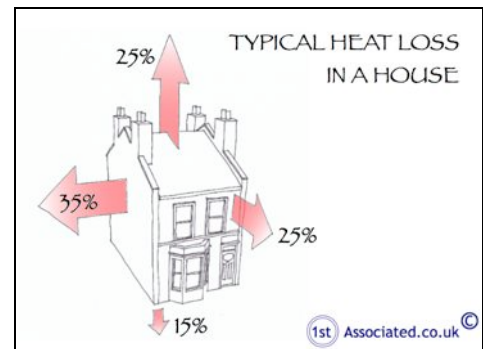
Some roof insulation was present although not to current Building Regulations requirements of 300mm. In this instance it looked as if spare insulation had been left in the roof.

Typical heat loss

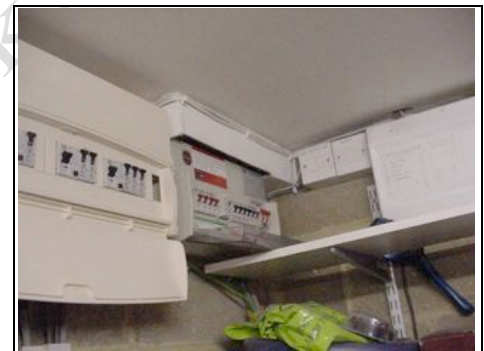
The electric fuses and consumer units were located in the garage. There appear to be two fuse boards, we are not certain why this is?

Two fuse boards

ACTION REQUIRED: Please see our comments in the Executive Summary.

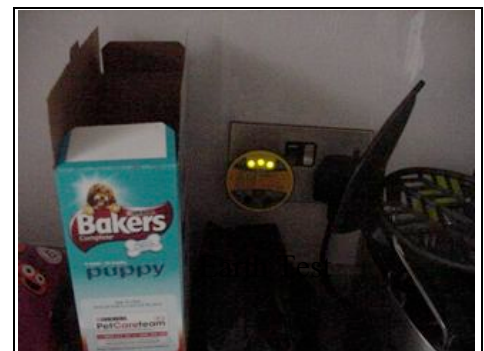
We carried out an earth test in the kitchen area to the socket point that is normally used for the kettle, this proved satisfactory.

Earth test

ACTION REQUIRED: As the property is changing occupancy an Institute of Electrical Engineers (IEE) test and report should be carried out by a NICEIC registered and approved electrical contractor or equivalent.

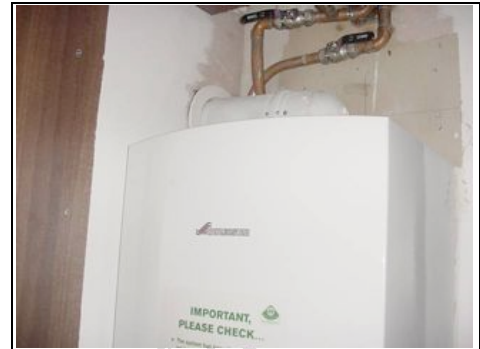
The wall mounted boiler was located in the study, it is manufactured by Worcester.

Our limited inspection of the hot water and central heating system revealed no evidence to suggest any serious defects but we would nevertheless recommend that the system be tested and overhauled before exchange of contracts and that a regular maintenance contract be placed with an approved heating engineer.

Worcester Boiler

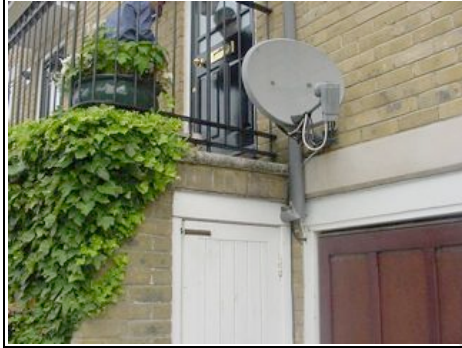
Storage cupboard under the steps.
We normally find dampness
can get into these.

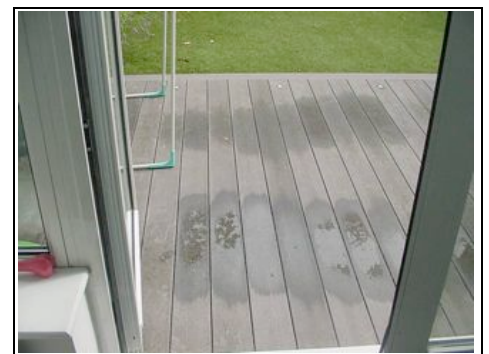
We are finding decking can become slippery over the years when not regularly maintained and can also be an ideal space for living under for wildlife.

Decking area
