RESIDENTIAL BUILDING SURVEY

**Leytonstone,
London.
E11 XXX**

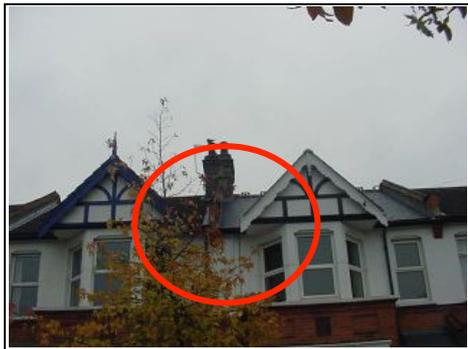
The front right chimney breast has been removed and the rear left chimney has been removed at the top and bottom. We couldn't see any supports.

Chimney

ACTION REQUIRED: In theory building regulations should be obtained when a chimney is removed. Your legal advisor to check and confirm. In practice we would not be happy with the situation where the front chimney breast has been removed in case your neighbouring property removes the front chimney breast as well.

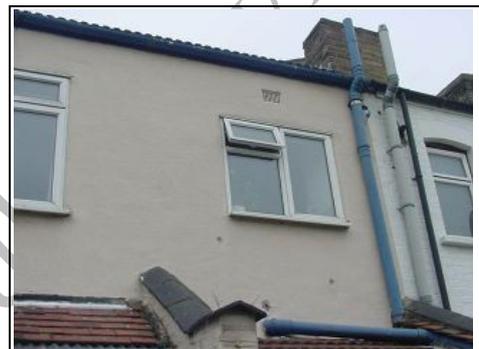
Rear chimney removed

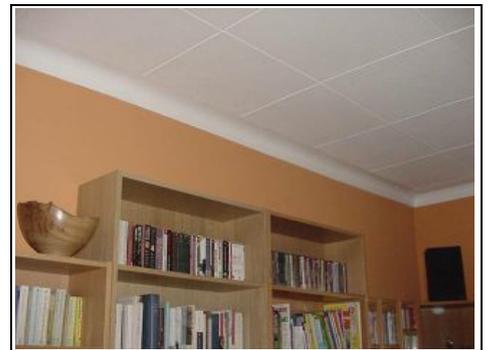
1.0) Front right chimney breast removed

Chimney breast removed to front

the time of the survey but there was no response. We would recommend you advise number 156 in writing that your chimney breast has been removed if you do proceed; in theory this should also have had a party wall notice.

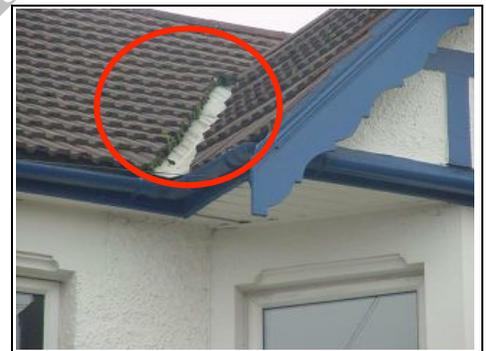
We can see within the roof space that the valley gutters are leaking. There are no obvious visual signs of where this was externally although we would say that sometimes it is the cement rendering to the side.

Green to the edge of the valley gutter

ACTION REQUIRED: You need to put a long ladder or tower scaffold up to have a close inspection of the valley gutters and carry out repairs to make watertight.

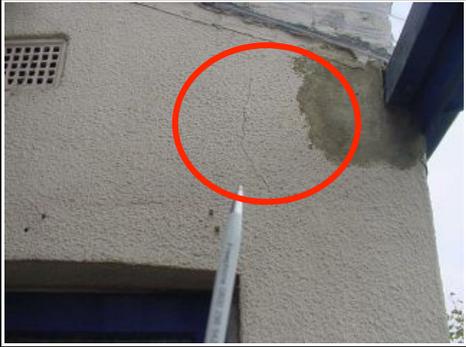
This can be seen both in the render at ground level and also the neighbouring property particularly number 156 which is the right hand side as you face the properties. We noted approximately four or five of the buildings have been re-rendered which could be to hide cracking/make watertight.

Crack to rear

We believe there may be drainage problems with the drains leaking. Cracking was noted to the rear garden path which would be consistent with next door having cracks as well. Unfortunately we could not find a manhole to check the condition of the drains.

ACTION REQUIRED: Close circuit TV camera report of drains. Your legal advisor needs to specifically request in writing if there have been any structural problems with the property and you also need to write to insurance companies to see if they are aware of problems in the area. The main problem in our experience with drains is that if they are not resolved then they will continue to leak and this can affect the clay soil that we have in London as well as eroding ground.

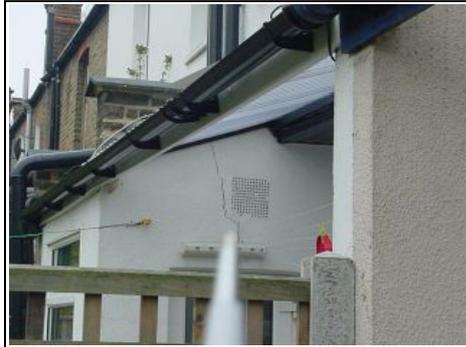
Cracking to next door

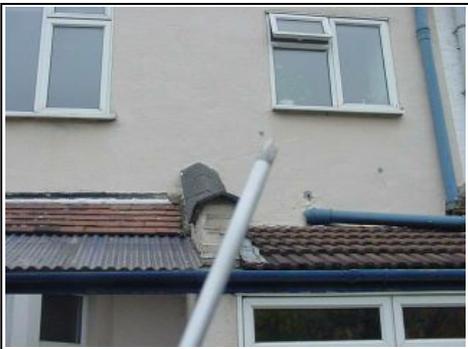
Cracking below window

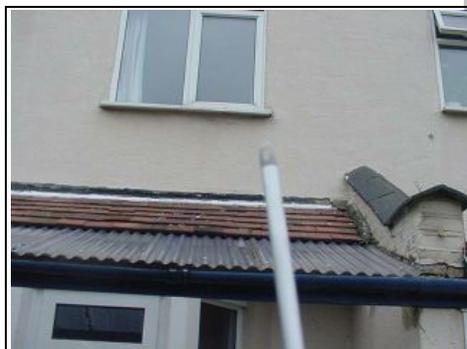
Cracking

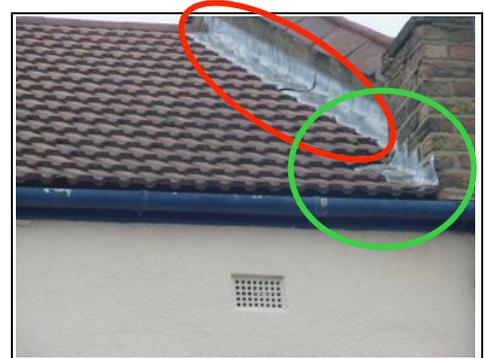
These are built in a soft red brick that does absorb a lot of dampness. We can also see that there is a straight flashing joint rather than a stepped flashing joint that follows the line of the brickwork which we generally find aren't as good.

Red – straight flashing to parapet wall
Green – stepped flashing to chimney which is how it should be done

ACTION REQUIRED: Repair parapet walls.

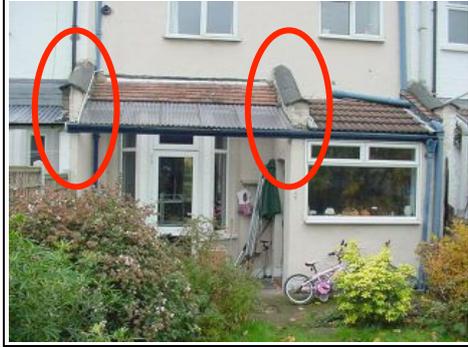
We can see to the rear roofs that plants are growing from them which of course means that dampness is within the parapet wall. There looks to be relatively new render.

Rear parapet walls

ANTICIPATED COST: A few hundred pounds to repair the low level parapet walls. To repair the high level parapet walls will be much more expensive. We would add that we can't see any excessive dampness getting into the structure at present but it is a potential problem. Please obtain quotations.

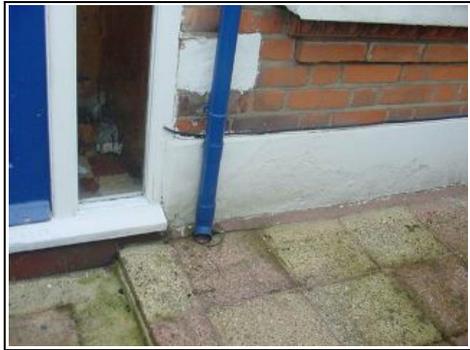
The property has a high ground level to the front and rear.

High ground level

ACTION REQUIRED: Ideally the ground level needs to be lowered at the front and rear.

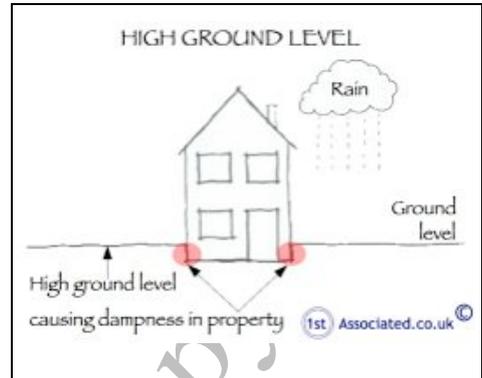
High ground level

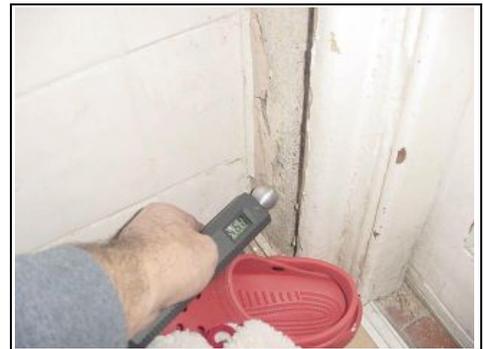
We found dampness within the kitchen that exceeded normal levels. We believe this is due to high ground level. It also may be due to poor construction without a damp proof course present. It is not possible to see if there is a damp proof course because there is a rendered finish to the wall.

The moss in the adjacent photograph indicates that water is going towards the wall.

Dampness

ACTION REQUIRED: Adding a French drain and a bell mouth would be ideal to reduce the dampness in this area.

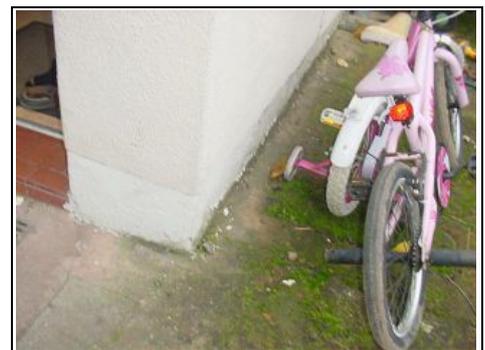
Not possible to see whether there is a damp proof course due to the render

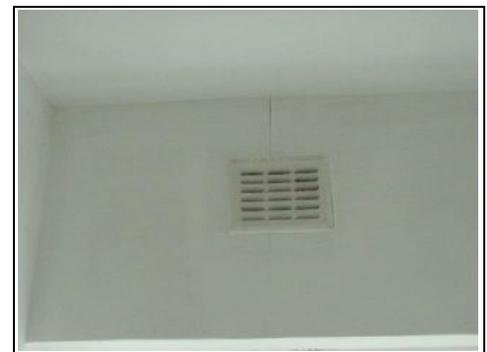
The property has a higher than average chance of condensation which is due to there being no mechanical extract fans in the bathroom and kitchen although they do have a natural high level wall vent.

Bathroom wall vent

ACTION REQUIRED: We would recommend large humidity controlled extract fans are added.

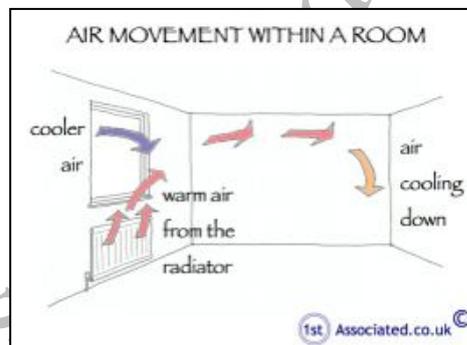
Another thing related to the higher chance of getting condensation would be that we noted the radiators are internal in some areas. This is often carried out on cheaper central heating systems to save the labour and piping costs of taking the radiators underneath the windows. However, it then reduces the air movement in the room.

Internal radiator

ACTION REQUIRED: We would live in the property and then if there are problems we suggest you move the radiators underneath the windows as this gives a better circulation of air and reduces the chance of condensation.

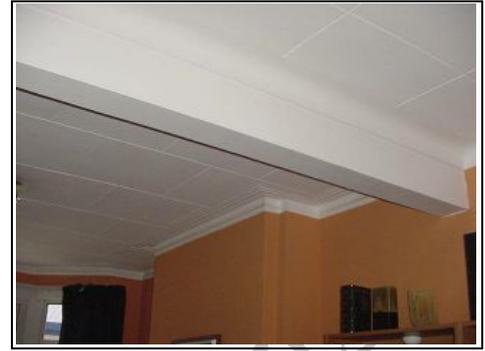
We can see that the wall has been removed in the through lounge without getting Building Regulations permission. This doesn't mean necessarily that there is a structural problem with the beam, it certainly doesn't mean that the house is going to fall over as it has stood the test of time; it literally means it doesn't meet Building Regulations requirements which came in as a national requirement in 1948 so this may well have been carried out prior to that.

Wall removed without building regulations

There is slightly more deflection that we would expect due to the removal of the wall.

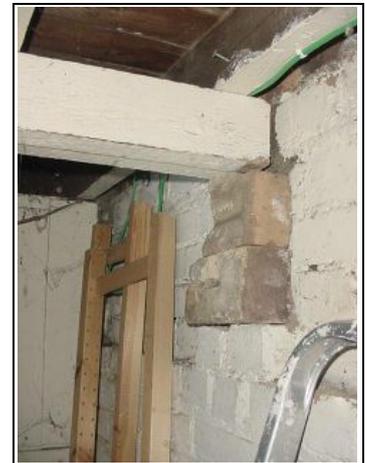
The cellar floor is propped up with bricks to the front left side. We would prefer to see these securely positioned

Bricks propping up joist that is holding the floor.

ACTION REQUIRED: Bed in cement mortar. Also use an angle bracket to hold the joist in place.

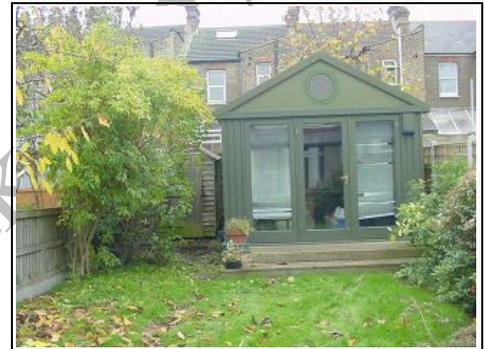
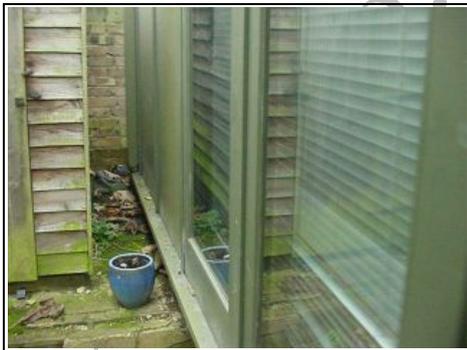
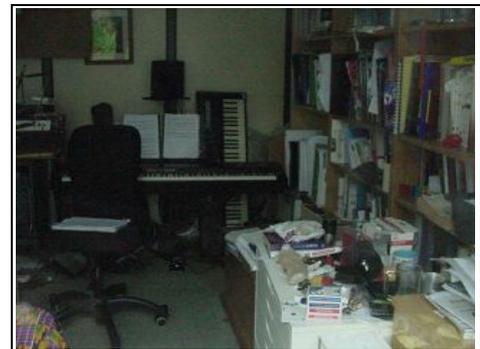
There is a home office/outbuilding in the garden of a substantial size. We would comment that larger units such as this one can require planning permission and building regulations (regardless of what the sellers of the product say).

Office/outbuilding

Side of outbuilding

Inside outbuilding

ACTION REQUIRED: Your legal advisor to request in writing confirmation whether planning permission or building regulations has been obtained.

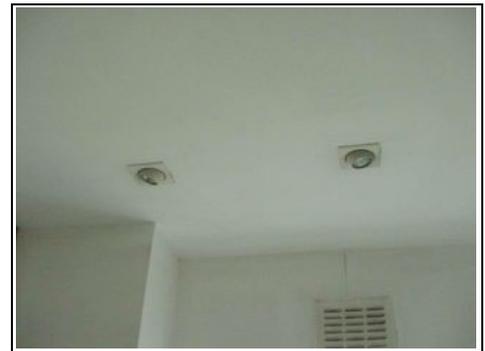
The property has electric lights to the ceiling. In some instances these can cause problems as the heat given off has in some cases lead to outbreaks of fire; these tend to be in the older type of ceiling lights and we recommend that where ceiling lights are used that the rear of the light is not covered.

Ceiling lights

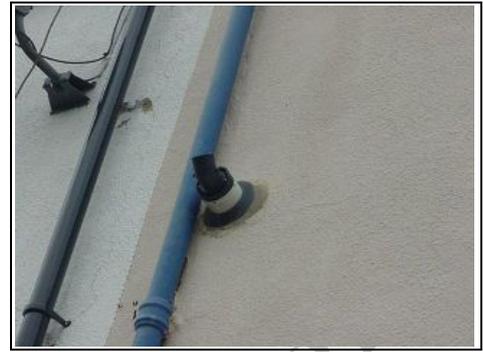
The property has a Worcester boiler in the bedroom. A boiler within a bedroom could be considered as a problem.

Flue from Worcester boiler

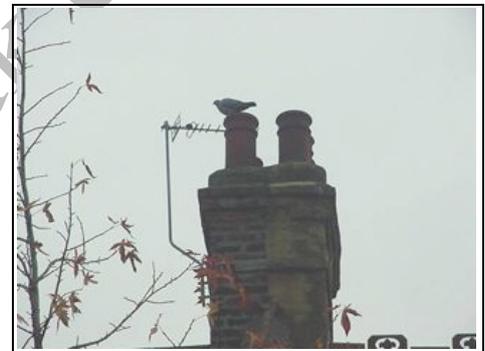
This chimney is brick finished with a lead flashing and you have two chimney pots. From what we could see from ground level it looked in average condition considering its age, type and style although the rendering of the adjoining chimney does indicate to us that there are problems with dampness getting into these chimneys which can often be the case where a softish red brick is used.

Front of chimney

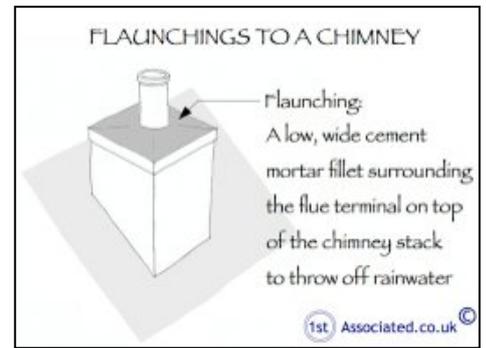
Unfortunately we were unable to see the top of the chimney known as the flaunching, we therefore cannot comment upon them.

Flaunching

ACTION REQUIRED: Periodically inspect the chimney.

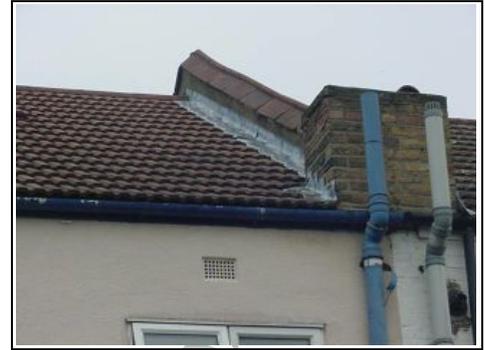
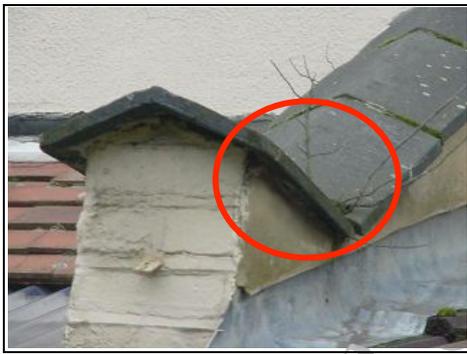
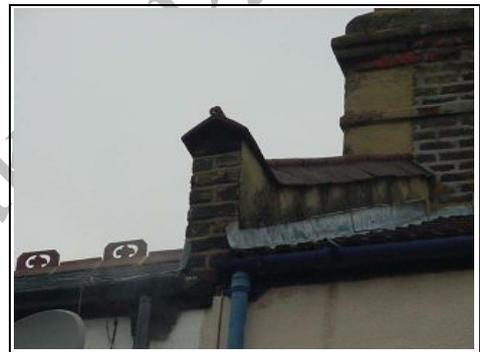
In this case there are parapet walls to the front and rear which are brick built with a coping stone and a straight flashing.

Rear left parapet wall

Plant growing from parapet wall

Flashing to parapet wall rear right side

ACTION REQUIRED: Please see our comments in the Executive Summary

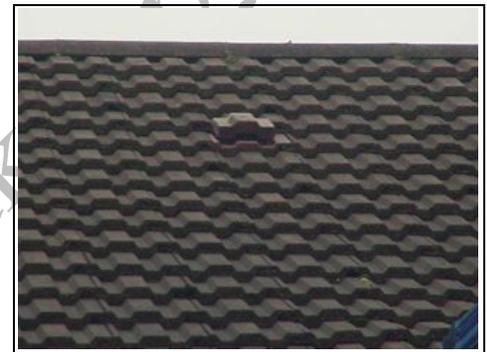
The main roof is pitched and clad with concrete tiles and, from ground level, this looks in average condition considering the roofs age type and style. We could see venting indicating that it is a relatively new roof (the last fifty or so years).

Main roof

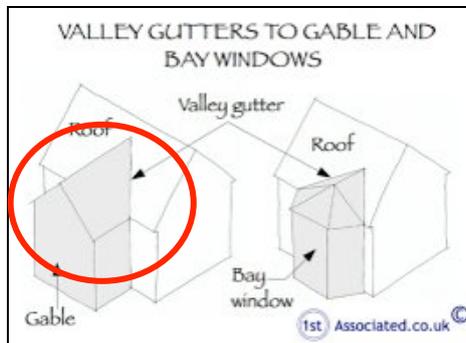
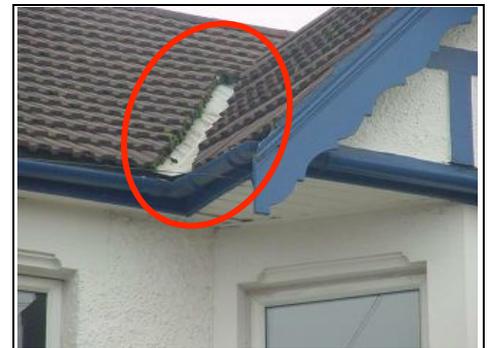
Valley gutter

ACTION REQUIRED: Please see our comments in the Executive Summary.

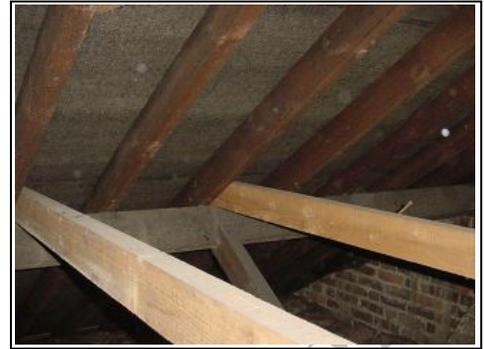
When we inspected the loft space we found a Hessian base Bitumen membrane. This type of membrane has been used since the 1960s. We generally found it to be in average condition, with damage in some areas which is what we typically find.

This photo shows the common rafters (the ones that form the pitch of the roof) and the dark area between is the protective underlayer

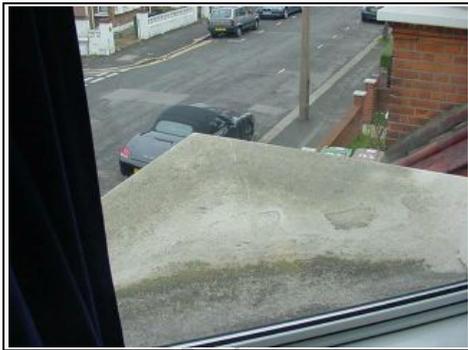
To the front of the property there is a square bay window. Bay windows are great for bringing light into the property. We can see some movement to the front of the property which in turn could have moved the roof slightly.

Concrete sills around bay window

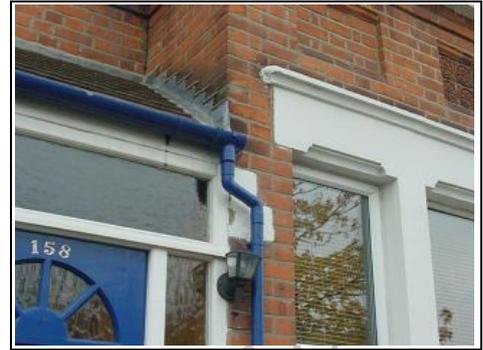
The front porch roof has a small tile and we were pleased to see it has a stepped flashing. Note our comments with regard to the parapet wall straight flashing.

Front porch roof

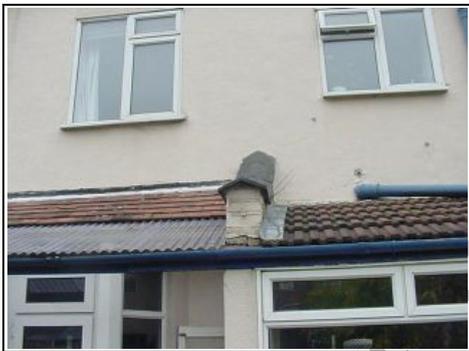
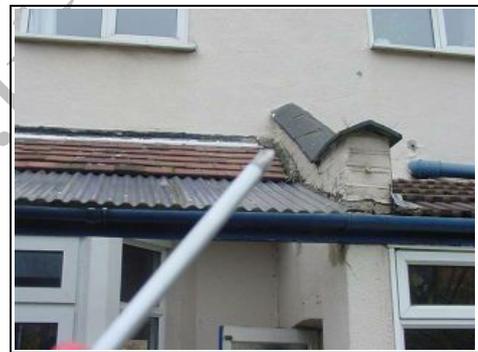
The rear roof is a mixture of older tiles, modern concrete tiles and plastic corrugated sheet. Please see our comments with regards to the parapet walls and the flashing. We expect repairs to be carried out.

Rear roofs

Concrete flashing

ACTION REQUIRED: Please see our comments in the Executive Summary.

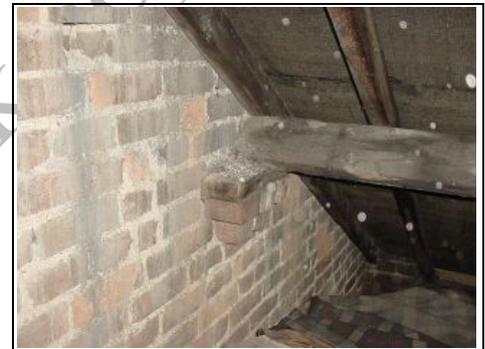
Our examination was limited by the general configuration of the roof and the insulation. What we could see was generally found to be in average condition for its age, type and style with the exception of the crack in the chimney, please see our comments on this in the Executive Summary. It is, however, feasible that there are problems in the roof that are hidden.

Purlin sitting onto brick which is reasonable

ACTION REQUIRED: The only way to be 100 per cent certain is to have the roof cleared and checked.

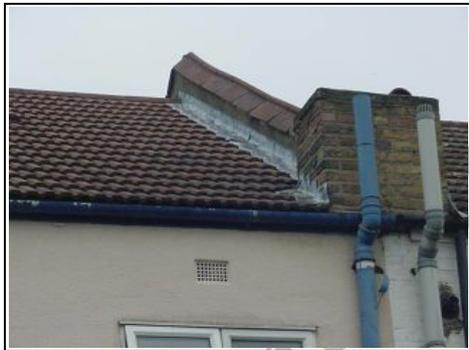
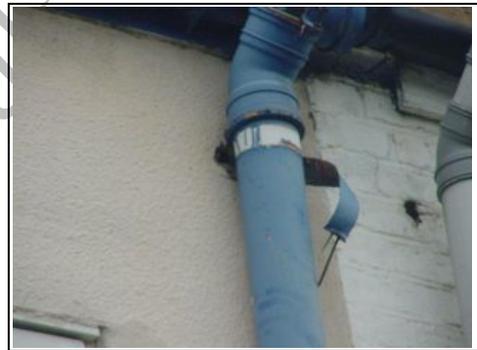
The property has plastic soil and vent pipes. The securing bracket to the soil and vent pipe has come away and needs refixing as does the birdcage at the top of it.

Plastic soil and vent pipe coming away

Securing bracket coming away from soil and vent pipe

ACTION REQUIRED: Re-secure.

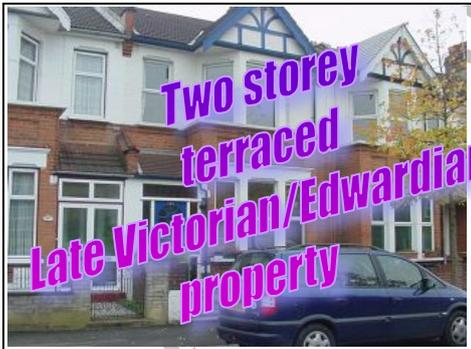
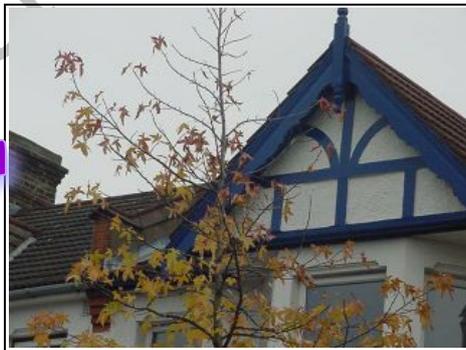
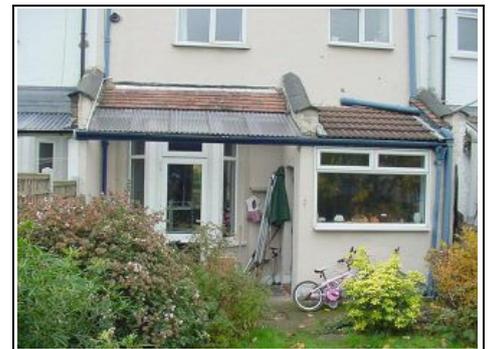
The external walls are finished in a painted roughcast render to the upper parts with feature timbers to the front and render to the rear. Adjoining properties have a stucco render (lines made lightly into the render). In this case the render has been added at a later date; we believe to help improve the water tightness of the building and also may be to hide the cracking to the rear. We find with render that there can be problems with deterioration and it does need regularly checking.

Render to top of property

Roughcast render with feature timbers

Render to rear

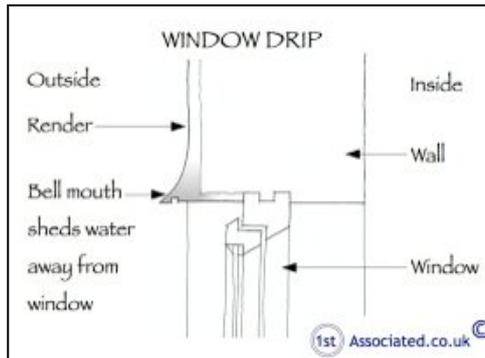
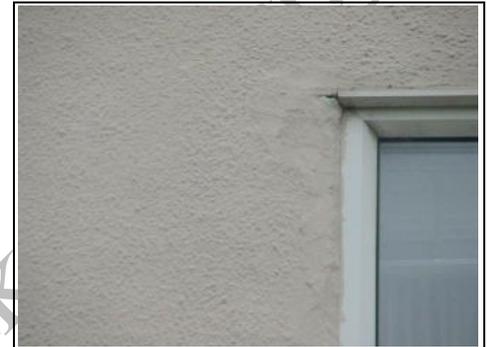
In this case we found a timber drip detail to the windows. We prefer these to be formed in the render but anything is better than nothing.

Timber drip over windows

Window drip

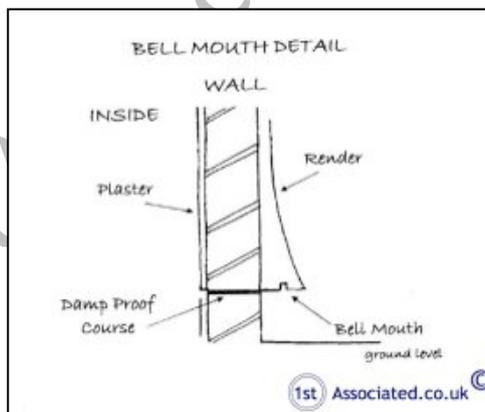
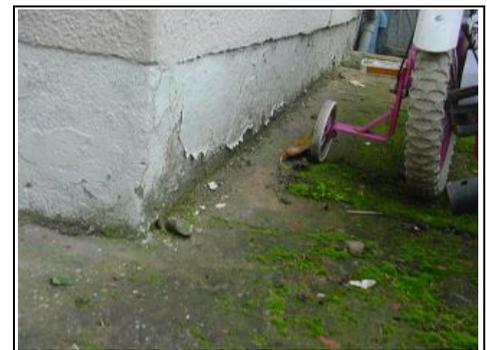
To the base of the render there was an attempted bell mouth detail which was not properly formed. Interestingly this is the area that is getting dampness in the kitchen.

No bell mouth

Bell mouth detail

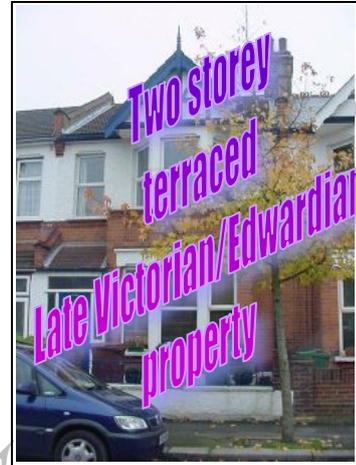
There is a small tree within what insurance companies would term as influencing distance of the property. Your insurance company may want to know about this. The root ball is unlikely to affect the property.

Tree to front

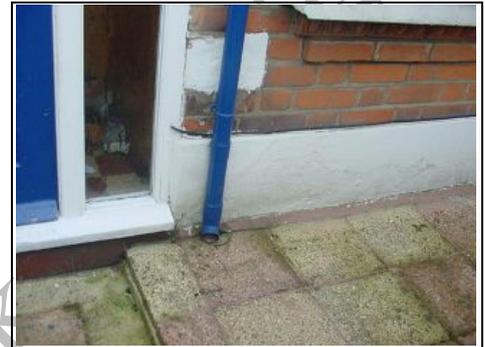
All modern properties should incorporate a damp proof course (DPC) and good building practice dictates that a differential of 150mm (6 inches) should be maintained between the damp proof course and ground levels. In this case, we cannot see a DPC.

DPC not visible

Your attention is drawn to the section of the report specifically dealing with dampness.

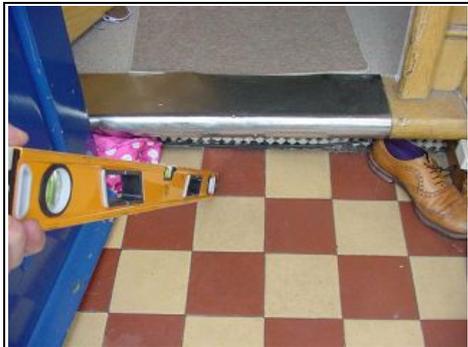
Air brick under front door

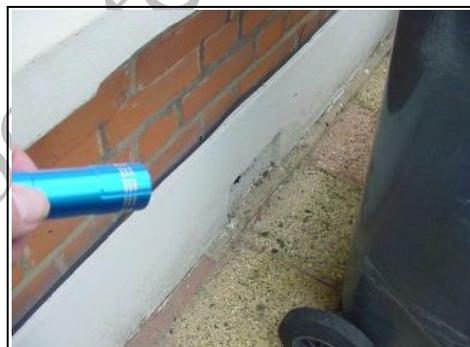
Air bricks were noted. The front air brick is acting as a gutter and water is likely to be going into the cellar area and possibly affecting the timbers in this area. Note we were not able to view the timbers in this section but we could see that they were embedded in the walls from the cellar area.

Front air brick

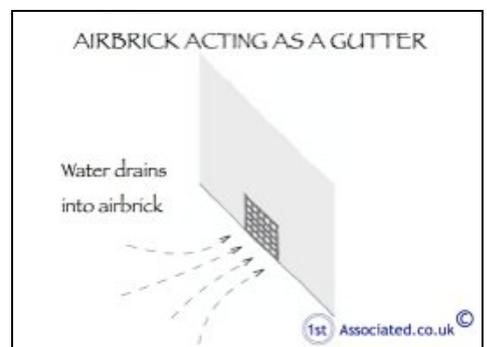
Air brick acting as gutter

ACTION REQUIRED: Protect airbricks.

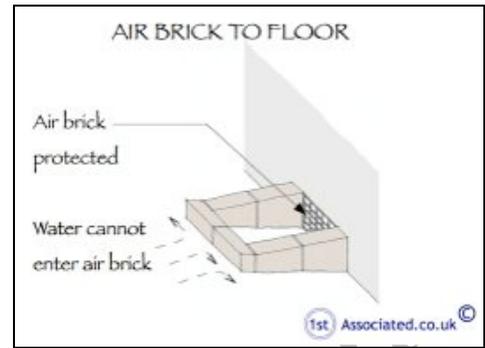
There are vents at high level.

ACTION REQUIRED: Ensure the air bricks are clear. Please see our comments in the Executive Summary.

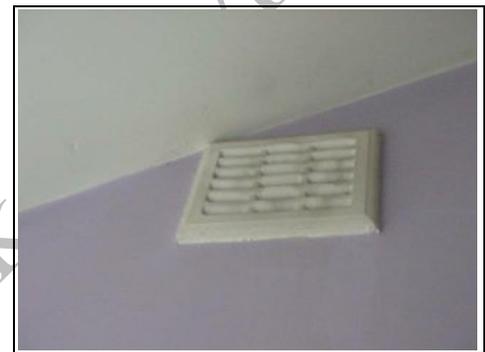
High level air vent in bathroom

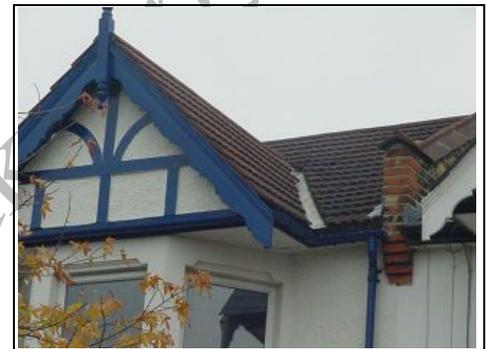
The property has decorative fascias which are a nice feature to the property. The fascias and soffits are timber. They are painted and we would comment they are in average to slightly below average condition for their age, type and style.

Decorative fascias

ACTION REQUIRED: Redecorate in the summer of 2014. Make sure gutters and downpipes are watertight before carrying out any work on fascias and soffits.

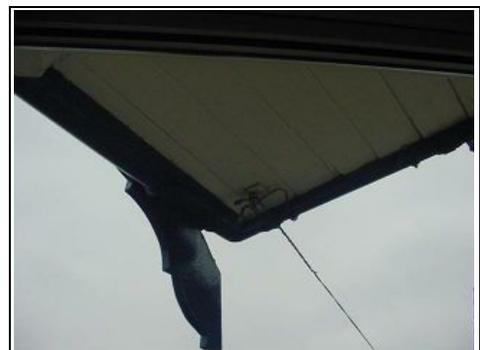
Painted timber fascias and soffits

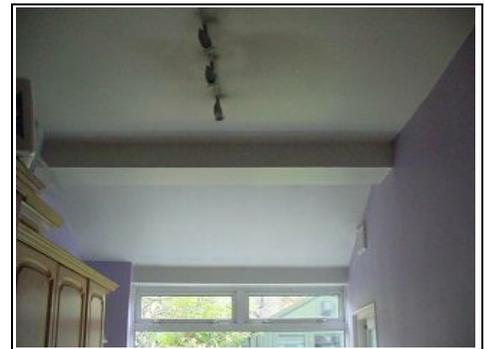
There are lintels where walls have been removed.

Lintels in rear lean-to

ACTION REQUIRED: Please see our comments in the Executive Summary.

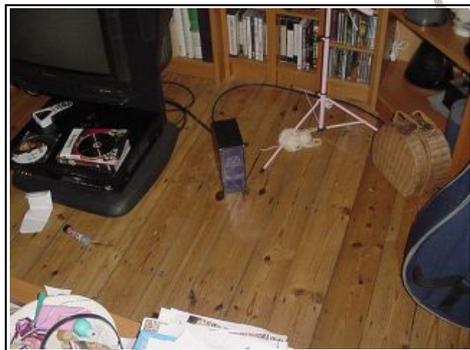
hides it; it was a poorer quality laminate. Where we could see the ground floor joists we could see there was some gaps which is not unusual in this age, type and style of property.

Floor slightly opened up on ground floor

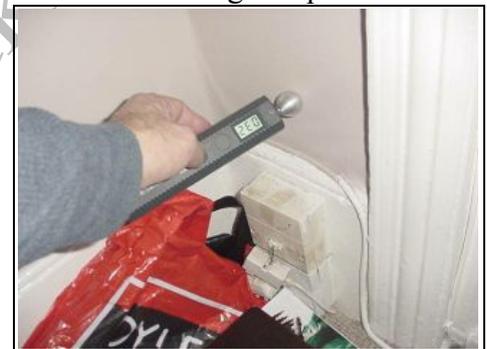
A random visual inspection and tests with a moisture meter have been taken to the perimeter walls. In this particular case we have found significant rising damp to the rear of the property in the kitchen area and slightly high to the front of the property.

Testing for rising damp to front of property

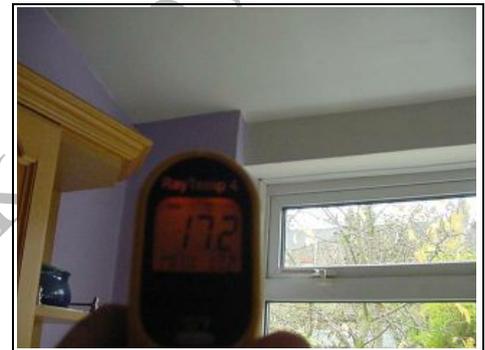
The property does have potential for cold bridging.

Testing for cold bridging

ACTION REQUIRED: Please see our comments in the Executive Summary.

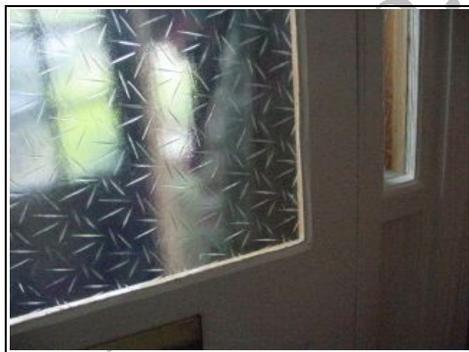
We have been unable to find a kite mark on the doors which indicates that they are not safety glass which means that if it breaks it shatters and can be dangerous.

Door not safety glass

ACTION REQUIRED: Please see our comments in the Executive Summary.

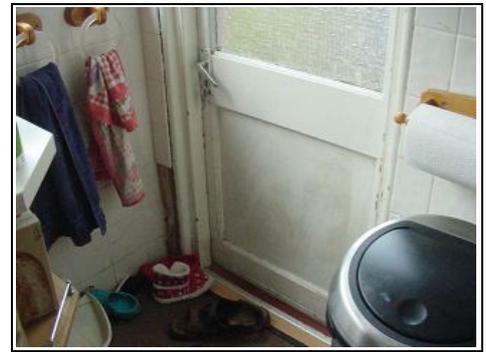
No safety glass

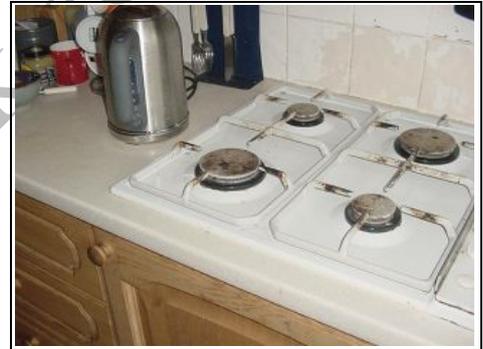
We found the kitchen in below average condition, subject to a lot of wear and tear such as the painted tiles and the condition of the cooker for example which would benefit from a clean.

Condition of appliances

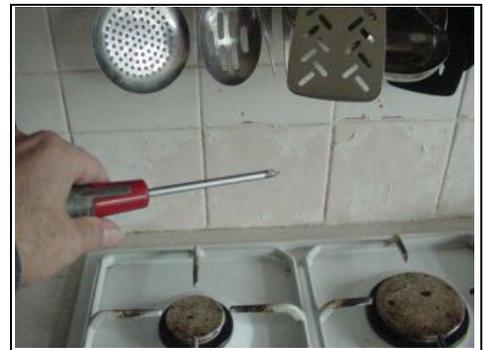
Painted tiles

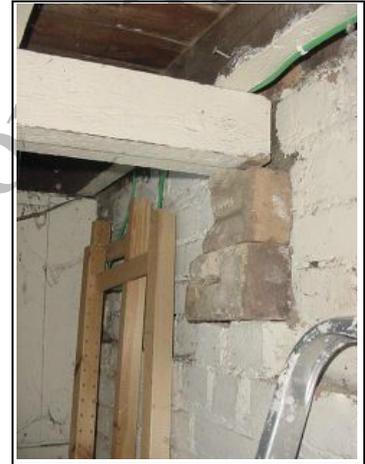
The cellar floor is propped up with bricks to the front left side. We would prefer to see these securely positioned.

Bricks propping up joist that is holding the floor.

ACTION REQUIRED: Please see our comments in the Executive Summary.

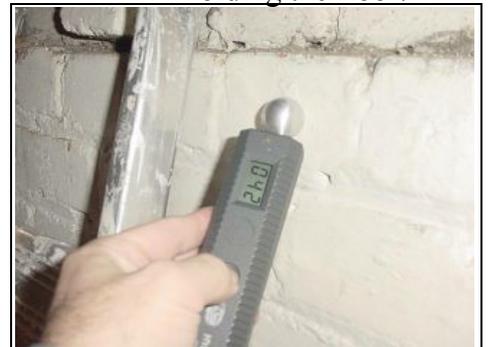
Surprisingly dry in basement, expected readings of 60 plus, obtained reading of 42

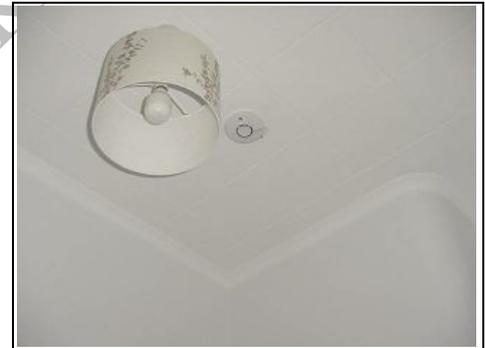
Some smoke detectors were noted. The current Building Regulations require that they be wired into the main power supply. Obviously in a property of this age this is difficult, as it would mean having surface mounted wires or cutting wiring into the plaster.

Smoke alarm

ACTION REQUIRED: We would recommend, for your own safety, that smoke detectors be installed. We would always recommend a hard wired fire alarm system and are also aware that some now work from a wireless signal which may be worth investigating. Whilst fire is relatively rare it is in a worst case scenario obviously devastating.

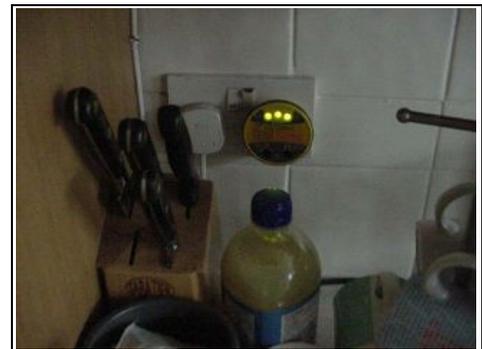
We carried out an earth test in the kitchen area to the socket point that is normally used for the kettle, this proved satisfactory.

Earth test

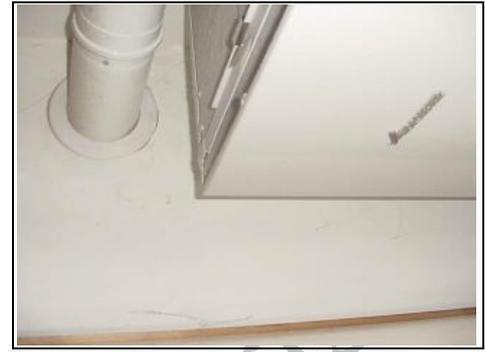
The boiler was located in the rear right bedroom which is not ideal; it is manufactured by Worcester.

Boiler vented to outside air

ACTION REQUIRED: Please see our comments in the Executive Summary.

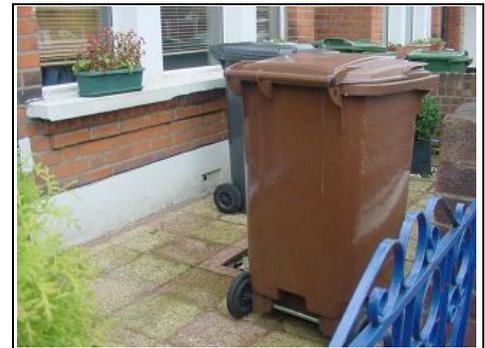
There is a small front garden. The boundary wall render is coming away and damaged and would benefit from repair.

Small front garden

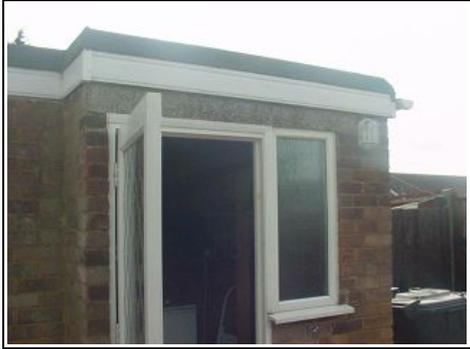
A rear door to a 1970's building.
Can you tell where the cold bridging would be in this photo?

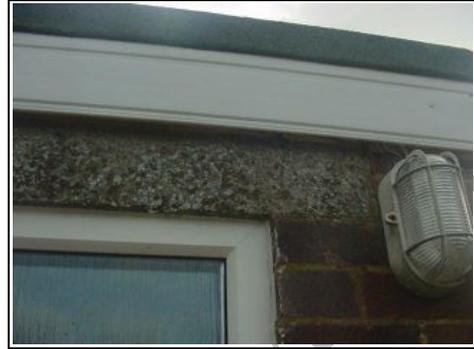
A close up view showing there is a concrete lintel over the door and window.
This is where the cold bridging occurs causing condensation inside

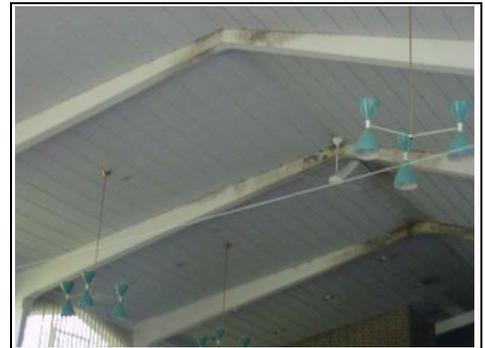
Cold Bridging in a commercial property with a concrete frame.

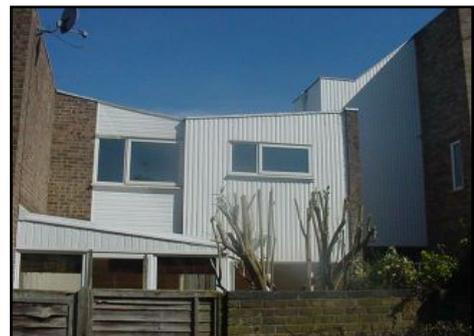
1970's property with cold bridging to the roof beams and the lintels

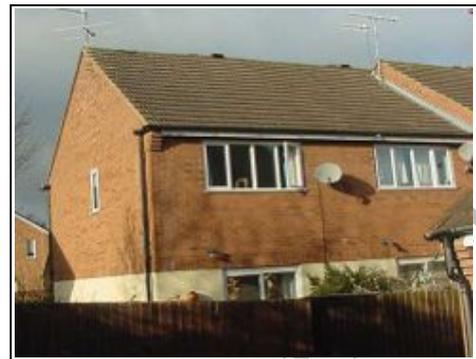
1980's property, cold bridging was found in the lintels
