JOB REFERENCE: XXXX

RESIDENTIAL BUILDING SURVEY

XXXX
London
SE14 XXX

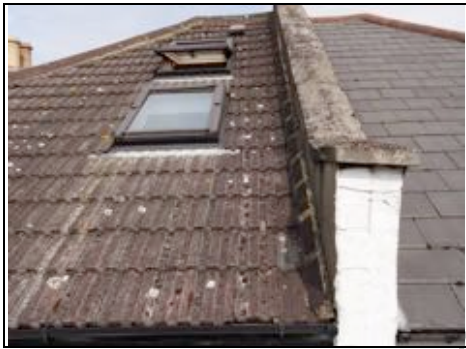
Front Right parapet wall
~ Aerial View - 360 Photo ~

Dampness is getting in via the parapet walls on the right hand side of the property where there is a tile on end flashing rather than a lead flashing, which we must prefer to see.

ACTION REQUIRED: Items 1.1 and 1.2 we recommend that all tiles on edge are replaced with a lead flashing. 1.3 where the tiles have moved, we recommend that the tiles are repositioned, in theory this should be a shared cost.

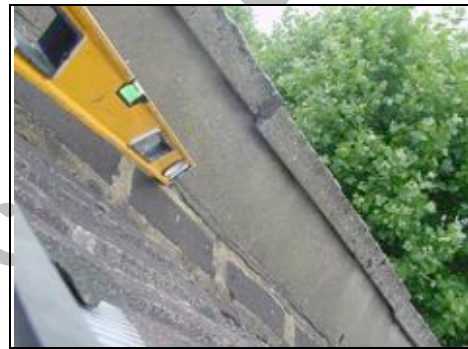
Tile on edge to the Front Right
Parapet wall

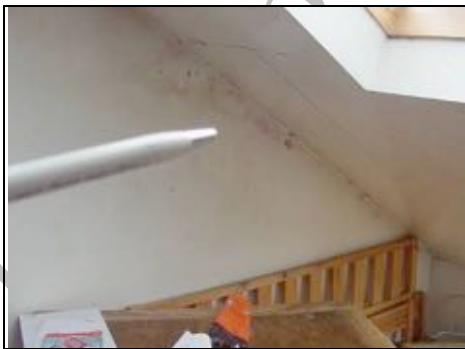
Dampness on front right side from
parapet wall

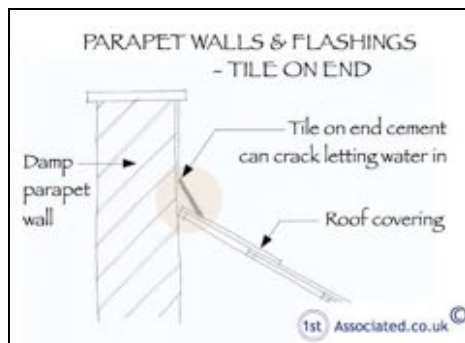
Tile on end to flashings

- 1.2 The chimney also has the tile on end, again we believe that dampness will be coming through sooner or later and we can see any areas that has been repaired to the rear.

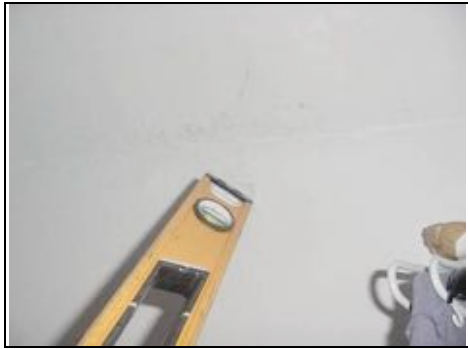
- 1.3 In addition to this we can see that a tile has moved around the flue to the rear left and this is allowing dampness to come in through the roof. It has previously repaired by a product known as Flashband, which we consider a temporary repairing material.

Dampness coming in at roof level where we believe the tile has come out of place

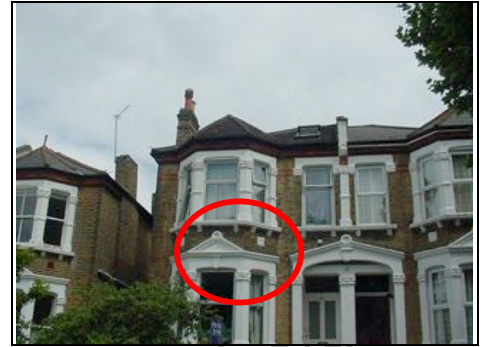
Front bay window

There is dampness visible in the front bay window, we believe this relates to cold bridging.

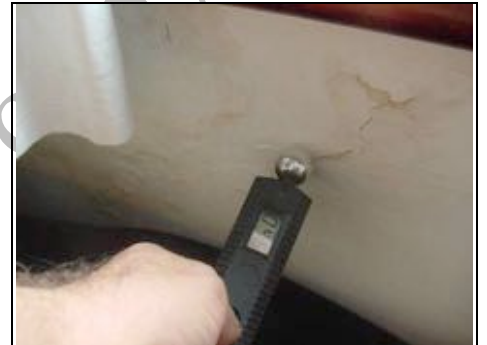
Dampness in front bay window probably wind driven rain or may be condensation

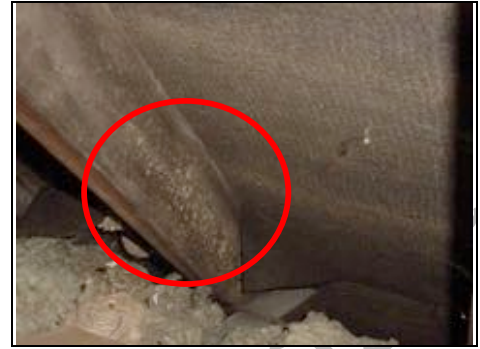
Within the rear roof (as this was the only roof we could view properly – the other roof was lined where it formed part of the front room in the roof) we found, what looks to be Frass which related to woodworm activity.

We believe that the over insulation of the roof may be contributing to the wood worm problems as this gives a warm environment that is ideal for woodworm.

Woodworm

ACTION REQUIRED: We recommend that insulation is removed in a section of the roof for the remaining timbers to be checked. We are more than happy to check any photos taken of the timbers.

We would recommend adding ventilation to the roof in the form of air bricks and roof vents. This should make the climate/environment not suitable for woodworm to breed and eradicate the problem.

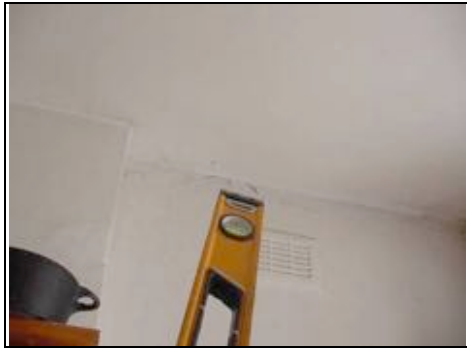
The property suffers from condensation. This is partly due to the age of the property, its construction, how it is being used and the number of occupants.

Condensation in kitchen

- 1) Removal of the humid air at source from humidity generating areas such as the bathroom, the kitchen and any areas that are used for drying clothing etc. We would recommend large good quality humidity controlled extract fans.

ACTION REQUIRED: There are various ways of improving the air movement and removal of humid air in the property such as adding large quality humid controlled extract fans. We also do not feel that the relatively high number of people living in the property (multi occupied property) is helping the matter. If the number of people reduced it would also reduce the humidity generated by breathing, washing, cooking etc. and may help to resolve the problem on its own.

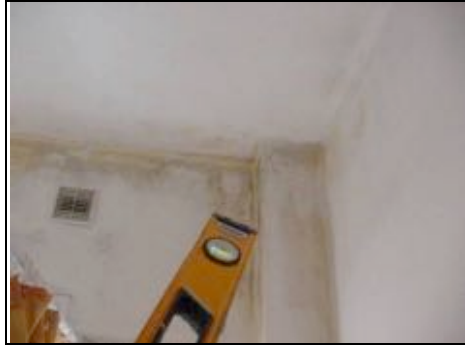
Condensation/mould in bathroom

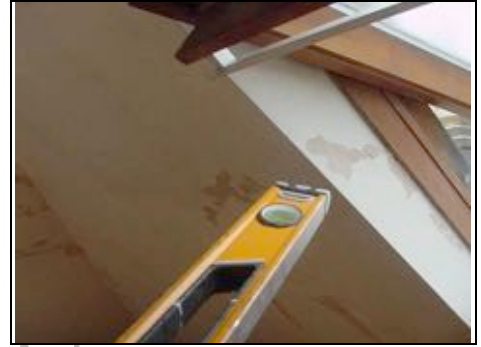
Paint coming off in room in roof

Improvements could be made in many ways to help reduce condensation:

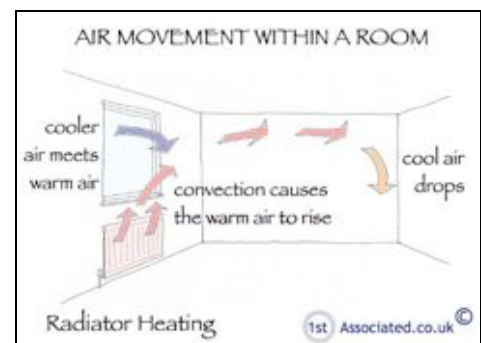
- 2) We noted some radiators were not underneath the windows, better air movement can be produced within the property by moving the radiators underneath the windows.

Air movement

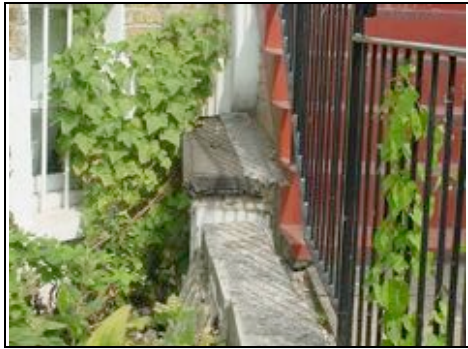
Awkward detail that we believe is allowing dampness into ground floor flat

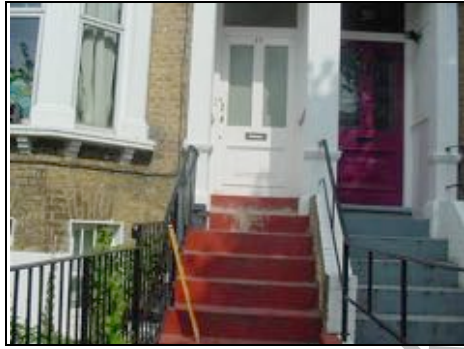
Stairs typical allow dampness in

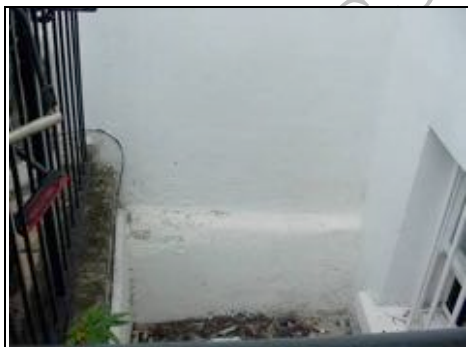
The whole of the property is on a sloping site and as such part of the Garden and Ground floor apartment are below ground (although this does not affect your property) and as such we suspect they are damp, although we have not been in these properties and you in turn may have a shared liability for resolving the dampness.

Flaking paint indicating dampness in lower ground floor flat

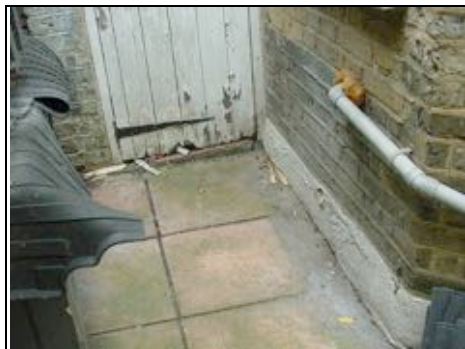
Dampness in lower ground floor flat on rear wall

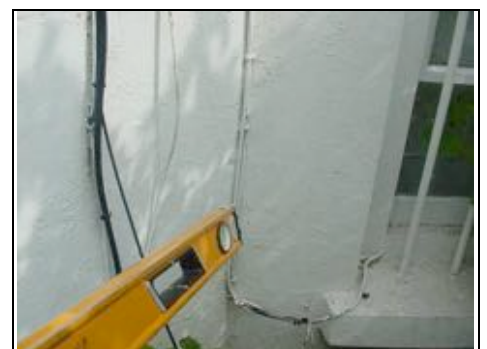
Dampness to ground floor flat at front

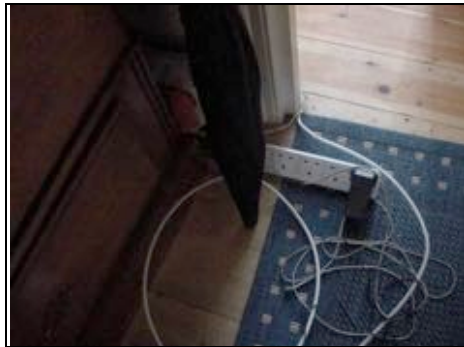
The electrics are dated. In addition some of the socket points are not secured and additional socket points would be beneficial as some are overloaded.

Overloaded electrics – additional socket points required

ACTION REQUIRED: We recommend an Institution of Engineering and Technology (IET) test and report to be carried out by an NICEIC registered and approved electrical contractor or equivalent.

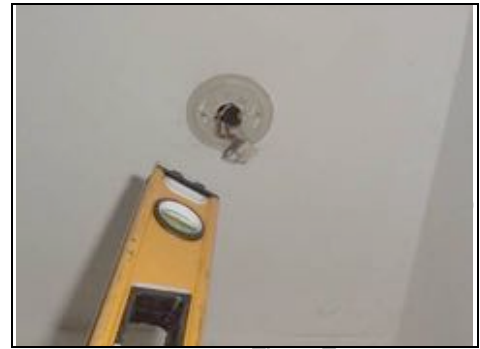
We could see where fire alarms have been installed but have been removed throughout the property. You need to have a hardwired fire alarm system. As the freeholder we would insist on a hardwired fire alarm system running throughout the whole property.

Smoke alarm removed

ACTION REQUIRED: We would recommend an integral fire alarm system running throughout the whole of the property which would indicate where the fire was coming from. This would be the best way for anyone to make an informed decision as to how best to escape in the worst case scenario of a fire.

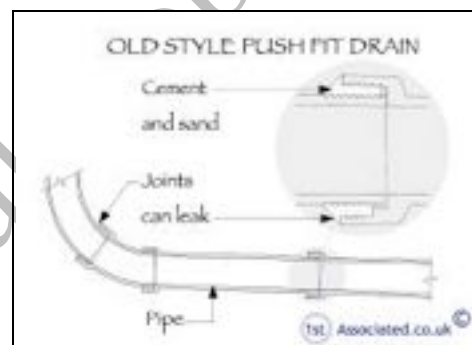
In this particular property we haven't been able to find any manholes to inspect. In older properties, such as this, drainage was often push fitted together rather than bonded together which means that they may leak over the years. Whilst we ran the tap for 15 minutes without any build up or blockages the only way to be 100% certain of the condition of the drains is to have a closed circuit TV camera report.

Push fit drain

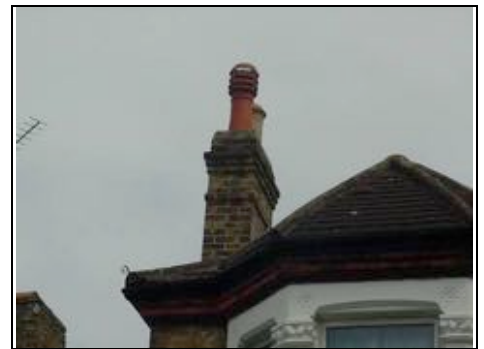
Front left chimney

This chimney is brick finished with various different types of flashing including a repair and two chimney pots. From what we could see from ground level it looked in slightly below average condition considering its age, type and style with a flashband repair. In our experience, these never last particularly long.

ACTION REQUIRED: Replace all flashing with lead flashing

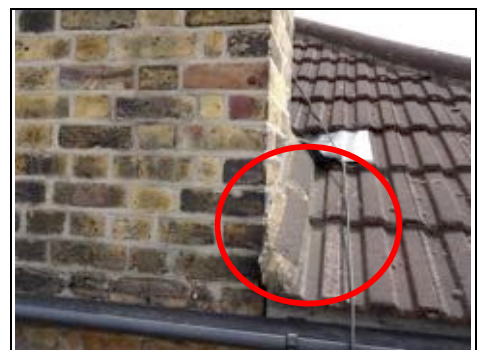
Tile on edge
~ Aerial View - 360 Photo ~

ACTION REQUIRED: Recommend replacing the tile on edge with a lead flashing.

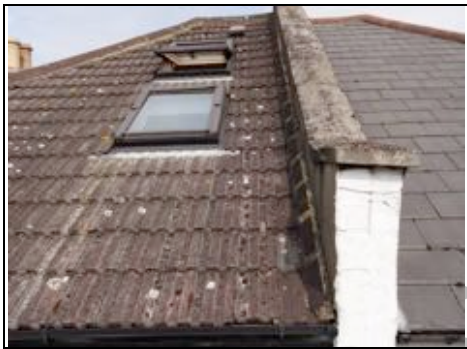
Front right parapet wall
~ Aerial View - 360 Photo ~

In this case there are parapet walls to the front right built from brick with a coping stone. It has a tile on edge which is allowing water in.

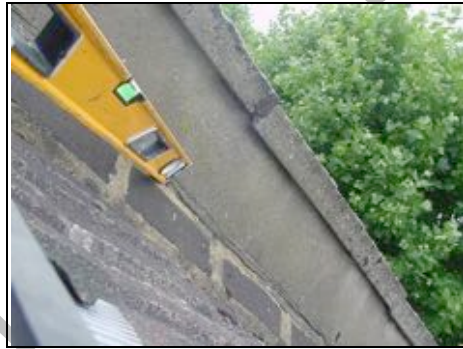
Tile on edge

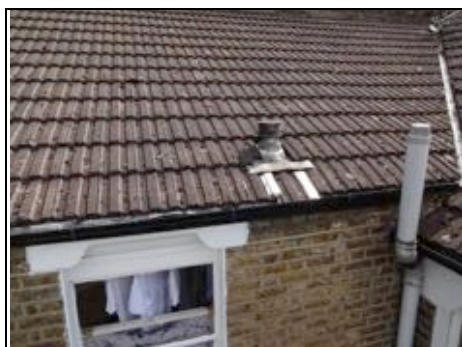
Slipped tile
~ Aerial View - 360 Photo ~

ACTION REQUIRED: Carry out periodic inspections and maintenance of the roof, as required.

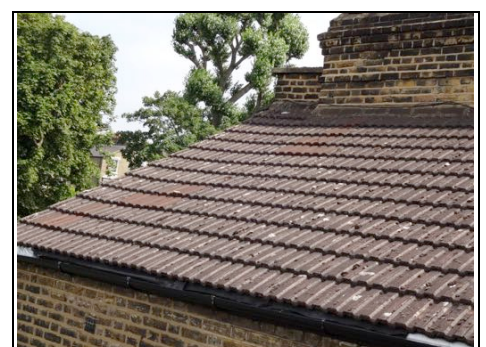
Some tile replacement to rear of
roof
~ Aerial View - 360 Photo ~

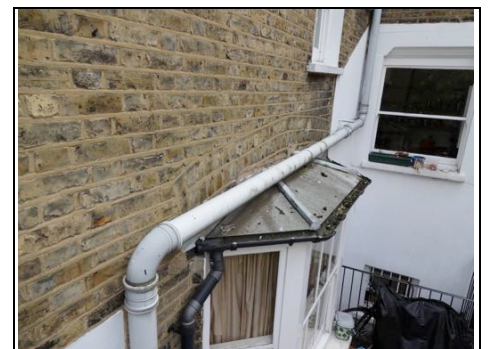
Left bay window
~ Aerial View - 360 Photo ~

There is a metal sheet bay window roof to the left which is starting to deteriorate. This is not part of the subject flat.

We sometime find that rusting can occur in this type of roof which will be part of your freehold responsibilities.

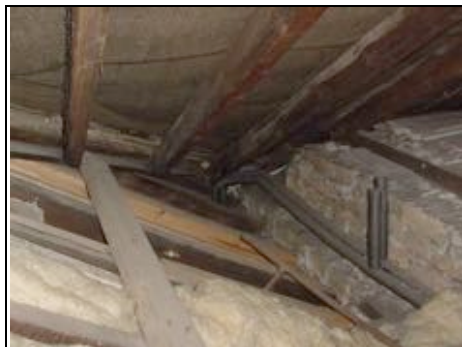
No ventilation was noted. Ventilation is needed as the insulation has made the roof very warm and an ideal environment for woodworm to breed and thrive.

Roof needs venting

ACTION REQUIRED: We would recommend that ventilation is added.

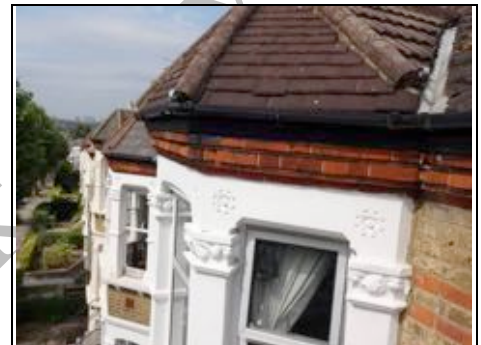
The property would originally have had cast iron gutters and downpipes. We have noticed that the majority of these have been replaced with plastic gutters and downpipes. Where these two materials are mixed there are often problems where they join and also in the falls to the outlets. In this particular case we couldn't see any particular problems other than that the high level gutters need clearing which is a usual problem.

Plastic gutters
~ Aerial View - 360 Photo ~

There may be some minor leaks but most people would be happy to live with these providing repairs are carried out within the next six to twelve months.

ACTION REQUIRED: We would also recommend that the gutters and downpipes are cleaned out, the joints are checked and the alignment checked to ensure that the gutters fall towards the downpipes. In order to clean the gutters at high level you will need long ladders or tower scaffolding.

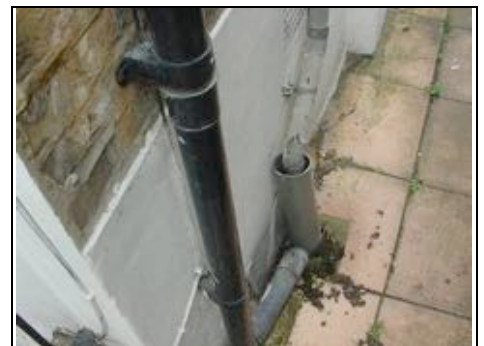
There does seem to be some waste pipes that are going into rainwater drain pipes, which isn't strictly allowed but does often happen in flat conversions such as this.

Waste going into downpipes

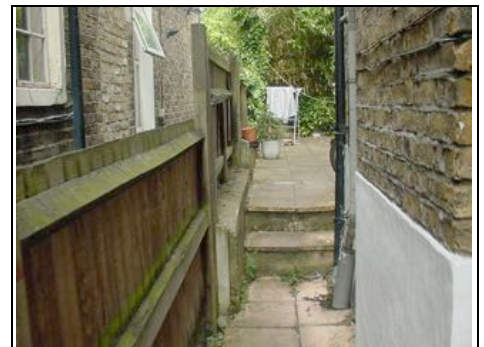
The render is showing signs that dampness is getting in.

Render at low level

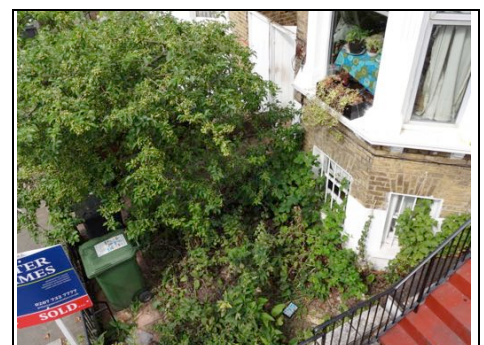
Render at low level below your
property

The render to the front, the side and to the rear of the property at lower level is painted and we can see that it is suffering from dampness in some areas, for example to the left side there is a void.

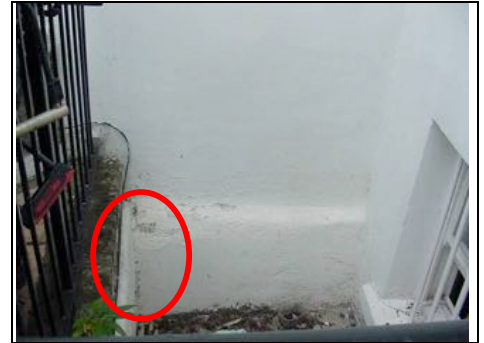
There is some dampness in the lower ground floor. We haven't been in these flats so we cannot comment further but, as the freeholder, we would suggest that you speak to the people in this apartment. We did knock on the door but did not get an answer.

Dampness in lower ground floor

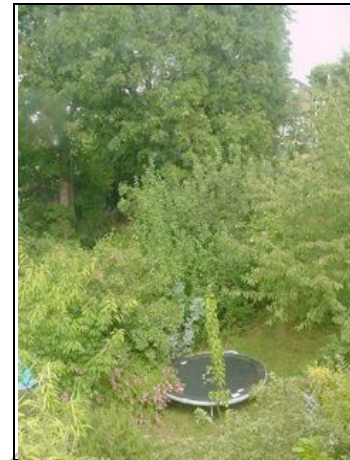
There are trees within what we would term as influencing distance but you do need to speak to your insurance company as they may have a different interpretation for insurance reasons.

Trees

ACTION REQUIRED: We would recommend an arboriculturalist (not a tree surgeon) is asked to view the property and give a ten year plan for maintenance to add to your maintenance plan for the whole property

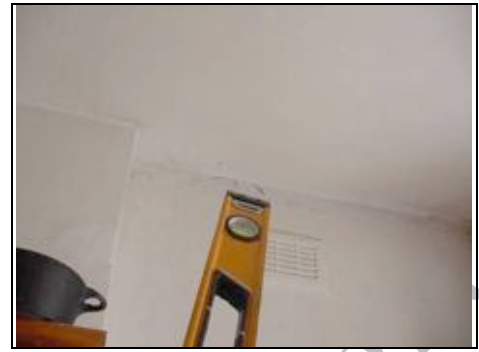
Internal photo of high level air brick

ACTION REQUIRED: Ensure the airbricks are clear.

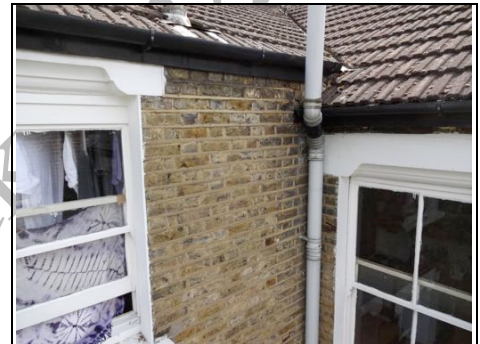
There was an area where the gutters were blocked so damage and deterioration could be poor around this area.

Top floor level fascias and soffits

ACTION REQUIRED: You do need to budget for clearing the gutters out and also some repairs to the fascias are likely.

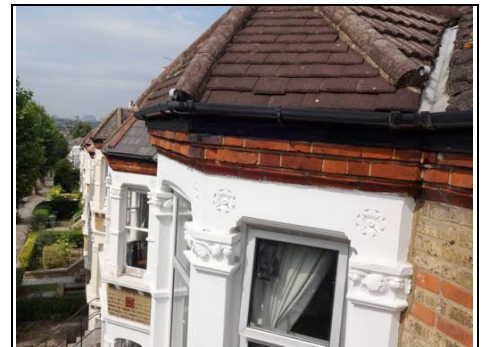
Fascia to the left side to the front around the splayed bay window

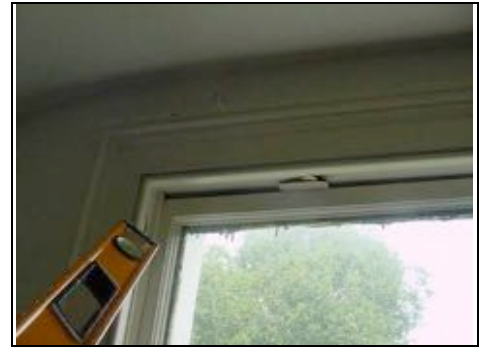
Typical sliding sash window
Rear bedroom top floor

The property has timber single glazed timber sliding sash windows. We would specifically comment that they are in below average condition.

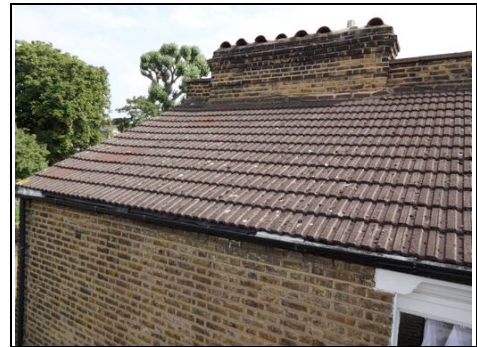
The rear right chimneys have hog back tiles and as such would need fairly major amendments to use.

Rear right chimney closed with the
hog back tiles

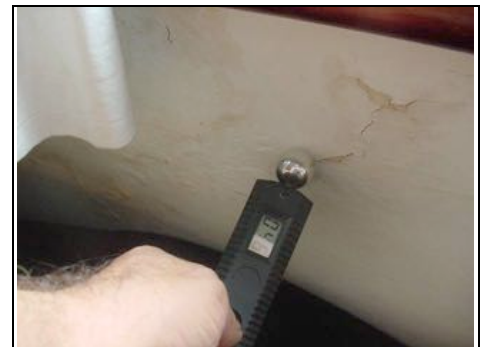
We used a resistance meter on the external walls. We have found significant dampness.

Dampness under the bay window

ACTION REQUIRED: Please see our comments in the Executive Summary.

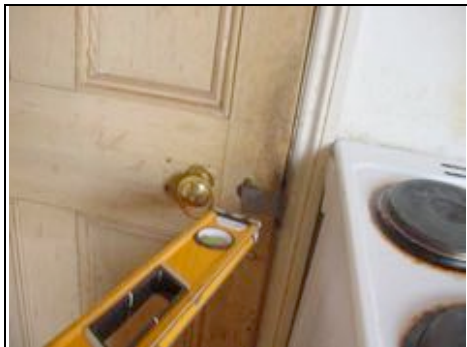
The doors are panel doors which are damaged and worn. We would term them as generally saveable and we noted that some of the doors have new locks. We would expect you would be able to bring these doors back to a reasonable standard.

Damage and wear to doors

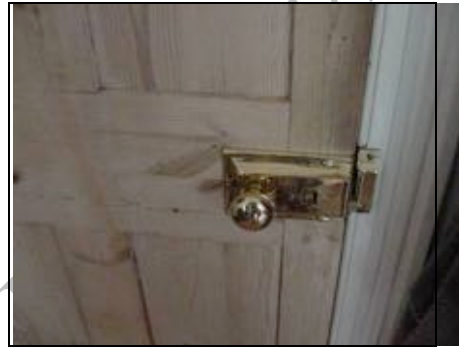
Doors have new locks

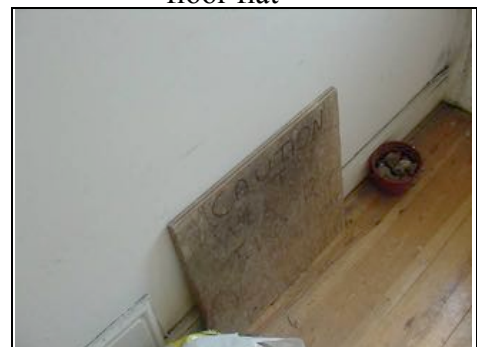
An external staircase is renowned for leaking and this looks to be leaking into the ground floor flat. We can also see some repair work has also been carried to the top step, fairly recently, there was even a sign still in the hallway.

Sign indicating recent work to the external steps

ACTION REQUIRED: Please see our comments in the Executive Summary.

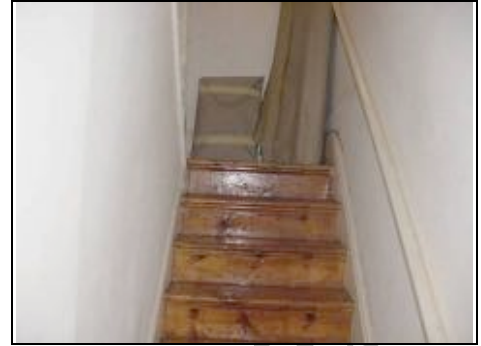
Where we could see the staircases they were lined, however were we were unable to examine the underside of the stair timbers due to it being within the other flat which precluded our inspection, we cannot comment further upon the stair structure.

Internal staircase to top floor

ACTION REQUIRED: You need to meet your neighbours and check to see that the staircases are lined within this area as this would be the only means of escape, given the worst case scenario of a fire.

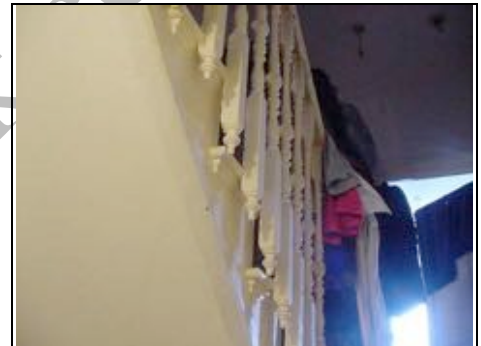
Balustrade quite detailed

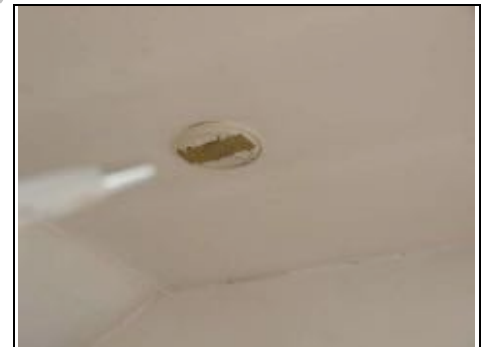
Smoke alarm system removed

We would recommend, for your own safety, that smoke detectors be installed. We would always recommend a hard wired fire alarm system and are also aware that some now work from a wireless signal which may be worth investigating. Whilst fire is relatively rare it is in a worst case scenario obviously devastating.

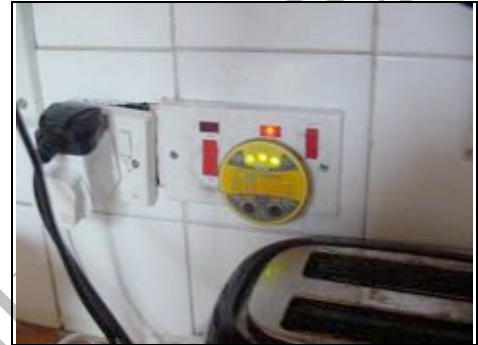
We carried out an earth test in the kitchen area to the socket point that is normally used for the kettle, this proved satisfactory.

Earth test

ACTION REQUIRED: As the property is changing ownership an Institution of Engineering and Technology (IET) test and report and any recommendations should be carried out by a NICEIC registered, or equivalent, approved electrical contractor or similarly approved.

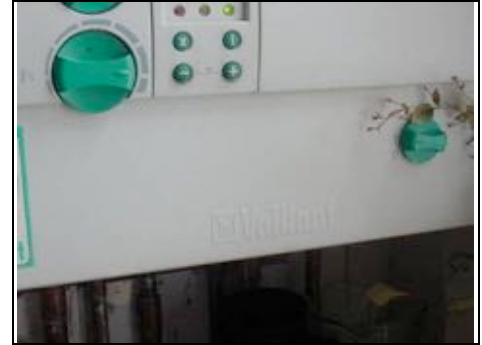
Our limited inspection of the hot water and central heating system revealed no evidence to suggest any serious defects but we would nevertheless recommend that the system be tested and overhauled before exchange of contracts and that a regular maintenance contract be placed with an approved heating engineer.

Boiler

ACTION REQUIRED: We recommend you return to the property with the estate agent to turn the heating on to ensure it is working.

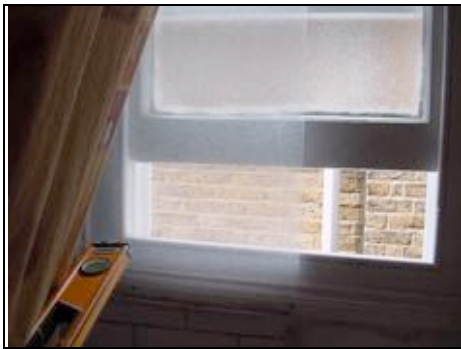
Plastic sheet over window in bathroom

ACTION REQUIRED: Please see our comments in the Executive Summary with regards to bathroom.

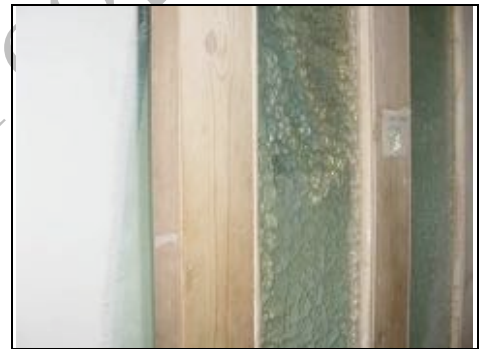
Glass door unusual in bathroom

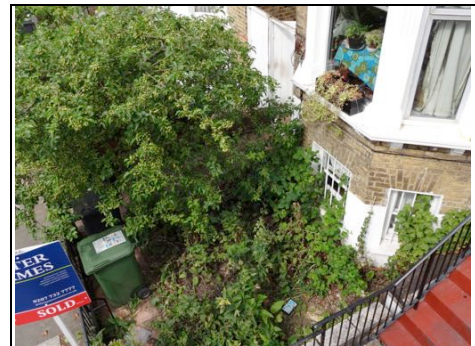
The front garden is very overgrown.

Front Garden

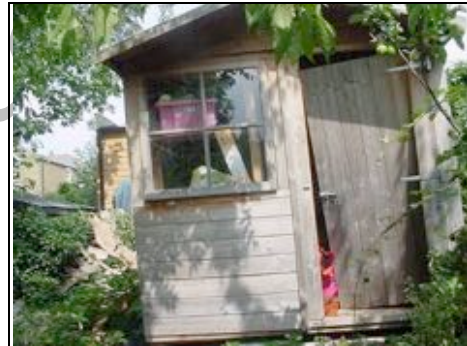
Dilapidated shed

ACTION REQUIRED: Your legal Advisor needs to check and confirm.

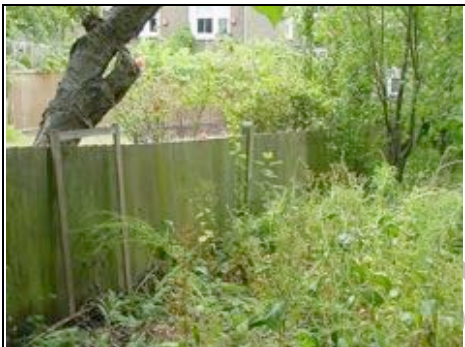
The fences are in poor condition and in need of repair.

Timber fence on rear right

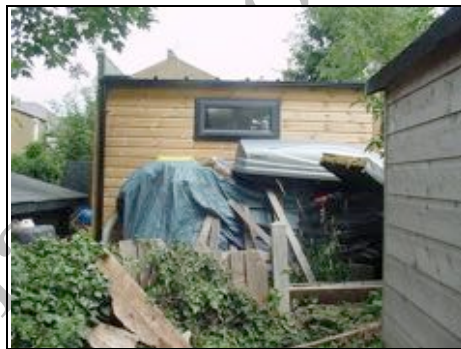
Rear boundary fence that needs repair
