# RESIDENTIAL BUILDING SURVEY

XXXXXXXXXXXXXX,  
Palmers Green,  
London,  
N13 xxx

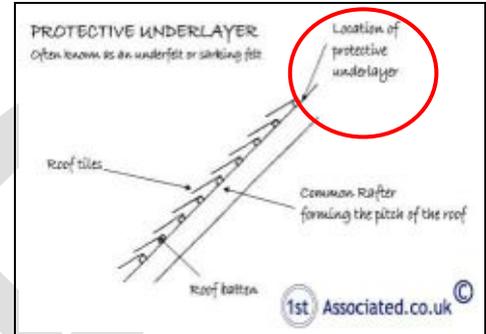
The roof is likely to be the original roof and does not have a protective underlayer. From within the roof space we can literally see light coming through from outside and clothes/rags have been used to block the gaps over the years to prevent water getting into the roof.

Protective underlayer

**ACTION REQUIRED:** Ultimately the property needs re-roofing but in the short term you may be able to limit the damage caused by adding a board with insulation beneath.

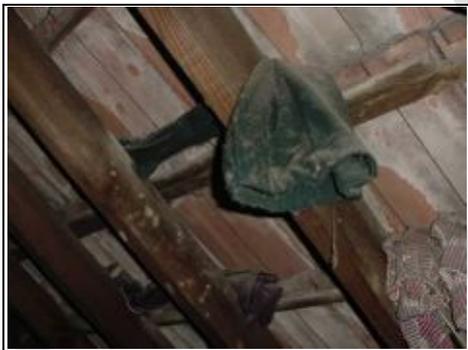
Rags filling gaps in roof

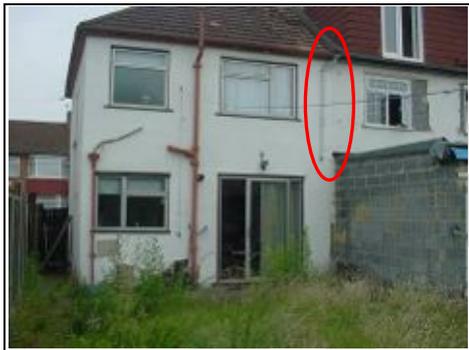
The property has predominantly cast iron gutters and downpipes. The gutters, in particular, need repair and redecoration.

Downpipe discharging down the wall to the rear causing dampness

**ACTION REQUIRED:** Repair and redecorate the cast iron.

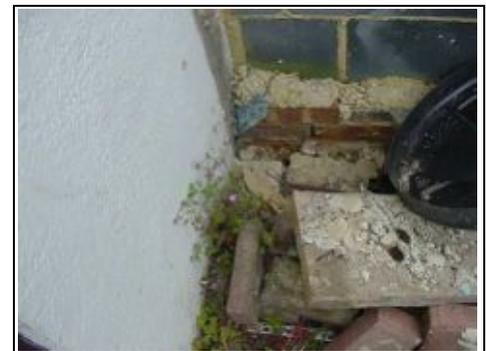
Where is the drain for the rainwater pipe to the rear?

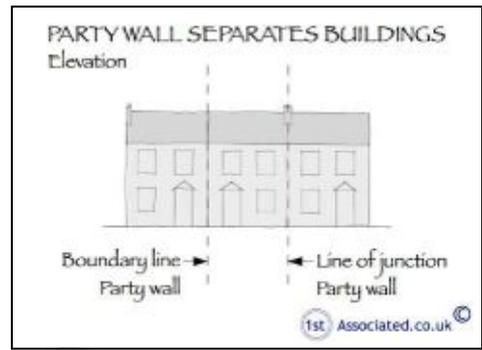
Party wall

There are various things that have been carried out on the adjoining property that we believe needed Party Wall Act agreement, (the work is nearly complete) for example the extension to the rear.

**ACTION REQUIRED:** You need to take legal advice as to what the future consequences are of next door carrying out work without a Party Wall agreement.

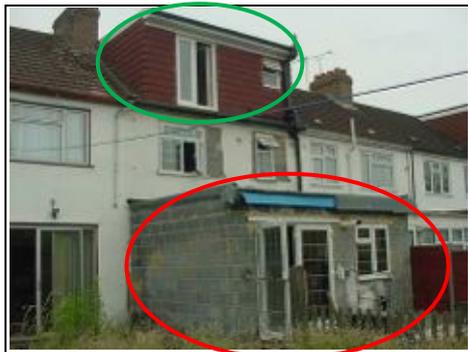
Neighbours rear extensions are on the party wall

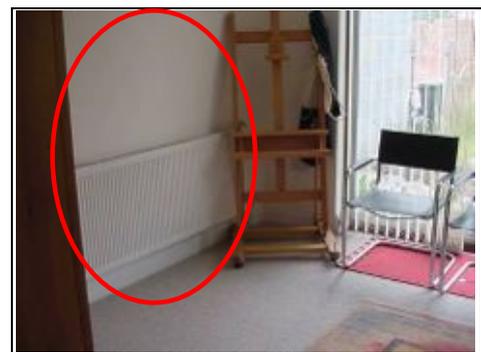
The chimney breasts have been removed at ground floor level and to the rear at first floor level. This may or may not have support we simply cannot see the brackets (often gallows brackets are hidden by the ceiling and the floor).

Chimney breast removed

When we viewed next doors property the neighbour advised that they have not carried out any work to the chimneys and that the chimney breasts had been removed to both the ground and first floor before they moved in (if we understood them correctly as it was a very brief conservation). This means that there is a large amount of weight from the chimney, which is currently unsupported as far as we could see.

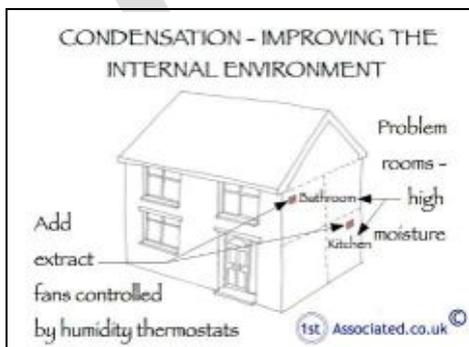
The property has older style aluminium double glazed windows in a timber frame. These were common in the 1970's and condensation can occur on them due to the coldness of the metal.

Condensation

**ACTION REQUIRED:** We would suggest that, to help prevent condensation, you add large humidity controlled extracts to areas of high humidity such as the bathroom, kitchen and areas where clothes are dried. You will also need to repair and redecorate the timber frames and sills

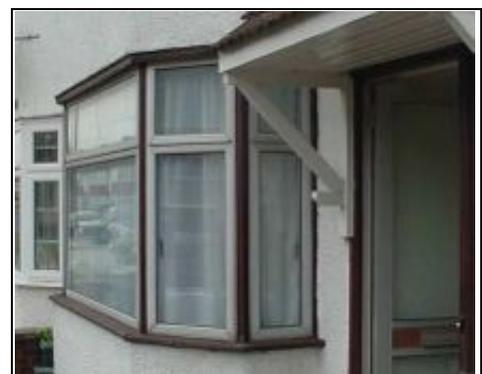
Aluminium windows

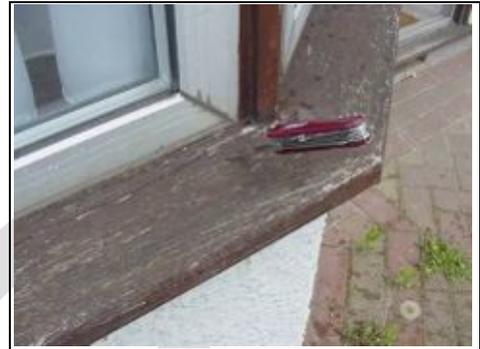
Also the timber frames and sills are in poor condition and need redecoration.

Knife test

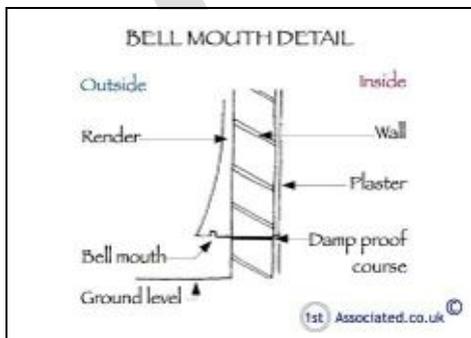
We were getting slightly higher readings than expected internally. This may be due to the render not having a bell mouth and also to the ground level being slightly high because of the brick pavers.

Bell mouth detail

**ACTION REQUIRED:** Ideally add a bell mouth detail to the property and lower the brick pavers.

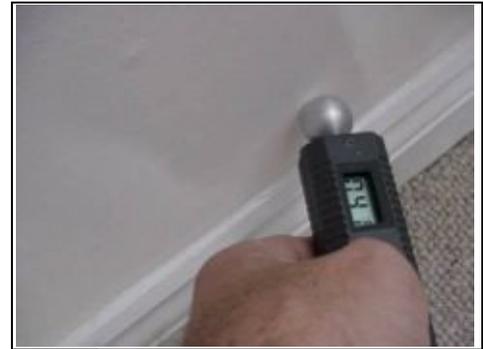
Checking for dampness

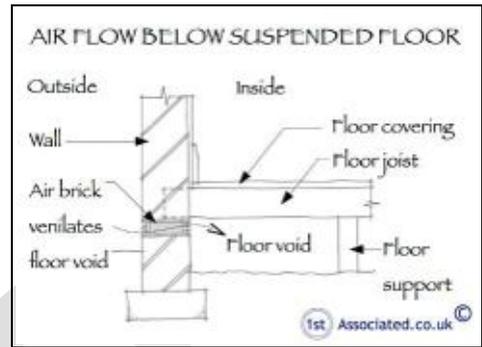
The property has a suspended timber floor which requires air flow underneath via air bricks to prevent wet rot, dry rot and woodworm.

Suspended timber floor

**ACTION REQUIRED:** We would suggest that you stand outside next time it rains heavily to see if water does flow towards these areas. When the opportunity arises you should open up the floor to check the condition of it.

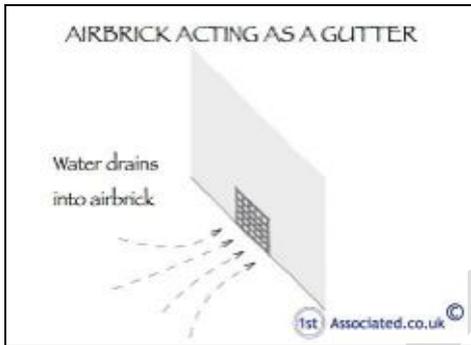
The airbricks to the rear of the property, due to the adding of brick pavers, can act as gutters. This area needs protecting from rainwater in one way or another.

Air brick acting as gutter

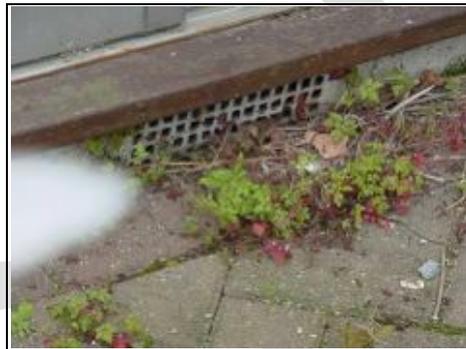
Air brick may be acting as a gutter

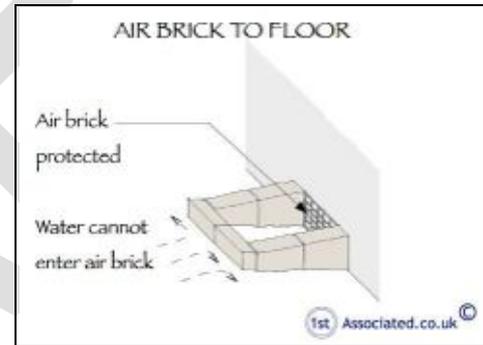
Protected air brick

**ANTICIPATED COST:** The best case scenario is a few hundred pounds to protect the airbricks. The worst case scenario would be to have to replace floor timbers. From walking on them it did not feel like this would be the case but obviously this is not the same as opening up the structure; please obtain quotations.

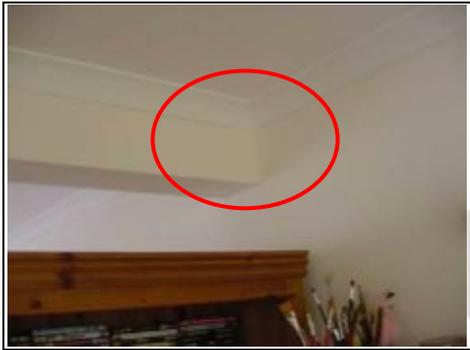
The ground floor wall has been removed to combine the front and the rear lounge. We can see on the left hand wall that the lintel is taking support from the party wall rather than being supported on a pier and this would not commonly be best practice or meet current Building Regulations. A pier can be seen on the right hand wall and is the size that we would expect, 450mm plus.

Wall removed without a pier support

**ACTION REQUIRED:** Please see our comments with the regards to the Party Walls as this is another factor to be considered.

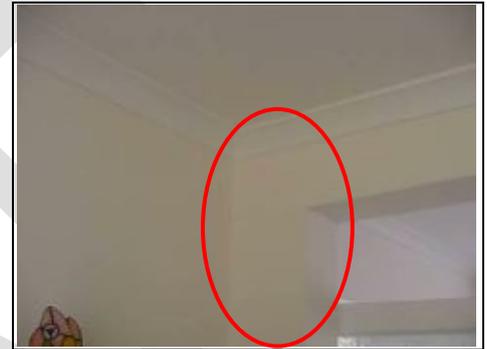
Wall removed with pier support

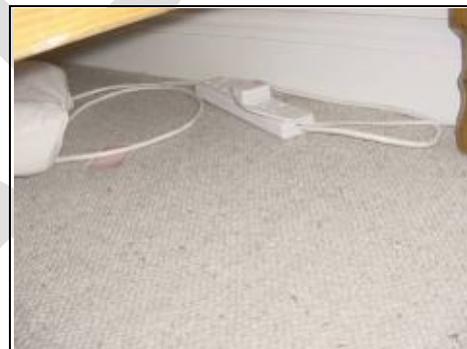
You may require extra socket points

**ACTION REQUIRED:** We suggest that this is replaced and that you may also require additional socket points adding.

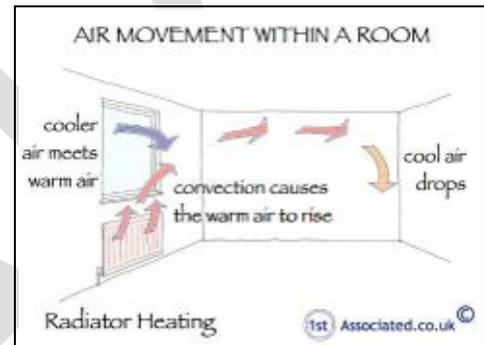
We noted internal radiators, which do not allow the flow of air around the property.

Air movement within a room

**ACTION REQUIRED:** We would recommend moving internal radiators to underneath windows if possible or replacing.

**ANTICIPATED COST:** A few hundred pounds per radiator; please obtain quotations.

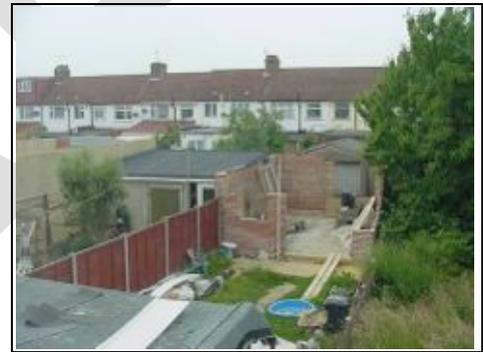
As we discussed the surrounding properties are extending to the rear in the garden area. For example the left hand neighbour is making the garage much larger. We spoke to the owners friend who advised it was being built for storage but did not advise of what.

Left hand neighbour's  
garage/storeroom

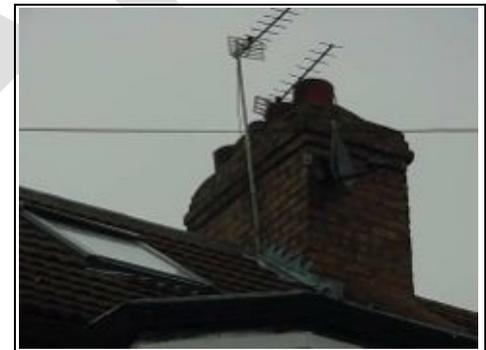
This chimney is brick built finished with a lead flashing. There are no chimney pots to your side of the chimney but several chimney pots to the neighbour's side of the chimney which leads us to believe that your chimney may have been capped.

Chimney

From what we could see from ground level it looked to be in average condition considering its age, type and style. However looks can be deceiving and as you are aware much of this chimney has been removed.

**ACTION REQUIRED:** Please see our comments within the Executive Summary.

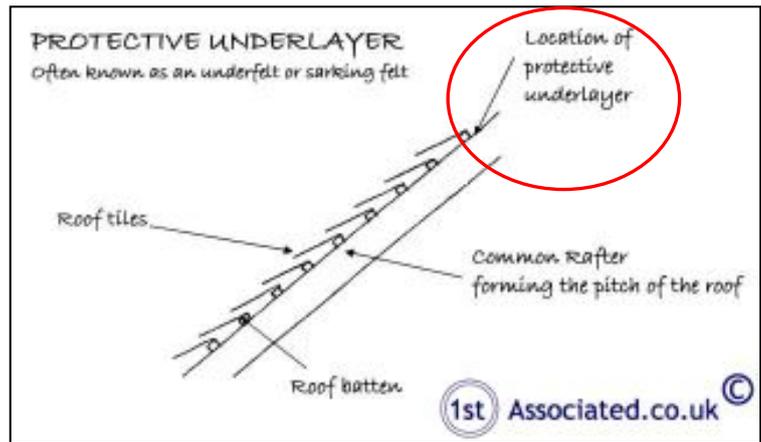
Protective underlayer

The tiles are nibbed tiles with no protective under layer. This means that wind driven rain can get underneath the tiles and indeed we can see that this is happening from the staining within the roof. We are always in a Catch- 22 with regard to this type of roof as although it is letting in some rain water it is not letting in that much. We have therefore taken guidance from the adjoining/nearby roofs which show approximately twenty per cent have been replaced and that there have also been a number of loft conversions.

**ACTION REQUIRED:** We mentioned to you earlier that we would recommend in the short term that you board out the roof space with insulated roof board. However, this may not be sufficient in this case as we you will have to carry out work to the roof as well and so we recommend that you budget to have this roof replaced.

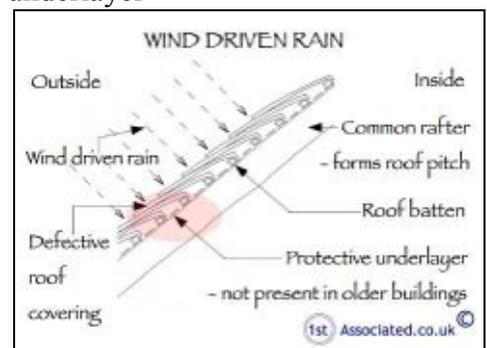
This photo shows the common rafters (the ones that form the pitch of the roof). Dampness can be seen coming through due to the lack of protective underlayer

Wind driven rain

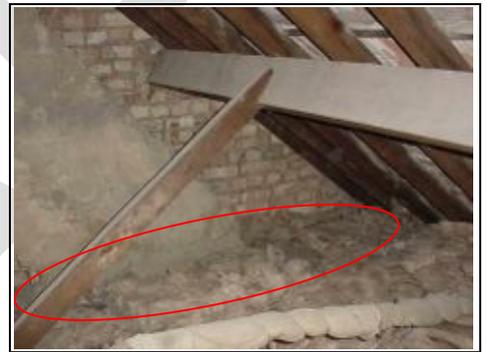
No support visible to the base of the chimney

**ACTION REQUIRED:** The only way to be 100 per cent certain is to have the roof cleared and checked.

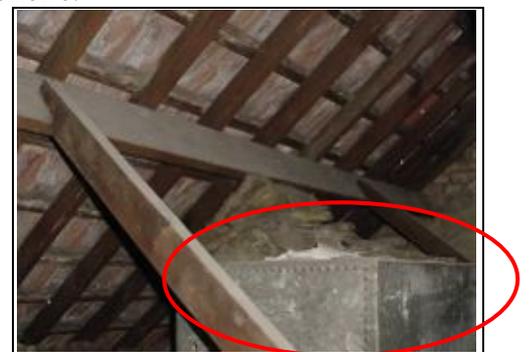
We noted a disused cast iron water tank within the roof space.

Water tank

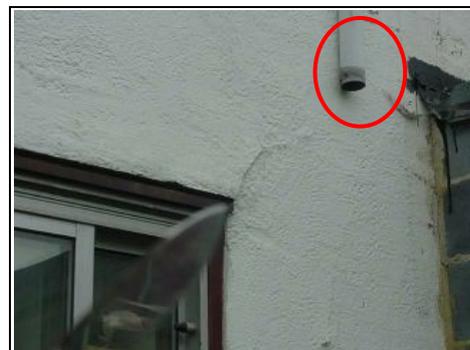
Down pipe with nowhere to discharge into

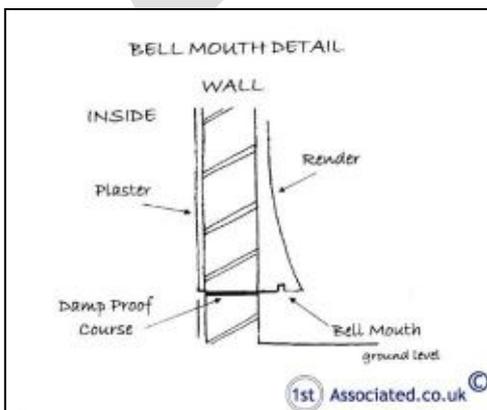
To the base of the render there was no bell mouth detail.

**ACTION REQUIRED:** Please see our comments within the Executive Summary regarding adding a bell mouth to the base of the render.

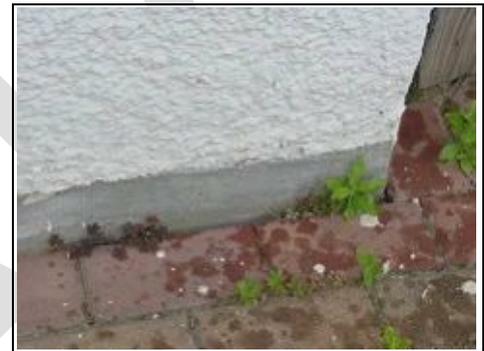
All modern properties should incorporate a damp proof course (DPC) and good building practice dictates that a differential of 150mm (6 inches) should be maintained between the damp proof course and ground levels. In this case, we cannot see a DPC because of the render.

No DPC visible

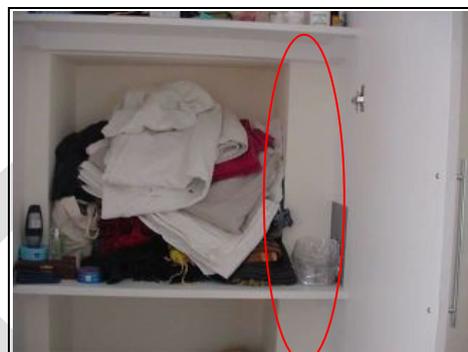
We note that chimney breasts have been removed at ground floor level and to the rear at first floor (all directions given as you face the front of the property). Please see our comments with in the Executive Summary.

Chimney breast in front left bedroom remains

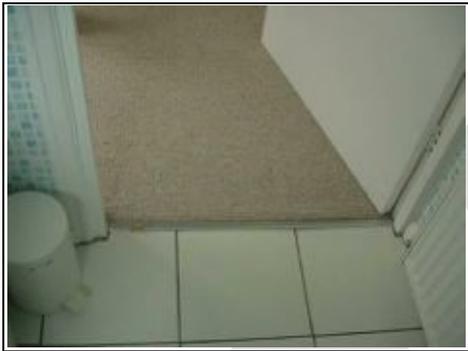
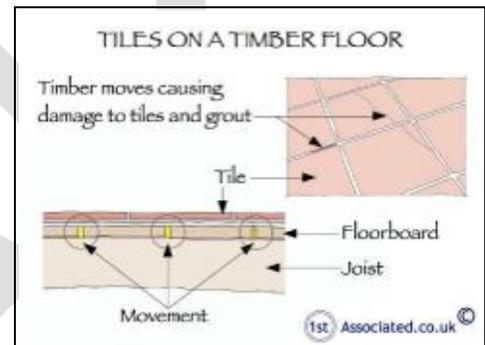
There are tiles onto a wooden floor in the bathroom. With a wooden floor you will always get some movement/deflection, however minor. This movement/deflection in the floor will ultimately mean that the tiles will need re-grouting.

Tiles in the bathroom

Tiles on timber floor

**ACTION REQUIRED:** Most people live with this type of floor when it has already been carried out. You just need to be aware that you may have to re-grout every now and then.

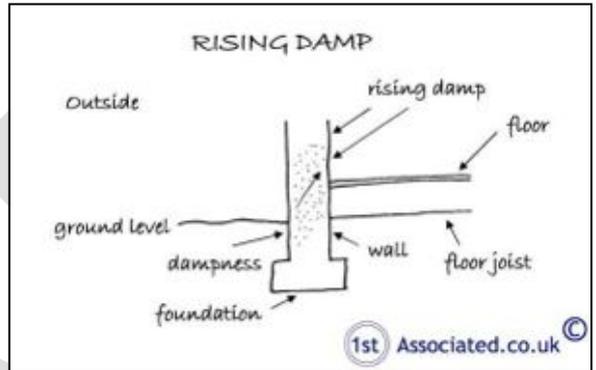
Rising damp

A visual inspection and tests with a moisture meter have been taken to the perimeter walls. In this particular case we have found a small amount of rising damp that we believe relates to the render.

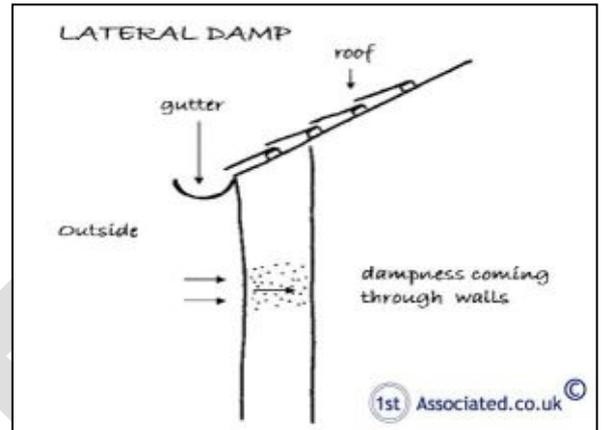
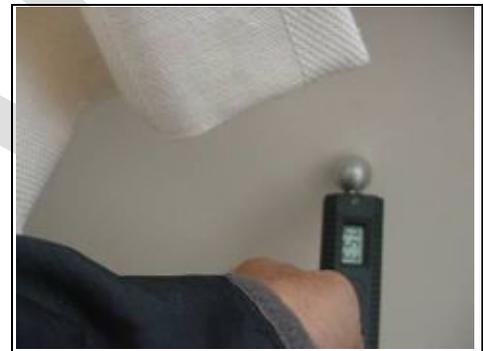
We used a damp meter on the external walls. We found it to be slightly higher than we would expect for this age, type and style of property.

Lateral dampness

Testing for lateral dampness

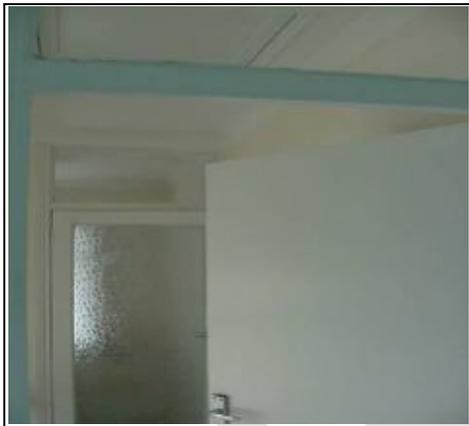
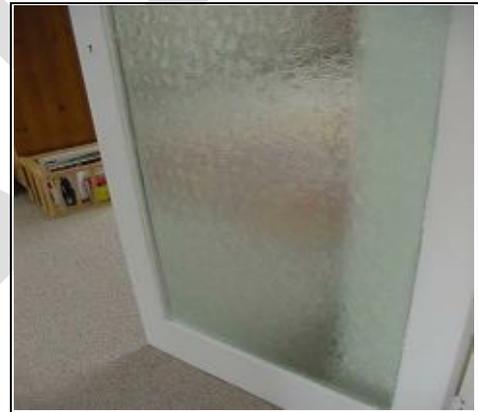
The doors are predominantly glazed doors. We could not see the British Standard Kite mark on the glass in the doors which is not unusual in this age of property but it does mean it is not safety glass.

Doors

Glazed door

**ACTION REQUIRED:** We would recommend that the glass is replaced with safety glass. Sometimes it can be more economical to replace the doors.

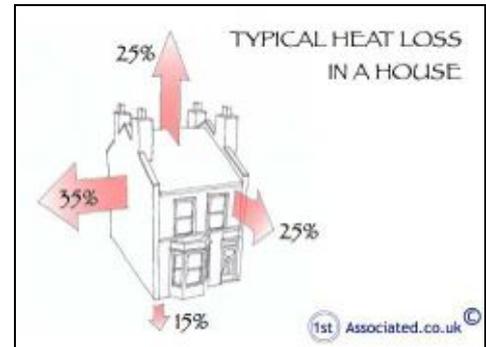
Some roof insulation was present although not to current Building Regulations requirements of 300mm. In this instance we could see approximately 100mm to 200mm.

Typical heat loss

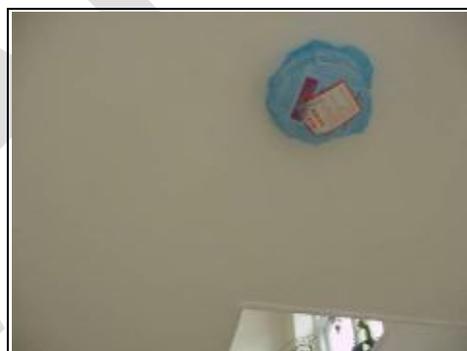
Some smoke detectors were noted. The current Building Regulations require that they be wired into the main power supply. Obviously in a property of this age this is difficult, as it would mean having surface mounted wires or cutting wiring into the plaster.

Smoke alarm

**ACTION REQUIRED:** We would always recommend a hard wired fire alarm system and are also aware that some now work from a wireless signal which may be worth investigating. Whilst fire is relatively rare it is in a worst case scenario obviously devastating.

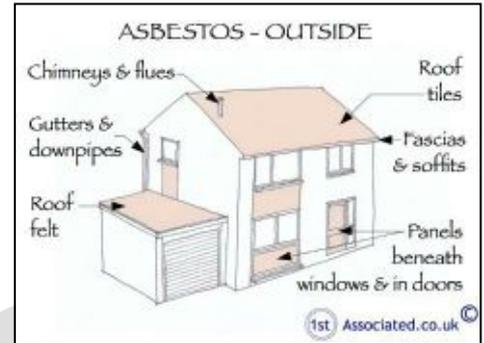
We are Building Surveyors and not Asbestos Surveyors and as such the only way to be a hundred per cent certain with regards to Asbestos in a property is to have an Asbestos report carried out.

Asbestos externally

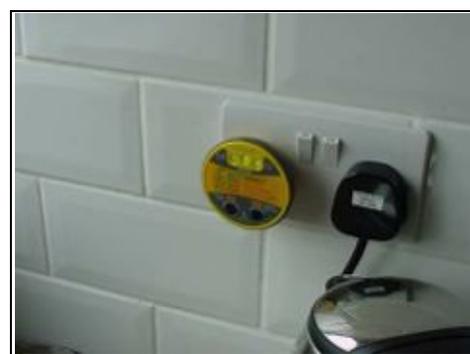
We carried out an earth test in the kitchen area to the socket point that is normally used for the kettle, this proved satisfactory.

Earth Test

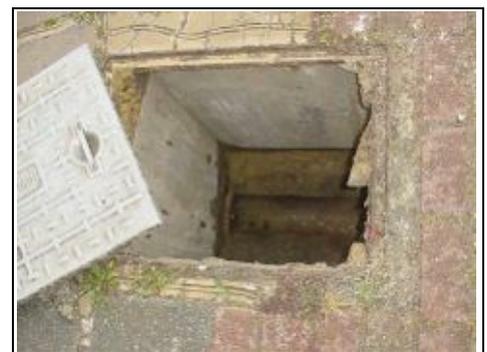
Manhole one (front right)

We duly lifted the cover and found it to be dry at the time of our inspection which we were surprised at. This manhole may be for rainwater but this would be unusual as they are usually combined drains.

From what we could see it is concrete built.

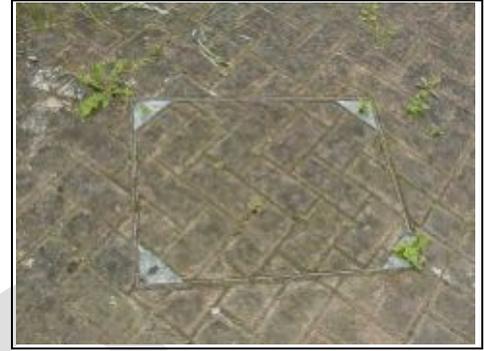
Manhole two (rear)

We were unable to lift the cover of this manhole.

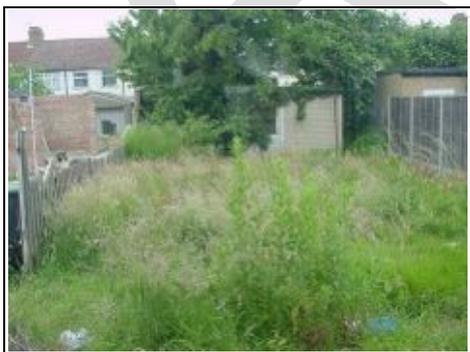
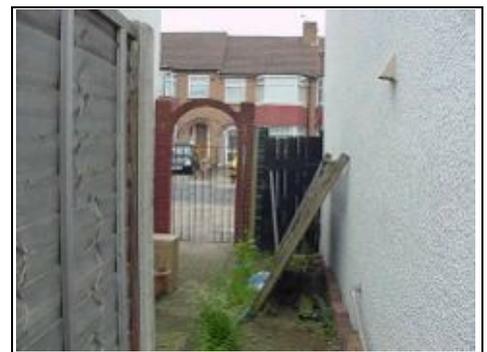
The garden to the rear is very overgrown. There is access to the rear garden via a gate to the right hand side of the property. The garden fence has fallen down in this area and there is a low fence to the left hand side.

Fence has fallen down to right hand side
