RESIDENTIAL BUILDING SURVEY

Earlsfield,
London,
SW18 xxx

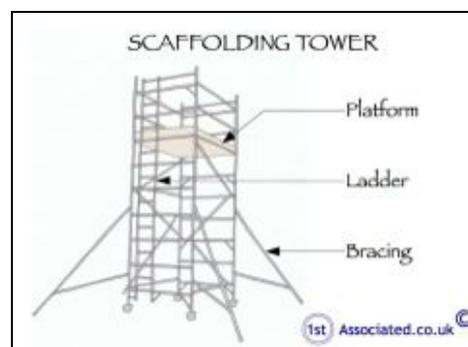
Tower scaffold

ACTION REQUIRED: We would anticipate repairs to the left hand parapet wall.

ANTICIPATED COST: To repair the left hand parapet wall in the region of £3,000 to £5,000 dependent upon access scaffolding required. It may be able to be carried out via a tower scaffold access. You need to allow for a worst case scenario.

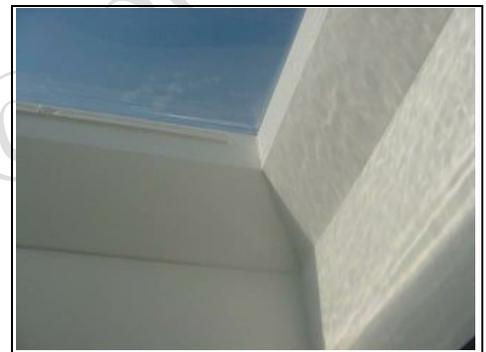
Roof window

ACTION REQUIRED: We are happy to return, if the roof windows can be removed, to view the roof. Or alternatively if this is not possible we would recommend that amendments are made to the roof window, preferably before you commit to purchase the property, so that the roof can be inspected.

ANTICIPATED COST: In the region of £200 to £300 for alterations to make the roof accessible, in our experience the roof window usually has to be replaced. Alternatively if the roof has an insurance backed guarantee this can be forwarded to us along with the specification of the work and we can comment on this; please obtain quotations.

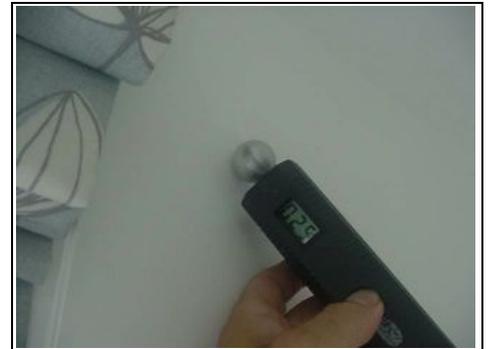
Checking that the flat roof is not leaking allowing dampness in

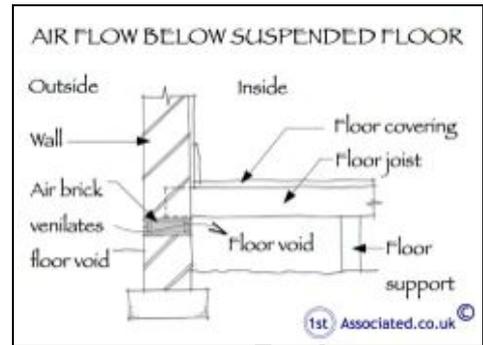
Air flow

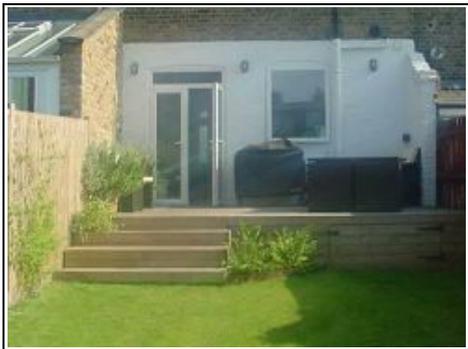
We can see air bricks to the front of the property that allow ventilation under the floor. We cannot see them to the rear of the property, due to them being covered/hidden by the decking but we would anticipate that they are there. The problem with not having a through flow of air is that rot can occur to the timber floor.

Decking to the rear, we believe, is covering the air bricks

ACTION REQUIRED: You will need to make sure that the air bricks are clear and that there is a through flow of air adding extra air bricks if required. Ideally an area of the flooring should be opened up so that the condition of the floor can be checked.

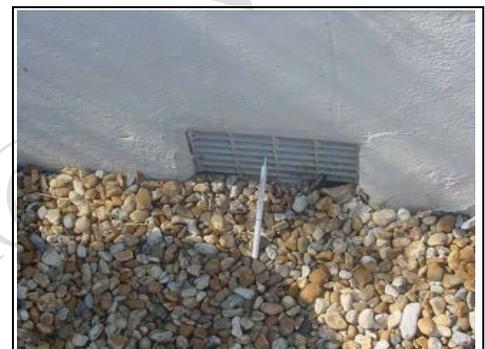
Air brick (front) allow ventilation under floor

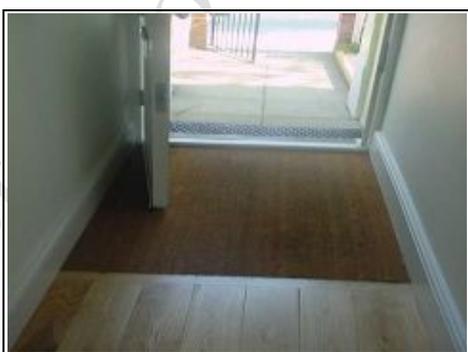
Usually we would be able to assess the condition of the floor by checking the floor boards but unfortunately in this instance there is a laminated floor over it and we have been unable to view it. Laminate floors do not allow the timber floor below it to breathe in the normal way.

Laminate flooring

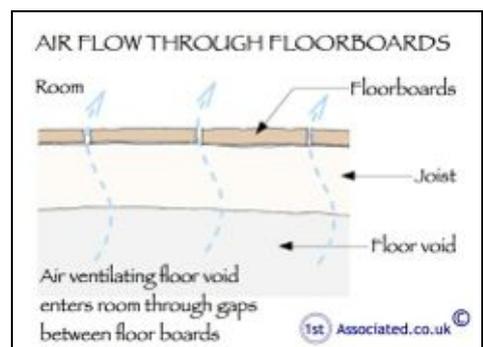
Laminate does not allow the floor to breathe

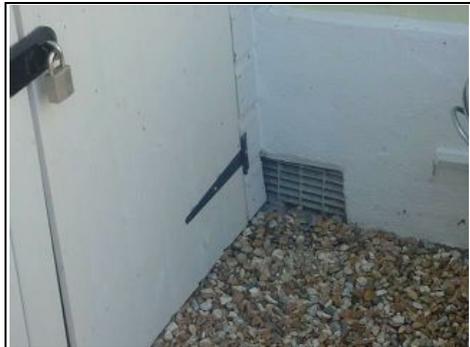
Our other concern is that the air bricks are too low and could be acting as gutters.

Air brick could be acting as a gutter allowing water in

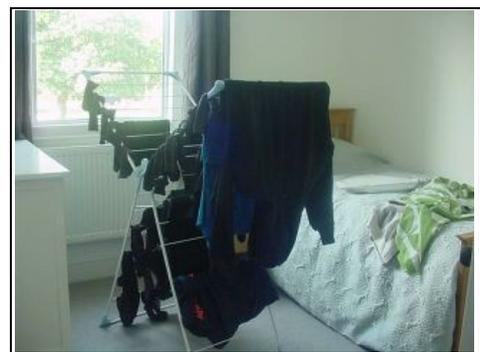
We can see that increased insulation has been added but there are no extract fans in the humidity creating areas of the kitchen, bathroom, shower room and any areas used for drying clothes.

Clothes drying in rear bedroom

ACTION REQUIRED: Add large humidity controlled extract fans to the kitchen, bathroom and any room used for drying clothes (rear right hand bedroom at the time of the survey). We would increase the size of the extract fan in the shower room which we think will be prone to condensation due to its design. Also ensure the roof windows are easy to open which these did not appear to be.

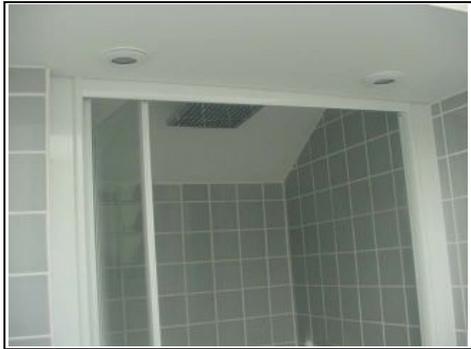
We are particularly concerned with regards to the shower room where we think condensation is very likely to occur due to the low head height in the area and the lack of air flow.

Low ceiling height

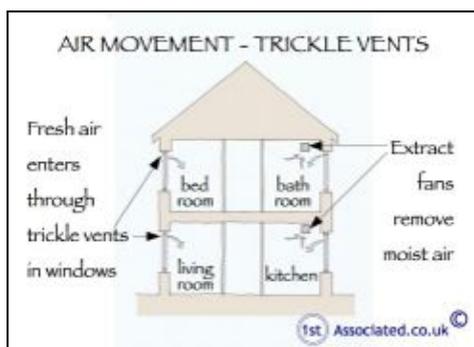
Further to the issue, with regards to air movement and the lack of ventilation that can cause condensation, we would draw to your attention the plastic double glazing to the property. This is from the cheaper end of the market and does not have trickle vents which will make the condensation situation worse.

Trickle vents help with air movement in a property

ACTION REQUIRED: Add trickle vents to the windows if possible.

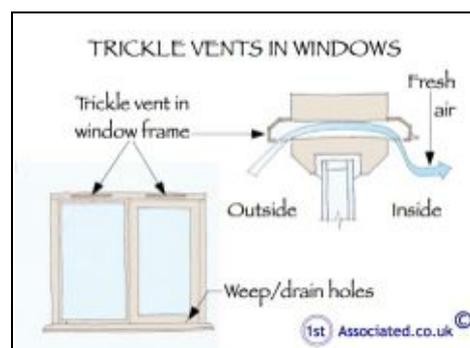
Trickle vents

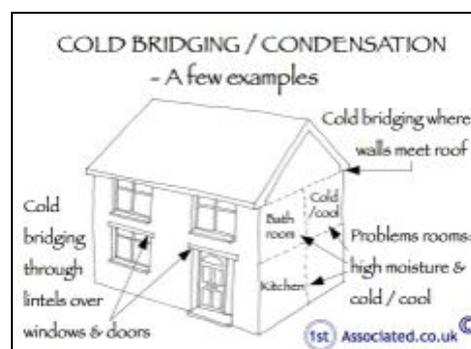
Another element to properties of this era is known as cold bridging. This is where condensation forms on colder elements within the property.

Cold bridging

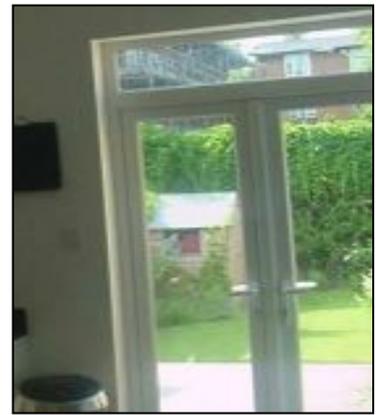
We would prefer to see additional security such a passive infrared lighting/alarm system as with French Doors like this it is possible to force them open.

French doors

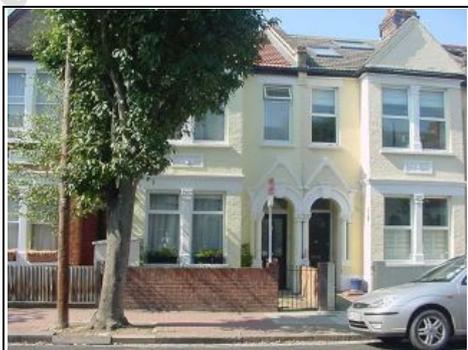
There is always a risk that trees can affect properties built on London clay soil, although, in our experience, older properties have a better chance of accommodating any problems.

Large tree close to the property

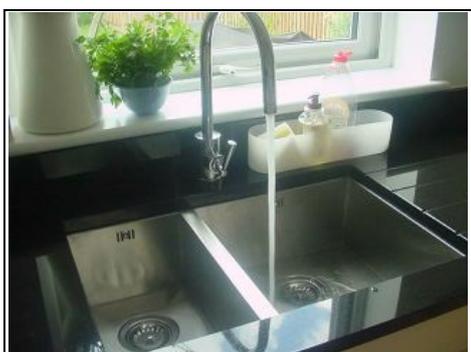
We did not locate a manhole during the course of our survey, however, this is likely to be under the decking to the rear.

Running the tap checking for back up as no man hole found

ACTION REQUIRED: Although the water drained away when we ran the taps it may be beneficial to have a closed circuit TV camera report carried out to establish the condition of the drains. Of course the owners need to be asked if there is a manhole and if so where it is.

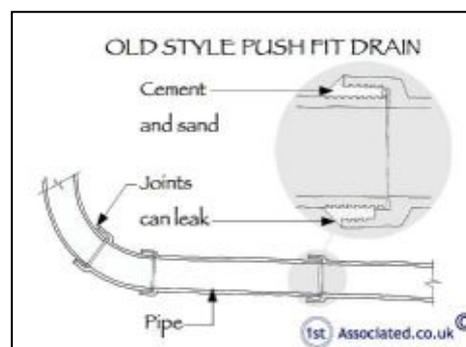
In older properties, such as this, drainage was often push fitted together rather than bonded

Push fit drain

together which means that they may leak over the years. Whilst we ran the tap for 15 minutes without any build up or blockages the only way to be 100% certain of the condition of the drains is to have a closed circuit TV camera report.

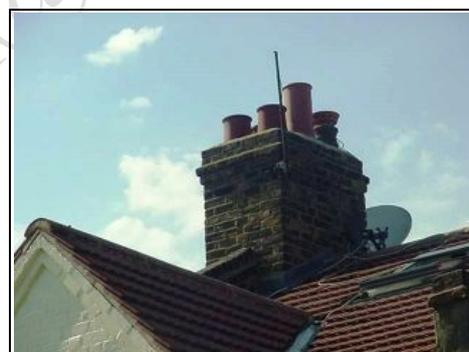
This chimney is brick, finished with a lead flashing and several chimney pots, we counted six. From what we could see from ground level it looked in average condition considering its age, type and style.

Chimney (left)

Unfortunately we were unable to see the top of the chimney known as the flaunching, we therefore cannot comment upon them.

ACTION REQUIRED: When high level work is carried out to the parapet walls then the chimneys should be checked.

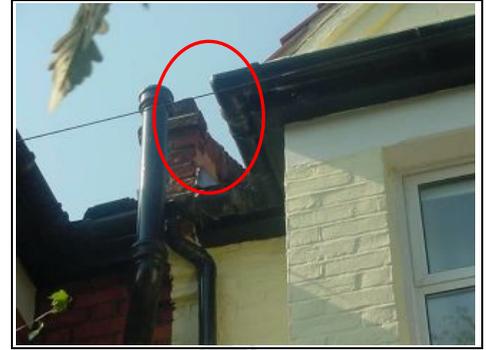
There certainly looks to have been problems with the parapet walls which is why we assume that work has been carried out to the right hand parapet wall. However, work does not appear to have been carried out to the left hand parapet wall which we believe is allowing dampness into the property.

Left parapet wall. We believe this is allowing dampness into the property

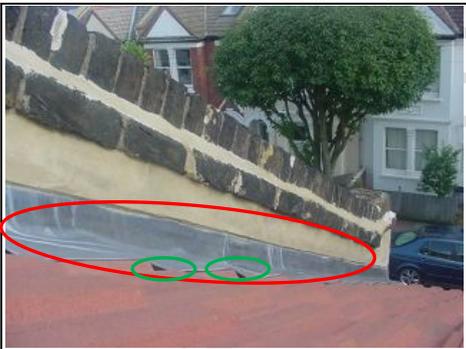
Right Parapet wall

We can see a lead flashing although it has not been bedded down properly, the green circles show the gaps. These can allow wind driven rain in

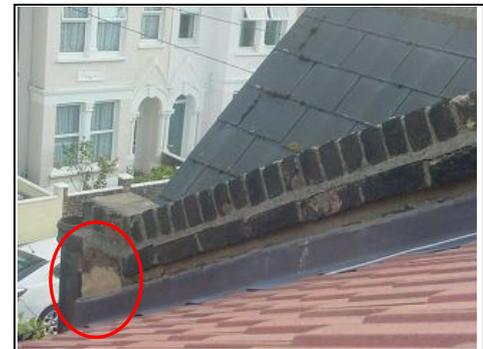
Repairs to parapet wall

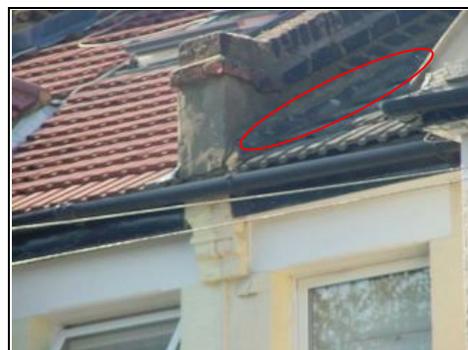
The neighbours side of the parapet wall looks to have a tile on edge flashing. This will eventually leak which could eventually lead to dampness entering your property as well.

Neighbours side of parapet wall has tile on edge flashing

ACTION REQUIRED: Your Legal Advisors to ask in writing specifically if there have been any problems with dampness coming through since the extension/alterations have been carried out. Please see our comments regarding the left hand parapet wall within the Executive Summary.

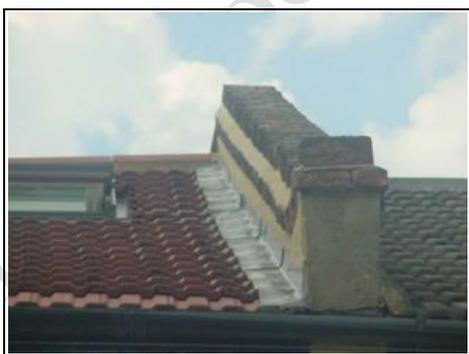
The main roof is pitched and clad with concrete nibbed tiles and, from ground level, this looks in average condition considering the roofs age type and style. This is with the exception of the tilting fillet to the edge of the roof. We cannot be certain if this is lacking completely or has been carried out poorly.

Poor tilting fillet detail to edge of the roof

ACTION REQUIRED: The main issue is the tilting fillet to the front which very little can be done about but it will mean the water can surcharge the gutter.

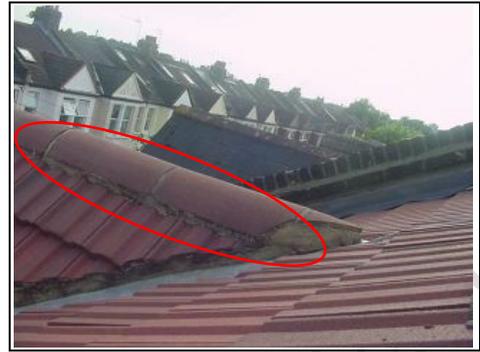
The roof ridge is poorly bedded.

Roof ridge tile is poorly bedded

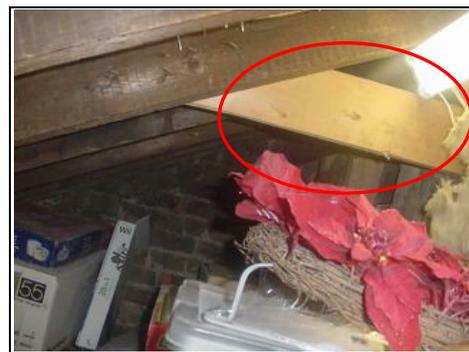
Our examination was limited by the general configuration of the roof, and the stored items. What we could see was generally found to be in average condition for its age, type and style. It is, however, feasible that there are problems in the roof that are hidden.

General view of inside of roof with new timbers added

ACTION REQUIRED: The only way to be 100 per cent certain is to have the roof cleared and checked.

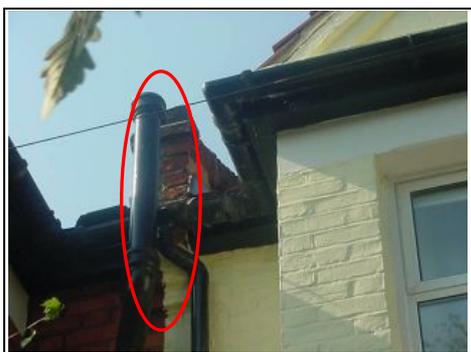
There is a cast iron soil and vent pipe to the front left of the property that does not appear to be in operation but possibly leads to a deep drain as we have not located any manholes.

Cast iron soil and vent pipe

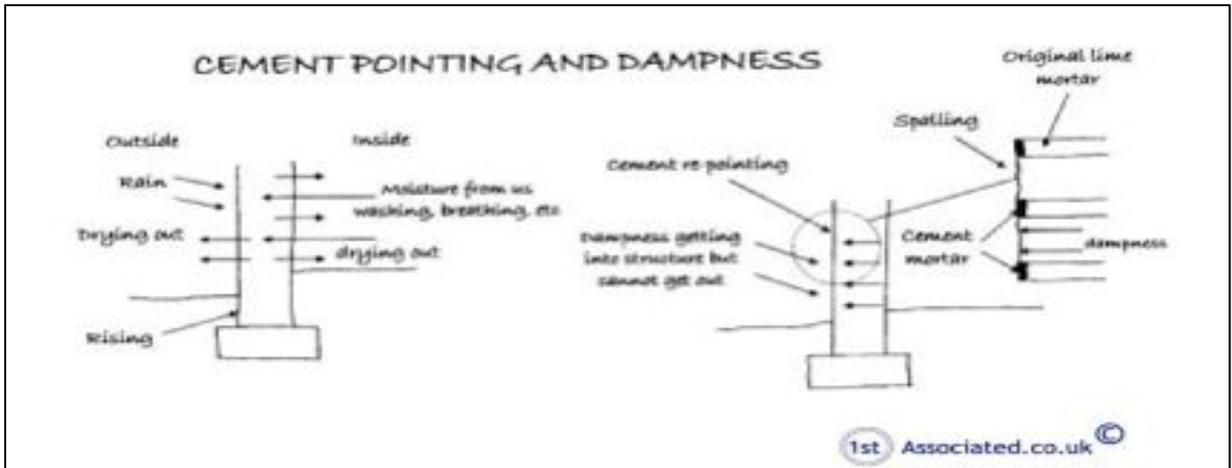
Unfortunately the cement re-pointing, whilst well meaning, is not appropriate for this type of older construction. This has been used instead of a lime based mortar. We recommend you use lime mortar in any future repairs regardless of what the builders say! Using lime mortar will limit further damage to the brickwork, which is almost impossible to repair successfully. We would add that many, if not most, of the properties that are re-pointed now are re-pointed

incorrectly; it is only in recent years that we have discovered the problems that can occur from it.

Older properties need to be able to breathe

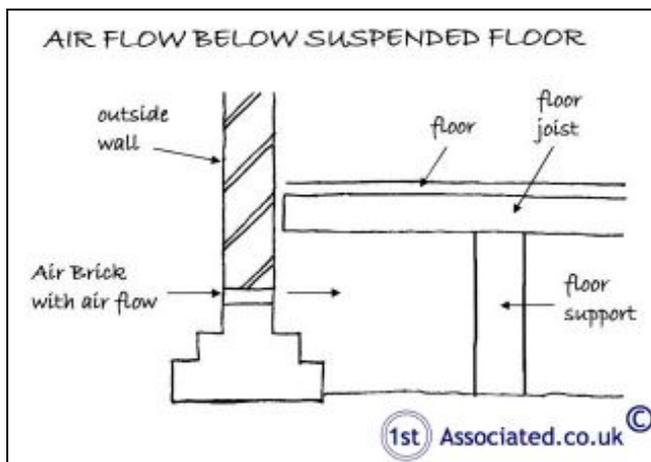
There are problems with the air bricks to the property. The property has a suspended timber floor, air bricks are essential to have a through flow of air as this helps to reduce the chances of wet rot, dry rot and woodworm.

Air brick

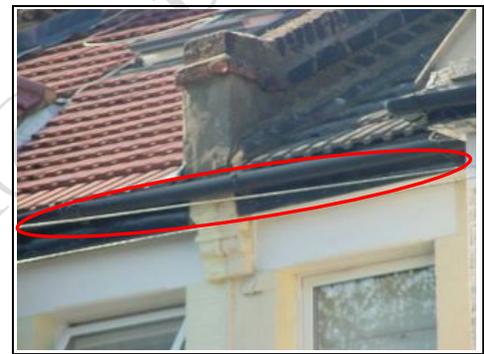
The fascias and soffits are timber. They are painted / stained and we would comment they are in average condition for their age, type and style.

Timber fascia

ACTION REQUIRED: Make sure gutters and downpipes are watertight before carrying out any work on fascias and soffits.

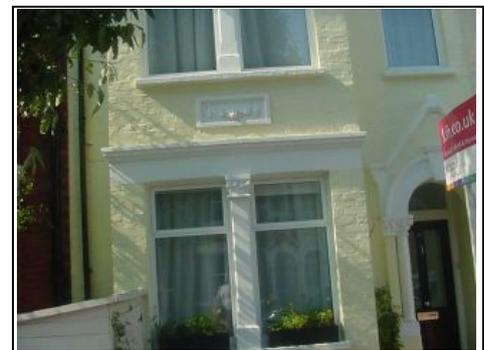
Double glazed windows without trickle vents

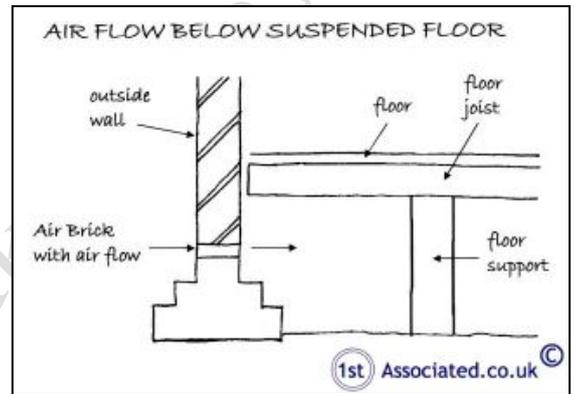
There is a suspended timber floor to the property which requires air movement underneath to minimise wet rot, dry rot and woodworm.

Suspended timber floor

ACTION REQUIRED: Please see our comments in the Executive Summary regarding air bricks.

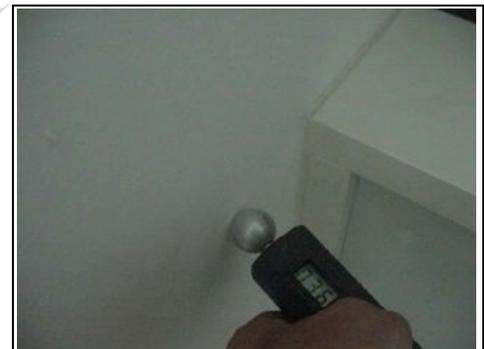
A random visual inspection and tests with a moisture meter have been taken to the perimeter walls. In this particular case we have found minor rising damp, although we expected to find higher readings. Our readings were limited as some of the property is dry lined.

Testing for rising damp

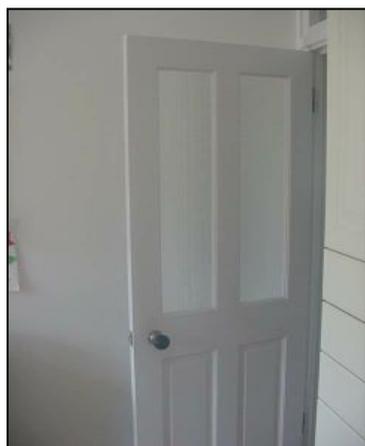
Glazed door to kitchen
without safety glass

ACTION REQUIRED: Please see our comments within the Executive Summary.

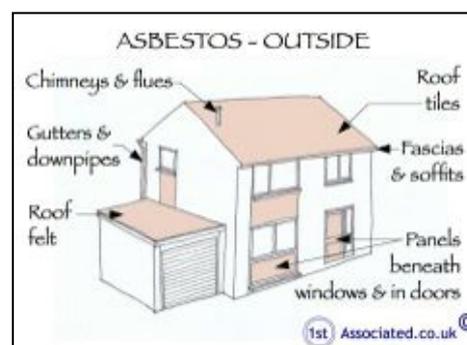
In a property of this age there may well be some asbestos as it was often used in refurbishments in the 1950's/1960's/1970's. In this case we have not noted asbestos. If Asbestos had been present it would have been removed during the last refurbishment.

Asbestos externally 73

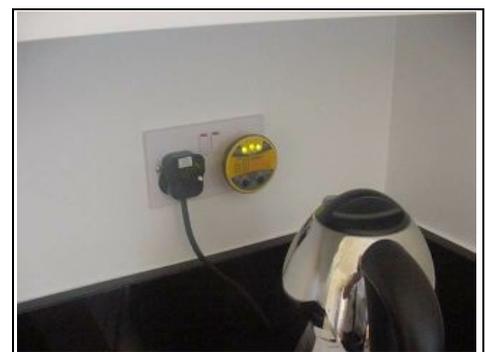
We carried out an earth test in the kitchen area to the socket point that is normally used for the kettle, this proved satisfactory.

Earth Test

ACTION REQUIRED: As the property is changing occupancy an Institute of Electrical Engineers (IEE) test and report should be carried out by a NICEIC registered and approved electrical contractor or equivalent and it is important to carry out any of recommended work.

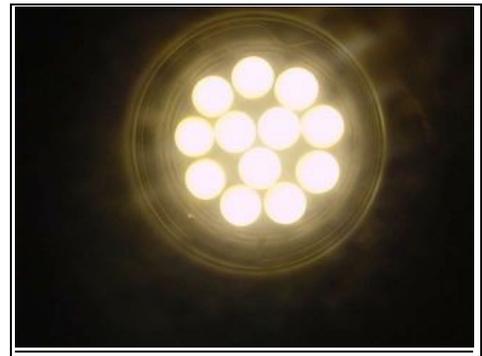
There used to be problems with the older ceiling lights allowing heat into the room above but as far as we aware LED lights are safer heat wise.

LED lights

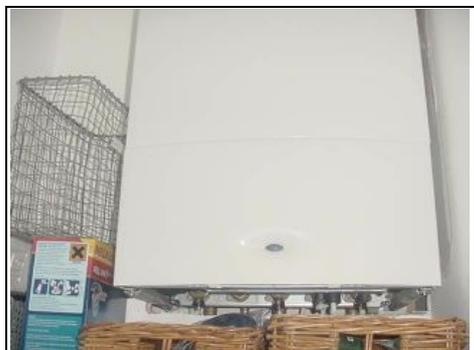
The wall mounted boiler was located under the stairs, it is manufactured by Worcester. There is an internal flue that appears to pass from the boiler under the stairs to the rear outside wall.

Wall mounted Worcester
Boiler

Our limited inspection of the hot water and central heating system revealed no evidence to suggest any serious defects but we would nevertheless recommend that the system be tested and overhauled before exchange of contracts and that a regular maintenance contract be placed with an approved heating engineer.

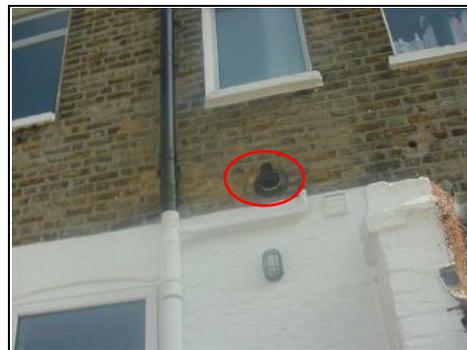
Boiler flue on outside wall

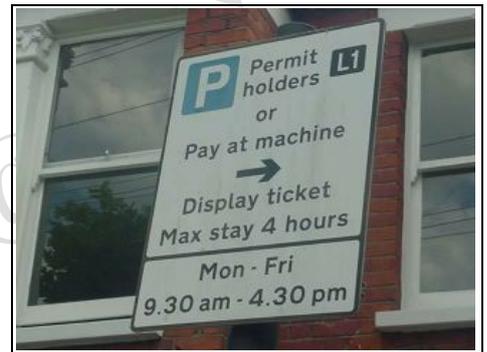
Parking permit sign

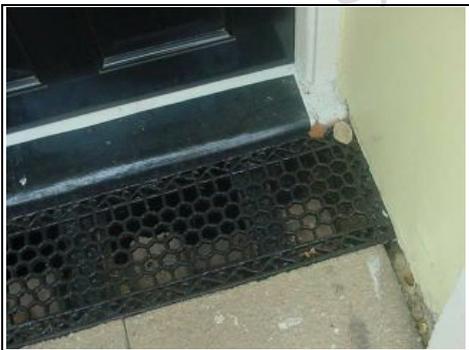
Grill in front of entrance door

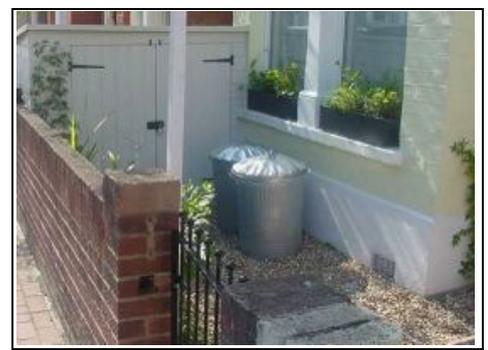
The property has a small front garden mainly laid with decorative aggregate and a pathway with a storage cupboard.

Front garden

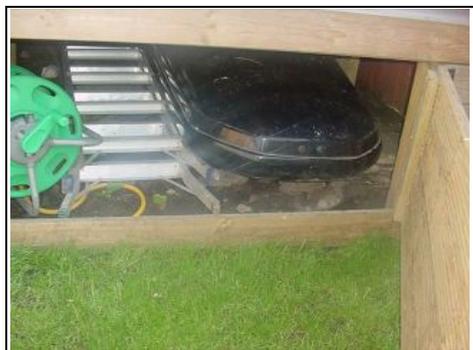
Storage space under decking

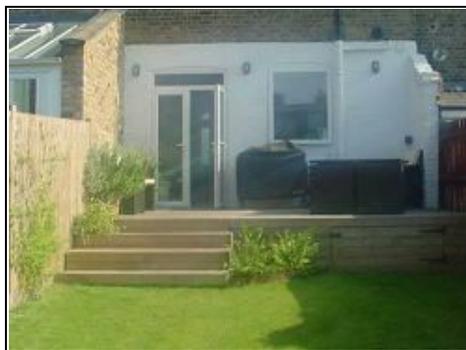
Patio/decking area

We are finding decking can become slippery over the years when not regularly maintained and can be an ideal space for wildlife to live under.

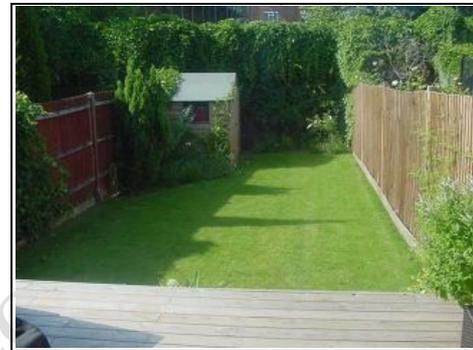
The garden to the rear of the property is mainly laid to lawn with a decking area that has storage built in.

Rear garden

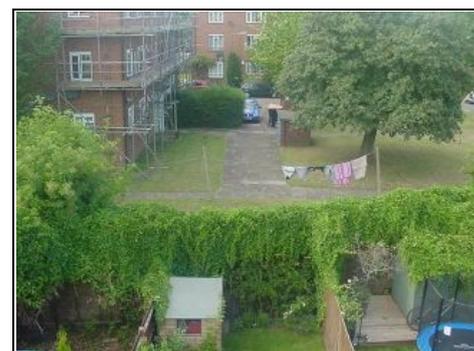
Flats overlook the garden to some extent to the rear
